COL-F25-W-4041

# Safe Passages for Wildlife in the Southern Canadian Rockies

2024-25 Final Report

**Prepared for:** Fish & Wildlife  
Compensation Program

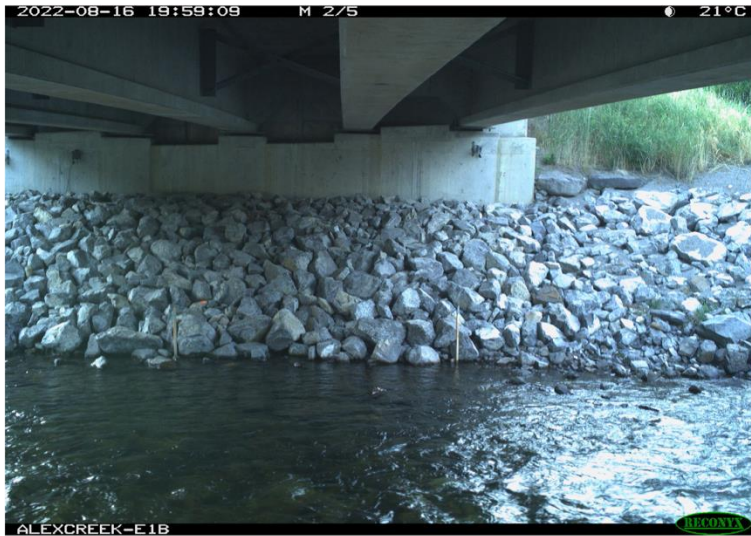
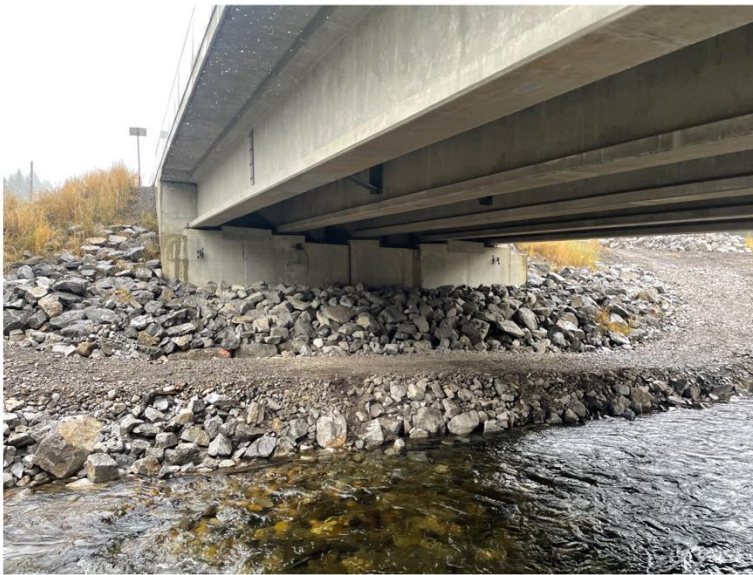
# Alexander Bridge

*Image 3. Example of an underpass retrofit at Alexander Bridge. Here a large open span bridge is in an ideal crossing location, but due to the rip rap right up to the creek there was limited opportunity for wildlife to cross under the bridge unless they went in the creek. While the creek is passable for some of the year, its is challenging to cross in the spring during high water, and during the winter when the creek is partially frozen. We engineered a solution that allowed a 1.5 m wildlife path through the rip rap while still protecting the infrastructure. In some high water years the smaller gravel from this path will be washed away but it can be replaced by hand when needed.*

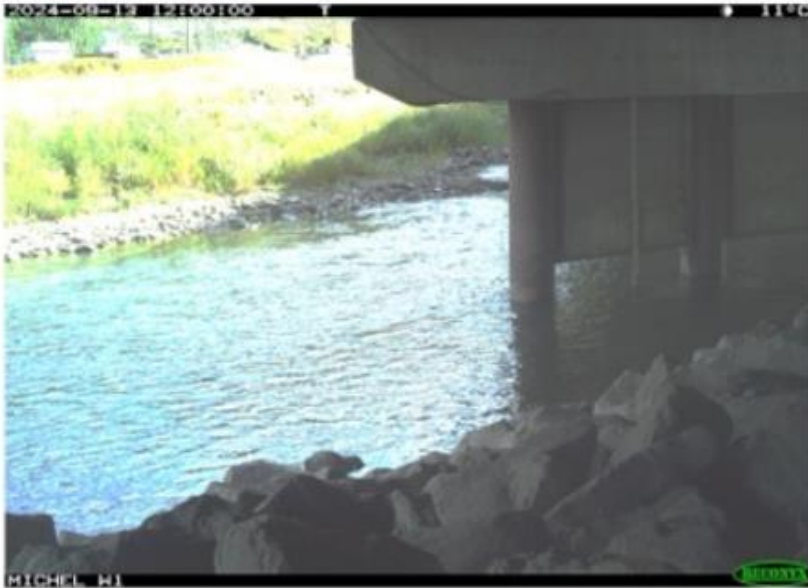
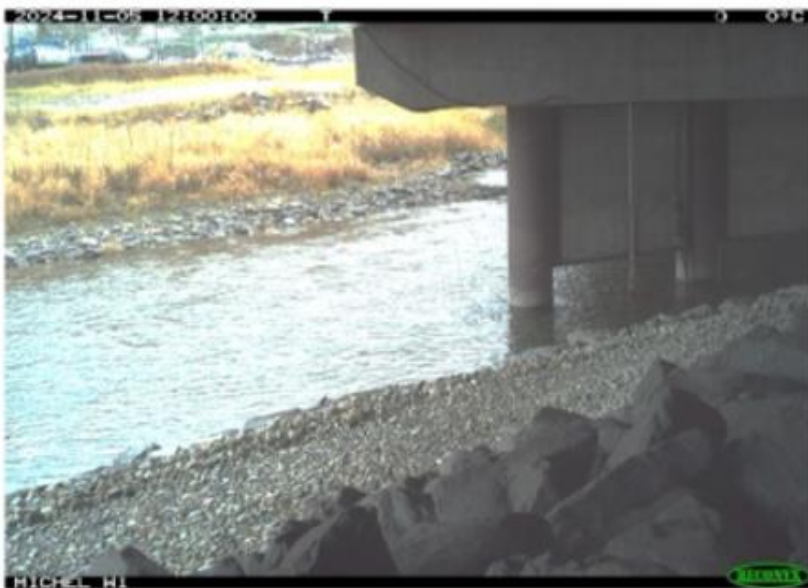
## Michel Bridge

*Image 4. Example of an underpass retrofit at Michel Mouth Bridge. A similar approach to Alexander Creek was used here, where a 1.5 m wide path was created through the large rip rap and filled with pea gravel to create a surface more amenable to wildlife use on both sides of the bridge.*

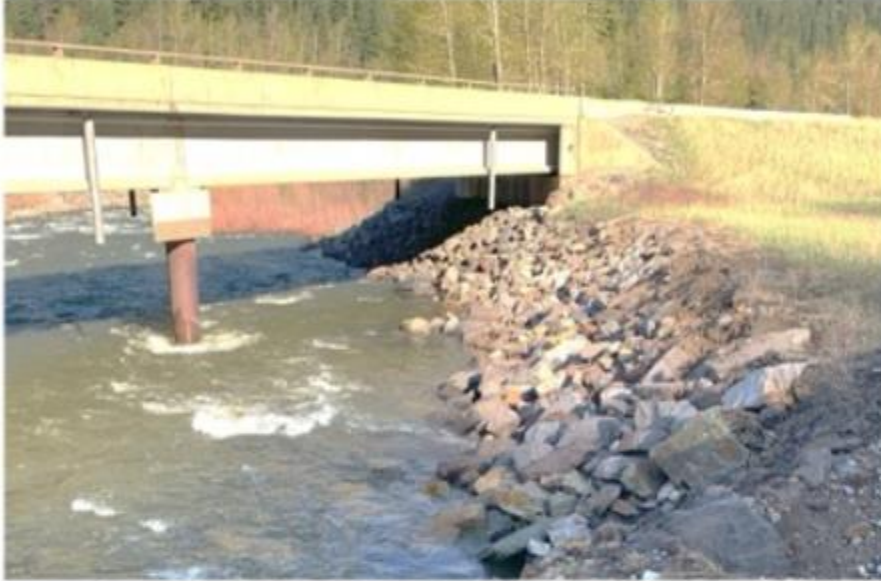
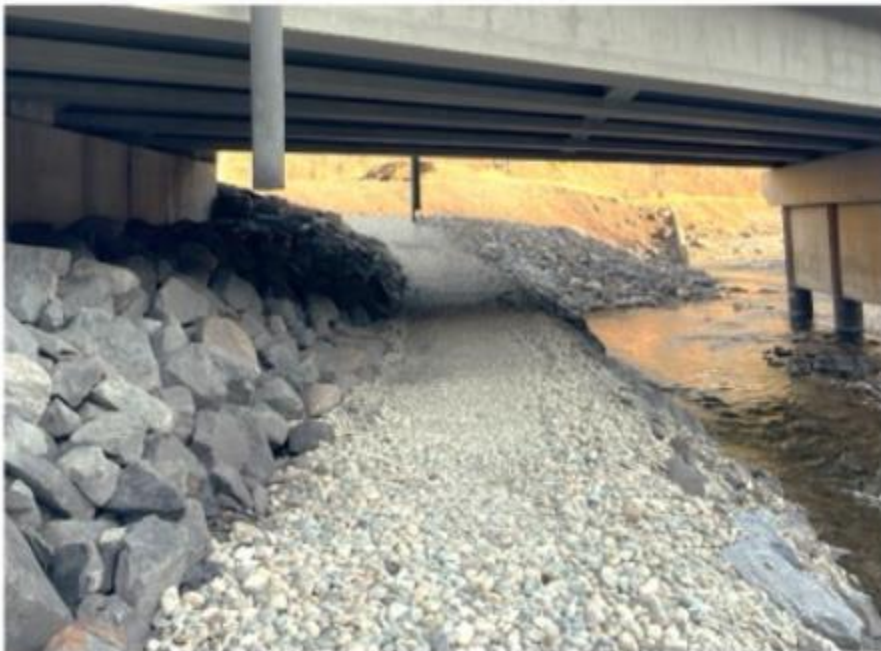
## Old Town Bridge

*Image 5. Example of an underpass retrofit at Old Town. A similar approach to Alexander Creek was used on the NW side of the bridge, where a 1.5 m wide path was created through the large rip rap and filled with pea gravel to create a surface more amenable to wildlife. The SE side of the bridge was already very open and serving as an underpass with no work needed.*

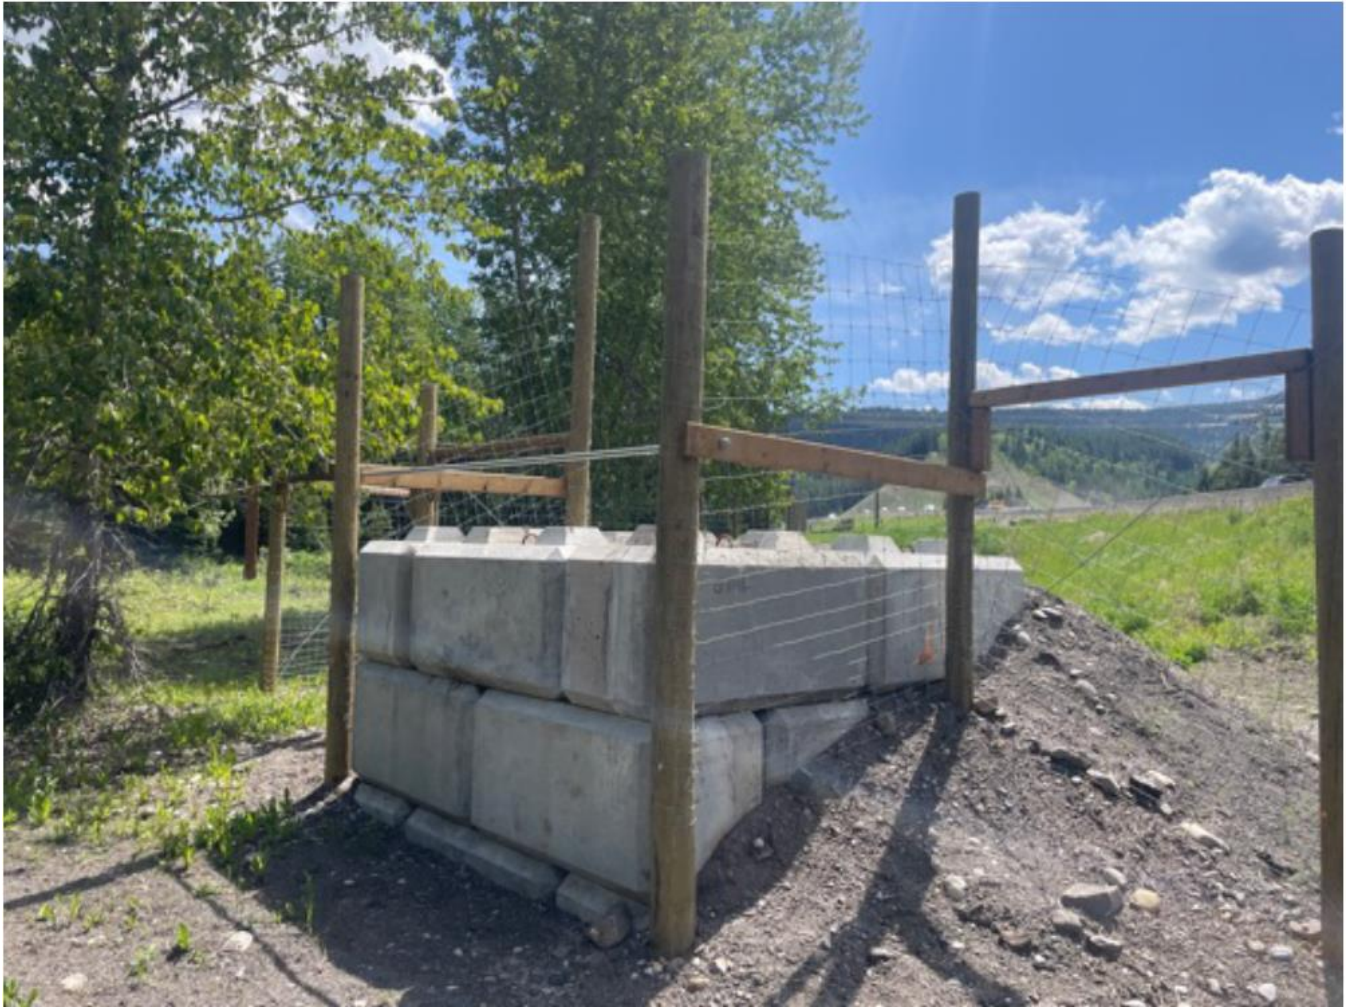
*Image 7. A jumpout along the Phase one fence. The jumpout was designed based on extensive testing from Arizona using elk, bighorn sheep, and deer (Gagnon et al. 2020). This design is simple and allows animals to safely exit the highway if needed, while precluding animals from jumping into the highway right of way in reverse. Where sheep are a concern the grooves between the blocks should be filled. The horizontal bar at 45 cm above the exit ramp reduces animals jumping back into the right of way.*

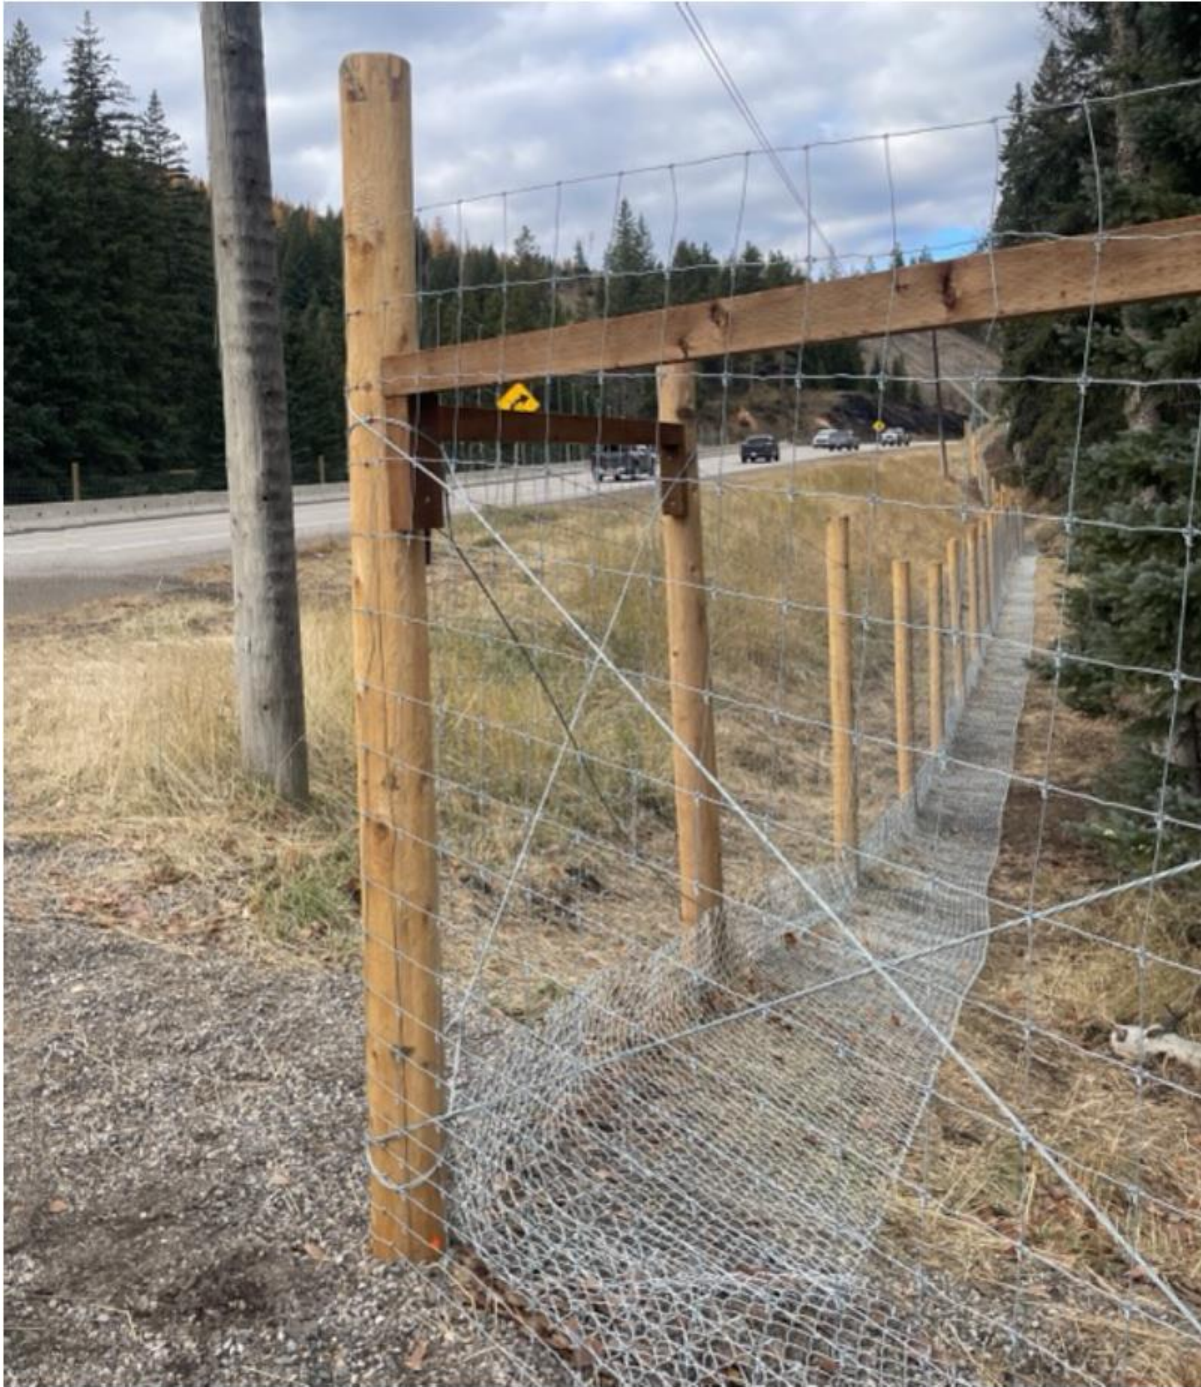
*Image 8. Phase two wildlife exclusion fencing between Carbon Bridge and Alexander Bridge. Chain link skirting to reduce animals digging under the fence shown at the bottom.*

Exclusion fencing is the heart of a wildlife collision reduction system. Excluding wildlife from the highway is the key to reducing collisions and ensuring effective delivery of the project. Weak points in the fence include the open ends, areas where animals can dig under the fence, ungulate guards, and jump outs. Fence ends will become increasingly less of a problem as the fence gets longer. We support MOTT's approach to whenever possible tie the fence ends into a bridge or similar structure, which will reduce wildlife breaching the exclusion area. All fencing needs to have protection from wildlife that may dig under the fence. Undulating terrain is typical along the project length and small gaps will emerge in the fence that animals can slip under or dig out. Canids (coyotes, foxes, and wolves) and Ursids (grizzly and black bears) are particularly adept at digging under. Ideally additional fencing is buried in the ground, as was done in Banff National Park as a strategy to reduce breaches onto the Highway. In many cases this may be cost prohibitive, or logistically challenging due to rocky ground etc. If additional fencing cannot be buried, we recommend attaching 6 ft chain link to the bottom of the wildlife fence and draping it along the ground. This will create at least a 5 ft barrier along the ground that will reduce risk of most animals from digging under. This draped chain link should be secured to the ground possibly with rip rap or ground stakes. These recommendations of attaching chain link to the bottom were used in the Phase 2 fencing completed in 2024.

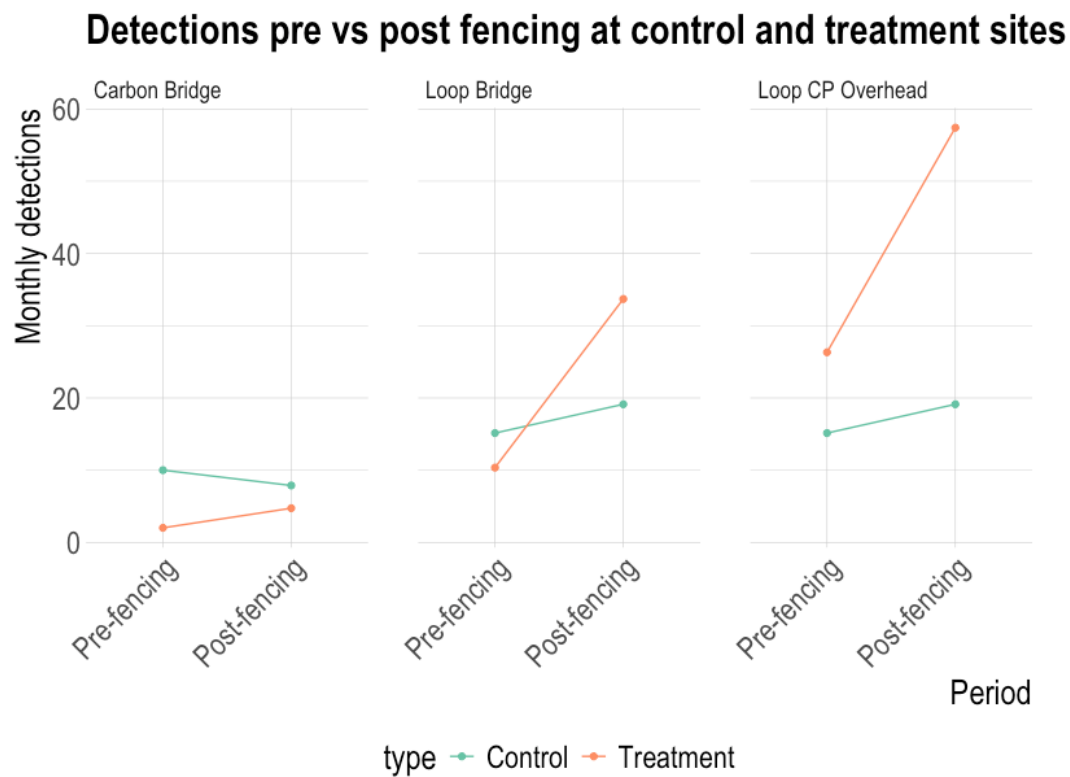
*Figure 11: Before-after-control-impact assessment of detection rate before and after fencing at treatment cameras under structures and control cameras adjacent to structure in forest*

We assessed monthly detection rates for structures within the Phase 1 fencing completed fall 2022. The before-after-control-impact design provided strong evidence that animals were dramatically increasing their use of the Carbon, Loop and Loop CP overhead structures following fencing (Figure 11). Carbon bridge, which is a small structure with limited potential as a crossing site due to low overhead dimensions, but even this structure saw a more than doubling in crossing rates post fencing. Compared to pre-fencing levels, wildlife detection rates increased post-fencing at the Carbon, Loop, and Loop CP overhead structures by 134%, 225% and 118%, respectively. Generally, most species increased their use of the structures following fencing, often exceeding detection rates found at control cameras (Figure 12). However, with only two years of data post fencing and some animals having low detection rates (0-3 detections per month) we are just starting to get a sense of how fencing is changing the use of these structures. Future years of monitoring on these sites and assessment of future phases will provide more robust insights.

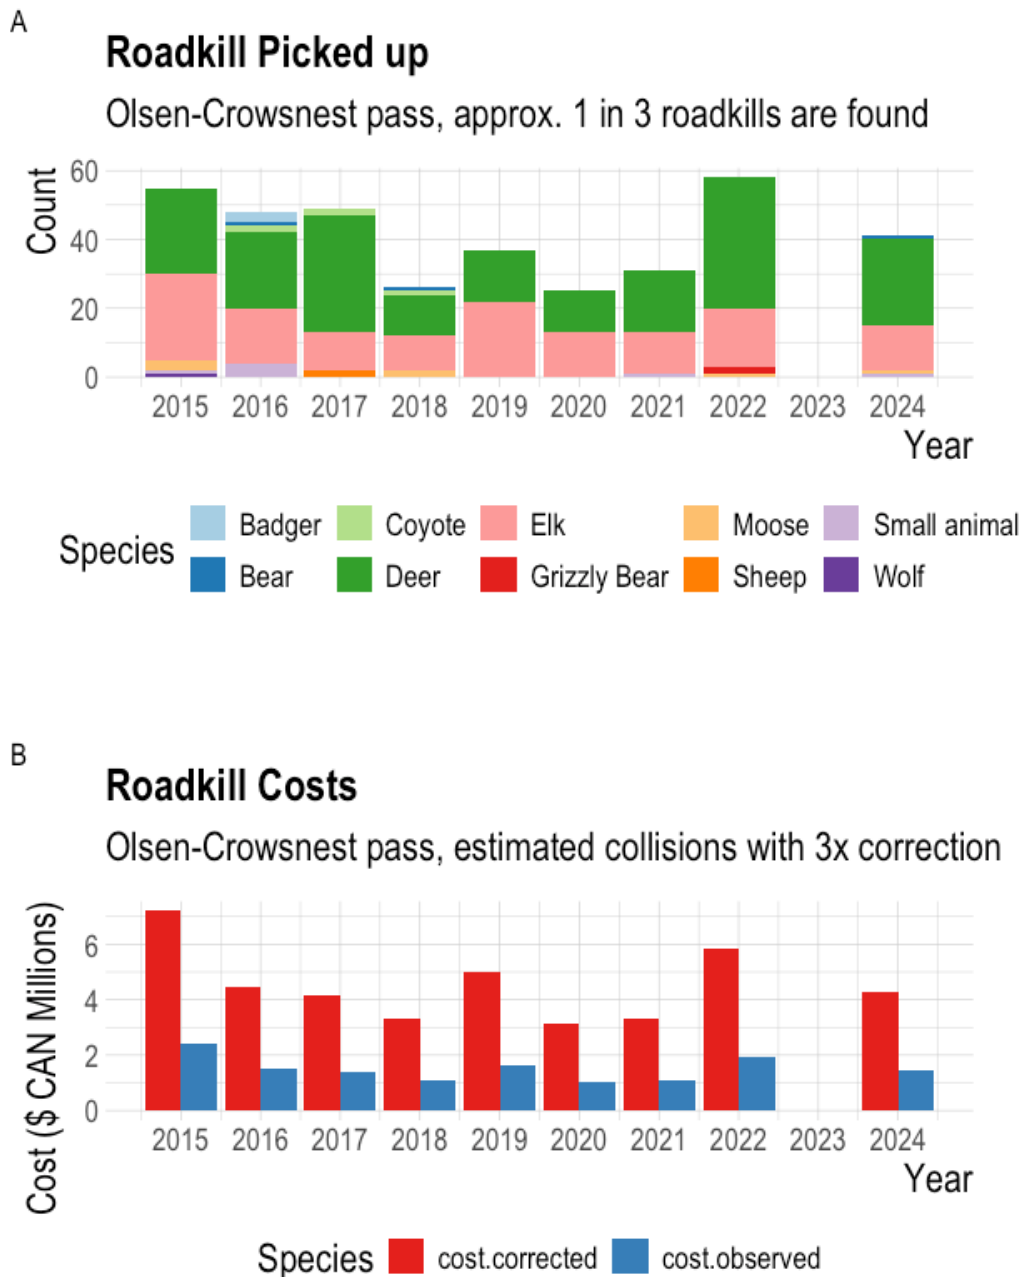
Figure 21: A) Number of roadkill detected along the project length per year. These counts are uncorrected for roadkill that are known to be missed in these data, and B) estimated cost of these collisions to society. Corrected costs account for unreported roadkill. Studies on collared elk, grizzly bear, and roadside surveys have indicated that only ~1 in 3 roadkill are reported. Grey shading shown over 2023 as data for this year are currently being checked for accuracy and cleaned by MOTT due to expected missing records.

We assessed the number of roadkill annually detected along the project length, which we then used in conjunction with Table 1 to estimate the cost of wildlife-vehicle collisions to society (Figure 21). On average, 41 roadkill are reported each year, and this may be as high as 123 after accounting for roadkill not detected. Wildlife-vehicle collisions in our study area are estimated to cost society at least an estimated \$1.5 million, but the cost could be as high as \$4.5 million after accounted for undetected roadkill. We confirmed that the RTR:BC focal area is a hotspot for wildlife-vehicle collisions (Figure 22). The RTR:BC project area has the highest rate of wildlife-vehicle collisions for a highway traversing the Rocky Mountains in Southeast BC (including Highways 43 and 93). We note that areas of high wildlife-vehicle collision intensity do occur outside the mountains in the Rocky Mountain Trench near Jaffray and could be the focus of future work.

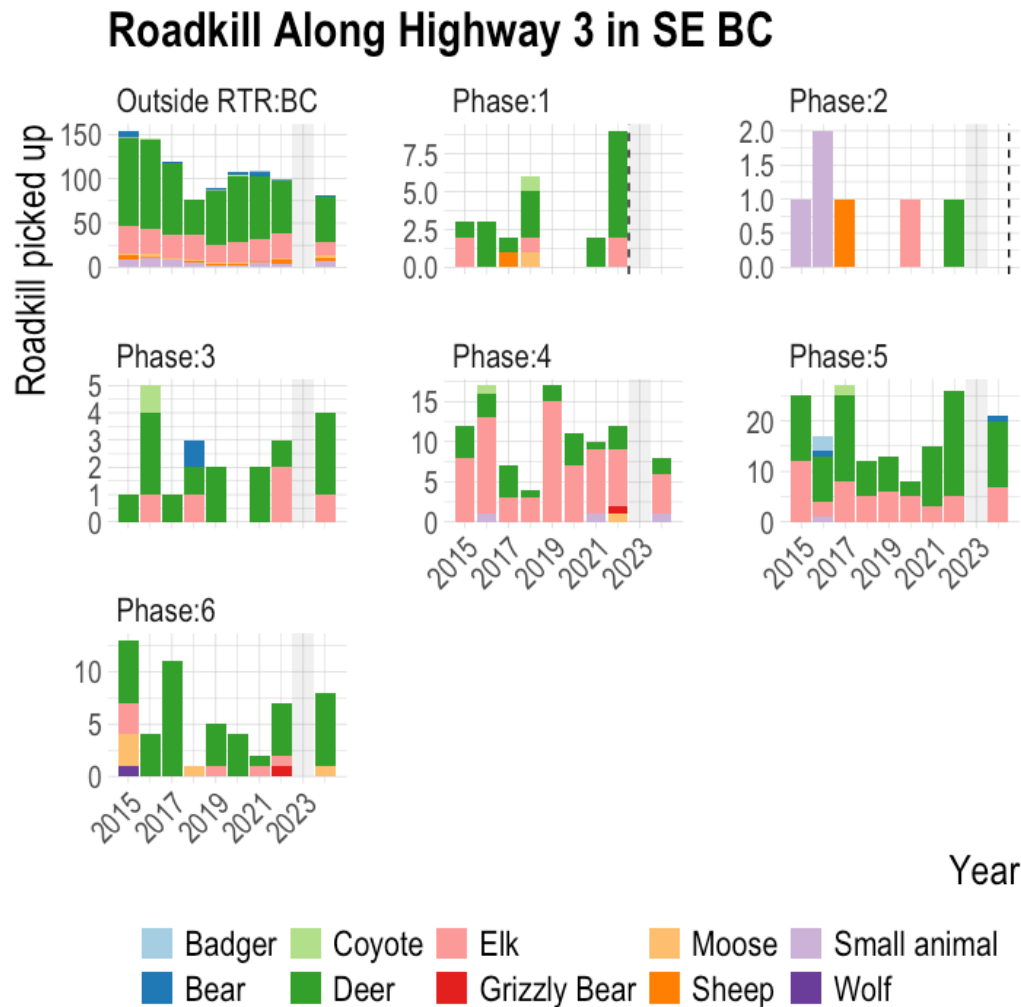
*Figure 23: Number of roadkill picked up along Highway 3 between Jaffray and AB Border per year, broken up by RTR:BC phases. 2023 (greyed out) as MOTT is still working to remedy some data issues. Dashed line indicates when fencing was installed in each phase. Studies on collared elk, grizzly bear, and roadside surveys have indicated that only 1 in 3 roadkill are reported.*

We assessed the influence of fencing along Phase 1 in reducing wildlife collisions (Figure 23). Phase 2 fencing was completed in Nov 2024 so it's currently too early to assess collision reductions in this section. Based on the data we had access to, the rate of collisions appears to have dropped in the Phase 1 section compared to the pre-fencing period (2015-2022). A few caveats are required for the Phase 1 interpretation, including 1) the "after" period is based solely off 2024 data, as 2023 has data quality issues which are actively being worked on by MOTT, and 2) it is known that some animals have been hit inside the Phase 1 section post fencing. They

presumably do not show up here either due to these animals not being picked up by the highway contractor, occurring only in 2023 and part of the missing data, or data quality issues such as reporting issues or spatial accuracy of pick up locations. The degree of roadkill reduction from completed project phases will become more robust as additional phases are completed, more post-fencing years accumulate, and the roadkill data error checking is completed by MOTT.
