SOCIETY FOR ECOSYSTEM RESTORATION  
IN NORTHERN BRITISH COLUMBIA

## Restoring Fish Passage in the Peace Region - 2024

Prepared for  
Fish and Wildlife Compensation Program  
and  
Fish Passage Technical Working Group

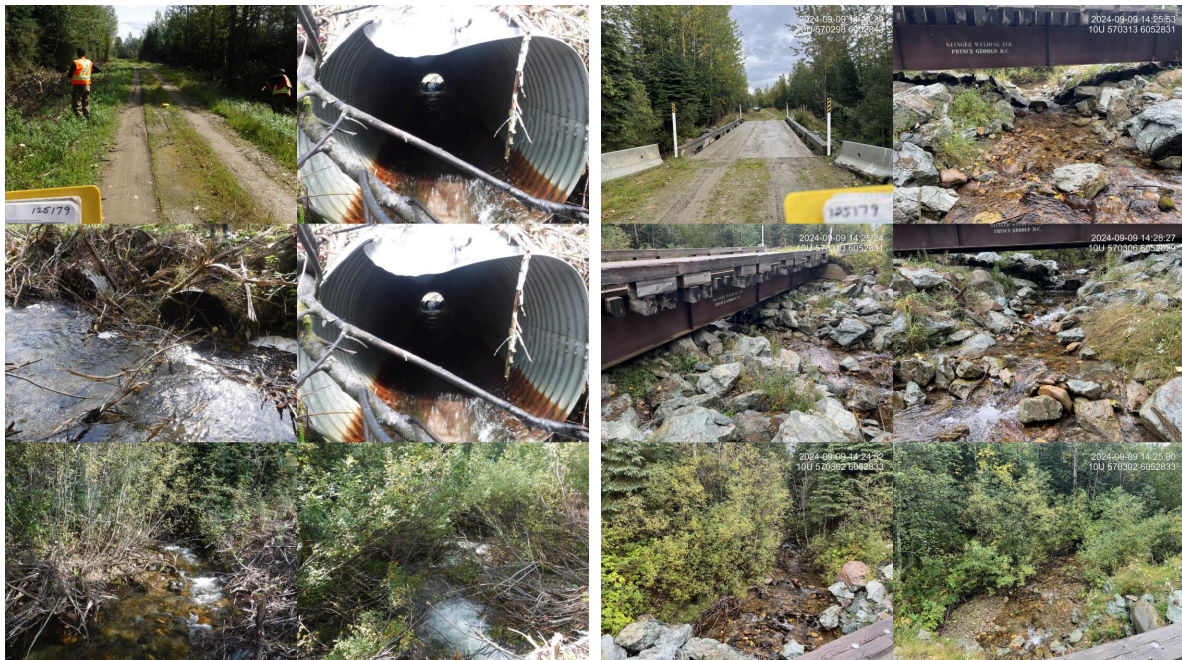
Figure 5.2: Left: Photos of crossing 125179 in 2019. Right: Photos of crossing 125179 in 2024.

variable	value
Pscis Crossing Id	125179
Stream Name	Tributary to Missinka River
Road Name	Chuchinka-Missinka FSR
Crossing Subtype	BRIDGE
Span	15
Width	4.8
Assessment Comment	Monitoring visit conducted. Electrofishing was performed upstream and downstream, with all fish >60mm tagged. See camera roll for additional photos.  Recommend bringing old photos as a reference to recreate photo angles and shutter length.
Dewatering Notes	No dewatering
Velocity Notes	Velocity was higher under the bridge than both upstream and downstream due to channel constriction from riprap.
Constriction Notes	Channel width measurements beneath the structure within the road right-of-way were 2.9m, 3.5m, and 2.5m, which were narrower than the typical channel width observed both upstream and downstream, as noted on the fish site cards.
Substrate Notes	A significant amount of riprap material was present within the channel in the road right-of-way. Occasional pieces of riprap were functioning to create step-pool habitat downstream. Overall, the substrate under the structure was slightly larger than that observed both upstream and downstream.

Riparian Notes	There did not appear to have been any riparian planting conducted during construction, with only herbaceous regrowth observed, including grasses and fireweed. The site could have been planted with willow whips to provide cover and food.
Flow Depth Notes	Flow depth was comparable to sections downstream, with measured depths ranging from 5–20cm. At the observed flow levels during the survey, migration was not likely hindered.
Stability Notes	The structure and extensive rock riprap appeared fully stable, with no evidence of slumping or instability.
Revegetation Notes	As noted in the riparian section, the construction footprint was vegetated primarily with herbaceous plants where rock was not present.

variable	value
Cover Notes	Due to the extensive rock placement within the construction footprint, there was no overhanging vegetation cover. However, occasional pieces of riprap and boulder lines within the channel provided some boulder and step-pool habitat. The larger substrate was providing fish habitat, as observed during electrofishing.
Maintenance Notes	It appears that no maintenance is required at this time.

through coordination from SERNbc. Effectiveness monitoring at the site was conducted in 2024 with the structure in stable condition with no maintenance required at the time of reporting. Lessons learned from the work - to be leveraged towards future projects - include reducing the amount of riprap material placed within the bankfull channel width and replanting of areas where riparian vegetation is removed during construction. This crossing serves as an example of a successful replacement, and the lessons learned through its implementation can help build stakeholder confidence in advancing additional fish passage remediation projects.

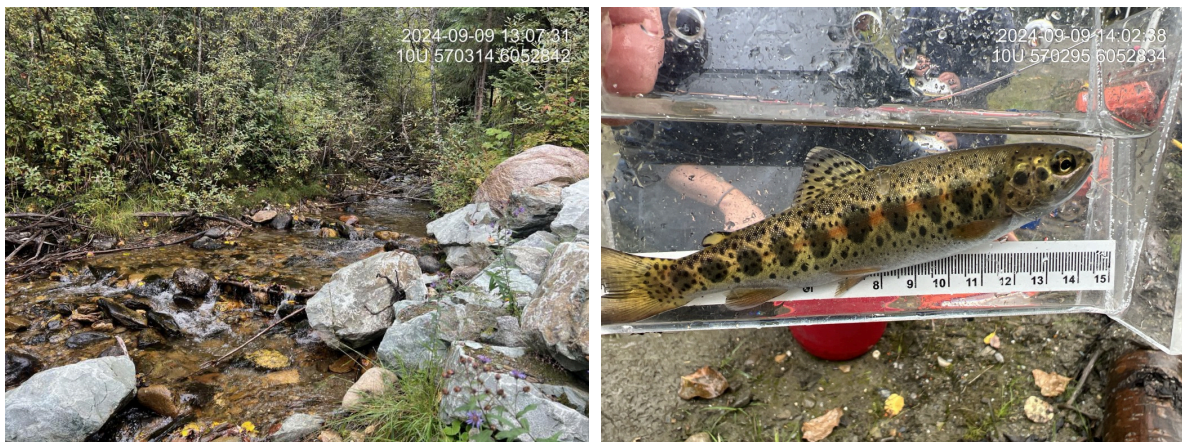
Figure 5.3: Left: Typical habitat electrofished upstream of PSCIS crossing 125179. Right: Rainbow trout captured upstream of PSCIS crossing 125179.

As per recommendations in Irvine (2020) and Irvine and Winterscheidt (2023) - to provide reference site data for comparison, electrofishing was conducted not only at the site of the remediation (PSCIS 125179) - but also at PSCIS crossing 125180, a similarly sized culverted stream - located approximately 660m east of the subject crossing (Irvine and Winterscheidt 2023; Irvine 2020). Another site (PSCIS crossing 125186) was also scoped as a potential reference site - however the stream was almost completely dry in 2024 (with the exception of the outlet pool and intermittent shallow pool sections).

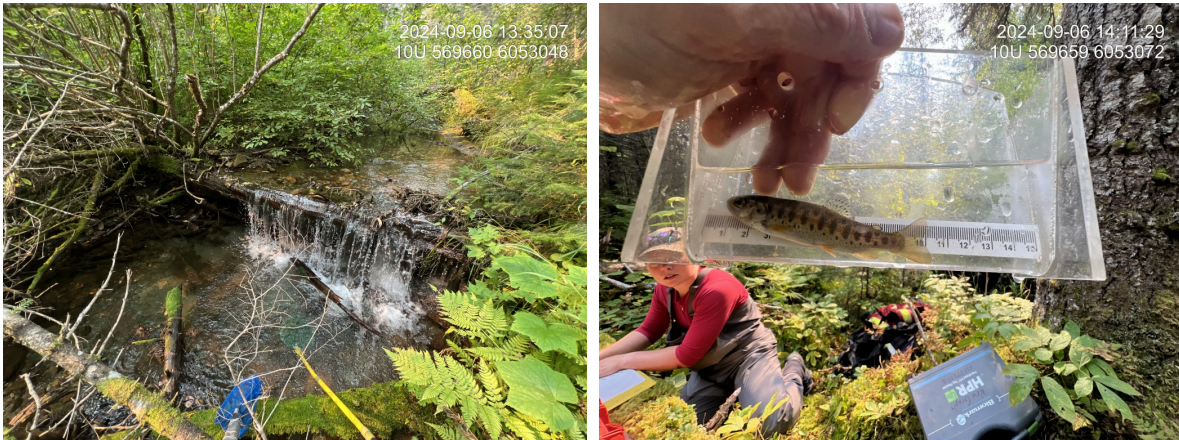
Figure 5.4: Left: Typical habitat electrofished upstream of PSCIS crossing 125180. Right: Rainbow trout captured upstream of PSCIS crossing 125180.

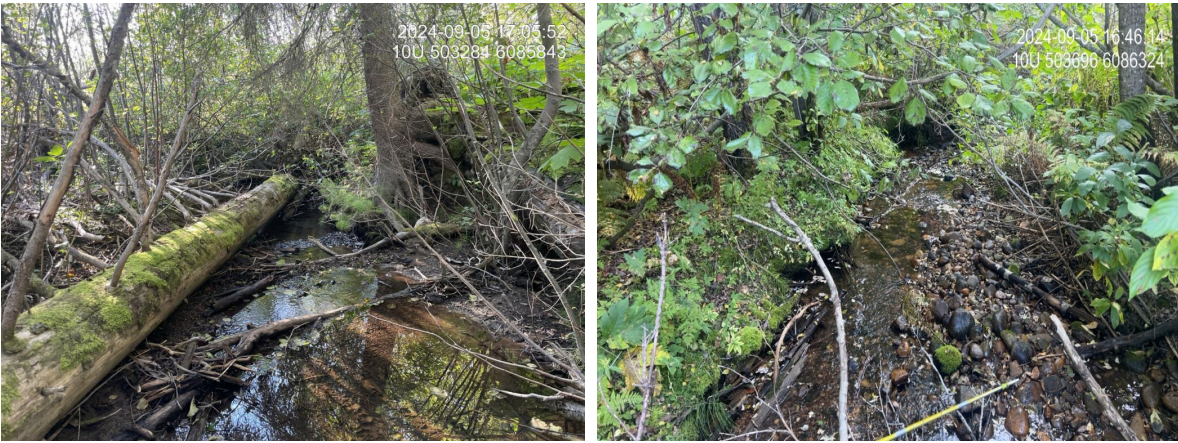
The stream was surveyed downstream from crossing 198669 for 250m , to the confluence with McLeod Lake. The stream had frequent pools, good cover, and abundant gravels, providing medium value habitat for overwintering and spawning fish. Beaver activity was visible and fish were observed the entire length of the survey (Figure 5.5). The dominant substrate was cobbles with gravels sub-dominant. Total cover amount was rated as abundant with undercut banks dominant. Cover was also present as small woody debris, large woody debris, deep pools, and overhanging vegetation. The average channel width was 3.4m, the average wetted width was 1.5m, and the average gradient was 1.6%.

The stream was surveyed upstream from crossing 198669 for 550m (Figure 5.5). Abundant gravels were present throughout the lower section, providing suitable spawning habitat. Near the powerline corridor, substrate composition transitioned to predominantly fines. Approximately 100m upstream of the transmission line, a 1.2m high beaver dam created a backwatered area. Numerous fish, ranging from 40-120mm, were observed throughout the surveyed section up to the beaver dam. Upstream of the impounded area, the stream returned to predominantly gravel substrates with frequent pools up to 40cm deep. The average channel width was 3.7m, the average wetted width was 2.4m, and the average gradient was 2.5%. The dominant substrate was gravels with fines sub-dominant. Total cover amount was rated as moderate with undercut banks dominant. Cover was also present as small woody debris, large woody debris, deep pools, and overhanging vegetation. The habitat was rated as medium value for salmonid spawning and rearing.

Figure 5.5: Left: Typical habitat downstream of PSCIS crossing 198669. Right: Typical habitat upstream of PSCIS crossing 198669.

Should restoration/maintenance activities proceed, replacement of the Hart Highway crossing with a bridge (4.5 m span) is recommended. At the time of reporting in 2025, the cost of the work is estimated at \$ 1,500,000.

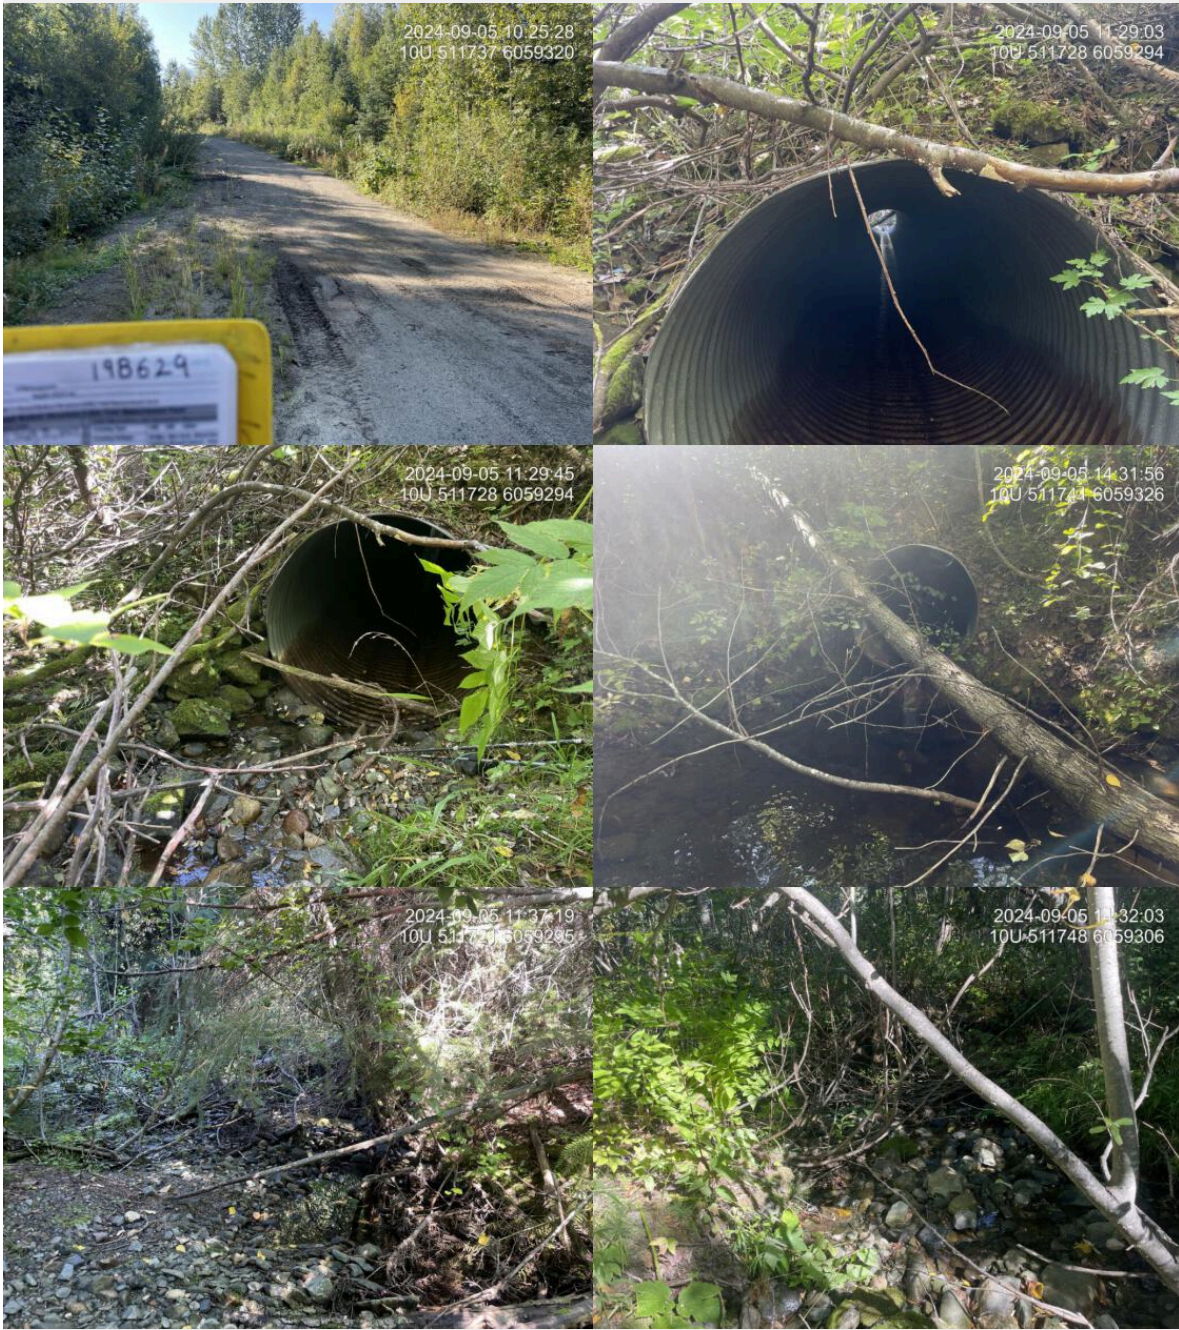
Photos: From top left clockwise: Road/Site Card, Barrel, Outlet, Downstream, Upstream, Inlet.

Comments: Rainbow trout juveniles and adults (40-120mm in fork length) were captured with electrofishing within sites located 50m upstream and downstream of the Kerry Lake FSR. Fish were also observed in the outlet pool and upstream of the FSR crossing. There was beaver activity near the inlet and a large outlet drop. Upstream gravels provide suitable spawning habitat for resident fish, with good riparian vegetation supporting overall habitat quality.. 11:12:52

If there are no plans for further logging in the area, removing the crossing and deactivating the road should be considered as a fish passage remediation option. If logging activities are planned to continue and restoration/maintenance activities proceed, replacement of the Kerry Lake FSR

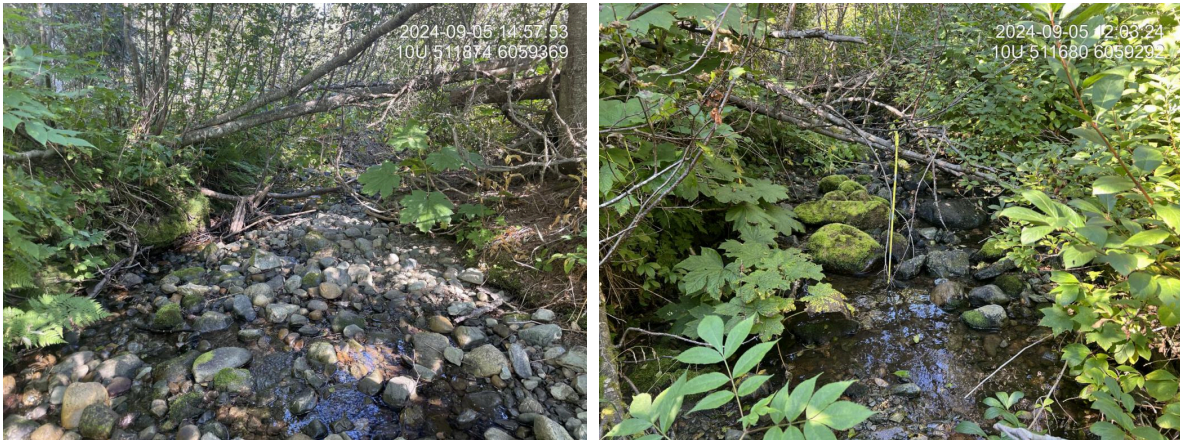
The stream was surveyed downstream from crossing 198692 for 230m . Frequent deep pools provided cover for resident fish and gravels were present for spawning. The habitat was rated as medium value for anandromous spawning and rearing (Figure [5.7](#)). The stream frequently flowed subsurface beginning around 200m downstream of the crossing. Total cover amount was rated as abundant with large woody debris dominant. Cover was also present as small woody debris, undercut banks, deep pools, and overhanging vegetation. The dominant substrate was cobbles with gravels sub-dominant. The average channel width was 3.0m, the average wetted width was 1.4m, and the average gradient was 2.5%.

The stream was surveyed upstream from crossing 198692 for 500m . The stream was noted as having significant flow for the time of year. The habitat was rated as medium value, with patches of gravel suitable for spawning resident rainbow trout and bull trout present (Figure [5.7](#)). The stream narrowed into a canyon approximately 150m upstream of Kerry FSR (Figure [5.8](#)). The dominant substrate was cobbles with gravels sub-dominant. Total cover amount was rated as abundant with undercut banks dominant. Cover was also present as small woody debris, large woody debris, deep pools, and overhanging vegetation. The average channel width was 4m, the average wetted width was 1.5m, and the average gradient was 5%.

Figure 5.7: Left: Typical habitat downstream of PSCIS crossing 198692. Right: Typical habitat upstream of PSCIS crossing 198692.

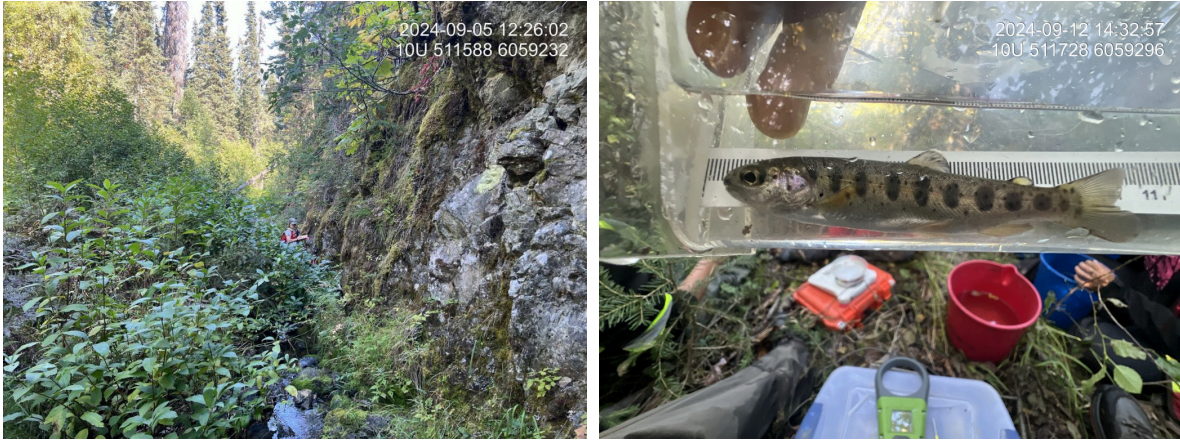
Figure 5.8: Left: Canyon located approximately 150m upstream of PSCIS crossing 198692. Right: Rainbow trout captured upstream of PSCIS crossing 198692.
