Alouette Watershed Community Connections Project

COA-F25-F-4086

Prepared for Fish and Wildlife Compensation Program

FINAL - 8 AUGUST 2025

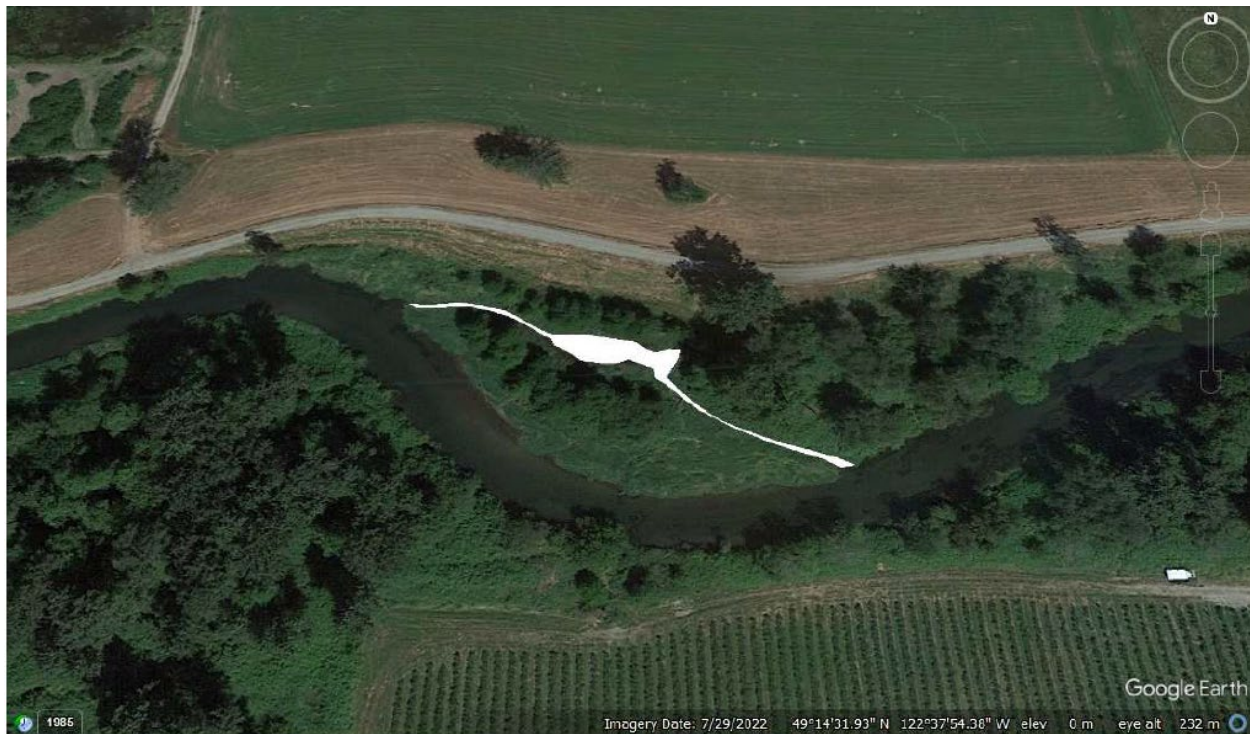
Figure 2 Trethewey Channel, Maple Ridge, B.C.

The project site is located as off channel salmon habitat along the South Alouette River. It is located on a private property in which deeded ownership includes both opposing riverbanks and the channel of the river, as was custom in old land grants on the Alouette. The land is owned by the Trethewey’s and is managed under the name of “Coniagas Ranches”. The original project was a partnership between Alouette River Management Society (ARMS), Department of Fisheries and Oceans Canada (DFO), and a private landowner in Maple Ridge, BC, with the financial support of BC Hydro Bridge Coastal Fish and Wildlife Restoration Program.

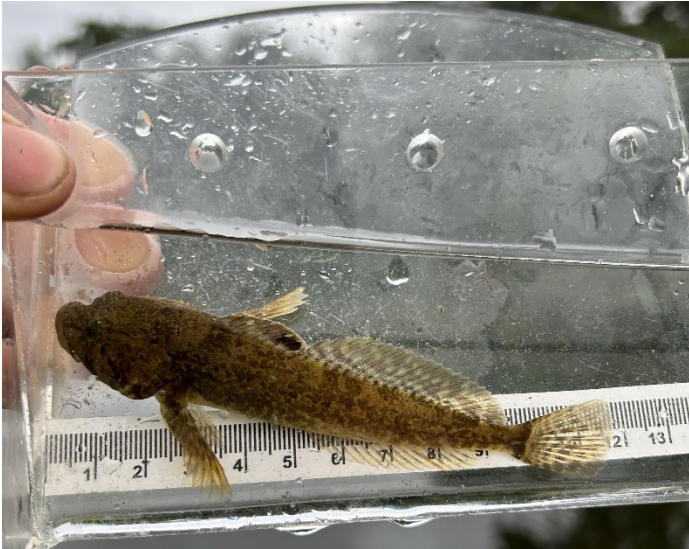
During the initial seine net and exclusion fences, the Fisheries and Ocean staff found the following invasive species in the Channel:

Figure 3 Sculpin

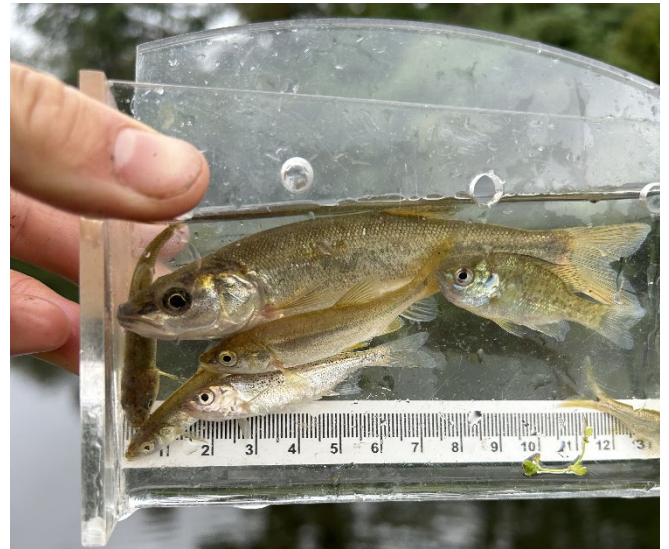
Figure 4 Pike minnows

The number of each species was not recorded, and all the invasive species were not returned to the river.

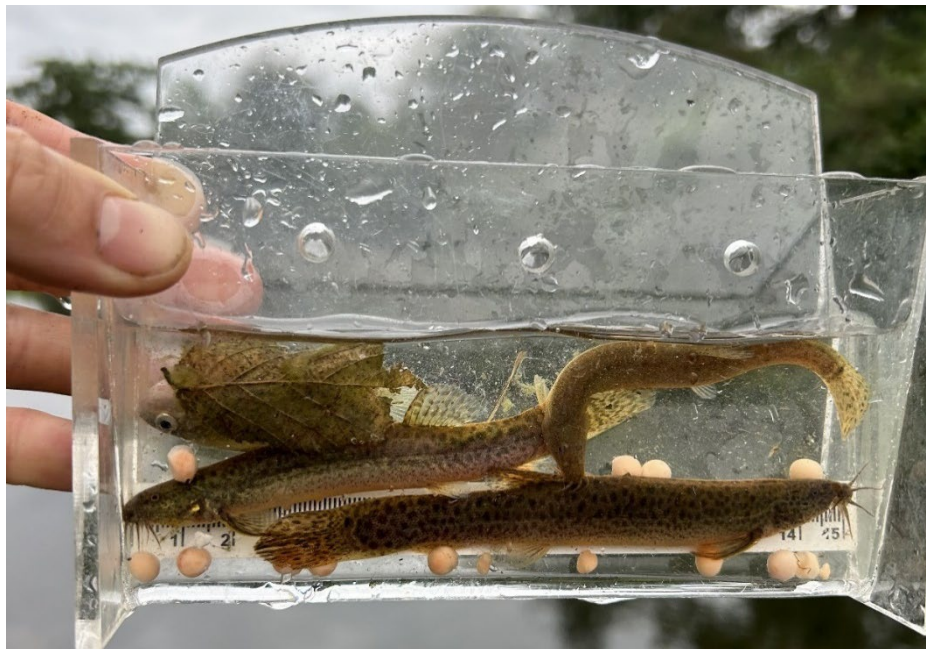
Figure 5 Weather loaches

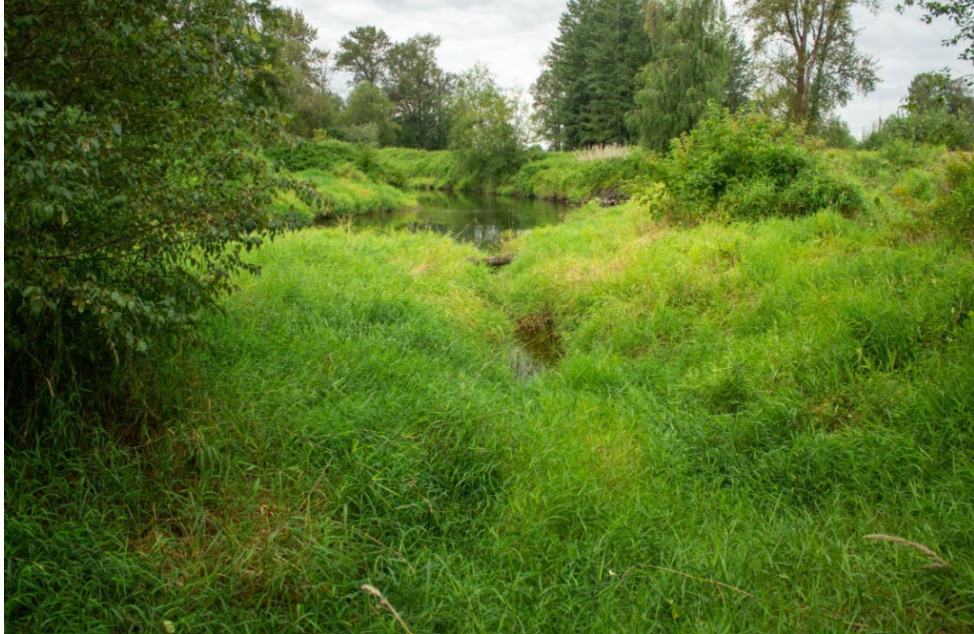
Prior to restoration, the upstream channel was completely sealed off from the Alouette River due to sediment buildup and dense reed canary grass, while the downstream channel had very limited access for juvenile salmonids.

Figure 6 Before - Trethewey Channel (downstream) choked with reed canary grass

Our efforts significantly improved connectivity and habitat conditions by removing excess sediment and invasive reed canary grass and replanting affected areas with native vegetation. However, we were unable to remove or treat the Japanese knotweed at this time due to its proximity to the water, as herbicide treatment was not an option.

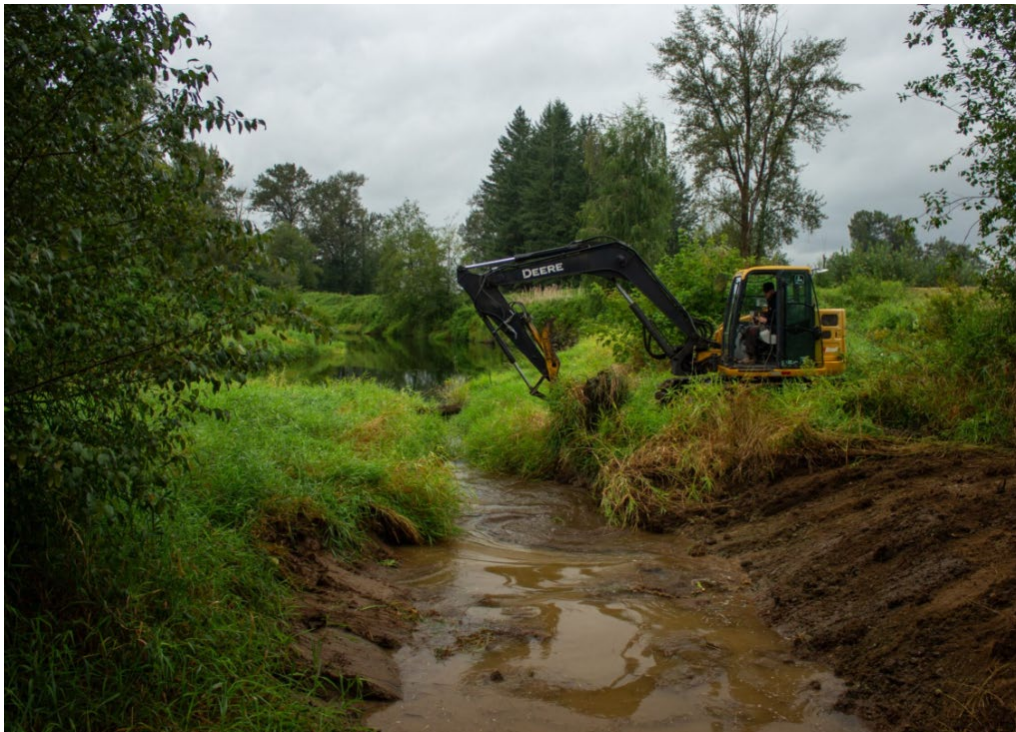
Figure 7 After - Longreach excavator in Trethewey Channel

For continued optimization of the work completed, we recommend that a long reach excavator be brought in for future work at this site due to mid-pond distance from streambank which we found difficult to reach with the equipment that was used during the project work this time around. There would be benefits to the ponded area with the addition of secured woody debris installations before the next storm season in 2025 if possible.

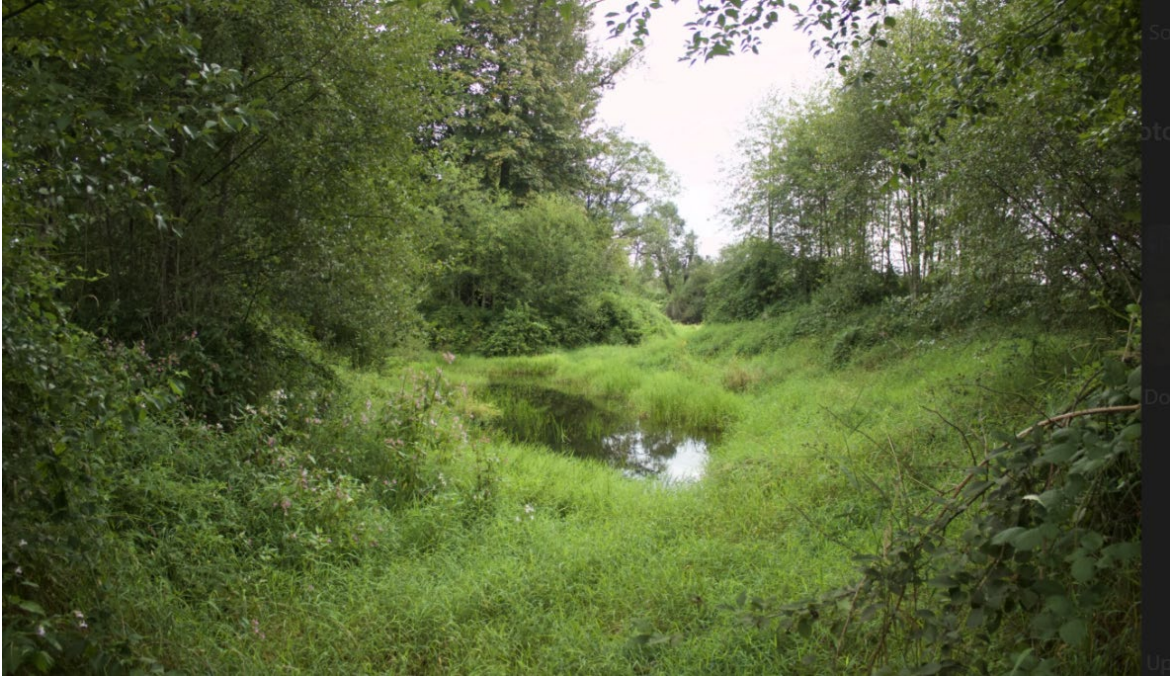
Figure 8 Upstream portion of Trethewey Channel - before

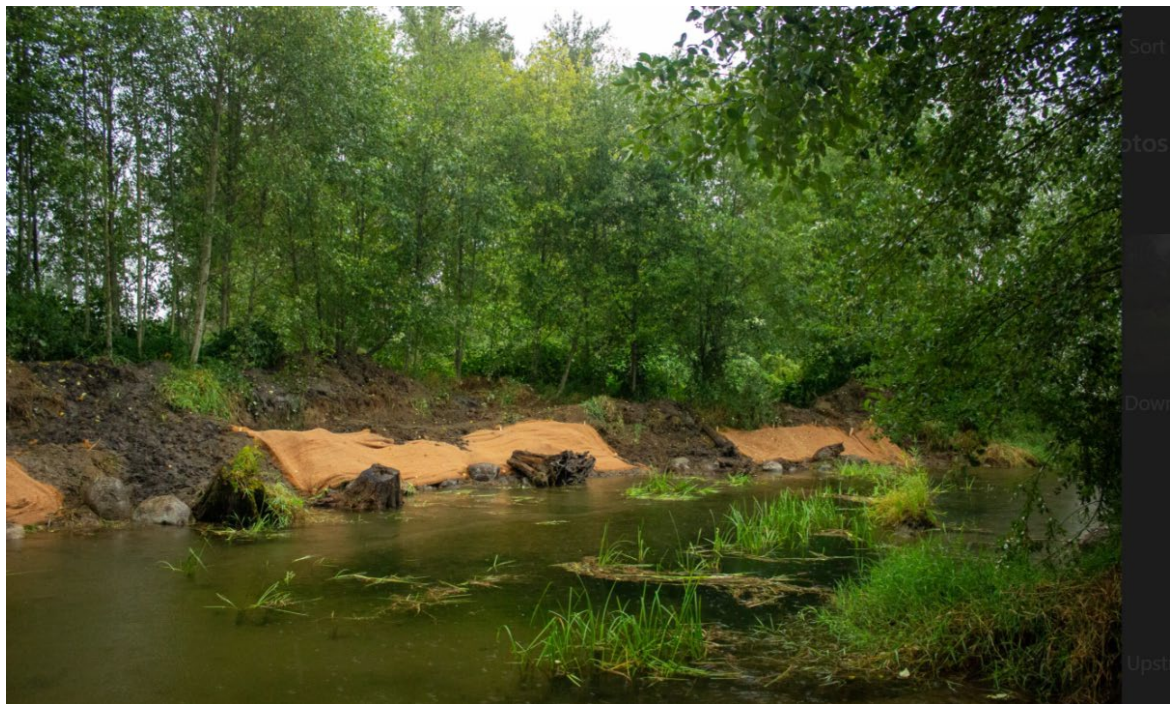
Figure 9 Pond section of Trethewey Channel with burlap coconut matting

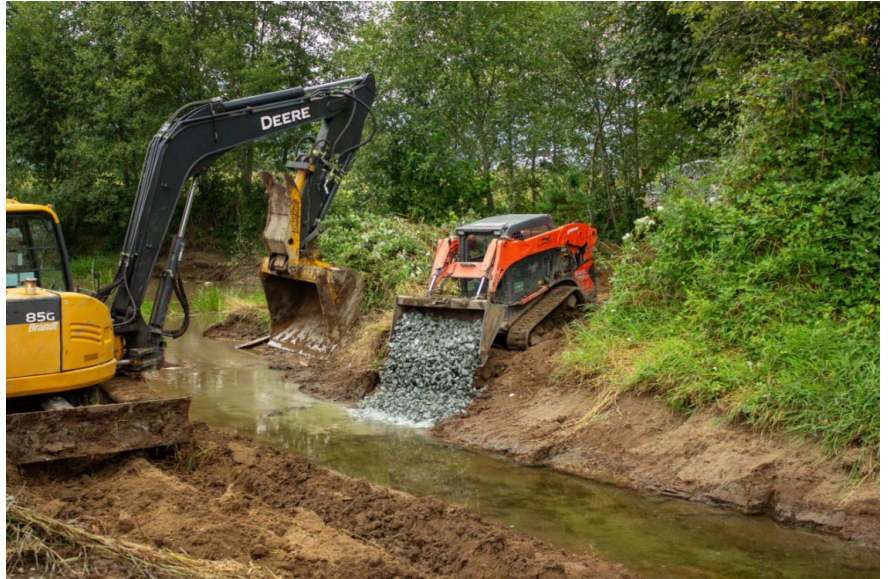
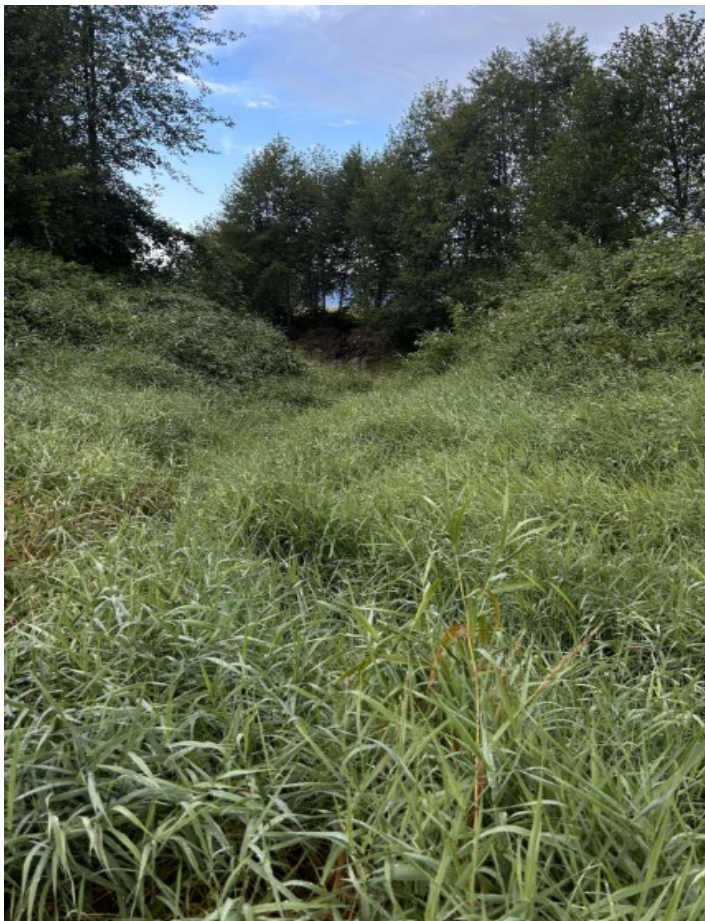
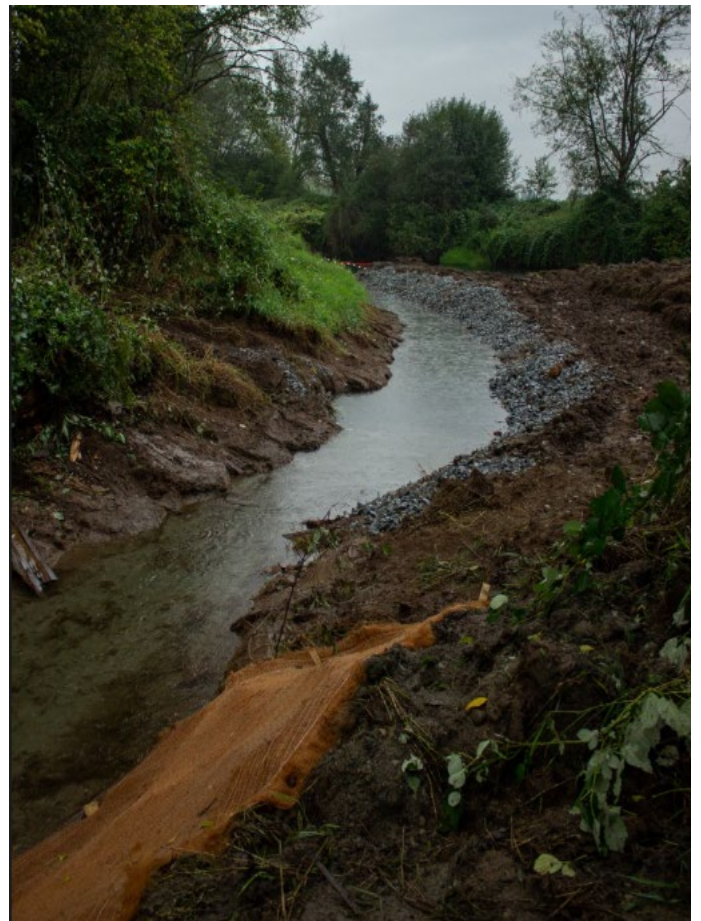
Figure 10 Addition of angular gravel on streambank

Figure 11 Upstream portion - Before and after with angular gravel and coconut matting for bank stability

We also noticed some bank sloughing from the new channel that was created, from when we had high water levels in November 2024. We installed more willow stakes to increase bank stability. We also came back in June 26, 2025, and did not see any juvenile salmon at that time. We took the YSI and completed some water samples throughout the channel. The measurement results are below:

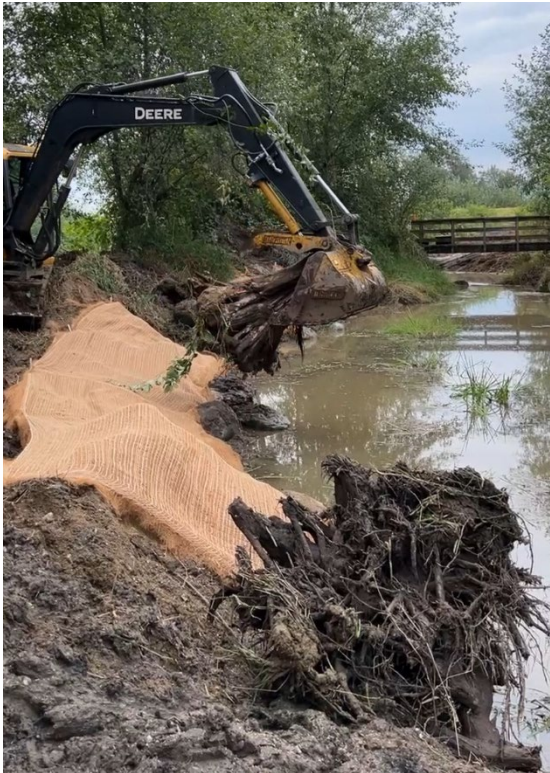
In addition, 4 large woody debris sections were installed in the pond area of Trethewey Channel, however, were not cabled in so two sections were caught up on a small foot bridge going over from the property over to the small island after the atmospheric river event in late October 2024 . These large woody debris sections were later removed by the property owner and pulled up onto the river bank for a future re-installation.

Figure 12 Large woody debris installation

As the large woody debris sections that were placed in the pond area of Trethewey Channel were not cabled in, a couple of those sections moved downstream in the channel so we would highly recommend cabling in those sections for next year.

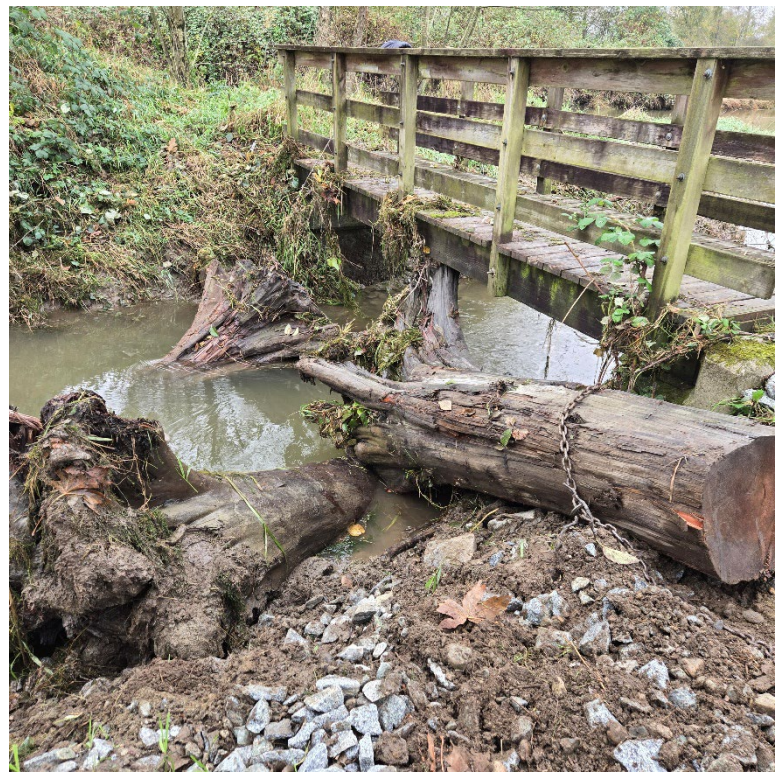
Figure 13 Large woody debris being removed after atmospheric river

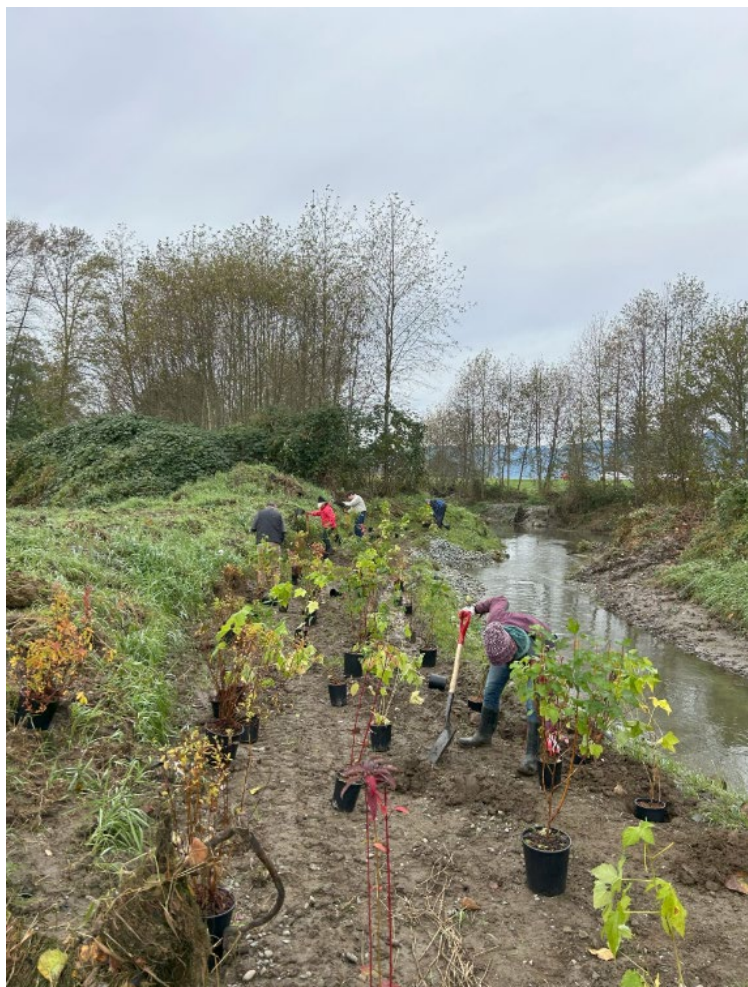
Figure 14 Planting natives at Trethewey Channel, Nov 2024

We also recommend continued native plants for shading along the channel bank as this is needed for shade, food drop, and bank stability. Increasing the number of in-water native plants such as sedges, rushes, and other native emergent would assist in creating more habitat for juvenile salmon to hide in away from predators.

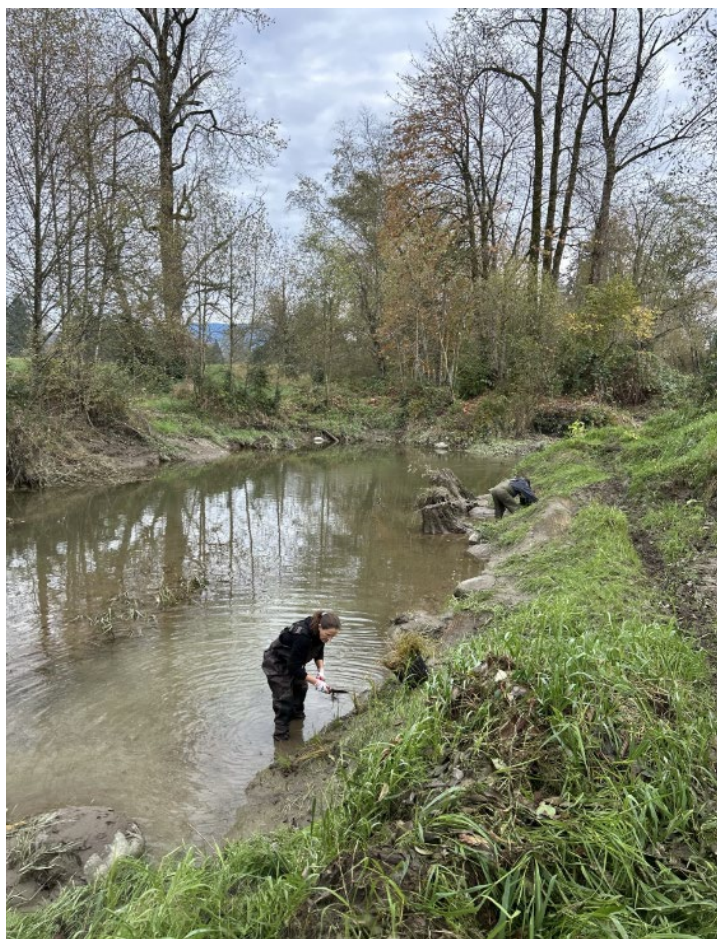
Figure 15 Replanting the pond area with small shrubs and emergent sedges

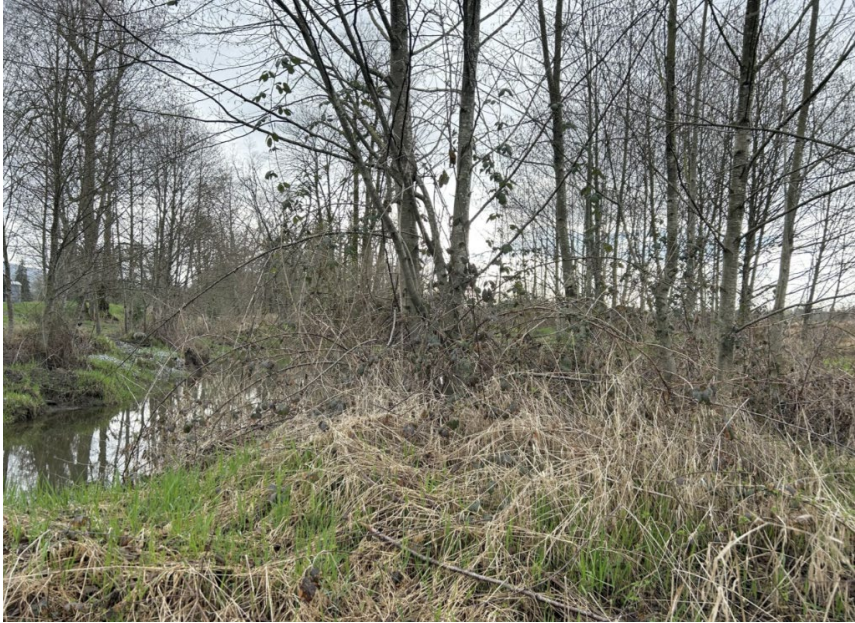
A significant challenge throughout the project was the density of invasive species, particularly Himalayan blackberry and Japanese knotweed, which exceeded initial expectations and required more time for removal. Knotweed management was particularly difficult, as herbicide treatment was not an option due to its proximity to water. Instead, we focused on manual removal and replanting with competitive native species, though long-term management will be needed to suppress regrowth effectively. Future efforts should allocate more dedicated time and resources for invasive species removal,

Figure 16 Himalayan blackberry before removal

Additionally, continued removal of Himalayan Blackberry removal will assist in the reclamation of the streambanks so that more native shrubbery can be planted, preferably those that were planted during this project work, those that are fast growing and can out-compete the invasive plants.

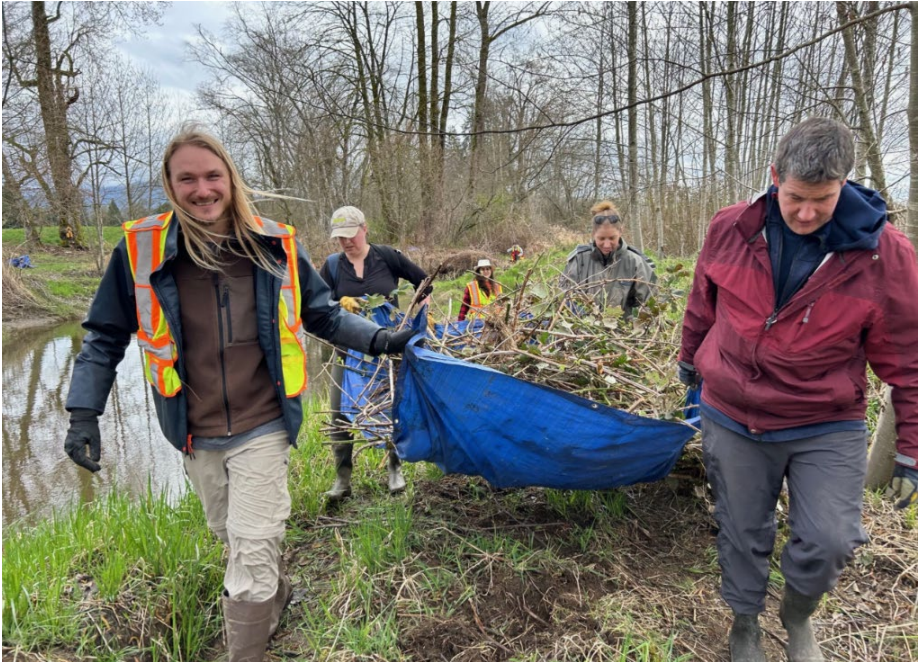
Figure 17 Lower Mainland Green Team volunteers remove blackberry from project area
