Central Squamish Estuary Salmon Passage Culvert

COA-F26-F-4287

Prepared for: Fish & Wildlife Compensation Program

March 15, 2026

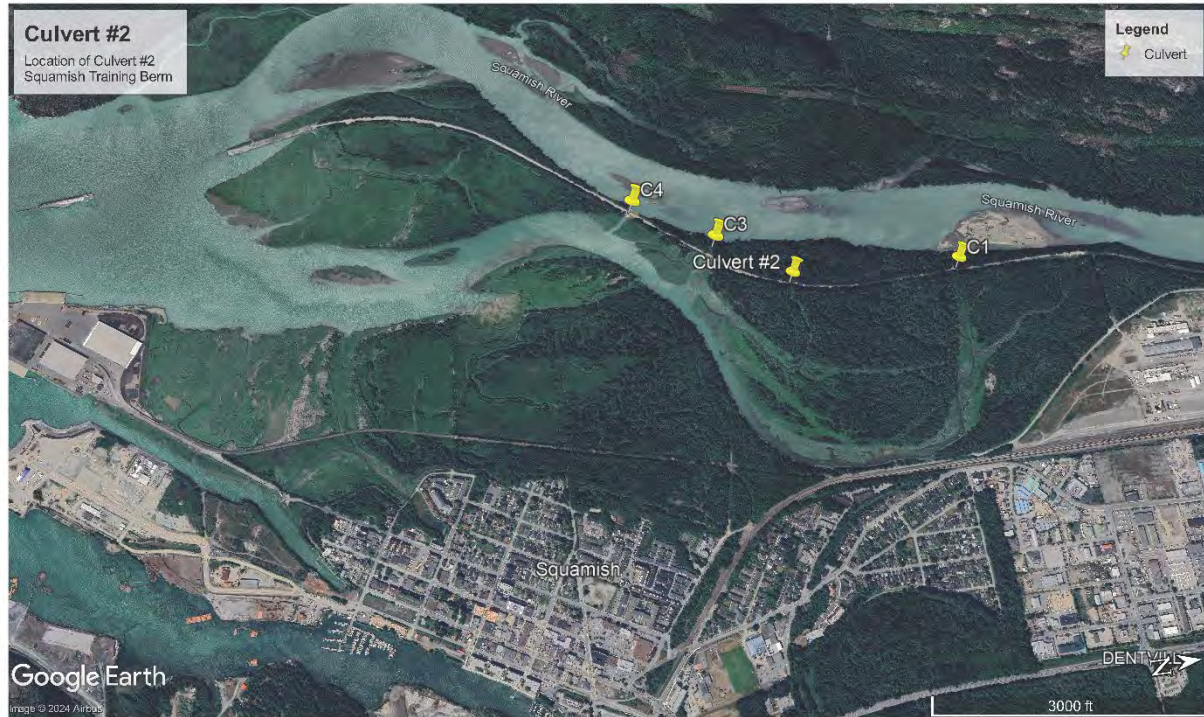
Google Earth map of Culvert #2 crossing

The purpose of this memo is to identify the total number of trees that will be impacted as part of the replacement of the twin corrugated steel pipes (CSP) with a single concrete box culvert at Culvert #2 along the Squamish Training Berm. The site is located around coordinates 49.709824lat x -123.168438long. The construction is intended to take place starting the week of March 17th with plans for tree removal and site preparation the week of March 10th and will include the construction of cofferdams on the east and west side of the culvert to isolate the site. The cofferdam located on the east side of the Training Berm will also provide an access route for equipment once the road has been excavated. Every effort has been made to minimize the disturbance to the trees. No coniferous trees will be removed as they are all located outside of the work area. The majority of the trees to be removed consist of red alder and black cottonwood although there is one mature bigleaf maple located on the east side that unfortunately will have to be removed.

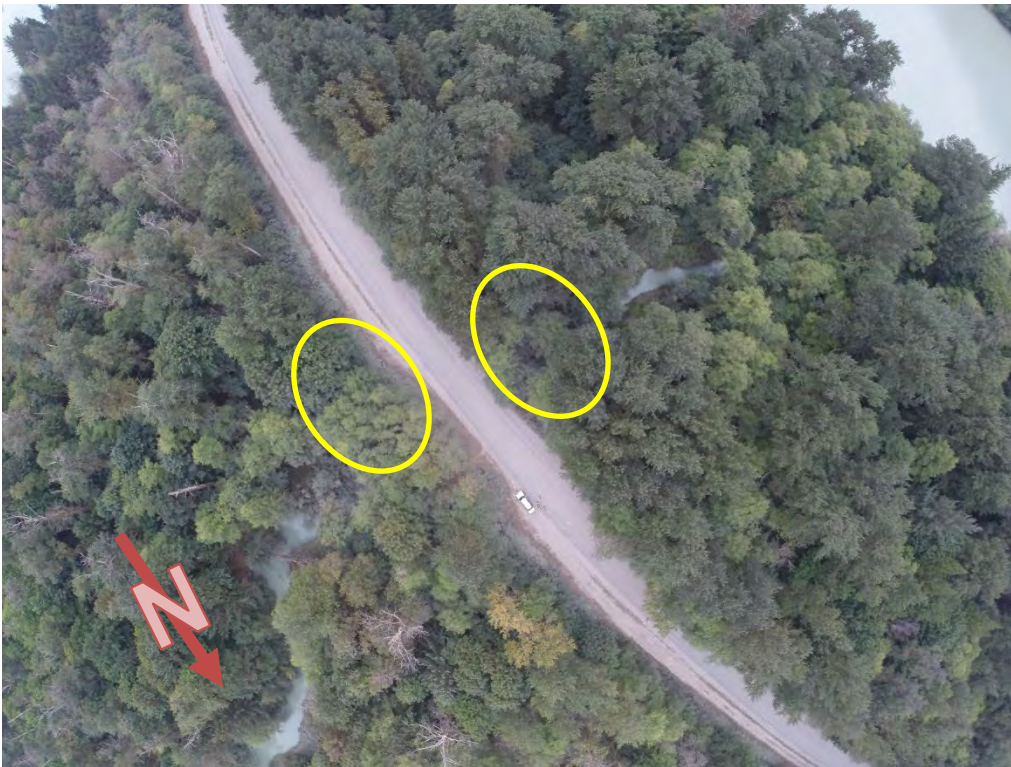
Drone overflight of culvert August 2017 (river is on right, estuary on left, and top is facing south)

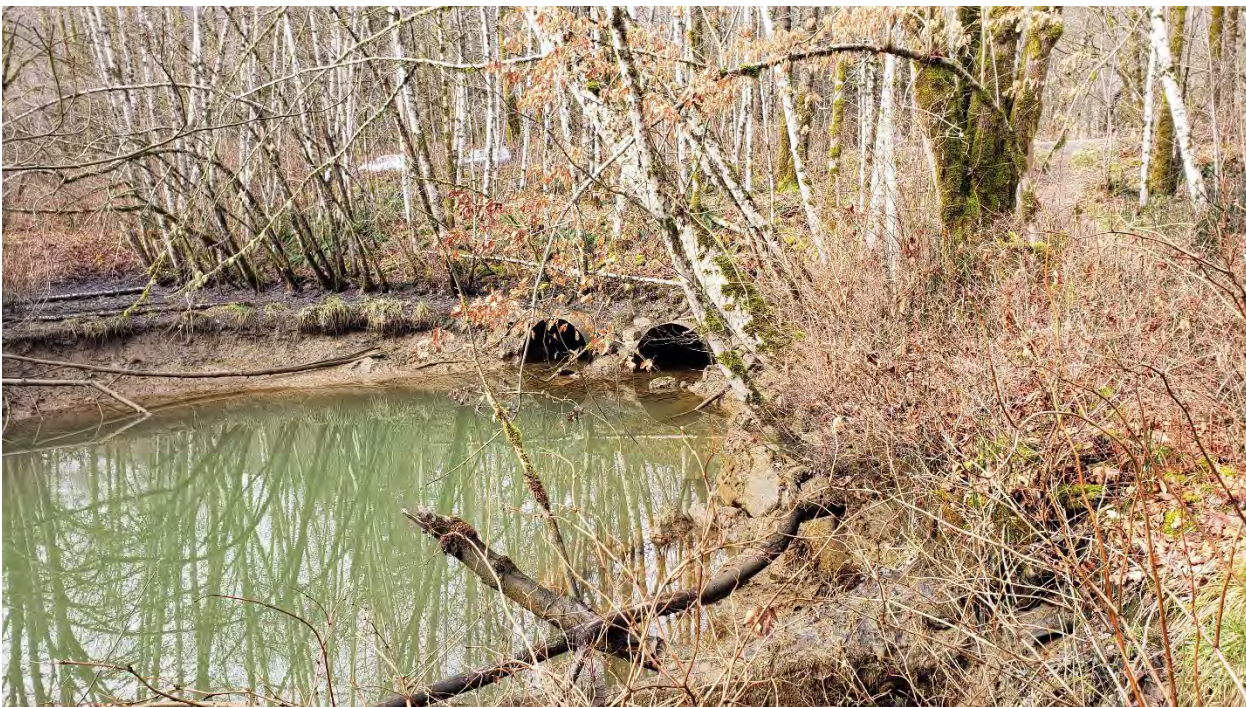
East side facing towards Training Berm and twin culvert

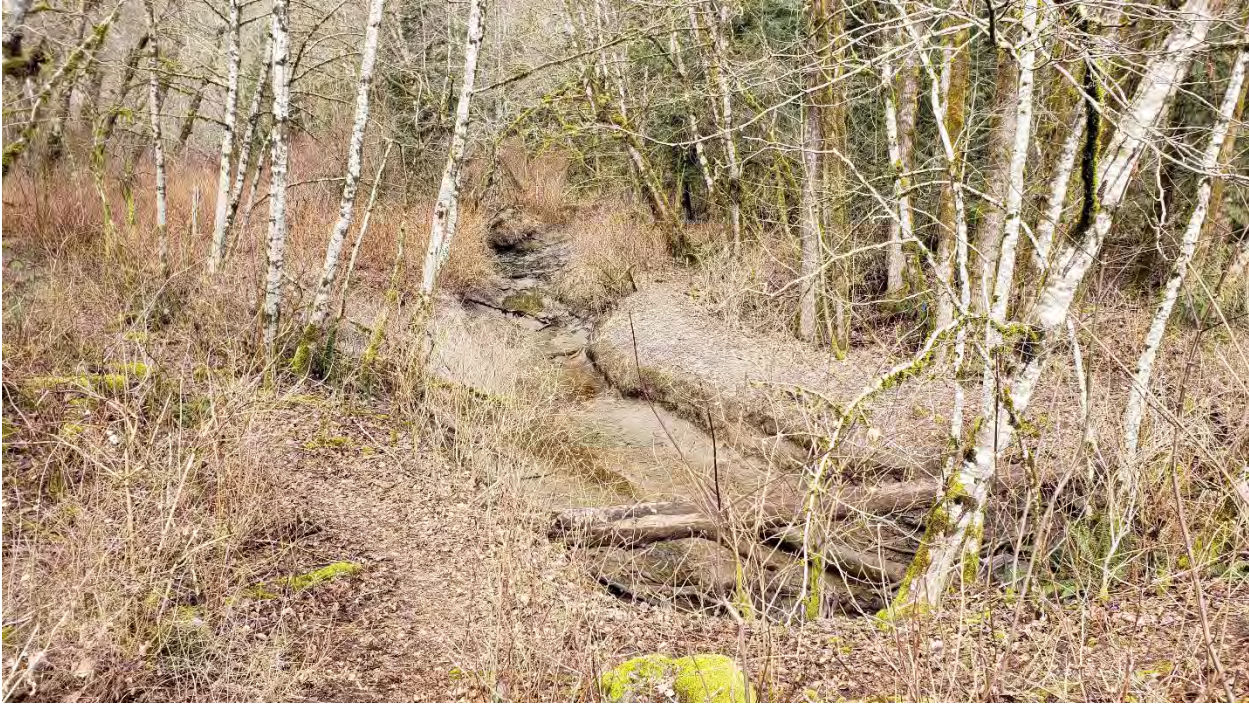
West side facing towards river from top of Training Berm (note culverts are buried behind debris)

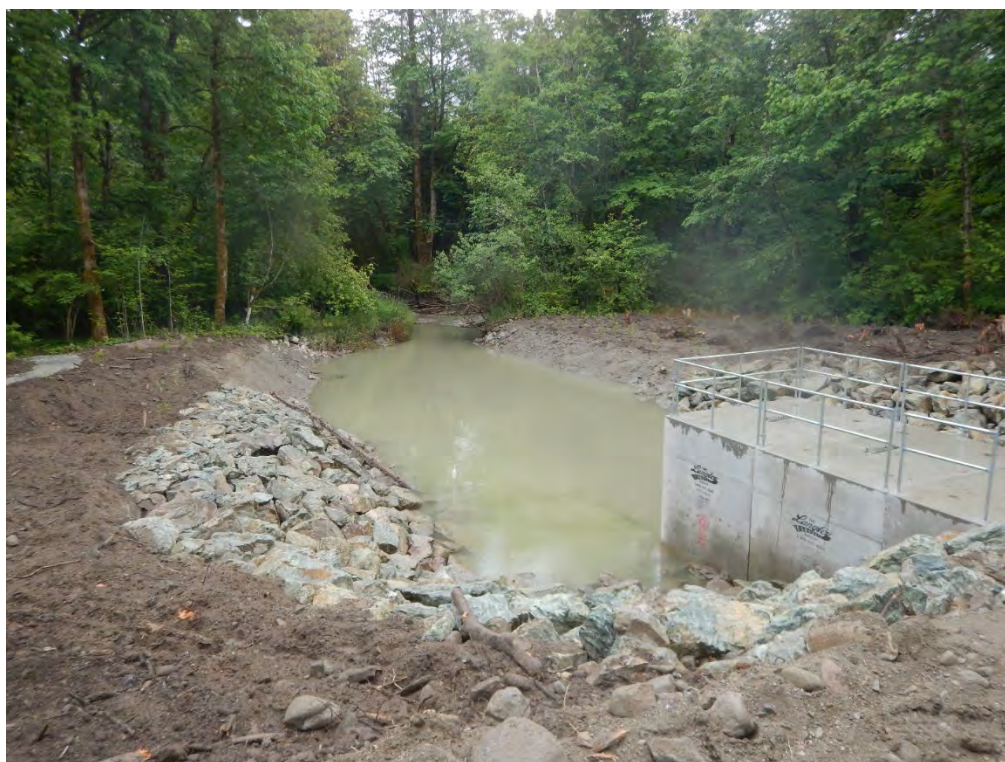
Facing east towards central estuary – note organic placement on each side of culvert

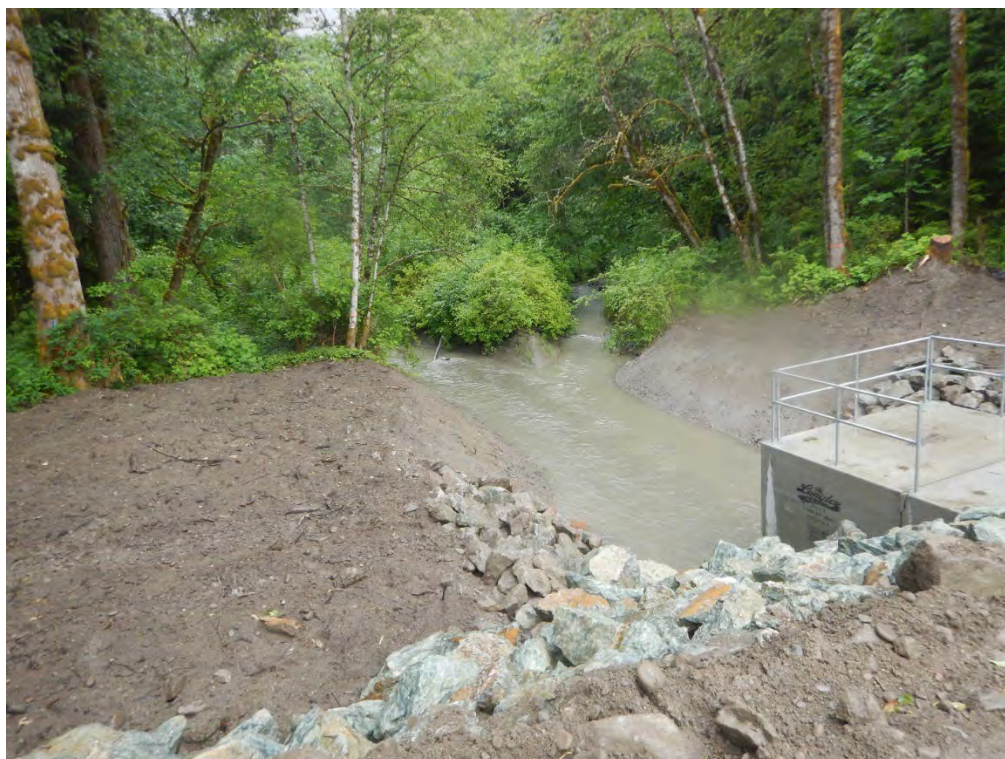
Facing west towards Squamish River

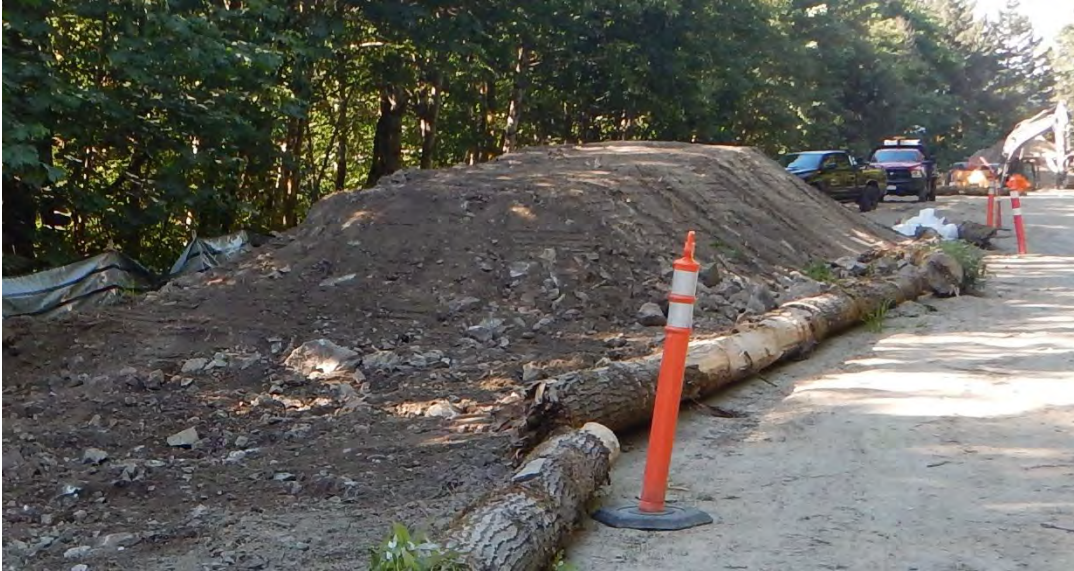
Stockpile of material from shoulder of road

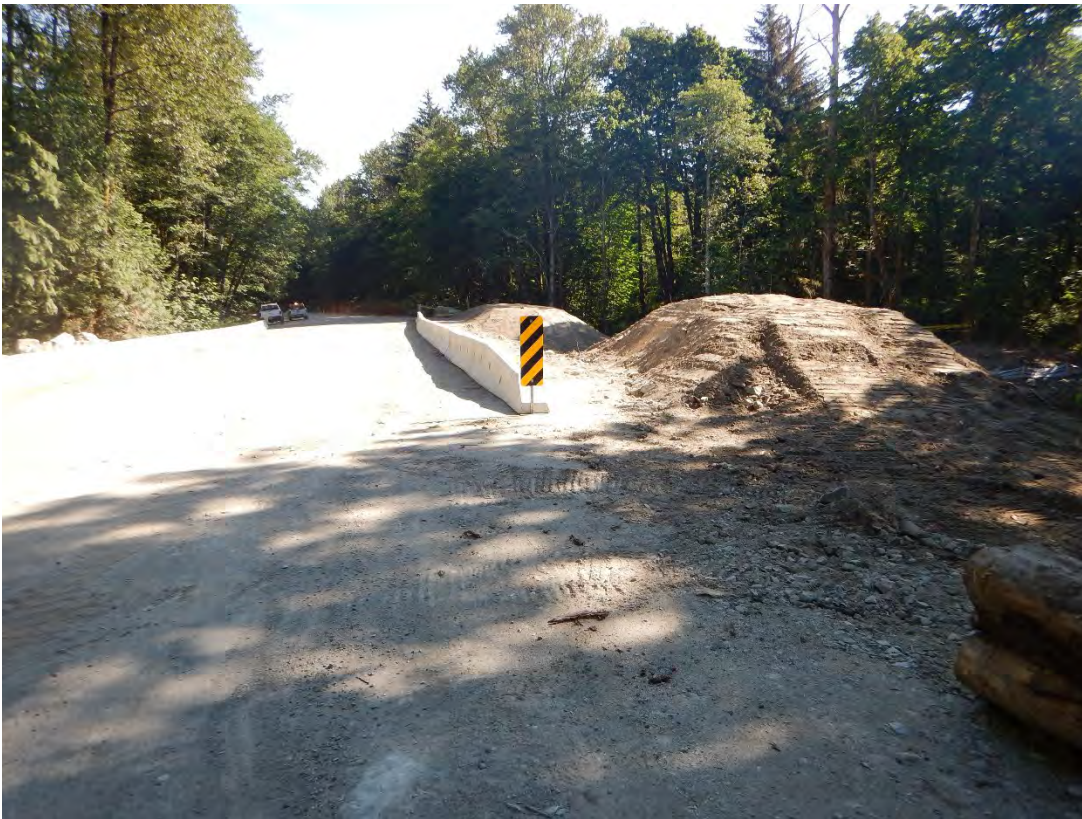
Stockpiles on north and east side of Culvert #2 on estuary side (east side of road)

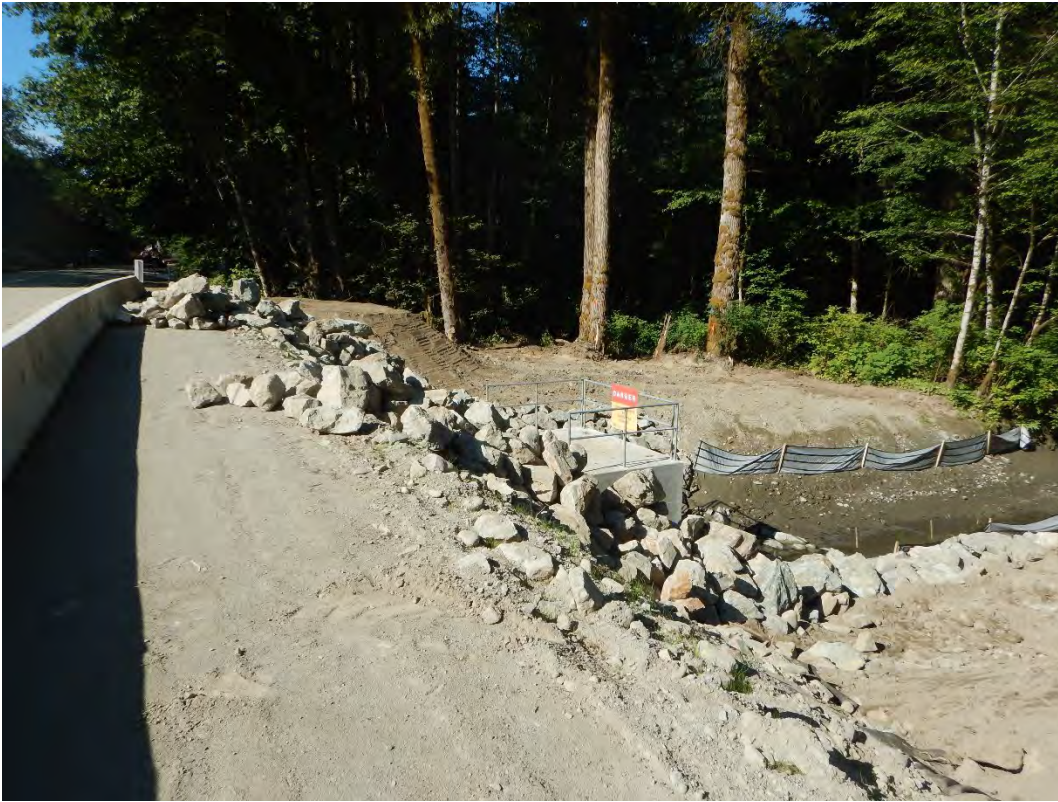
Photo of stockpiled material on south quadrant of west side of Culvert #2

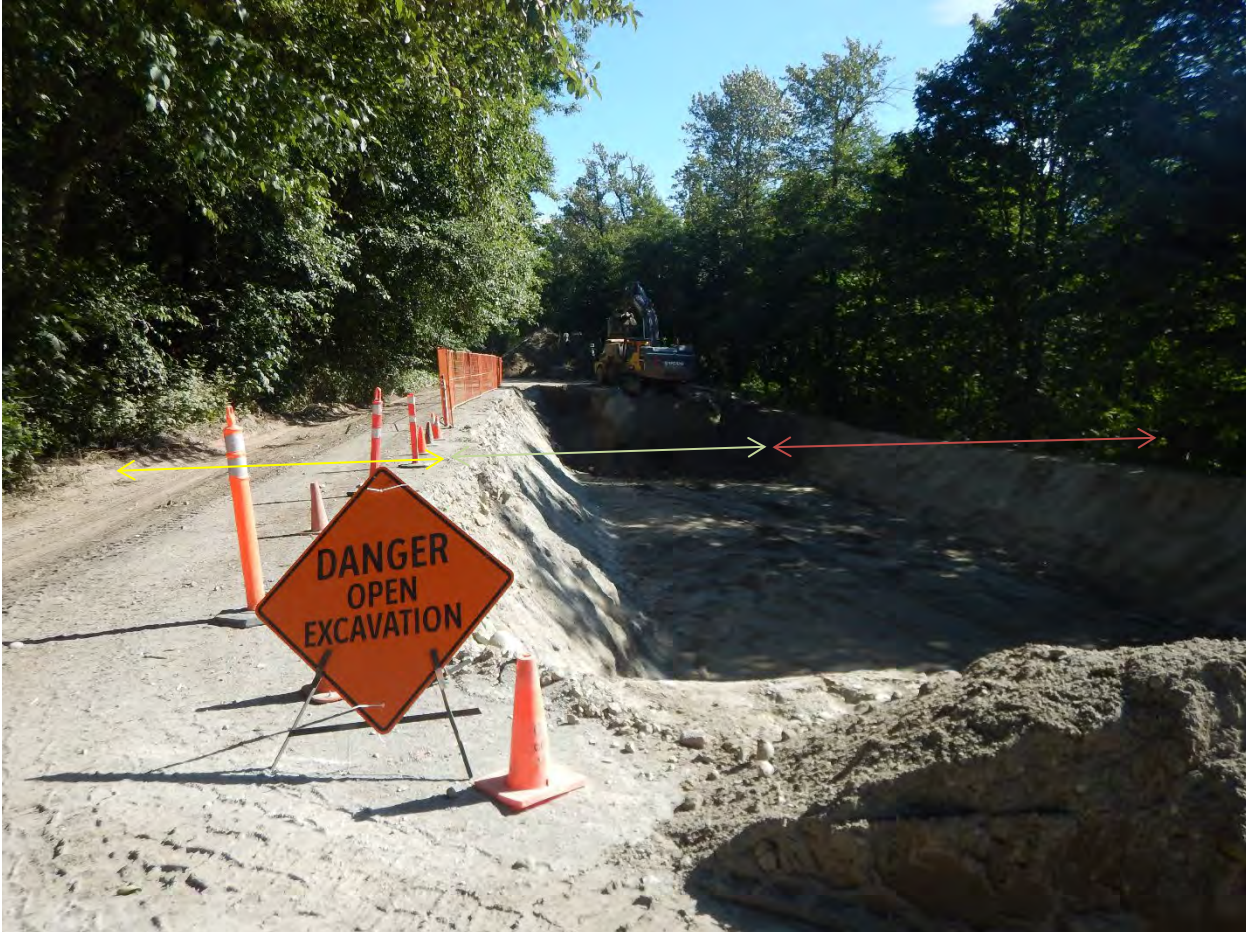
Photo 1. Approximate width of road depicted with yellow representing west lane of Berm/Spit Road and green representing east side. Orange line depicts approximate width of east shoulder. Pit dimensions approximately 13m in width at the surface and 8m at the base, 50m in length and the depth was 4m.

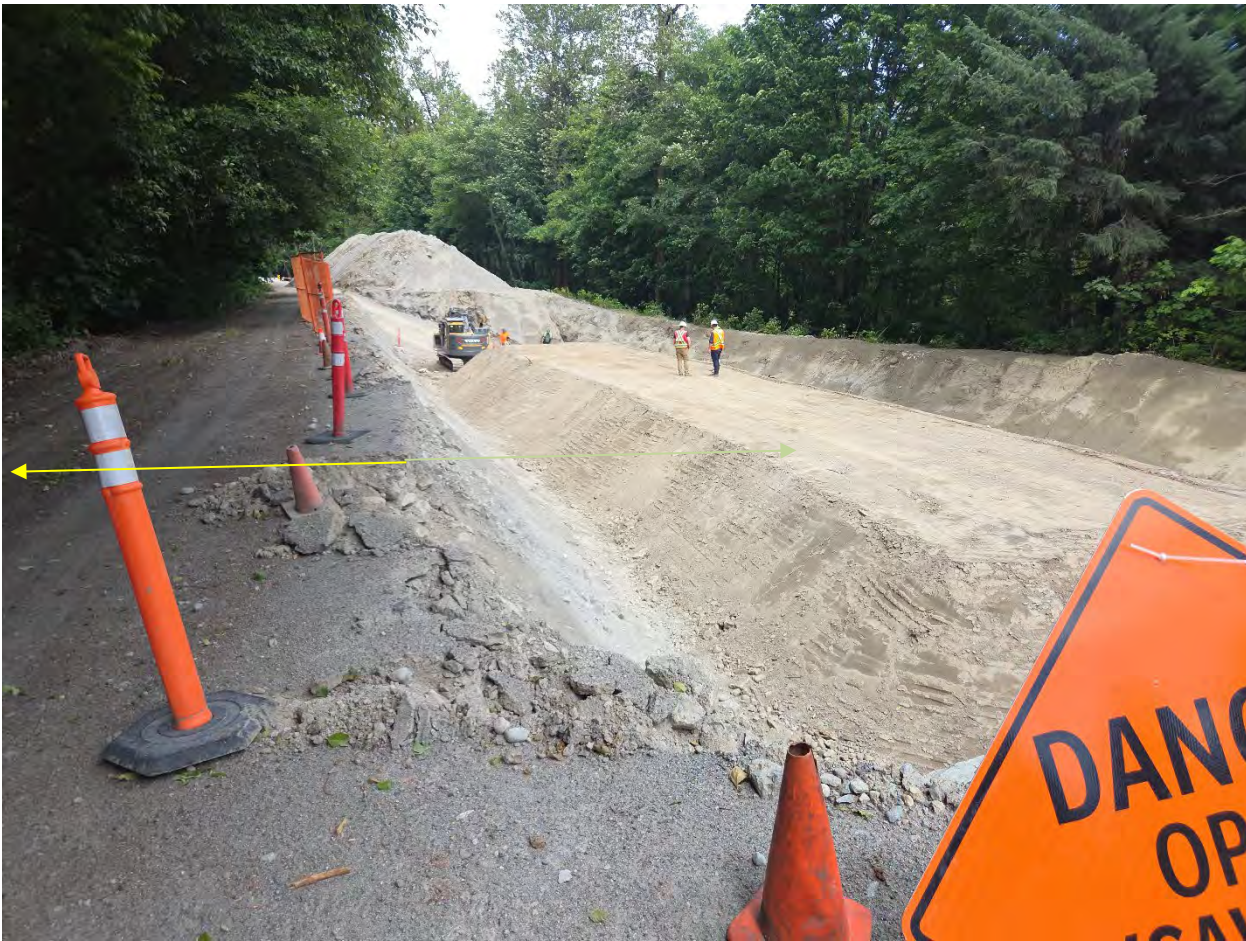
Photo 2. Placement of JK impacted fill complete. Note the western slope extends into the “road”. The dimensions of the stockpiled contaminated soil were approximately 35m in length, 6-7m in width (wider at the base), and 2m in depth.

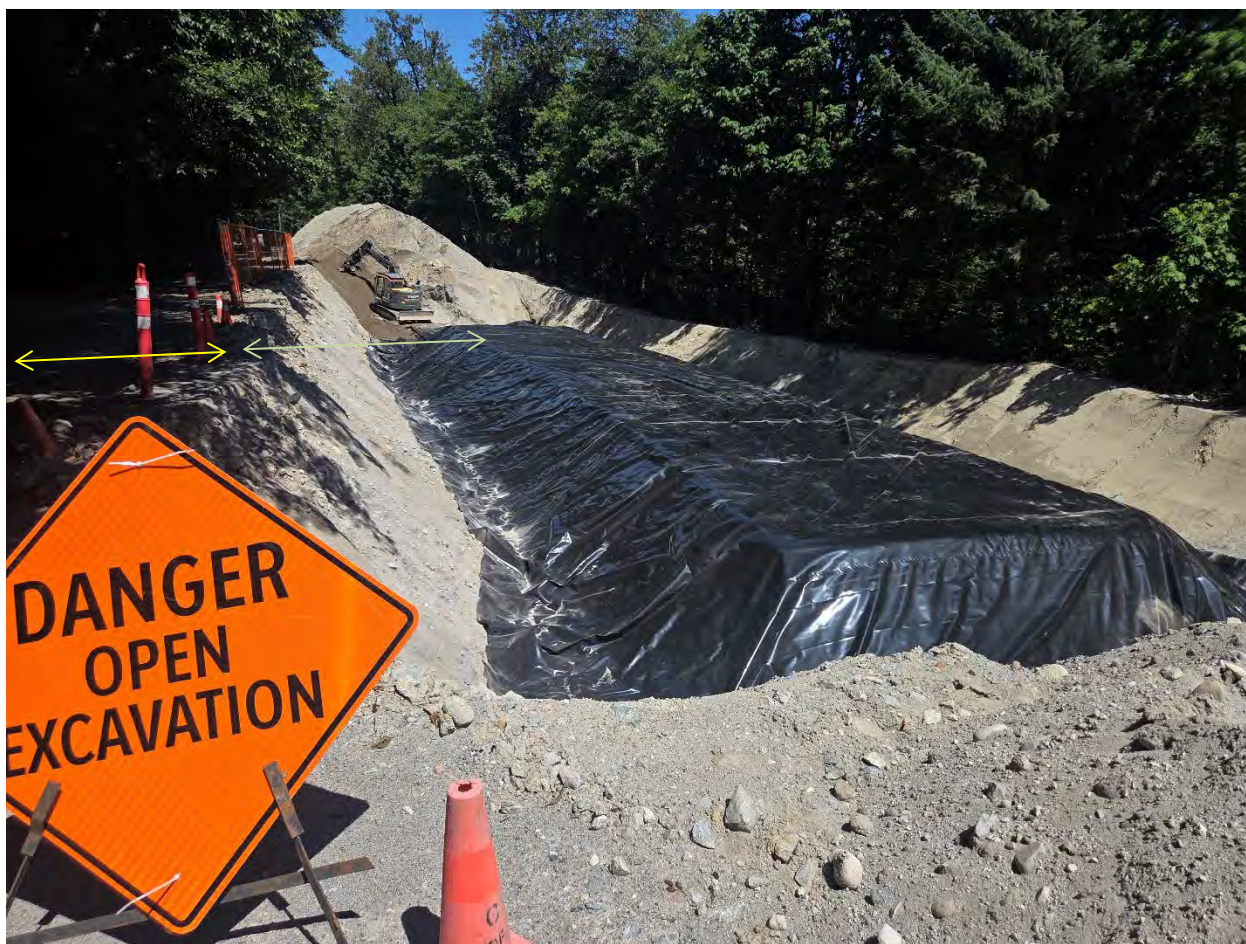
Photo 3. Placement of impervious liner covering entire JK soil complete.

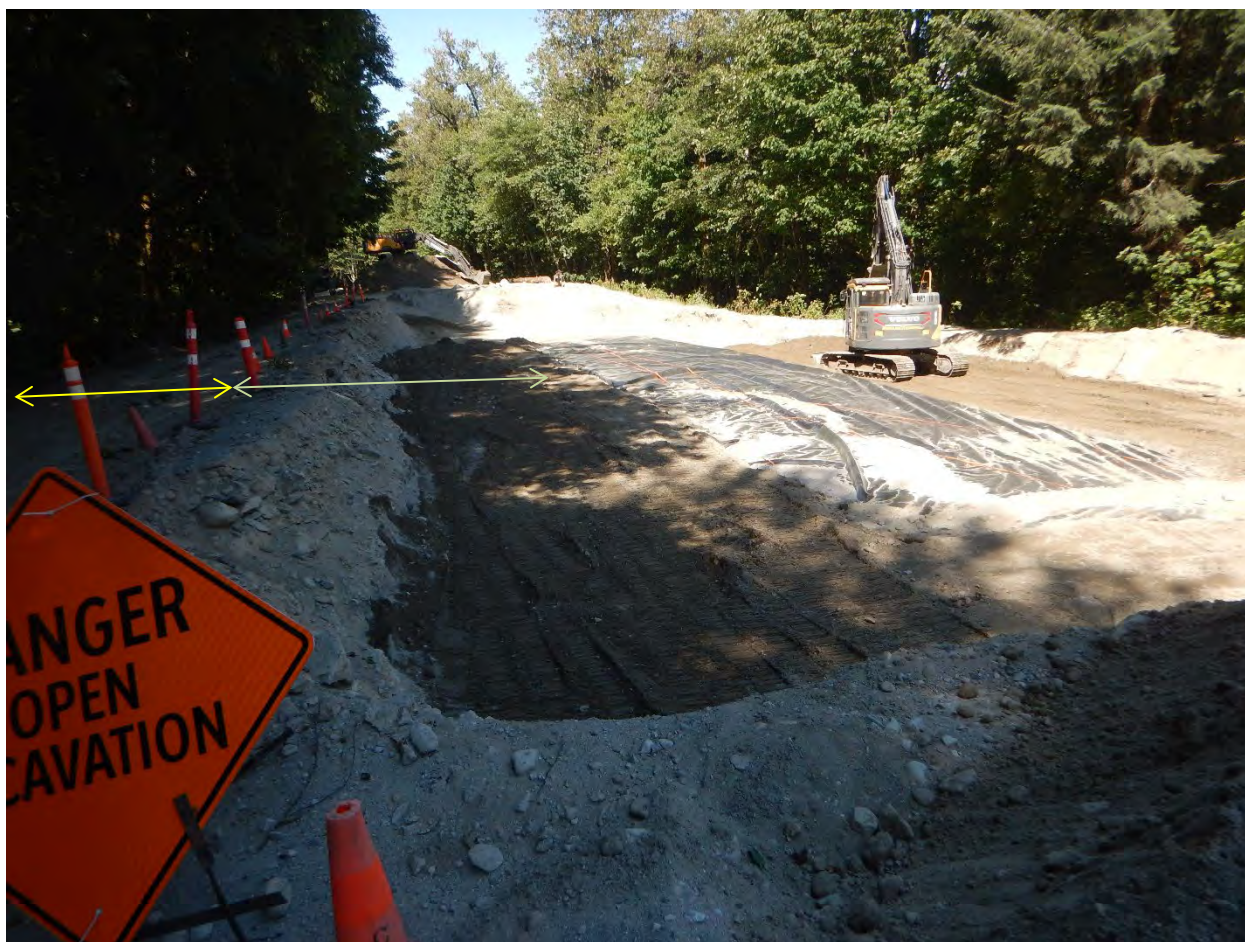
Photo 4. Backfilling underway, note ribbons of “invasive species” flagging tape placed along top of liner and every metre until top of berm as warning for any future disturbance.

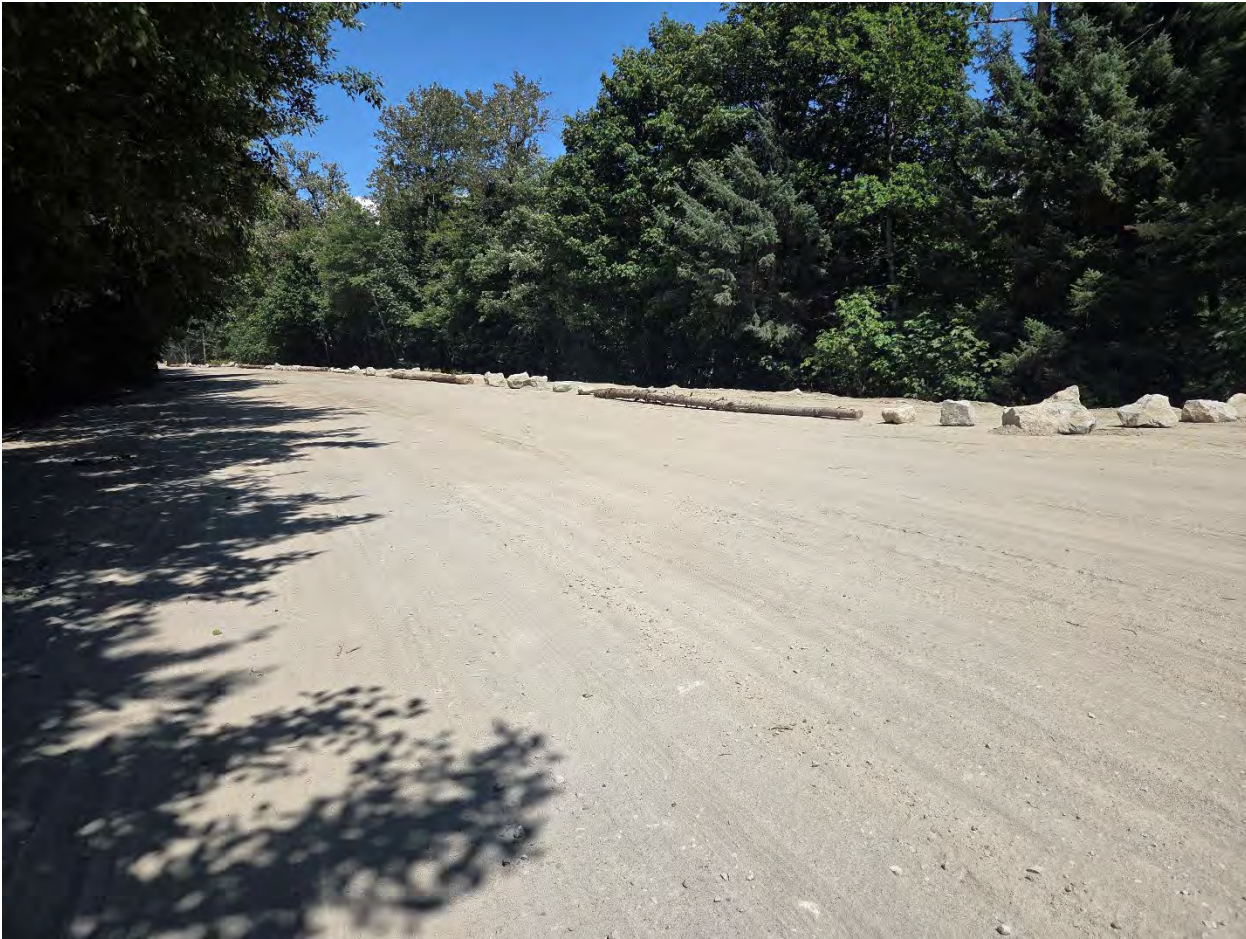
Photo 5. Road restored to original grade and compacted. Cordon of logs/rocks to prevent public from driving or parking along the shoulder and potential disturbance or distribution of knotweed.

The SRWS will continue to monitor the disturbed areas around Culvert #2, the eastern shoulder south of the culvert where the original JK impacted material had been stockpiled, along with the filled in pit location for the next three years or as needed. A cordon of trees and rocks have been placed to the southeast of Culvert #2 extending from the no-post barriers to prevent the public from driving along the shoulder where there remains potentially impacted material. We do not recommend the District of Squamish do any road maintenance in this area for the foreseeable future until we can confirm a complete absence of Japanese
