**BIOPHYSICAL SURVEYS AND ENHANCEMENT
OPPORTUNITIES FOR TRIBUTARIES OF THE
UPPER COLUMBIA RIVER**

Mica Fisheries Technical Committee
B.C. HYDRO/B.C. MINISTRY OF ENVIRONMENT,
LANDS AND PARKS
c/o 1312 - 808 Nelson Street
Vancouver, B.C.
V6Z 2H2

April 1992

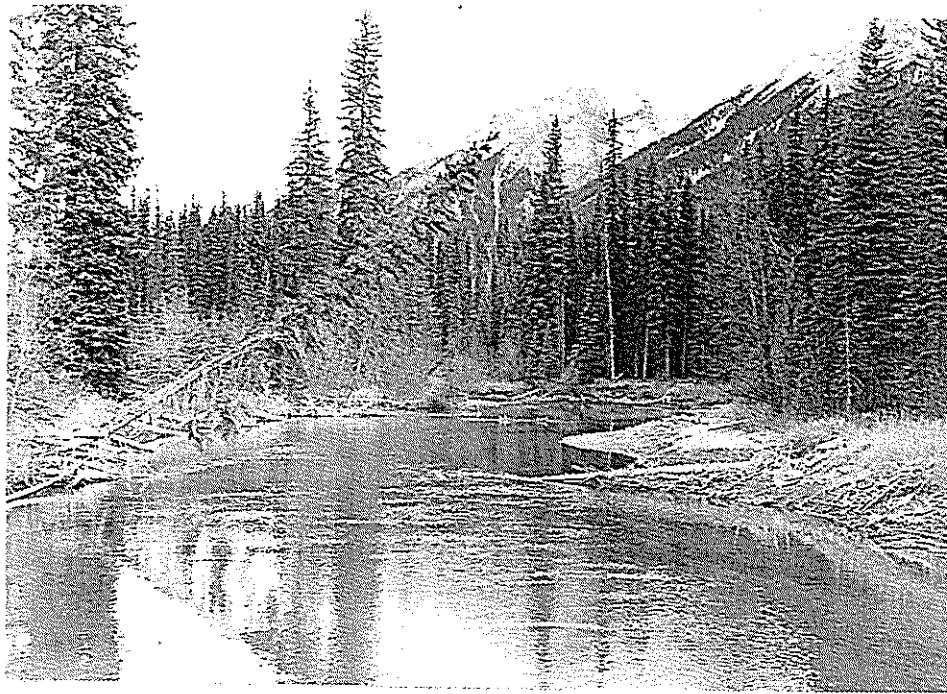
Photo 1. Deep glide section at site 1, reach 1 of the Beaverfoot River.

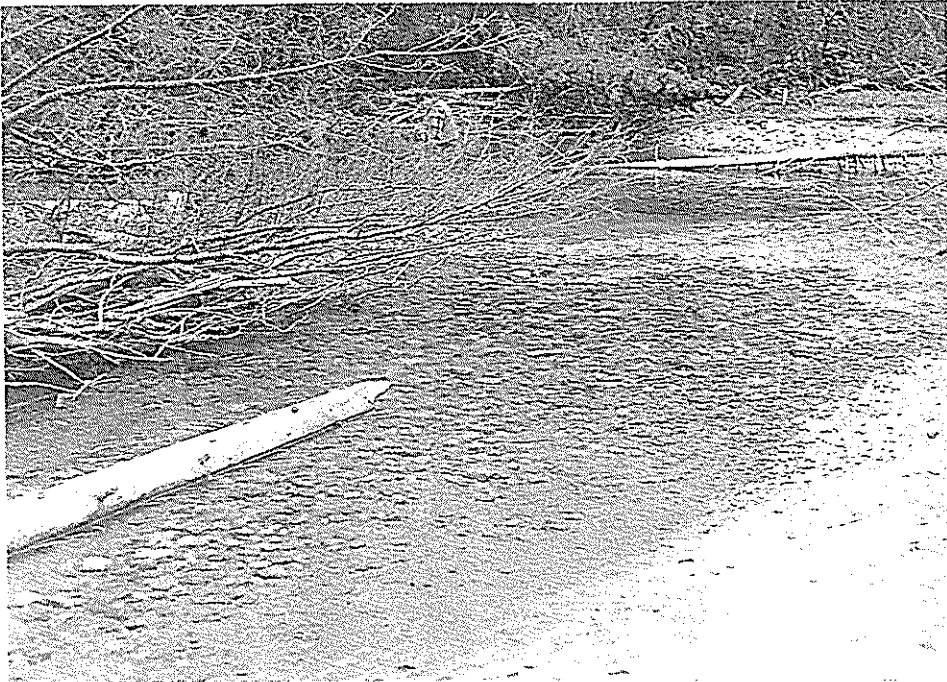
Photo 4. Riffle/run section of reach 2 at site 3, Beaverfoot River.

This section extends approximately 18 km upstream from the top of reach 1 and is very similar to the first reach but the gradient is somewhat steeper at 1.4%. The main channel is shallower, a greater percentage of riffle area, and higher water velocities (Photo 4). The stream channel meanders along the valley bottom and is generally bordered by older fir forest with some areas of extensive beaver activity that has resulted in flooded areas with small channels (Photo 5). The substrate in the main channel tends to slightly larger gravel and cobble than reach 1.

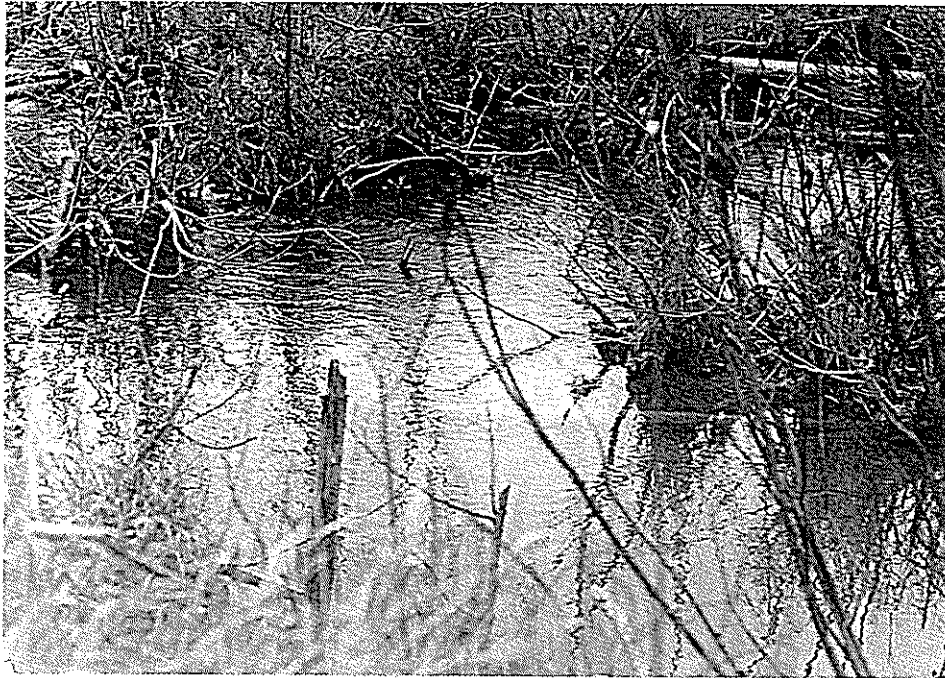
Photo 5. Swamp area created by beaver activity, site 4, reach 2, Beaverfoot River.

At the observed flow level there was considerable edge habitat consisting of LOD and cut banks. Electroshocking in the main channel produced bull trout and sculpins. The char ranged between 93 and 159 mm and 1 to 2+ in age. Two bull trout escaped capture, both between 200 to 250 mm. Only sculpins were taken from the side channel pictured in Photo 5.

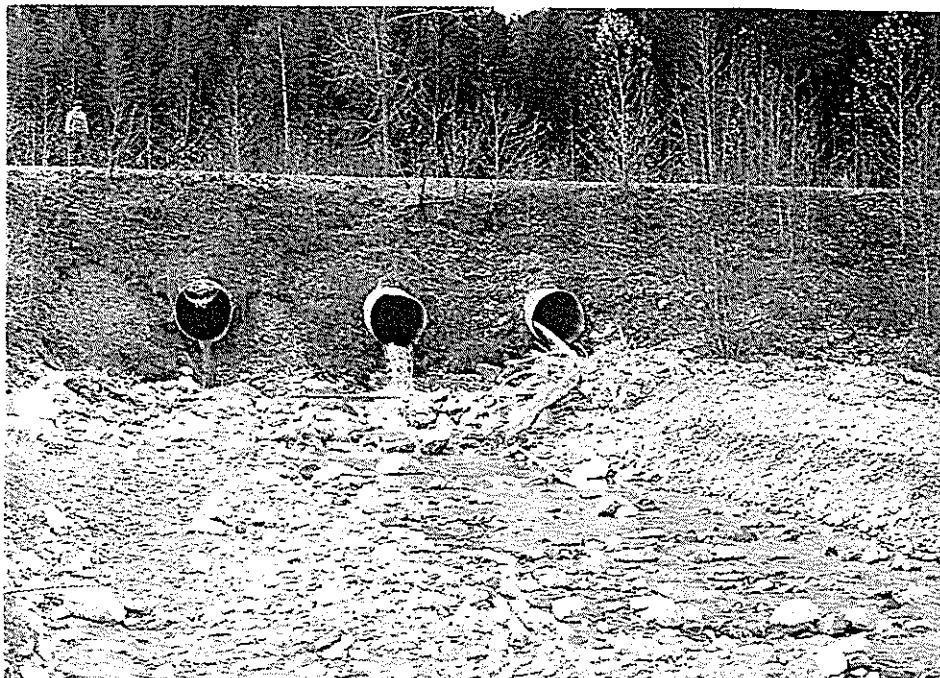
Photo 7. Culverts on Fraser Creek.

Fraser Creek enters the Beaverfoot River approximately 2 km upstream of the confluence with the Kicking Horse River. The lower one kilometer of Fraser Creek is accessible to fish from the Beaverfoot. Three culverts placed for the logging road create a one metre high barrier blocking further upstream movement of fish (Photo 7). Bull trout and mountain whitefish were collected below the culverts but no fish were found upstream of the barrier. The lower section of this creek may provide spawning habitat for bull trout however, observations suggest that lower sections of this stream may be unstable during high spring flows (Photo 8).

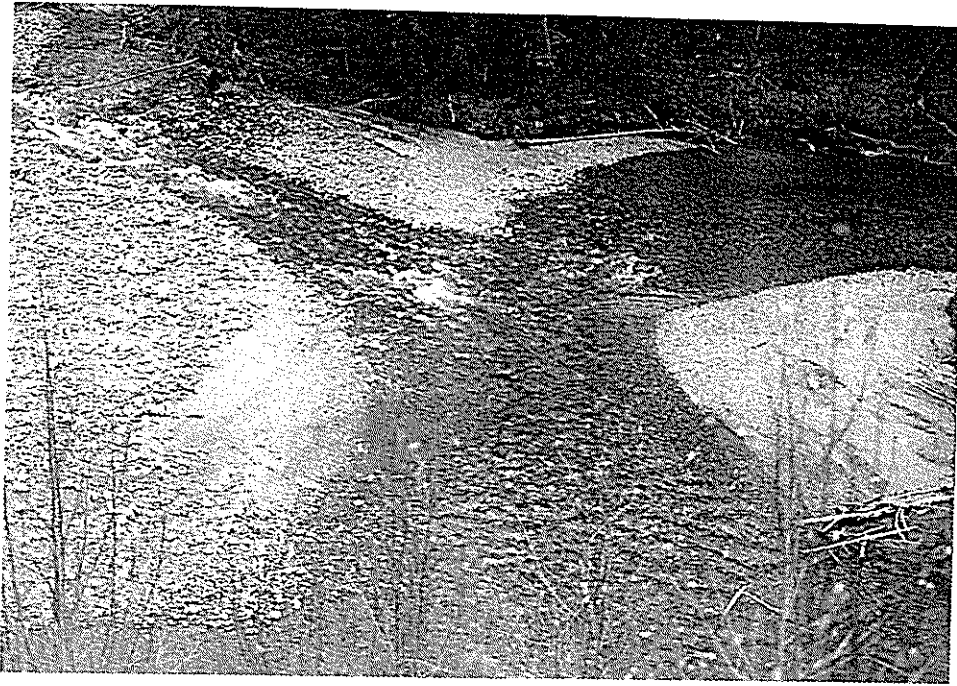
Photo 9. Confluence of Ice River and Beaverfoot River.

Is the longest tributary flowing generally south for approximately 20 km through Yoho National Park entering the Beaverfoot River in the lower section of reach 2 (Photo 9). During this survey only the mouth and a location 4 km upstream were visited. In the lower 1.2 km, or the first reach of the Ice River the gradient is 3% and the stream is primarily tumbling riffle with large cobble and boulders. This is followed by a 1.7 km section of slower water with a 1.5% slope. At the point where the stream survey card was completed the stream gradient increased to 3.4% and was similar to the first reach. Since this river is primarily under the jurisdiction of Parks Canada a detailed study was not done, however studies by Parks Canada (Murdy 1975, Pole 1991) reported finding bull trout, pygmy whitefish, mountain whitefish, eastern brook trout, and slimy and torrent sculpins in the Ice River. Bull trout captured near the mouth of Ice River were between 98 and 196 mm and further upstream char up to 229 mm were captured along with mountain whitefish up to 258 mm (Pole 1991).

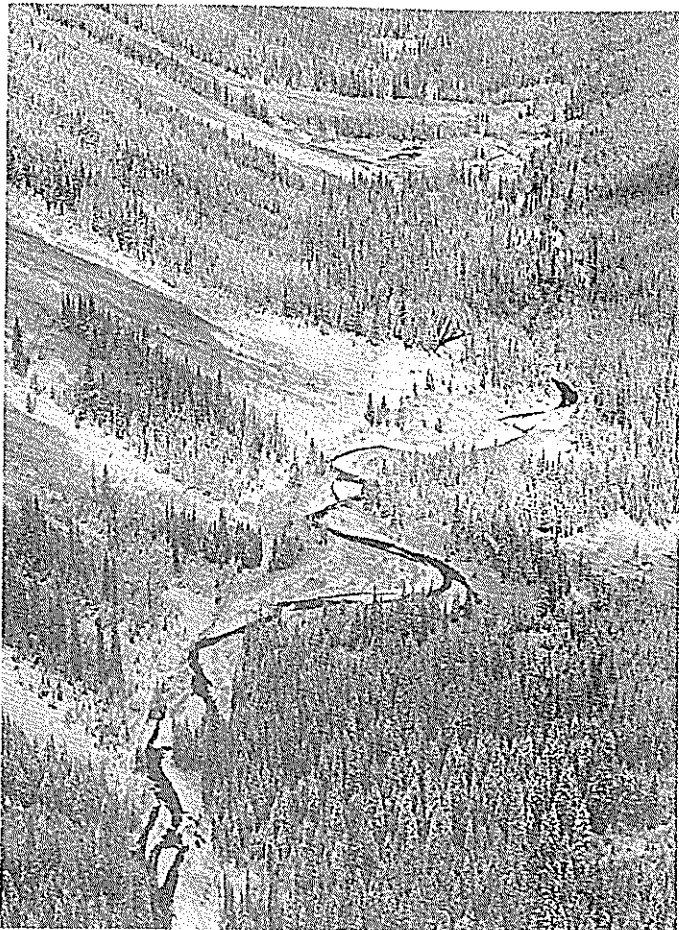
Photo 10. Meandering Section of Moose Creek.

The lower section of Moose Creek has been described as part of reach 3 of the Beaverfoot River. Moose Creek begins at the 2286 m elevation and drops to 1676 in the upper 6 km with stream gradients between 4 and 19% and from there slowly drops to 1112 m elevation (Figure 2). There is no road access to the upper section of Moose Creek so there was only a cursory evaluation of this area by helicopter. For approximately 5 km upstream of reach 3 the creek meanders through a forested valley with some open meadows with a gradient of 1 to 1.6%. The stream has sections of overstory cover and LOD is evident in the stream channel (Photo 10).

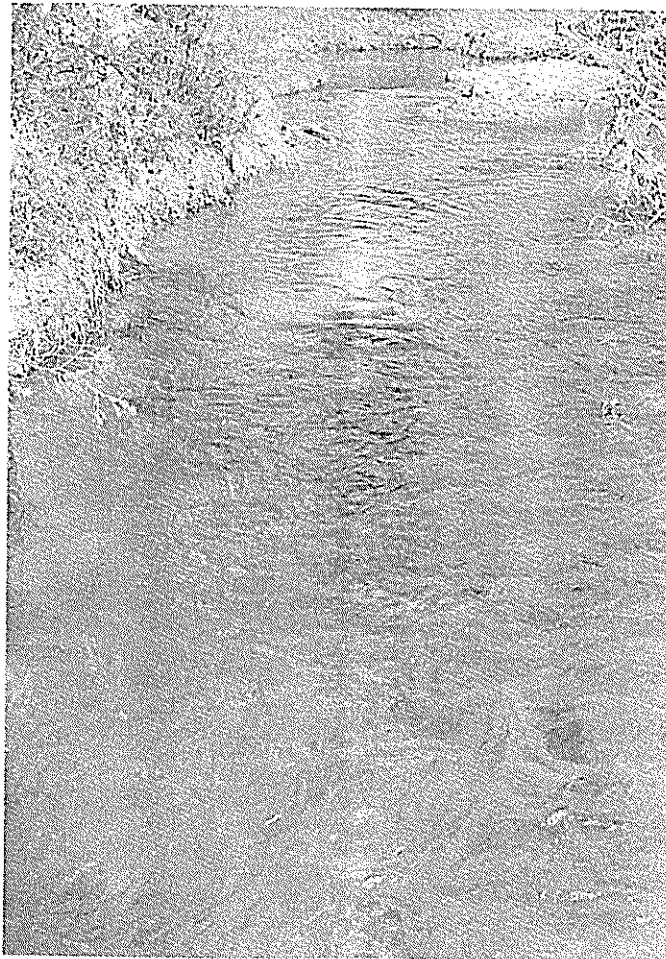
Photo 13. Area electroshocked at site 5, reach 2, Blaeberry River.

A 26 m section of river bank and organic debris was shocked in this reach (Photo 13). Two rainbow trout and six sculpins were captured. Both trout were young of the year. Kokanee were observed migrating through and spawning in this reach.

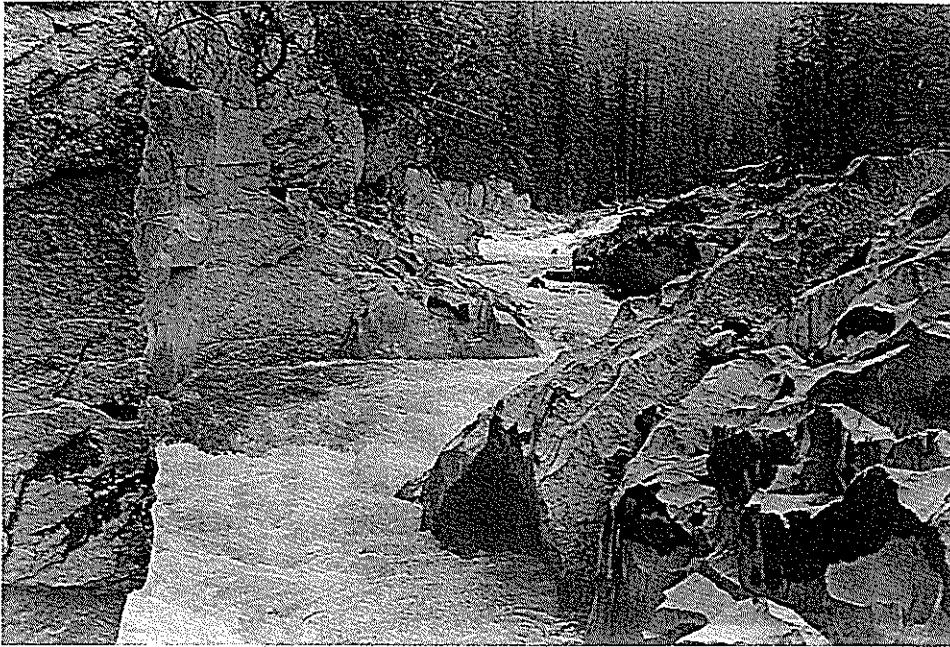
Photo 14. Section of canyon in reach 3, Blaeberry River.

This section of the river extends upstream for 11 km with an average gradient of 1.2%. This section flows through a more confined valley than the lower reaches and includes several areas where the channel cuts through bedrock forming canyon like sections (Photo 14). One such section includes Blaeberry Falls which is 9 m high. Between the sections of falls, chutes and deep pools, the stream consists of riffles separated by short runs and the stream channel predominantly consists of cobble and boulders (Photo 15).

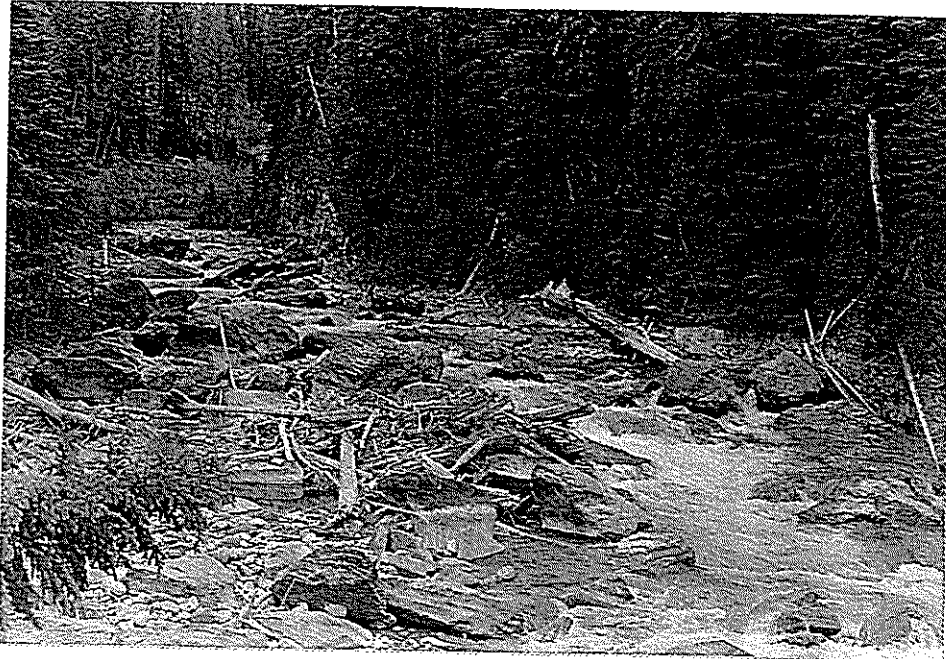
Photo 18. Steep section with boulders in reach 5 of Blaeberry River.

This reach is a relatively steep section with a gradient of 3.5% and approximately 3.6 km long. The substrate consists of mostly cobbles and boulders with some pockets of gravel. The stream is primarily riffles with some run and pool areas (Photo 18). Fish habitat is available in the form of LOD, boulders, and some cutbanks.

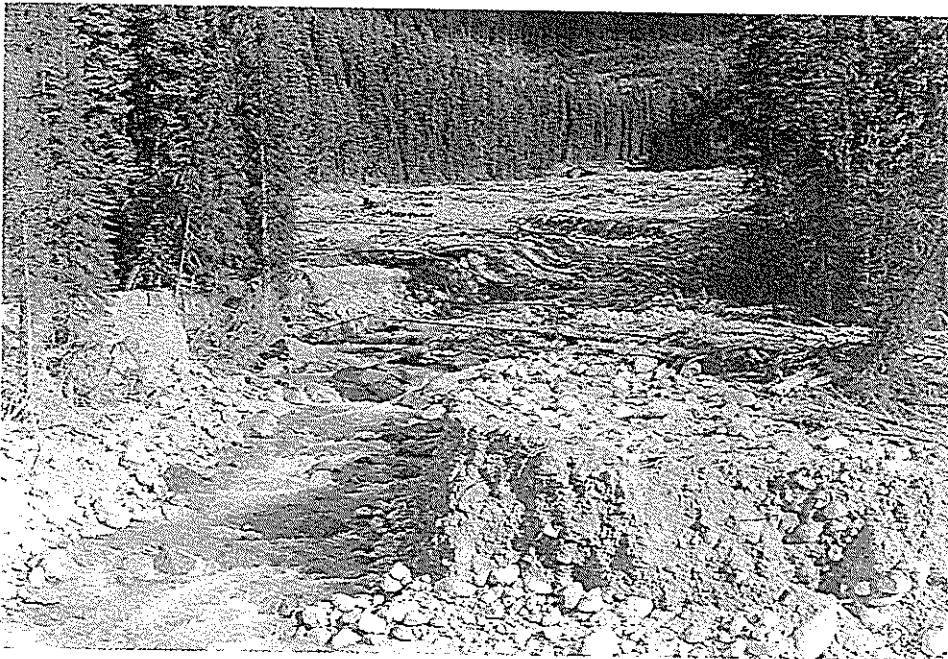
Photo 19. Mouth of Collie Creek showing deposits of bed load.

This section of stream seems to be prone to significant annual movements of bed material. Collie Creek which enters at the upstream end of this reach appears to have deposited a large volume of cobble and gravel into the Blaeberry River sometime in the past year (Photo 19). A bulldozer had been used to establish a new channel to divert the river away from the logging road on the right bank and a berm of loose cobble and gravel was built up possibly to try and minimize future damage to the logging road.

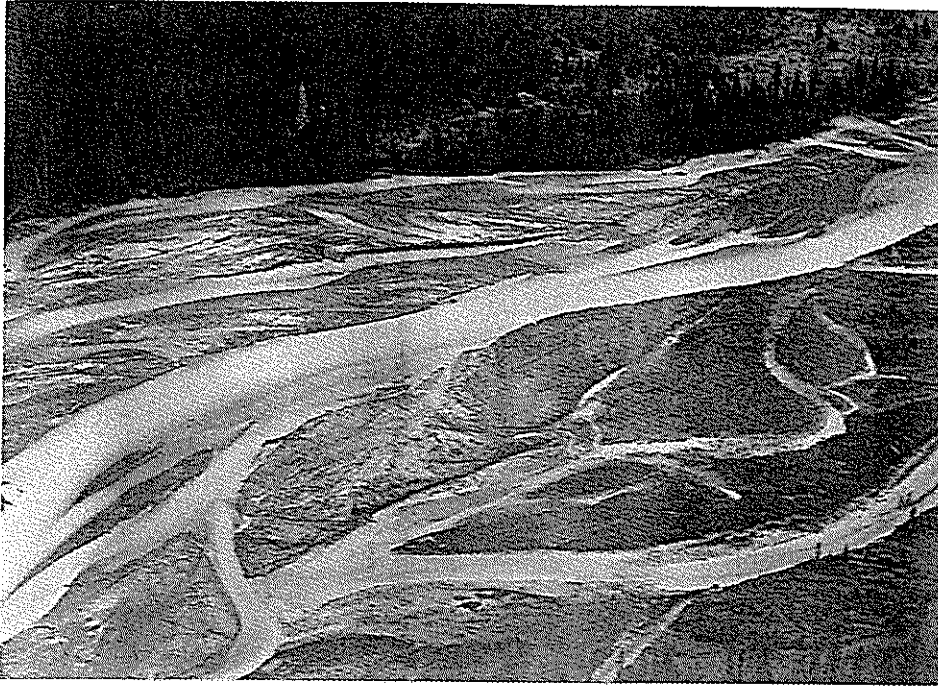
Photo 20. Aerial view of braided channel in reach 6 of Blaeberry River.

This section of river is 2.7 km long with a low gradient of just over 1%. The valley is wide and the channel becomes very braided in this reach (Photo 20). The substrate consists of gravel, cobble, and sand with less LOD in the channel due to the reduced amount of logging in this upper section of the river. No electrofishing was carried out in this section and no fish were seen.

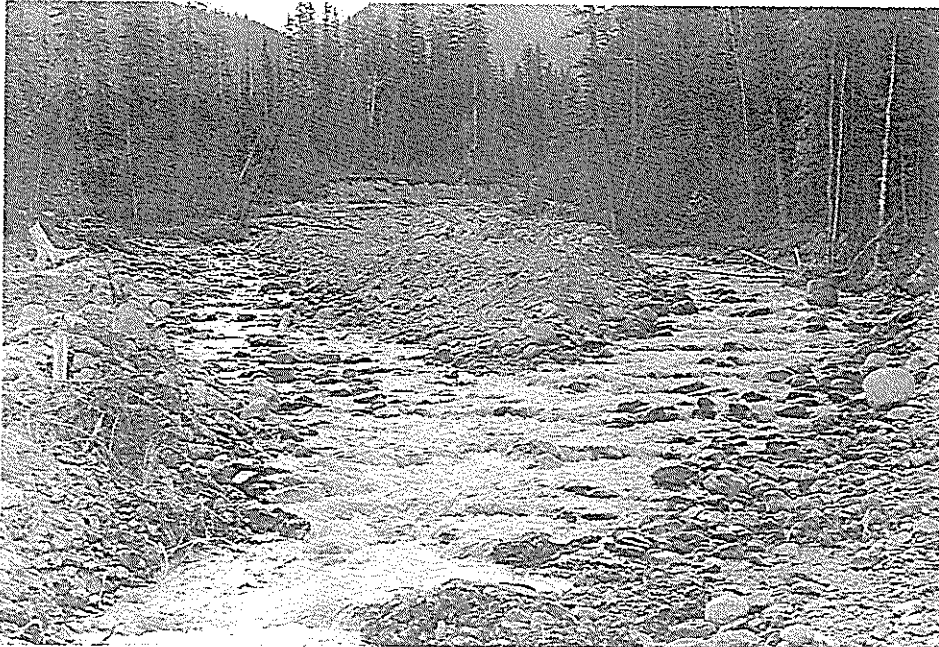
Photo 21. Split Cr. just upstream of logging road crossing.

Split Creek enters the Blaeberry River 24 km upstream of the Columbia River. The stream flows approximately 14 km originating at an elevation of 1900 m near the boundary to Yoho National Park. At the point where the logging road crosses this creek, approximately 200 m upstream from the Blaeberry River, the stream appears to be very unstable (Photo 21). There has been considerable instream work with heavy equipment to channelize the stream and protect the bridge crossing. This lower section of Split Creek contained minimal fish habitat.

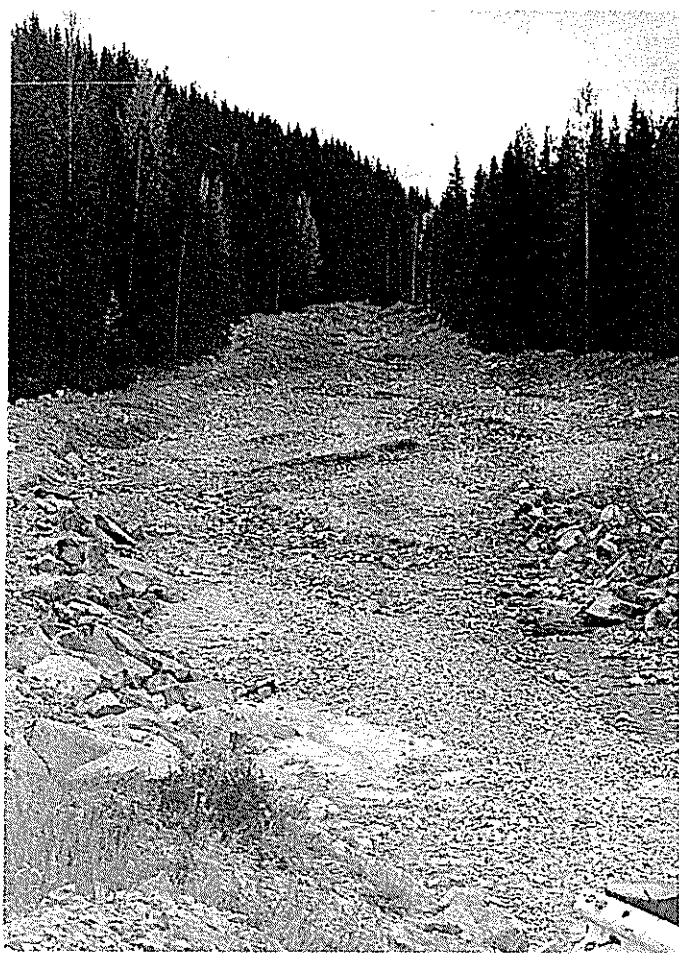
Photo 22. Hedberg Creek just upstream of road crossing.

This small creek is 8 km long entering Blaeberry River 9 km upstream from its confluence with the Columbia River. At the time of this study this creek had almost no flow. The channel indicates that it is subjected to high flood flows and the channel configuration probably changes significantly during flood events. There appears to be little fisheries potential in this creek (Photo 22).

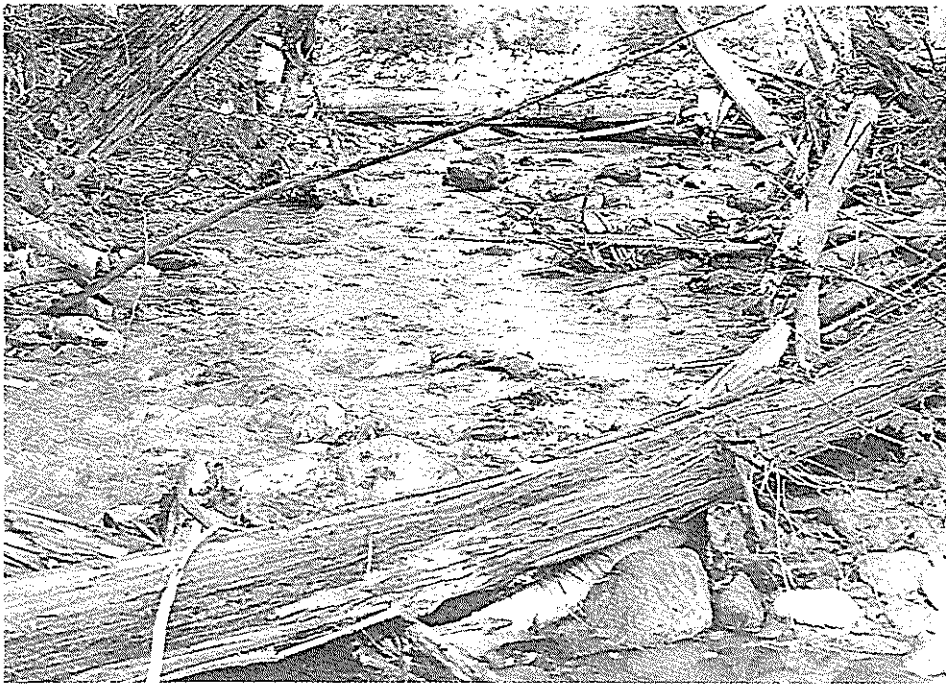
Photo 23. Willowbank Creek; section of creek that was electrofished.

This small creek is approximately 10 km long, entering Blaeberry River 14 km upstream of the confluence with the Columbia River. The lower 1 km of the creek remains unlogged and it was this section of stream that was surveyed. The wetted stream channel was 4 m across with complexes of LOD and boulders and stream side vegetation overhanging the channel. In one area just upstream from the logging road bridge crossing, a series of man-made pools had been created with small weirs of rocks and logs. Two of the pools were shocked and 12 rainbow trout between 38 and 125 mm were taken. These fish were 0+ to 2+ in age and had an average condition factor of 1.3. A riffle/pool area was shocked downstream of the bridge and 4 rainbow and 3 bull trout were collected (Photo 23). The bull trout were all young of the year while the largest rainbow, 208 mm, was 3+. These fish also had condition factors over 1. The rainbow trout showed some evidence of hybridization with cutthroat trout with characteristics such as spotted tails and yellowish marks on the throat but teeth were not evident on the base of the tongue.

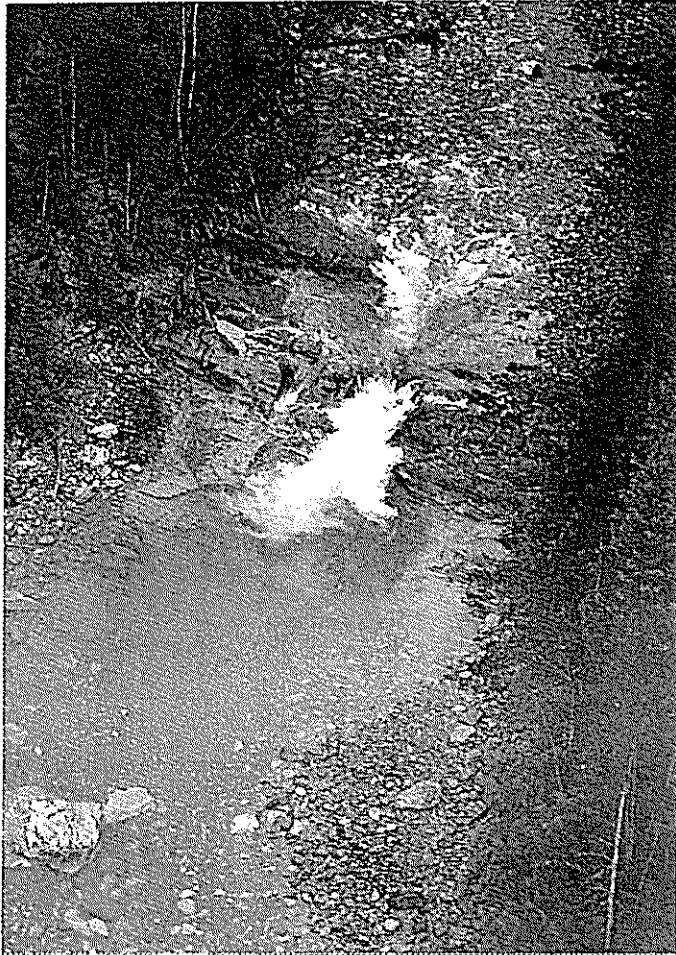
Photo 26. Approximately 2 m high waterfall in middle of reach 2 of Bluewater Creek.

high and kokanee were holding below the falls (Photo 26). Kokanee were not observed upstream of this barrier. The gradient in this reach averaged 1.6%. The substrate consisted primarily of cobble, boulders, and bedrock with occasional pockets of gravel. The stream character was primarily riffle/run with pools (Photos 27 & 28). While there was not a lot of LOD, cutbanks, or overhanging vegetation to provide cover for fish there were large boulders scattered throughout the stream channel and deep pools.

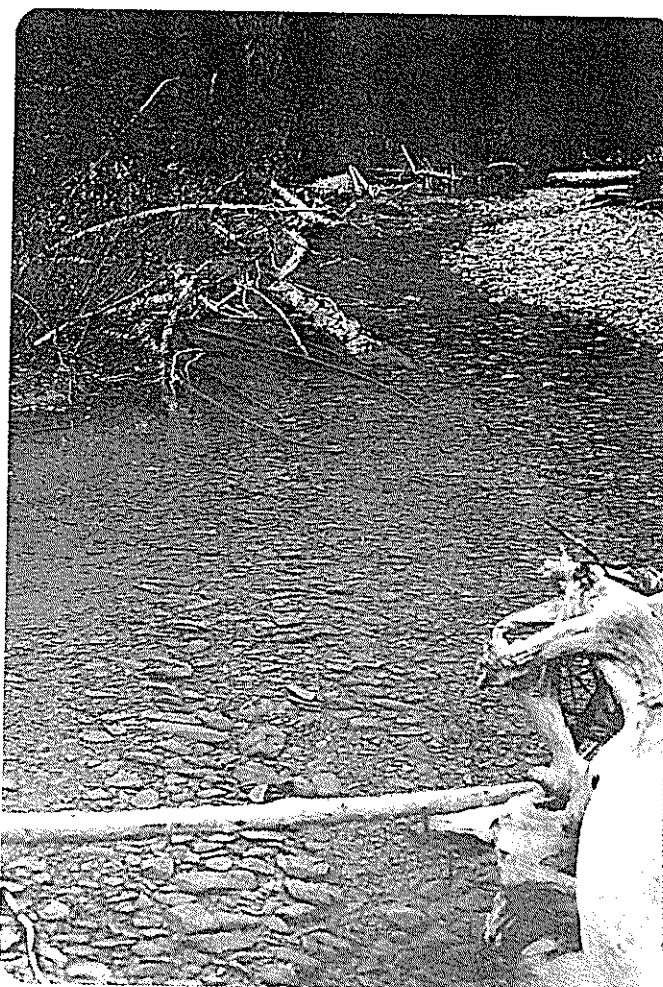
Photo 31. Side channel in reach 3, Bluewater Creek, where bull trout were collected.

Only bull trout were captured in this reach, ranging from 40 to 140 mm, ages 0+ and 1+ and the condition factors ranged from 0.75 to 1.43 with a mean of 1.01 (Photo 31). The flow of Bluewater Creek in this reach was estimated to be 1.1 m³/s with an average velocity of 0.8 m/s.

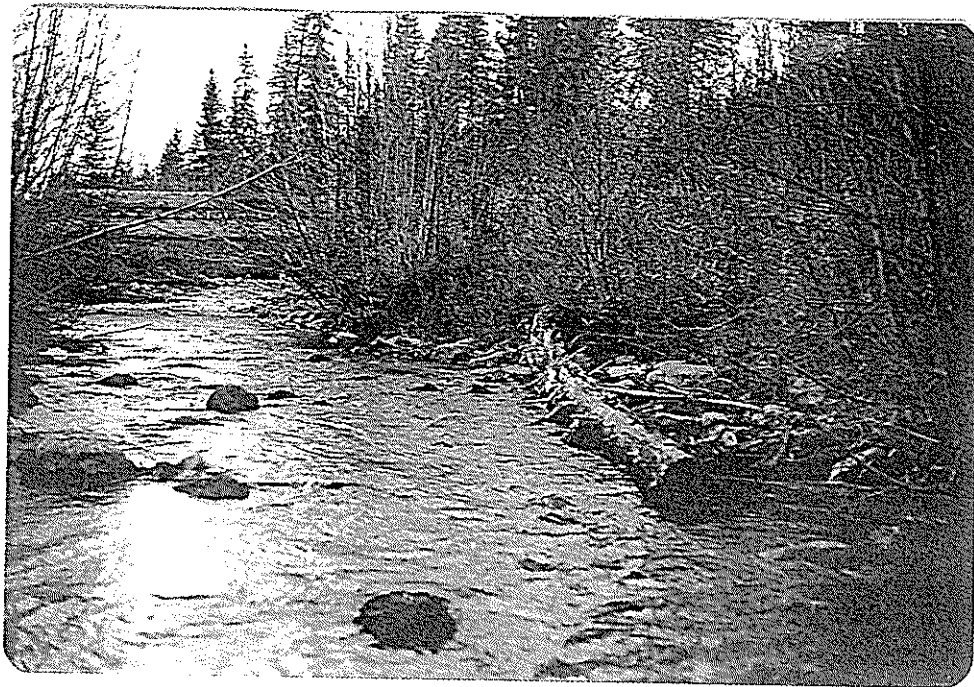
Photo 37. LOD and boulders in riffle section, site 5, reach 3, Blackwater Creek.

gravels. Fish habitat throughout the section is provided by boulders, LOD, and to a lesser extent, instream and overstream vegetation (Photo 37).

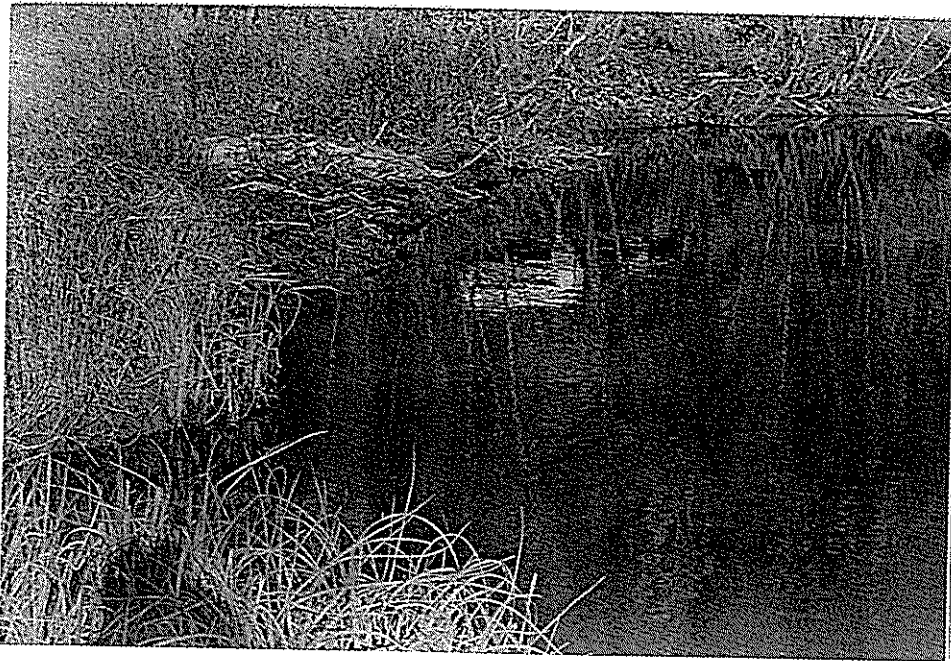
Photo 40. Section of stream electrofished at site 2, Blackwater Creek where one rainbow trout was collected.

A 30 m section of a deep glide was electroshocked (Photo 40). One 37 mm rainbow trout was captured and a salmonid approximately 100 mm long was observed. A second site in this reach representing the riffle character was shocked. This sampling collected 5 rainbow fry, all in the 0+ age group.

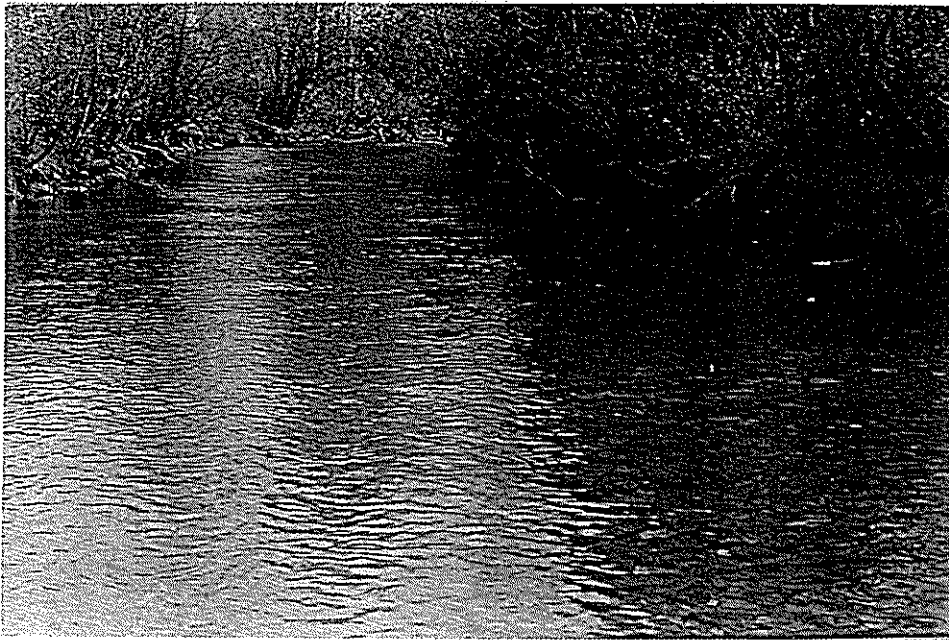
Photo 47. Straight glide in reach 4, Camp Creek.

This 5 km stretch of creek is generally low gradient with an average slope of less than 1% consisting of slow deep, meandering sections, and straight, steeper riffle areas (Photo 47). The presence of the railroad through this reach has confined the channel on the east bank as the grade is built up of rip-rap and gravel forming a berm through the marshy low land. The railroad grade has caused flooding on the

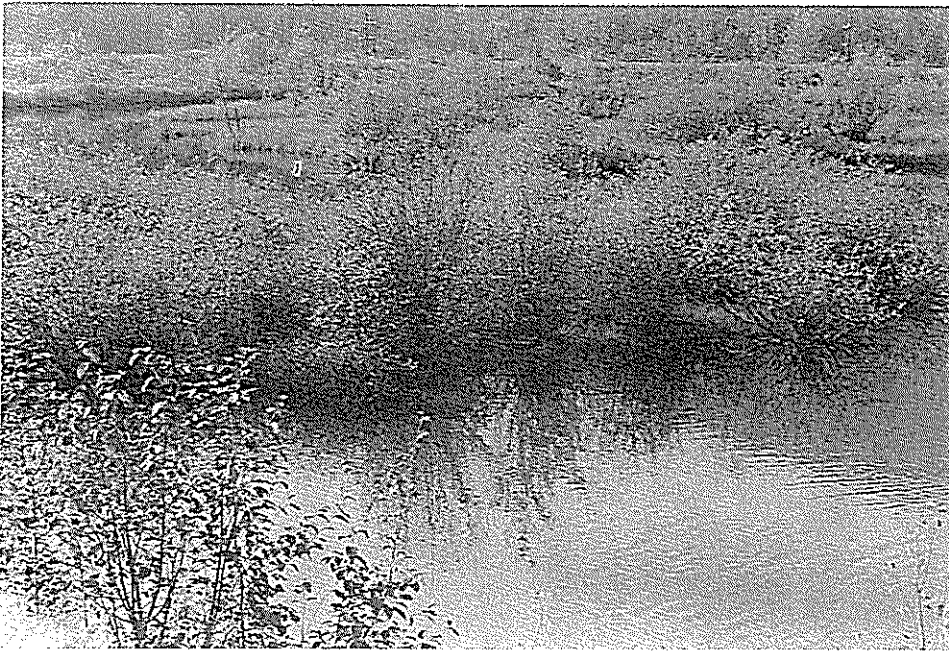
Photo 48. Ponds on east side of Camp Creek in reach 4.

east side of the berm creating a large pond (Photo 48) connected to the main channel through culverts passing under the right-of-way.

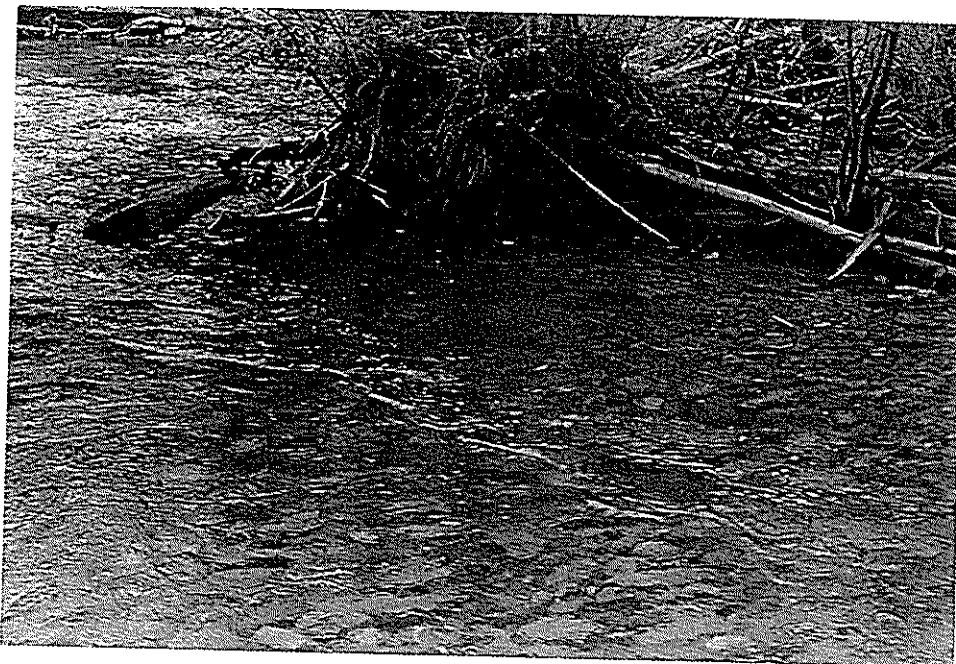
Photo 49. Bull trout fry were collected from this edge habitat in reach 4, site 11, Camp Creek.

The substrate in this area consists of gravel and cobble with sediment build up in slow moving areas. Boulders, LOD, deep pools, and cutbanks are the primary types of cover available in this area (Photo 49). Bull trout (52 - 89 mm FL) and rainbow trout (63 - 73 mm FL) and sculpins were captured in this section of stream. One of the trout collected showed evidence of hybridization with cutthroat trout with a faint red slash under the chin but teeth at the base of the tongue were not evident, however, at this size they are sometimes difficult to detect. The trout had an average condition factor of 1.1.

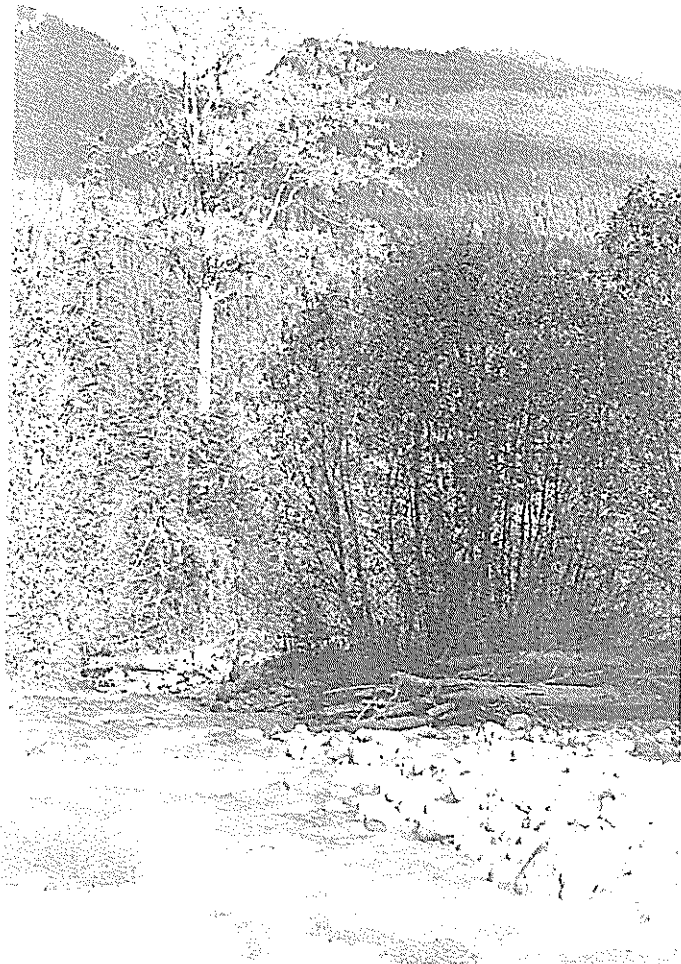
Photo 50. Representative stream channel at the lower end of reach 5, Camp Creek.

One sample site was established in the lower section of this reach where the stream was tumbling/riffle with boulders and cobble substrate (Photo 50). Flood signs indicated that there is a fair amount of flood flow outside the main channel of the stream in this area. There also existed small side channels that contained small pools and flowing water where small fry were observed, possibly bull trout. Electroshocking was not done at this site.
