**An Inventory of Watershed Conditions
Affecting Risks to Fish Habitat
in the
CARIBOO, COTTONWOOD & HORSEFLY
WATERSHEDS**

VOLUME II
Cottonwood River Watershed
(Sections 1 to 5 & 7)

**Prepared for
CARIBOO REGION INTERAGENCY MANAGEMENT COMMITTEE
Williams Lake, BC**

**by
CHAPMAN GEOSCIENCE LTD.
Nanaimo, BC
&
DOBSON ENGINEERING LTD.
Kelowna, BC**

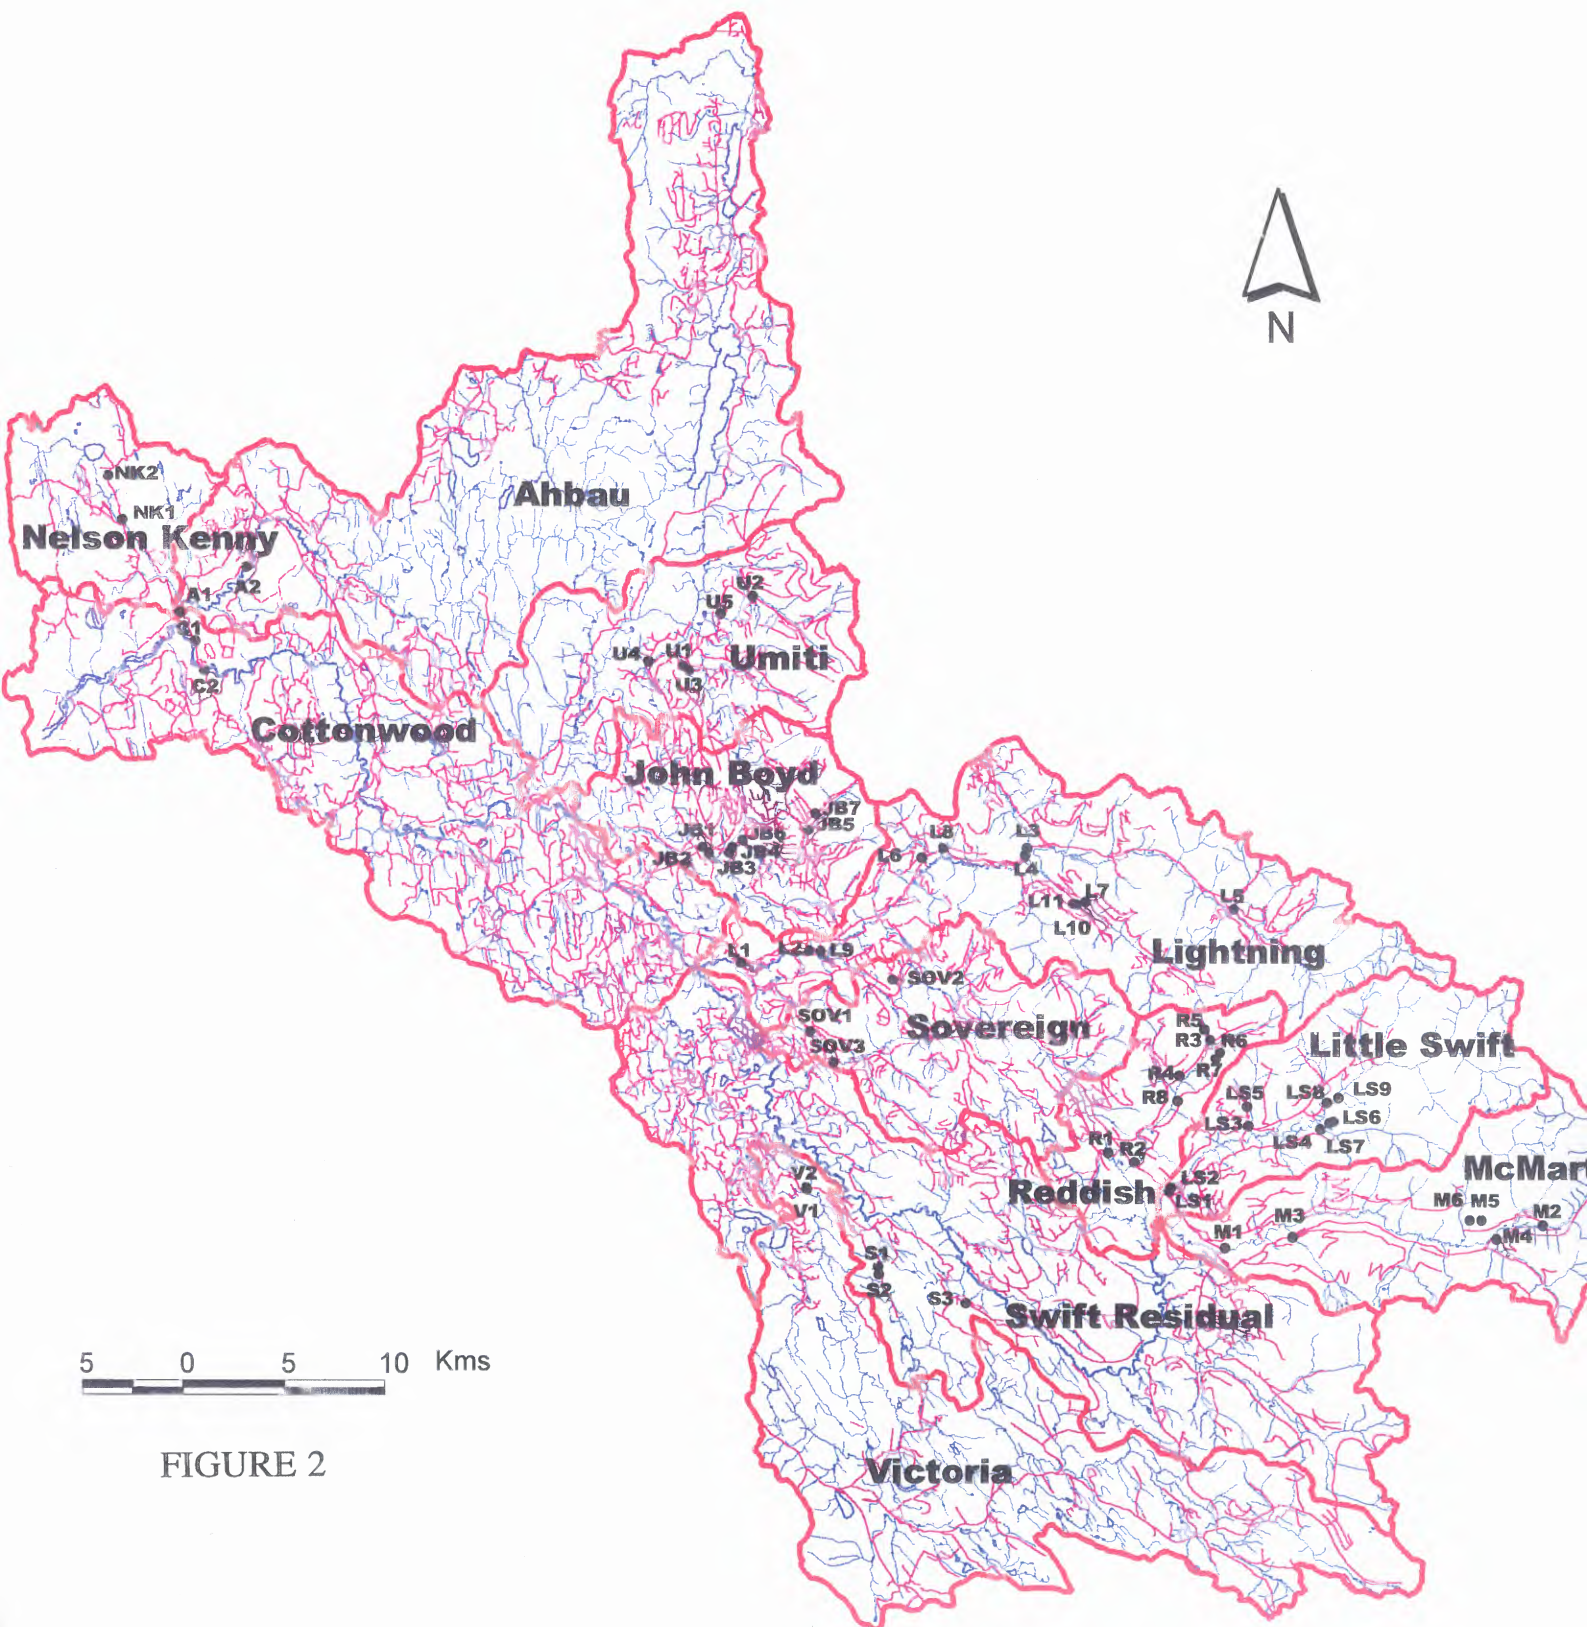
FIGURE 2

• Location of channel and road assessments, and photos referenced within text

The Cottonwood River watershed has a drainage area of 2,474 km². The watershed is located east of Quesnel, with the confluence with the Fraser River situated north of Quesnel [Figure CW1]. The characteristics of the watershed and its sub-basins are presented in Table 1. The sub-basins are shown on Figure 2.

The inventory results indicated that channel disturbance related to land use is common in portions of the Cottonwood River watershed. Channels in Lightning Creek have been disturbed by placer mining activity [*Sites L1, L2, L3, L4 and L5*] [*Figure 2*] and in John Boyd Creek the disturbance is associated with harvesting in the riparian zone (pre-FPC) [*Sites JB1, JB2, JB3, JB4 and JB5*]. The impact of these disturbances was indicated by:

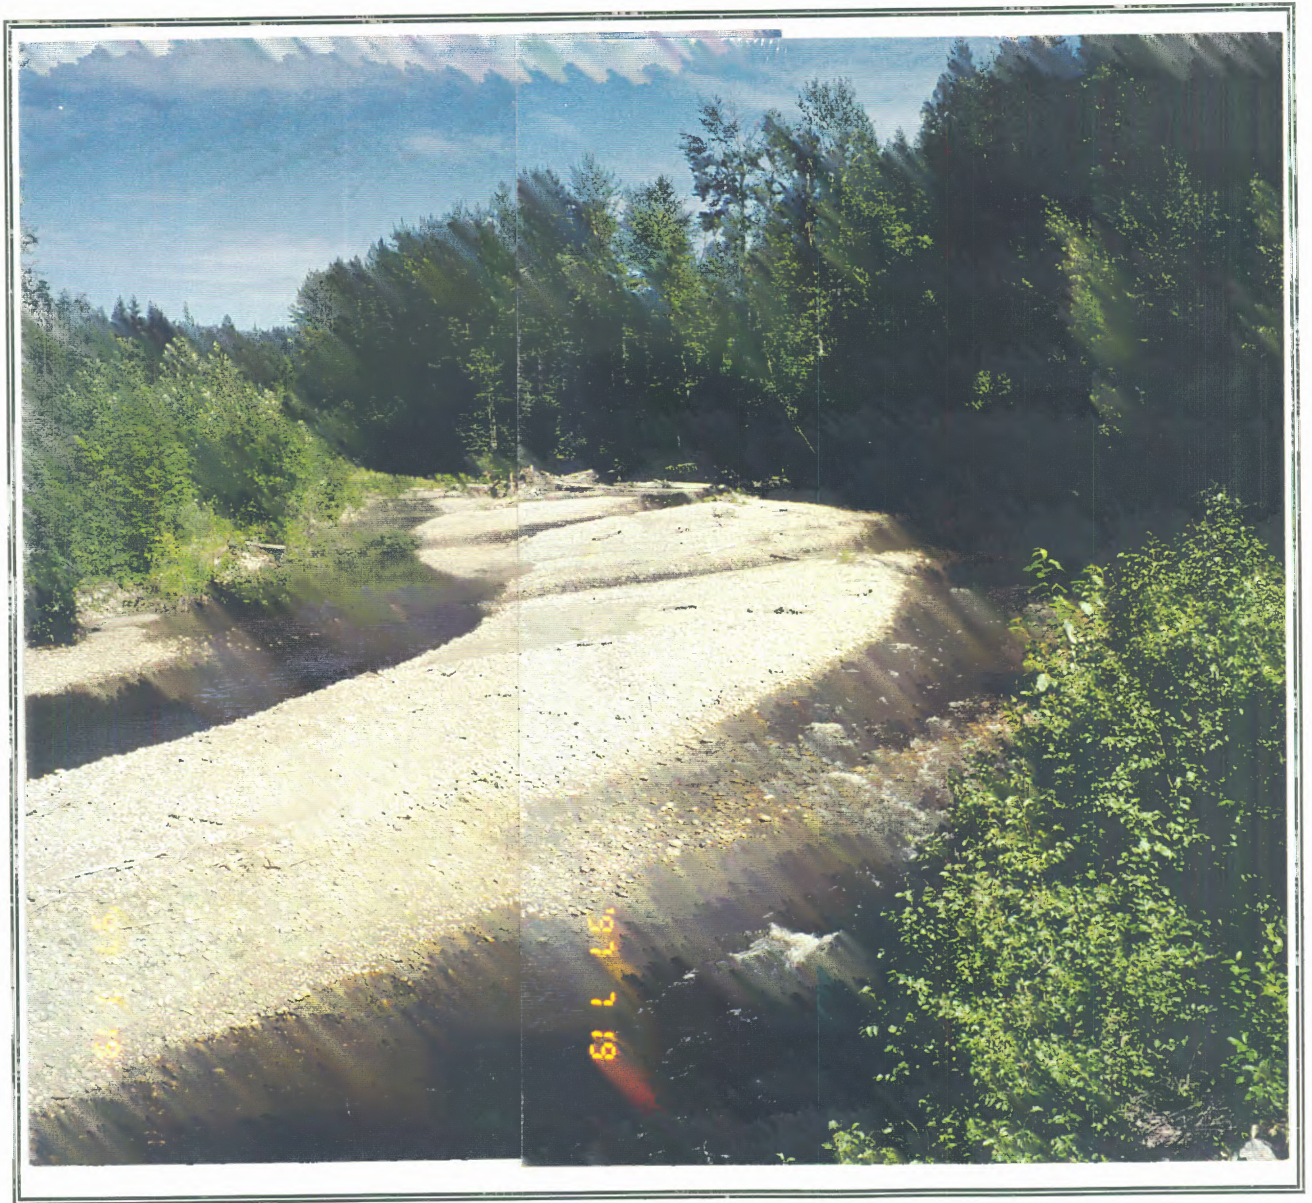
SITE A1. Lower Ahbau Creek, upstream of the Cottonwood River. This is an aggrading reach. Note the large, elevated mid-channel bar. Some bank erosion is evident here.

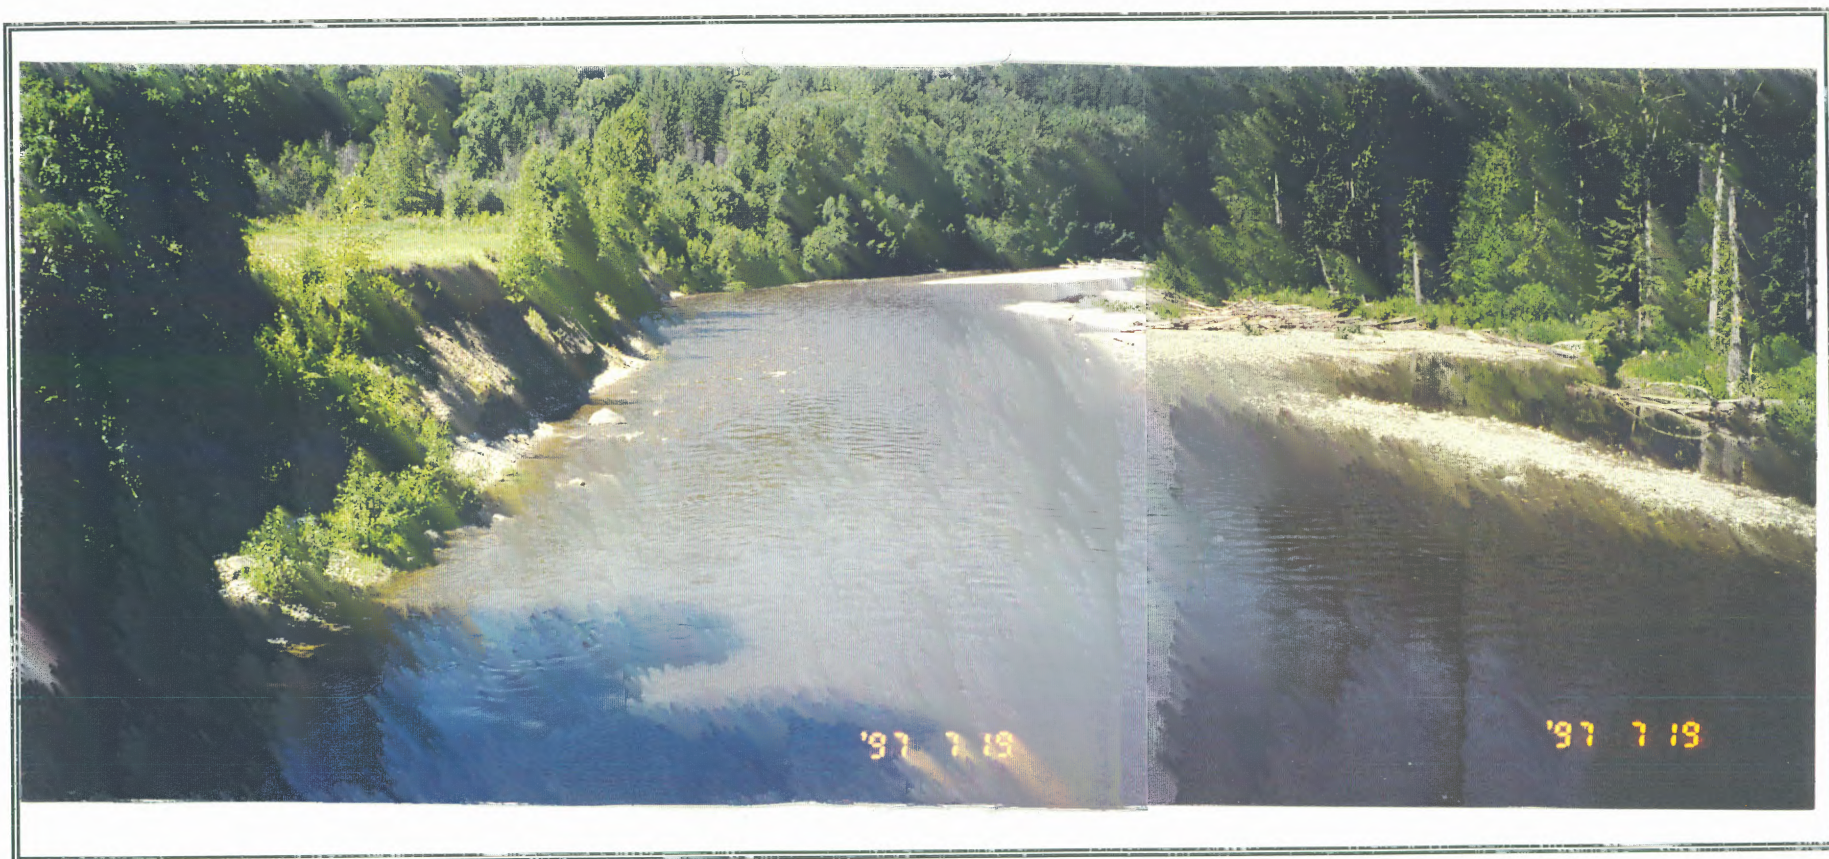
SITE C2. Cottonwood River mainstem channel, below Ahbau Creek. This is a wide, low gradient alluvial channel. Note the erosion into glaciofluvial gravels on the left bank.

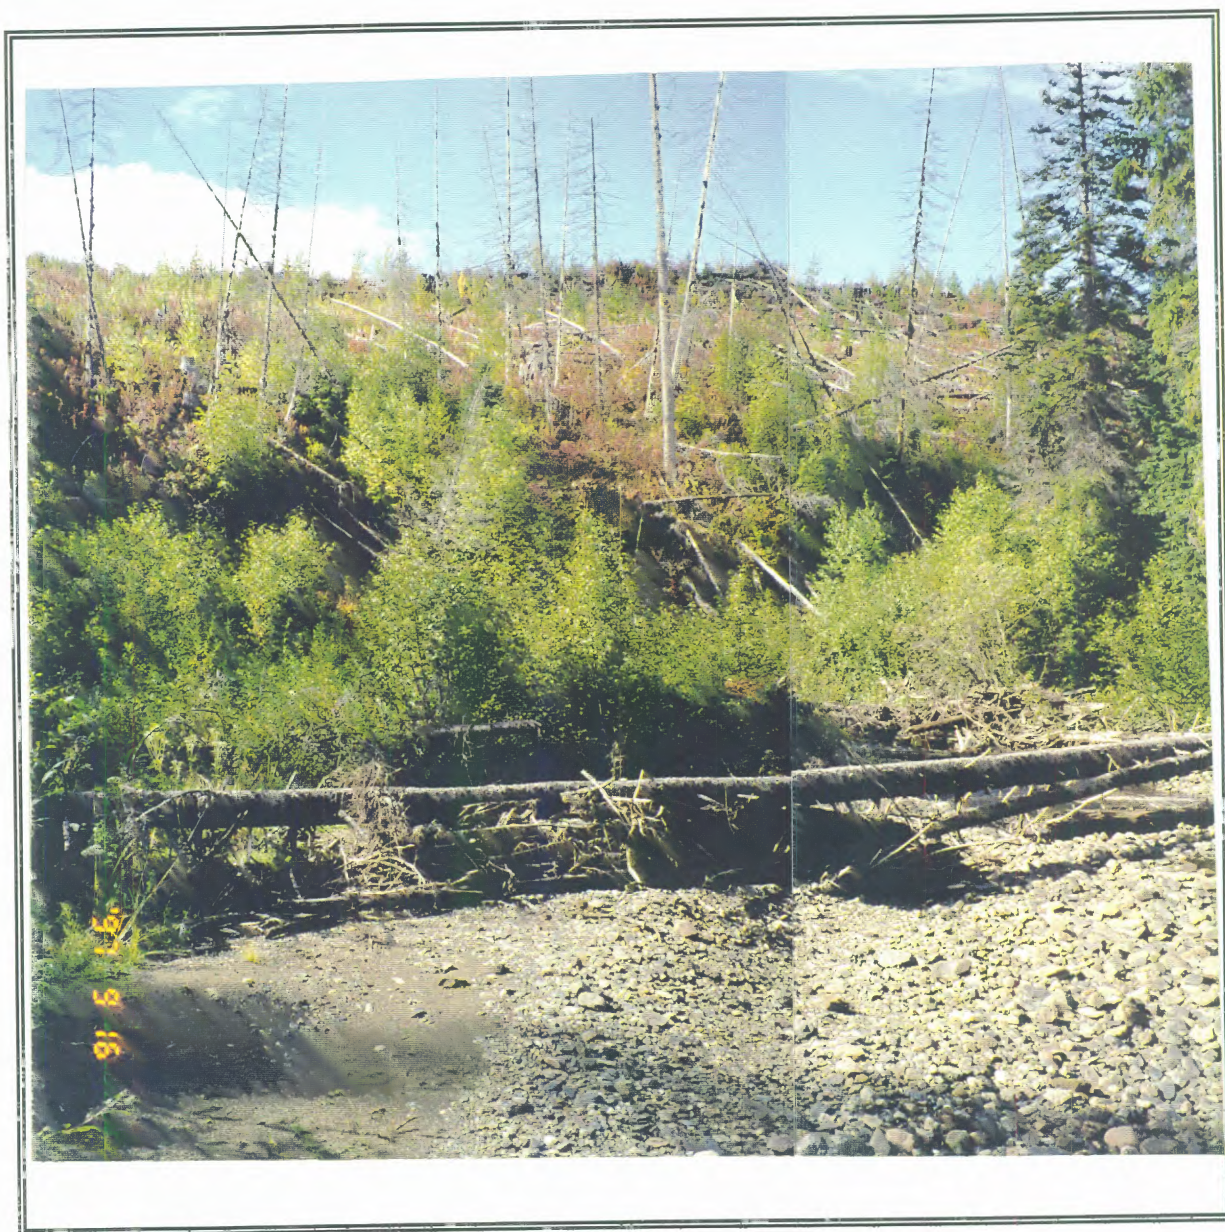
SITE JB4A. John Boyd Creek. A narrow riparian fringe of trees was apparently left during harvesting. The trees subsequently have been killed by fire. Note the bank erosion just below the dead trees, where John Boyd Creek is incising into a fluvial bank deposit.

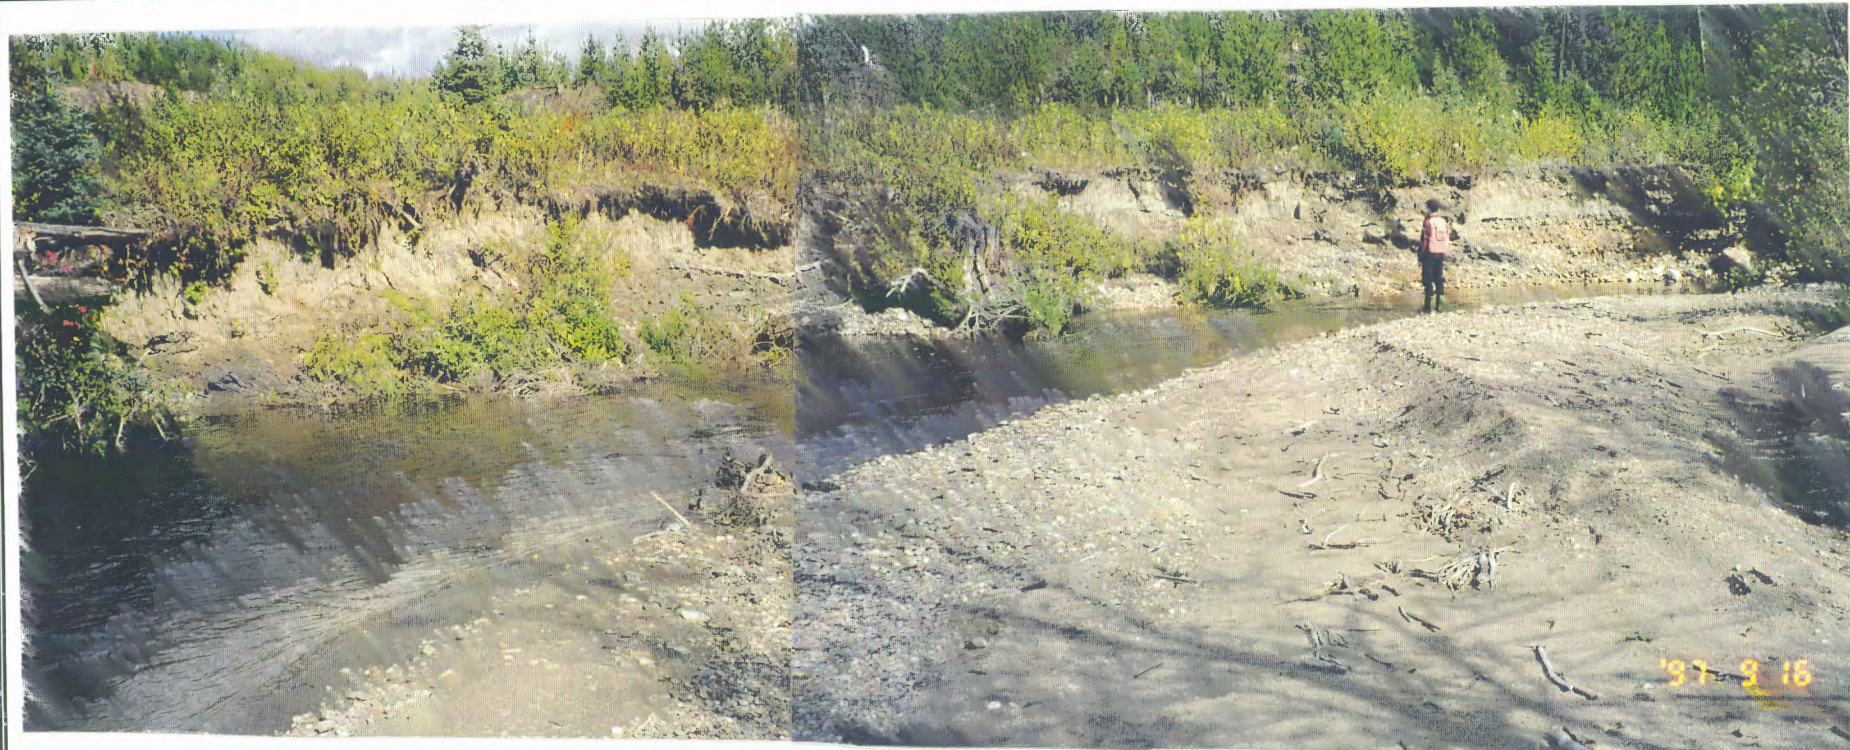
SITE JB4B

Large eroding fine textured bank on lower John Boyd Creek.

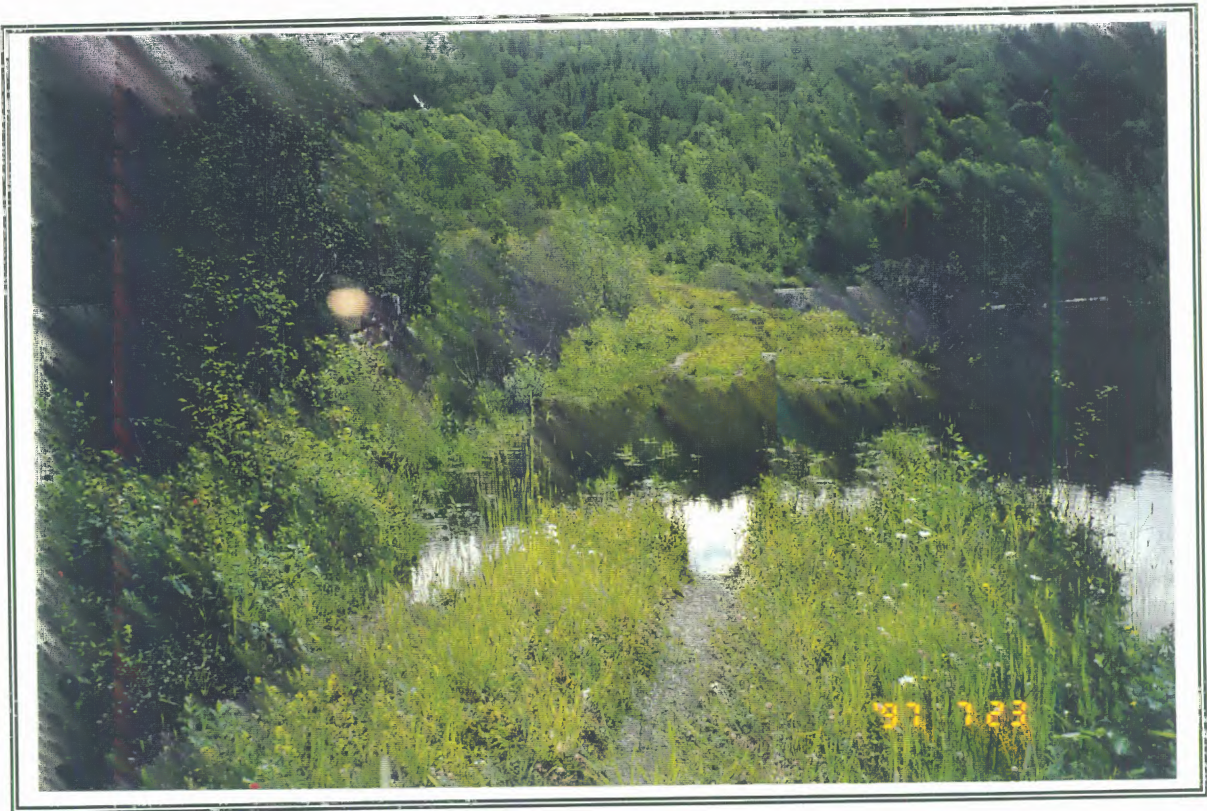
SITE JB5. John Boyd Creek. This reach has severe bank erosion and lateral shifting through fine-grained fluvial sediment. This erosion is partly the result of the riparian logging (circa 1980).

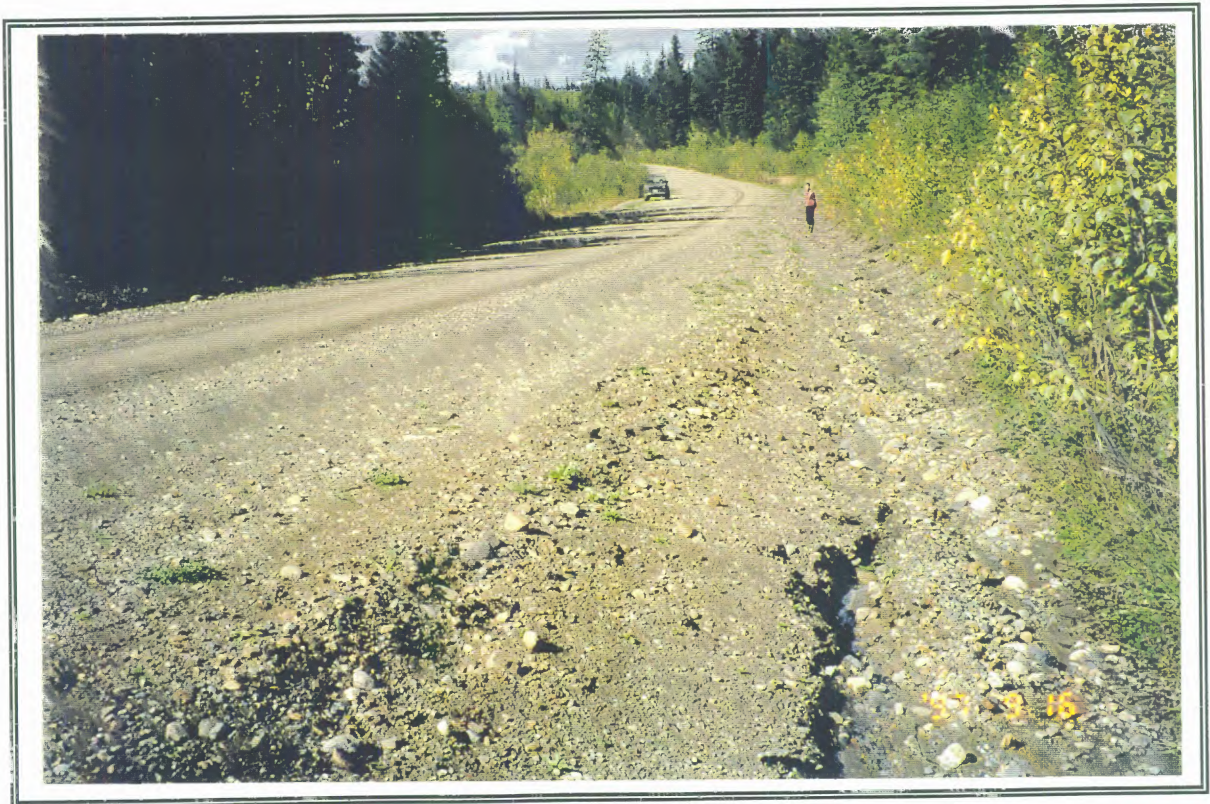
SITE JB6. Ditch erosion in the John Boyd Creek basin. This ditch drains about 150-200 m of road, and discharges directly into John Boyd Creek. The road itself is stable, but the ditch erosion transfers fine sediment into the creek.

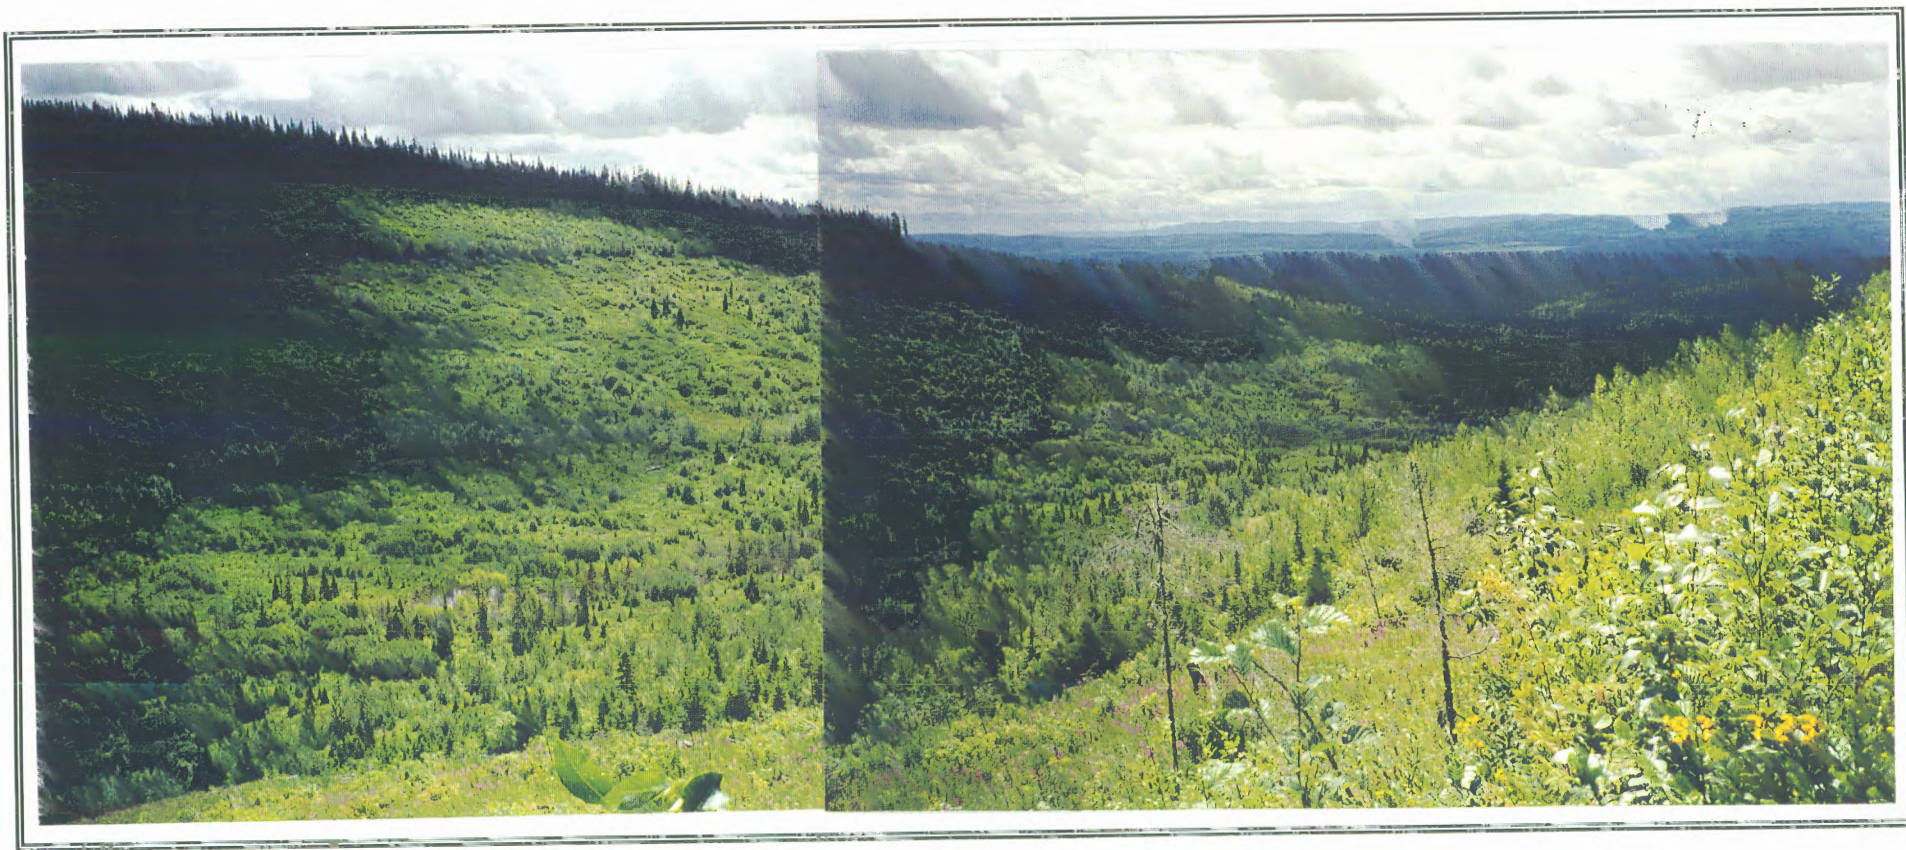
SITE JB7. Panorama across the Mary Creek sub-basin of John Boyd Creek, indicating the extensive harvesting that has occurred.

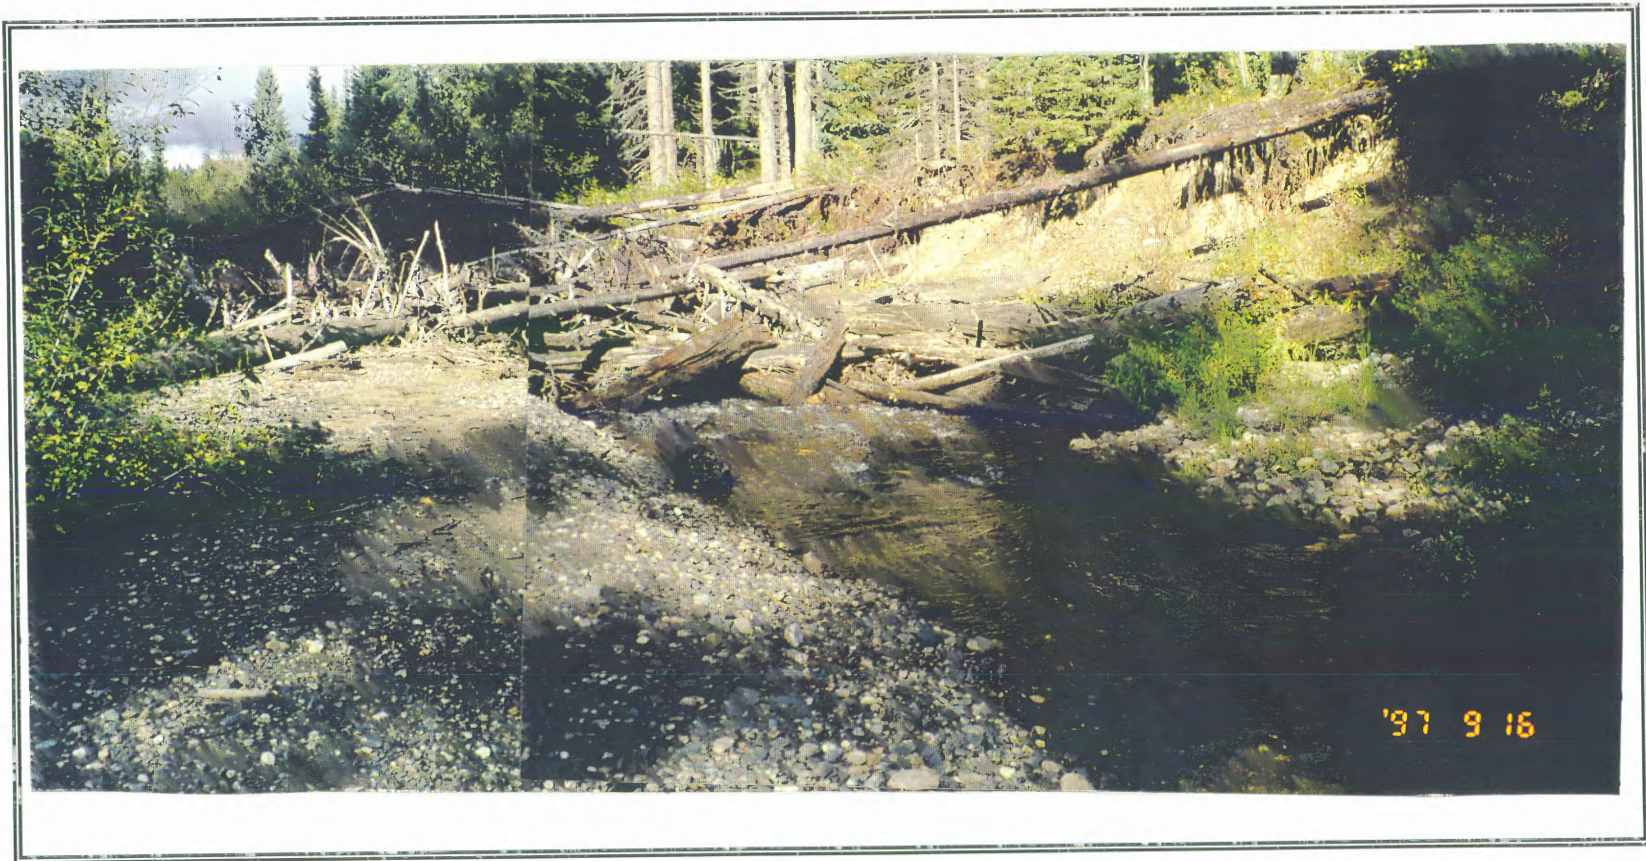
SITE JB3. John Boyd Creek. This reach is experiencing severe bank erosion, widening, and aggradation.

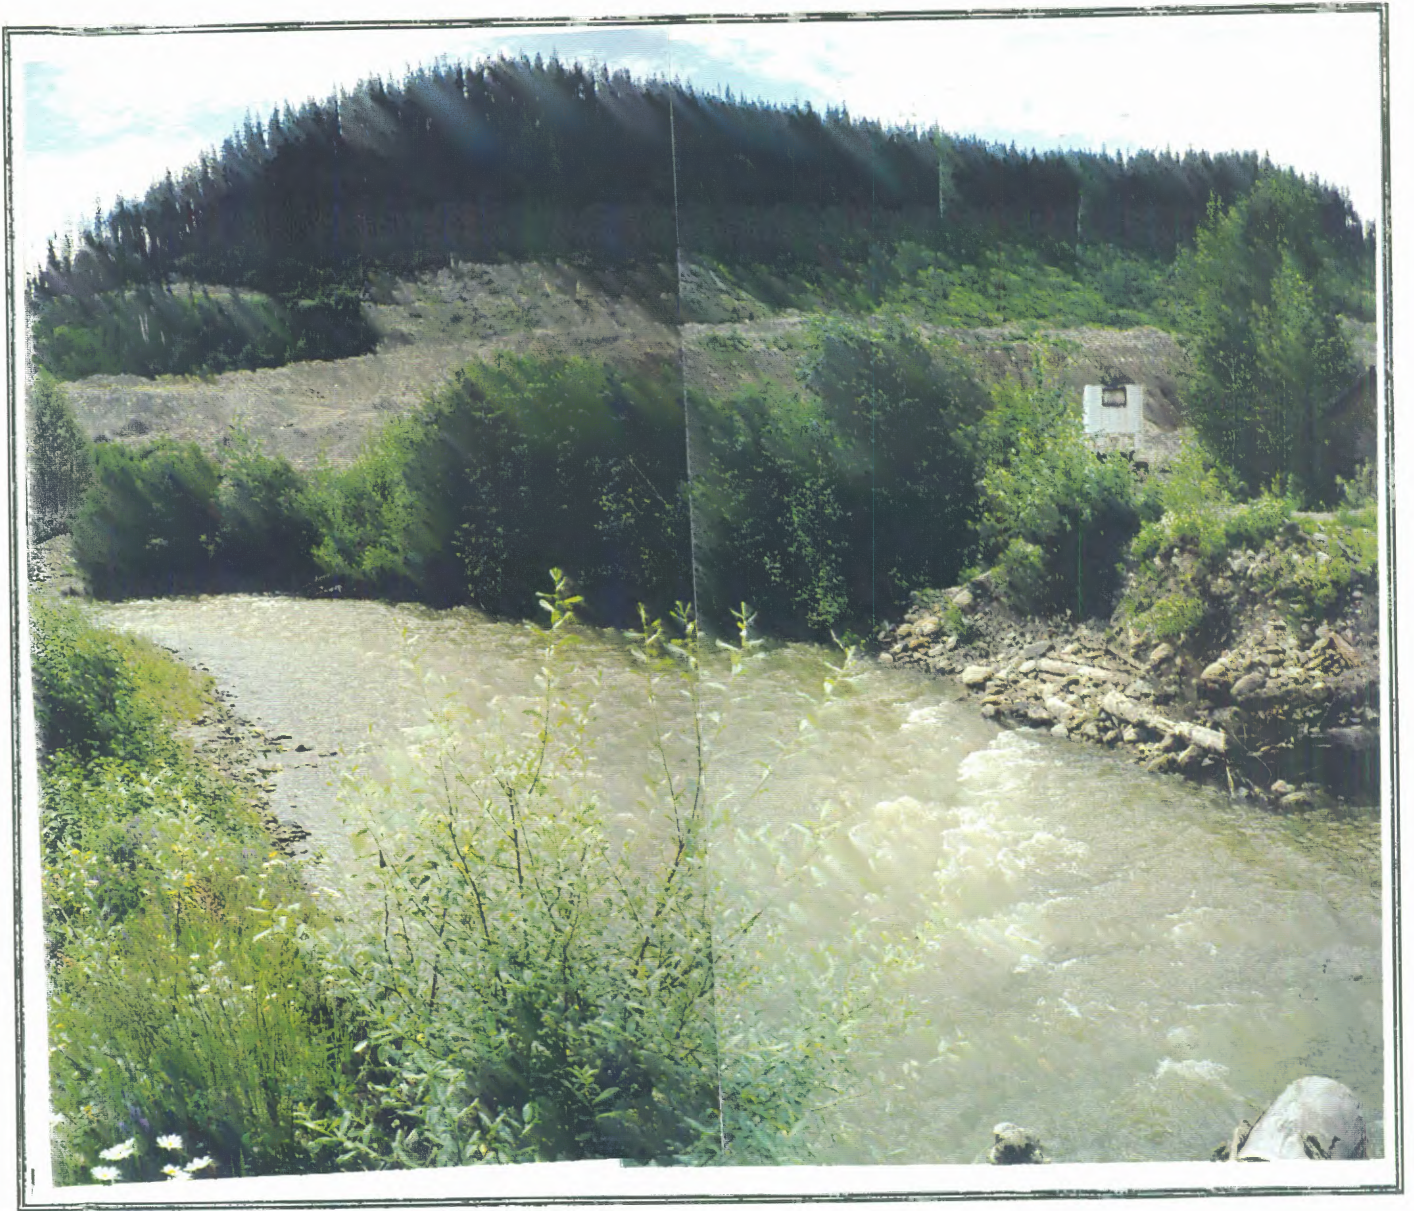
SITE 12. Active placer mining operation on Lightning Creek. A narrow band of riparian vegetation has been maintained along the stream bank, providing some stability. However, gravel and sand still enter Lightning Creek from the operation, from locations where there is no riparian vegetation.

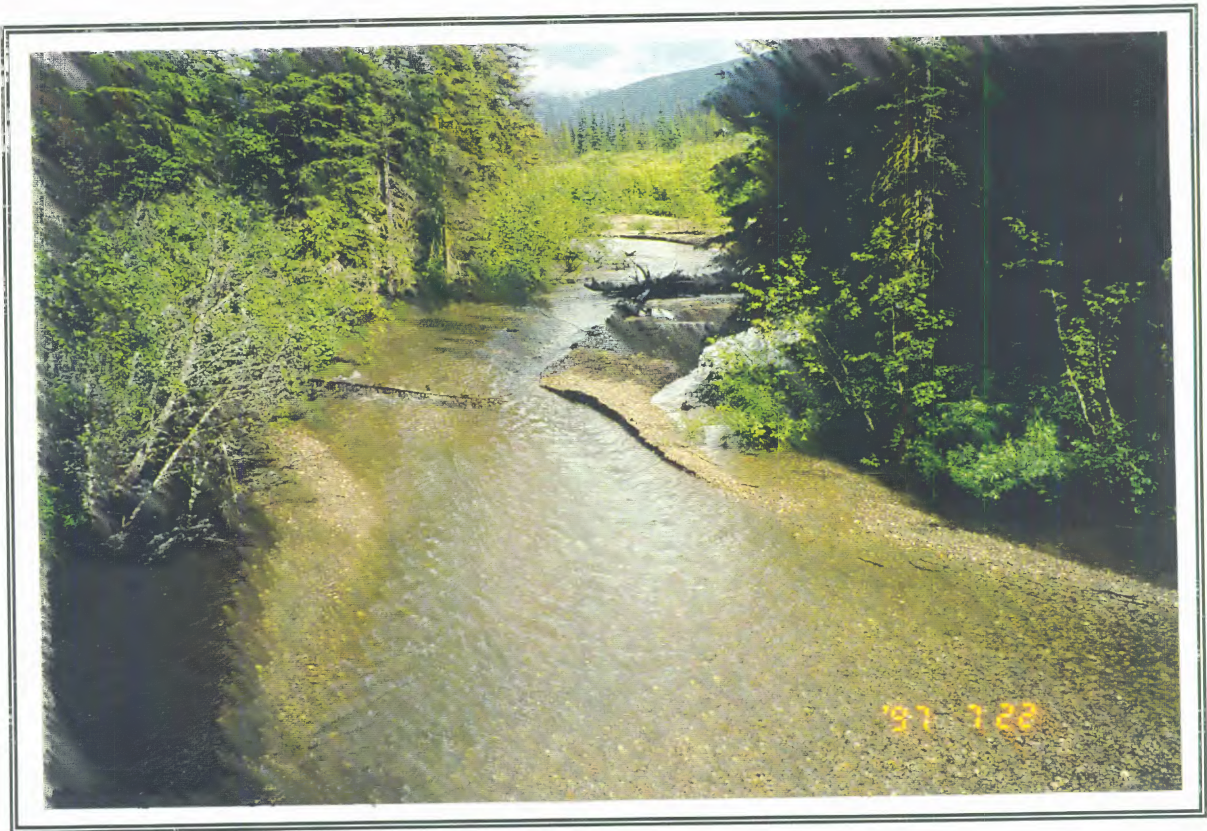
SITE L3. Lightning Creek. This reach is about 200-400 m downstream of a floodplain with historic placer mining. The channel is aggraded.

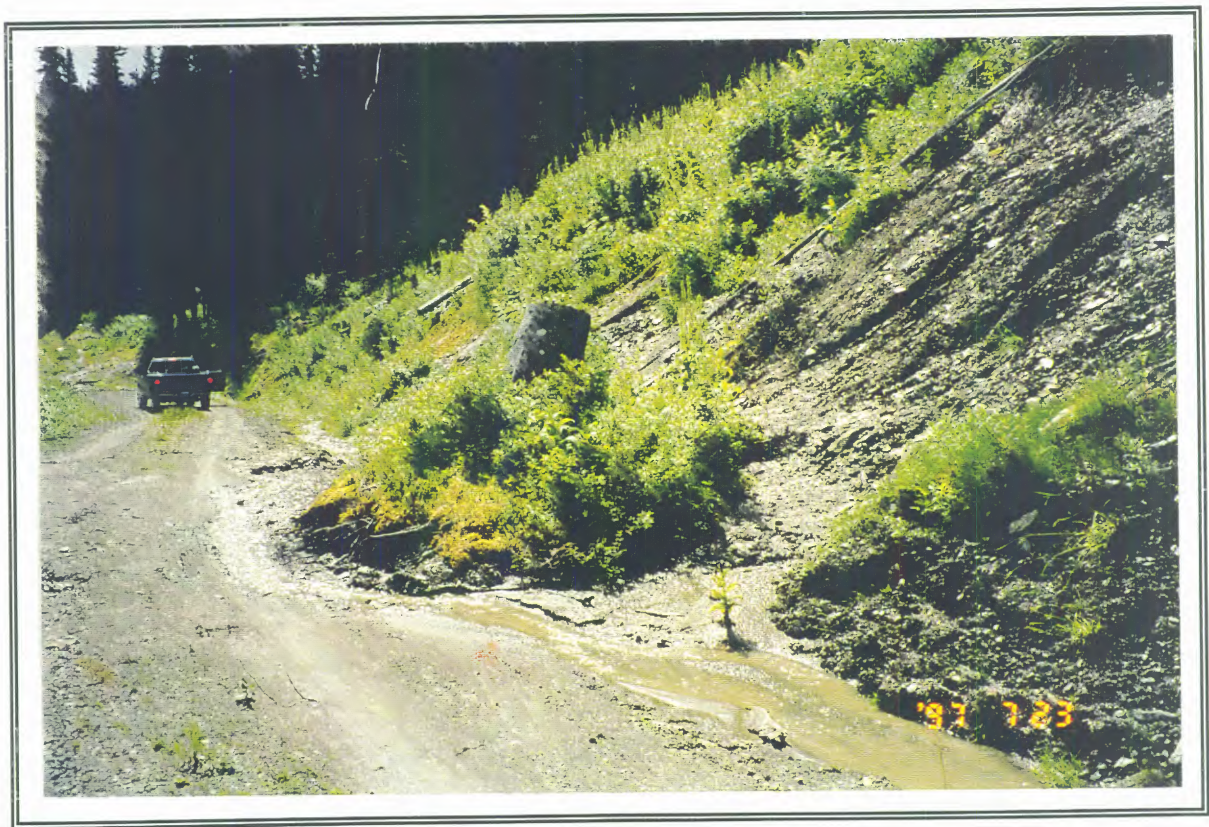
SITE L11. Cut slope slumping and ditch erosion in the xxx sub-basin of Lightning Creek. This piece of road needs increased cross-drain frequency to remove the runoff water from the ditch.

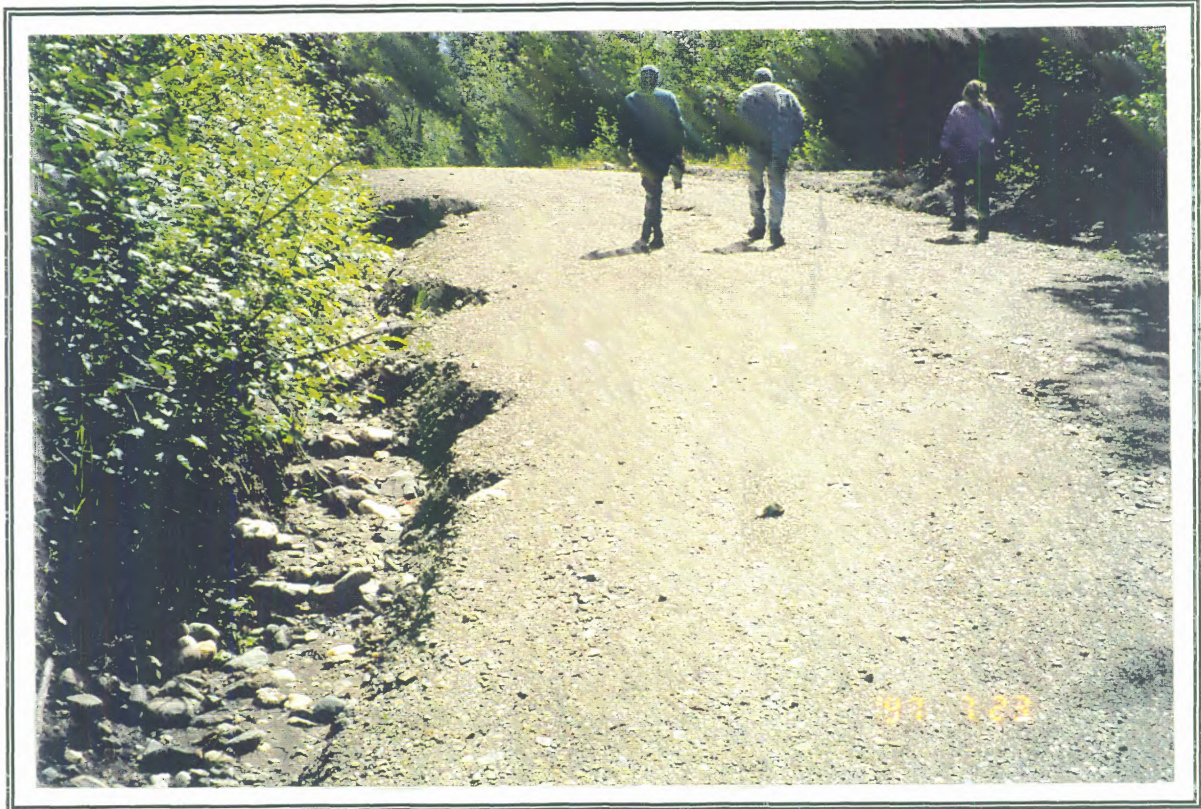
SITE L9. Ditch erosion along a mining road in the lower Lightning Creek watershed. This ditch discharges directly into Lightning Creek.

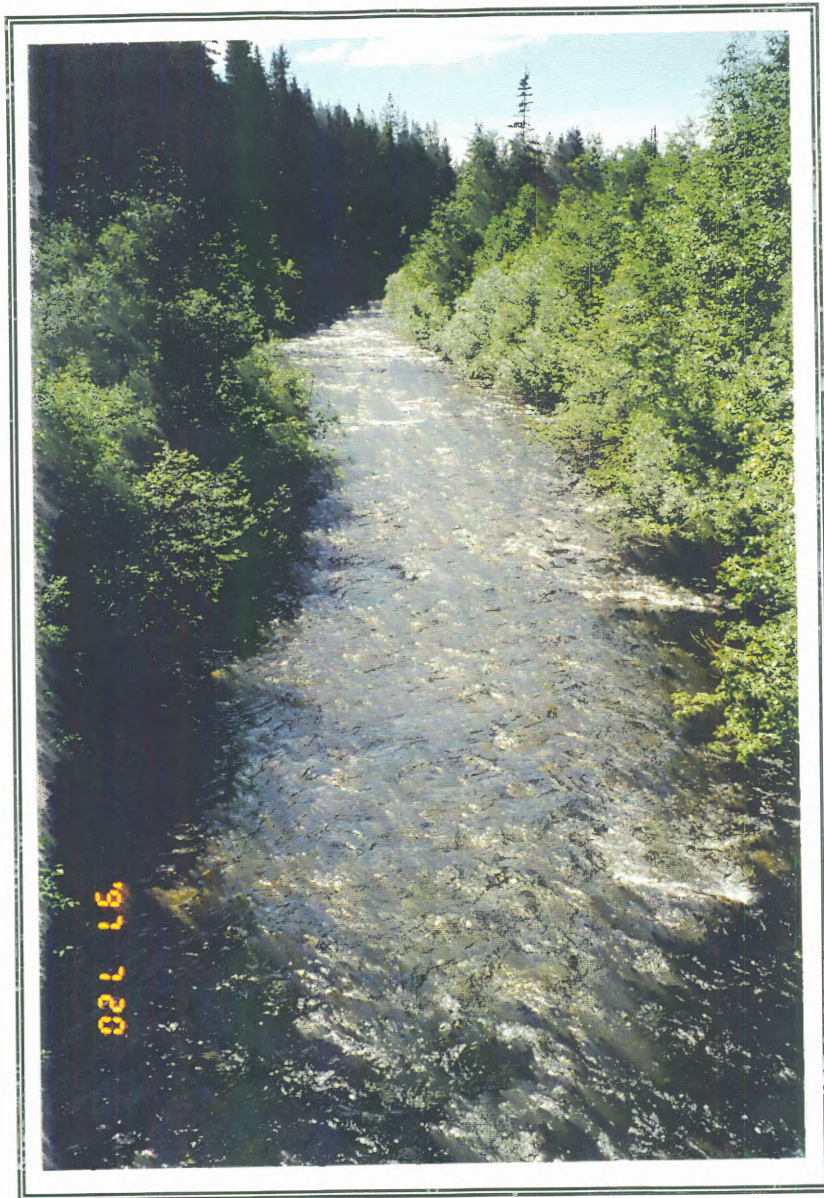
SITE LS1. The lower mainstem channel of the Little Swift River. This reach has been placer mined. Channel disturbance is minimal.

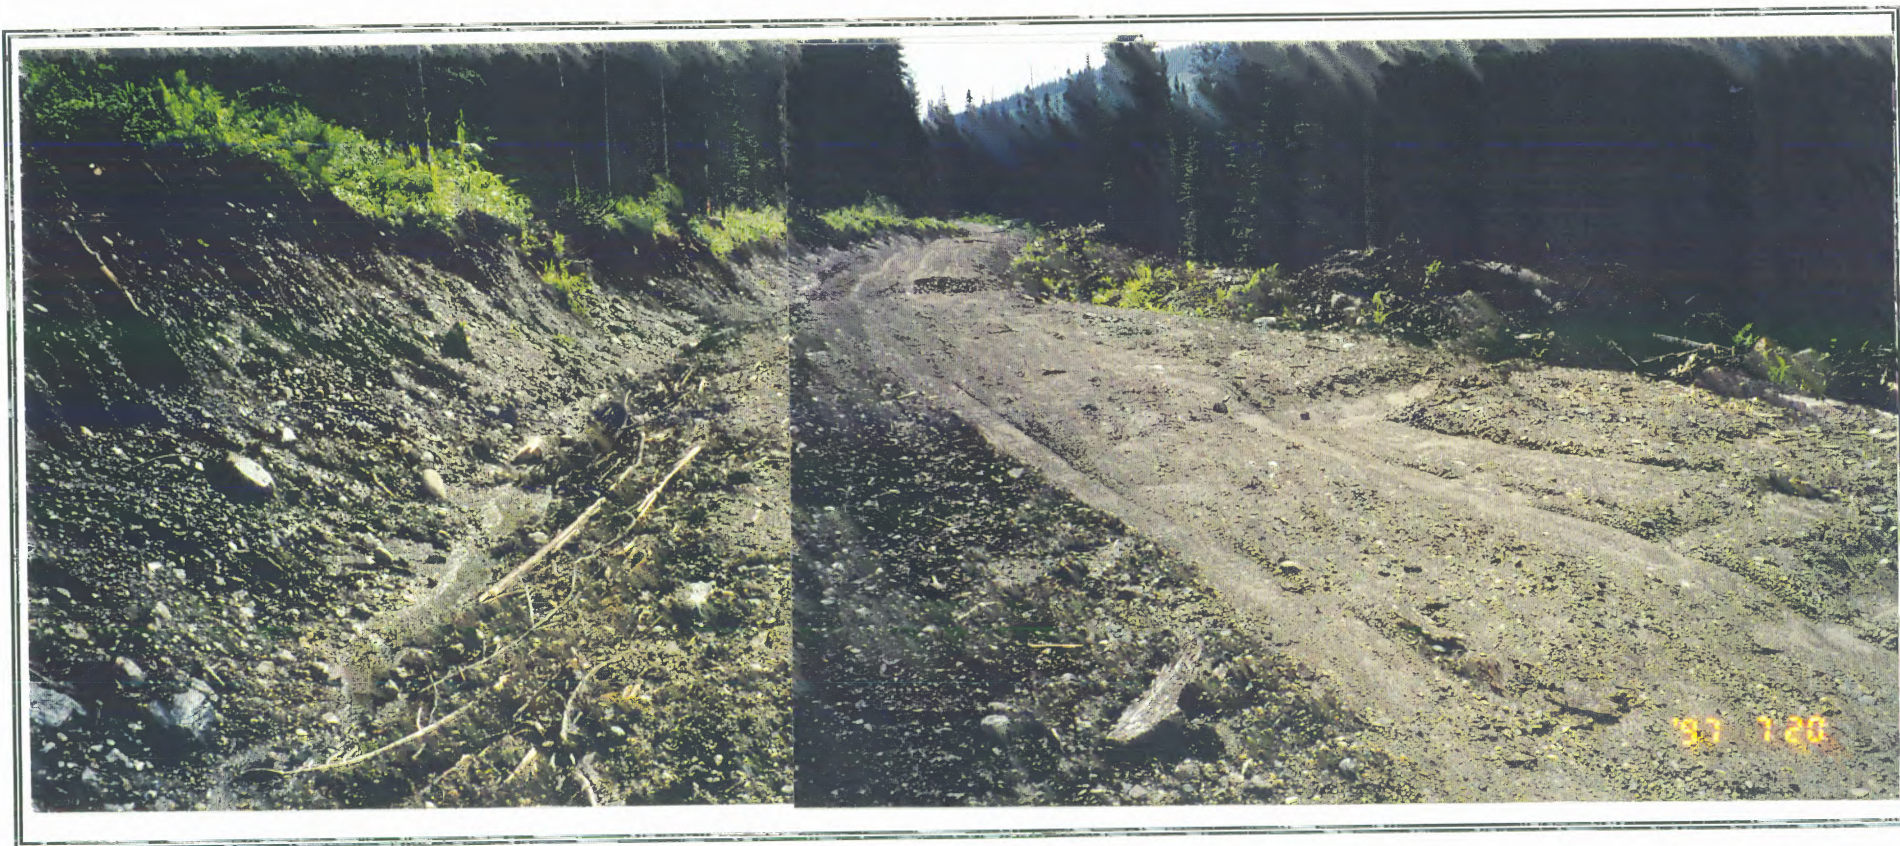
SITE LS6. A recently constructed road in the upper Little Swift River basin. The site disturbance and lack of erosion control has resulted in large amounts of fine sediment being transferred to a tributary stream.

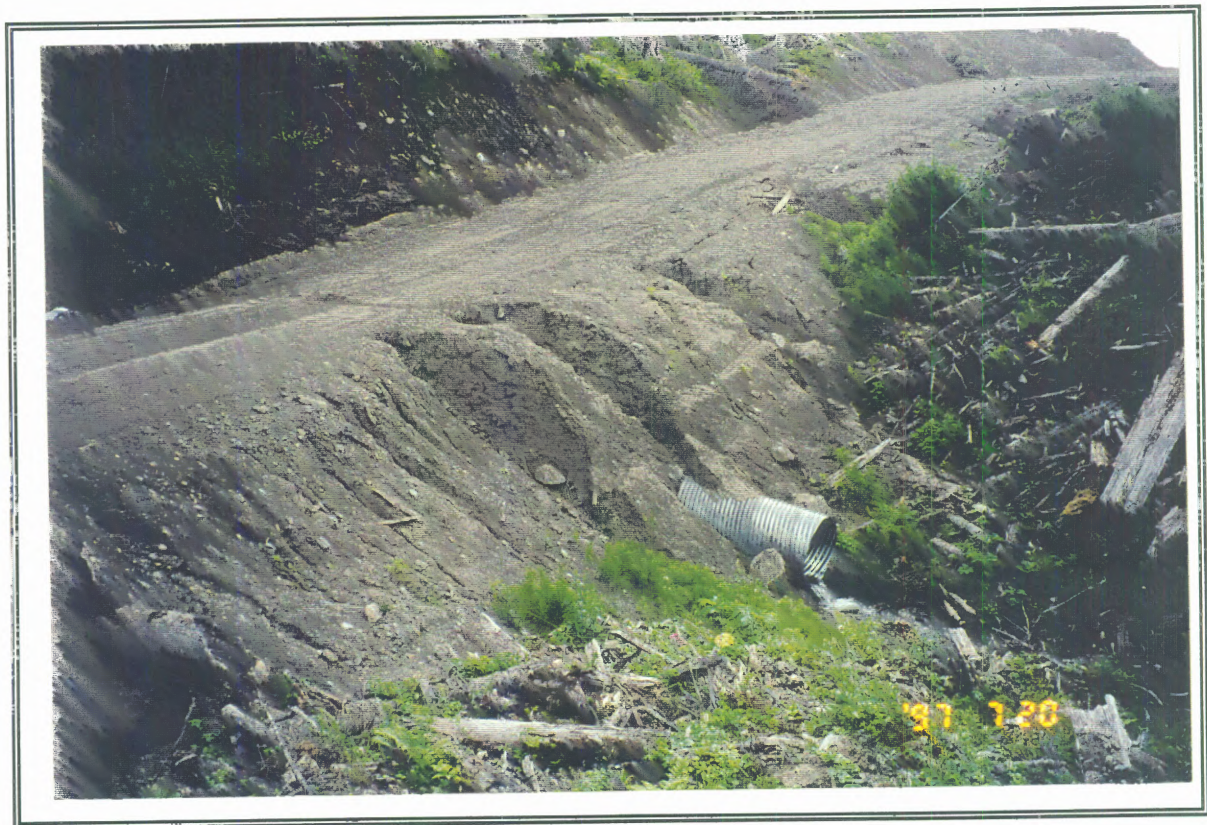
SITE LS7. A recently constructed road in the upper Little Swift River basin. At this site the fine-textured road fill is being eroded by water flowing along the road surface and ditch. The eroded sediment discharges directly into a tributary to the Little Swift River.
