**An Inventory of Watershed Conditions
Affecting Risks to Fish Habitat
in the
CARIBOO, COTTONWOOD & HORSEFLY
WATERSHEDS**

VOLUME II
Cottonwood River Watershed
(Sections 1 to 5 & 7)

**Prepared for
CARIBOO REGION INTERAGENCY MANAGEMENT COMMITTEE
Williams Lake, BC**

**by
CHAPMAN GEOSCIENCE LTD.
Nanaimo, BC
&
DOBSON ENGINEERING LTD.
Kelowna, BC**

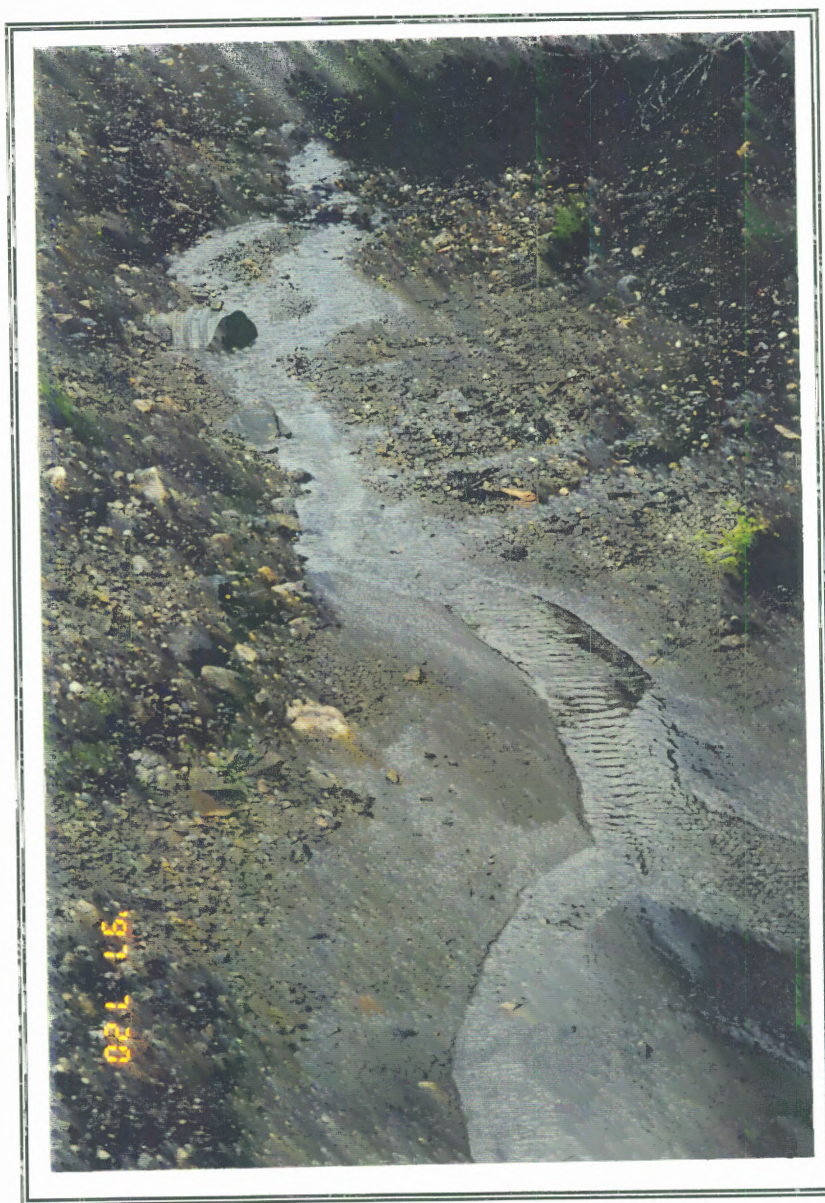
SITE LS8. An aggrading ditch line in the Little Swift basin. There is active erosion along the ditch and cut slope, and sediment is infilling the culvert.

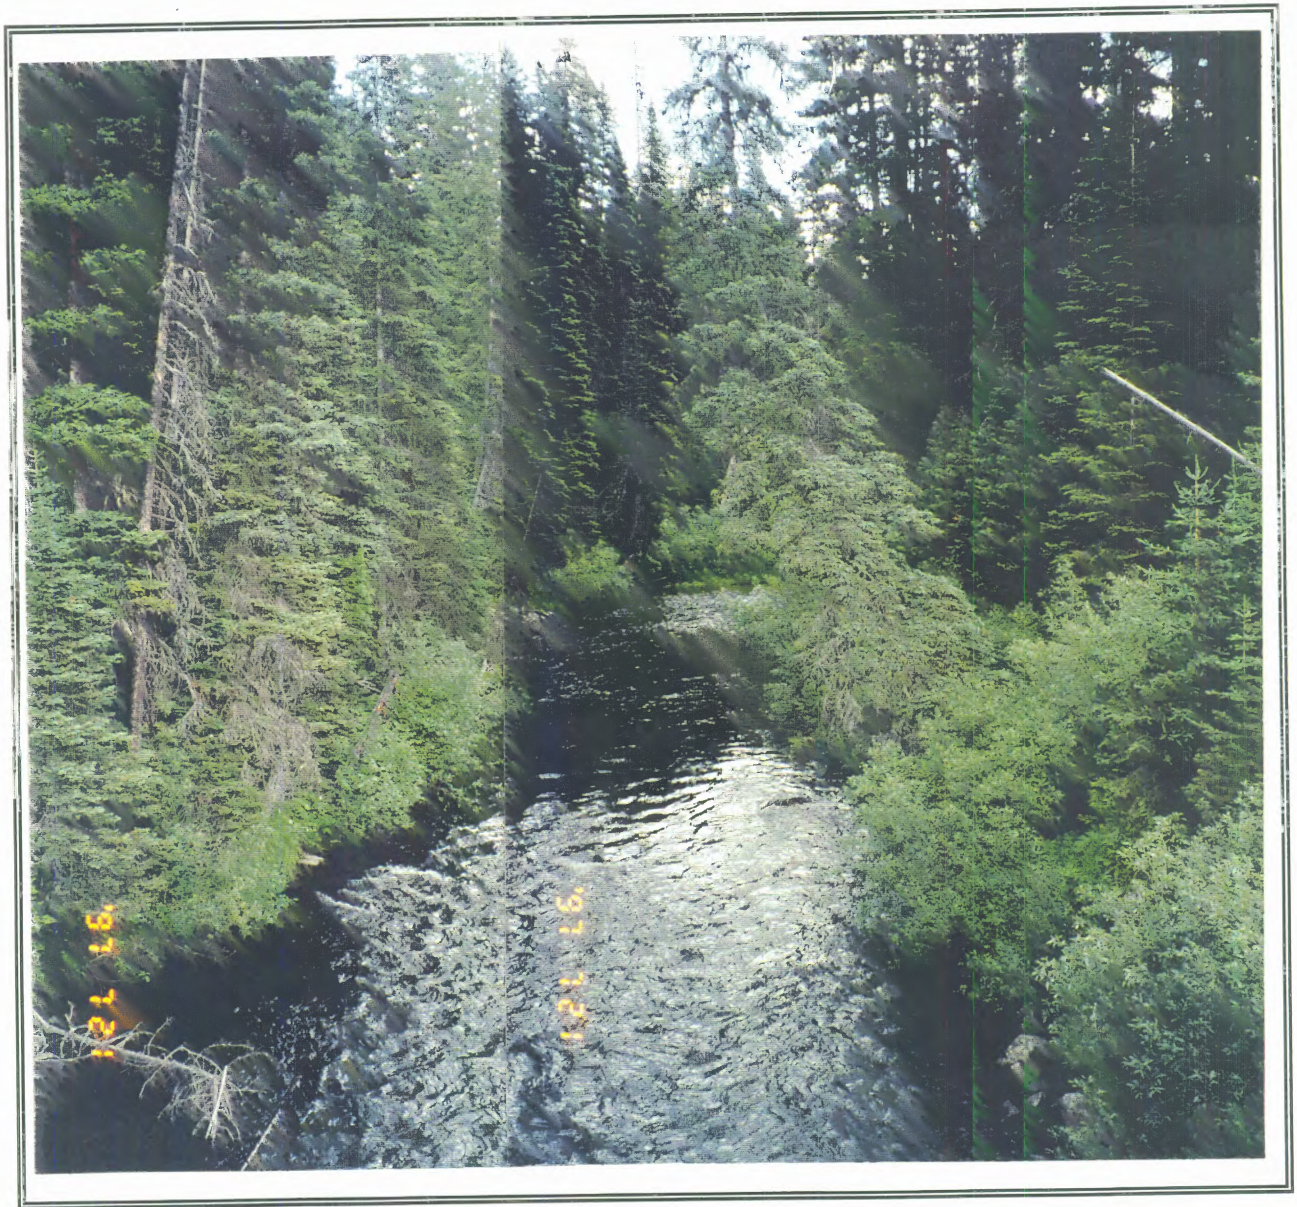
SITE M1. The rather lovely mainstem channel of McMartin Creek.

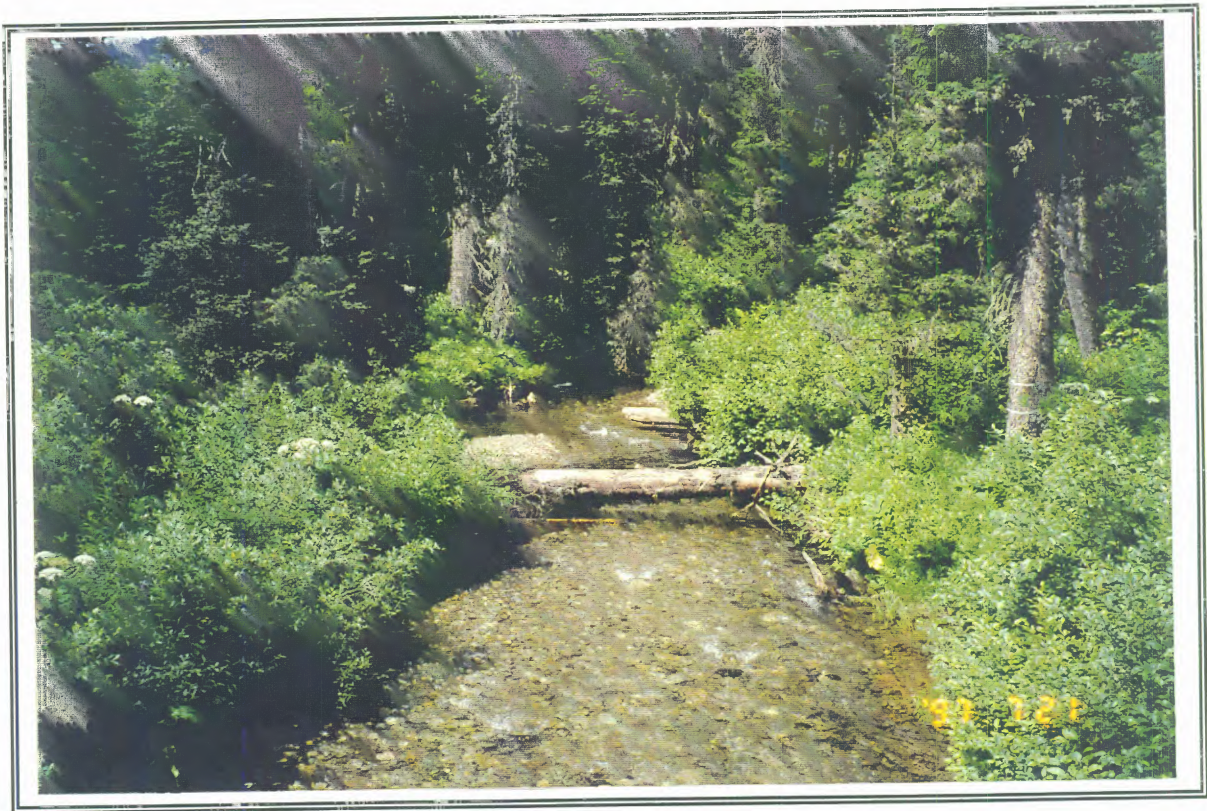
SITE M4. A small, undisturbed tributary of McMartin Creek.

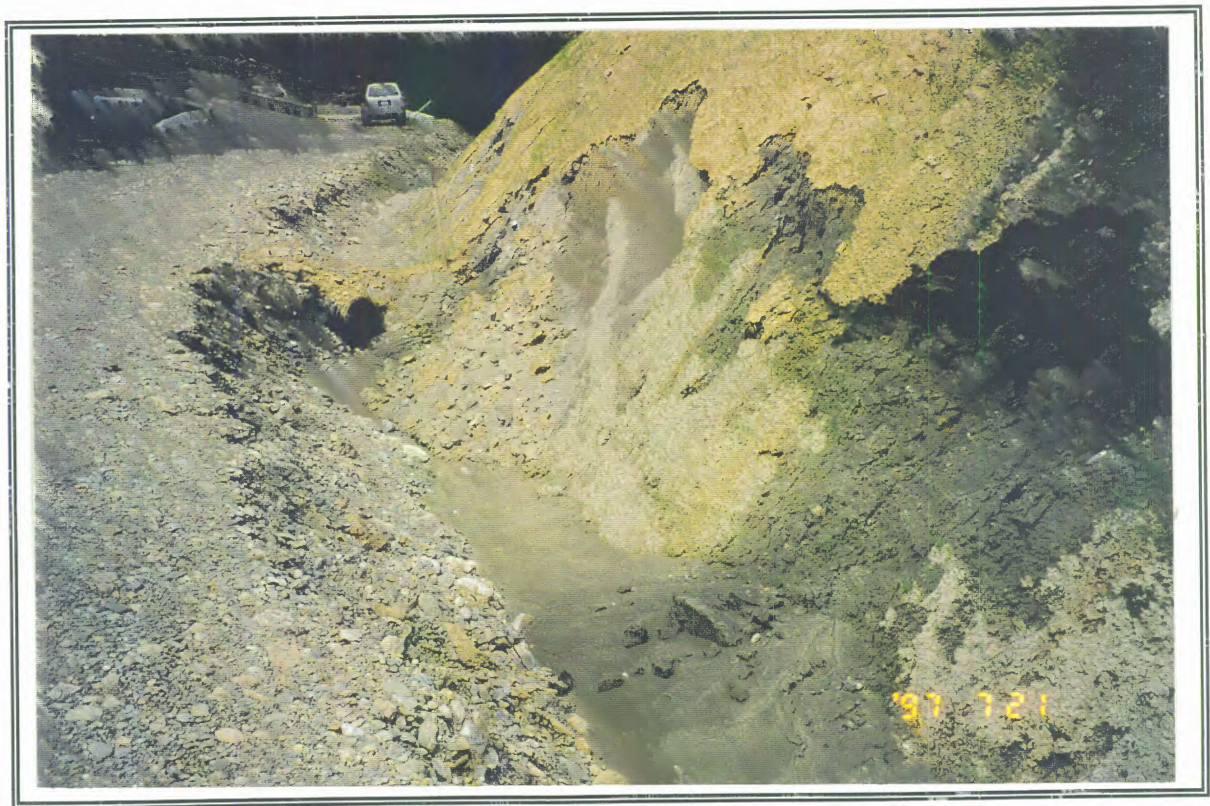
SITE M5A. Extensive cut slope erosion through a fluvial terrace. An attempt has been made to deal with this erosion by grass seeding the sandy cut slope. However, this has failed and the slope is continuing to slough large amounts of sand-sized material into the ditch. This sediment enters a tributary to McMartin Creek.

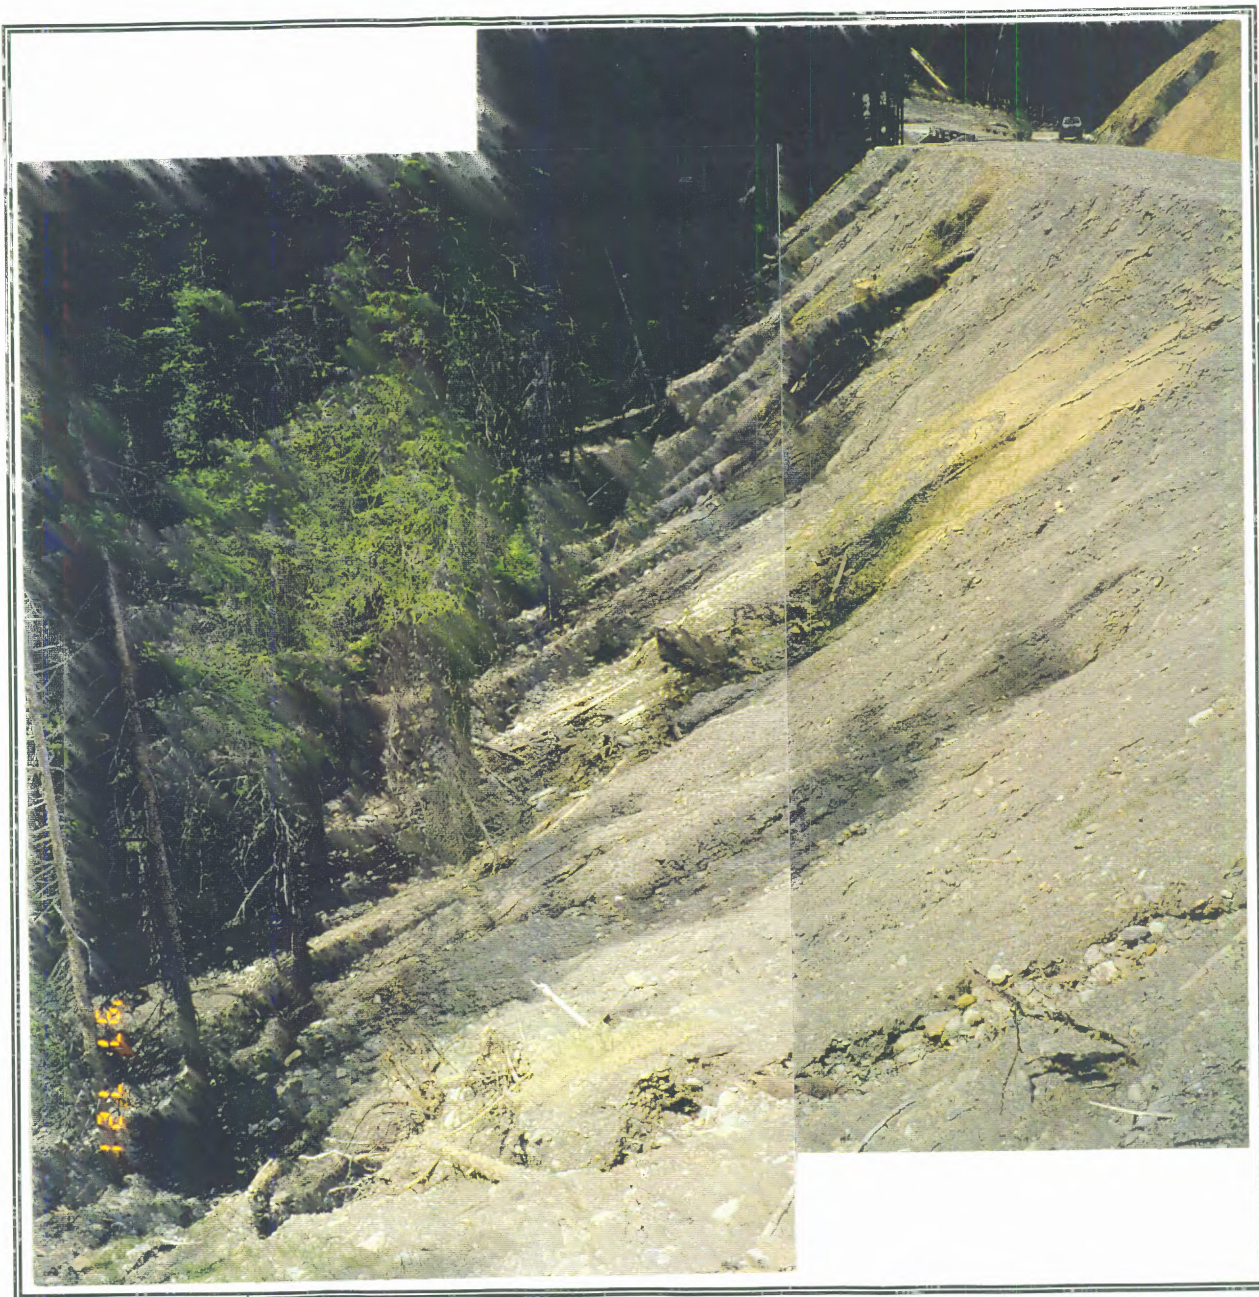
SITE M5B. The road fill is fine textured, and is not stable. An attempt has been made to control erosion by applying grass seed, but this has not succeeded. This slope is supplying large amounts of fine sediment to a tributary of McMartin Creek.

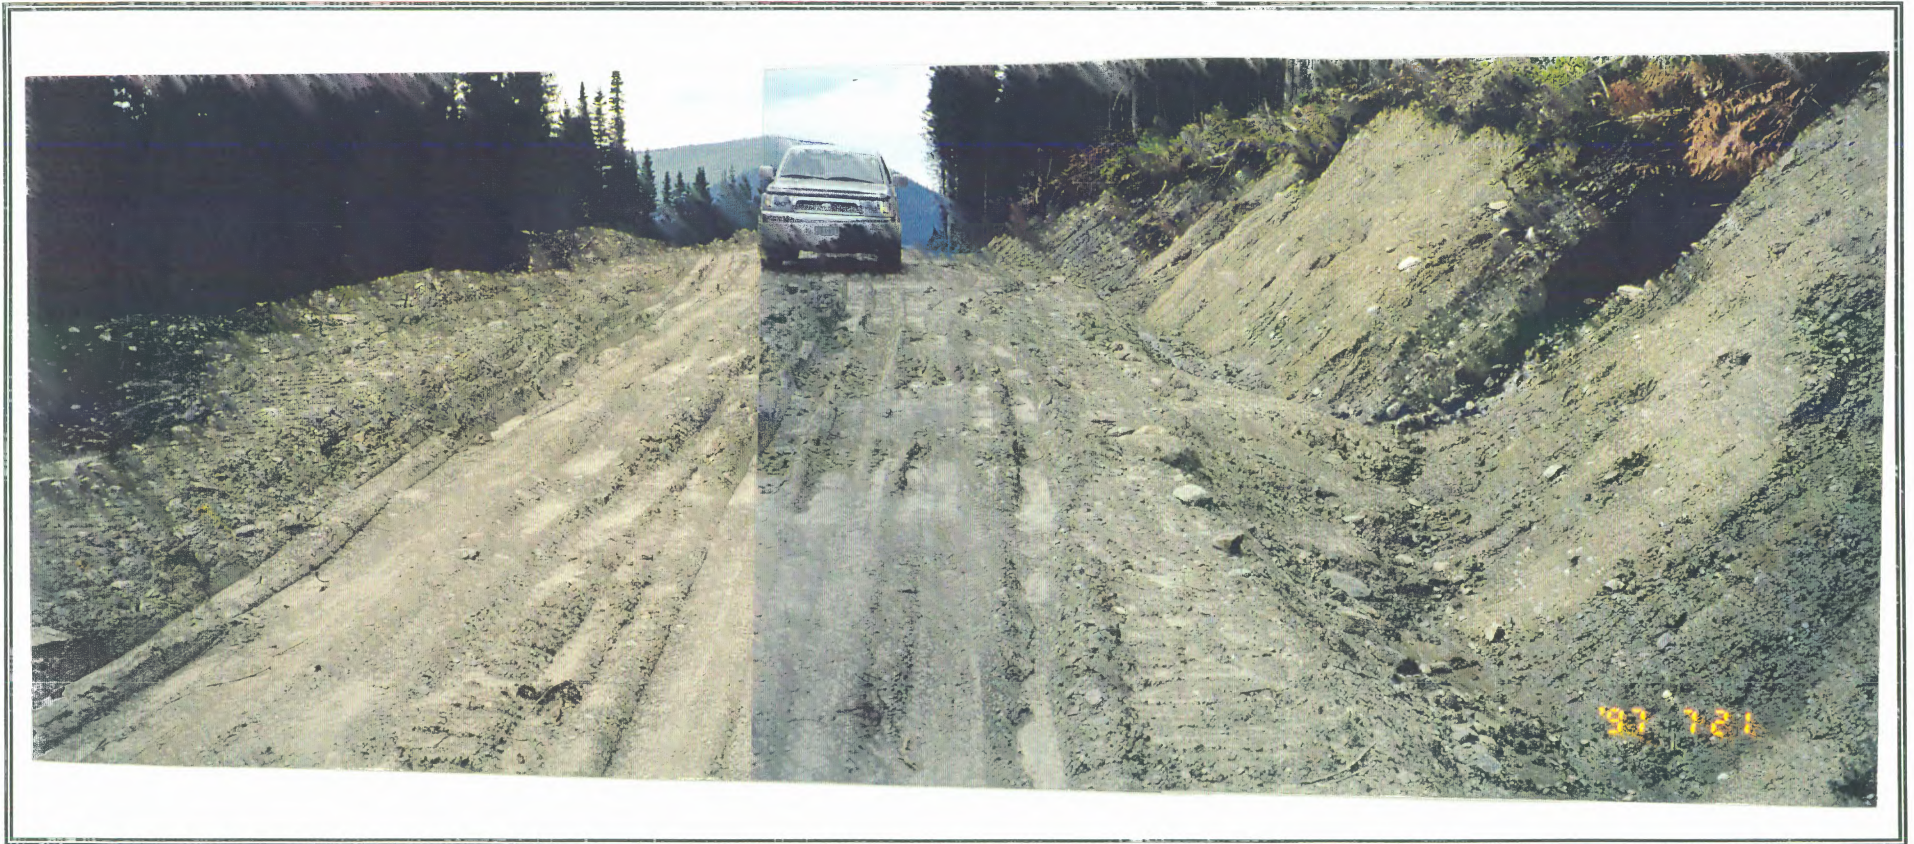
SITE M6. A recently constructed road in the upper McMartin Creek basin. Erosion of the road surface and the cut and fill slopes was very evident. No sediment control measures had been used.

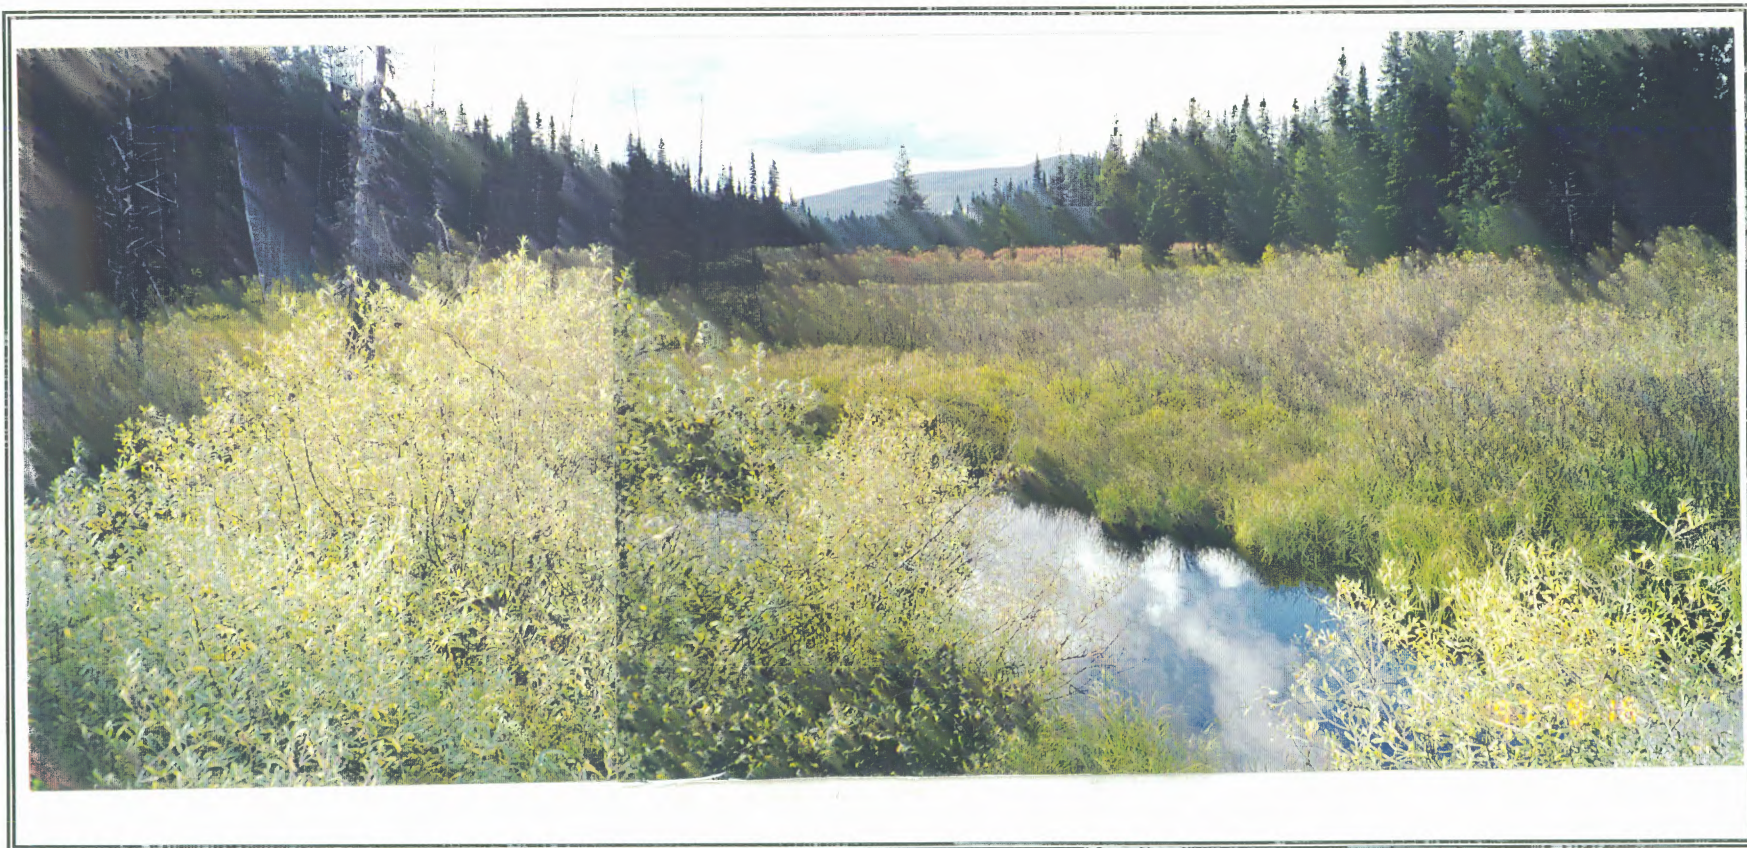
SITE R1. Reddish Creek upstream of Fontaine Creek. This is more of a wetland than a stream.

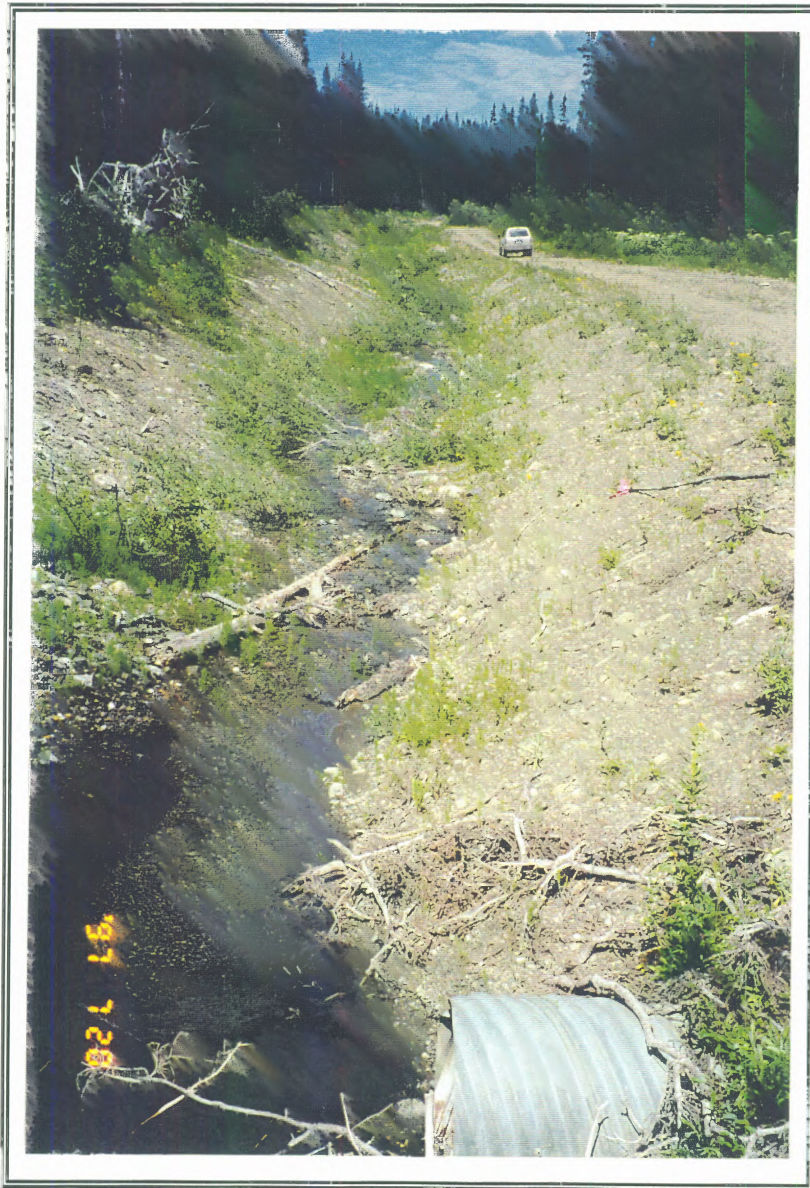
SITE R5. A ditch line in the Fontaine Creek sub-basin. Water is being concentrated in the ditch and some erosion is occurring.

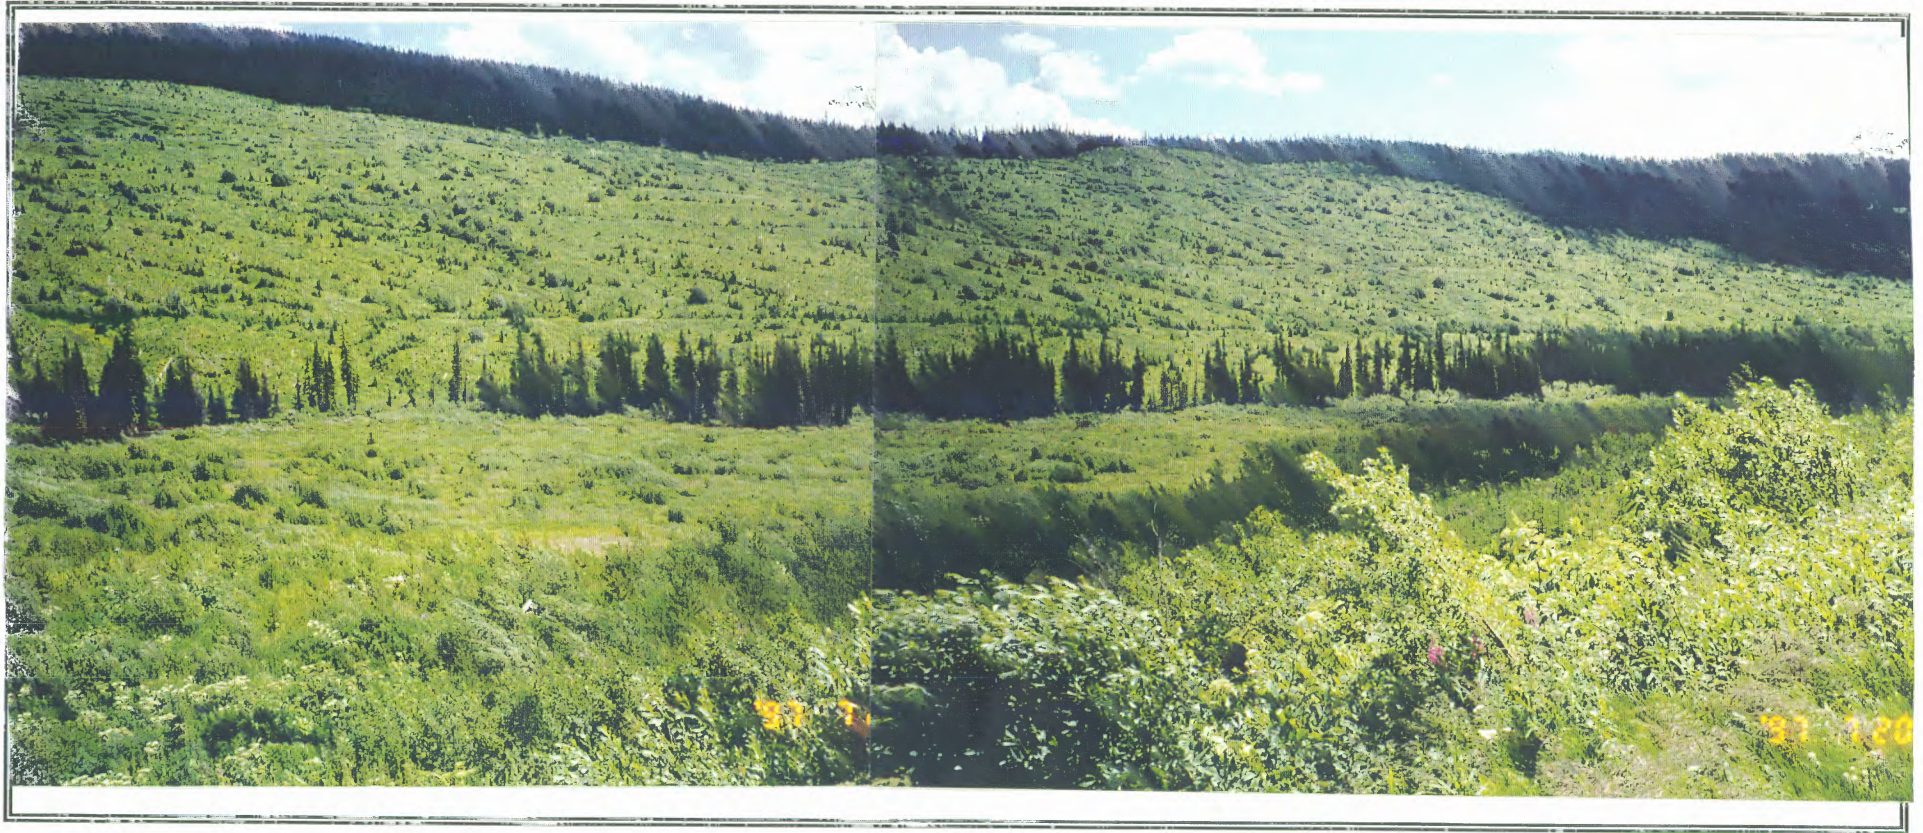
SITE R8. A panorama across the Fontaine Creek valley, showing the extensive harvesting and the riparian buffer.

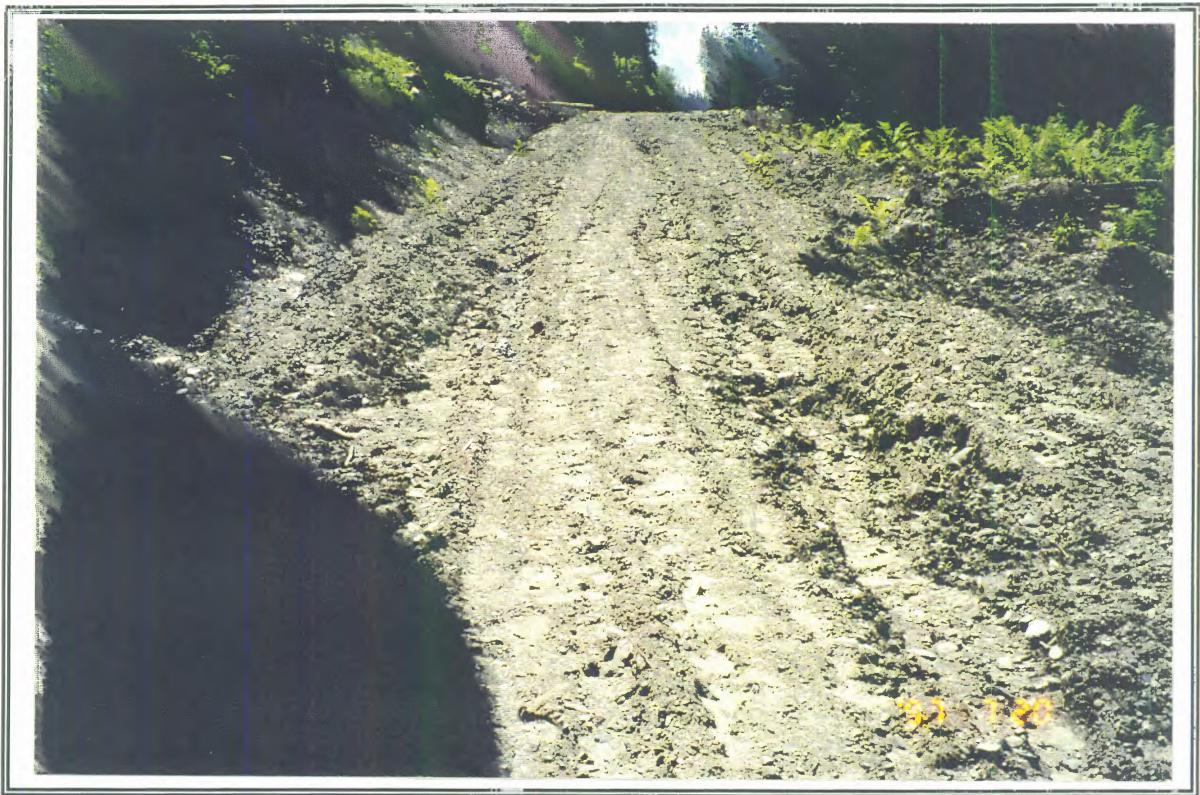
SITE R7A. A recently constructed road in the Fontaine Creek sub-basin. This site is experiencing extensive erosion. No sediment control measures have been used.

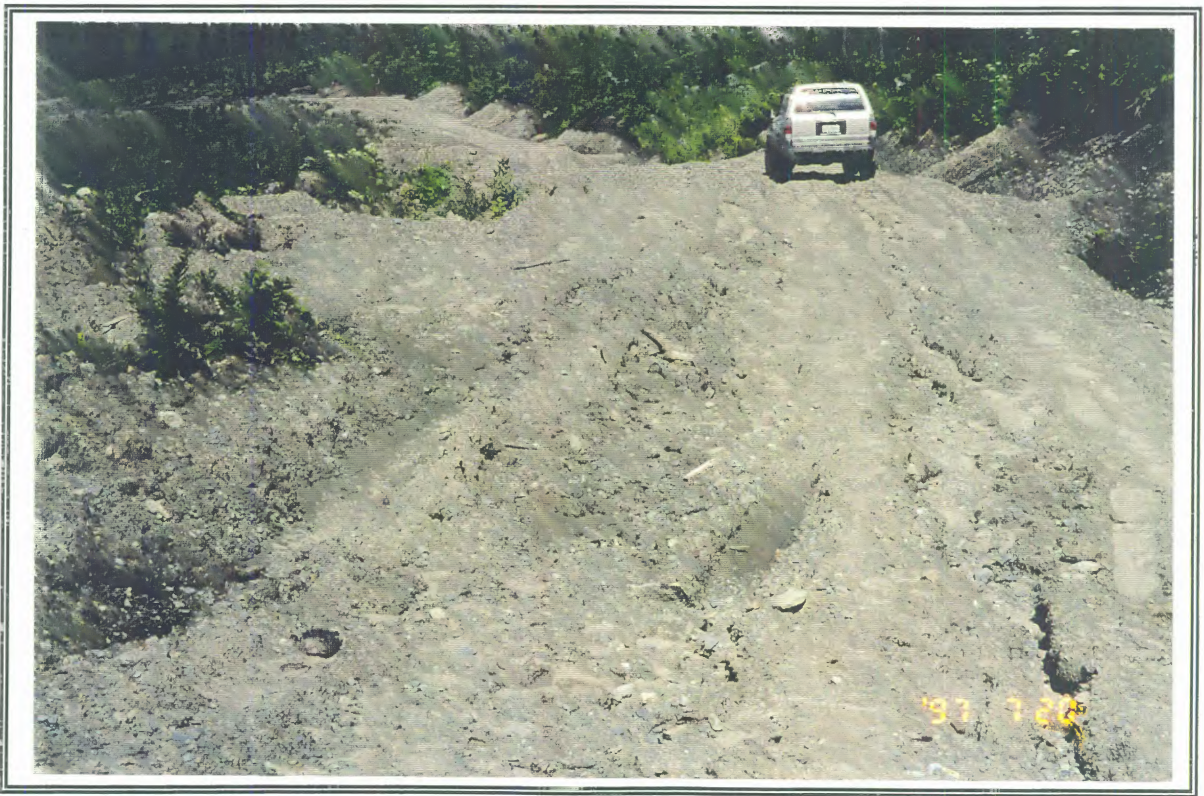
SITE R7B. A recently constructed road in the Fontaine Creek sub-basin. This site is experiencing extensive erosion. Note the rutting and the eroding running surface and cut slope.

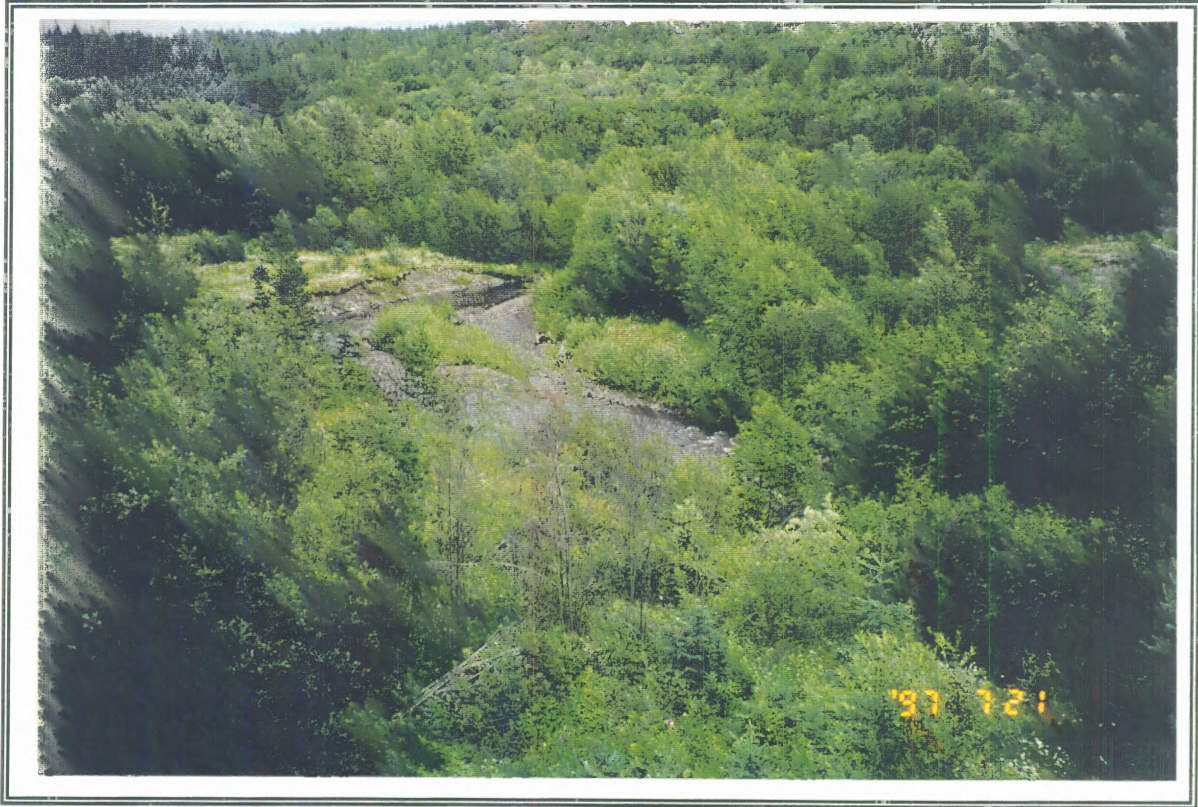
SITE SOV1. Sovereign Creek, showing bank erosion along a harvested and placer mined reach.

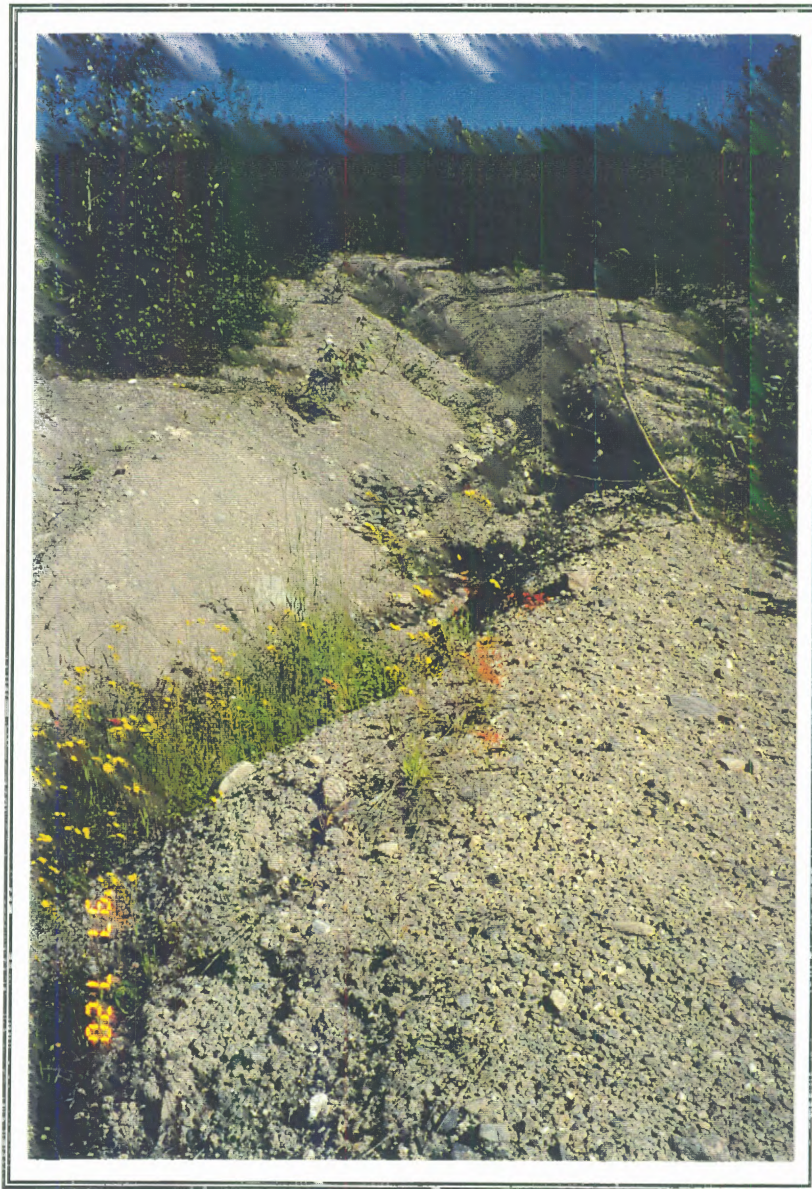
SITE SOV2. Deep gullying and erosion on an undeactivated road. The erosion occurred some time in the past and the site is stable now.

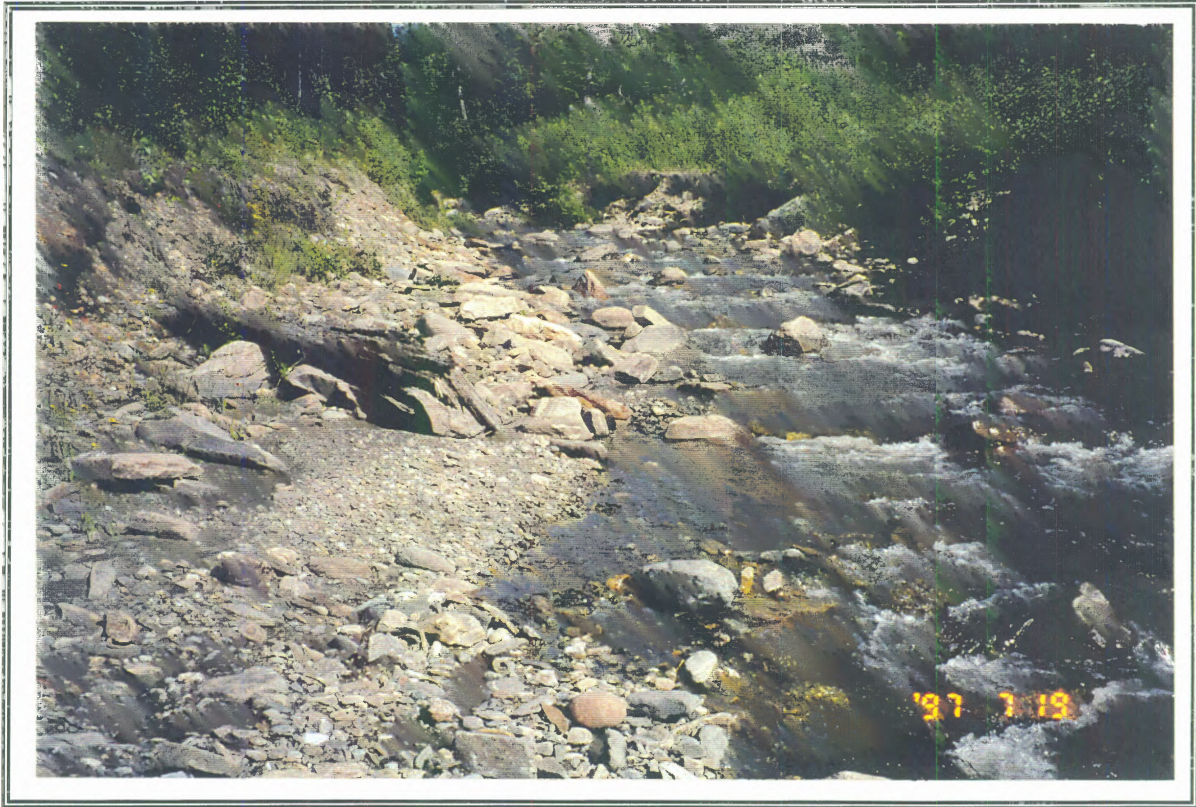
SITE U2. Upper Umiti Creek. This reach has widened and has extensive bank erosion. Proximal land uses are placer mining and riparian logging.

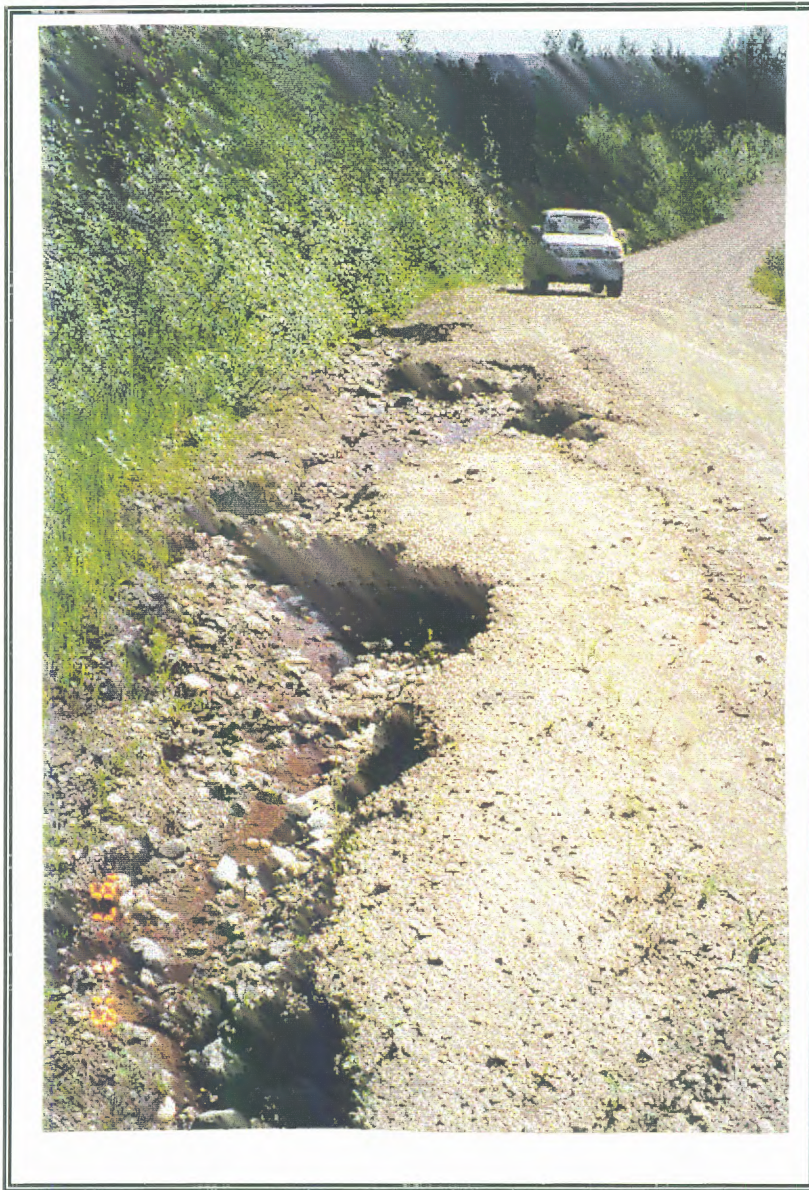
SITE U5. Road and ditch erosion in the Umiti Creek basin. The road itself is stable. However, the infrequent cross-drains allows surface runoff to concentrate and occasionally trigger extensive erosion. At this site, the ultimate discharge point was a tributary stream channel.

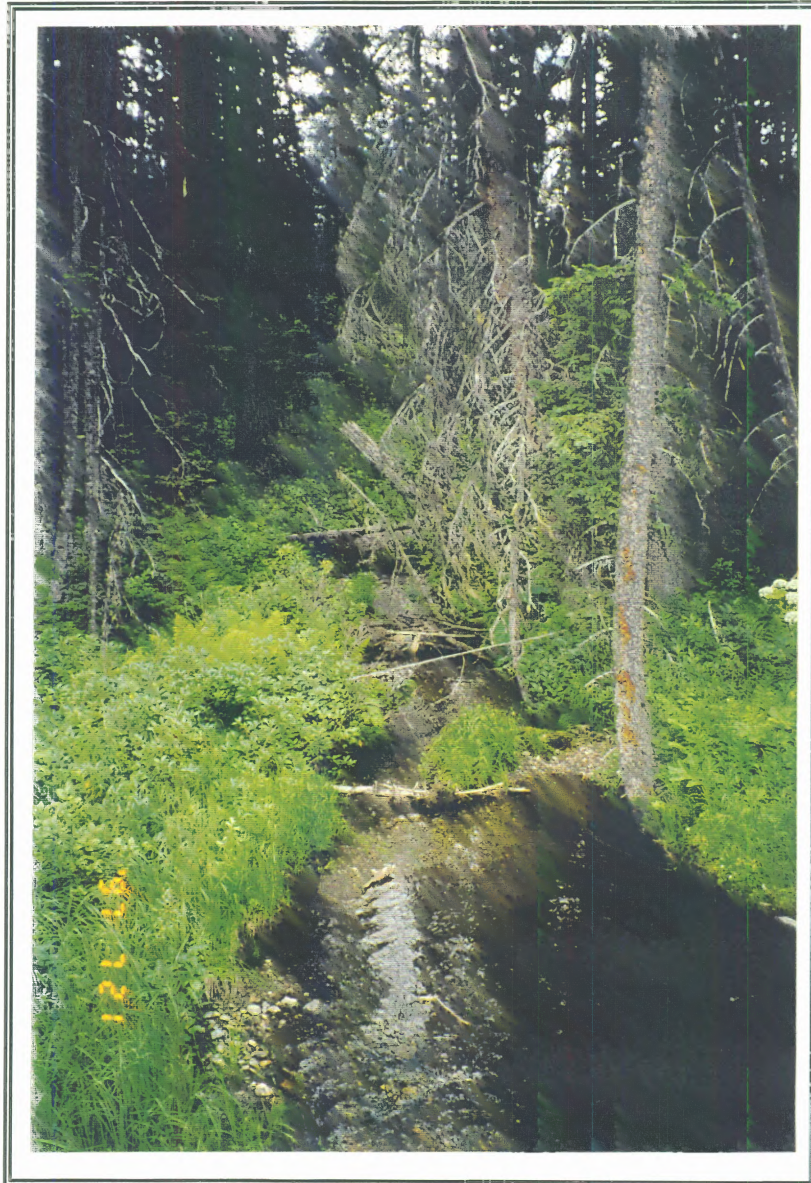
SITE S1. A small, undisturbed tributary of the Swift River.

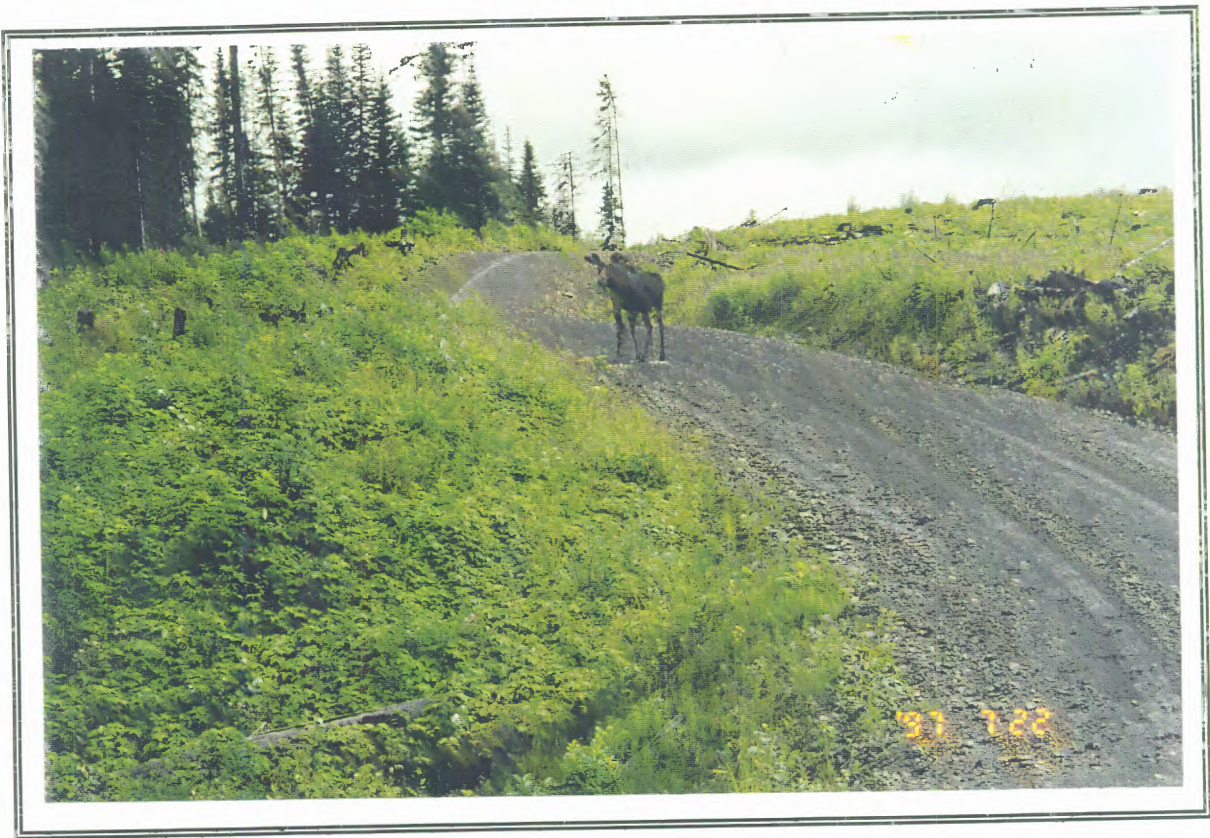
SITE S4. A stable road on flat terrain in the Swift River watershed.

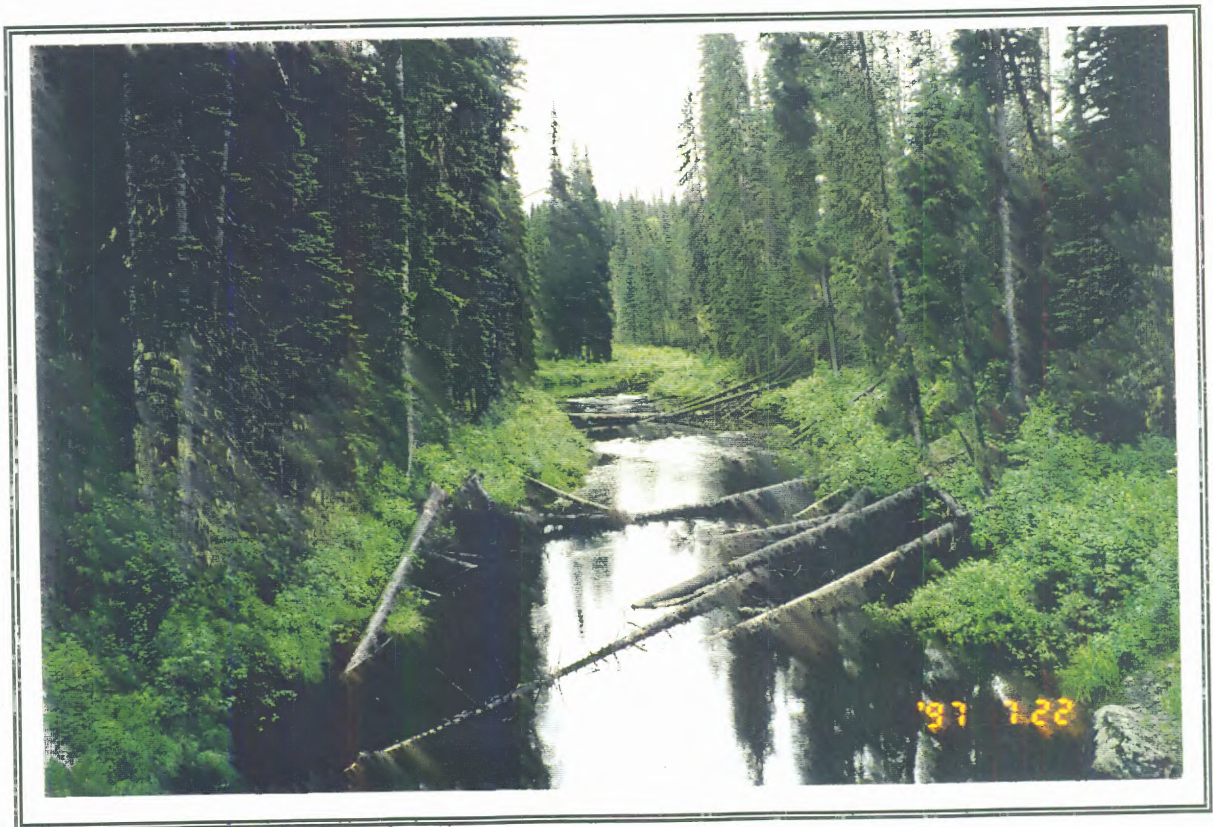
SITE V1. The mainstem channel of Victoria Creek. This river is undisturbed. Discharge during spring freshet was clear.

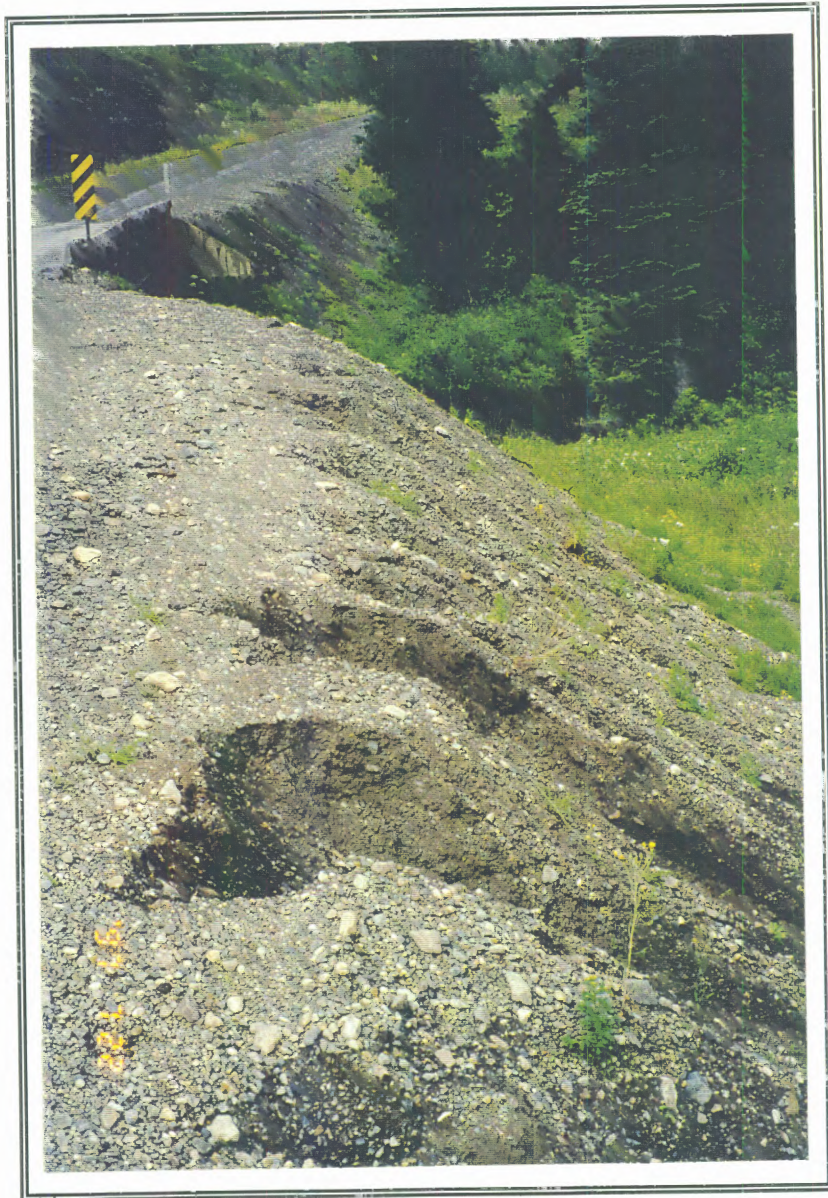
SITE V2. Erosion of fill material at a bridge crossing of Victoria Creek.
