Interior Watershed Assessment Procedure
for the
HYDRAULIC/KLO/POOLEY
CREEK WATERSHEDS

UPDATE REPORT

Prepared for
WEYERHAEUSER CANADA LIMITED
Okanagan Falls Division

by
DOBSON ENGINEERING LTD.
#4 - 1960 Springfield Road
Kelowna, B.C.
V1Y 5V7

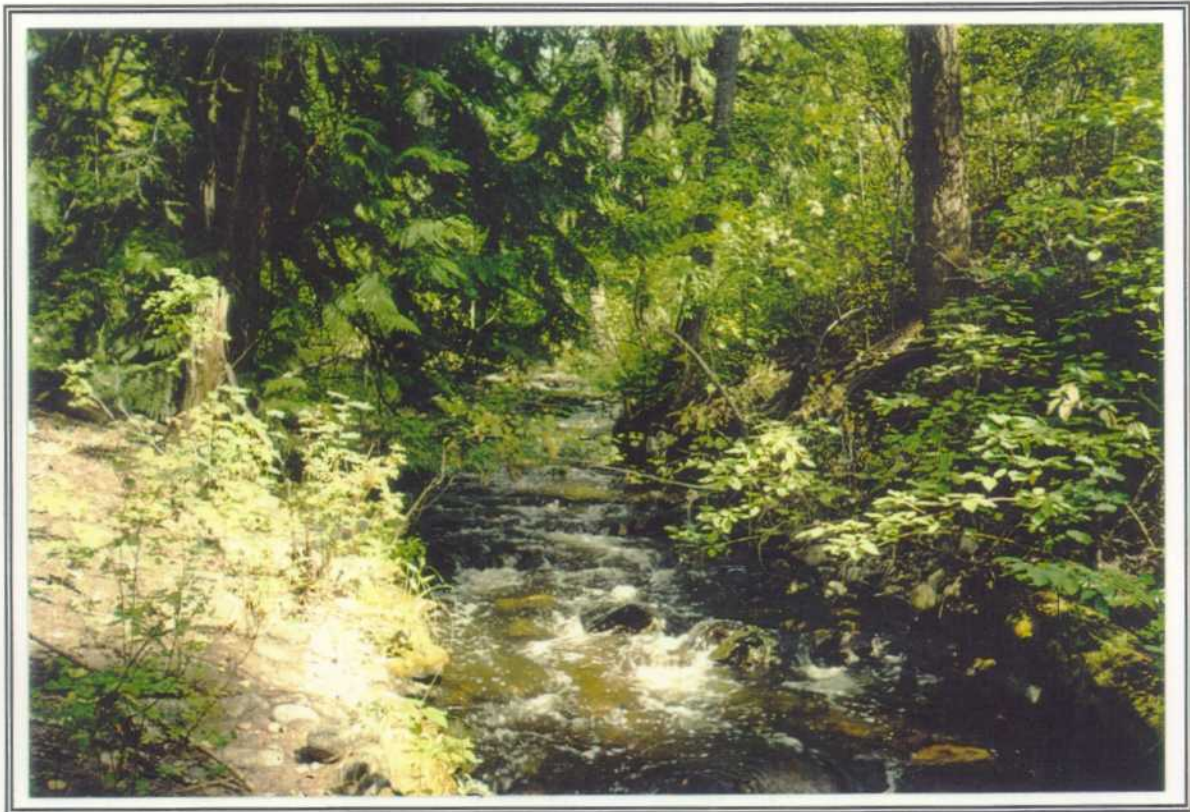
PHOTO HA-1. Reach HA - Upstream (R1, P23)

Comments: Bed materials are cobble and gravel and channel is partially degraded. The banks are eroded in places, but not significantly (the 97 flood likely played a role). The riparian vegetation is dominated by mature alder and the hills are decoupled.

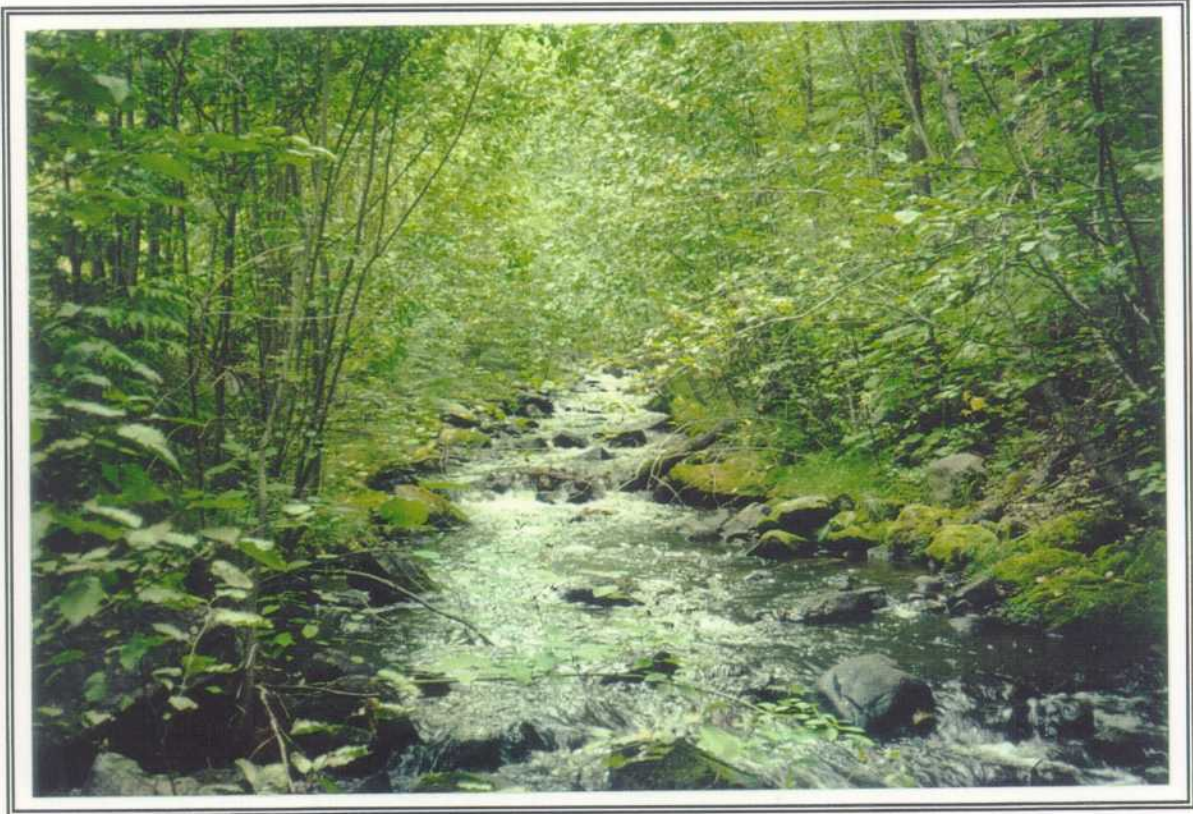
PHOTO HC-1. Reach HC - Upstream (R2, P5)

Comments: Bed materials are cobble and boulder with intact stone lines. Banks are cobble and gravel and no erosion is evident. Riparian vegetation consists of pole sapling alder and mature cedar. The reservoir access road parallels the left bank and the hills on the right bank are coupled. The channel is stable.

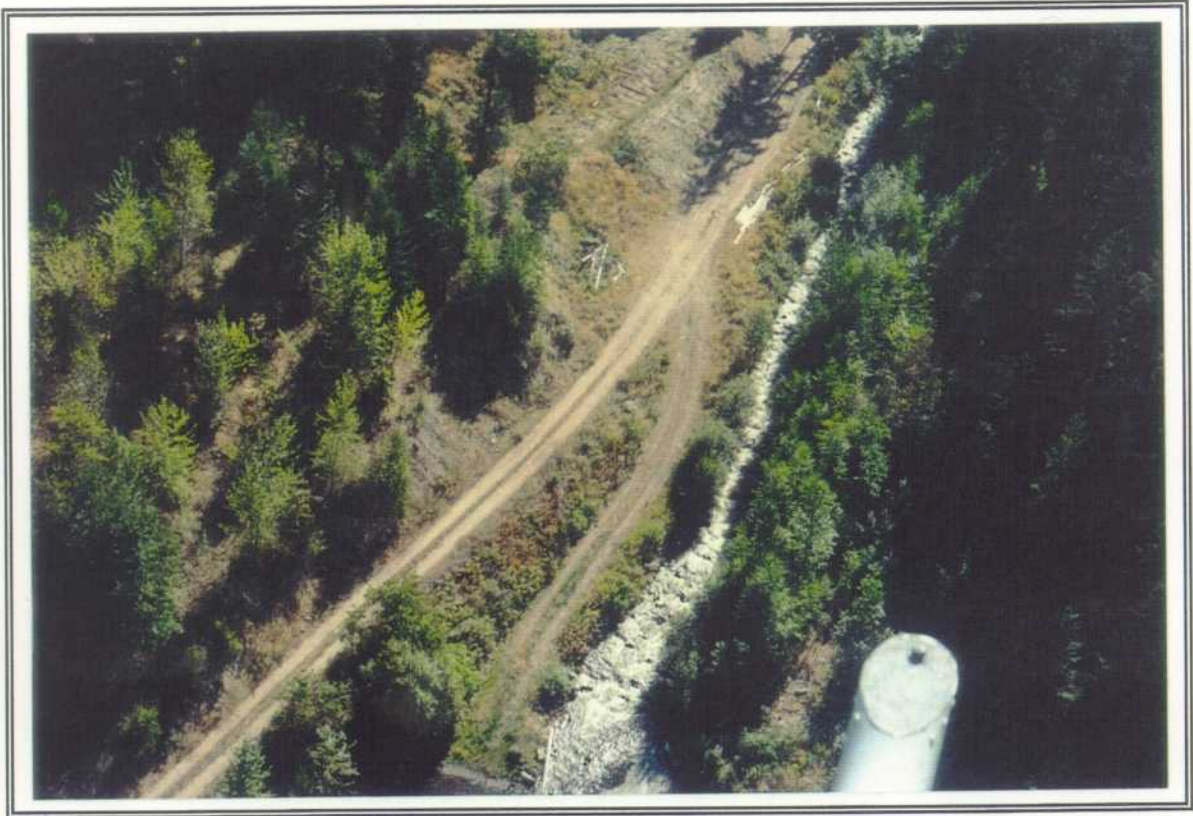
PHOTO HD-1. Reach HD - Overview (RA4, P4)

Comments: This is a channelized reach upstream from the intake and detailed field measurements were not recorded. The channel is stable.

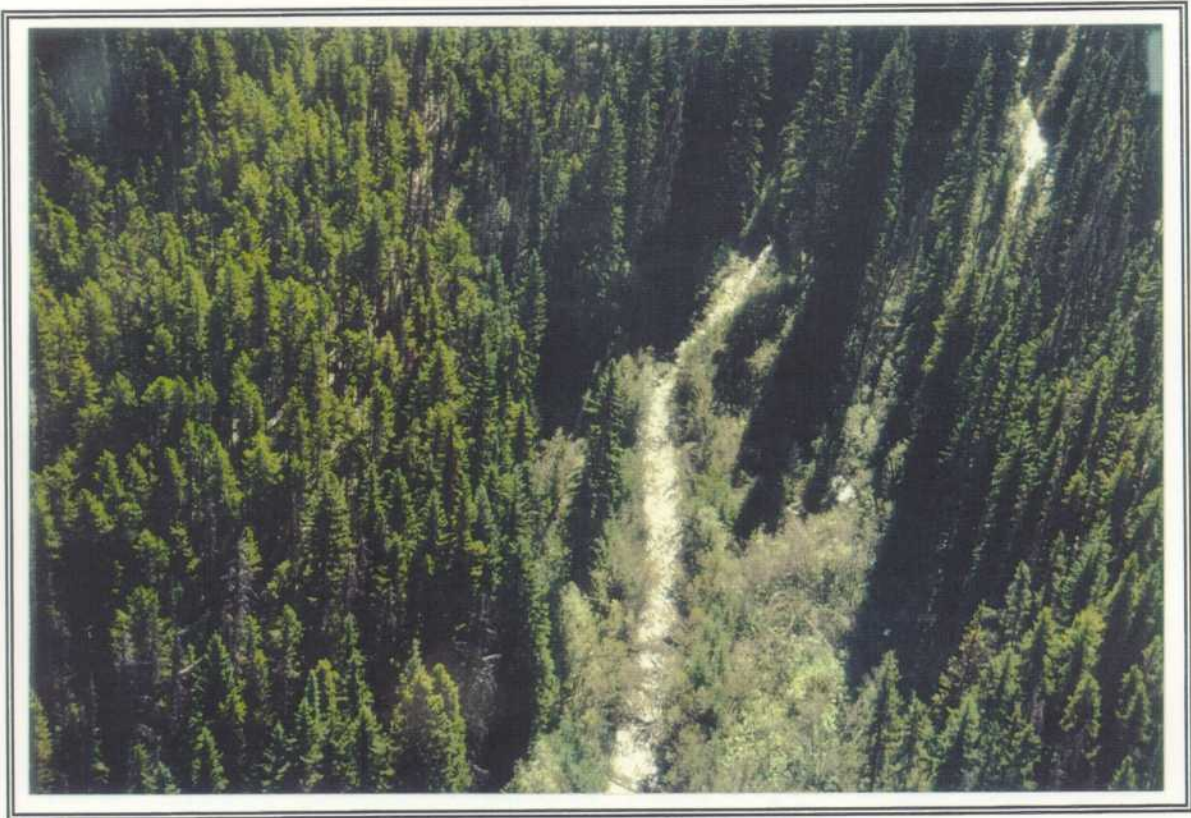
PHOTO HE-1. Reach HD/HE - Overview (RA4, P8)

Comments: This reach has the same characteristics as reach HD, except it is not channelized. The channel is stable.

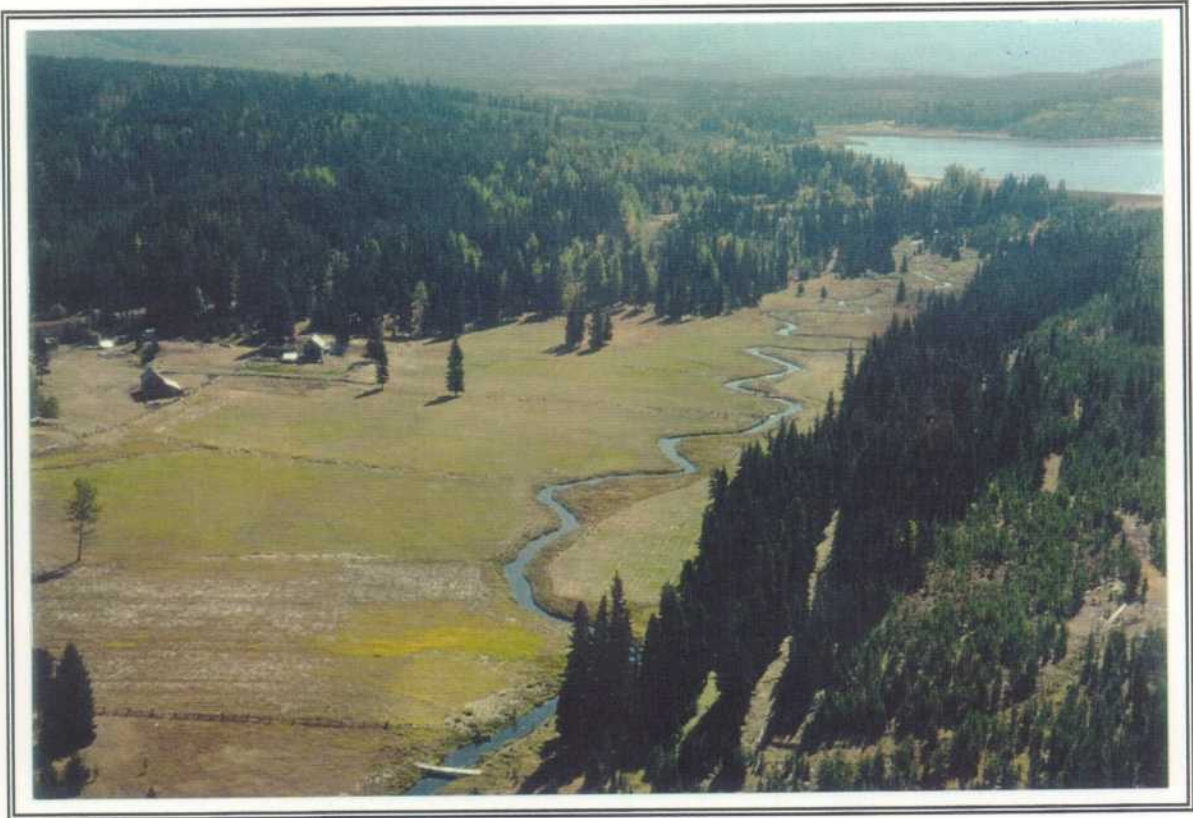
PHOTO HF-1. Reach HF - Overview (RA4, P9)

Comments: This reach is channelized through what used to be a wetland near the outlet of Hydraulic Lake. The channel is stable.

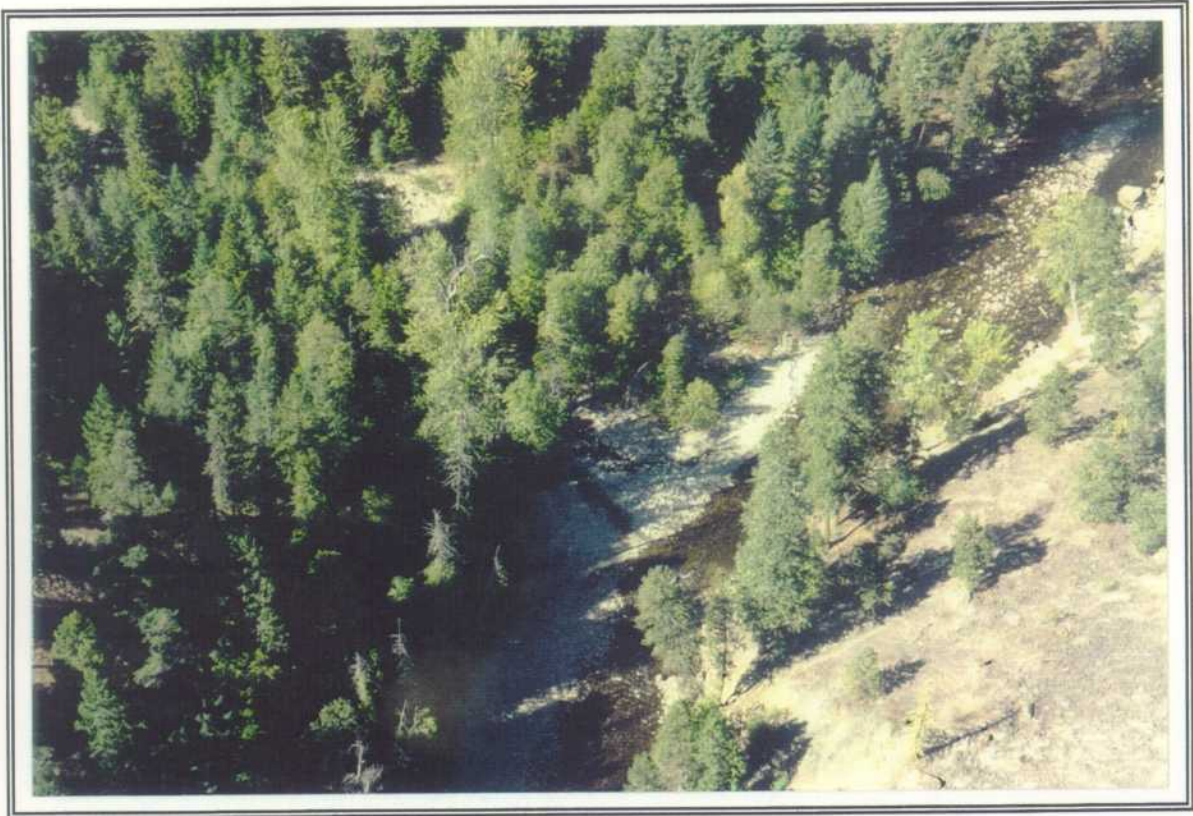
PHOTO KA-1. Reach KA mouth - Overview (RA4, P13)

Comments: This fan reach is slightly aggraded as evidenced by cobble deposits at the mouth of K.L.O. Creek. Material is transported through the canyon reach KB, and although some material is held up in reach KA, there are deposits reaching Mission Creek.

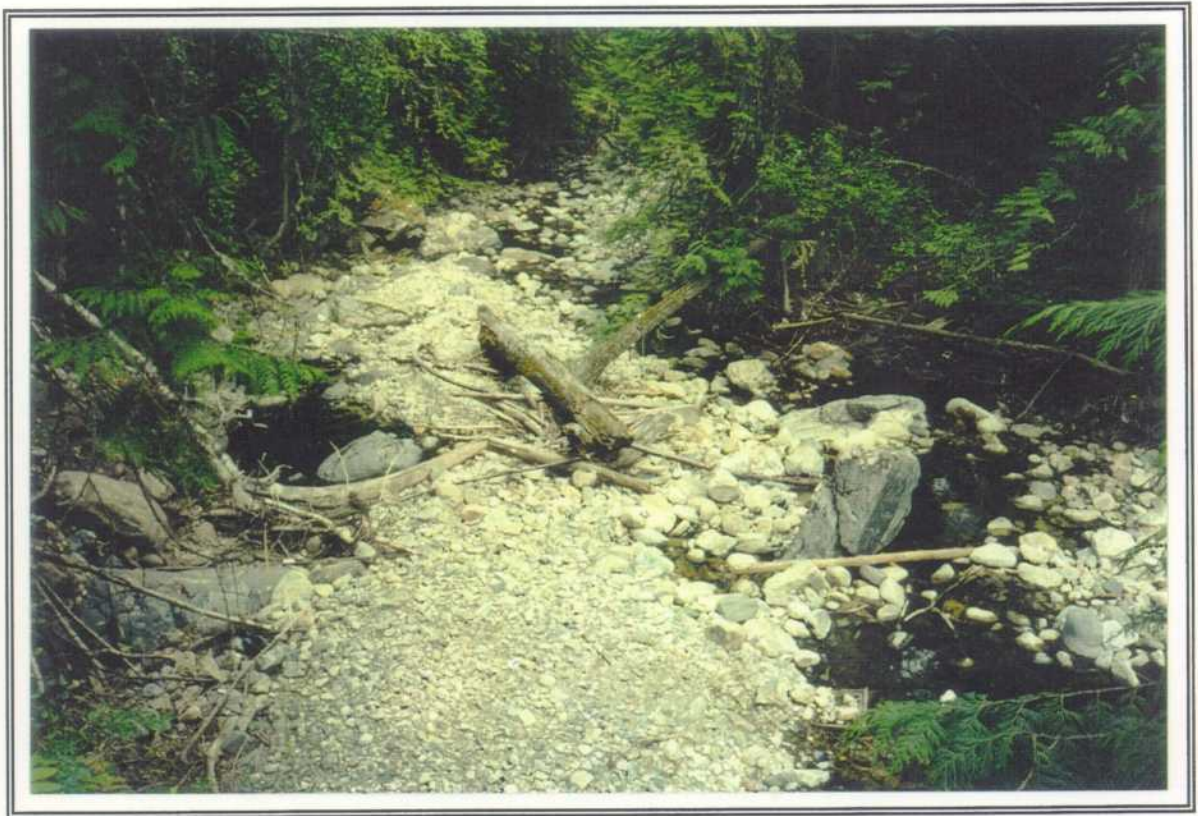
PHOTO KA-3. Reach KA/KB - Downstream (R2, P9)

Comments: This is a bedrock canyon reach and detailed field measurements were not recorded. Any sediment input to this reach is transported to the lower channel. Cobble and gravel deposits are located near the bottom of the canyon reach (Photo KA3).

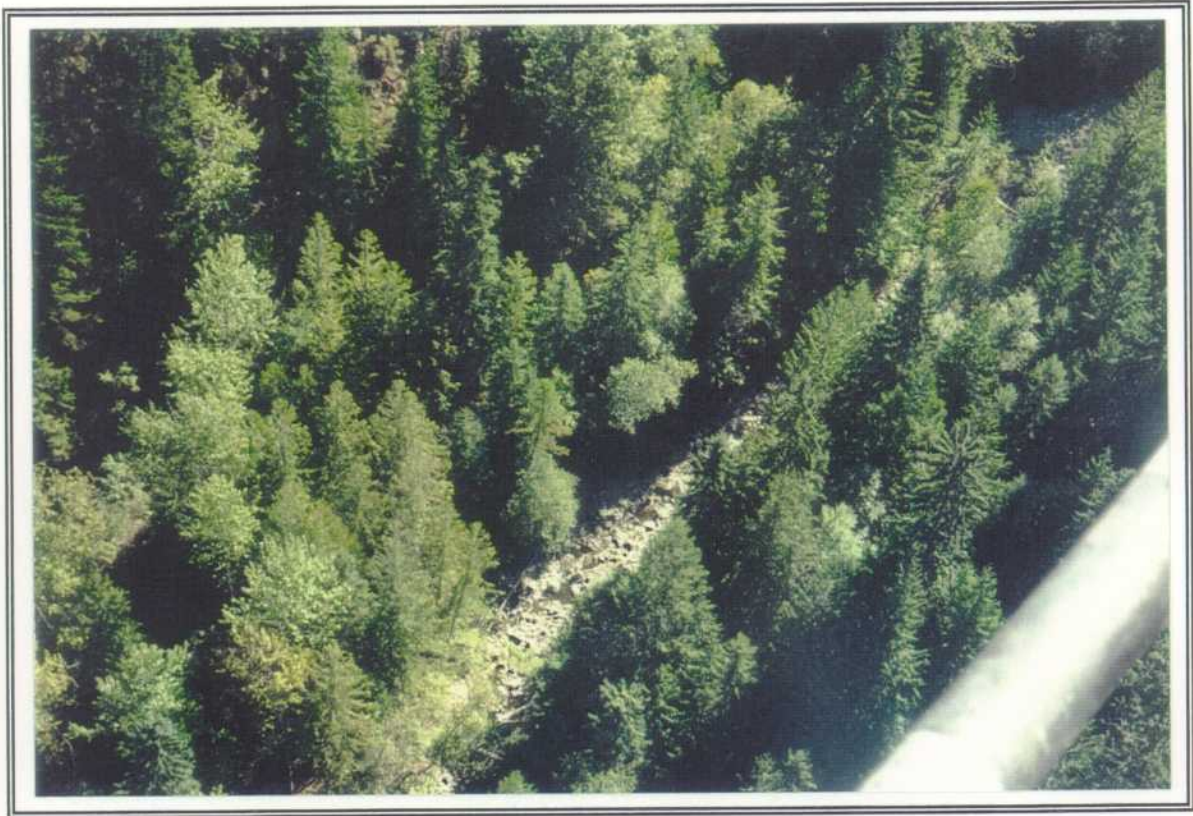
PHOTO KC-1. Reach KC - Overview (RA4, P19)

Comments: This is a canyon reach with poor access. This reach was primarily assessed via helicopter. There are several small sediment wedges (cobble sized material) throughout this reach. LWD is present in the channel, but not abundant. One large landslide off the east bank has impacted the channel. Upstream of the slide, there is limited channel disturbance.
