FINAL REPORT

ROBERT CREEK
Watershed Assessment

Prepared by:
Integrated Woods Services Ltd.
1425 Hugh Allan Drive
Kamloops, BC
V1S 1J3

August, 2000

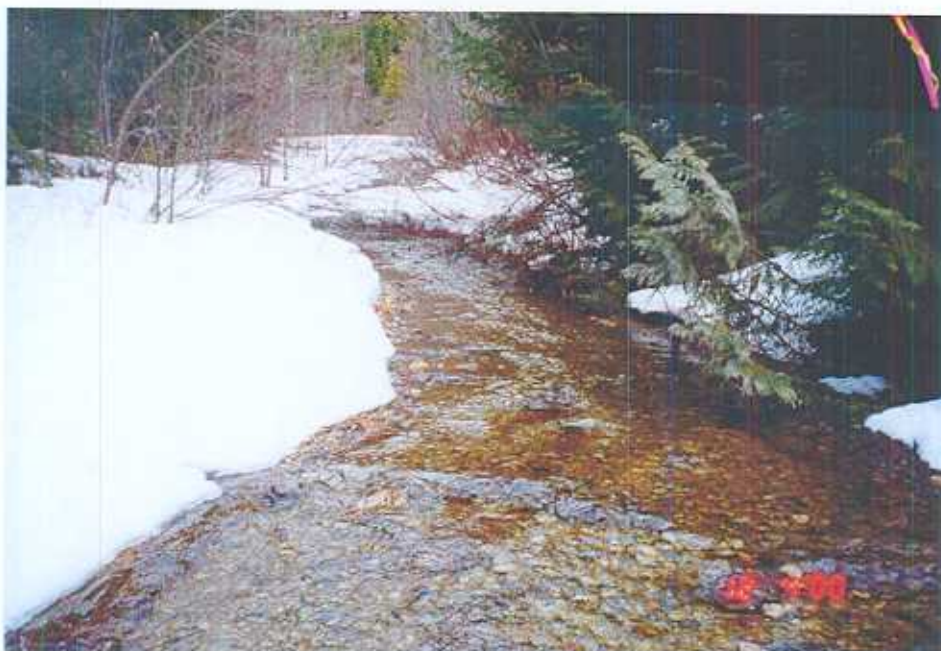
site occurs on an unmapped skid road, adjacent to reaches 3 and 4. This site has stream flow from a tributary to Robert Creek eroding the road surface (see photo 1).

Photo 1: Priority site #2, tributary to Robert Creek flowing down road surface

There are opportunities for productive and cost-effective watershed restoration activities within the upland portions of this watershed. As many stream channels are highly sensitive to increases in coarse-textured sediment supply, minimization of accelerated sediment inputs to stream channels in the watershed would be beneficial with respect to aquatic resources. To this end, the completion of road deactivation activities on the road priority site # 2 is recommended.

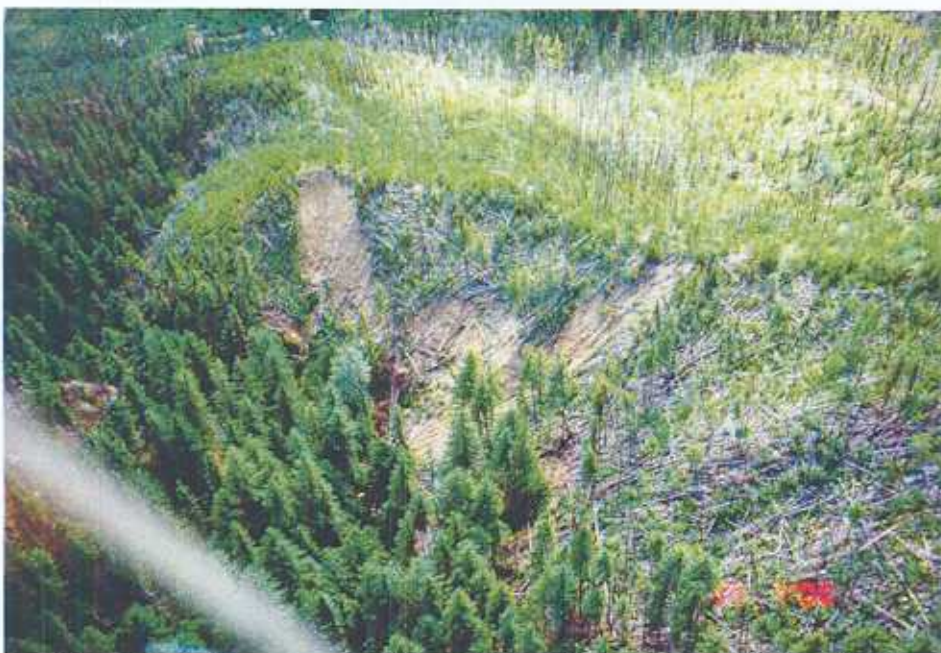
Only two large sediment sources were identified from the aerial photograph review and during the overview flight. Both sources are directly coupled to stream channels. Sediment source (SS) #1 is coupled directly to reach 5 of Robert Creek, while SS #2 is coupled directly to the largest tributary to Robert Creek (see photo 2). The materials from this site may contribute to the sediment aggradation just upstream of the confluence of this tributary and Robert Creek. A number of potential sediment sources identified on the aerial photographs are labeled as rock in the forest cover database. These sites were not included in the sediment source survey.

Photo 2: Sediment source #2, upslope of tributary to Robert Creek

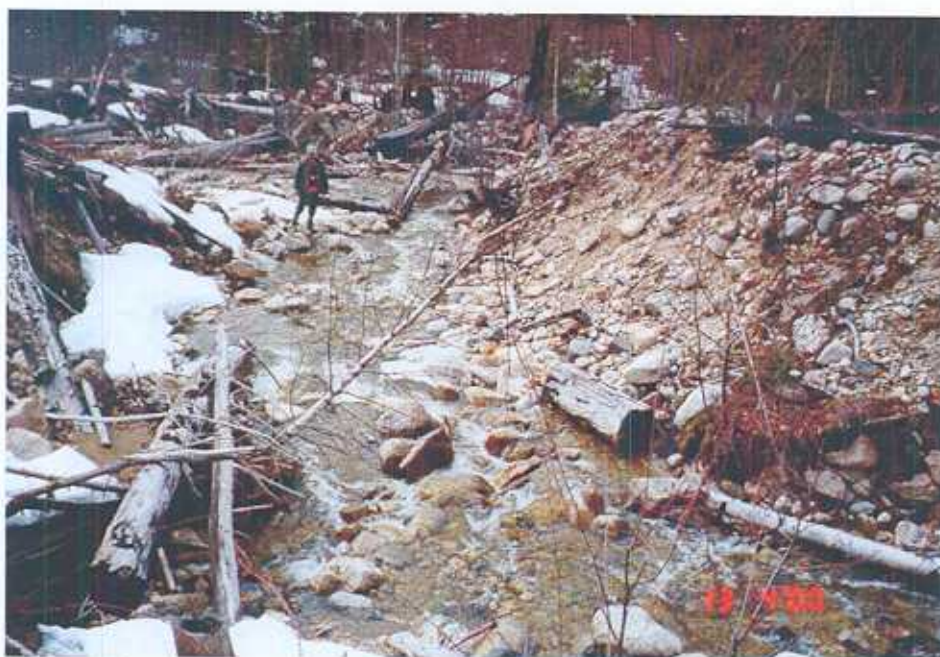
Downstream of a large rock waterfall, moderate to severe levels of channel degradation have occurred in the largest tributary to Robert Creek (see photo 3). The channel of this tributary is significantly downcut, while the lower segment of the stream is now a multi-thread channel. Four larger channels and numerous smaller channels now deliver the stream flow into Robert Creek. The lower stream reach occurs on an alluvial fan that was logged to both banks in 1985. A prescribed burn followed harvesting activities within the cutblock. The stream channel has severely downcut (prior to 1997) over a distance of about 150 m. Sediment aggradation at the toe of the fan then causes the channel to take on a multi-thread pattern, with one of the channels following an existing road (priority site #2). Both fine and coarse textured-sediment from this stream was delivered to the lower reaches of Robert Creek. It is possible that a mass wasting event (identified as sediment source #2) initiated the destabilization of the lower reach of this stream. As the stream appears to be a single-thread channel on the pre-harvest aerial photographs, it is also possible that the forestry activities resulted in the destabilization of the lower reaches of this tributary.

Photo 3: Tributary to Robert Creek, extensive degradation

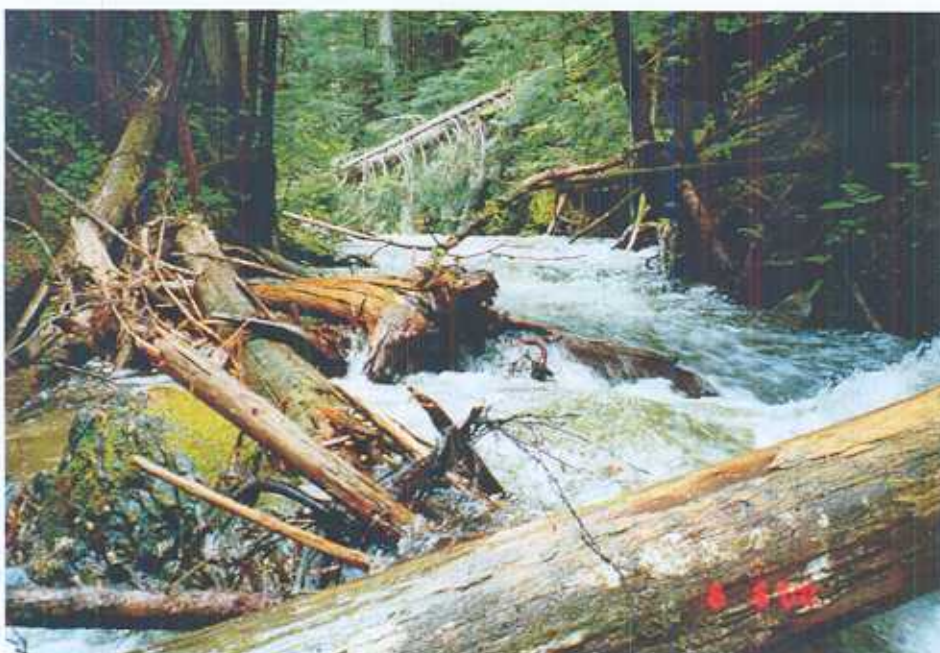
The existing levels of disturbance observed within the stream channel varied between stream reaches and stream segments. Only low levels of disturbance were observed in reach 1 of Robert Creek (see photos 4 & 5). The upstream end of reach 1 is highly entrenched, with cascade-pool morphology dominating. Entrenchment decreases in the lower half of the reach, channel gradients are reduced and riffle-pool morphology appears to dominate (see photo 6). Channel complexity appeared to be high, with a frequent occurrence of large woody debris in the channel.

Photo 4: Reach 1 of Robert Creek, relatively undisturbed

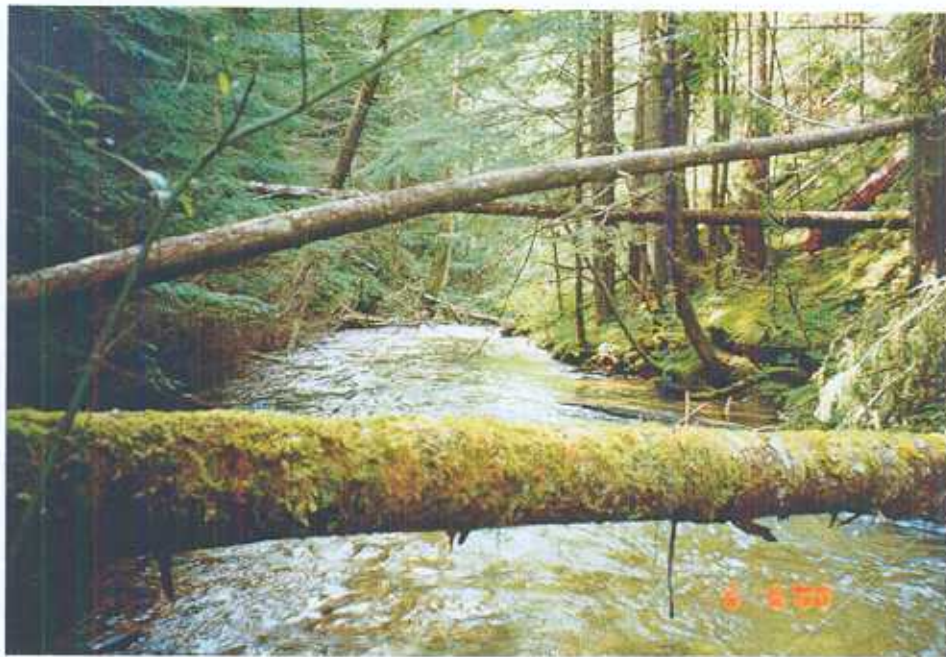
Photo 5: Reach 1 of Robert Creek, just downstream of reach 2

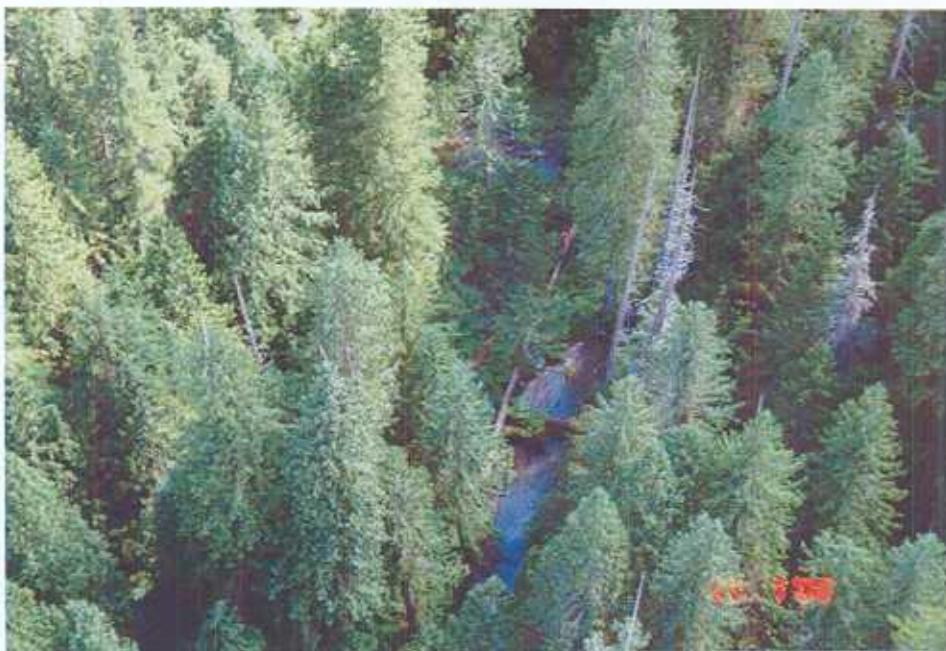
Photo 6: Reach 1 of Robert Creek, just upstream of Burton Creek

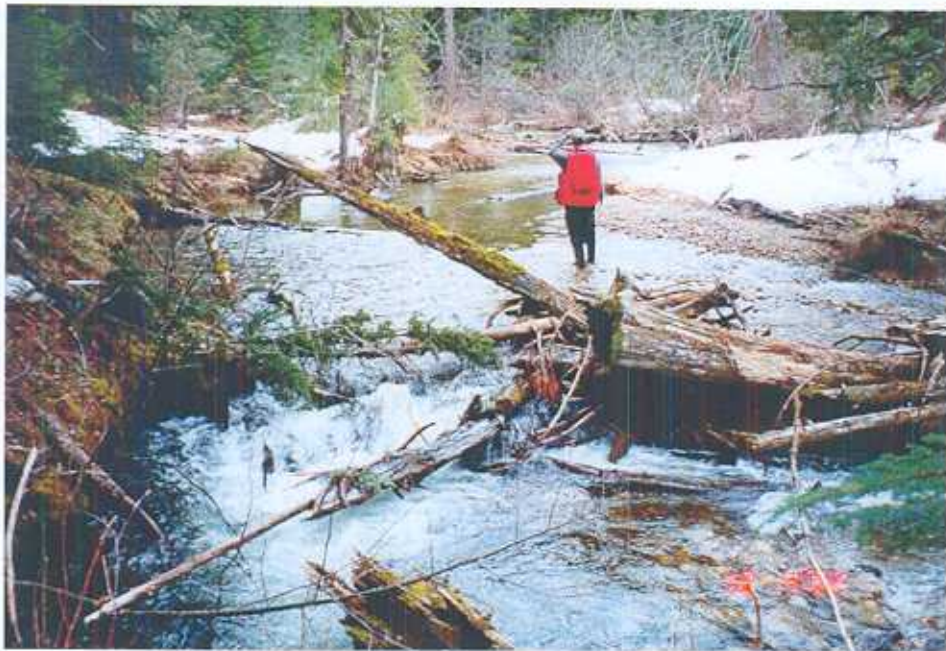
Reach 2 was observed at the upper and lower ends of the reach. Disturbance levels were low (see photos 7 & 8) to moderate in the upper segment of the reach. The moderately disturbed areas were associated with debris jams in the upper portion of the reach (see photo 9). Multi-channels, channel widening, channel braiding and sediment wedges were observed in this segment. The majority of this reach was selectively logged to one or both banks in 1968. The forest cover database lists this polygon (opening 60, polygon 520) as not satisfactorily restocked. Mature forest often occurs in the riparian areas within this polygon however.

Photo 7: Reach 2 of Robert Creek, partial disturbance

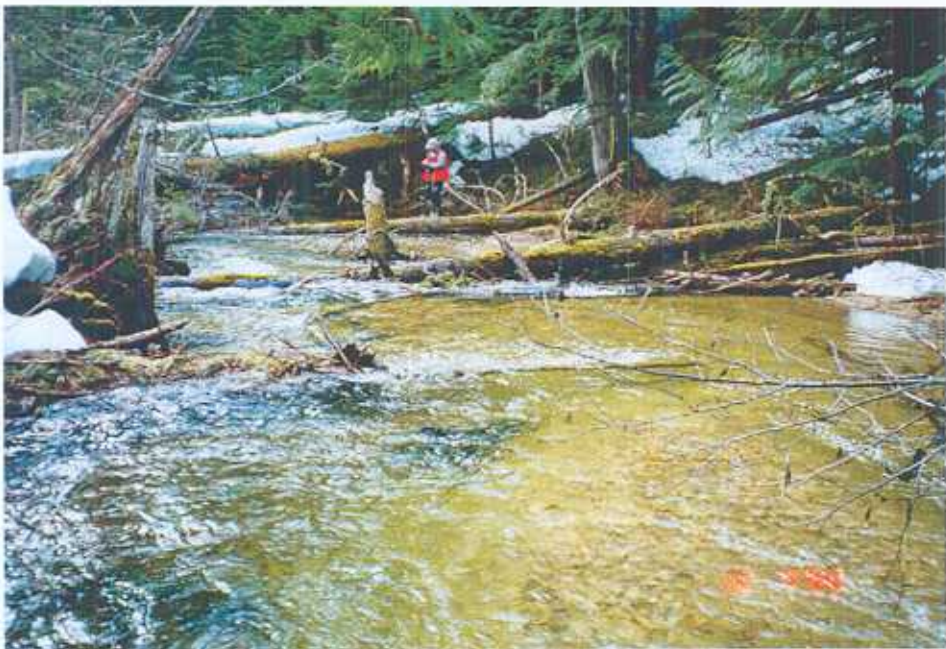
Photo 8: Reach 2 of Robert Creek, partial disturbance

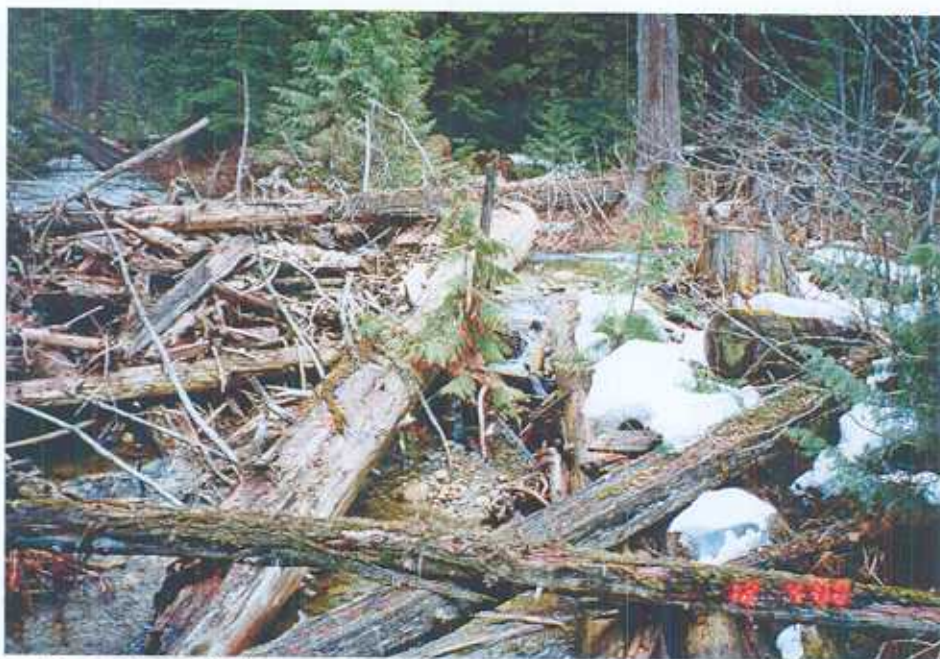
Photo 9: LWD jam downstream of reach 2-3 break on Robert Creek

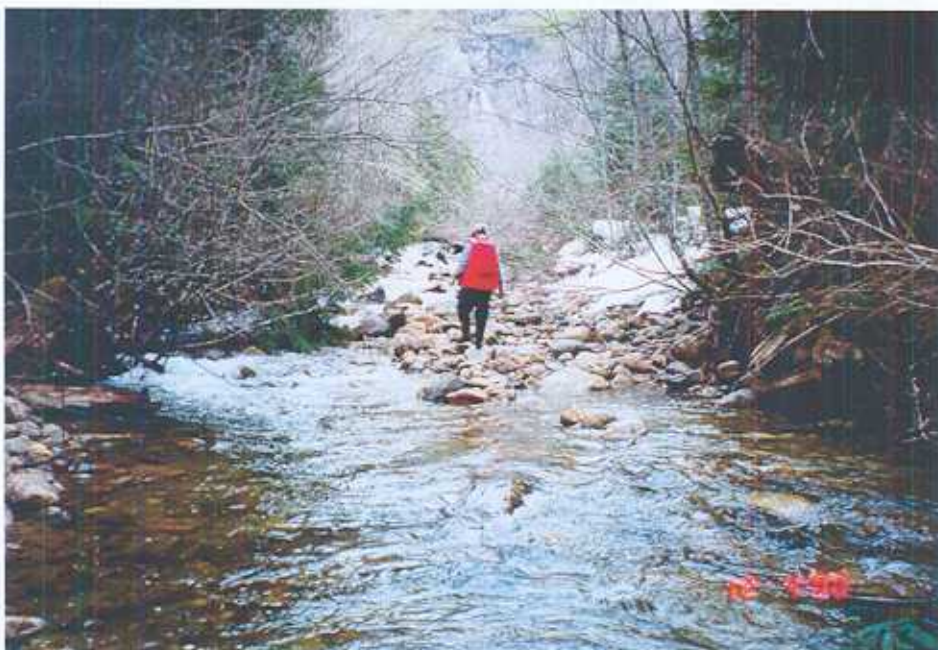
Reach 3 (cascade-pool morphology) was assessed as partially to moderately disturbed downstream of the Road 2 crossing (see photo 10). Disturbance coincided with an old bridge site and disturbance indicators included bank erosion, channel widening and mid-channel sediment deposits at the old bridge site. Channel degradation and disturbed stone lines were also observed within this segment downstream of the site. Bridge stringers were observed within the stream channel downstream of

Photo 10: Reach 3 of Robert Creek, partial disturbance

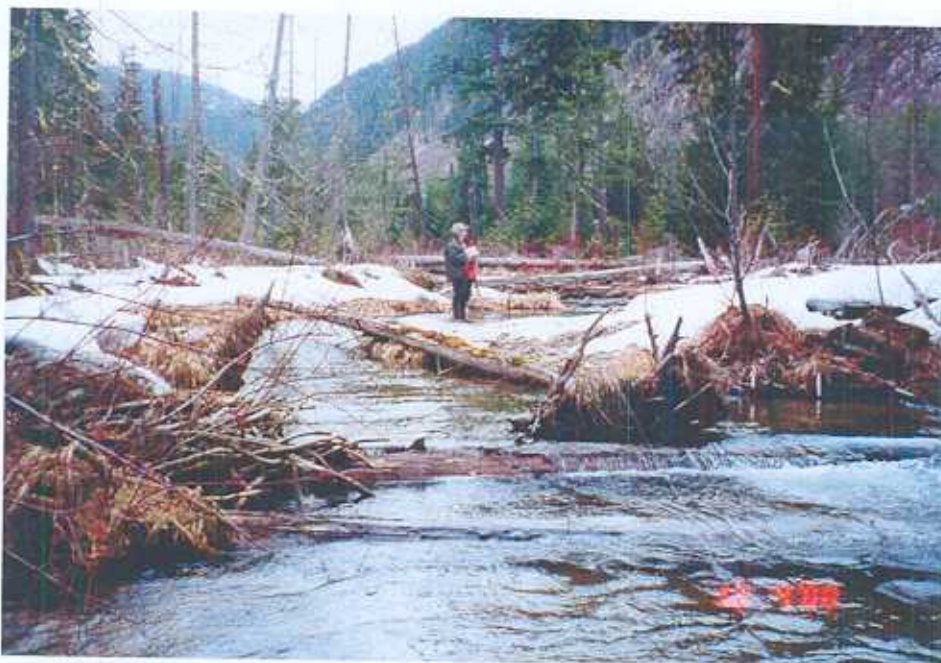
The channel becomes unentrenched just upstream of the reach 3-4 break. Reach 4 was logged to one or both banks in 1968 for most of the reach length (opening 60, polygons 411 and 519). Only low levels of disturbance were observed in the lower reach (see photos 11 & 12). A number of beaver dams occur within this reach resulting in disturbances to flow and sediment transport patterns. The first beaver dam is approximately 180 m upstream of the reach 3-4 break.

Photo 11: Reach 4 of Robert Creek, historic logging to both banks

6. An assessment of riparian rehabilitation (deciduous planting) potential should be completed for reach 4 of Robert Creek. This assessment and fulfillment of any recommendations will be the Ministry of Forest's responsibility to complete prior to 2004.

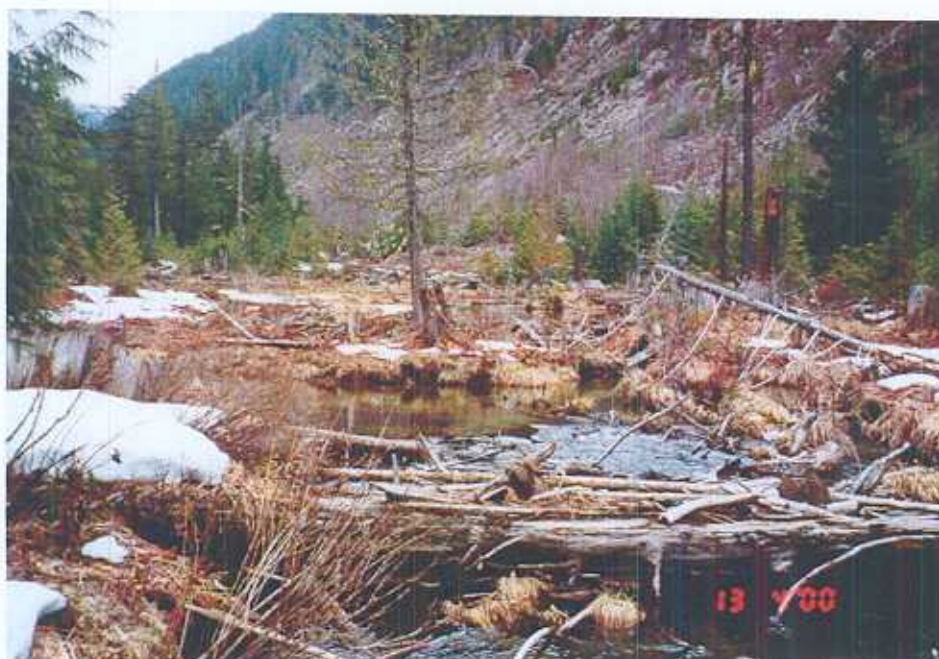
Photo 12: Reach 4 of Robert Creek, logged to both banks and with beaver dams just upstream
