Re: Nicoamen River Watershed, Hydrologic Review

FINAL REPORT

Long Profile of Nicoamen River and Major Tributaries

Photographs

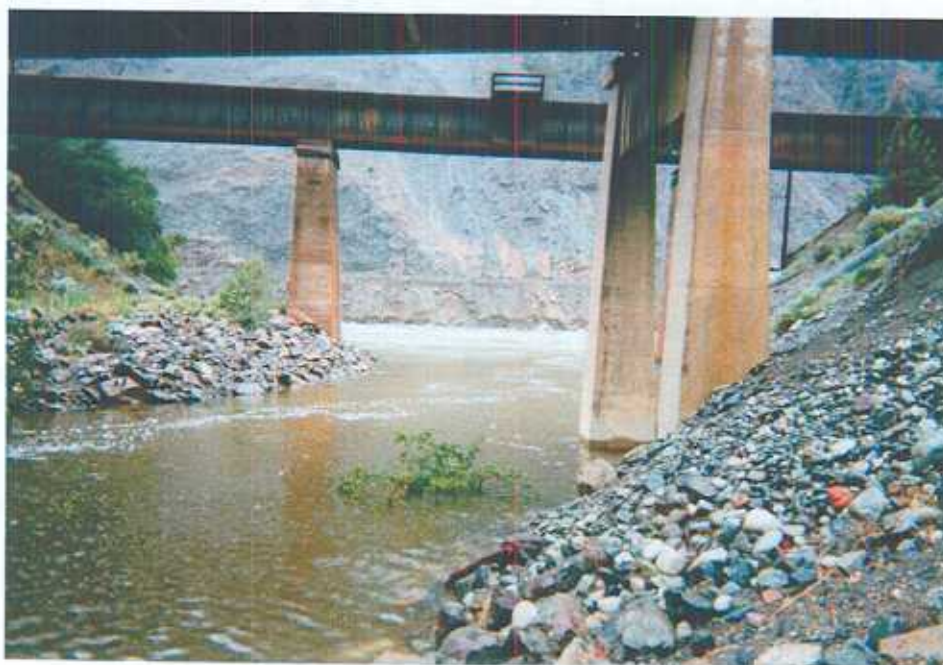
Photograph 1: Reach 1 of the Nicoamen River backed up by the Thompson River during the July 1999 Flood.

- Stream channels generally exhibit undisturbed to slightly disturbed characteristics.
- Hydrologic regimes and the physical composition of the drainage network combine to generate powerful peak flows.
- Stream channel morphology is generally insensitive to increases in peak flows, and fine textured sedimentation.
- Depositional zones where fine textured sediments can settle out of suspension are very limited. This fact may have implications for fisheries interests within the fish bearing reaches of the lower mainstem.
- The lower 100m of the mainstem (reach 1) undergoes annual rejuvenation. This is initiated by an increase in the gradient of reach 1 after the Thompson drops. Thus resulting in the Nicoamen River downcutting into the Thompson's sediment deposit.

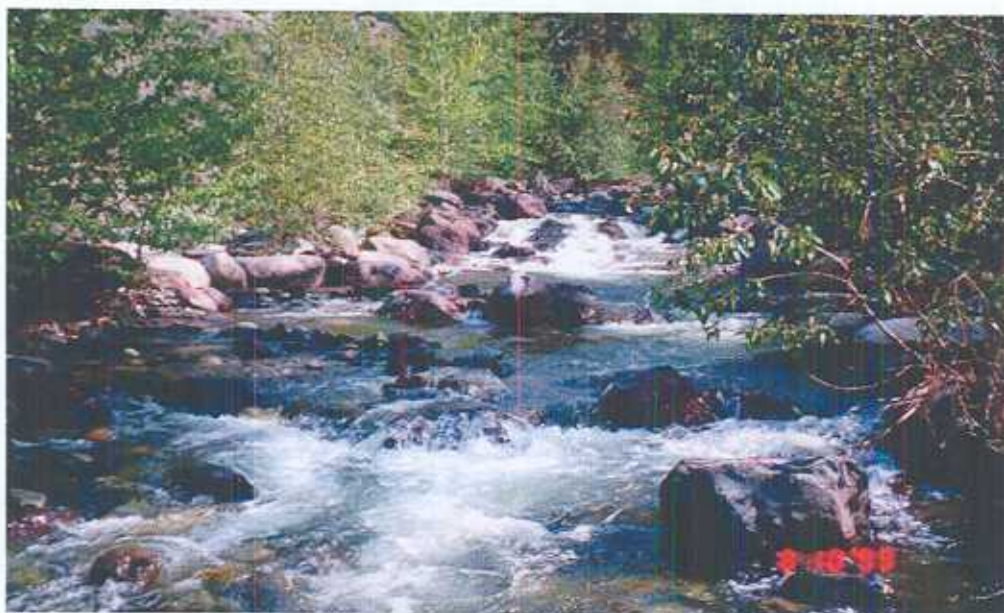
Photograph 2: Reach 3 of the Nicoamen River, cascades and deep pools with stable banks.

creek is generally able to maintain natural diversity of habitat (cascades with deep pools). However this diversity was identified as decreasing downstream of the three bridges in the lower 200m stream section.

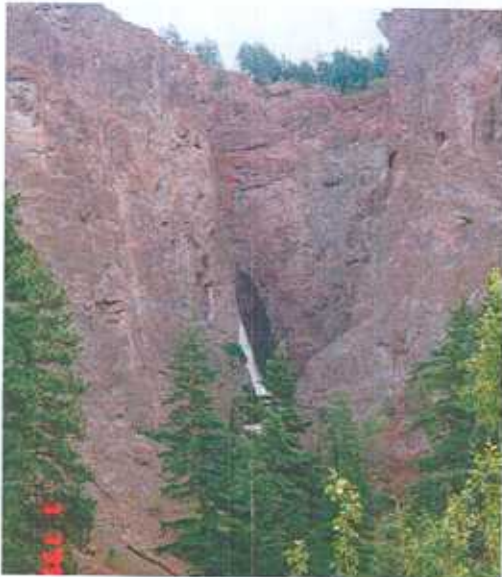
Photograph 3: Nicoamen River waterfall in Reach 4

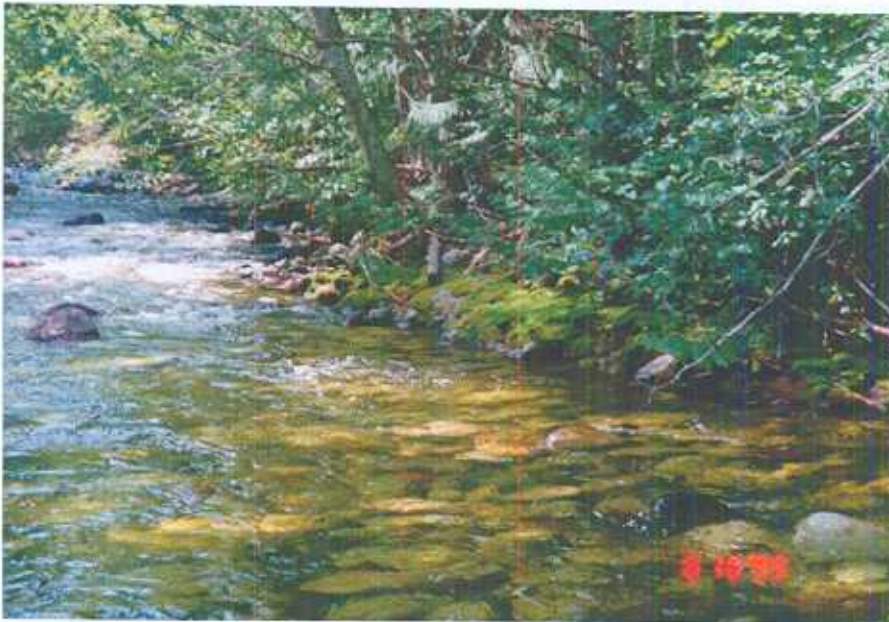
Photograph 4: Stable banks in Reach 5 of the Nicoamen River.

Streambank erosion was observed within areas of both undisturbed and harvested riparian vegetation. This condition attests to powerful flow characteristics within the Nicoamen drainage. Streambanks in reach 5 of the mainstem, upstream of the high value fish habitat, were identified as not disturbed during field assessment after the spring freshet. They are generally cobble dominated banks with a gravel component and heavily covered in moss (refer to photograph 4). In the lower 330m stream section of reaches 1 and 2 of the mainstem the banks are dominated by non-cohesive cobble, boulder, gravels and sands that are susceptible to erosion. Contributing to their erodability is the lack of riparian vegetation that is influenced by climatic conditions and highway and railway development. Despite the stream bank conditions in reach 1 and 2 the

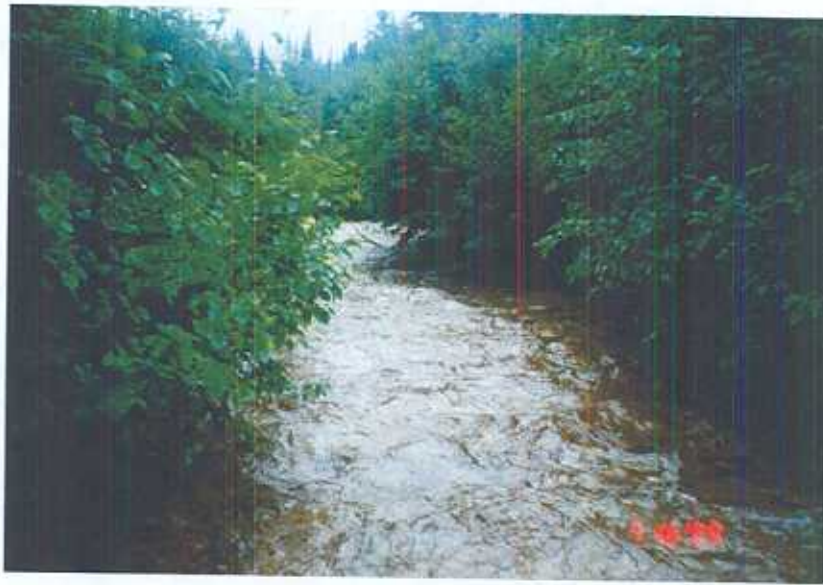
Photograph 5: Revegetating riparian buffers in the South Sub-basin, reach 3.

Reaches 2, and 3 within the South sub-basin are lacking adequate amounts of functioning large woody debris where pre-code logging did not provide for riparian buffers. Regulations in the 1970's and 1980's (when a majority of the harvesting occurred) may have required the loggers to remove woody debris from stream channels. This practice often resulted in stream channels with much less woody debris presence than seen in non-manipulated systems. Fisheries values are generally low within this sub-basin where creeks are lacking large woody debris. As a result the loss of channel diversity has had less significance from a fisheries standpoint. Logged riparian buffers generally have deciduous regeneration greater than 3m in height. Coniferous (and possibly deciduous) vegetation will not likely provide sufficient large woody debris recruits for 80-180 years, however existing successional riparian vegetation will provide shade and potentially alleviate concerns of increased stream temperatures.

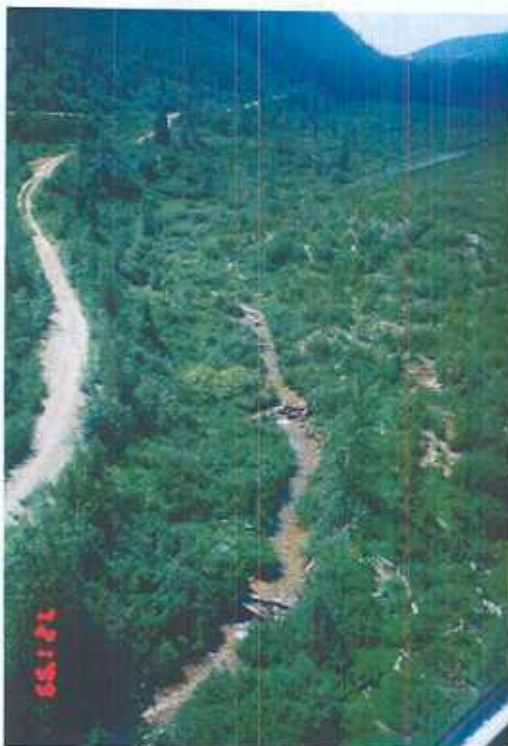
Photograph 6: Harvesting in the Nicoamen River watershed completed in the late 1980's.
