Appendix 3A: Form 1: CAP - Field Data and Photo Documentation by Site

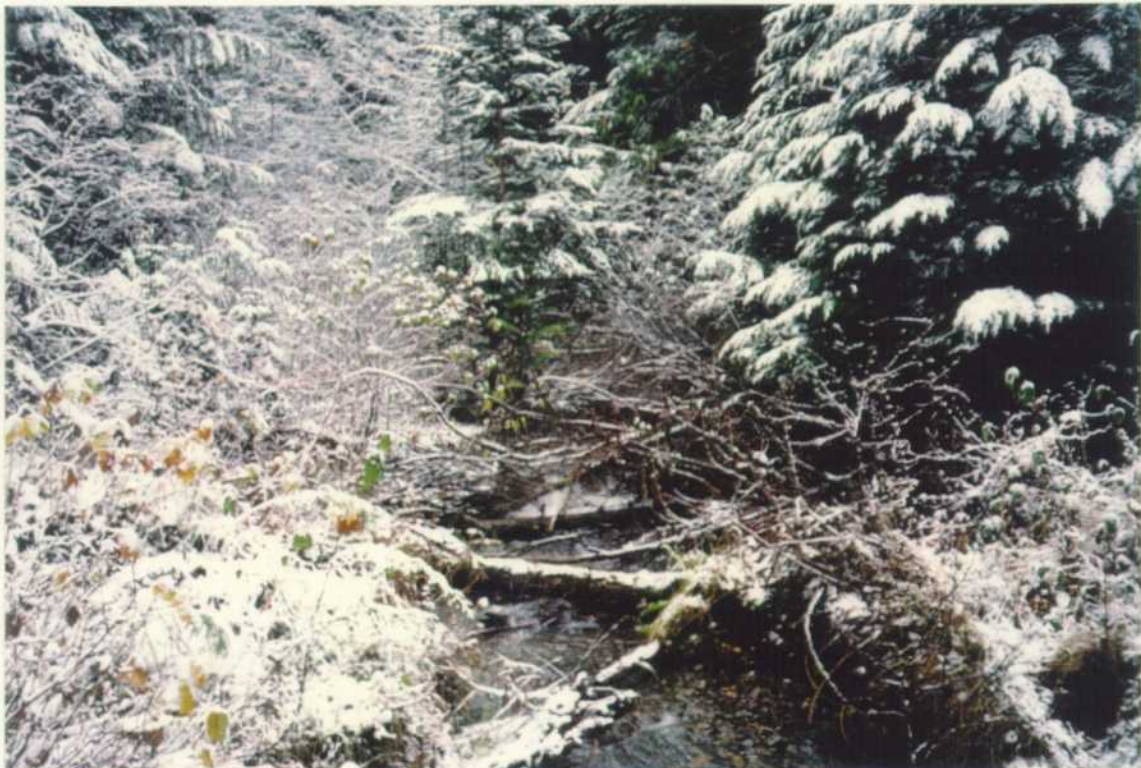
Downstream view of Reach 1, Monashee Pass Creek. Aggradation is occurring due to confinement by an old bridge and is indicated by extensive riffle and minimal pool area.

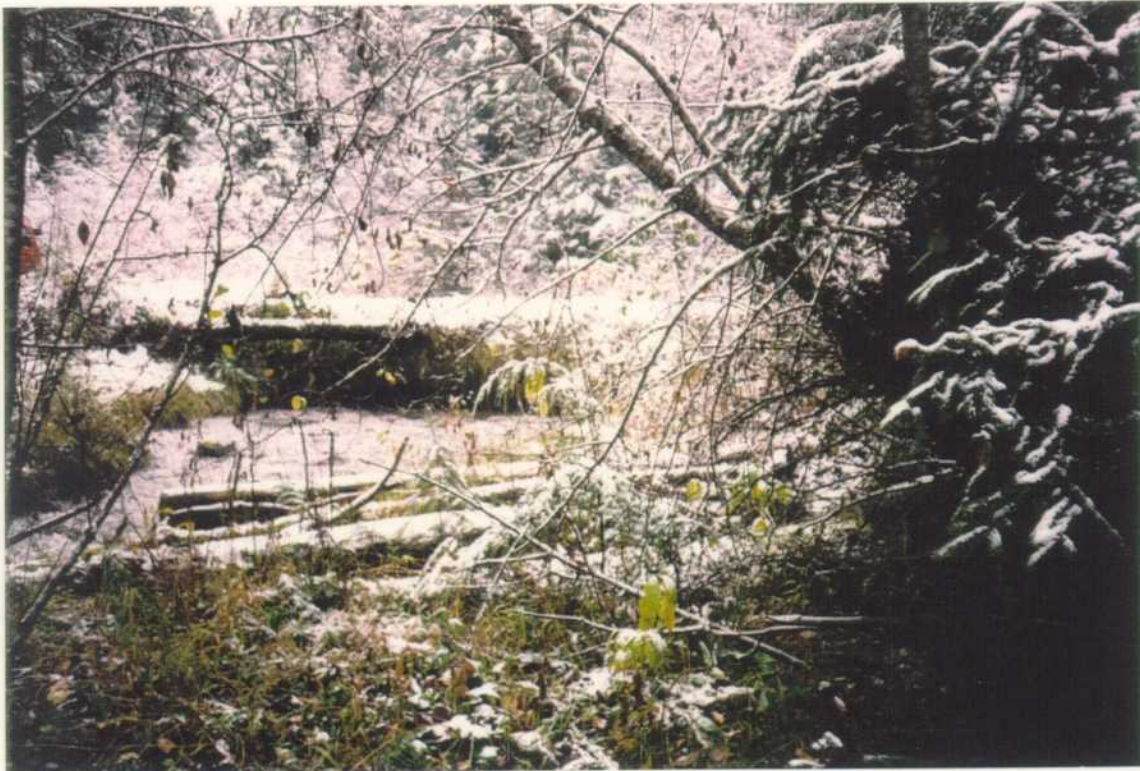
The side channel in the foreground and the old bridge in the background are features of site 2604.

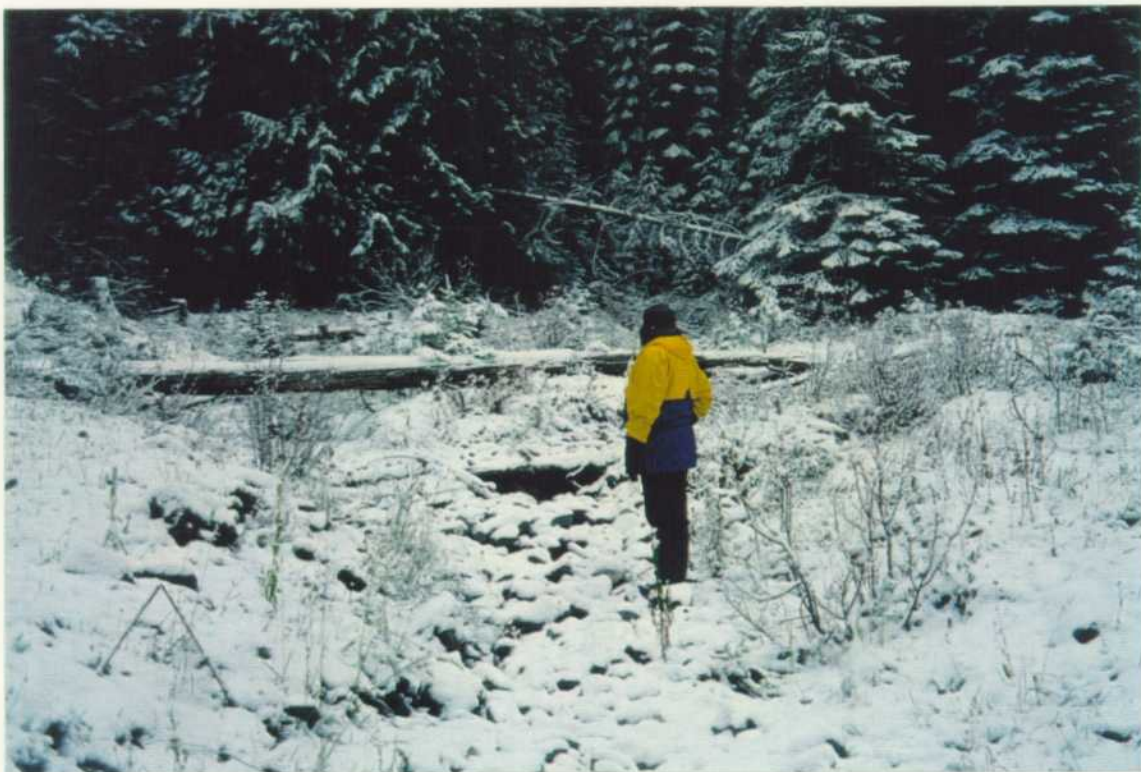
Upstream view of Reach 1, Tributary 6 to Monashee Pass Creek shows the disturbed stonelines. In addition, downstream of the photo there is a culvert which is out of alignment with the stream channel and is causing erosion and a sediment source.

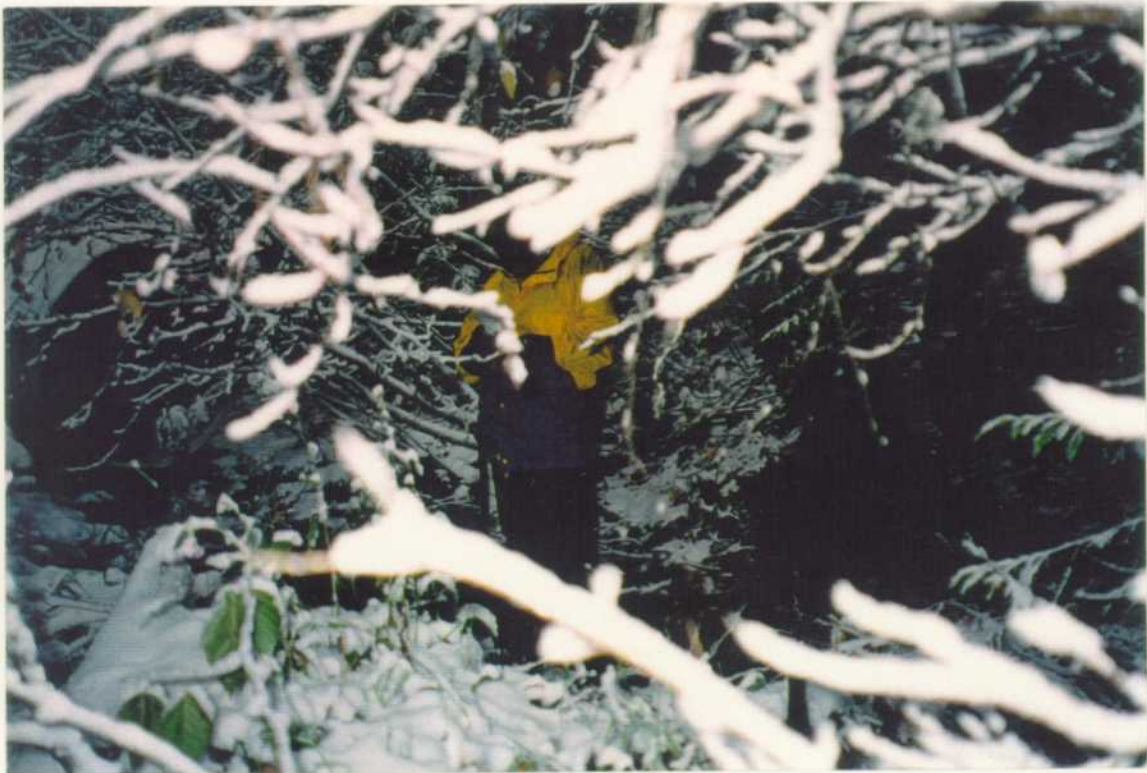
The banks are eroding at the downstream end of the culvert as a result of its misalignment.

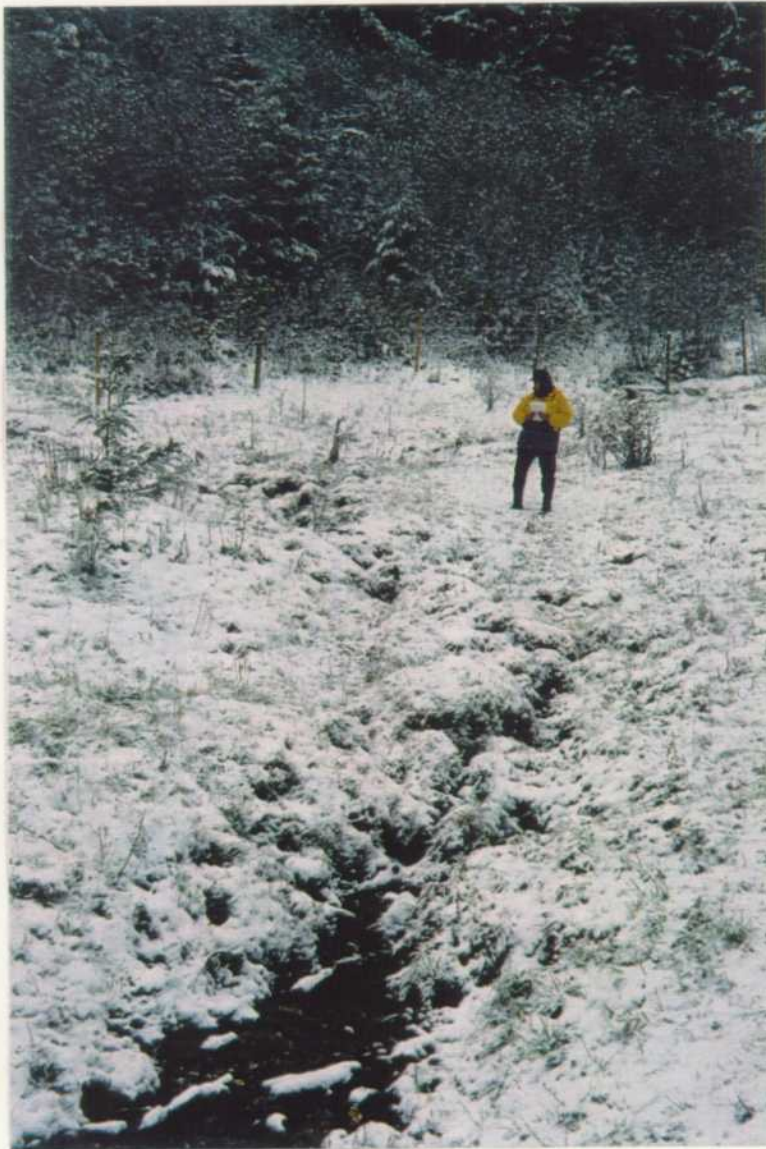
Upstream view of Reach 1,
Tributary 9 of Monashee
Pass Creek shows the
absence of a riparian
buffer under the
powerlines and the impact
of cattle on the channel.

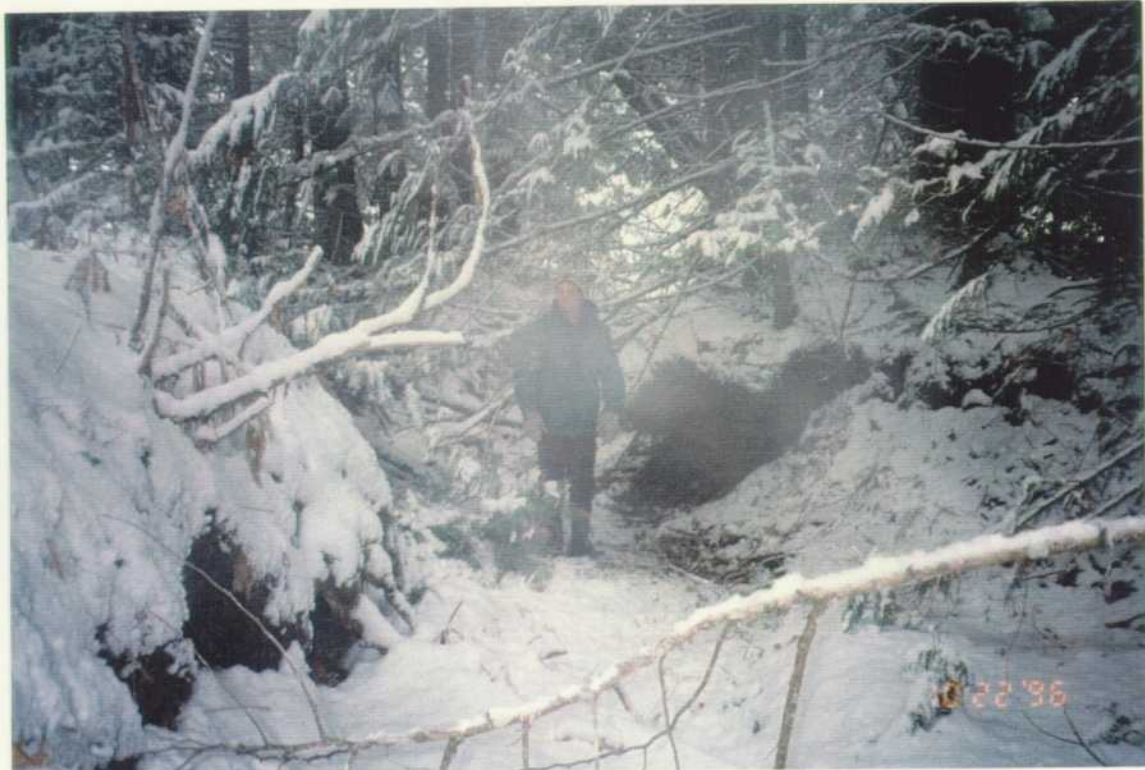
Eroding banks downstream of culvert in Reach 1, tributary 9 to Monashee Pass Creek. The banks downstream of the Monashee Pass FSR culvert are composed of road gravel fill eroded from upstream. The culvert is damaged and partially filled with gravel.

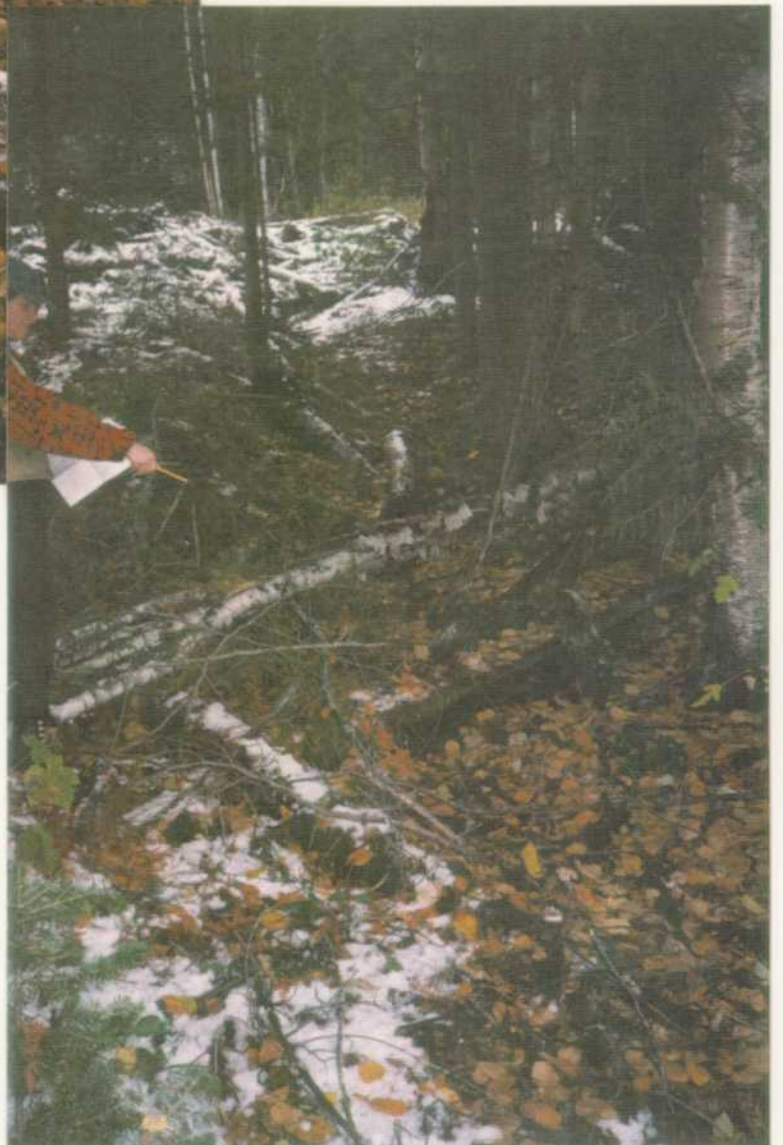
Sediment wedges, minimal pool area, disturbed stonelines, abandoned channels, eroding banks, avulsions and small woody debris influence the channel downstream of the logging road crossing on tributary 5 to Monashee Pass Creek.

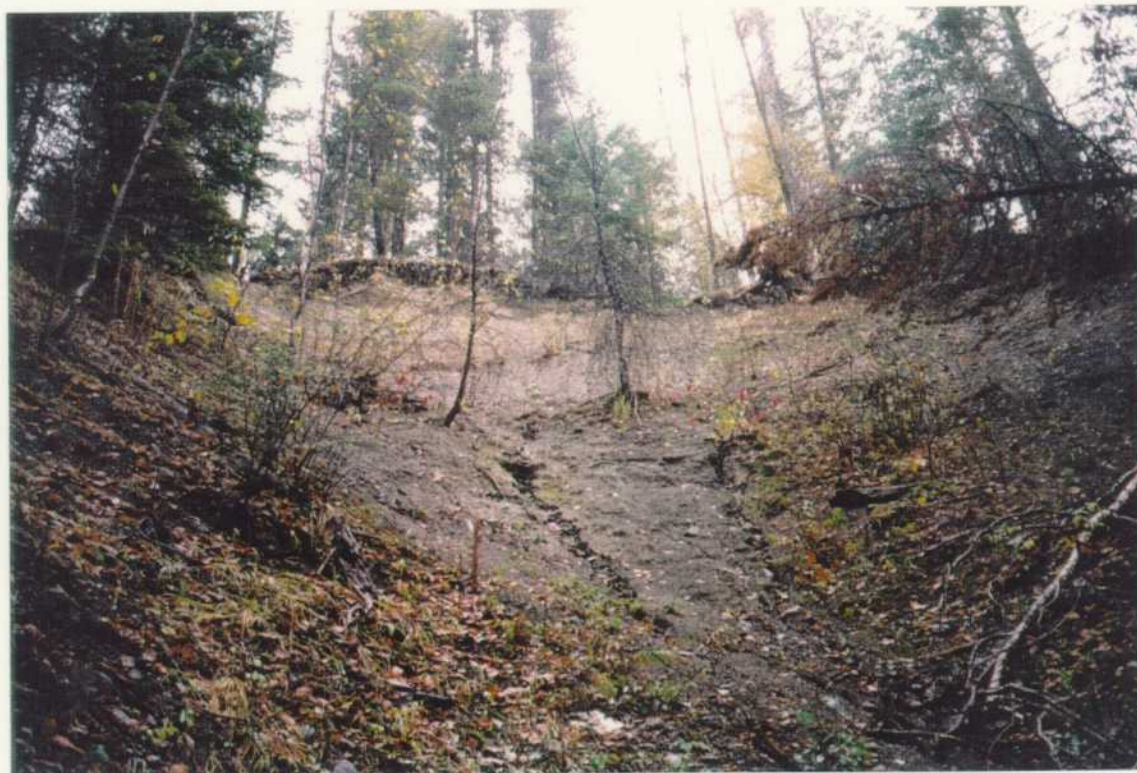
Slide into Tributary 14 to Monashee Creek.

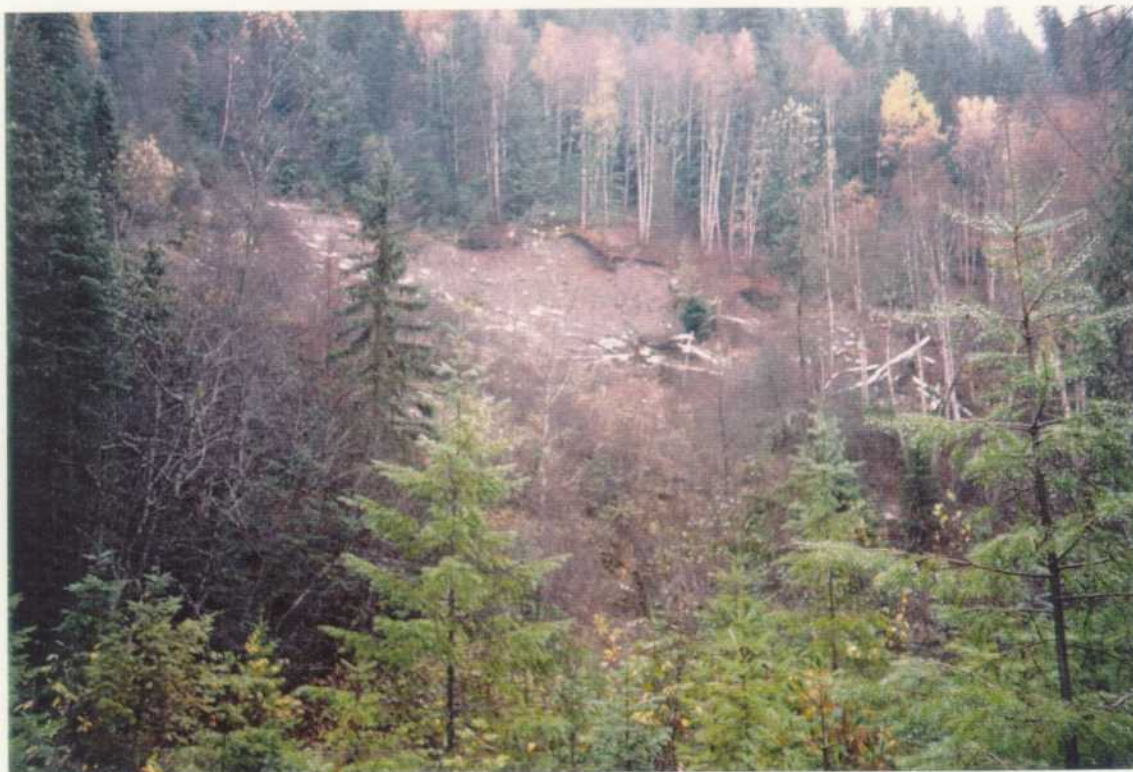
Slumping south bank of Monashee Creek demonstrates the dynamic nature of the flood plain in Reach 5.

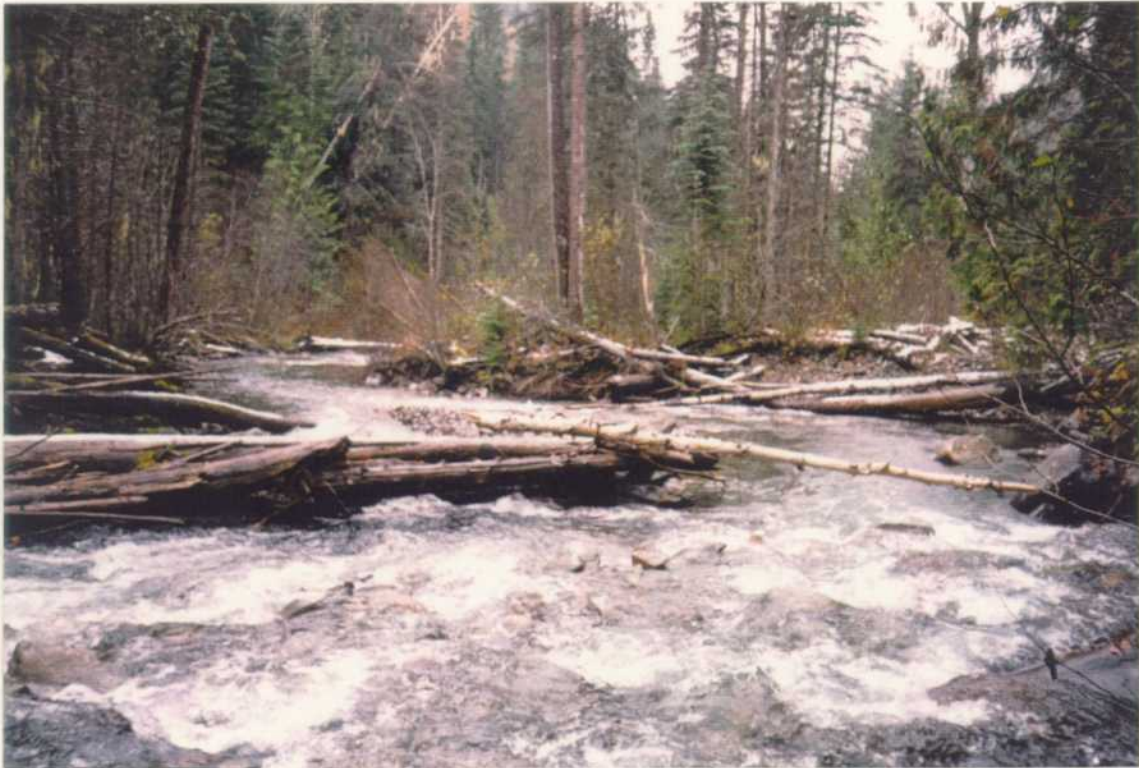
The sinuous channel has extensive scoured zones, disturbed stonelines, minimal pools, elevated mid-channel bars, abandoned channels, eroding banks, avulsions and large woody debris function.

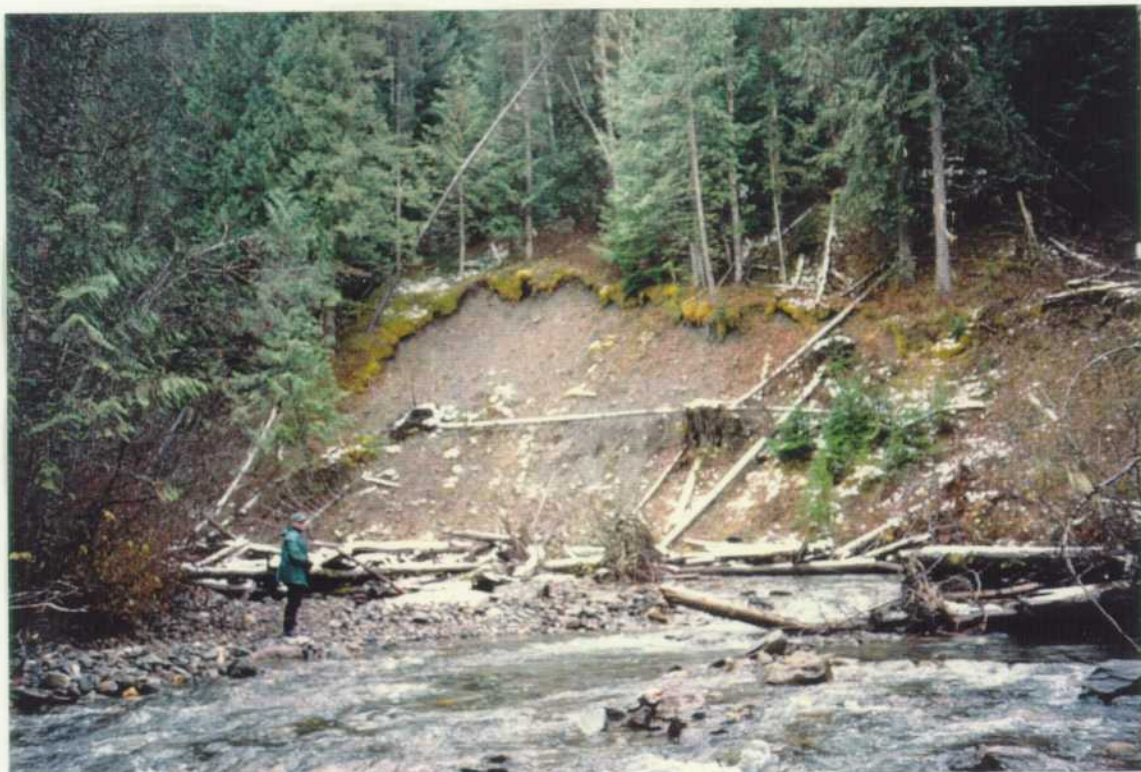
Upstream view showing eroding bank, recent log jams and large woody debris function.

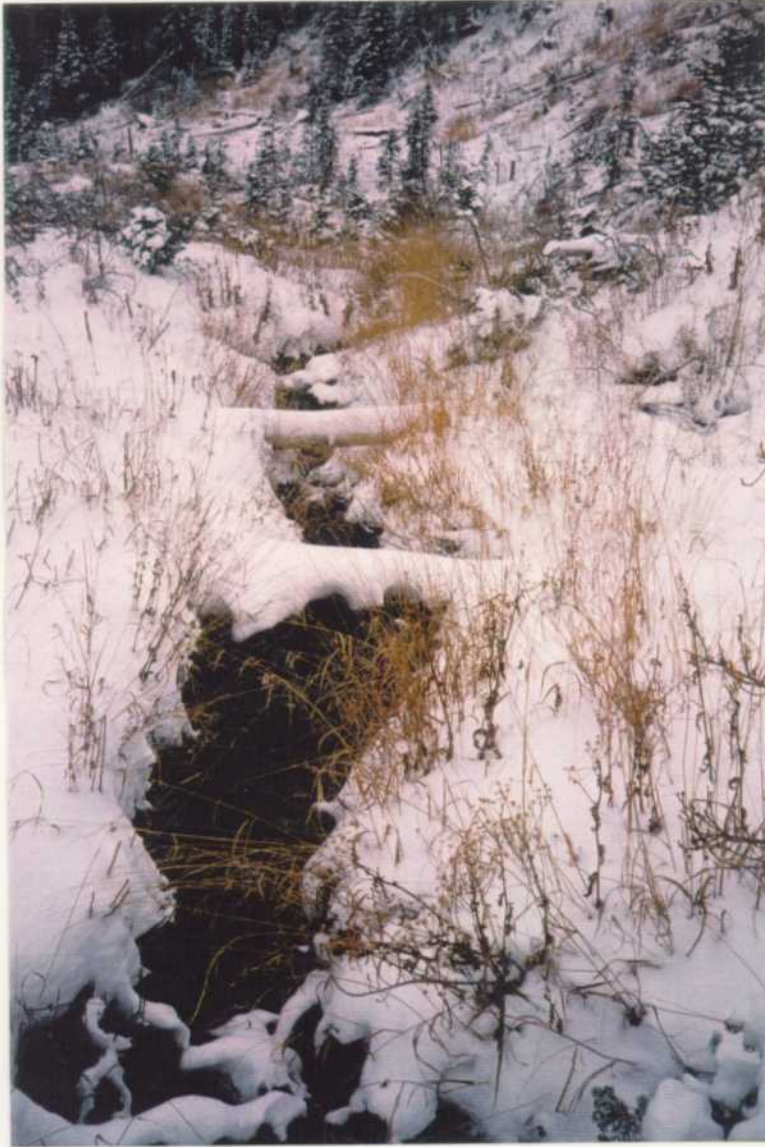
Upstream view of a degrading channel Reach 1, tributary 7.6 to Monashee Pass Creek. The creek headwaters drain a clearcut that has not reached free to grow. Downstream, where the creek enters the forest, the channel is dry.

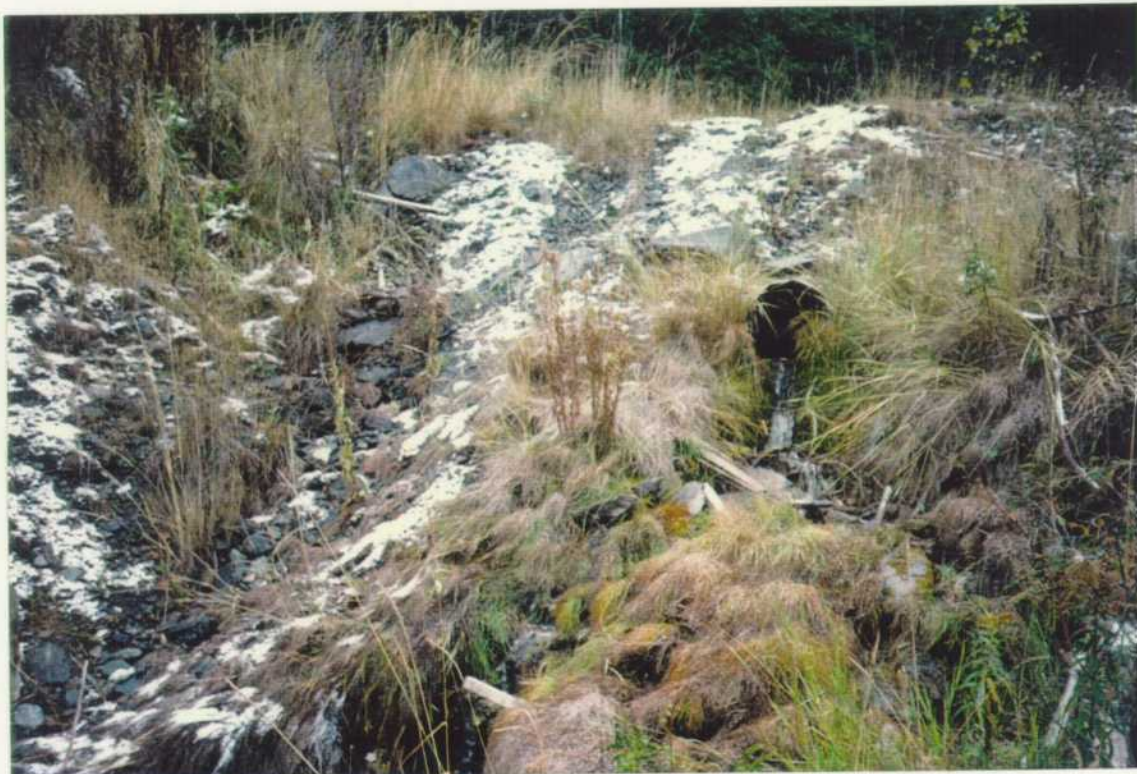
Culvert draining Reach 1, Half Mile Creek under Hwy. 6. The creek forms multiple channels immediately downstream of the culvert under the powerlines. The creek becomes a single channel when it re-enters the young, coniferous forest. Upstream of Hwy. 6 the channel is functioning well in a mature coniferous forest.

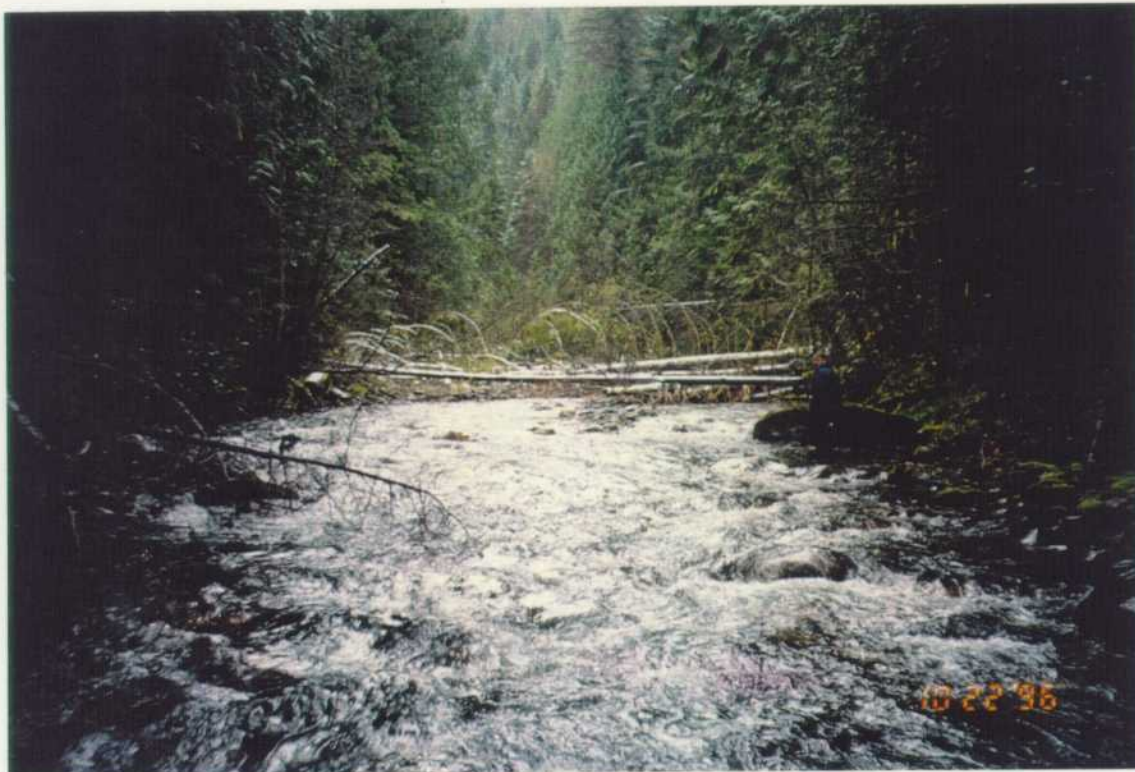
Upstream view of Reach 4, Monashee Creek. The channel is showing signs of degradation including: extensive riffles, minimal pool area and disturbed stonelines.

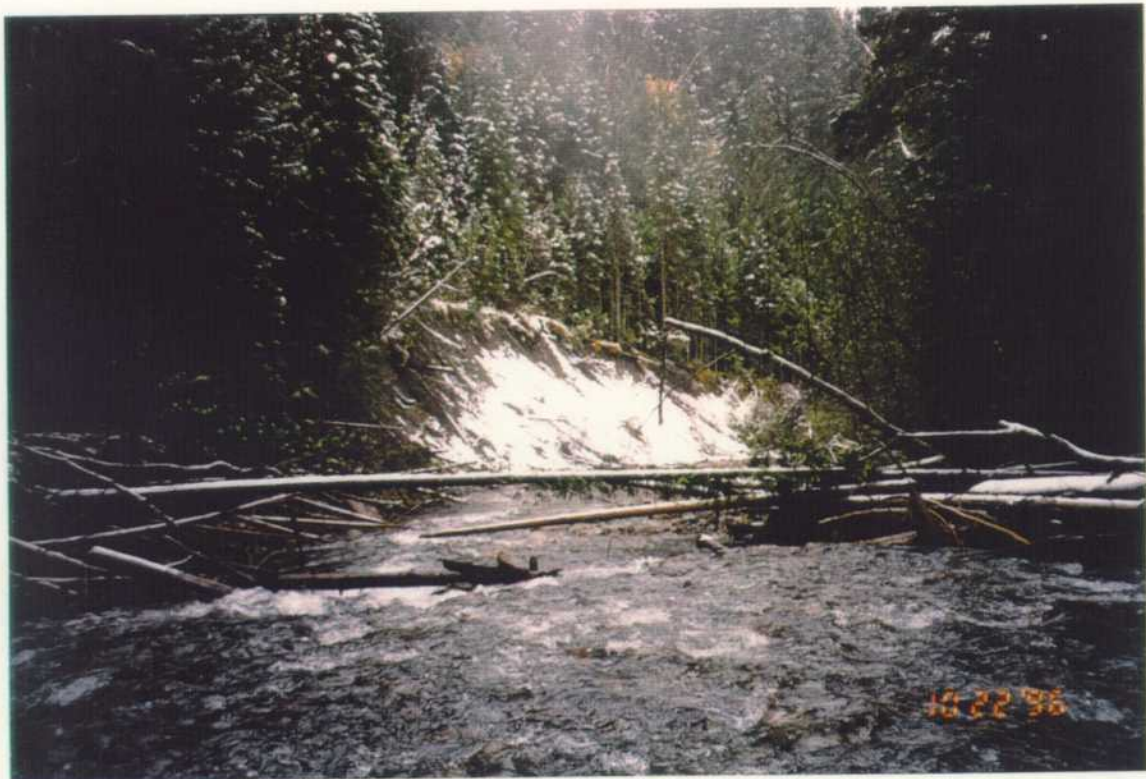
Downstream view of Reach 5 shows the dynamic nature of the channel and the continuous erosion of banks as the channel changes course. In addition, LWD is creating log jams and parallels the banks.

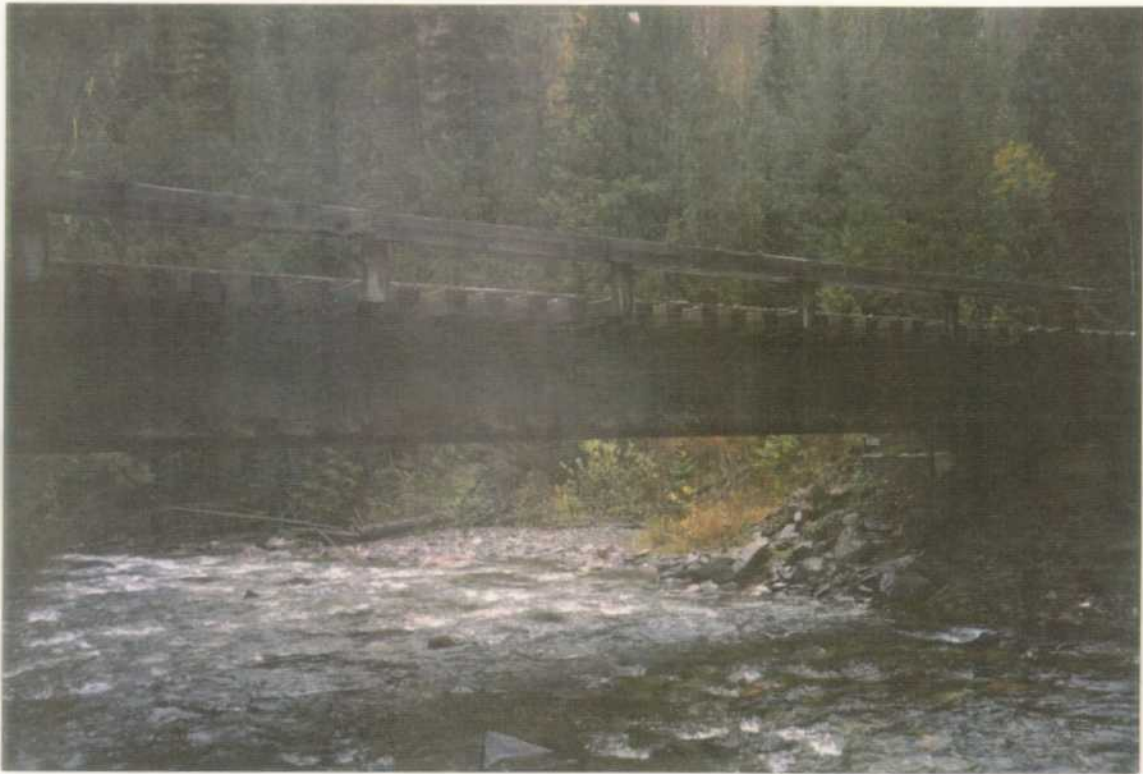
The bridge crossing to the Yeoward sub-basin is sound, however, aggradation of the channel is occurring in the vicinity.

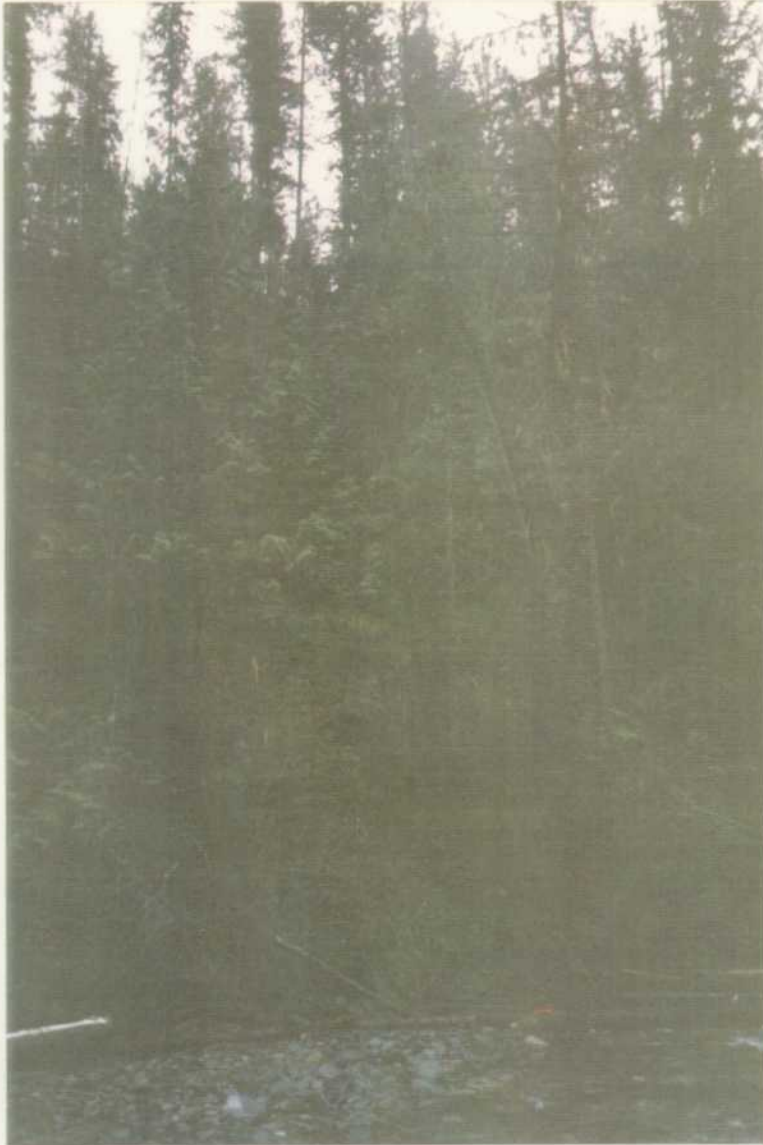
Erosion, slumping banks and cobble bars are characteristic of this site in Reach 5.

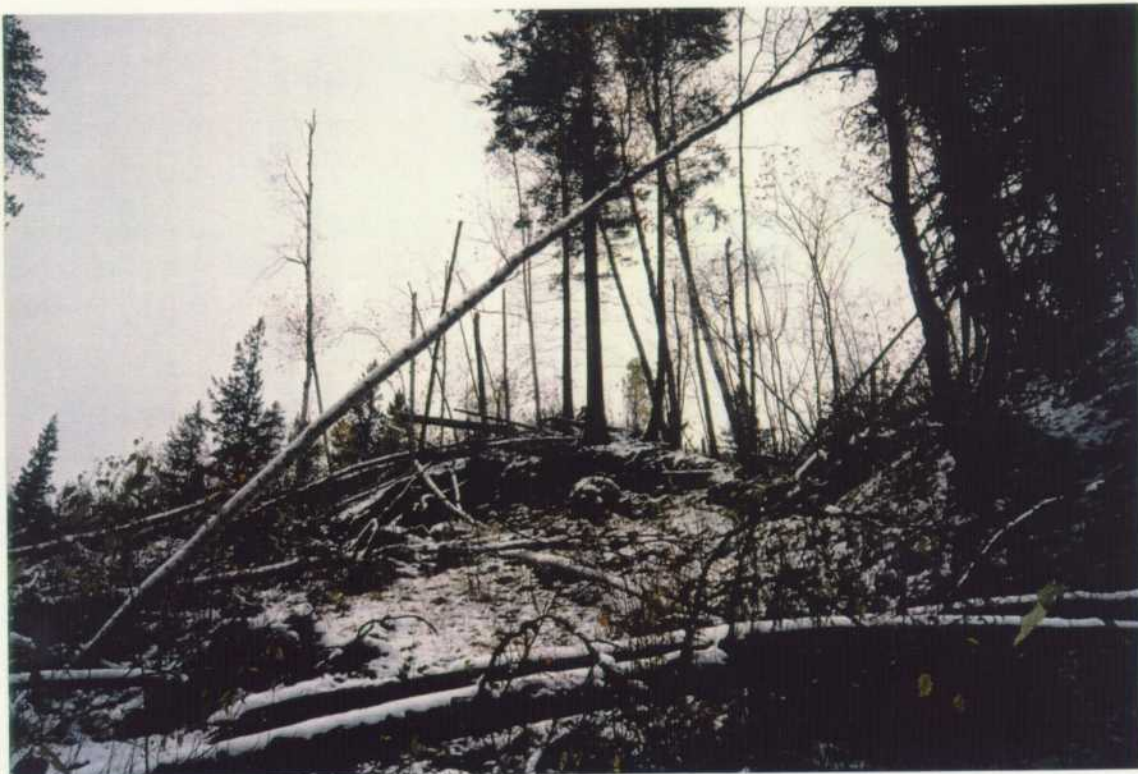
Slumping banks adjacent to Reach 2, Yeoward Creek are related to a trail parallel to the north side of the creek, a landing and old upslope logging. Bank stabilization with rooting vegetation is recommended, however soils are fine colluvium and trees have been easily uprooted.

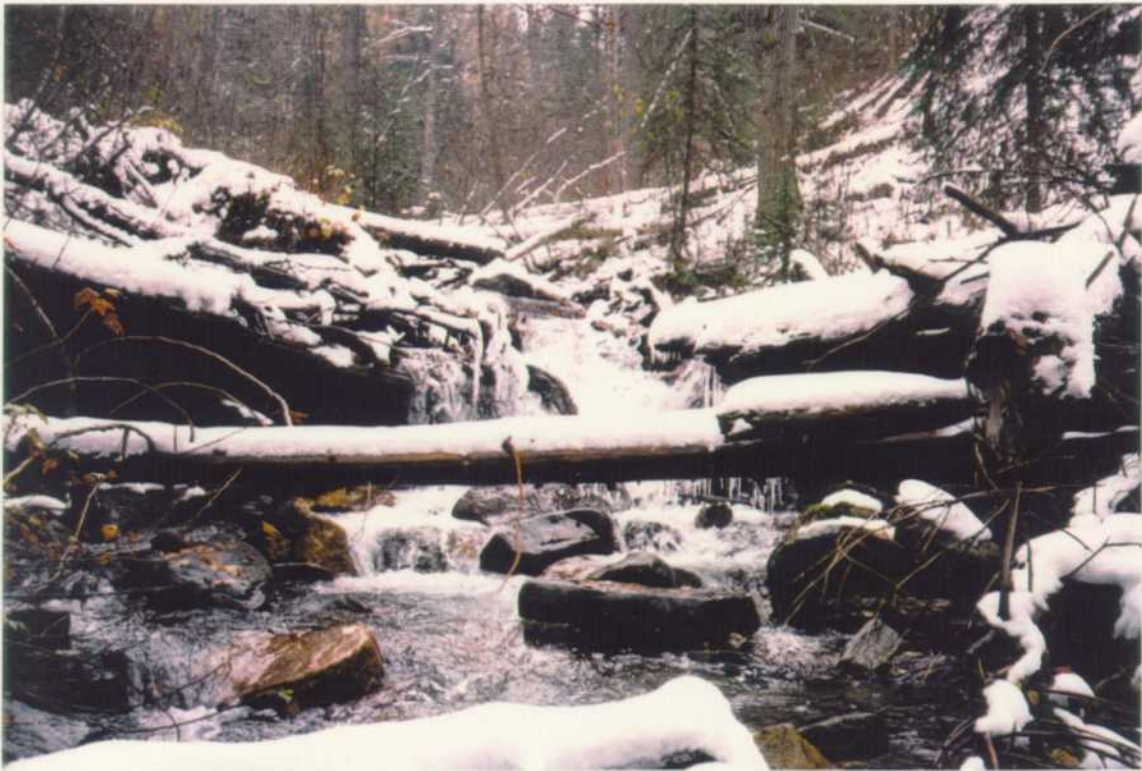
An ATV bridge, log dump and truck box are human disturbances at this site. Downstream the creek is functioning well with some eroding banks and disturbed stonelines.

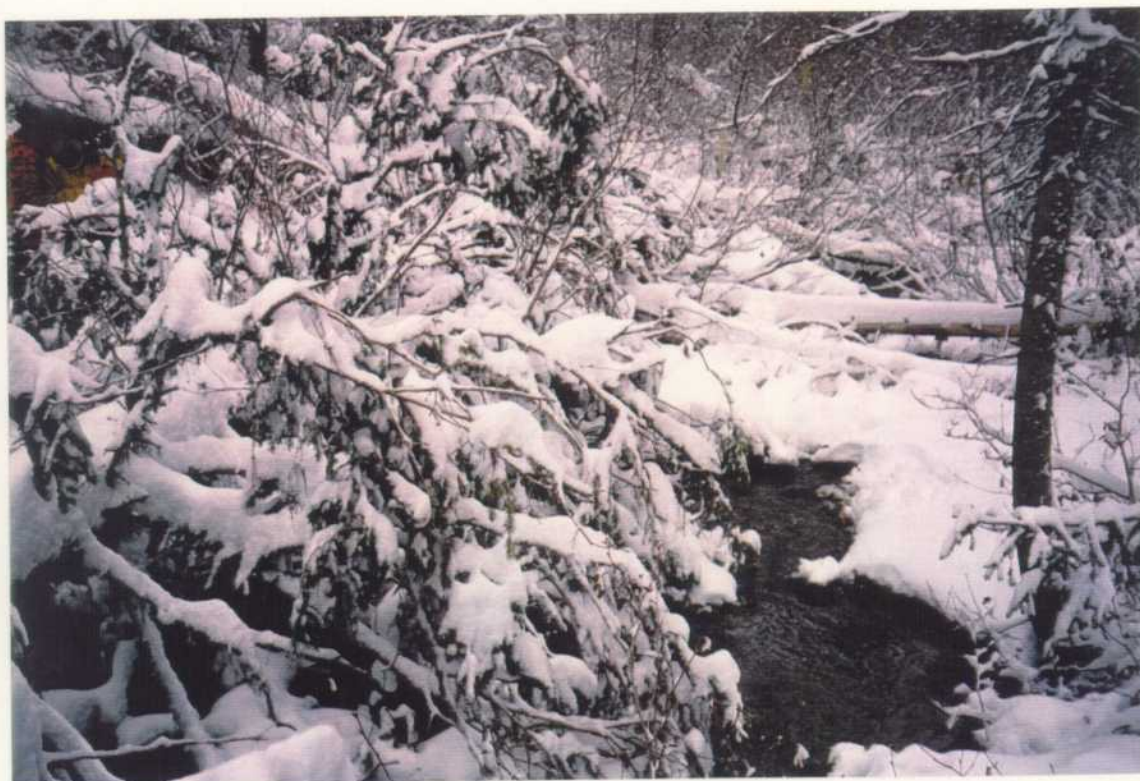
Downstream view of Yeoward Creek, downstream of the culvert demonstrates the abundant blowdown that was the riparian buffer to the adjacent clearcut.

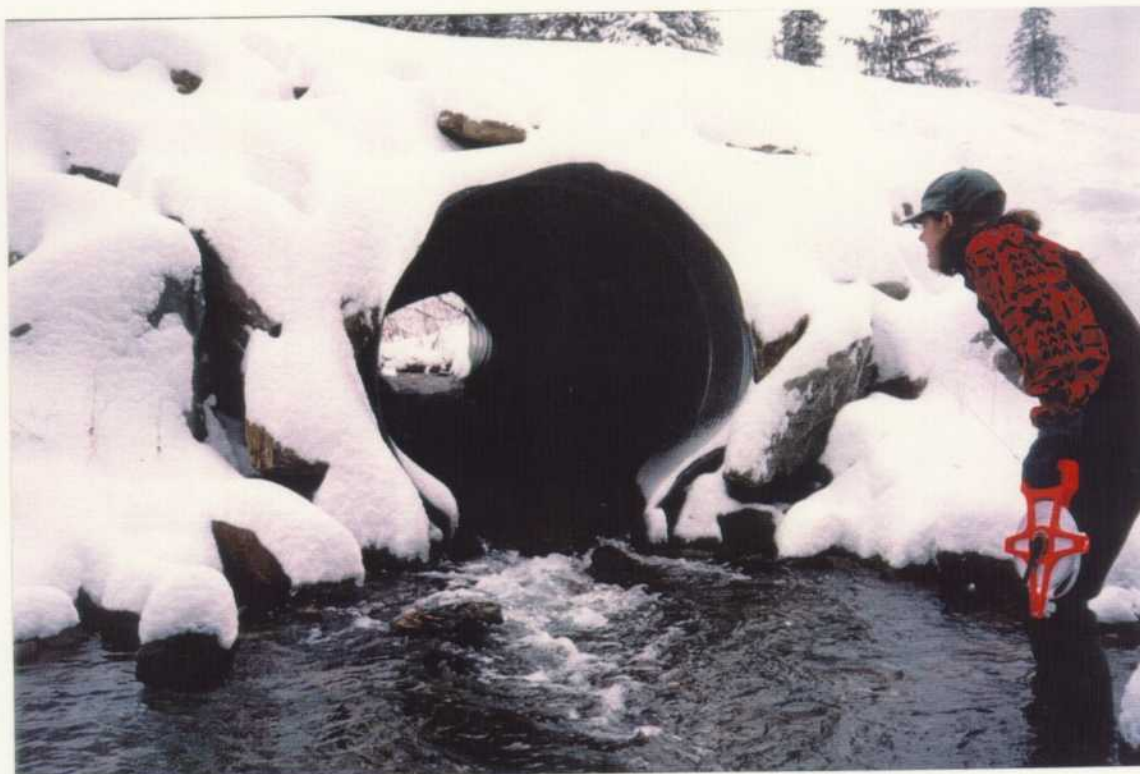
View of the dented culvert at the Yeoward road crossing. A possibility for culvert failure exists.

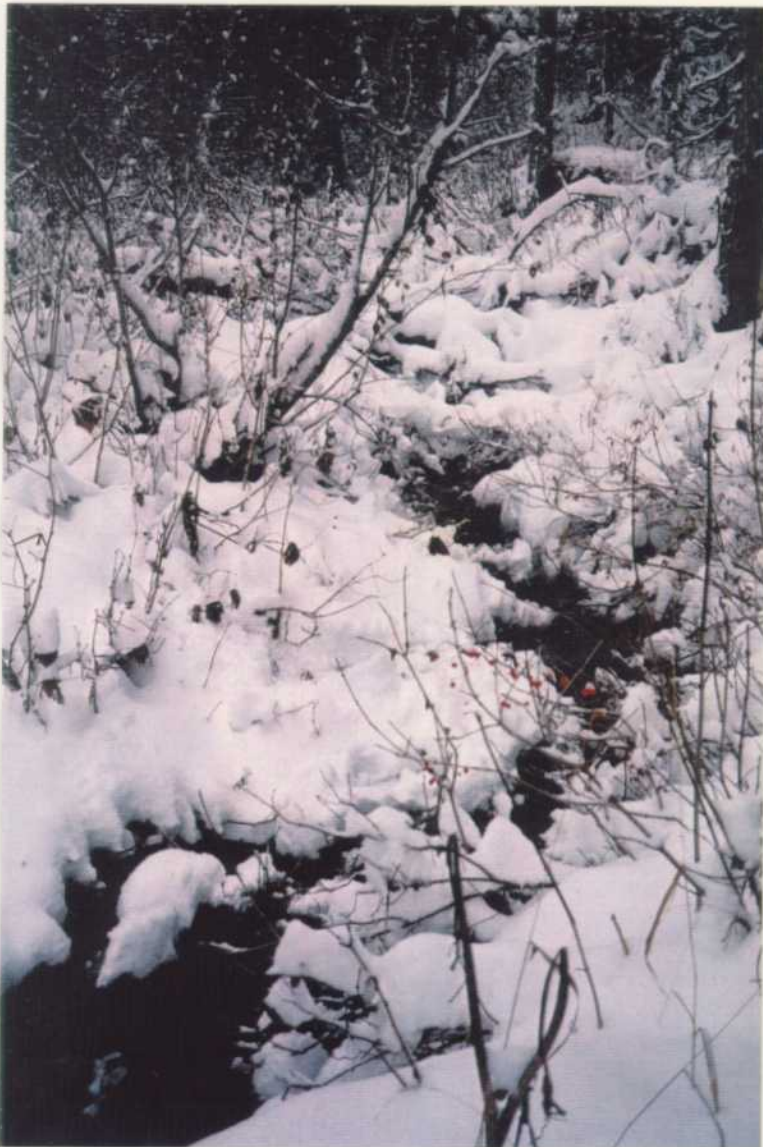
Reach 1, Tributary 10 to Yeoward
Creek is aggrading which is
indicated by sediment wedges,
extensive riffles and minimal pool
area.

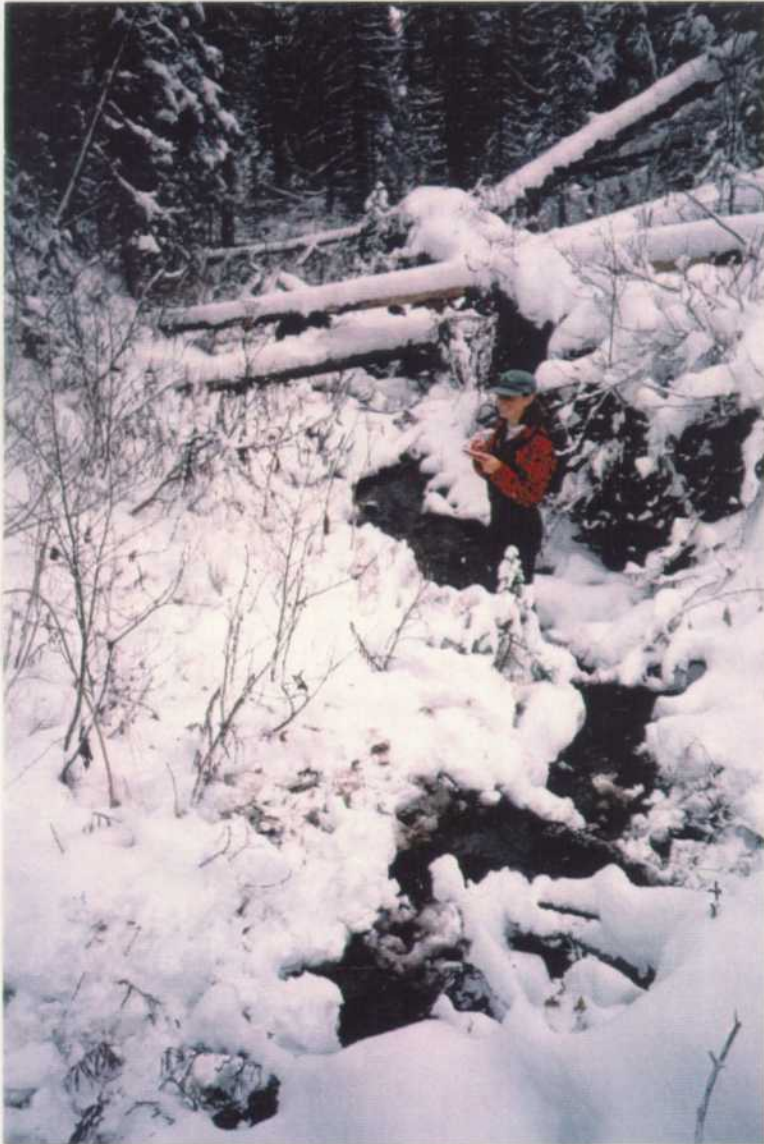
Upslope logging and a culvert are human impacts to Reach 1, Tributary 11 to Yeoward Creek. The impacts have caused blowdown across the stream, high silt content and side channels during high flows.

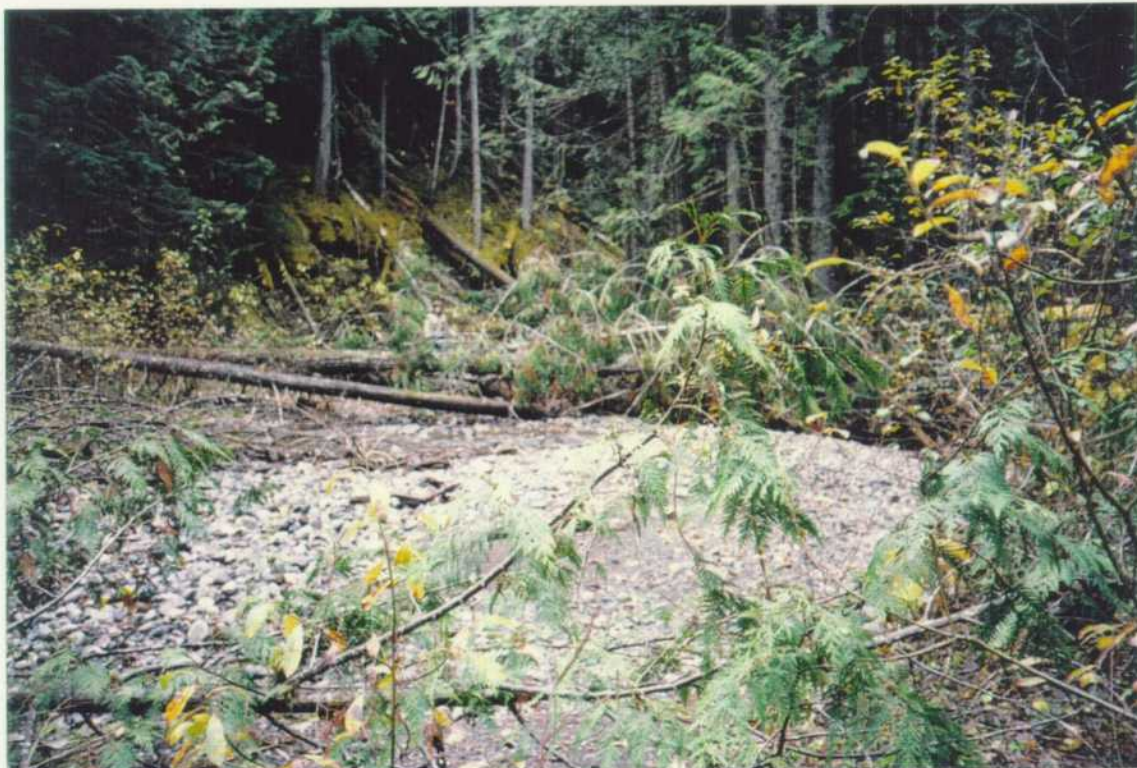
Downstream view showing fallen trees from the eroding bank. Cobble bars are common.

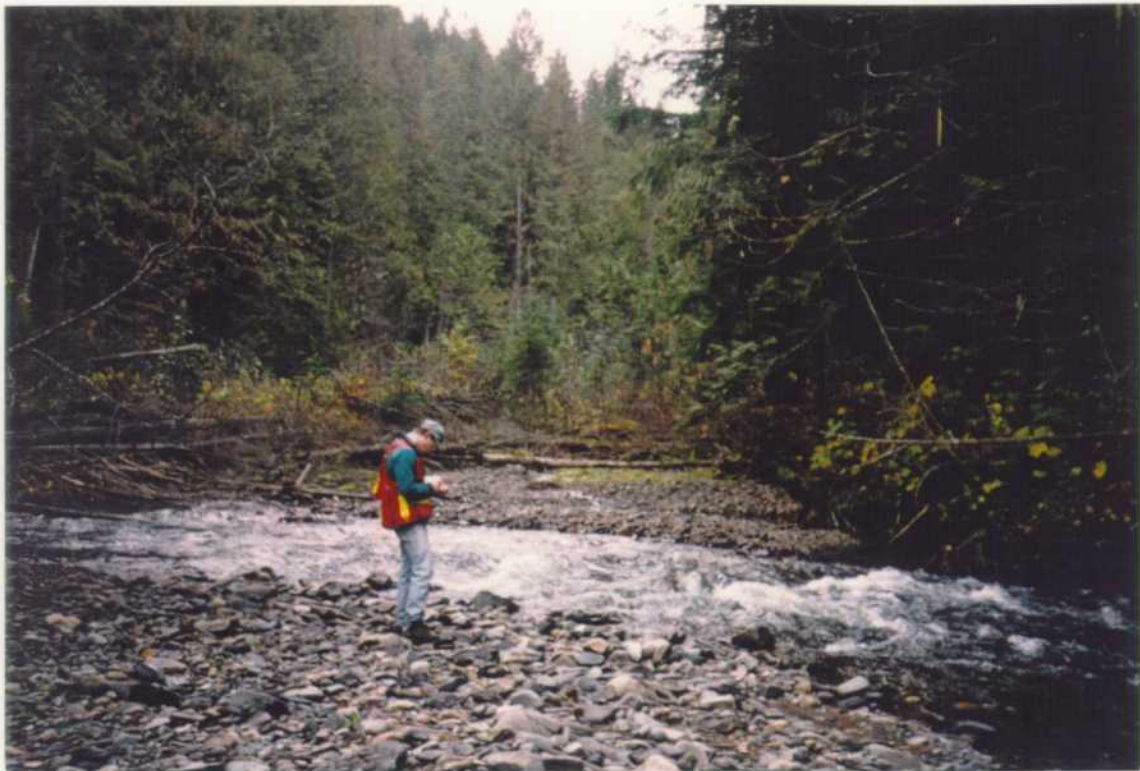
Upstream view of Reach 5, Monashee Creek showing side channel, extensive riffles and disturbed stonelines. A 5m wide side channel was created by a log jam.
