Appendix 3A: Form 1: CAP - Field Data and Photo Documentation by Site

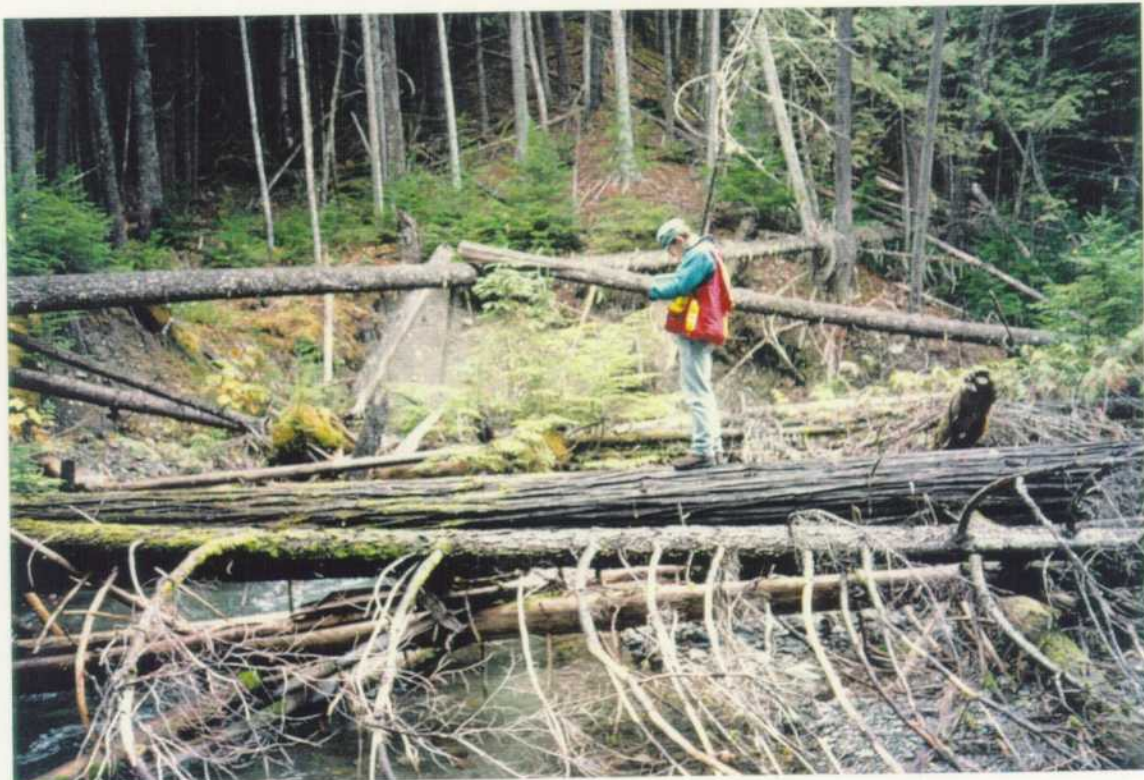
Upstream of site 2641 at site 2642 Reach 5, Monashee Creek the channel is heavily impacted by fallen trees.

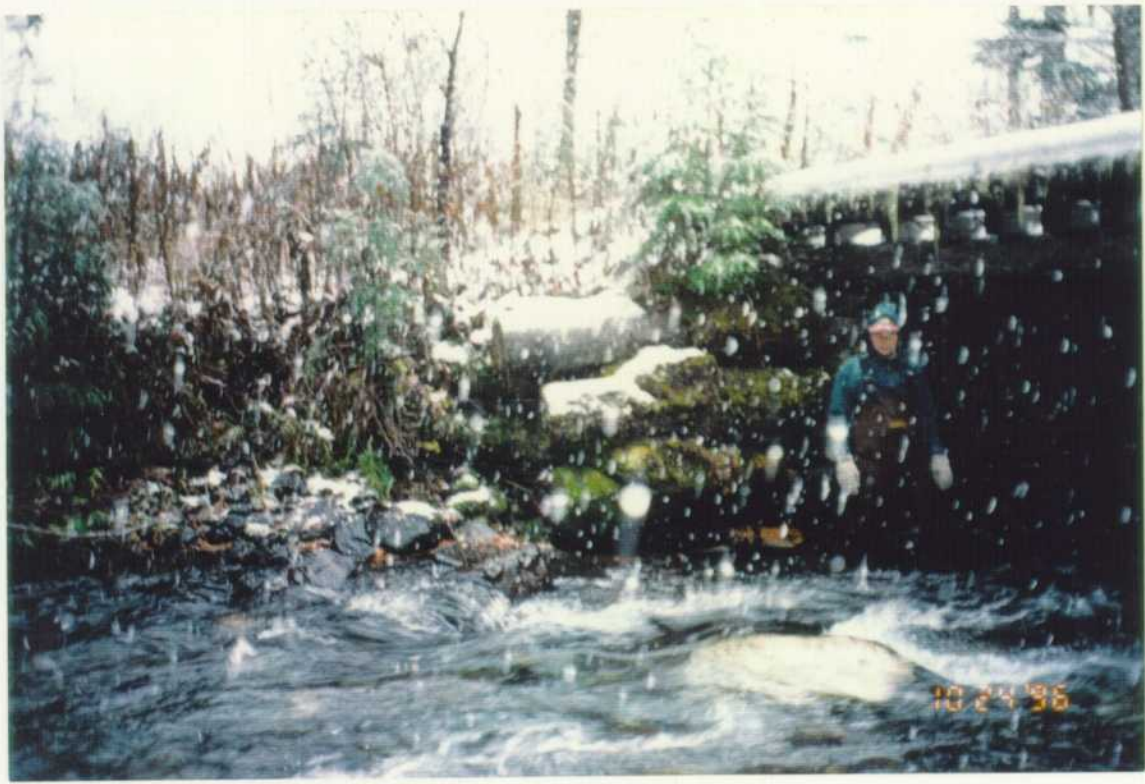
View of bridge crossing and abutment in Reach 6B, Monashee Creek which is a human impact to the channel.

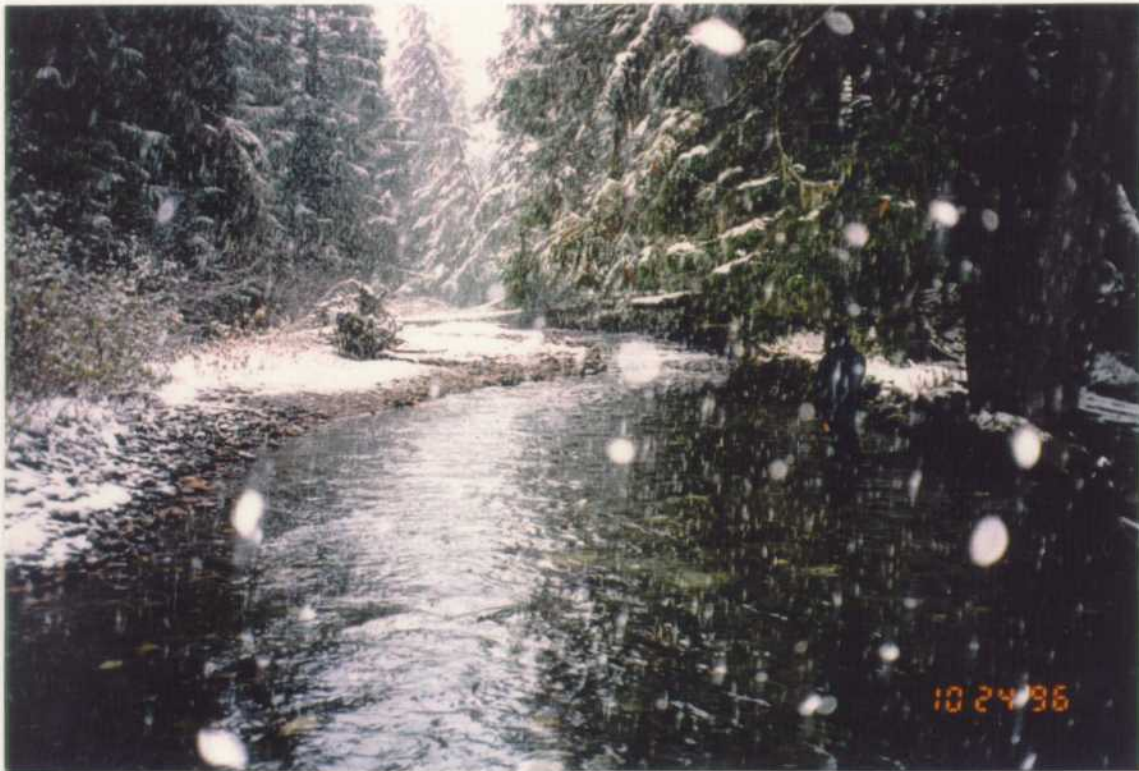
Downstream of the bridge. Upstream view of Reach 6B shows extensive riffle, sediment fingers and wedges and disturbed stonelines in this heavily aggraded channel.

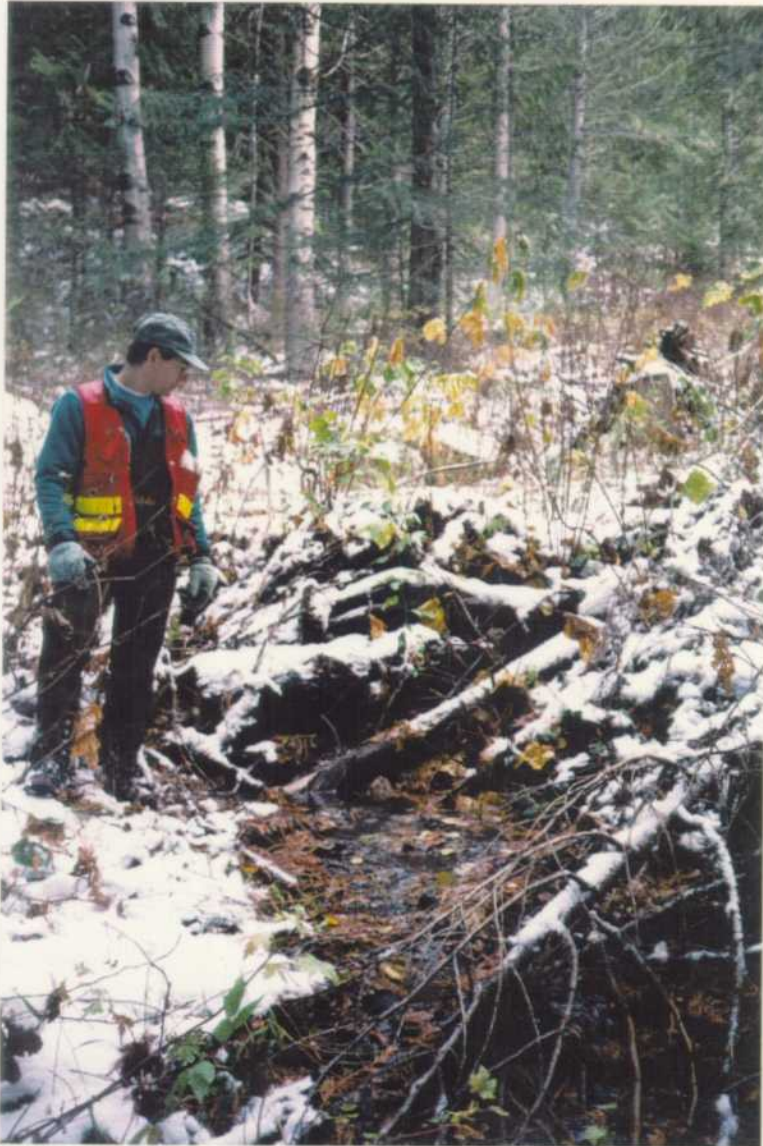
View of collapsed bridge. In order to reduce the aggradation process the bridge should be removed. In addition, the adjacent landing should be revegetated to stabilize the soils.

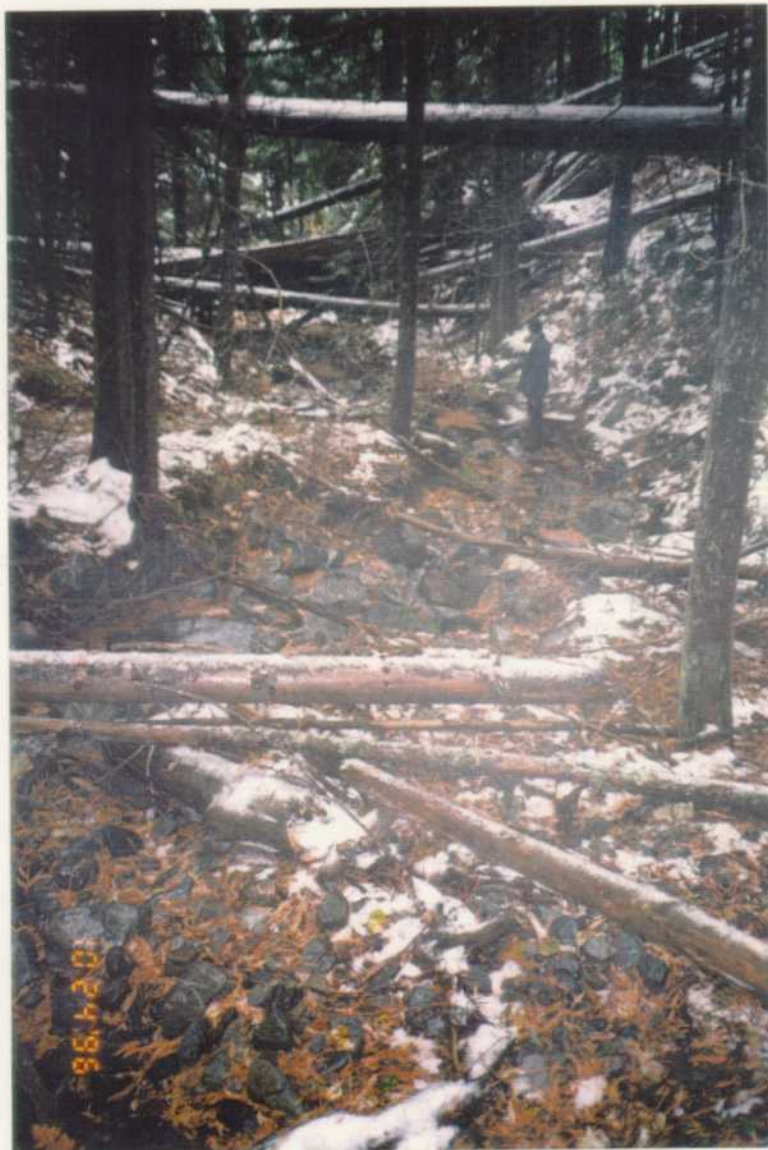
The heavily scoured bed of Reach 1, Tributary 27 to Monashee Creek indicates seasonal high velocity.

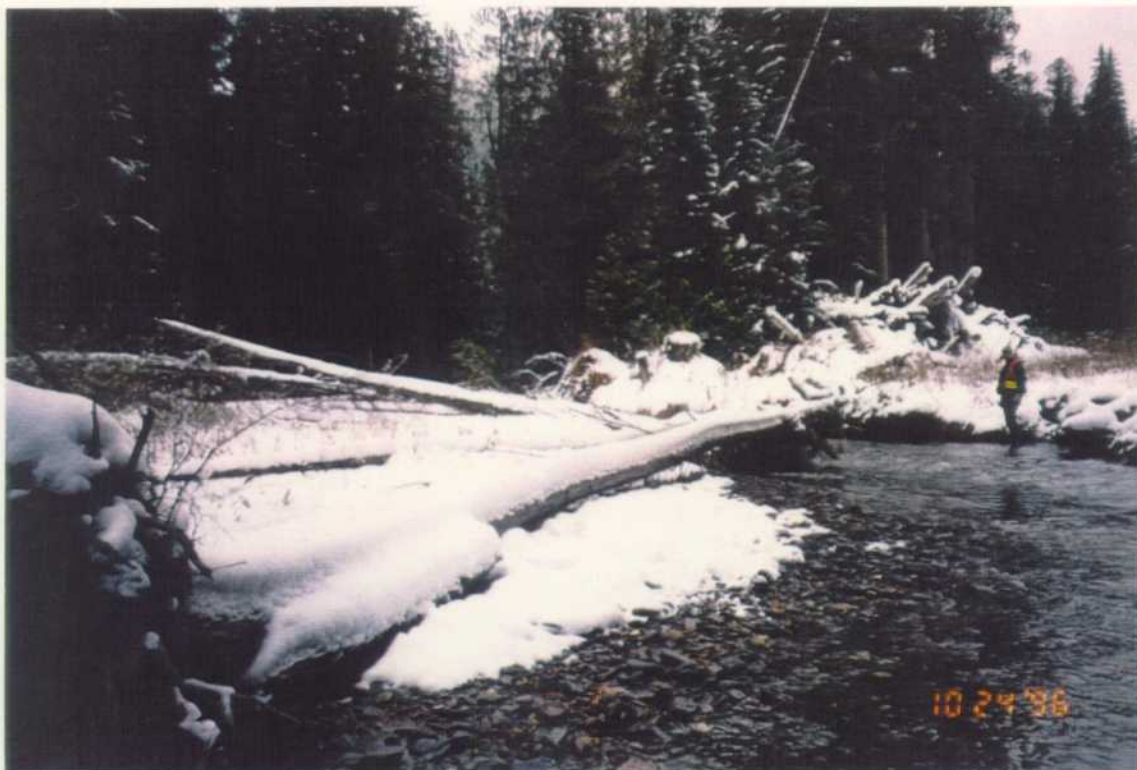
Upstream of the site there is a 70m zone of heavily aggraded channel.

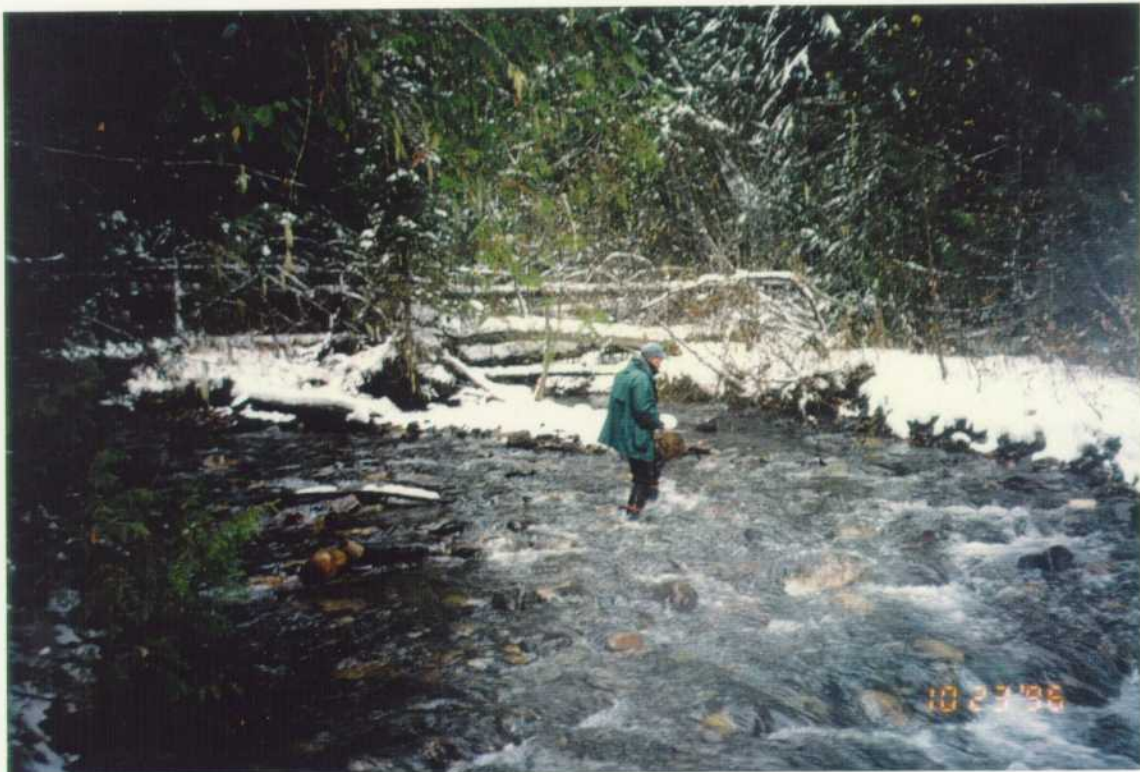
Upstream view of Reach 7, Monashee Creek shows the extensive riffle, a midchannel bar and disturbed stonelines.

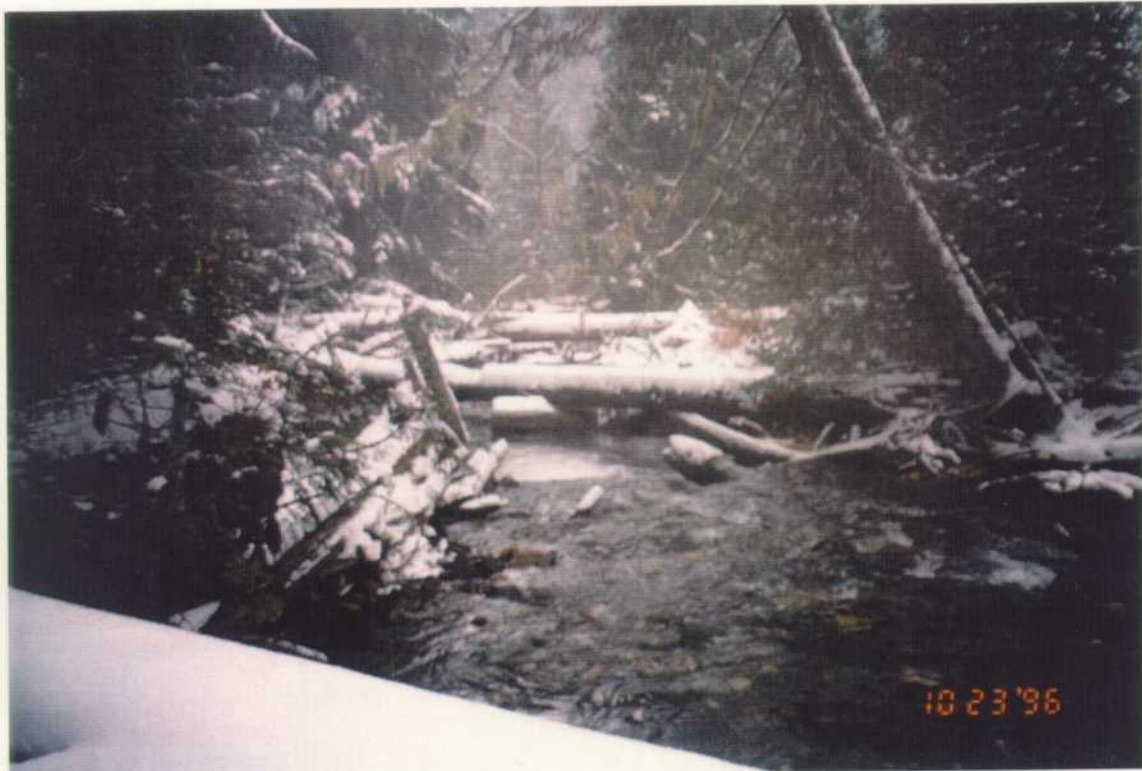
Downstream view shows the LWD function and a log jam. This site is considered to be moderately aggrading.

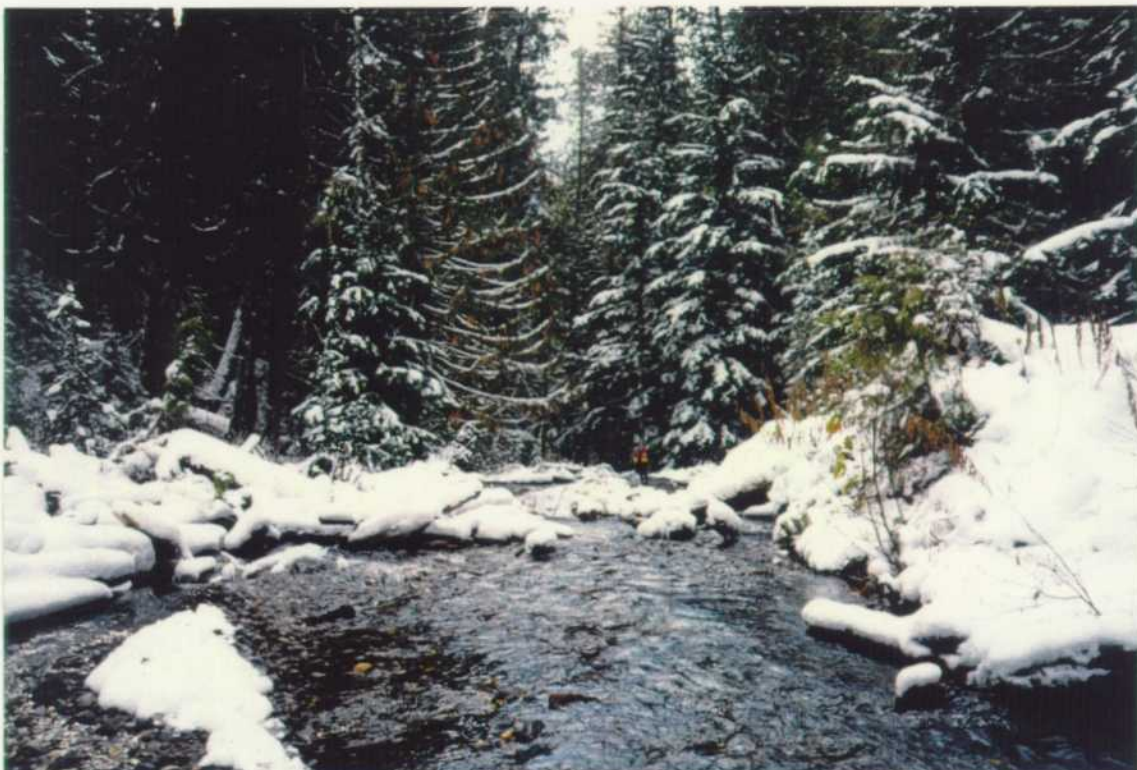
Downstream view of Reach 1A, Tributary 32 to Monashee Creek shows an unnaturally wide channel due to aggradation.

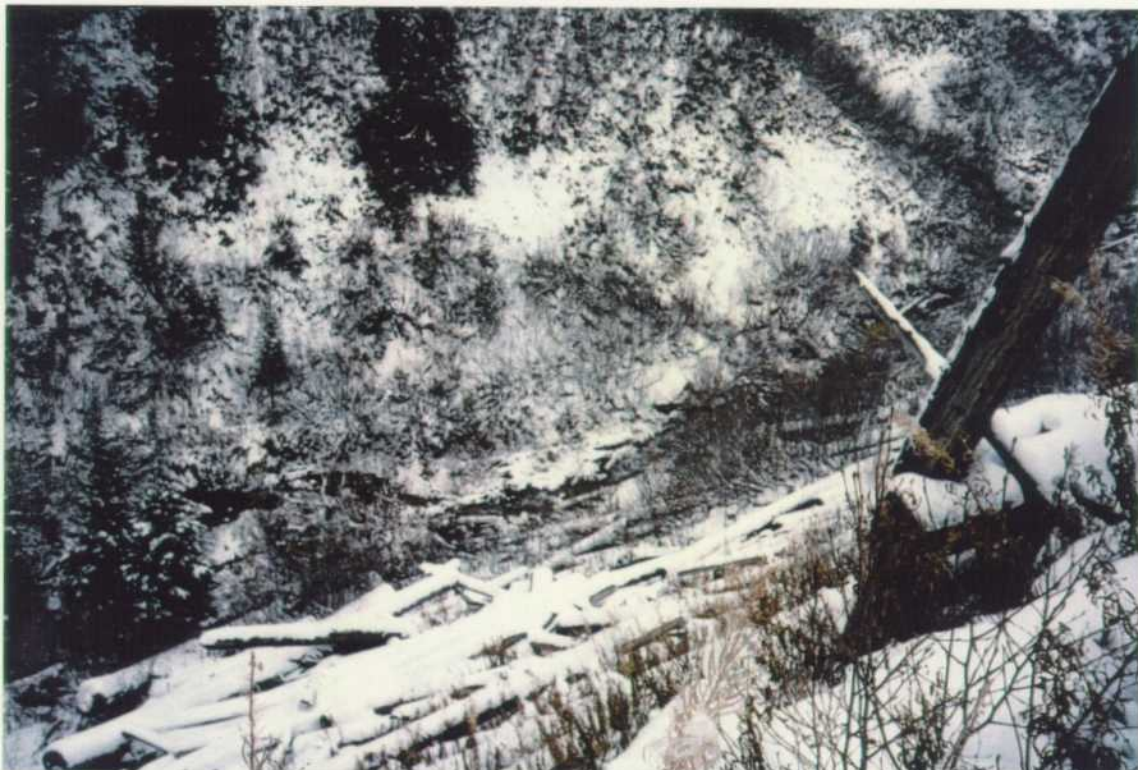
Reach 1, Tributary 32 to Monashee Creek has been impacted by a landing and a disturbed log dump. Disturbance in the channel is indicated by multiple channels.

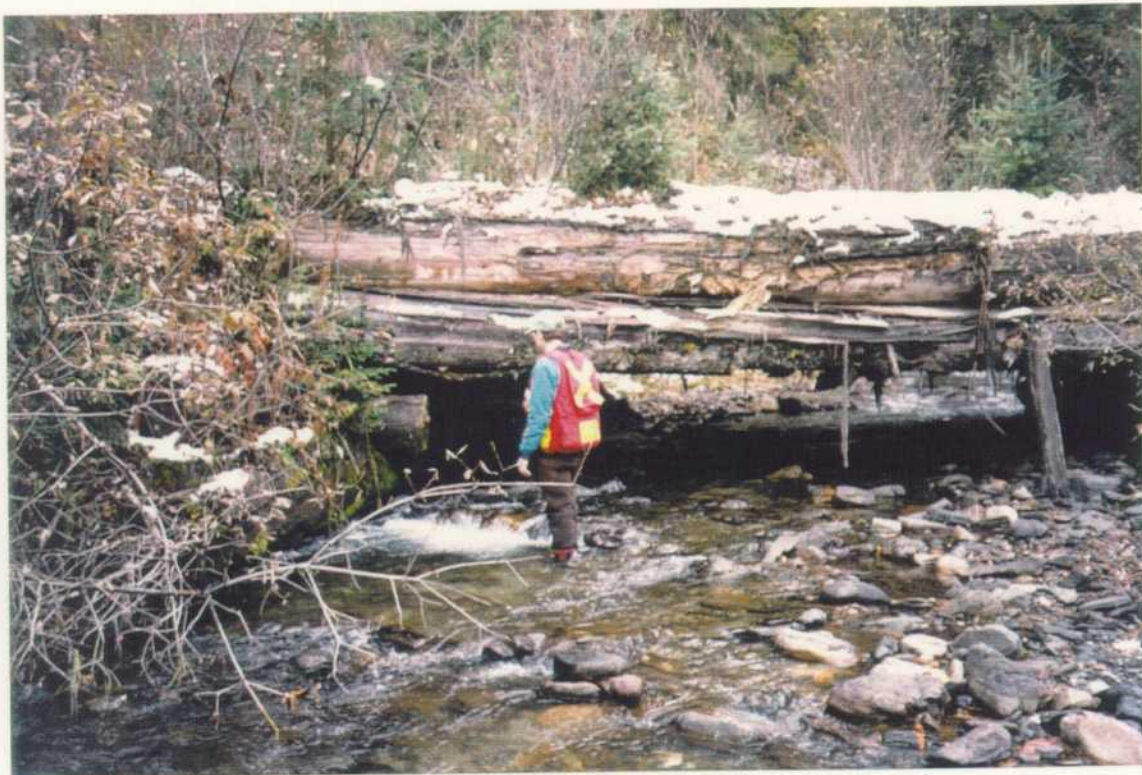
The bridge has vegetation growing on it, rotten stringers, 3 of 4 abutments are eroded, the bridge is sinking and sediment is evident in the channel. The bridge requires removal.

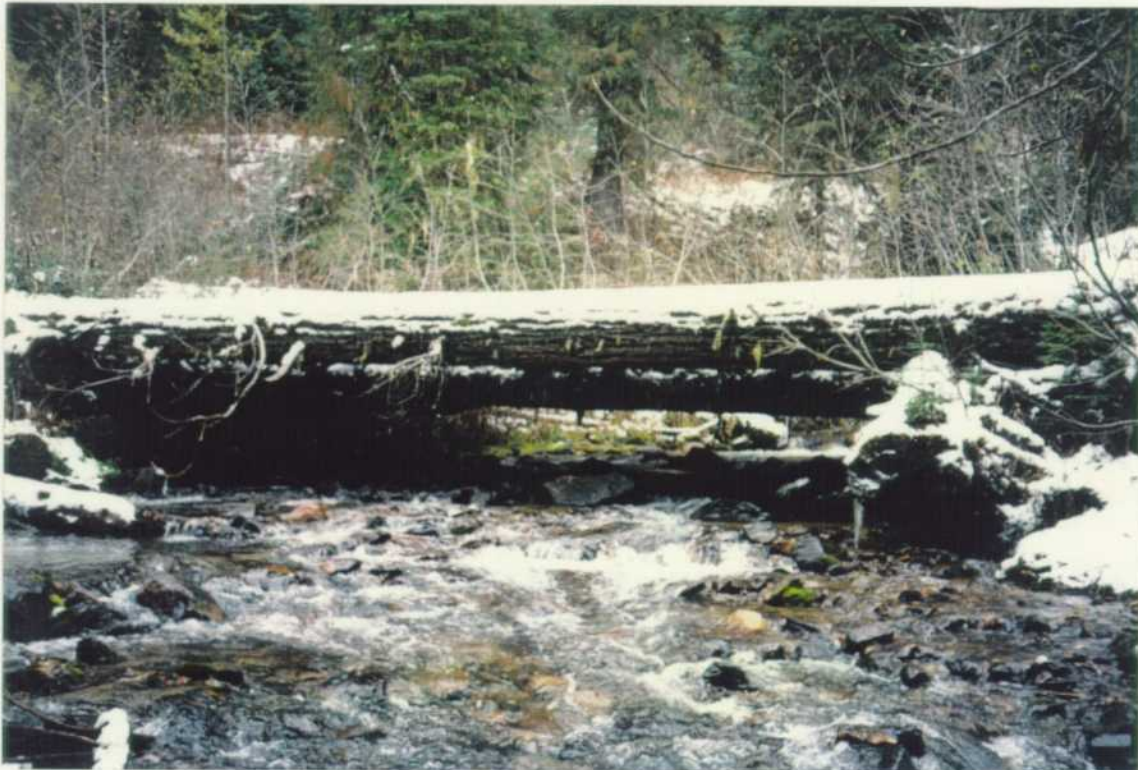
Upstream view of Reach 8B, Monashee Creek shows an abandoned bridge with a rotten deck.

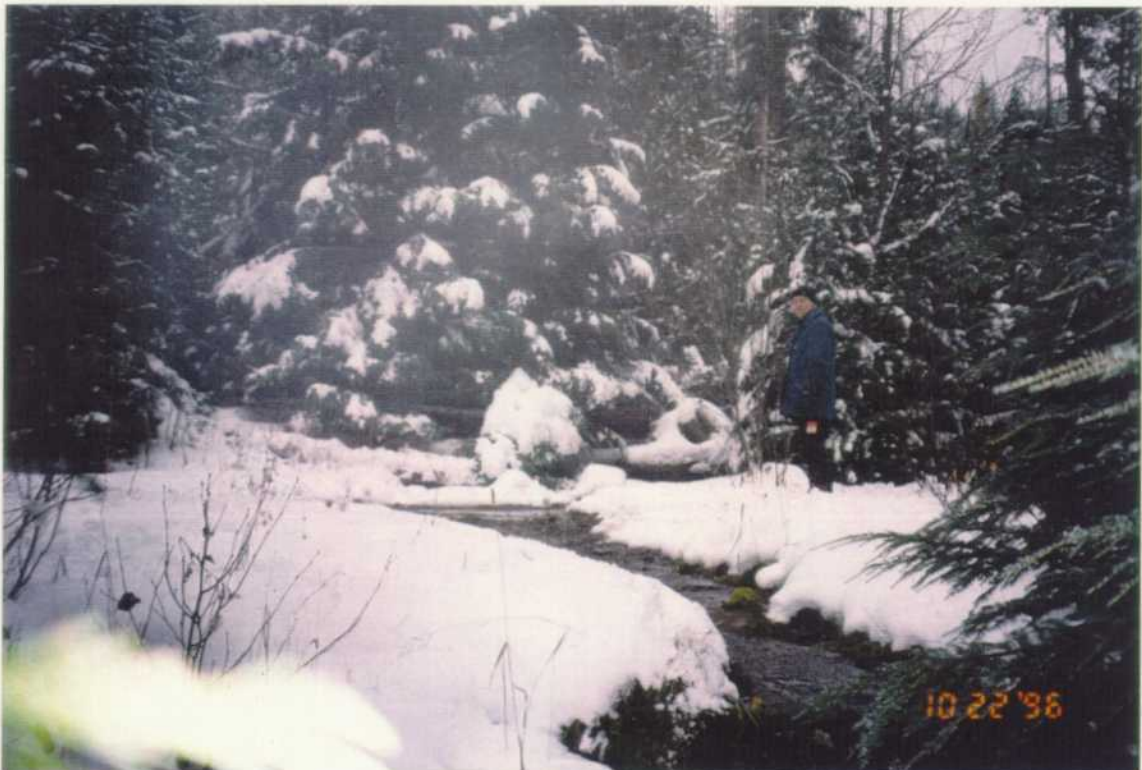
On the access road to site 2660 an old wooden culvert is not functioning and the creek is flowing over the road. The culvert should be unplugged or replaced.

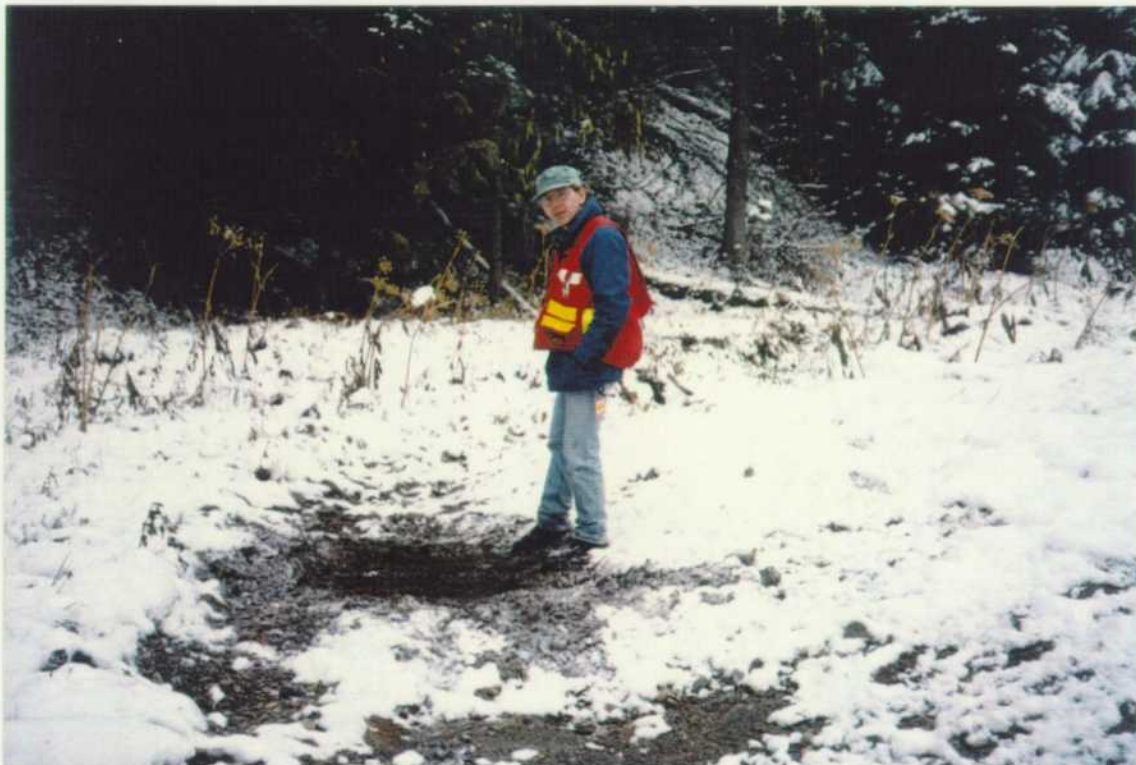
Upstream view of unnatural section of Reach 2, Railroad Creek upstream of a lake. The normally cobble bed texture has been replaced with fine dirt.

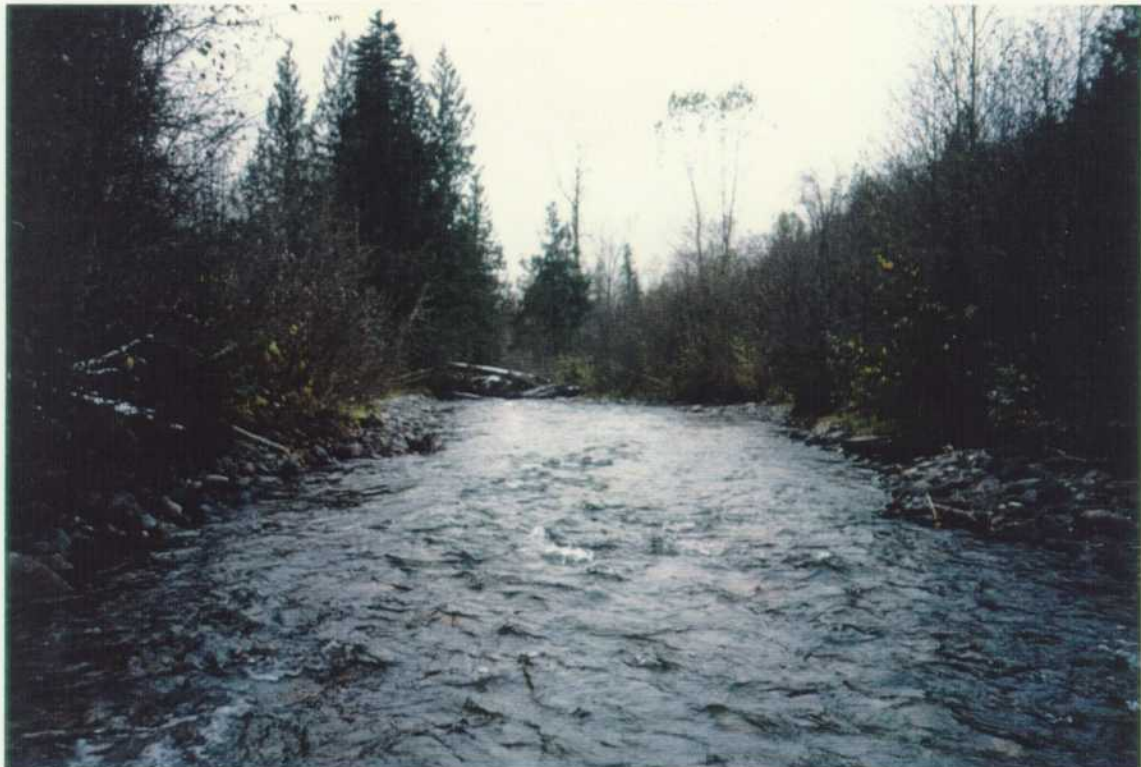
Upstream view of Reach 6, Monashee Creek shows sediment wedges, extensive riffles and minimal pools.

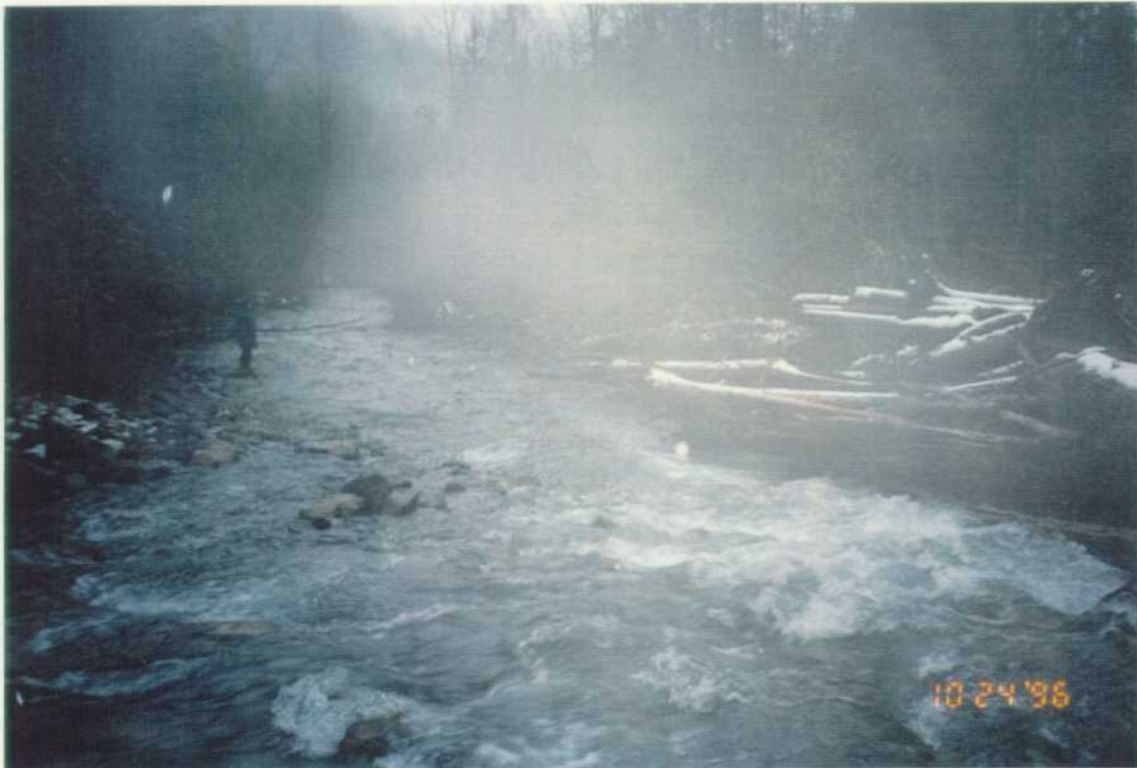
Downstream view of Reach 6, Monashee Creek shows LWD parallel to the channel bank, extensive riffle, extensive scouring, minimal pool area and disturbed stonelines.
