Overview Hydrologic Assessment of Juliet Creek Watershed

Henderson Environmental Consulting Ltd.

January 2002

Prepared for
Tolko Industries Ltd.
Nicola Valley Division

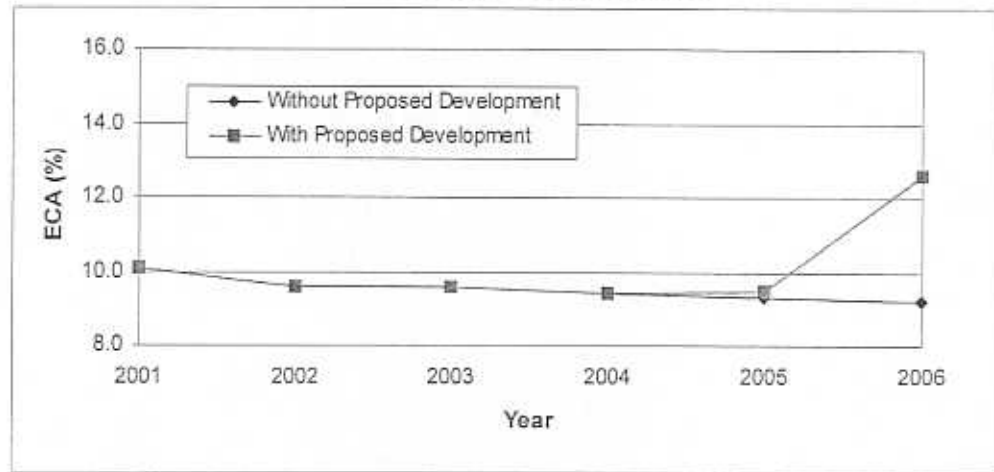
FIGURE 1
2001-2006 ECA for the Juliet Creek watershed

The current ECA at the POI of Juliet Creek is 10.1%, which represents a low potential for increased peak flows over natural levels (Table 3). Note that the 1998 ECA was reported at 10.1% by Borrett Engineers Inc. With proposed development the ECA will increase by 2.5% to 12.6% which still represents a low concern for increased peak flows due to forestry development. If there was no proposed development the ECA would be 9.2% due to hydrologic recovery at planted openings (Figure 1).

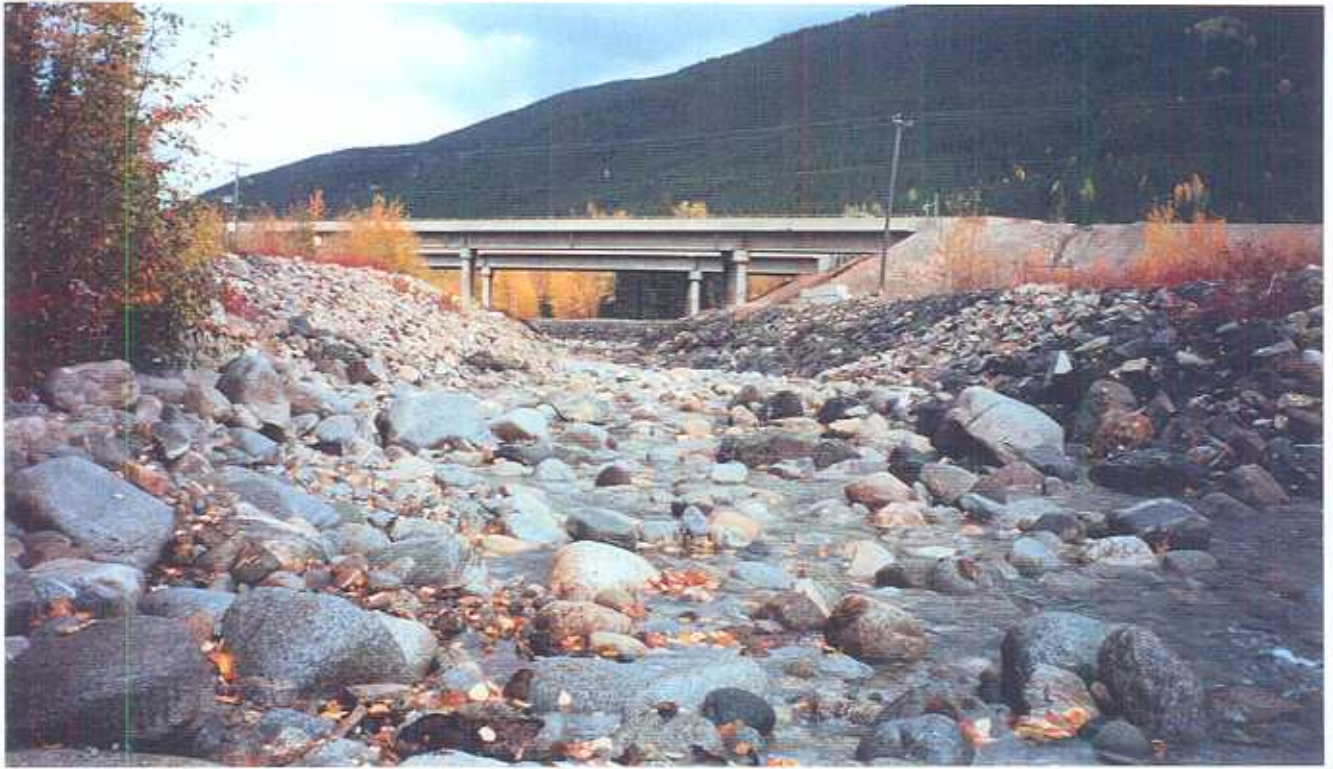
Photo 1: Juliet below confluence with July Creek. Note armoured banks upstream and downstream of Coquihalla highway.

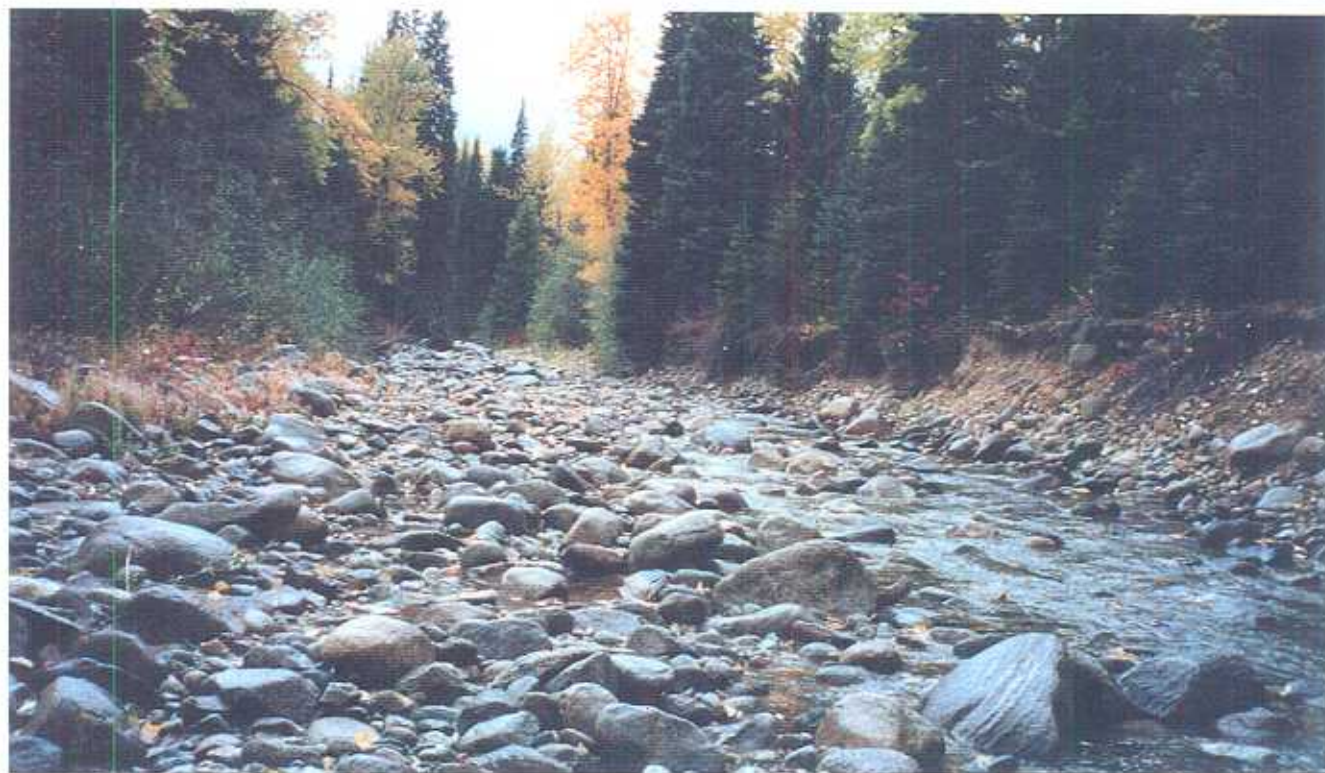
Juliet Creek above the confluence with July Creek was an average width of 15.8m with a gradient of 2% in an unconfined valley flat. The channel is aggraded with accumulations of coarse sediment. The bed is dominated by large boulders that also control flow: fine sediment and large woody debris was virtually absent from the channel. Disturbance indicators included extensive gravel and boulder bars, multiple channels, levees and extensive riffles. Eroding banks were also observed in the initial 100m.

Photo 3: Juliet Creek just above July Creek. Generally aggraded bed, and eroding banks at right.

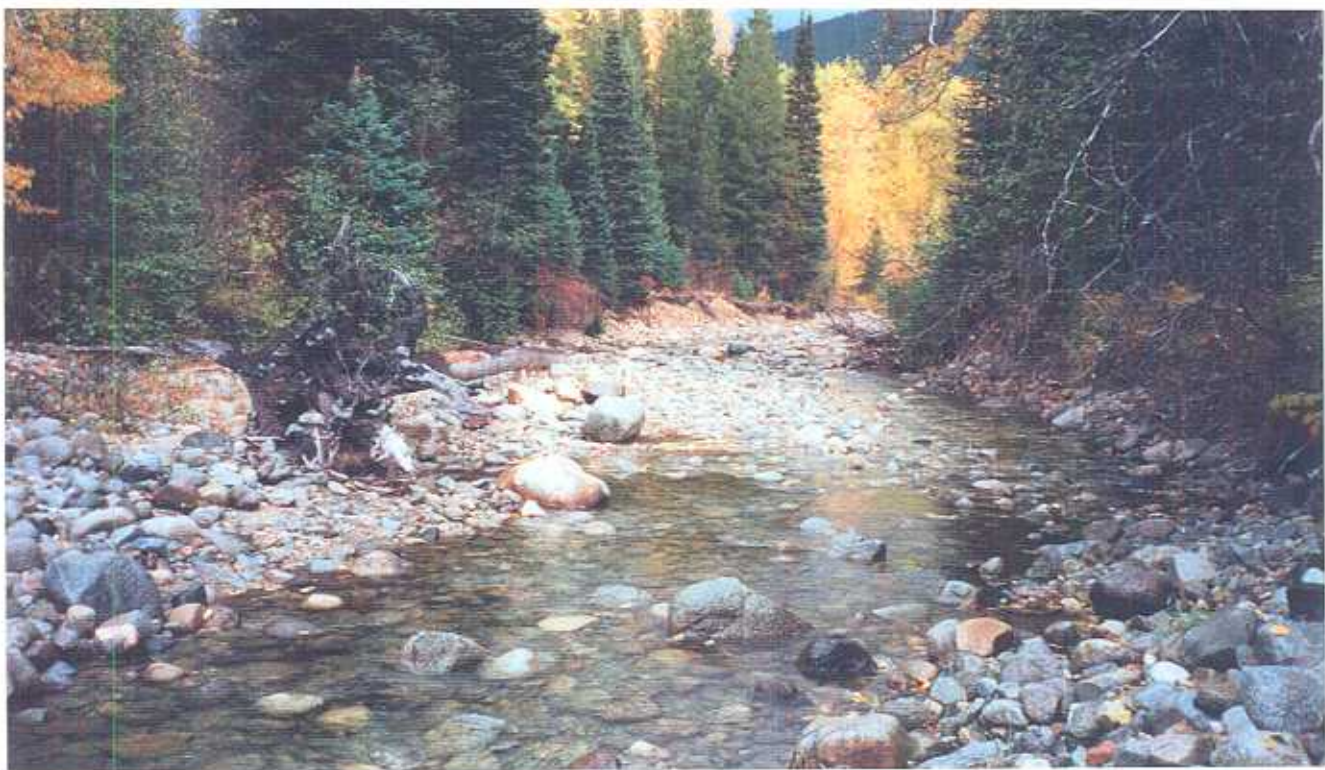
Photo 4: Juliet @ 101m. Note large boulder, lateral bars, and tree turned parallel to the channel.

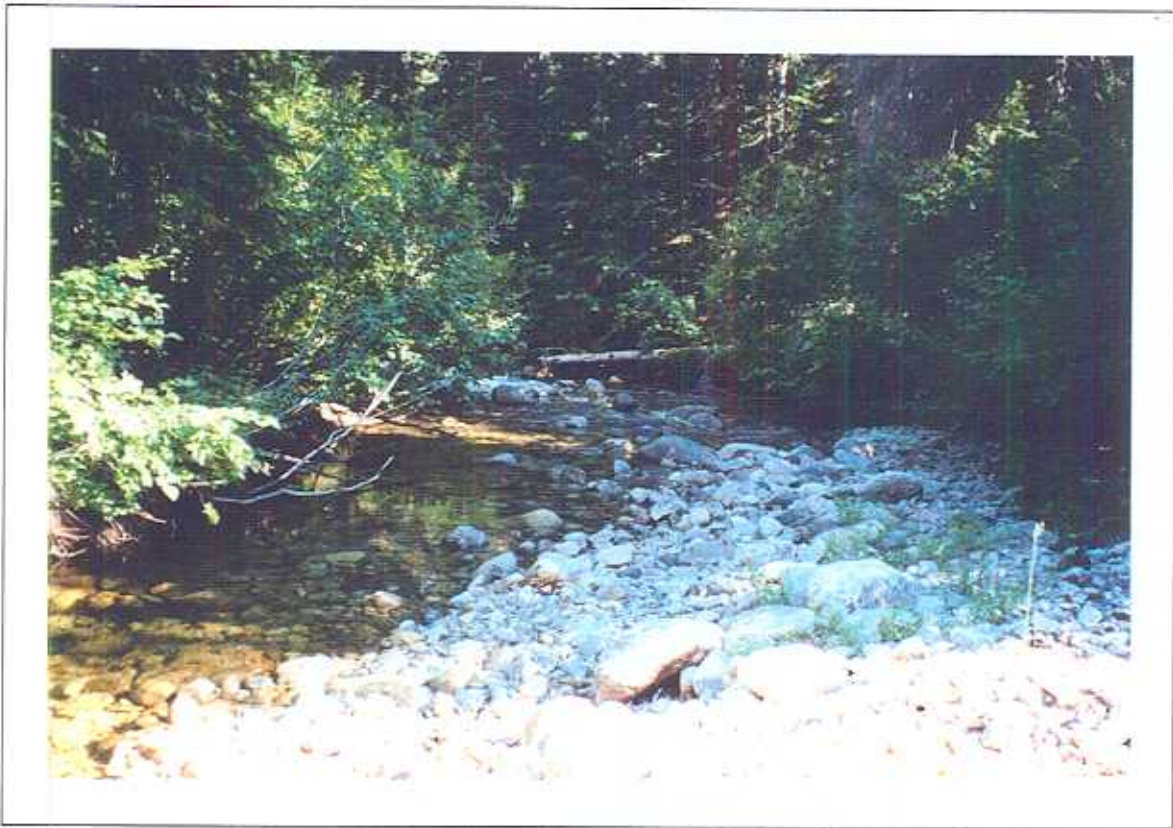
Photo 5: Early colonization of lateral bar in Juliet mainstem @ CSS4.

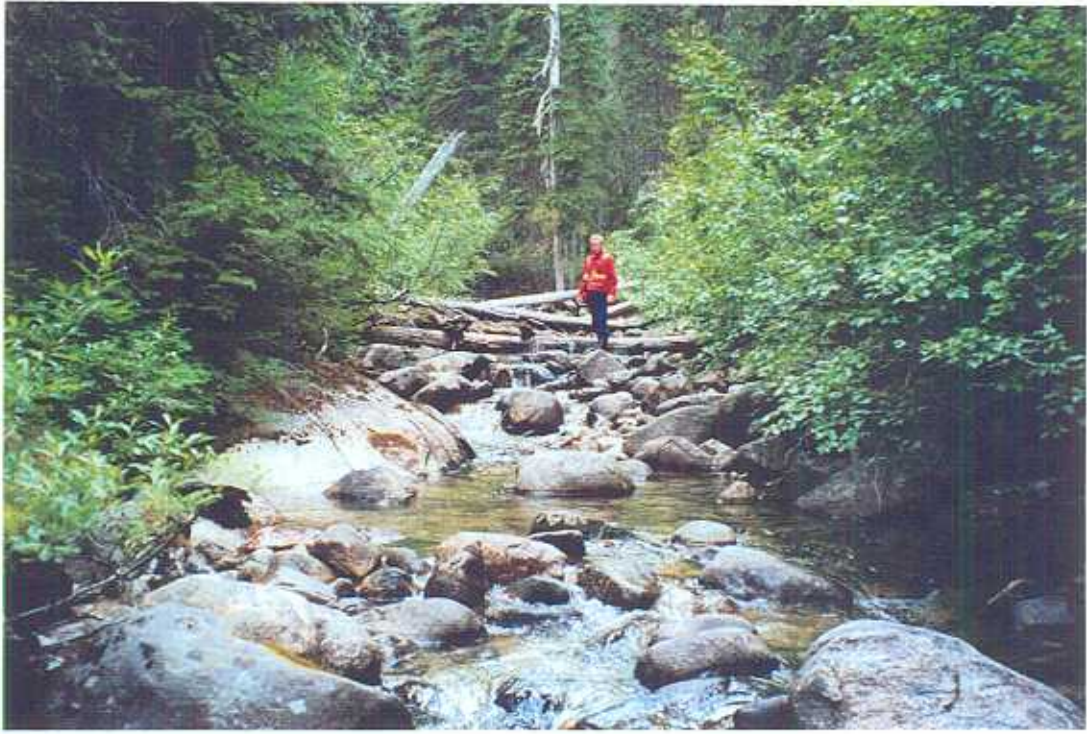
Photo 7: Stable, bedrock and boulder controlled Juliet channel @ CSS1.

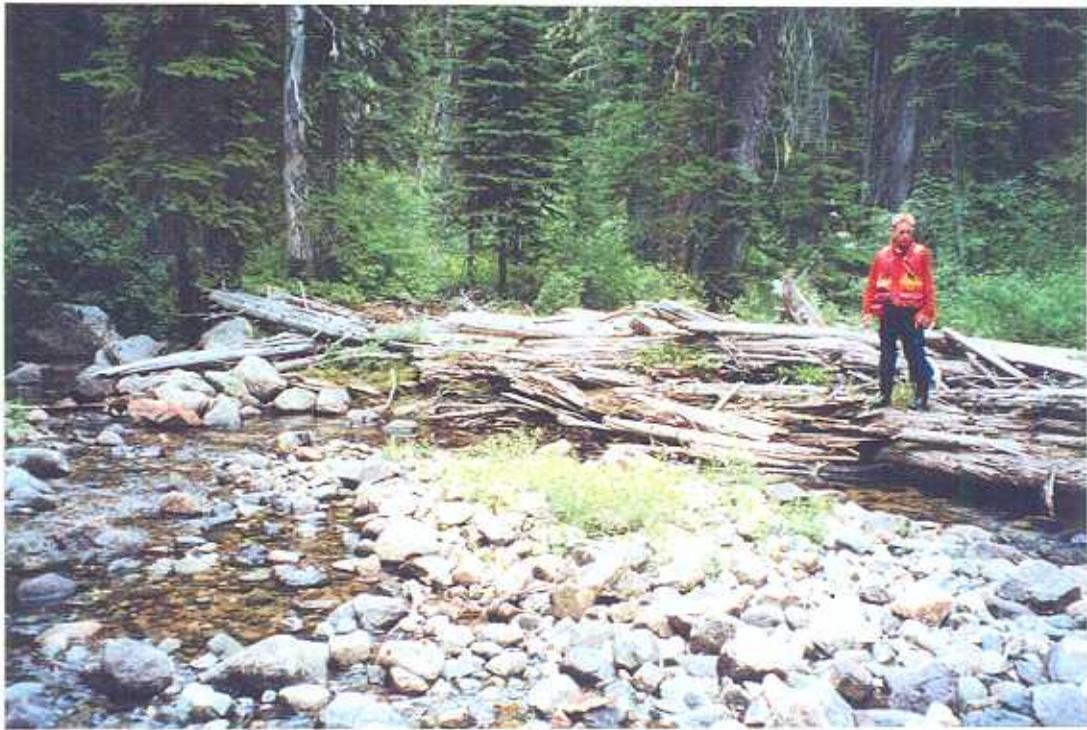
Photo 8: Old jam (rt.) at CSS3, Juliet.

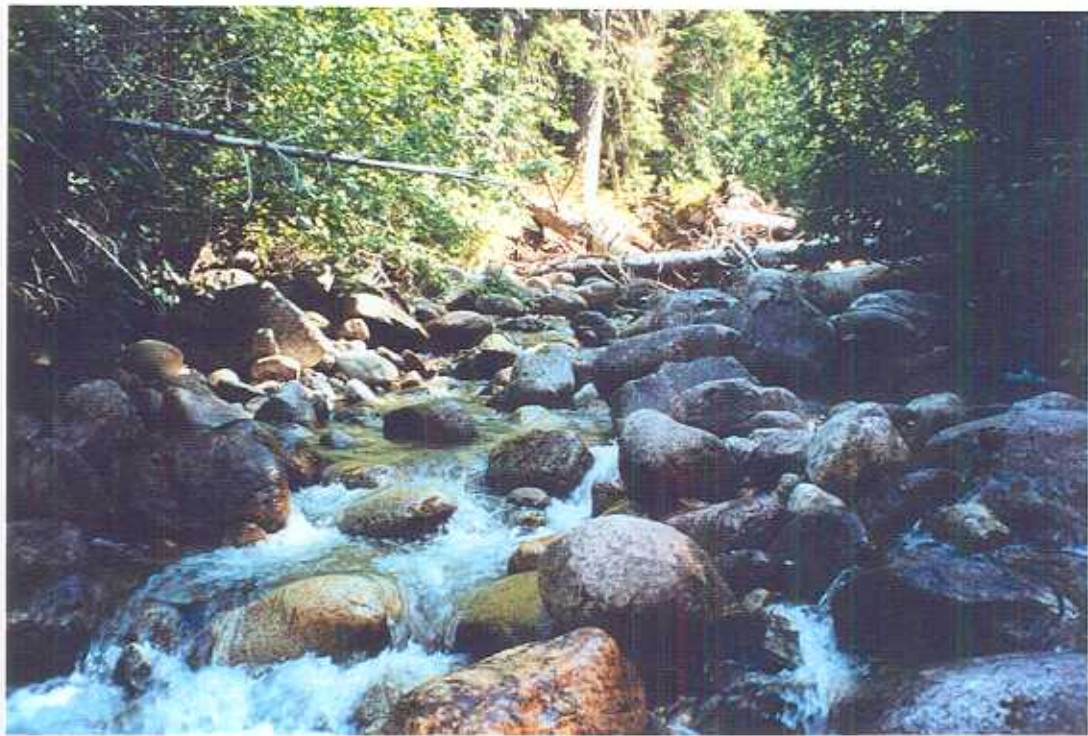
In Juliet south (CSS5), the channel was observed to be stable to partially aggraded, however, near the mouth in a depositional section (@102m-205m), there was still evidence of channel widening, bars, and avulsions.

Photo 9: Stable Juliet south @ 78m (CSS5).

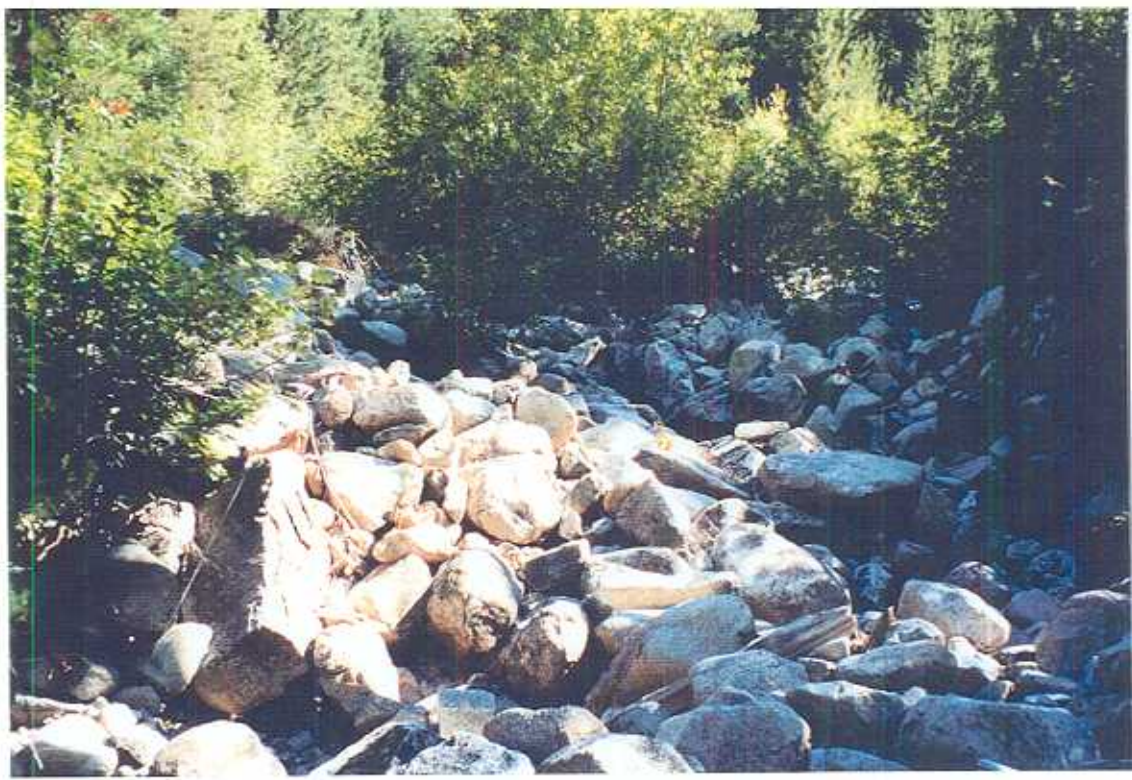
Tributary channels were also inspected (channel inventory forms not completed for tributaries). Tributaries 1 through 4 on the north flank of the mainstem Juliet channel were of particular interest because they drain areas of proposed development. Tributary 1 is steep (> 20%) and appears to have recently torrented or be a debris flow, although it was dry at the time of the survey. Large boulders (i.e.> 60cm diameter) control flow, banks were eroded and avulsions evident (see photo 10). The channel is very unstable and erosion of the cutbank at the road was observed. Below the road, the channel splits into multiple channels and sediment fans over the forest floor. The channel appears to be still active.

Photo 10: Tributary 1, Residual area. Dry channel. Note boulder size, avulsion at right.

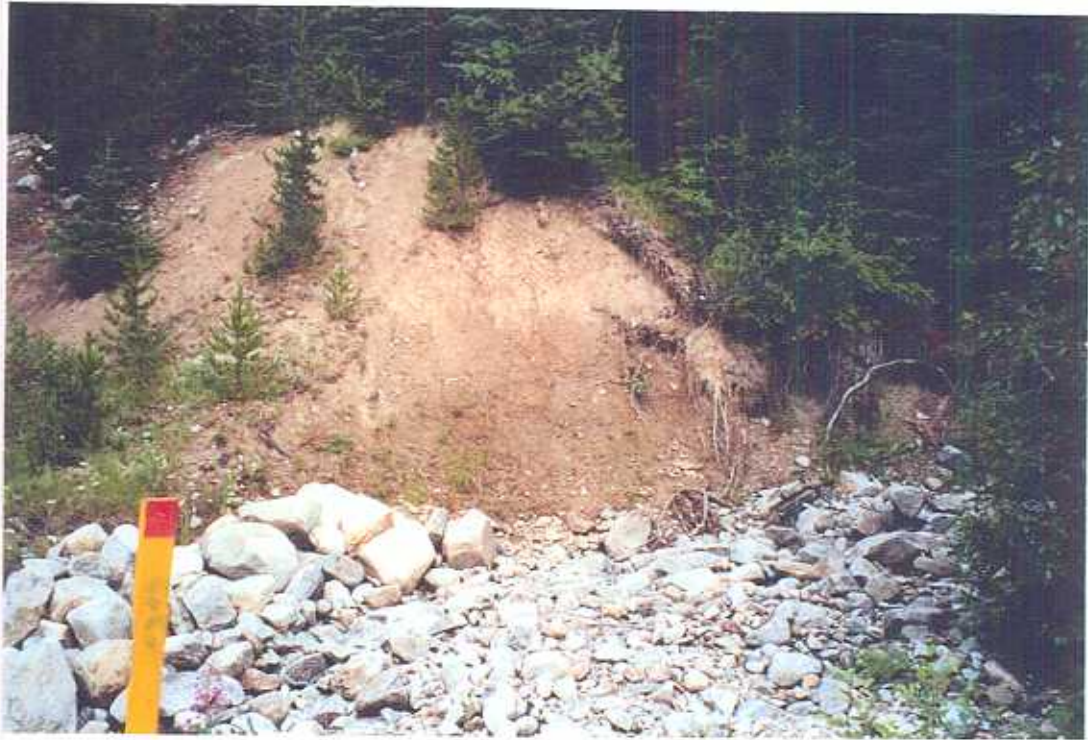
Photo 11: SS3 @ crossing at Tributary 1.

1. Stabilize sediment sources SS1, 2 and 3 prior to road building or harvesting on the north slope of the residual area. This can be done by deactivating or upgrading the access route to proposed 156-1.

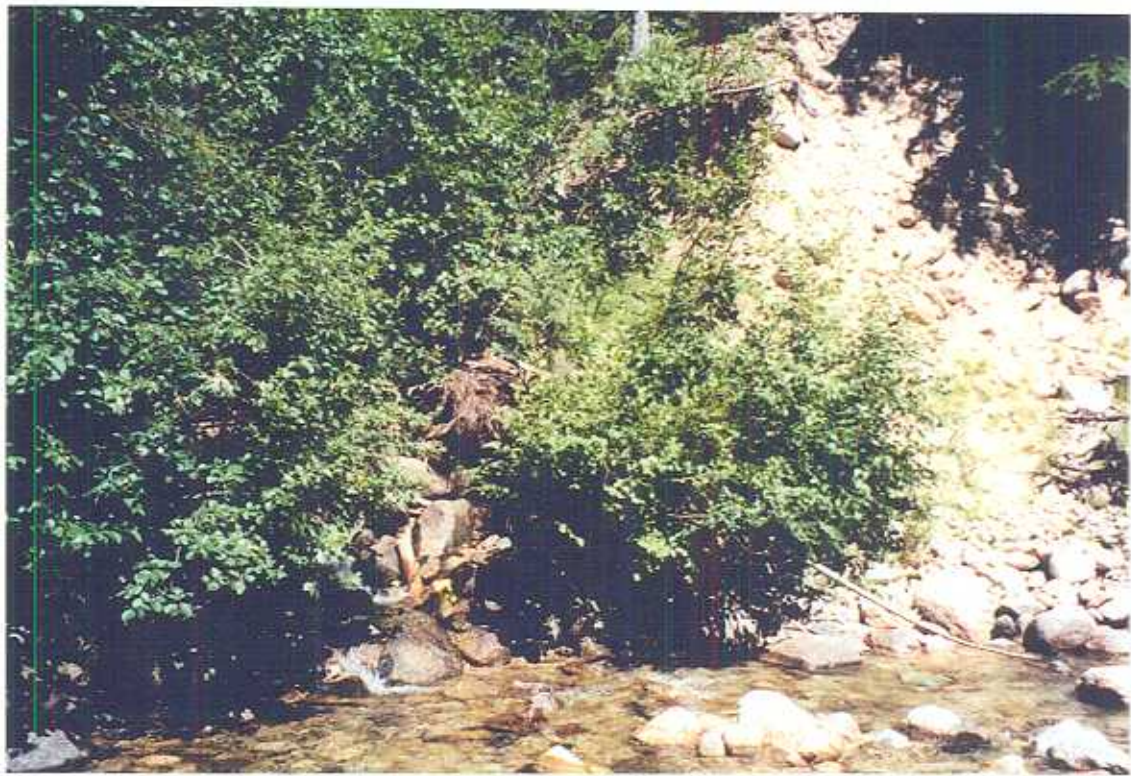
Logging has occurred along small tributary creeks (<1.0m-3.0m) but, in general, no stability concerns were observed. An exception is channel disturbance for approximately 50-75m (bank erosion and trees felled/windthrown into creek) associated with riparian logging (opening 6, polygon 669) at Tributary 4.

Photo 12: Juliet Tributary 4 @ mouth with Juliet (centre of photo).

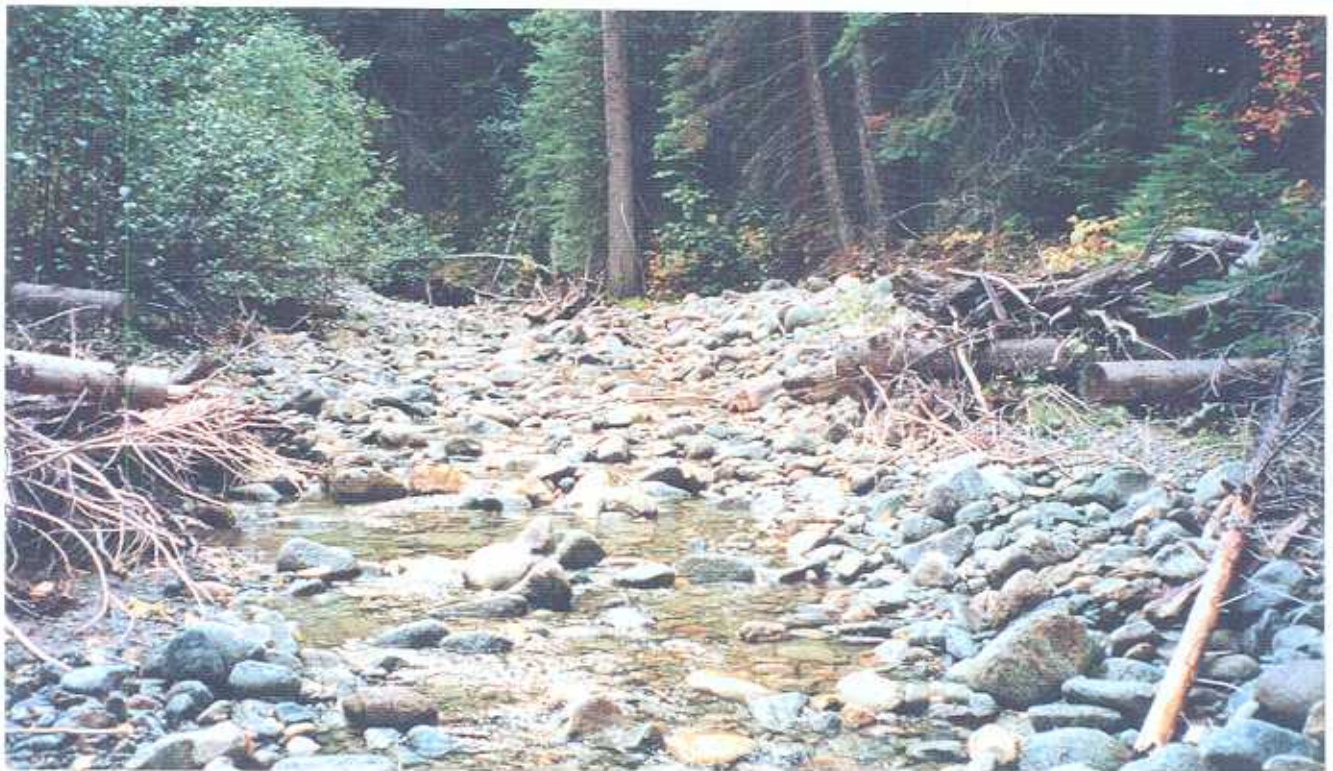
Near the mouth, July Creek is low gradient (~3%), unconfined in a valley flat, and flow is controlled by large boulders up to 520mm in diameter. The channel is braided in sections, and large woody debris is mainly absent. Disturbance indicators are extensive bars, extensive riffles, and minimal pool area. A levee at 234m is evidence of former debris flow in the channel. Overall, the channel is aggraded with sediment, but channel bars show some revegetation by herbaceous species. Klohn-Crippen (1999) reports similar channel conditions for this reach. Upstream (more than 900m above the mouth) July Creek is more confined with exposed bedrock sections. Debris jams and sediment wedges are common (Klohn-Crippen 1999), and were also evident in the aerial survey. A waterfall/chute was seen in the channel above existing logging from the helicopter (see map).

Photo 14: July Creek @ 234m above mouth. Levee at channel edge deposited by debris flow.

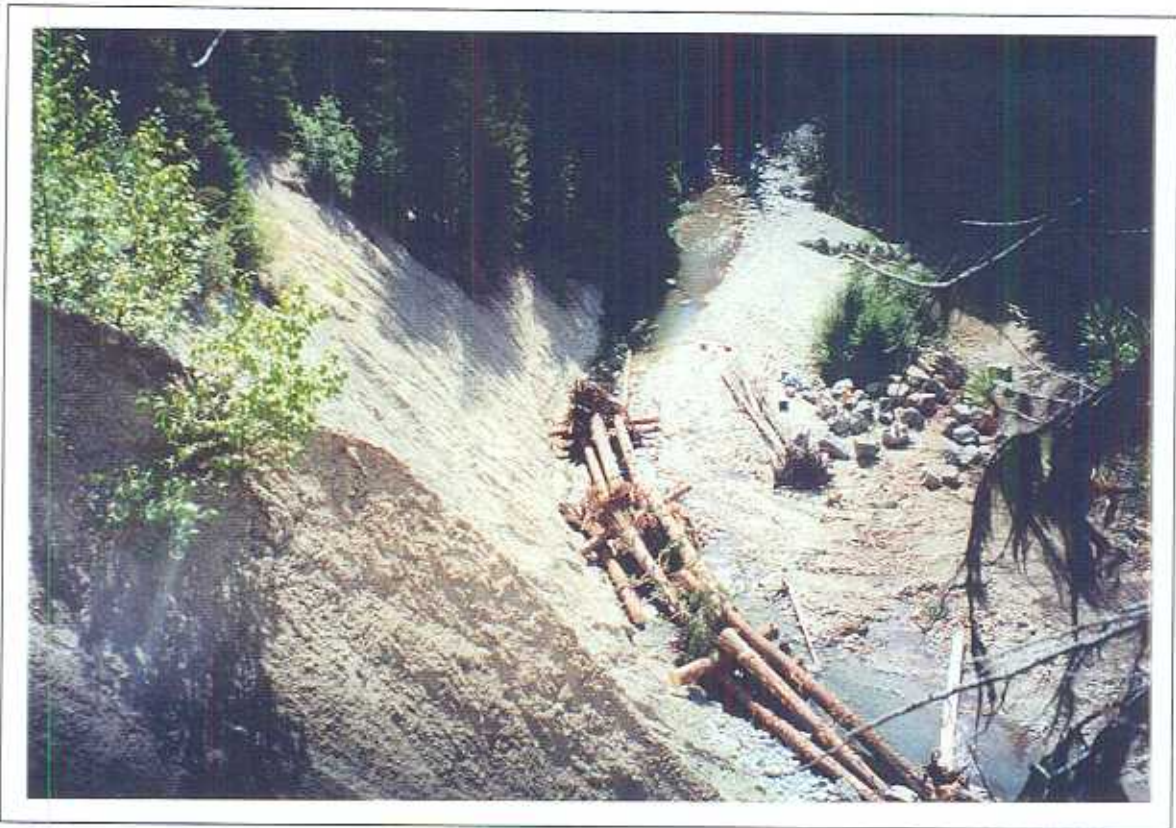
Mass Wasting Event	Location & Description	Recommendation
MW1	Residual. Large stream bank failure to Juliet Creek (appears natural). Stabilization works ongoing at time of field visit.	Monitor performance after annual freshets.

Photo 16: MW1, with slope stabilization works in progress.

7. Deactivate all proposed roads after harvesting.
8. Remove/replace the collapsed crossing at SS11 in July Creek sub-basin.
9. Periodically monitor the performance of the in-stream works at MW1 after the annual flood.

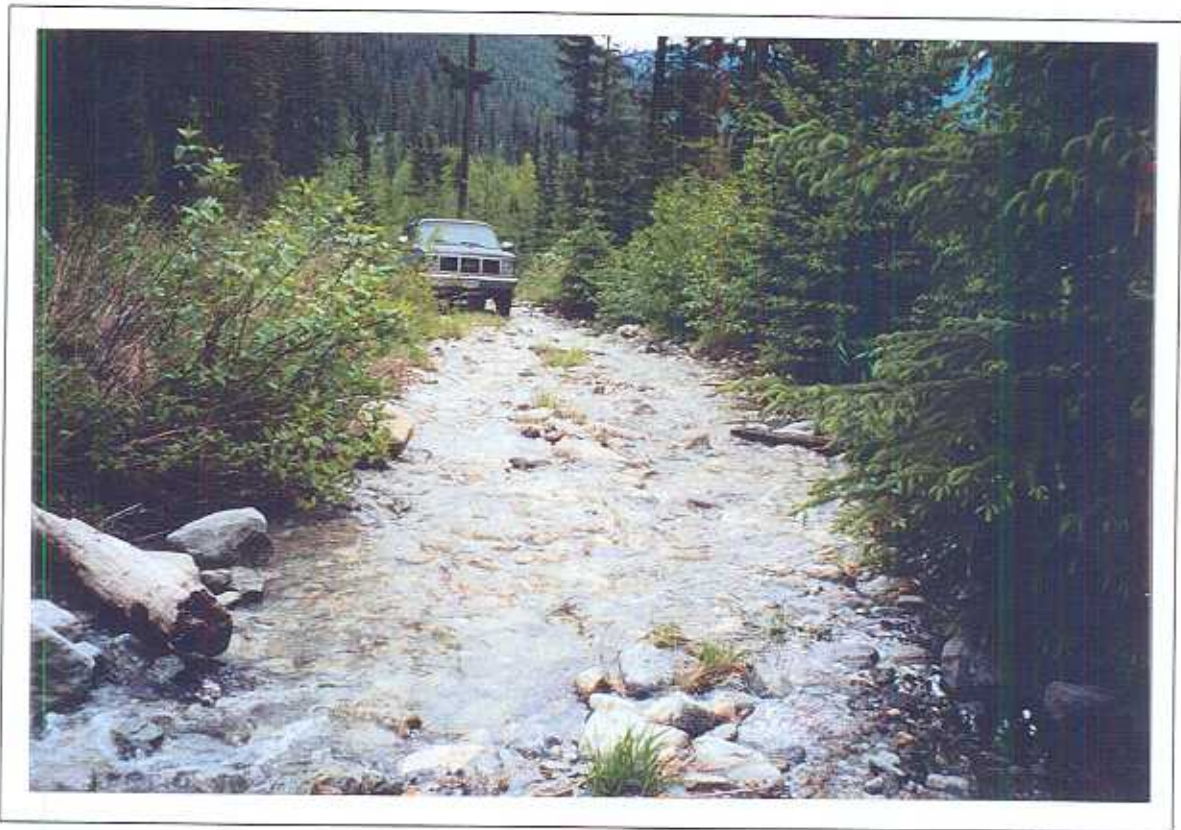
Tributary 2 was dry at the road but a installing culvert is suggested, because of flow suspected over the road at spring. Tributary 3 appears blocked, causing diverted flow and erosion over the road surface (SS1). Tributary channel 4 (CSS7) was stable at the mouth of Juliet Creek and for most of the 180m survey length. Channel disturbance (windthrow into creek, eroding banks) was observed for approximately 50m to 75m near the access road at 154m and adjacent to riparian logging above the road. Deactivation of the access road is recommended to mitigate sediment input to the channel.

Photo 18: SS1. Flow diverted over road.

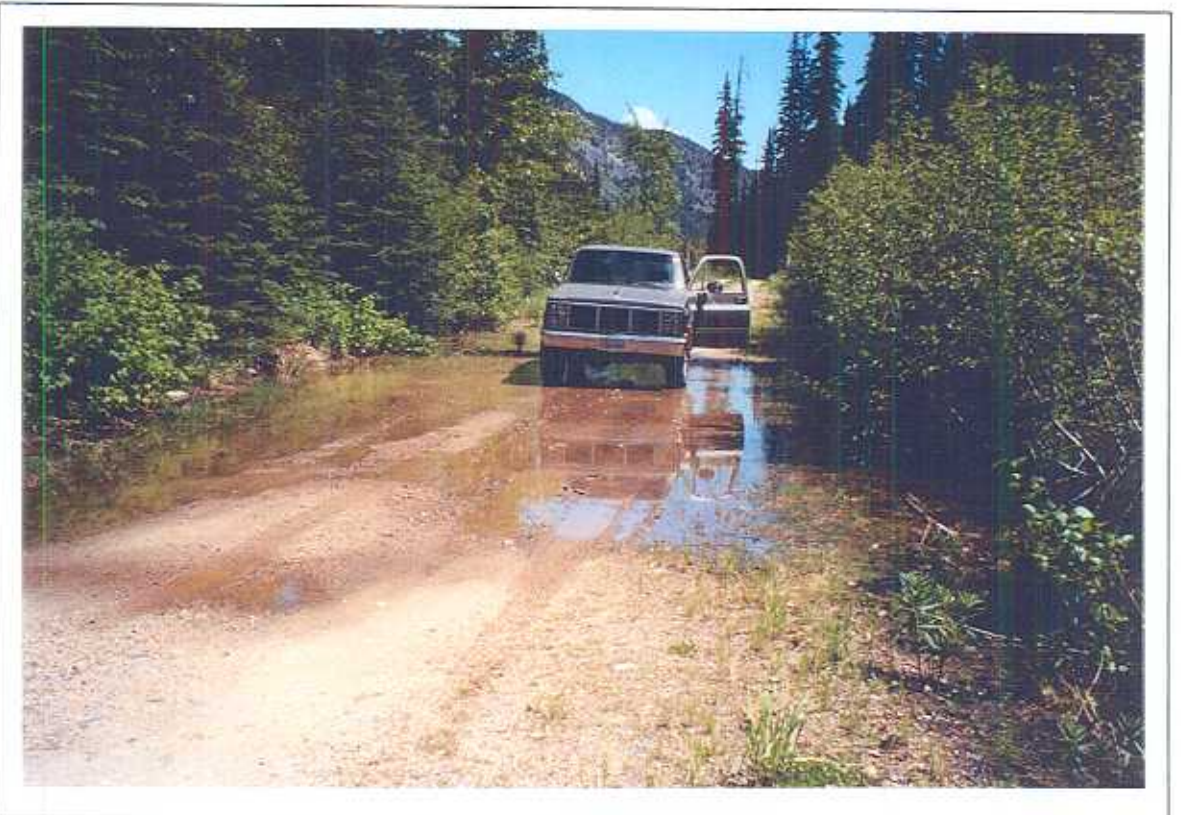
Photo 19: Culvert recommended at SS5 to prevent flow over road.

3. Install or replace culverts at SS5 and SS4 and stabilize SS6 prior to harvesting upslope blocks 156-2 and 3.
4. Assess the potential for harvesting in the south portion of Block 106-6 to initiate a landslide by a terrain specialist.

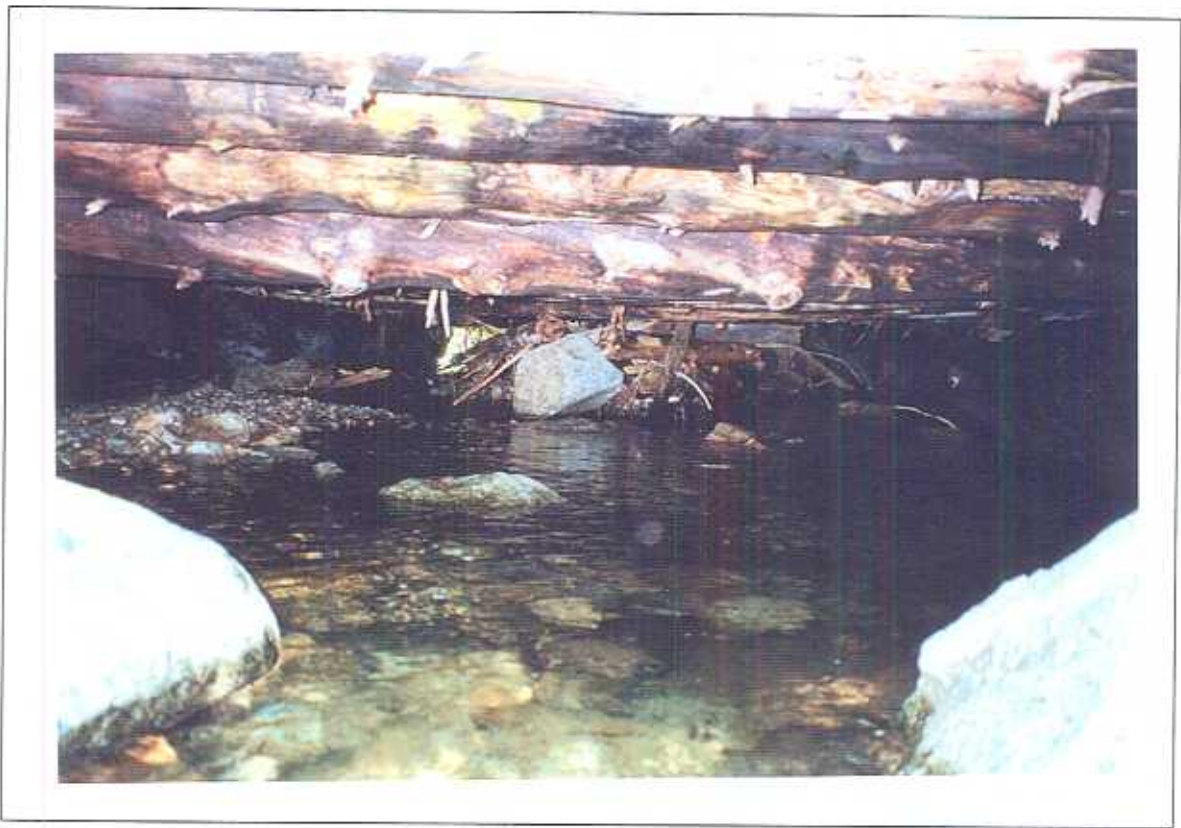
Only SS11 is recommended for deactivation in the north road network of July sub-basin, related to a collapsing wood culvert (photo 20, previously identified by Klohn-Crippen 1999, restoration site 3).

Photo 20: Collapsed structure in July Creek.

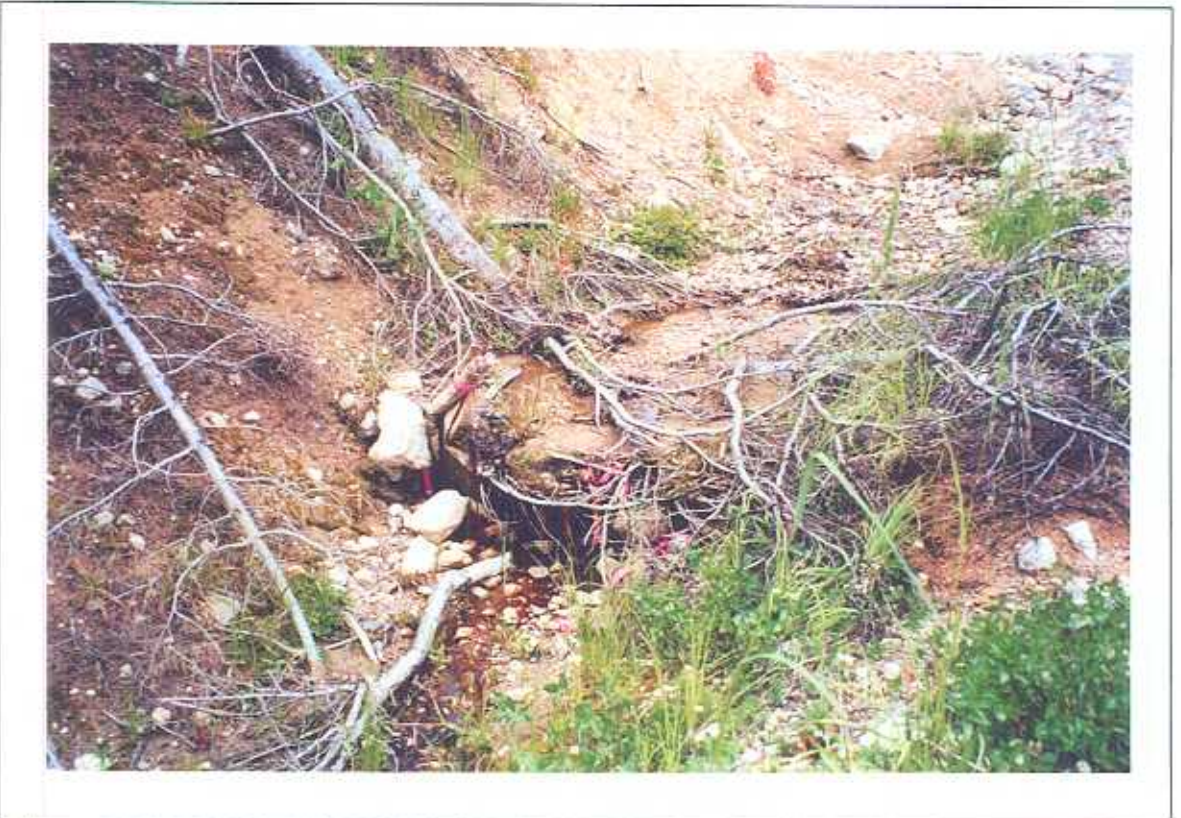
Photo 21: Full sediment silt fence at SS9.

2. Move the south border of A56181 away from the creek, and stabilize SS7 to SS10 prior to harvesting. Should development not proceed, or following the completion of harvest, deactivate the south road system in the July Creek sub-basin due to sediment delivery potential to streams from an eroding road surface and ditchline, and to mitigate road wash-out potential from torrents at tributaries.

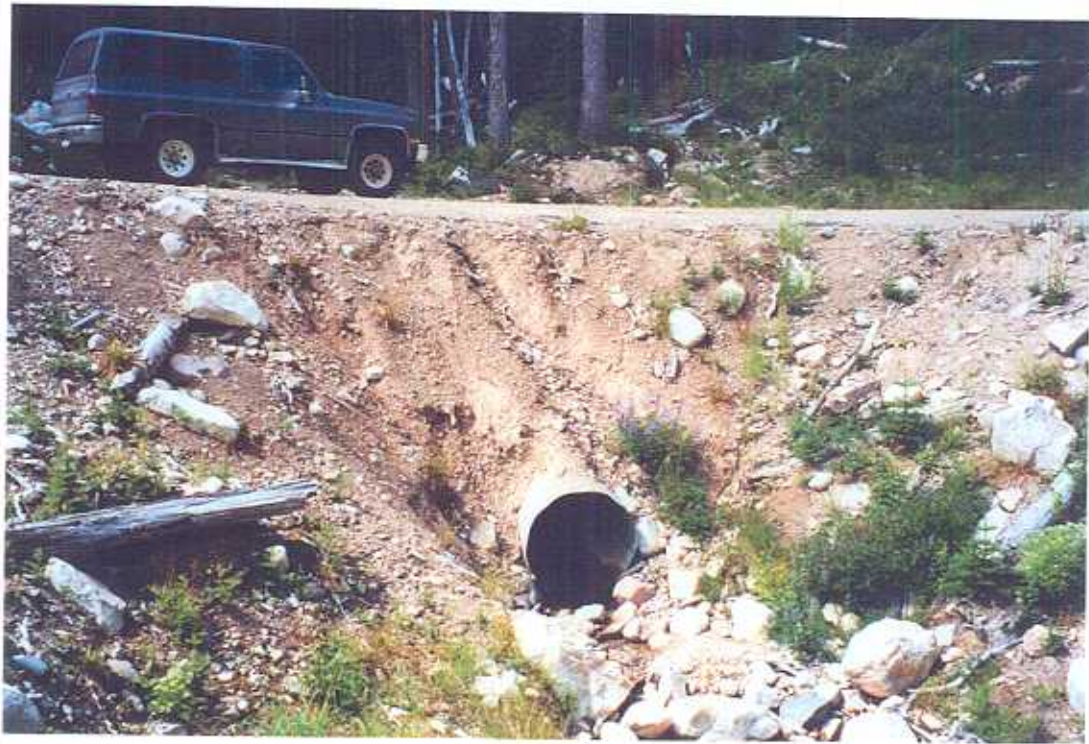
Photo 22: Raveling at fillslope to culvert outlet, SS10.

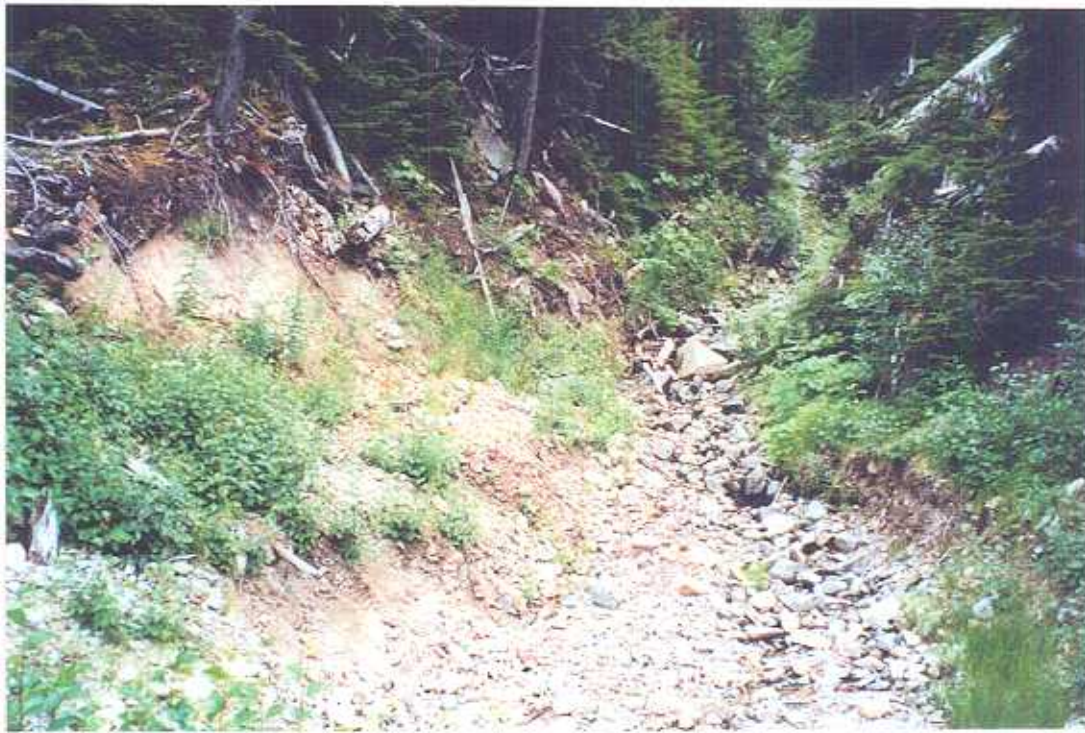
Photo 23: Debris/torrent @ SS6.
