The City of Chilliwack 2007 Ditch Maintenance Program Environmental Monitor's Report

**Prepared for:
The City of Chilliwack**

By
David Blair, Fisheries Tech. Dipl.

**Nova Pacific
Environmental**

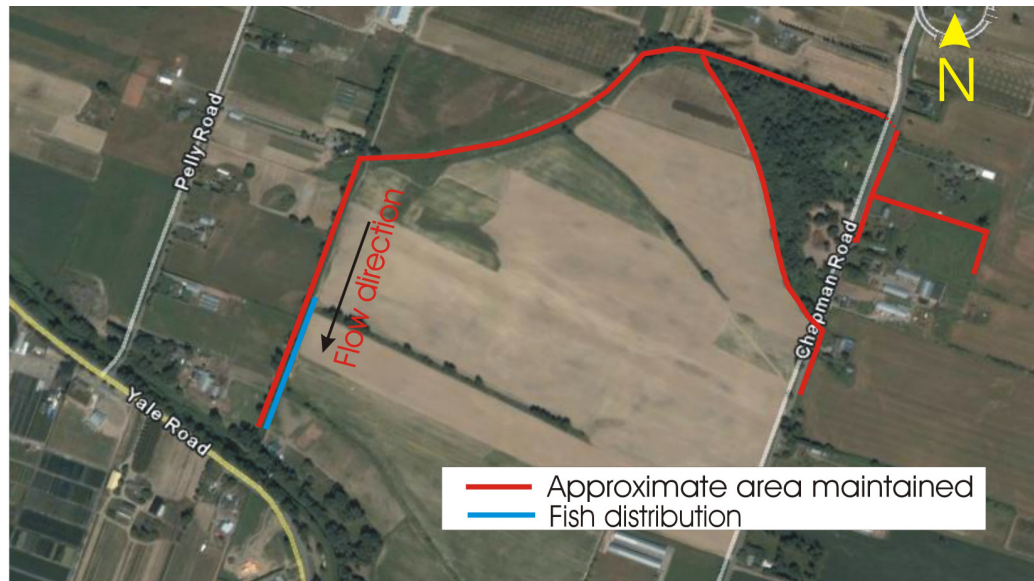
Figure 1.

Instream sediment and vegetation was removed from the stream channel from the area indicated in figure 1.

Water quality data from Rae Ditch showed marginal dissolved oxygen levels not conducive to high salmonid productivity (Table 2). Prior to maintenance, spot electro-fishing was undertaken throughout the system to determine fish presence/absence. The fish salvage crew encountered salmonids only within the initial 300 m of the confluence with Hope Slough.

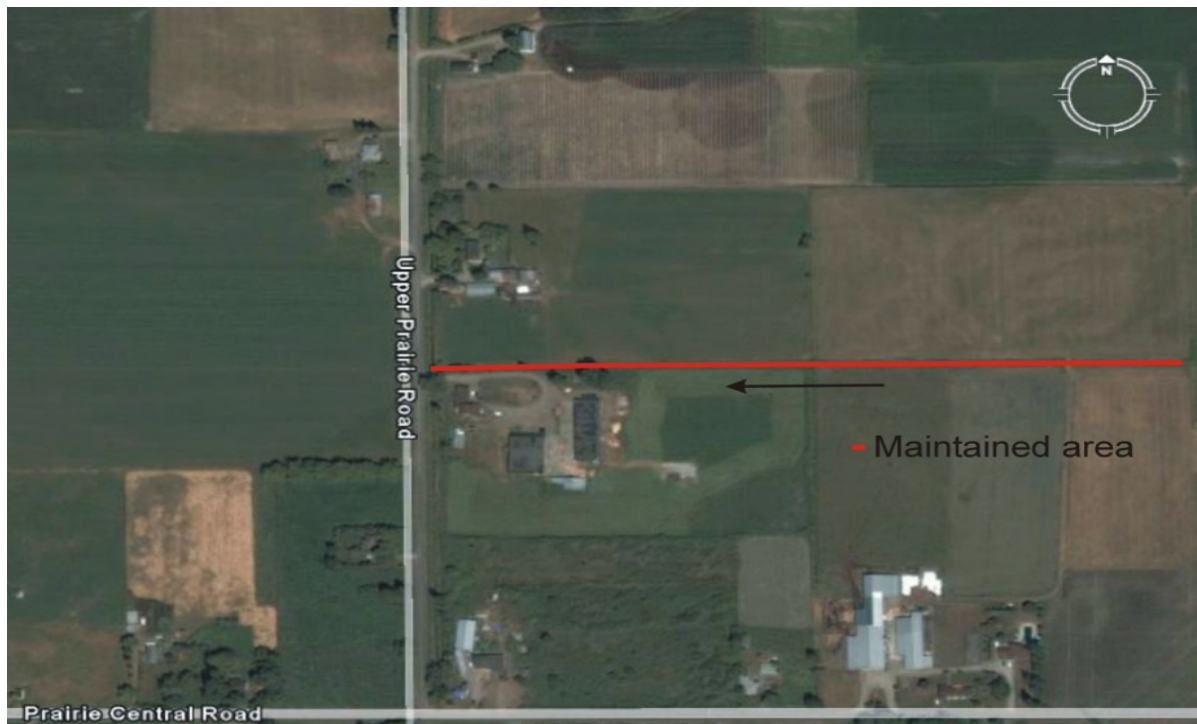
Figure 3.

Instream sediment and vegetation was removed from the watercourses' confluence with Big Ditch, upstream for approximately 500m (Figure 3). Gillespie Ditch is surface water-fed. Recent and historic water quality data collected during summer months indicates that this system may only support rearing salmonids during winter months. The fish salvage crew electro-fished in the first 50m of Gillespie Ditch starting at the confluence with Big Ditch. No salmonids or other fish species were captured. A down-graded re-classification from Class A to Class A (over-wintering) has been requested by the City.

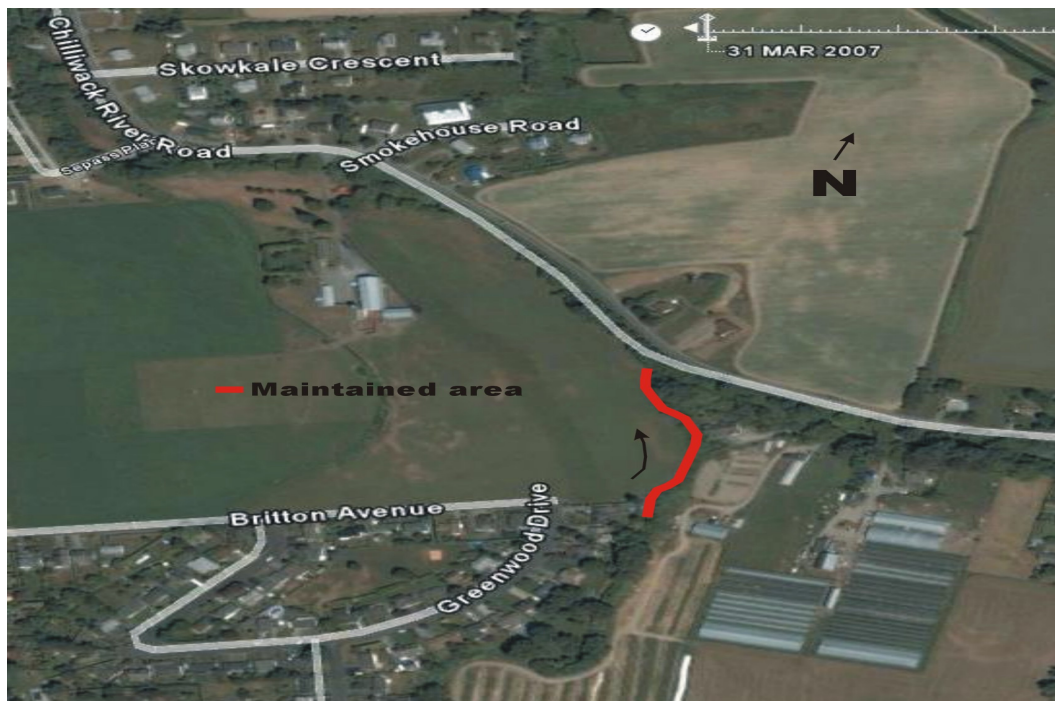
Figure 4.

The projected work at Carl Creek called for the removal of instream sediment and vegetation from its confluence with Chilliwack Creek, upstream for a total length of 500m. Ultimately, only 200m of the downstream segment underwent drainage maintenance works (Figure 4). Machinery access issues associated with large trees in the upper 300m segment prevented excavation in the upstream area.

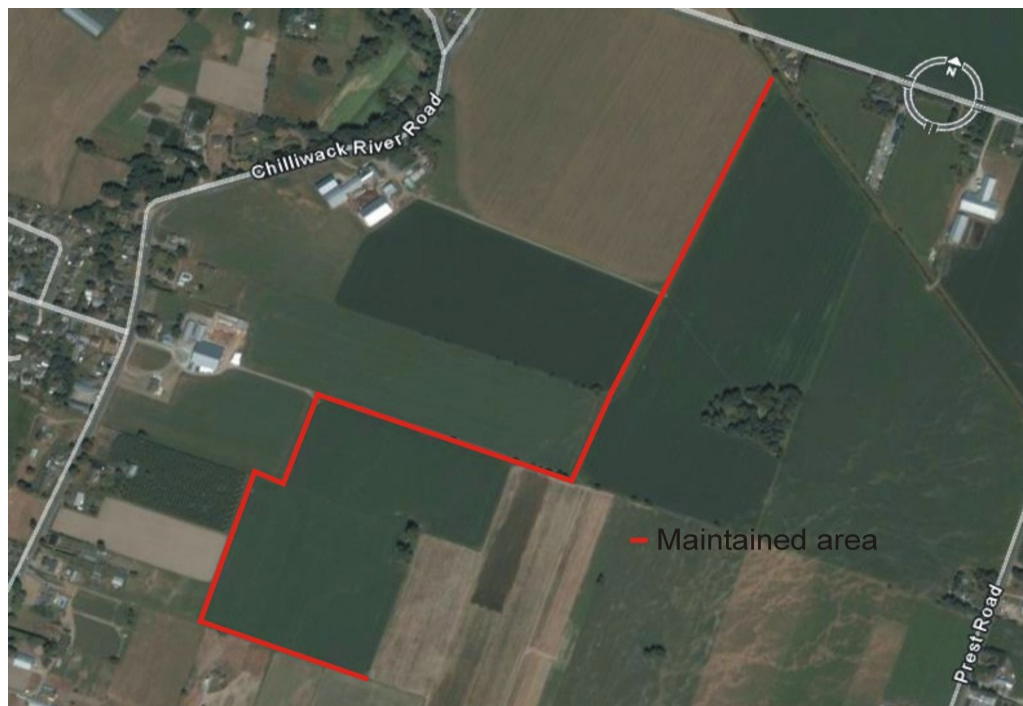
Figure 5.

Instream sediment and vegetation was removed from Kropp Ditch from Interception Ditch, upstream for a total length of 2000m (Figure 5). The ditch was found to be dry at the time of pre-maintenance data collection and fish salvage. An outfall drop of approximately 1.2m exists at the ditch’s confluence with Interception Ditch. The drop likely acts as a year-round fish barrier. This ditch is currently classified as year-round fish-bearing. Re-classification is recommended based on the ephemeral nature of the ditch, its lack of head-waters, and the permanent fish passage barrier.

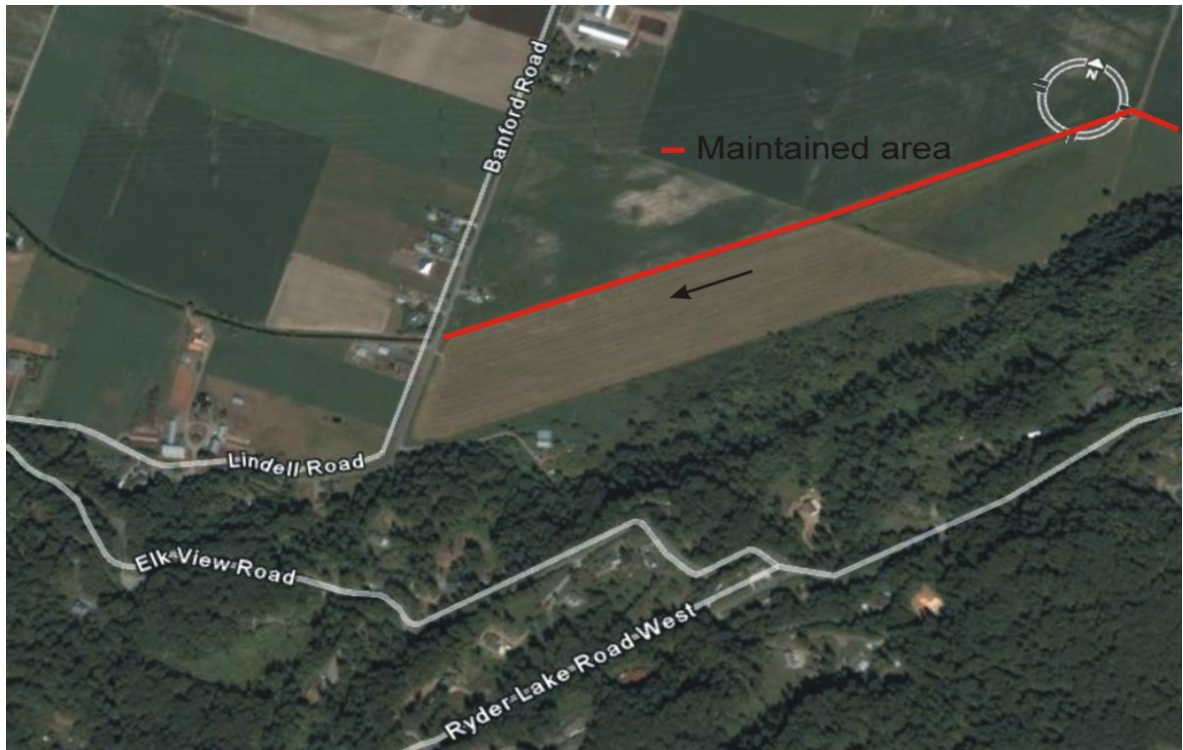
Figure 6.

In-stream sediment and vegetation was removed from the channel from Banford Road, upstream for a total distance of 800m (Figure 6). The lower reaches of Interception Ditch have historically produced Salish Sucker. However, no historic fish

salvage data for the projected upper, eastern-most reach was available. As a result, this office included this reach of Interception Ditch in a SARA permit application in the event that Salish Sucker were encountered during salvage or associated maintenance work. Extremely low water quality values, particularly dissolved oxygen, encountered during 2007 pre-maintenance stream data collection (Table 5) precluded the need for fish salvage.

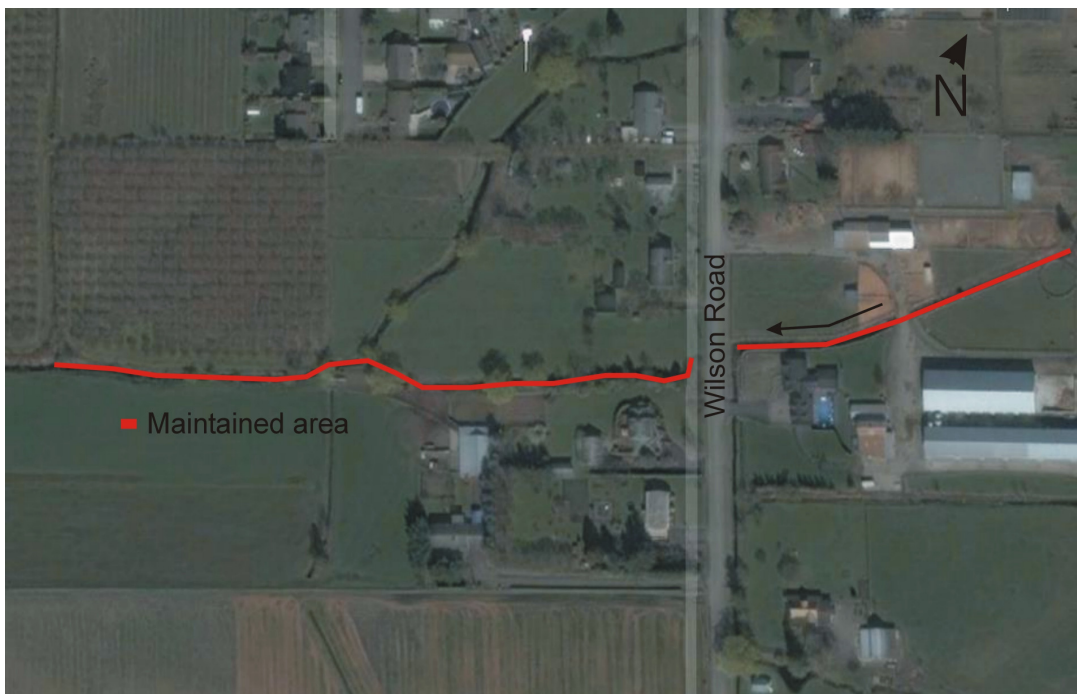
Figure 7.

Instream sediment and vegetation were removed from the channel from Stewart Creeks' confluence with Branch A, upstream for distance of 700m (Figure 7). Comprehensive fish salvage was conducted from the Branch A confluence, upstream to Wilson Road. At this point the channel passes under Wilson Road, veers sharply to the south, and becomes Wilson Road Ditch. Connectivity and general degradation of habitat and water quality (<15% dissolved oxygen) to that portion of Stewart Creek cited in the authorization as Top End of Branch A precluded the need for fish salvage in the reach.

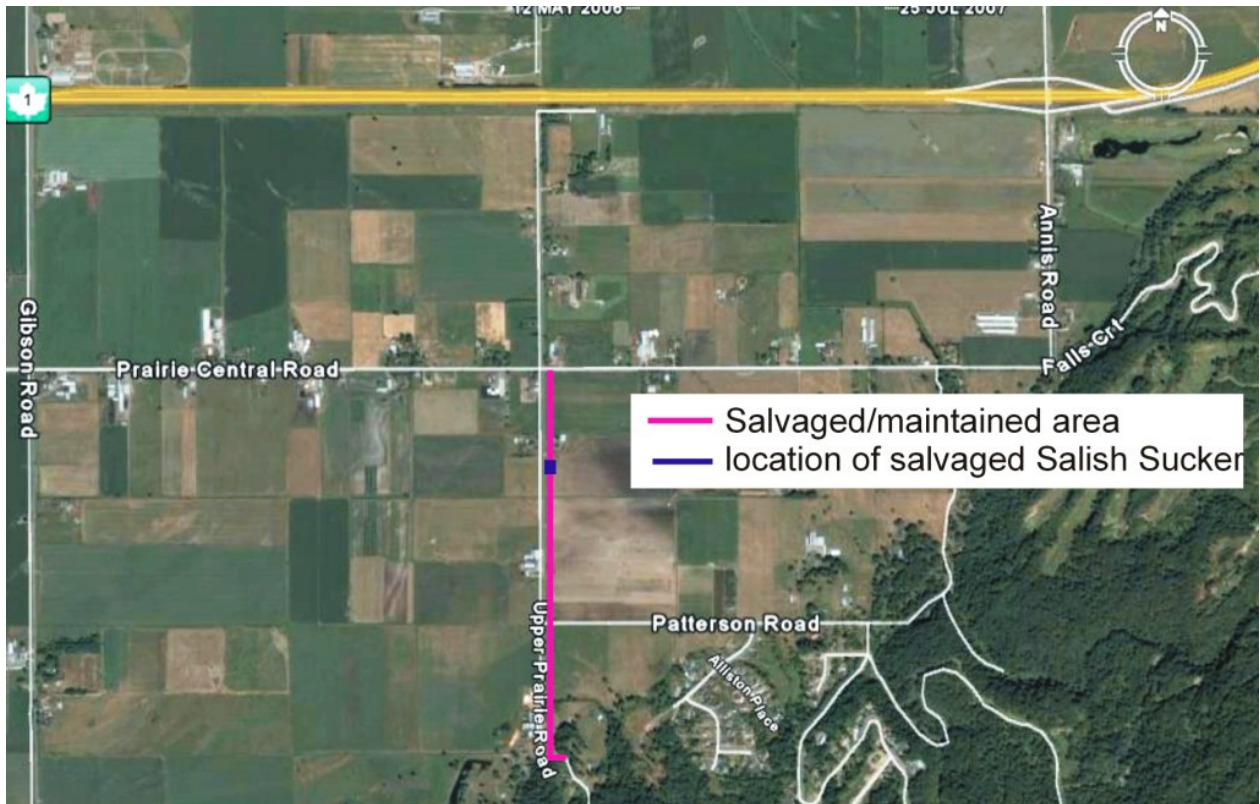
Figure 8.

In-stream vegetation and fine sediment was removed from the channel from Prairie Central Road, upstream for a distance of 1200m (Figure 8). Turbidity downstream of works was kept below 75 NTUs by the installation of a gravel check dam lined with geo-textile clothe (Photo 2). Banks were mowed and the monitor ensured that no desirable native riparian species were lost (Photo 3). Gravel weirs installed in previous years remained in tact and the monitor ensured that they were not excavated (Photo 4). Prior to undertaking fish salvage, the stream channel was cleared of instream vegetation that would otherwise hamper fish salvage efforts (Photo 5). This was achieved by using light equipment and hand tools. Big Ditch is a highly productive trout and salmon producer and also supports a population of the SARA listed Salish Sucker *Catostomus catostomus* in its lower reaches. Details pertaining to Big Ditch Salish Sucker associated with the 2007 works can be found in Appendix 3 of this report.

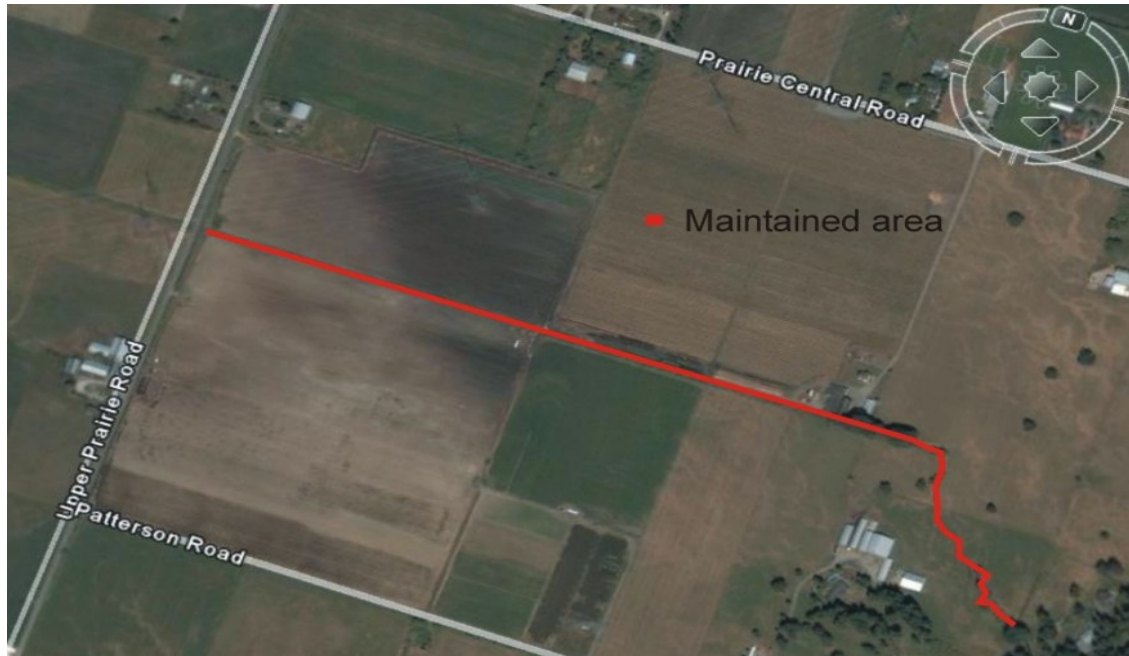
Figure 9.

Fine sediment and in-stream vegetation was removed from the channel from the creeks' confluence with Big Ditch, upstream for a distance of 900m (Figure 9). Pre-clearing of some in-stream vegetation was required at this site to allow for effective fish salvage. A series of three sediment traps near the top end of the authorized work area were also excavated. The implementation of an environmental management plan that addresses the need for streamside planting, livestock watering stations, and improving flow complexity would greatly improve Marble Hill Creek's functionality as salmon and trout habitat.

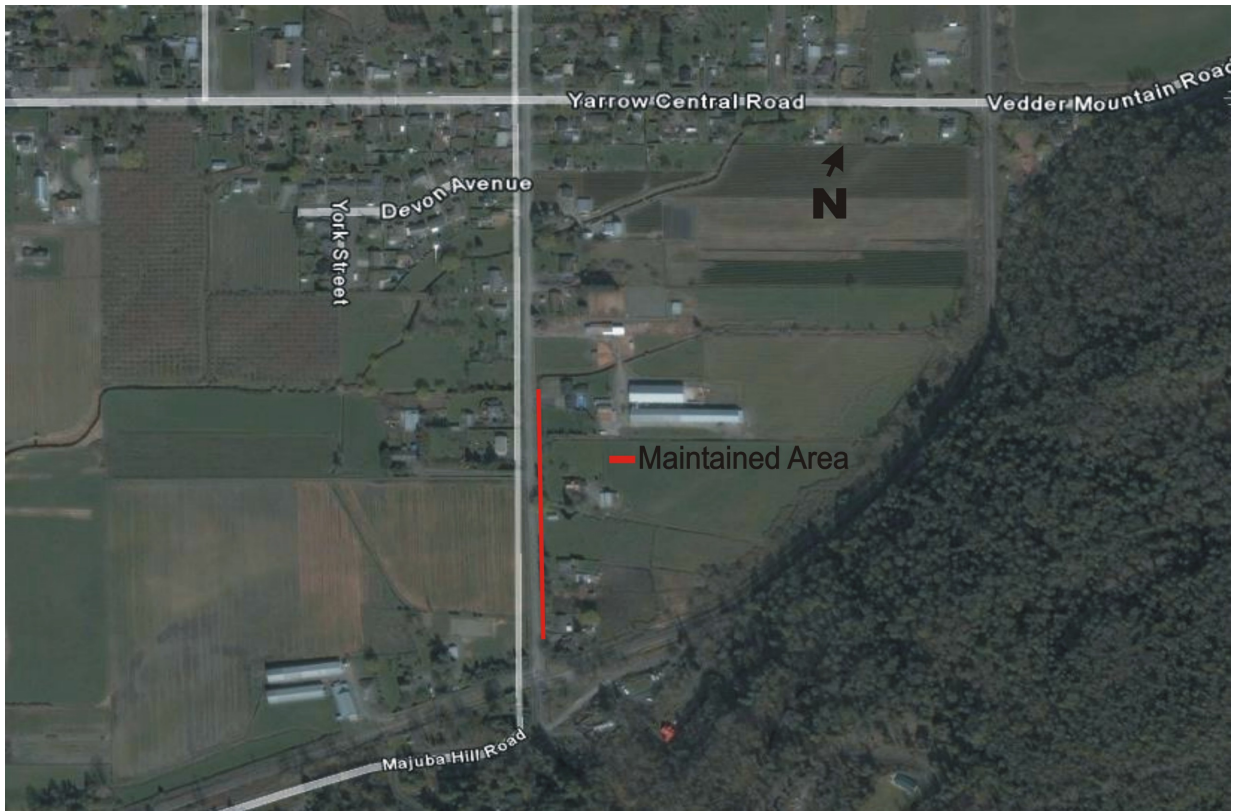
Figure 8.

Instream sediment was removed from the stream channel from Majuba Hill Road downstream for a total length of approximately 200m (Figure 8). The work area was isolated with stop nets and fish salvage was undertaken. Gravel sections within the maintained area of Wilson Road Ditch were left intact as suggested by the monitor.

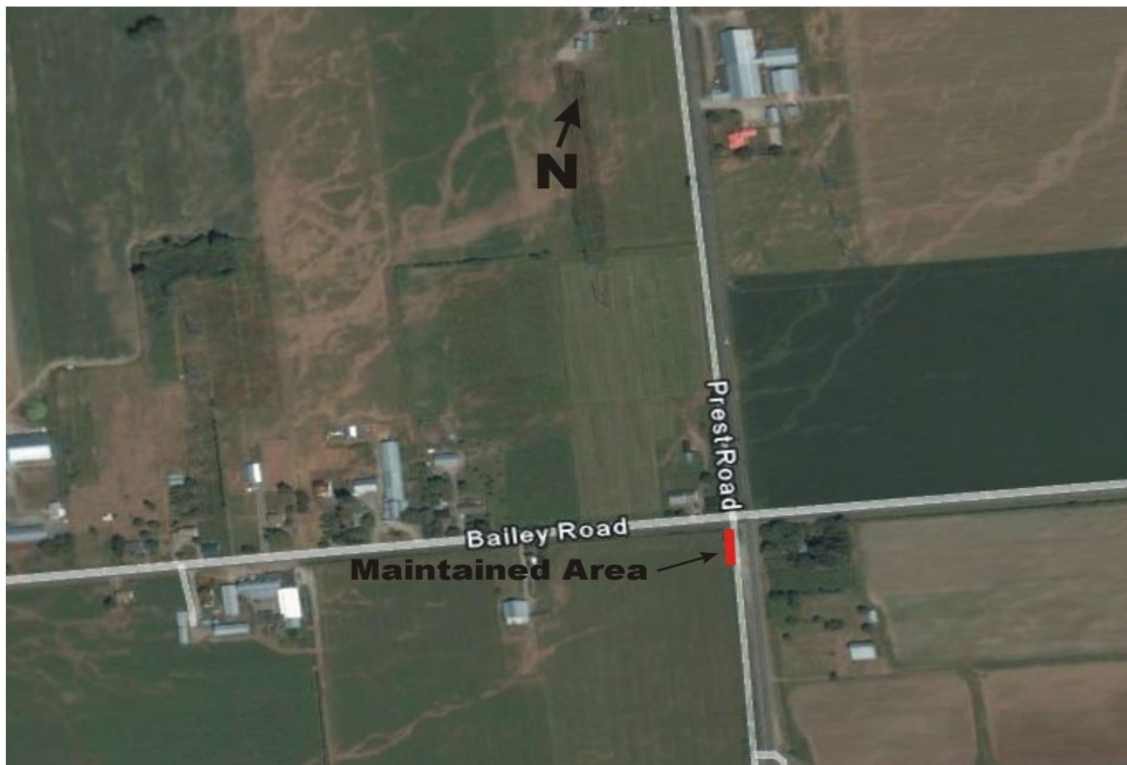
Figure 9.

Instream sediment and vegetation was removed from approximately 40 linear metres of the sediment trap on Teskey Creek. Prior to cleaning, electro fishing was undertaken throughout the reach to determine fish presence/absence. No fish were encountered. Though this segment of watercourse offers good riparian cover, marginal water quality may account for the lack of fish use during summer months. Post-maintenance data collection occurred following a significant rain event and this may account for improvements in water quality parameters.

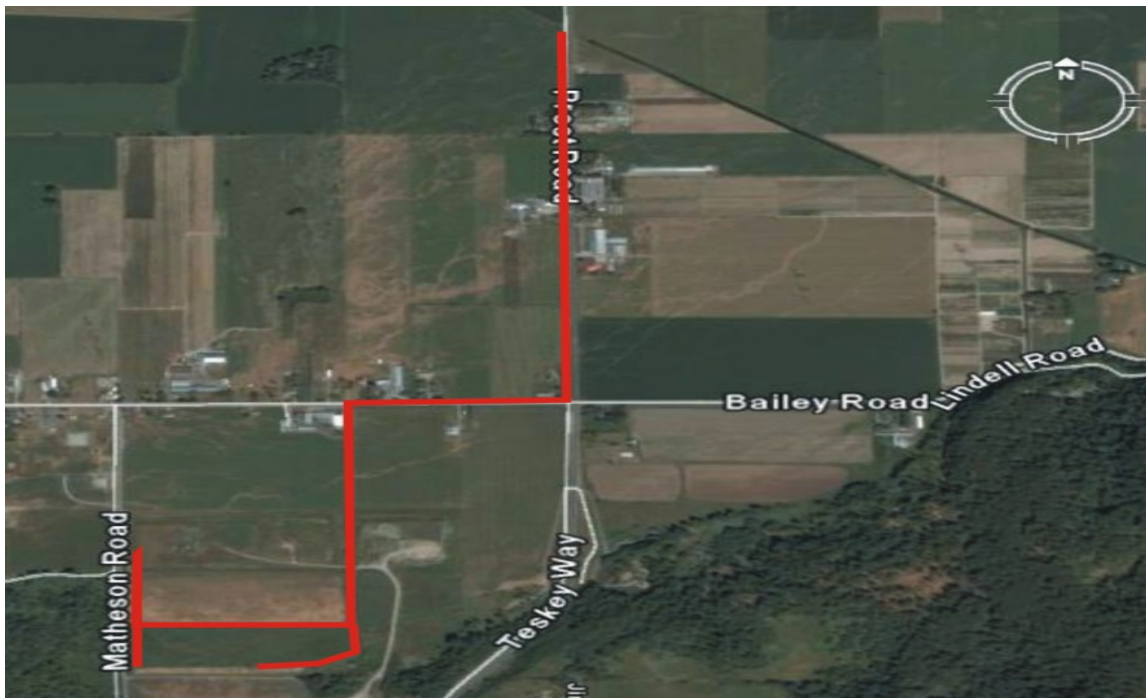
Figure 10.

Instream sediment and vegetation was removed from the watercourse from its confluence with interception ditch, upstream for approximately 2700m. Given the significant length of the area to be maintained, a total of three silt control fences were installed to keep turbidity below the safe limit set out by the DFO. A potential barrier to fish passage exists at Bailey Ditch's confluence to Interception Ditch in the form of a cement weir that creates a .6m drop at low summer flows. This may account for limited fish salvage results within the maintained section (Table 17).

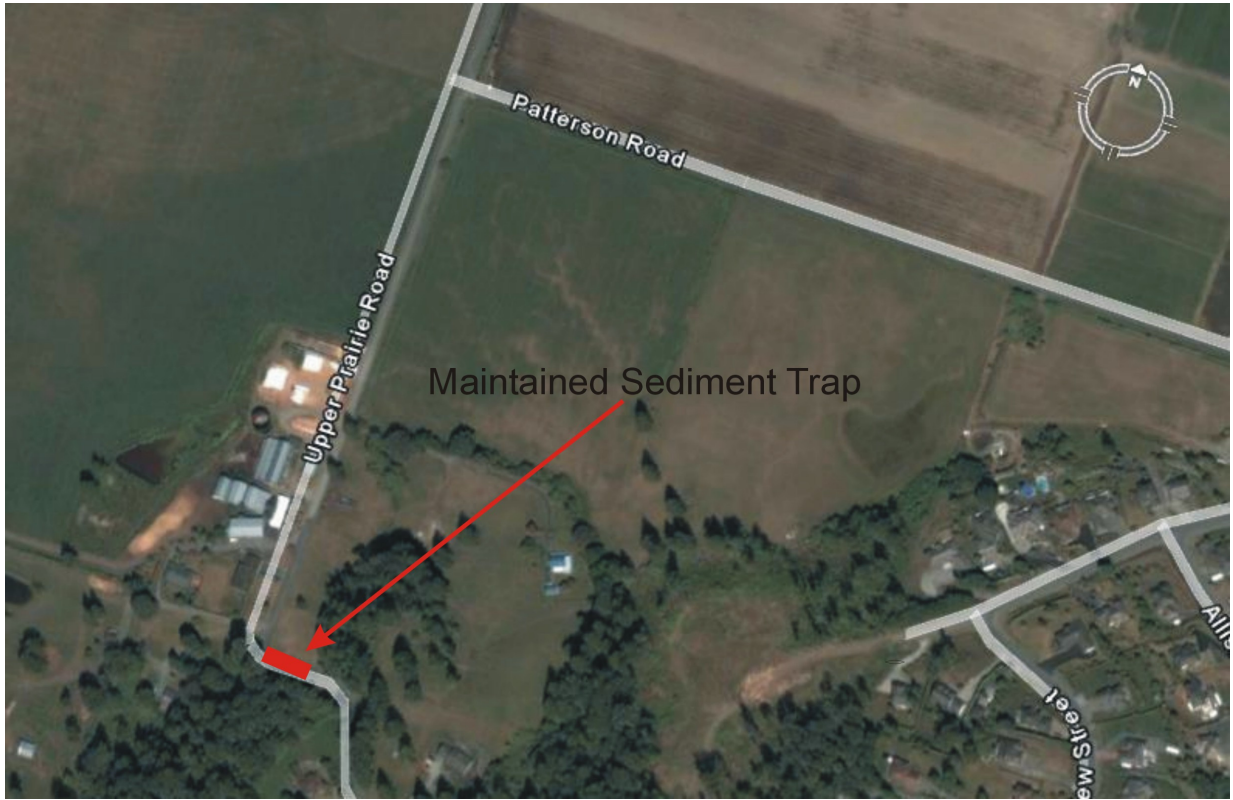
Figure 11.

Instream bed load material and vegetation was removed from the sediment trap for an approximate length of 35m. The traps functionality had been significantly reduced due to in-filling since its excavation during the 2006 fisheries works window. Works at this site in 2007 also included enlargement of the sediment trap to reduce the frequency of future drainage maintenance works downstream. Stream-side planting at this site will be undertaken in the spring of 2008 (as per authorization compensatory habitat conditions). A rock weir was installed at the mid-point of the trap to increase habitat and flow complexity (Photo 8). Large woody debris pieces installed in 2005 were left intact.

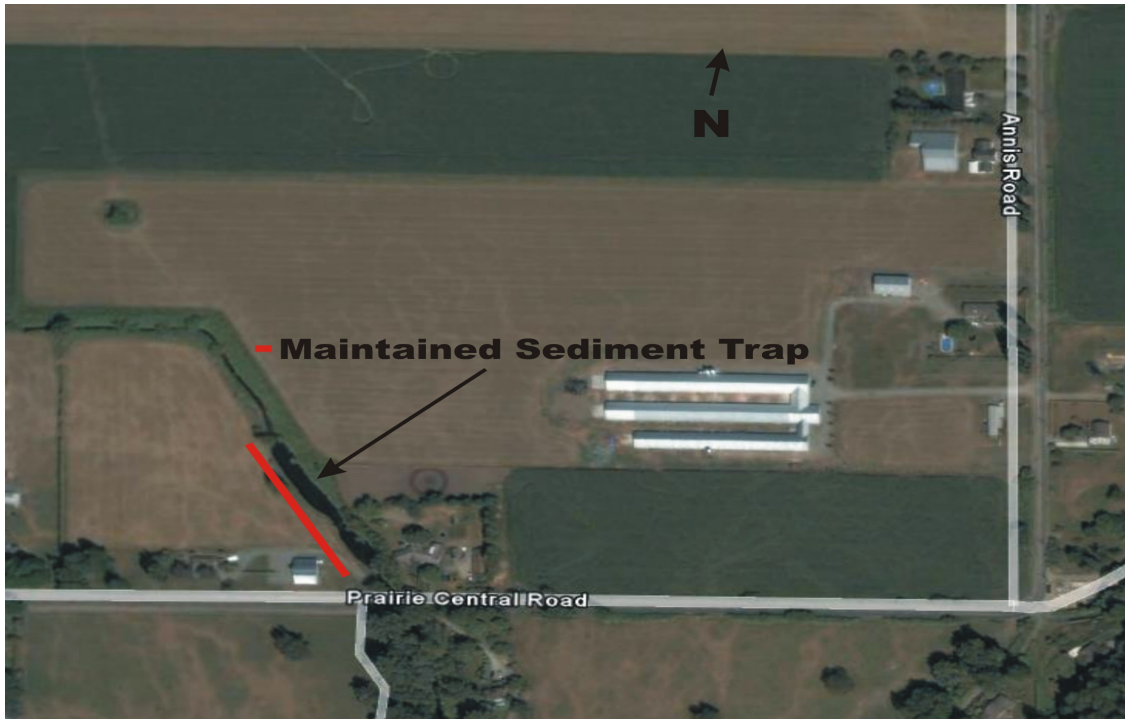
Figure 12.

Bed load material was removed from the sediment trap located downstream of Prairie Central Road. The maintenance area was approximately 125 linear metres that included two large sediment traps. The traps had aggraded more sediment than in previous years and flow through the area existed as shallow riffle and glide with no pool habitat (Photo 9). The lack of pool habitat explains lower fish densities encountered during the 2007 fish salvage work. Salvage crews employed a combination of seining and electro-fishing at this site.

Downstream turbidity levels remained within acceptable limits throughout maintenance works. Turbidity was kept in check through the installation of a gravel check dam lined with filter clothe. In addition to this turbidity control method, the

monitor instructed excavation crews to take frequent breaks that allowed for a 'flushing' of fresh water that aided in maintaining low turbidity levels.
