STREAMFLOW AND FLUVIAL GEOMORPHOLOGY
OF THE LOWER GOLDSTREAM RIVER

- SUPPLEMENTARY ANALYSIS AND REVIEW

prepared for BC Parks

April 2008

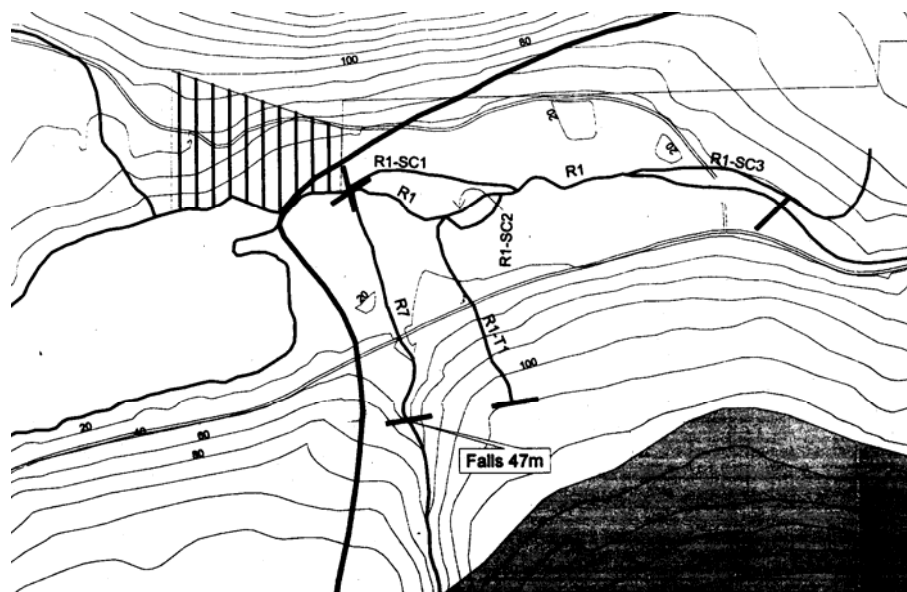
Figure 6 Lower Goldstream River

Figures 6 and 7 are reach maps from the 1998 and 1999 LGL Ltd. reports respectively. Figure 6 shows the broadening floodplain as it leaves the confined valley upstream of the Finlayson Road bridge. Figure 6 is at a scale of 1:2,500 and shows the numbered location of proposed restoration sites. It shows the bifurcation of the stream channel into east and west side channels. It has been annotated to show the location of the 2006 debris jam and corresponding reach names used in the 1998 overview assessment. At the time of assessment in 1997 the river had already avulsed into the west side channel causing widening at the inlet.

In 2006 winter storms resulted in formation of an extensive debris jam that now occupies the upper half of what was the centre channel R1-SC2 (former main channel). The November 16, 2006 storm was noted for accompanying high winds that resulted in extensive windthrow across Vancouver Island. Consequently, with the exception of side channel flow in the eastern side channel R1-SC1, all flow appears to be now diverted through the west channel.

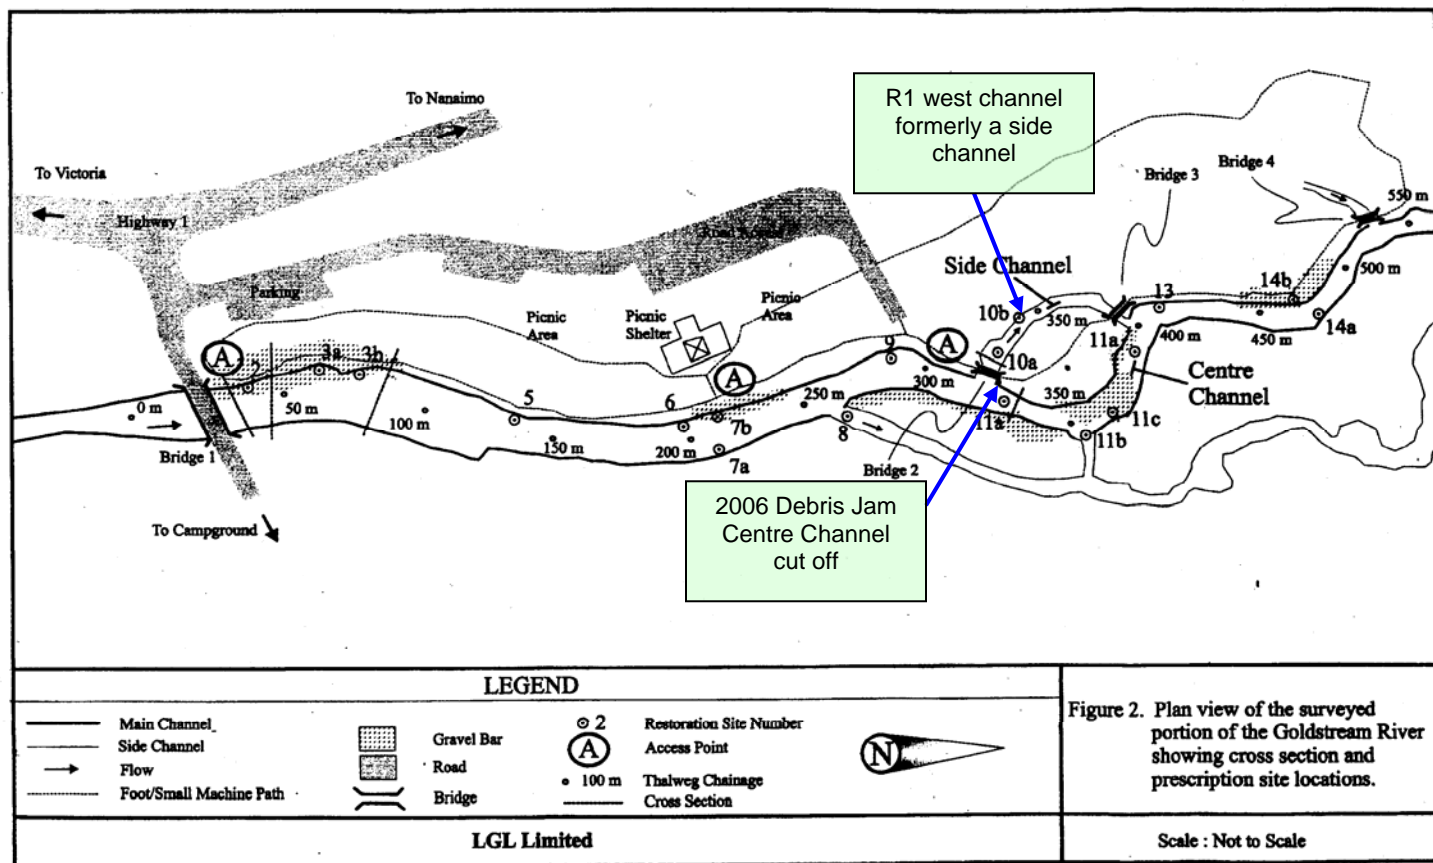
Figure 7 Detailed planform of Reach 1 and Side Channels

Reach 1 is a riffle-pool morphology dominated by gravel with large woody debris complexing expected to be important. It has a stream slope between 0.5 and 1.0 percent characterized by a bi-modal distribution of sand and gravel dominated substrate. It has a sinuosity ratio of 1.2 as measured from Figure 7. It is generally a single thread channel that remains stable subject to periodic avulsion rather than undergoing continuous braiding. Channel cross sections are typical of the Rosgen classification C5 stream type with one low bank at low floodplain height (Rosgen, 1996).

Bed shear stress is related to the radius of curvature and increases exponentially as stream radius is reduced. An estimate of the radius of curvature for the west channel taken from Figure 7 is approximately 35 m. Increased shear stress at the bend is estimated to be 1.6 times the straight channel shear stress. (Washington State Integrated Stream Bank Guidelines, 2003). Bankfull bed shear stress on the outside bend is estimated to be between 3.3 to 4.0 kg/m². Corresponding bank shear stress is expected to be approximately 80 percent of bed shear stress. These values correspond closely with straight channel tractive force in the main channel upstream based on a stream width of 18m and a bankfull depth of 0.8m. Maximum stress locations would normally be expected on the right bank at the inlet to the meander and along the outside left bank at the top of the loop. Additional variables and monitoring data would be required to predict rates of bank erosion. The method proposed by Rosgen (2001), that relates a bank erosion hazard index to near bank shear stress is one approach.

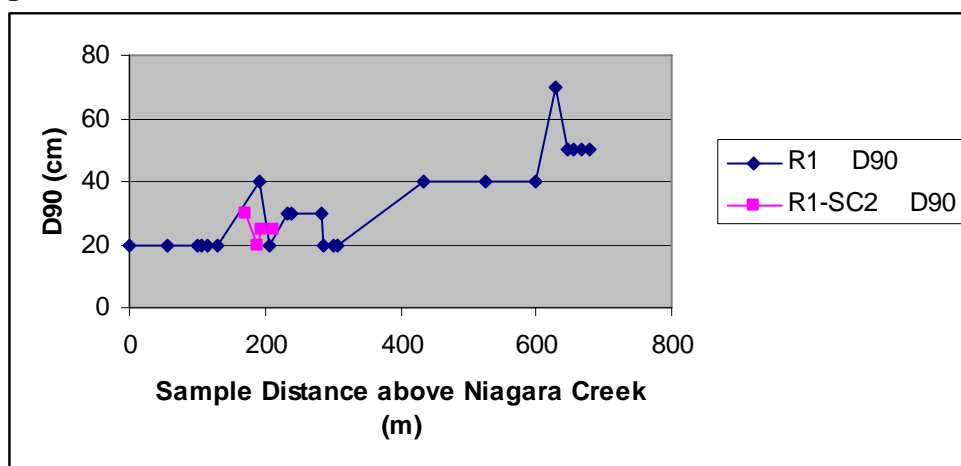
Figure 8 D90 Particle Size in the main channel and west diversion channel

Slightly less than 50 percent of the bed material in side channels was observed to be fines. Average 90 percentile diameter size (D90) for the west side channel is approximately 25cm with a maximum D90 of 40cm. The median diameter for the R1 reach is estimated to be approximately 1 cm based on a plot of the estimated mid point for each sediment class and an upper limit D90. This yields a calculated Mannings roughness co-efficient of 0.025.

Figure 8 shows a characteristic pattern of increasing D90 in an upstream direction. There is a local increase in the west channel where avulsions have diverted primary flow. Assuming no change in stream slope, particle size may be expected to vary inversely with sediment load and proportionately with discharge.
