Lower Coquitlam River Fish Habitat and Flooding Assessment

Prepared for
Watershed Watch Salmon Society and
Kwkwetlem First Nation

Prepared by
Tanis Douglas, RPBio
Fernhill Consulting

Project # 07 COQ.01

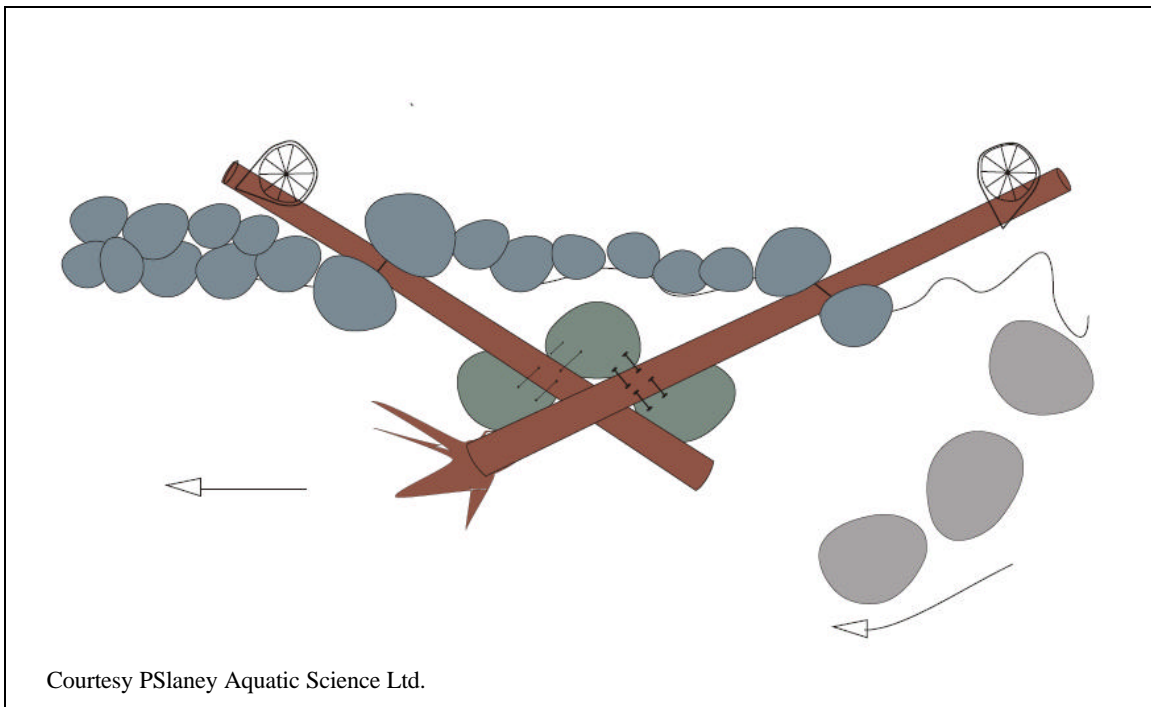
Figure 13: Flat triangle LWD structure with bank revetment and guard boulders

Figure 13 is provided by Pat Slaney of PSlaney Aquatic Science Ltd., and depicts a flat triangle anchored by alluvial boulder ballasts and with alluvial boulder bank revetments to ensure that bank erosion does not occur. This bank protection is particularly applicable for banks dominated by erodible fine materials, such as those found in the study area, as the upstream log directs flow towards the bank. The alluvial boulders used are more natural in appearance than quarried rock. The triangulation of the structure offsets drag forces, so the rock ballast is required only to offset the buoyancy of the logs. The ends of the logs are anchored to the bank using either large trees or buried boulders. In compliance with navigable waters requirements, a cluster of ‘guard’ boulders is also included in the design. These boulders will deflect any watercraft (including inner tubes) away from the structure. The triangle will create a scour pool off its apex as well as providing overhead cover, thus providing rearing habitat for juveniles. The guard boulders and bank protection will also provide for juvenile habitat (Pat Slaney, personal communication).

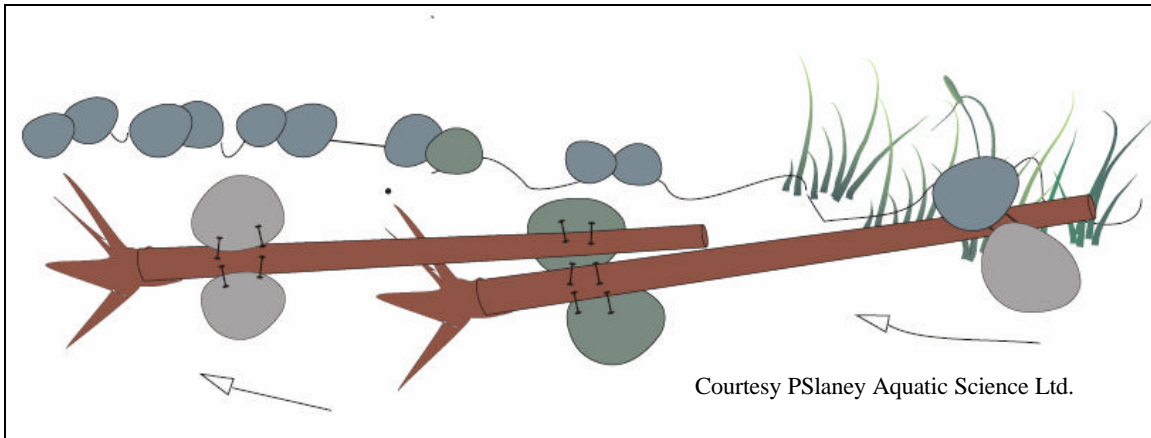
Figure 14: Lateral log pair with intact downstream facing rootwads and alluvial boulder ballast

Figure 14 is also provided by PSlaney Aquatic Science Ltd. and is a variation on the design. It depicts a pair of lateral logs with intact rootwads, with some scattered bank boulders. The rootwad is facing downstream to minimize potential hazards to watercraft. Guard boulders are not necessary, and the logs are ballasted at the bank on the upstream end, and a few meters above the rootwad mass on the downstream end.

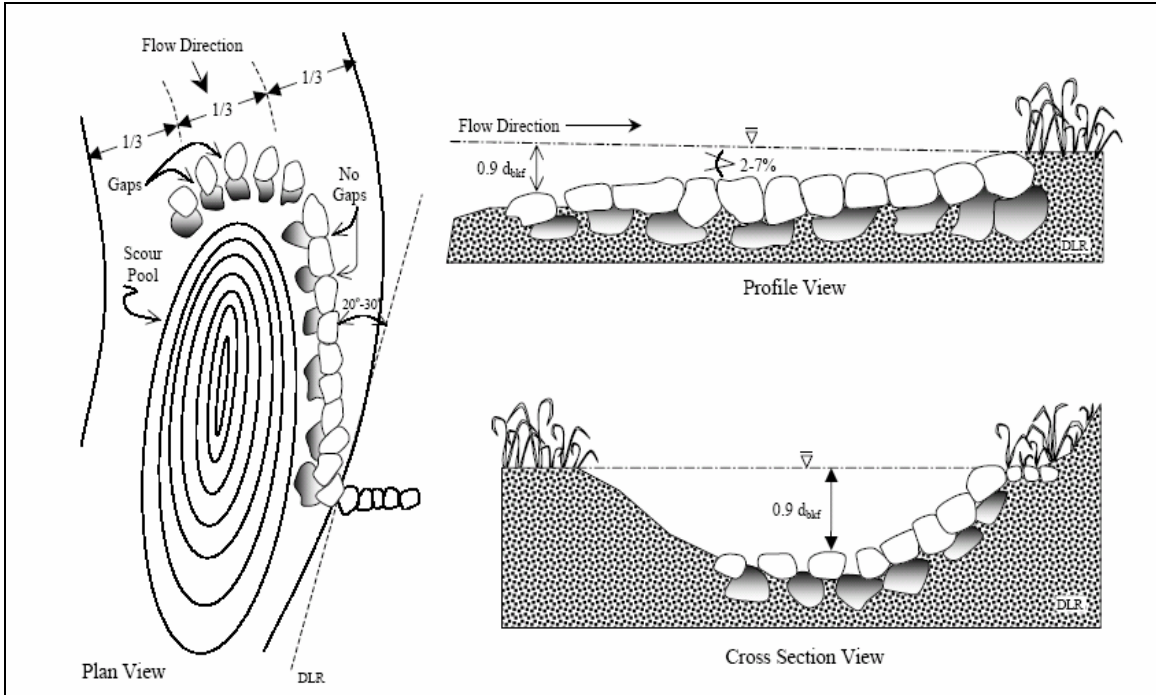
Figure 15: The J-Hook Vane developed by Dave Rosgen (diagram from Rosgen (N.D.))

Figure 15 shows a design developed in the United States (Rosgen N.D), called the J-hook vane. This has also been adapted in British Columbia to be used with a ballasted log pair with a boulder “J-hook” off the tip of the logs (Figure 16). The J-hook vane directs flow away from the bank and creates a scour pool that improves instream complexity. The boulders/logs also provide instream cover. This structure tends to provide more summer habitat, whereas the two log structures shown in Figures 13 and 14 provide winter refuges and summer rearing habitat, with coho fry and steelhead parr the targeted species/life stages (Pat Slaney, personal communication).
