## 2012 Fish Passage Assessments in BCTS Kootenay Business Area (PD13TFE006)

Prepared By:  
**VAST Resource Solutions Inc.**  
4500 Mennie Road  
CRANBROOK, BC  
V1C 4J1

Prepared For:  
**Ministry of Forests, Lands and Natural Resource Operations**  
Kootenay Business Area, BC Timber Sales Office  
1907 Ridgewood Road  
Nelson, BC, V1L 6K1

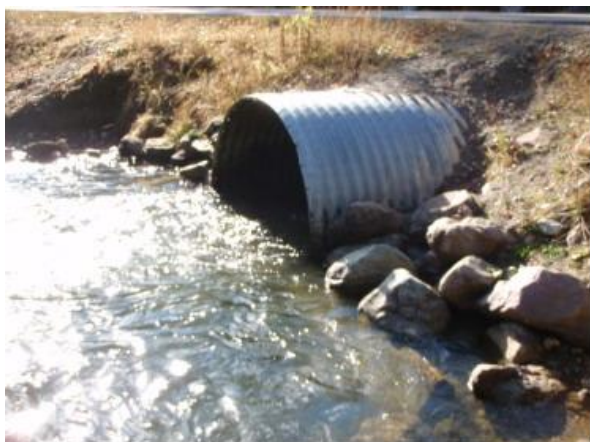
Priority Sites\_SAND012\_Outlet

- SAND011 and SAND012  
These crossings are located on Little Sand Creek along Baynes Lake Road. Both crossings consist of large round culverts, which are not properly embedded, creating velocity barriers. Sand Creek and Little Sand Creek are known spawning streams for Kookanusa Bull Trout and Kokanee populations. Westslope Cutthroat Trout also occur throughout the watershed. Approximately 40Km of fish habitat is available upstream of these crossings. The replacement of the current culverts by a bridge or an arch structure is recommended. The minimum recommended span of the replacement structures for SAND011 and SAND012 is 10 m and 12 m respectively.

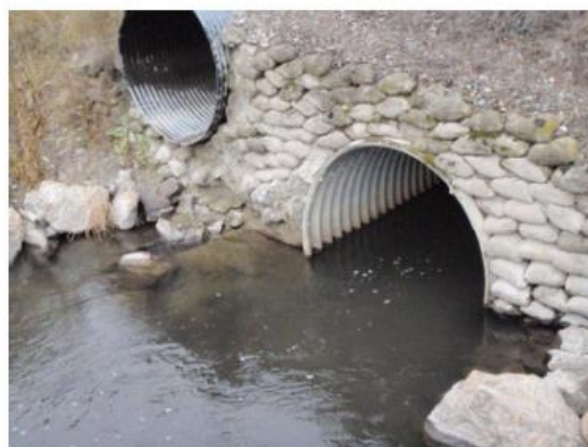
Priority Sites\_JOSP007\_Outlet

- JOSP001, JOSP002, JOSP004, JOSP005, JOSP006, JOSP007  
These 6 crossings are located on the lower reaches of Joseph Creek near the confluence with the St Mary River. The structures are not properly embedded, creating velocity barriers to juvenile fish. These crossing were selected due to the recorded presence of two listed fish species in the stream (BT and WCT) and the large potential upstream habitat gain. However, it should be noted that Joseph Creek flows through the town of Cranbrook, likely resulting in a deterioration of instream habitat. Some barriers may exist within the city limits that have not been assessed during this study. Further study is needed. Nevertheless, restoration of fish passage within the Joseph Creek watershed is highly beneficial to the stream's fish community. Replacement of existing closed bottom structures by open bottom structures, such as low profile arches, is recommended.
