# Crawford Creek Hydrogeomorphic Investigation and Identification of Habitat Restoration Opportunities

Apex File HA-15-PL-01

Prepared For: Fish and Wildlife Compensation Program

24-Dec-2015

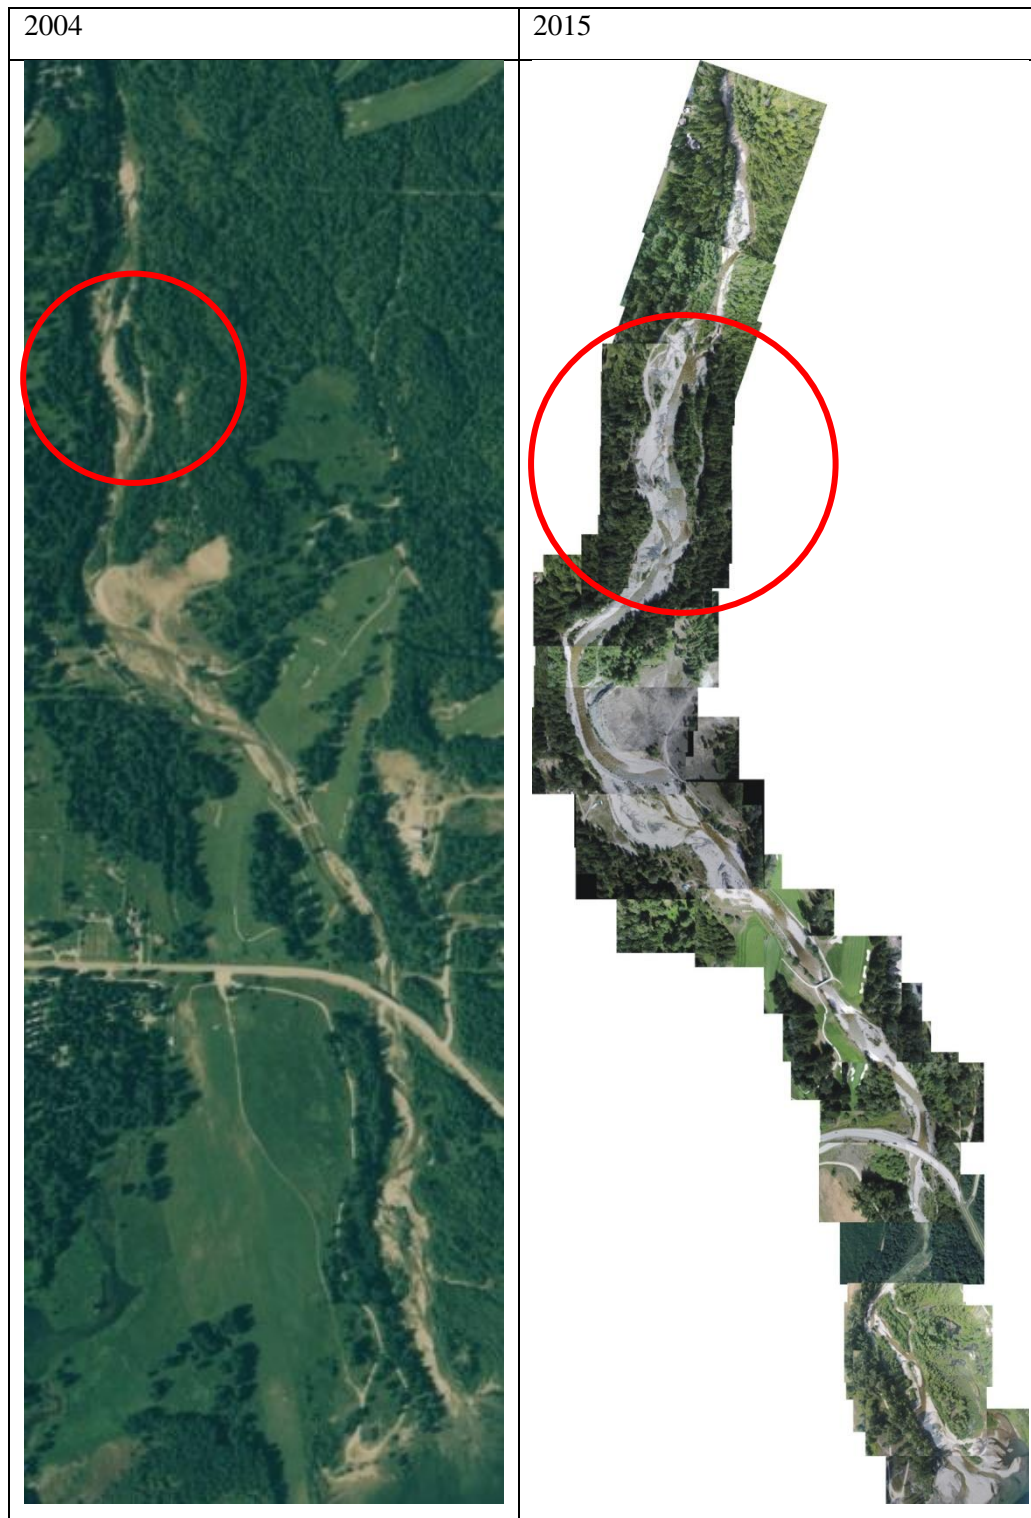
Figure 4. Larger scale comparison between 2004 air photograph and 2015 drone imagery shows that the disturbance associated with the 2012/2013 floods was greatest in the area upstream from the golf course gravel pit.
