Eagle Creek Feasibility Assessment: Improving Kokanee Access to Spawning Habitat in Eagle Creek (2016 - 2017)

FWCP COL-F17-F-1456

April 2017

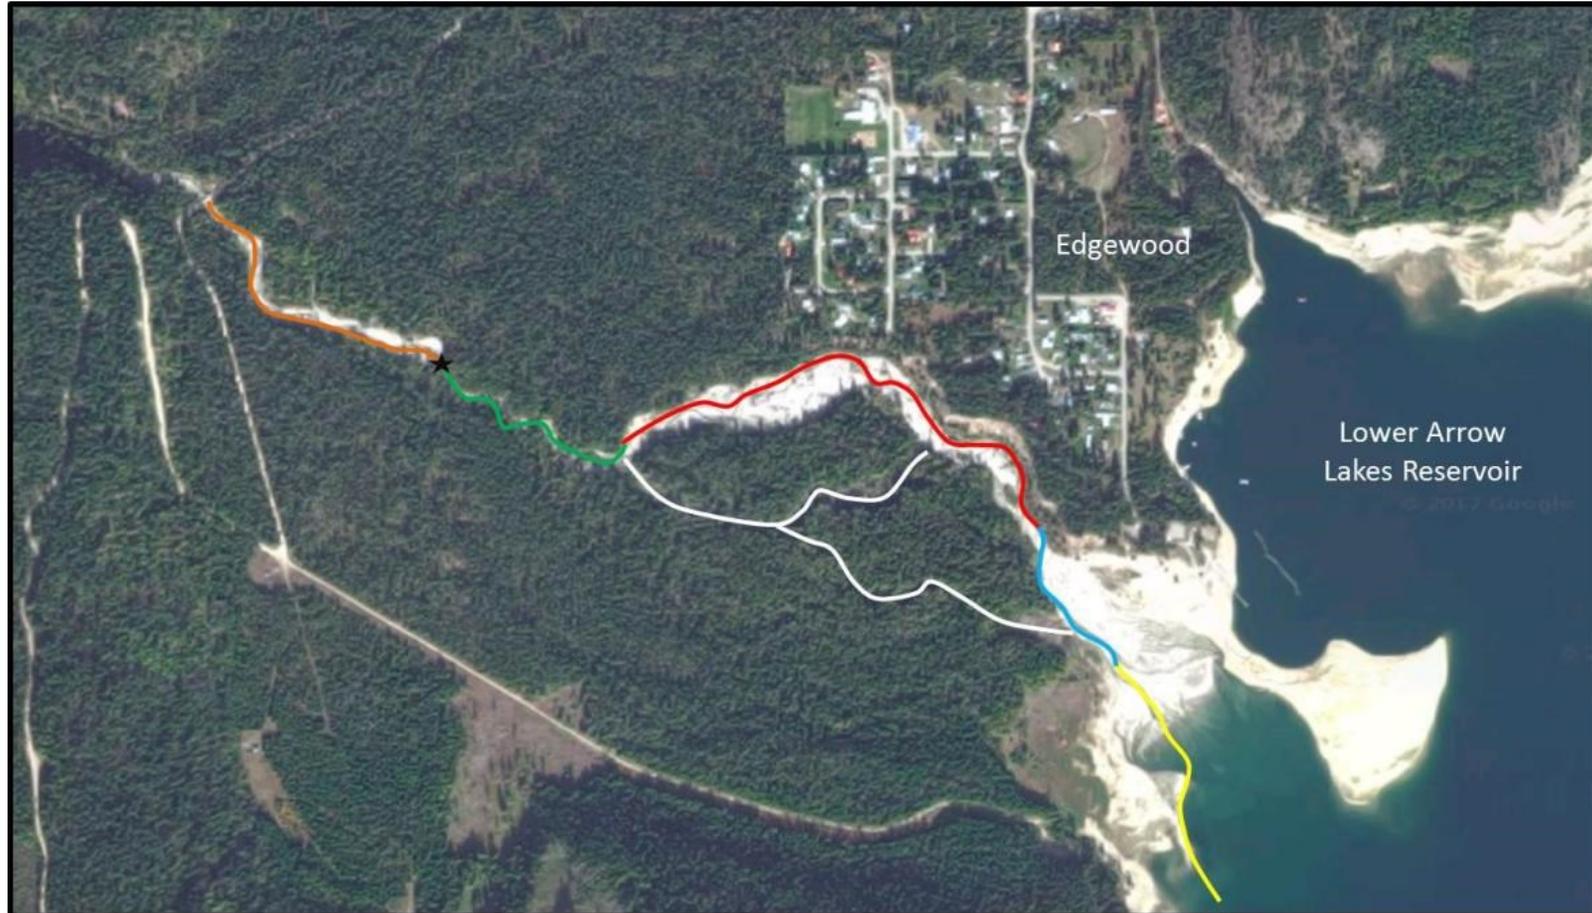
Approximately 2.6 km of Eagle Creek was ground-assessed to document stream morphology, sediment, and upstream stability characteristics. It was determined the creek could be separated into six different management zones based on the findings of the desk-top and field assessments. (Fig. 4).

Figure 4. Eagle Creek management zones and features: (Yellow) Management Zone 1 - lower drawdown zone, (Blue) Management Zone 2 - upper drawdown zone, (Red) Management Zone 3 - laterally unstable section, (White) Feature - old stream beds, (Green) Management Zone 4 - narrow stable section, (Black Star) Management Zone 5 - log jam, (Orange) Management Zone 6 - aggregated section (created by Evan Smith using map data 2016, Google).

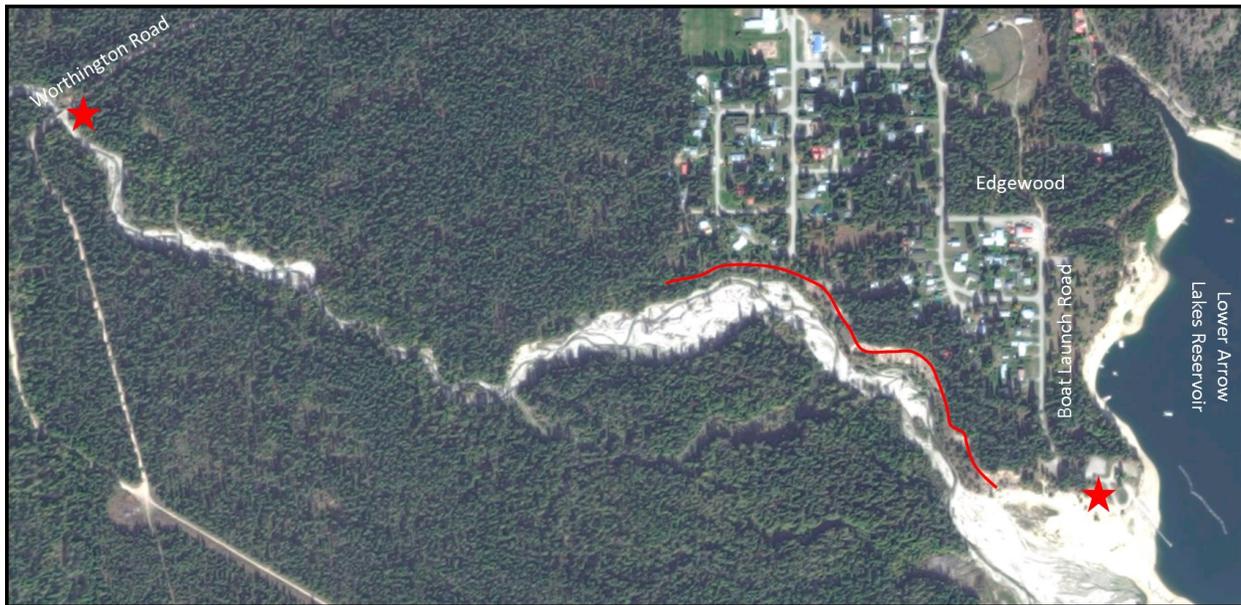
Three locations were identified as possible heavy machine access points (Schiller, pers. comm.). However, due to concerns of damage to white-tail deer habitat and possible increased hunter access into the area, only two locations are being considered (Fig. 11; Schiller, pers. comm.). These locations provide access to recommended treatment sites with minimal tree removal. Since the channel is over widened in MZ 3 and MZ 6 there is plenty of area for a machine to travel down without disturbing vegetation and minimal instream disturbance. An excavator size 325 or 330 is recommended for the work considering size of material, reach requirements, and cost effectiveness (Schiller, pers. comm.). A danger tree assessment may also be required while working in MZ 3, 5, and 6 with heavy machinery (Schiller, pers. comm.). Local BC Parks staff are supportive of the works (Mike Flintoff pers comm.), and regional staff have also been briefed on the potential and interest in fish habitat improvements in the Eagle Creek drawdown zone (Chris Price, pers comm.)

Figure 11. (Stars) Access points for heavy machinery off of Worthington Road (top left) and Boat Launch Road (bottom right). (Red Line) Old access road with little vegetation suitable for excavator use that provides access to MZ 2 and 3 without entering the stream bed (created by Evan Smith using map data 2016, Google).
