**ARTIFICIAL NESTING STRUCTURE USE AND MAINTENANCE**  
**PROJECT # PF15 – W16**

**March 2015**

**FISH & WILDLIFE COMPENSATION PROGRAM – PEACE**

**Ecofor Consulting Ltd.**  
1575 2<sup>nd</sup> Ave.  
Prince George, BC  
V2L 3B8  
250-960-1155

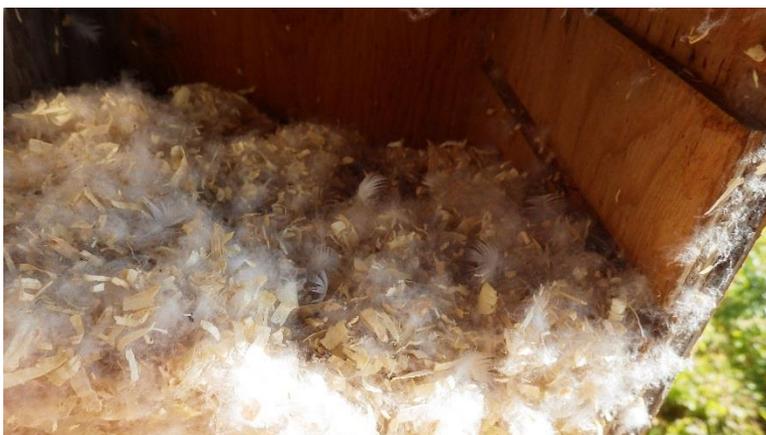
GPS: D8-2014

Dina Lake: Active nestbox.

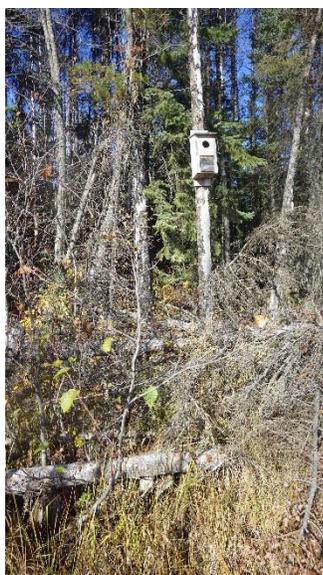
Rocky Marsh interpretive sign along trail. Heavy mountain pine beetle blowdown behind the tree and situated below nestbox in the below photo.
