# Executive Summary

In the spring of 1997, the Nadina Community Futures Development Corporation (NCFDC) was designated as a proponent for FRBC funding in a Watershed Restoration Program (WRP) project in the Mid-Bulkley Watershed (see figure 1). The NCFDC is a non-profit community economic development corporation based in Houston, British Columbia. The implementing partner in this endeavor was the Ministry of Environment, Lands, and Parks, Skeena Region BC Environment office (MELP).

The British Columbia Conservation Foundation (BCCF) was contracted by NCFDC to carry out a WRP Detailed Level 1 Fish, Fish Habitat and Riparian Assessment in the summer of 1998.

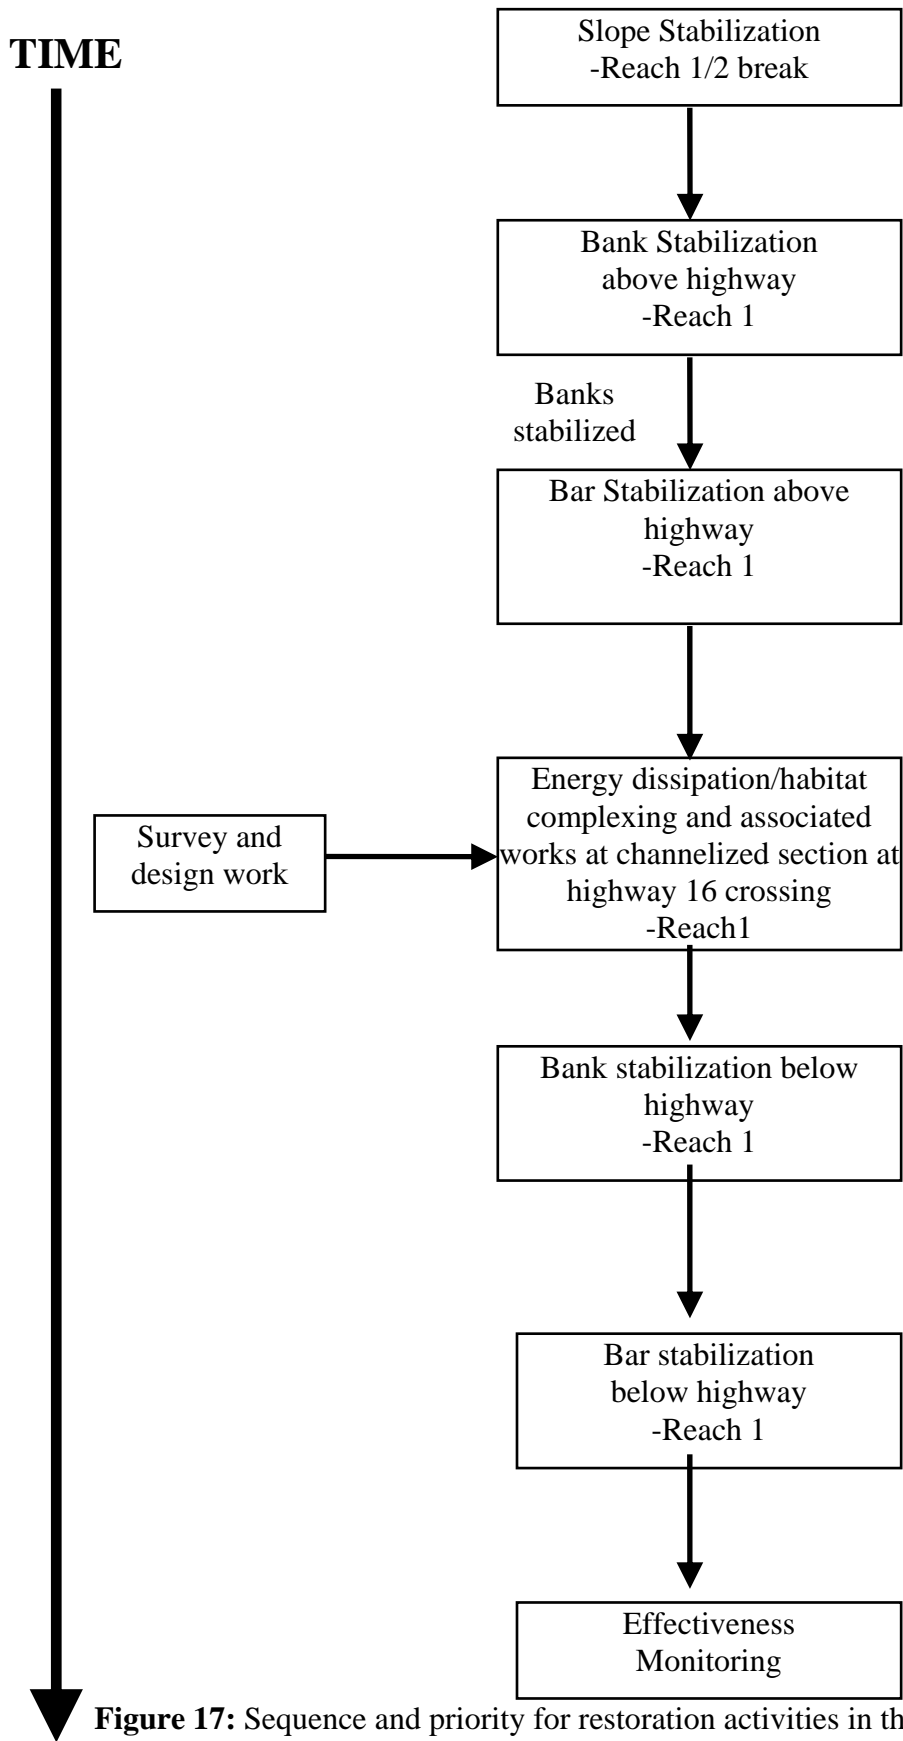
Figure 17: Sequence and priority for restoration activities in the Richfield Creek sub-basin.

Land-use in this reach has not damaged fish habitat quantity and quality significantly. Of particular concern is the level of nutrient loading from cattle manure, but such concerns are beyond the scope of this study.

As indicated by low levels of impact, this reach has no restoration work prescribed at this time.

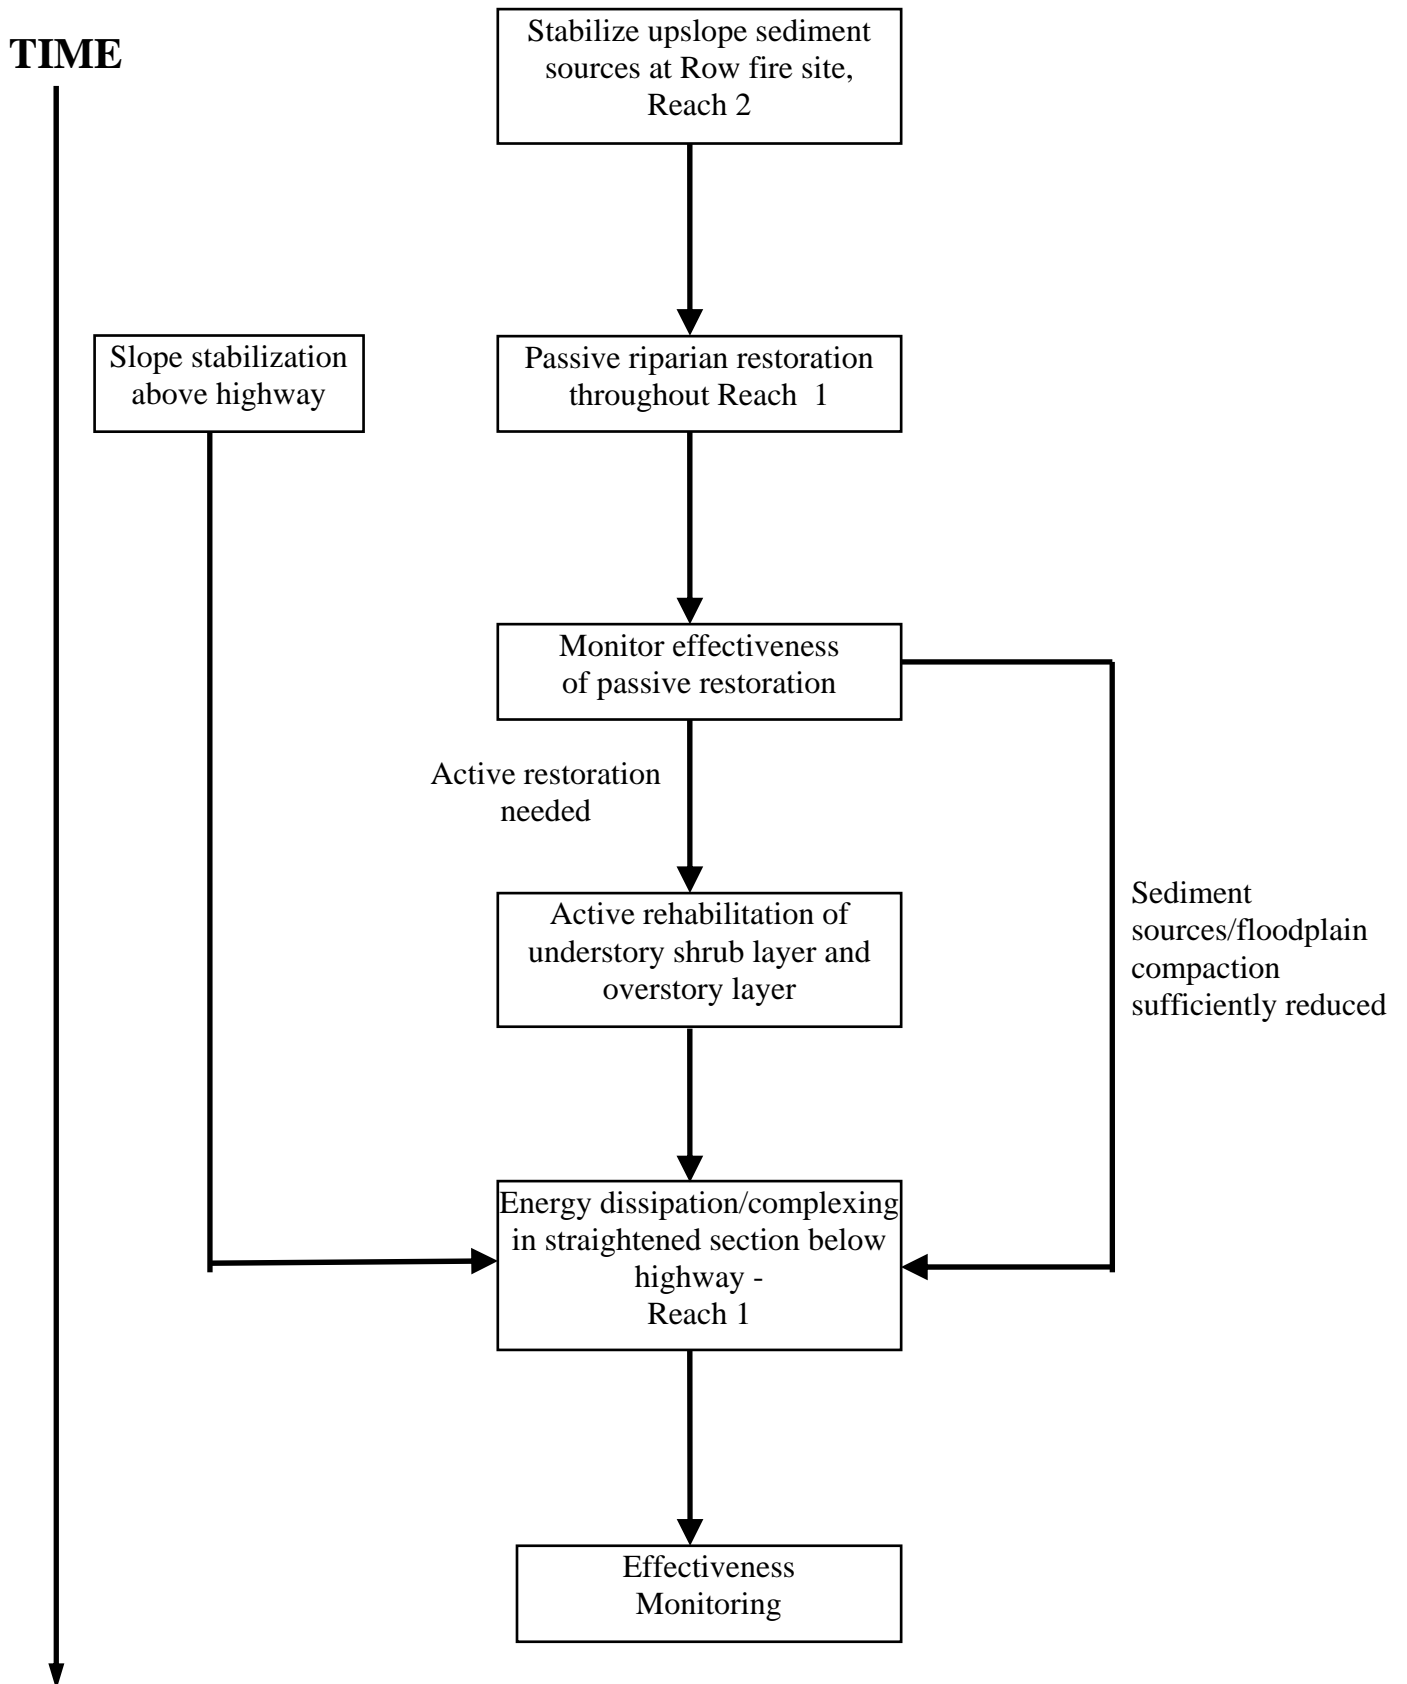
Figure 25: Sequence and priority for restoration activities in the Byman Creek sub-basin.

Land-use in this reach has damaged fish habitat quantity and quality. Of particular concern are high water temperatures, poor LWD frequency, extensive channel and slope disturbance and high sediment load, substrate embeddedness and pool frequency and quality. Impact sources are dominantly isolated to this particular reach, but are partially related to upstream sediment sources and possibly an altered runoff regime due to extensive cleared land in the headwaters. Impacts are mostly cumulative in nature. Poor LWD function is likely due to a combination of poor bank stability (anchoring), high

Priority and sequence of prescriptions is presented in figure 25. This reach has a high priority for restoration as indicated by the reach prioritization table in appendix H
