Hartley Creek Restoration Project- 2007 As-built Report

Prepared for:
Ministry of Transportation
231 - 447 Columbia St.
Kamloops, BC
V2C 2T3

Prepared by:
Interior Reforestation Co Ltd
4142 McPhee Road
Cranbrook, BC V1C 4J6

RE: Hartley Creek Restoration 2007 As-built Report

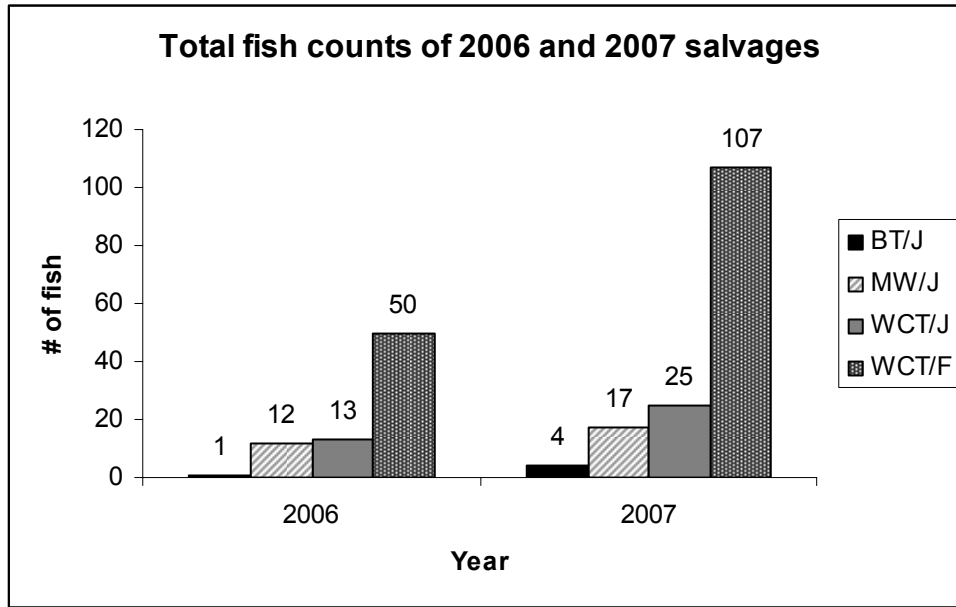
Figure 4: Total fish counts of 2006 and 2007 salvages.

Fish salvage efforts were also completed prior to undertaking the 2006 instream works, within the same area. Salvage collection data suggests a considerable increase in fish abundance between 2006 and 2007 (Figure 4 and Table 4). In 2006, 98 m were salvaged before dewatering and comparably, 105 m in 2007. Between years, salvages were also similar in electrofishing seconds (1586 in 2006 and 1530 in 2007). A comparison between years shows an increase in abundance for both WCT fry and juveniles of approximately 50%, regardless of if abundance was calculated as density (fish/m) or catch per unit effort (fish/second) (Table 4).

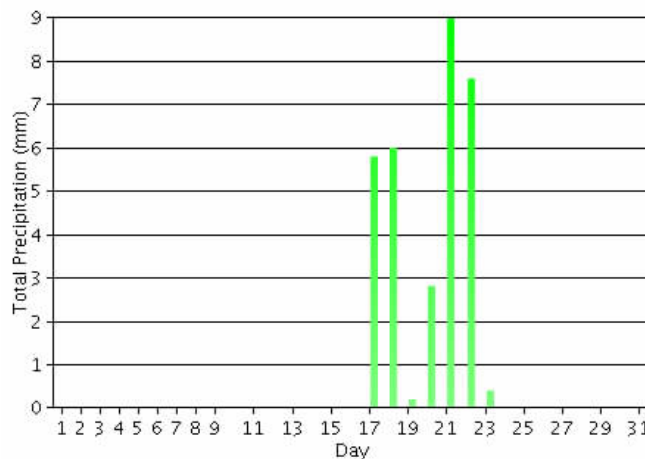
Figure 9: Bar graph depicting July 2007 rainfall (www.climate.weatheroffice.ec.gc.ca). Note y-axis scale.

On August 7, 2007, Interior staff visited the site to evaluate the success of the spring plantings. Vegetative monitoring plots were repeated in Planting Area's #2 and #3. All plants in these plots were found to be dead in appearance and yielded no change in height. Live cuttings placed along the stream edge were the only planted stock that showed any green leaves. The apparent dead/desiccated state of planted stock is likely a result of the abnormally dry month of July, where only 20 mm of rainfall was recorded. This is well below the average of 73.9 mm of rainfall derived from values recorded between 1971-2000 (<http://www.climate.weatheroffice.ec.gc.ca>). Although plants appeared to have died from lack of moisture, it is unclear if many were not simply dormant. A survey in early summer 2008 will help quantify plant loss due to drought stress. The rye/clover seed mix appeared to have had adequate growth before turning dormant. This is predicted to greatly limit surface erosion during fall rains and snowmelt in 2008, as well as to provide organic material to the soil.

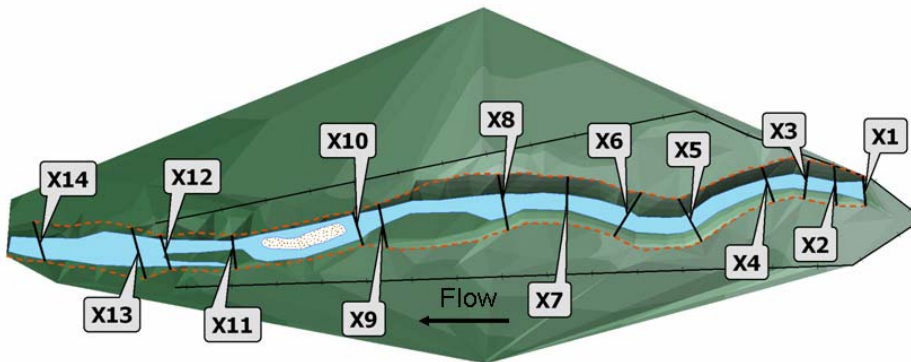
Figure 11: Location map of cross-sections completed during the 2007 as-built survey.

On November 16, 2007, Interior staff completed an as-built topographical survey of the Hartley Creek site. The survey focused specifically on the 2007 instream works. This data provided a means of identifying changes in the w/d ratio, channel sinuosity and channel slope, from the 2004 pre-construction conditions through the 2006 and 2007 restoration works (Figure 10). A comparison between the years showed a measurable decrease in the w/d ratio with time. Cross-sectional data collected in 2004 and 2007 was used to calculate the w/d ratio at twelve locations within the site (Figure 11). The w/d ratio of the reconstructed channel is presently more comparable to that of the undisturbed section upstream of the Highway 3 crossing (upstream w/d = 4.82). Although the photos and topographical surface appear to show an improved sinuosity (meander morphology), the current position of the thalweg does not yet fully conform to the restored banks, therefore yielding only a minor increase in sinuosity (Figure 10). Sinuosity is expected to improve (i.e. increase) with each spring freshet as the channel morphology develops in response to the new bank structures. The thalweg is expected to more accurately reflect the bank meander pattern as high flows create areas of erosion and deposition.
