Fish Habitat Assessments for Fish Passage Restoration in the Kootenay Business Area

Project Number PD13TFE005

Prepared For: **Ministry of Forests, Lands and Natural Resource Operations**
British Columbia Timber Sales
907 Ridgewood Road
Nelson, British Columbia
V1L 6K1

Prepared By: **Vast Resource Solutions Inc.**
PO Box 538
Cranbrook, BC
V1C 4J1

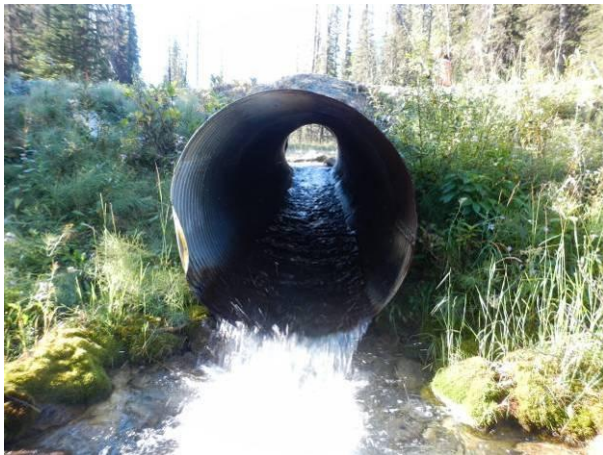
EFork 13 (Appendix I – Fig.4; Appendix II) is a closed bottom structure approximately 9.90 m in length, 1.35 m in diameter, with a fill depth of 0.45 m. The culvert is not embedded and the outlet is perched at 0.25 m above the current water level (outlet drop = 0.40 m) creating a barrier to juvenile and some adult fish species. Boulders added near the outlet suggest that backwatering of the structure was attempted but was not successful.

Culvert barrel at outlet.

Culverts at EFork13 and EFork25 should be replaced by bridge structures. Based on the downstream channel width measured at both sites, we estimate that the span of the two structures should be at least

9.00 m. Alternatively, low profile arch structures could be used given the relatively low stream gradient. Following replacement of the culvert, some stream restoration work should be conducted upstream of the structures where impoundments have altered the original instream habitat.

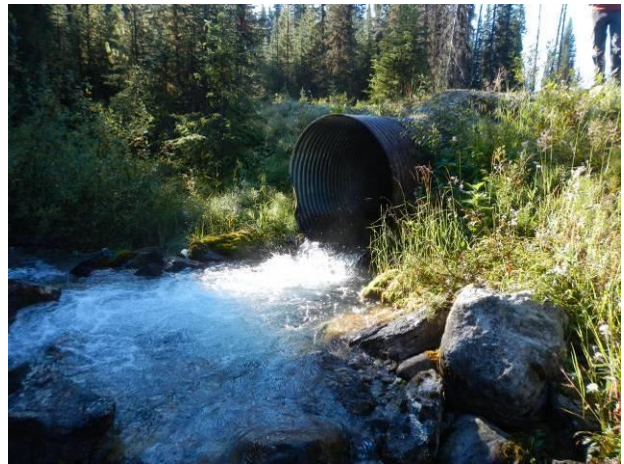
Outlet of culvert.

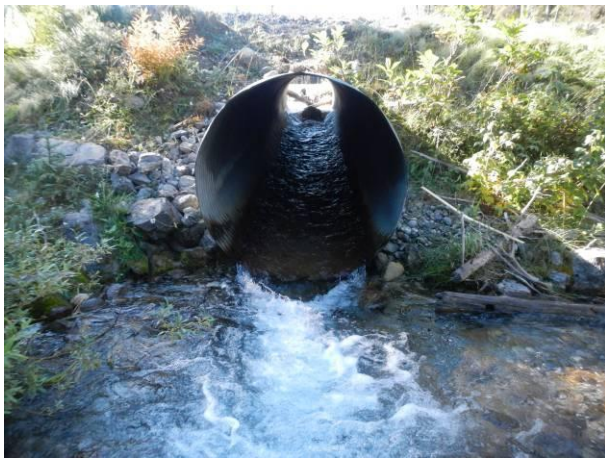
EFork 25 (Appendix I – Fig.4; Appendix II) is a closed bottom structure of 12.00 m in length and 1.45 m in diameter with a fill depth of 0.45 m at the inlet and 0.85 m at the outlet. Although the outlet is not perched, this culvert is not properly embedded, which results in a velocity barrier for juvenile fish. Boulders added near the outlet suggest that backwatering of the structure was attempted but was not successful.

Culvert barrel at outlet.

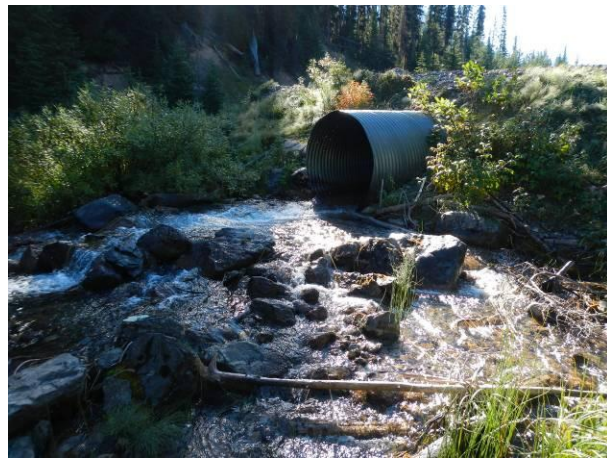
Outlet of culvert.

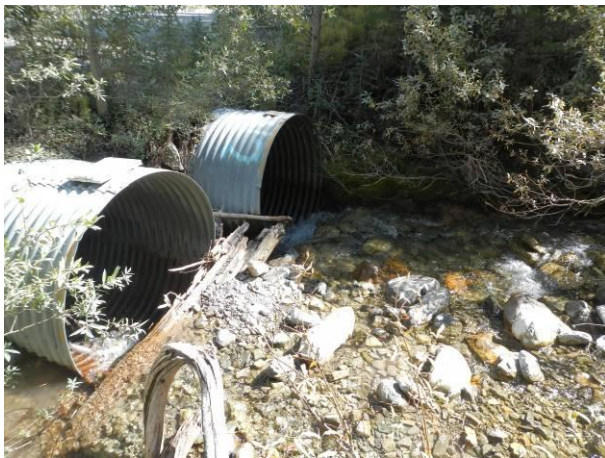
Inlet of culvert.

Due to a stream gradient greater than 5%, a bridge should be considered to replace the current culverts. Based on the measured channel width, we estimate that the structure span should be at least 6.00 m.

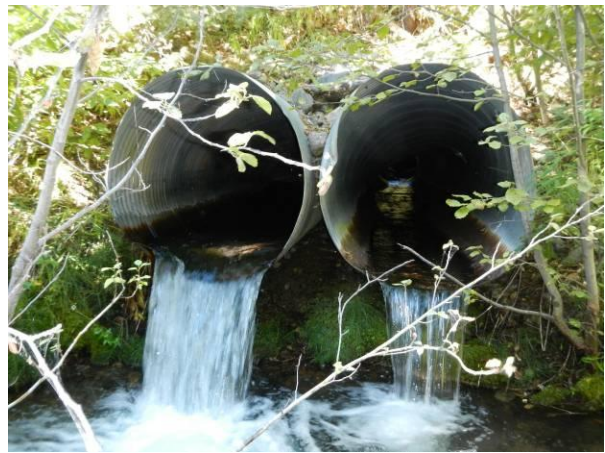
Outlet of culvert. Note that culverts are perched.

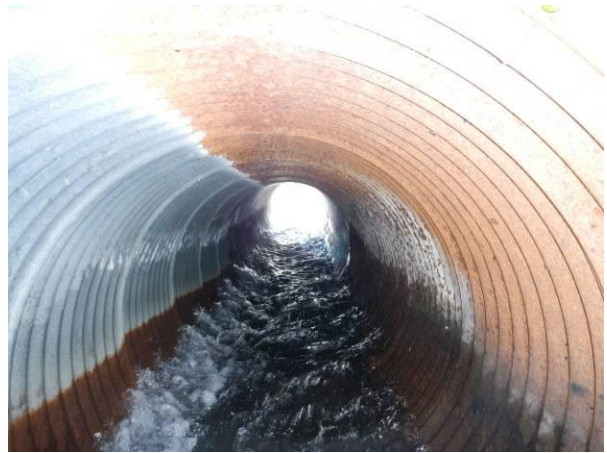
Barrel of right downstream culvert.

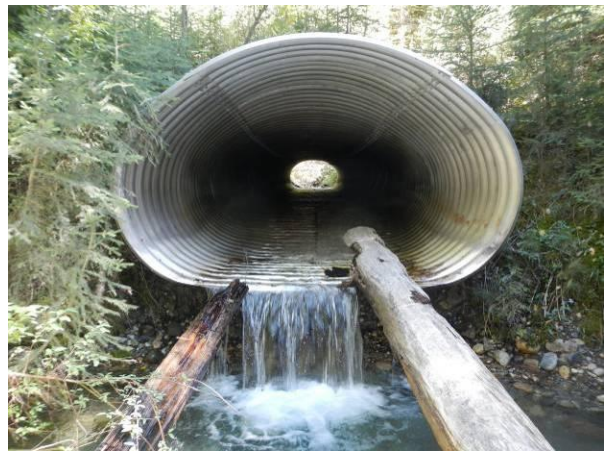
Perched culvert barrel at outlet.

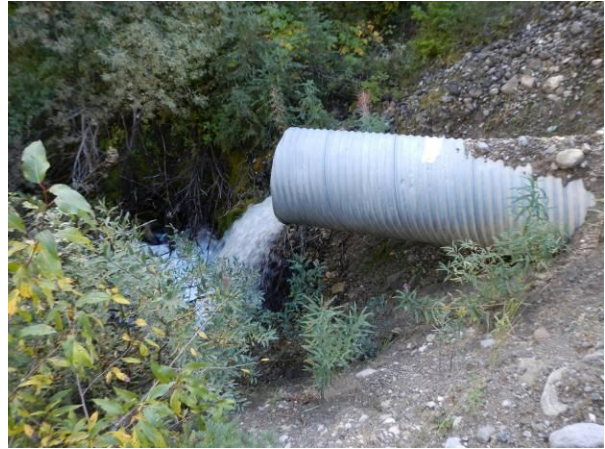
Perched culvert outlet.

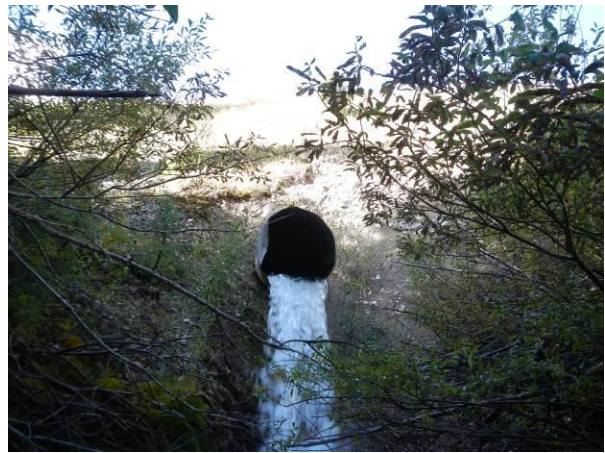
Road fill is approximately 10.00 m deep.

Due to the high fill depth and marginal fish habitat quality, we suggest assigning a low replacement priority to this stream crossing. Replacement with a bridge structure (with span of at least 6.00 m) is recommended.

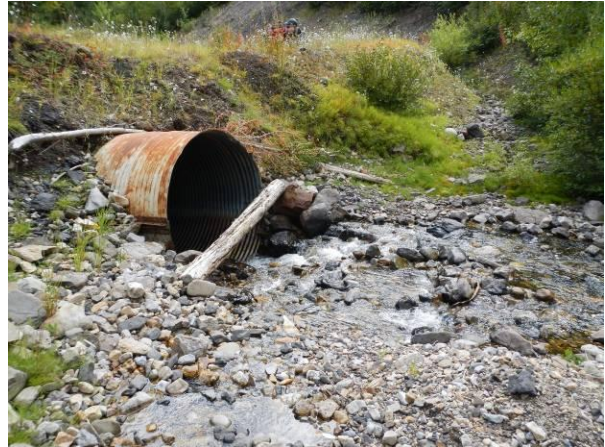
Inlet of culvert. Note high depth of road fill (> 1.00 m).

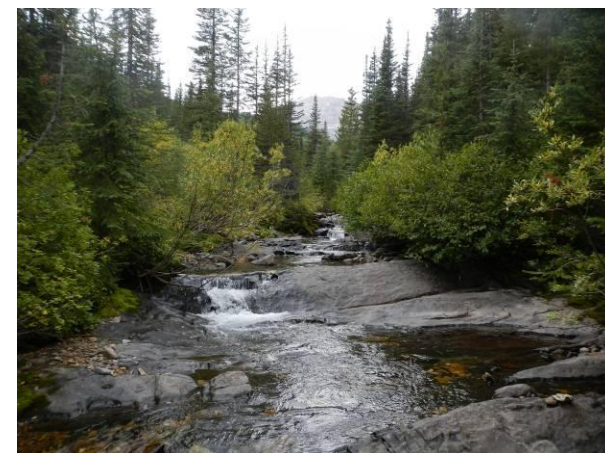
Downstream Habitat: Approximately 500 m of stream were assessed downstream of the crossing. Numerous bedrock cascades (0.7 to 1.0 m high) were noted and no fish were observed. The presence of waterfalls beyond the assessed section is very likely.

Bedrock cascades 100 m upstream of culvert.

A low priority should be given to the replacement of this crossing due the presence of bedrock, which would impede embeddedment of the new structure. Multiple impassable barriers were also observed. Replacement with a bridge structure (with a span of at least 5.00 m) is recommended.

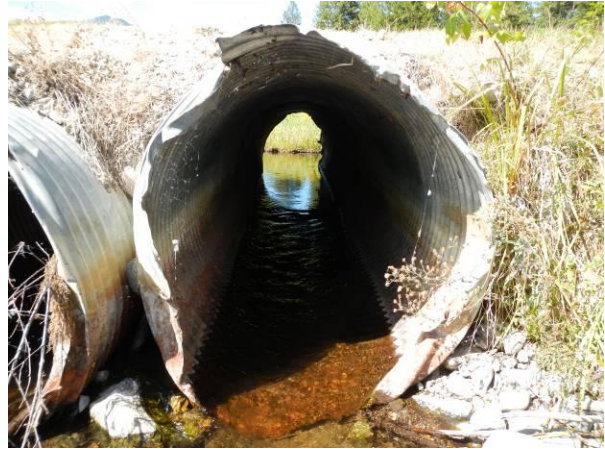
Barrel of left downstream culvert at outlet.

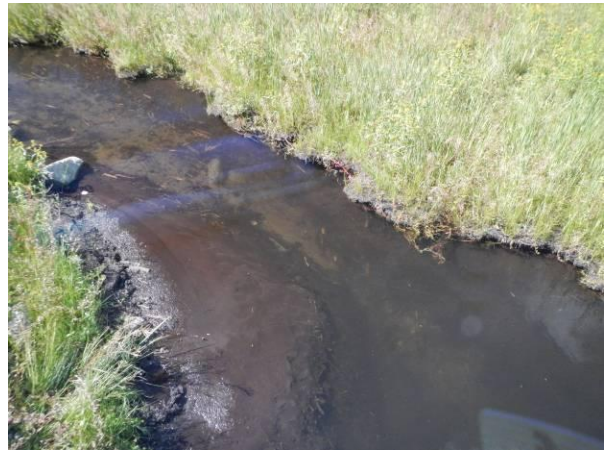
Organic material and silt substrate downstream of culvert.

Due to the low fish habitat quality for native salmonid species, the replacement of this stream crossing structure should be treated as a low priority. A substrate simulation culvert with a span of at least 5.00 m would be a suitable replacement at this site.

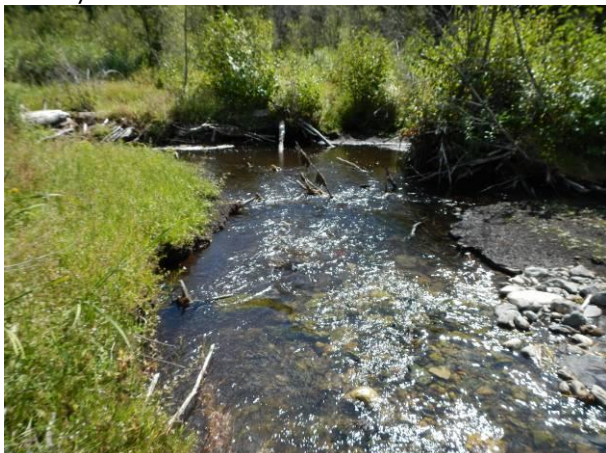
Downstream from culvert.

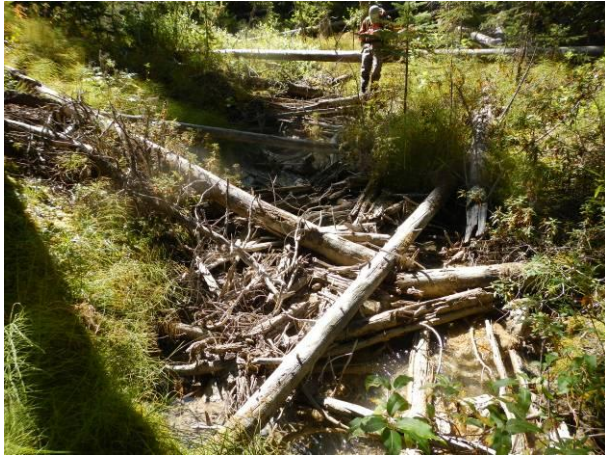
Upstream Habitat: The crossing is located at a reach break where stream gradient increases from 2% to 12%. The substrate is dominated by fine sediments. Abundant large woody debris is present. Overwintering and spawning habitat are poor due to the lack of deep pools and suitable substrate. However, WCT fry were observed in the upper reaches suggesting that the species manages to spawn in the creek. The water has high conductivity (370 μ S) due to the high amount of organic matter. The riparian area was heavily impacted by logging.

Upstream of culvert. Abundant large woody debris and sediment are present in the stream.

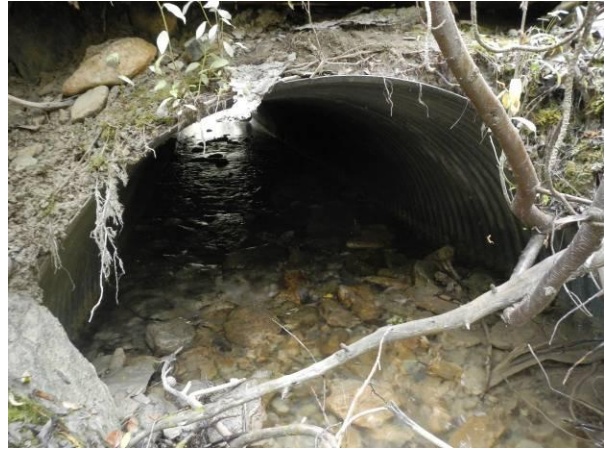
The culvert is only partly embedded but is not a significant barrier to fish since it has low velocity. The road fill material was observed to be spilling over the culvert and is slowly covering the outlet.

Culvert is partially embedded at the inlet.

Due to the low fish habitat quality, the assigned priority for replacement of this culvert should be low. A bridge would be a suitable replacement structure (with a span of at least 4.00 m) due to the high stream gradient at this crossing location.

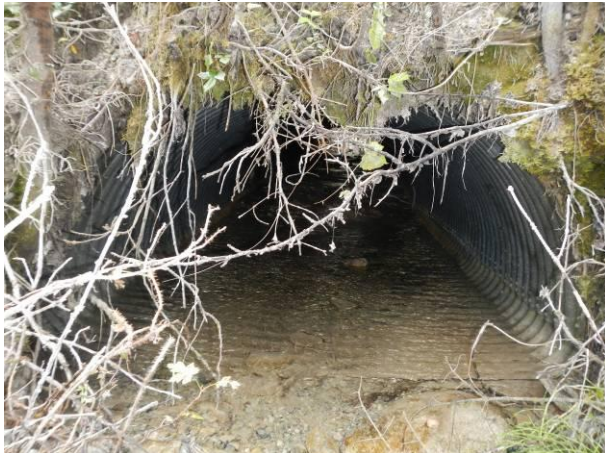
Outlet of culverts. Road fill is spilling over the culvert and covering the outlet.

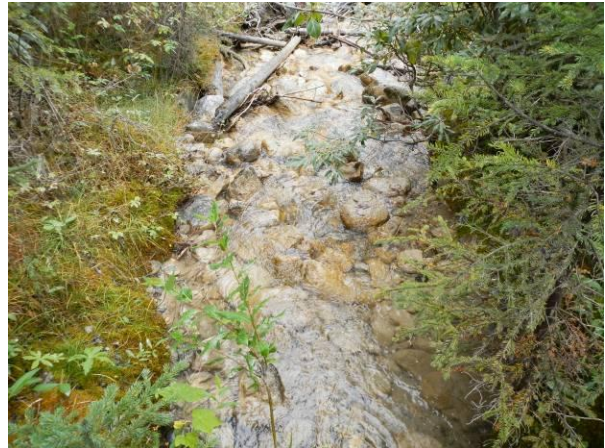
Downstream view from outlet.

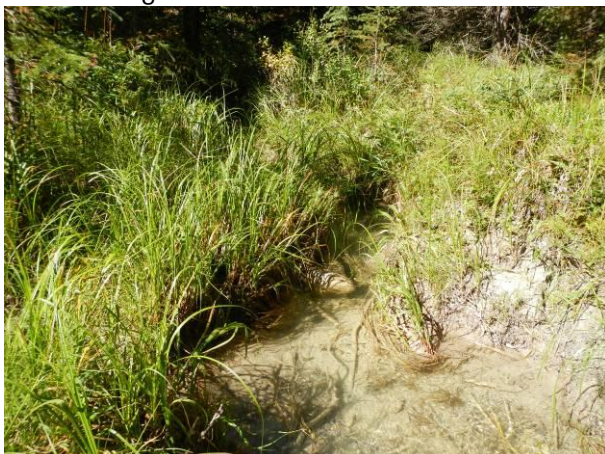
Downstream from culvert.

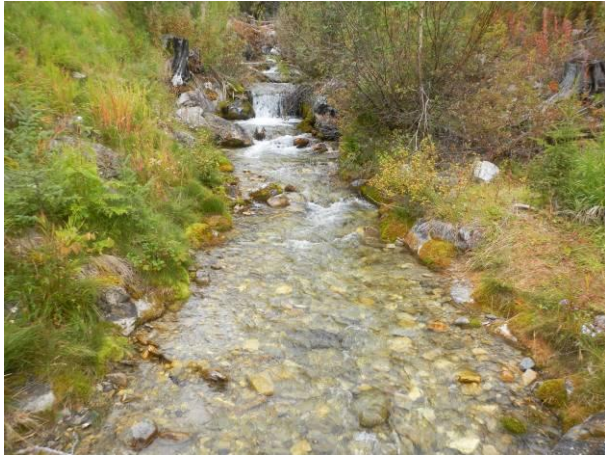
Upstream Habitat: The creek is relatively steep with many barriers (up to 1 m high) that likely impede upstream fish movement. The substrate is dominated by cobbles with a significant fine sediment component. Few pools are available. An extremely large amount of persistent debris caused by avalanche and wildfire at km 38 fills up the creek channel for approximately 400 m. Further upstream, the stream becomes ephemeral and the creek channel was dry. The riparian area is heavily impacted by logging.

Upstream of inlet.

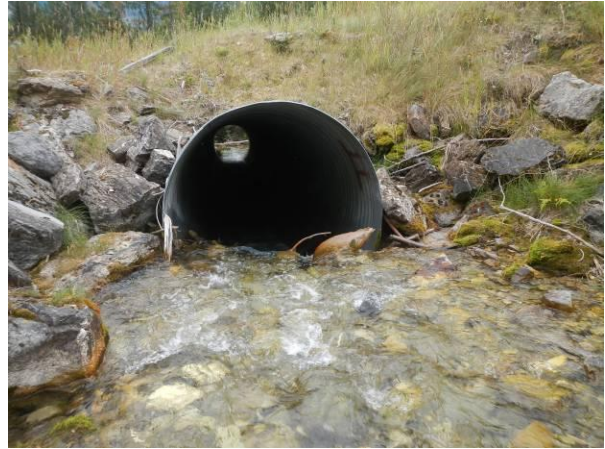
Inlet of culvert with inlet drop (0.70 m).

Restoration work on this creek is low priority due to the particularly poor fish habitat quality. Replacement by open bottom arch structures (with spans of at least 4.00 m) is recommended.

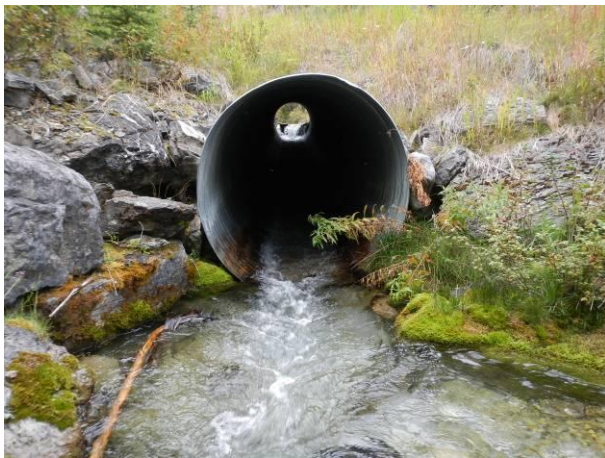
Outlet of culvert.

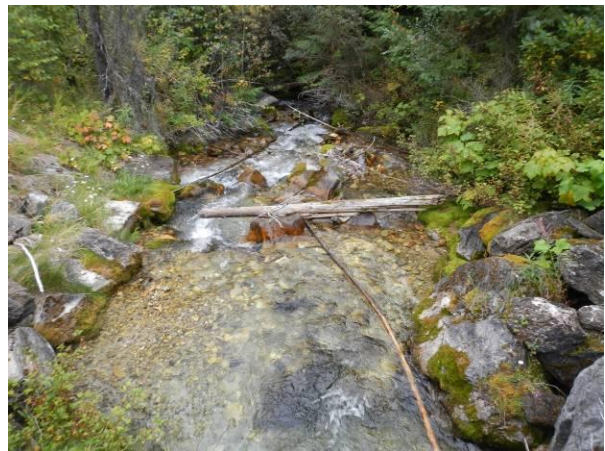
Downstream Habitat: Downstream of White18, instream habitat is similar to the upstream section with high stream gradient and numerous cascades and persistent debris likely impeding fish passage. No fish were observed. Approximately 750 m of stream were assessed downstream of White18.

Downstream view from outlet.

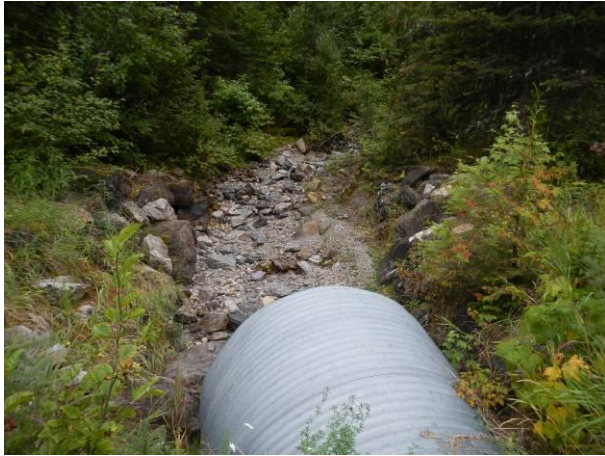
Upstream of inlet of White19.

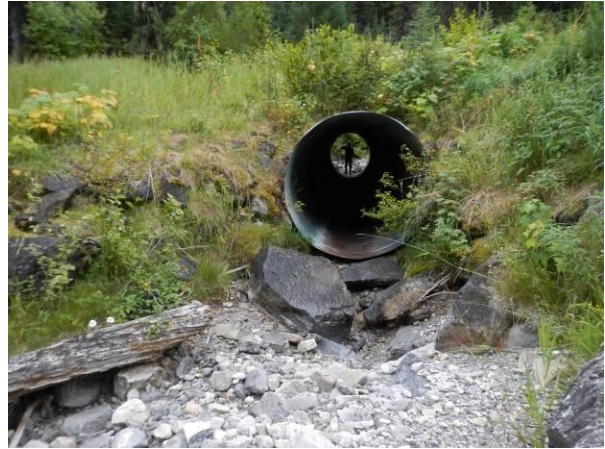
Culvert barrel at outlet of White19. Backwatering was attempted.

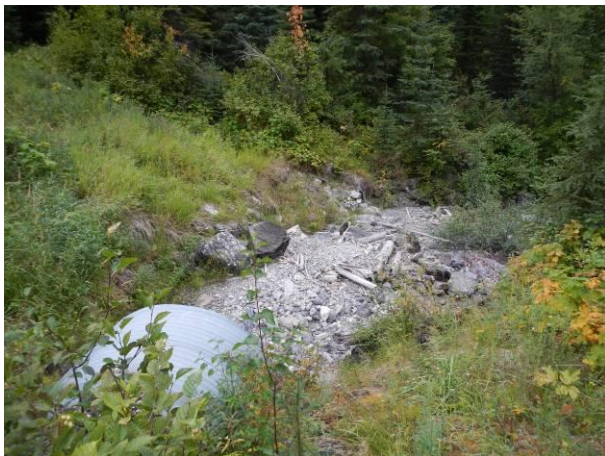
Downstream of outlet of White19.

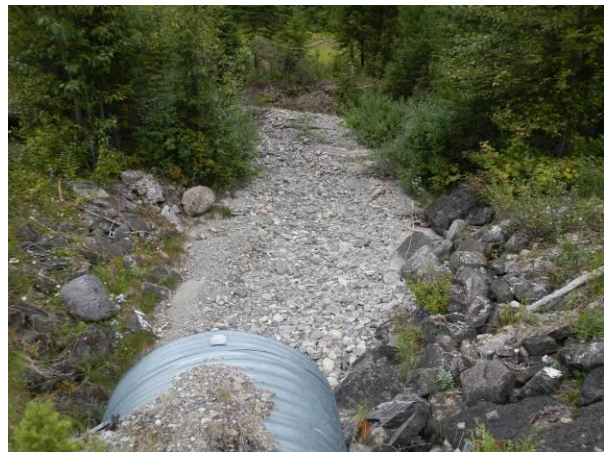
Upstream of inlet of White 20.

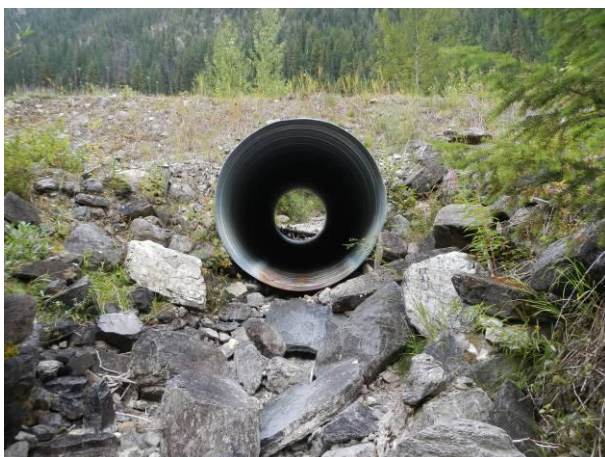
Culvert barrel at outlet of White20.
