## **Fish Passage Culvert Inspection - City of Prince George**

Prepared for:  
**City of Prince George**  
505-4<sup>th</sup> Avenue  
Prince George, British Columbia  
V2L 3H2

EDI Project No.: 04-BC-0104

February 2005

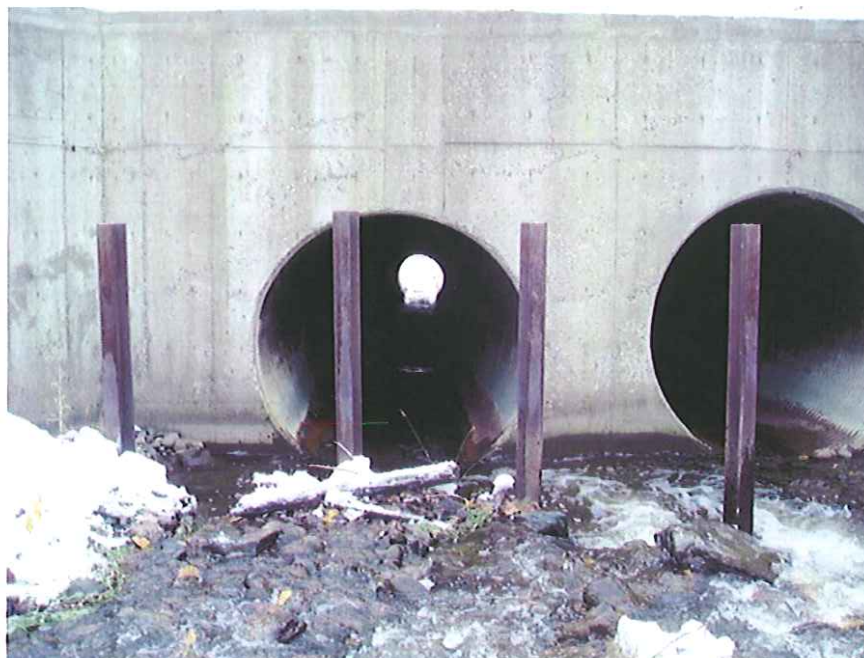
**Site 1 - McMillan Creek (Prince George Pulp Mill Road): Full Seasonal Barrier, High Priority**

View of left bank inlet.

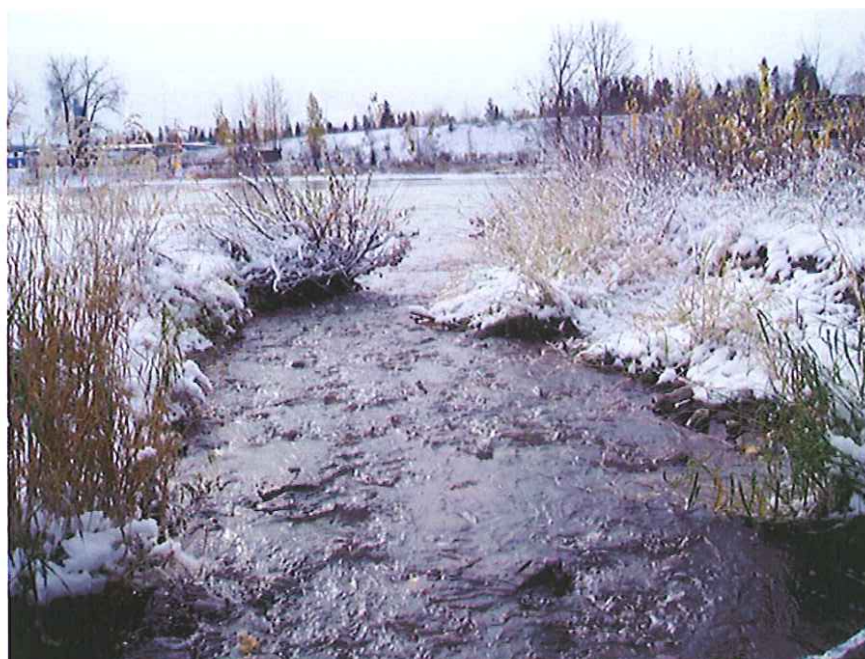
**Site 1 - McMillan Creek (Prince George Pulp Mill Road): Full Seasonal Barrier, High Priority**

View downstream of outlets. Note the close proximity to the Fraser River.

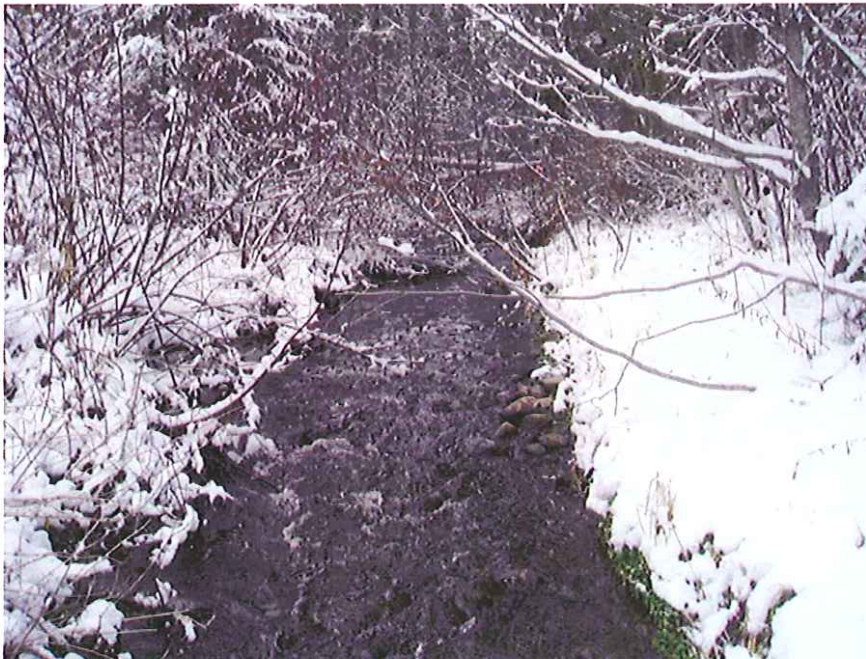
**Site 2 – McMillan Creek (Hoferkamp Road): Full Barrier, High Priority**

View upstream of inlet.

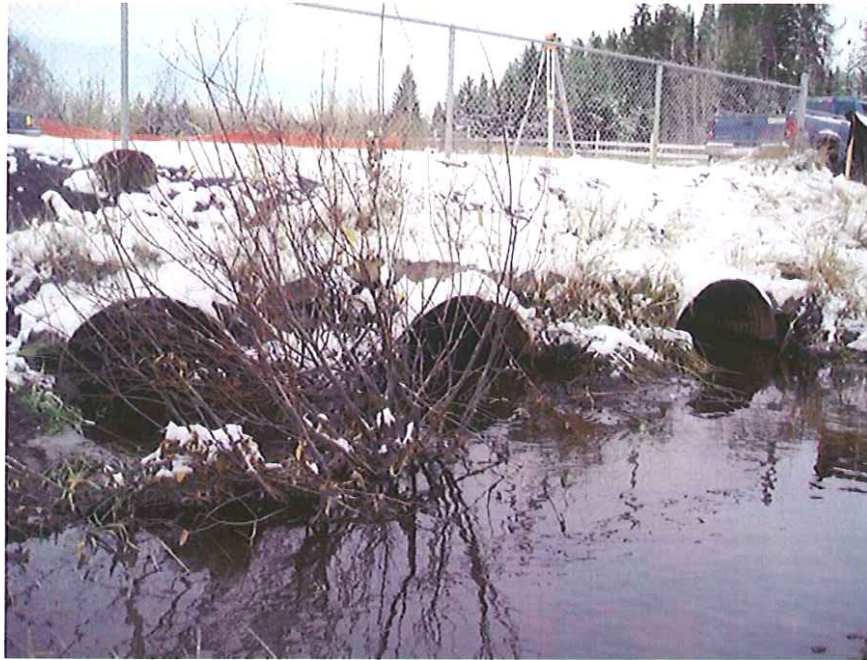
**Site 3 McMillan Creek (Aberdeen Road): No Barrier, No Maintenance Concerns**

View of inlets.

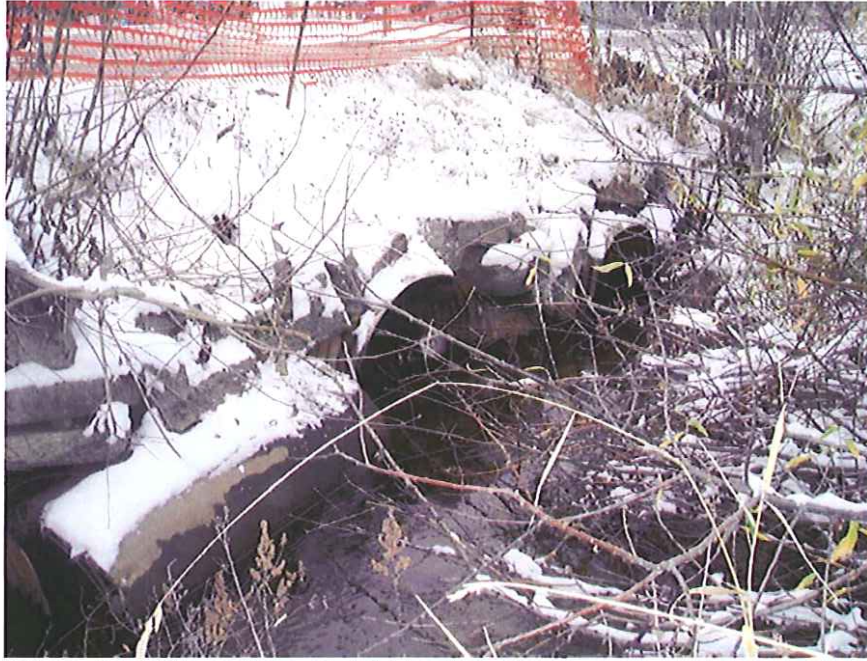
**Site 3 McMillan Creek (Aberdeen Road): No Barrier, No Maintenance Concerns**

View of middle outlet and right bank outlet.

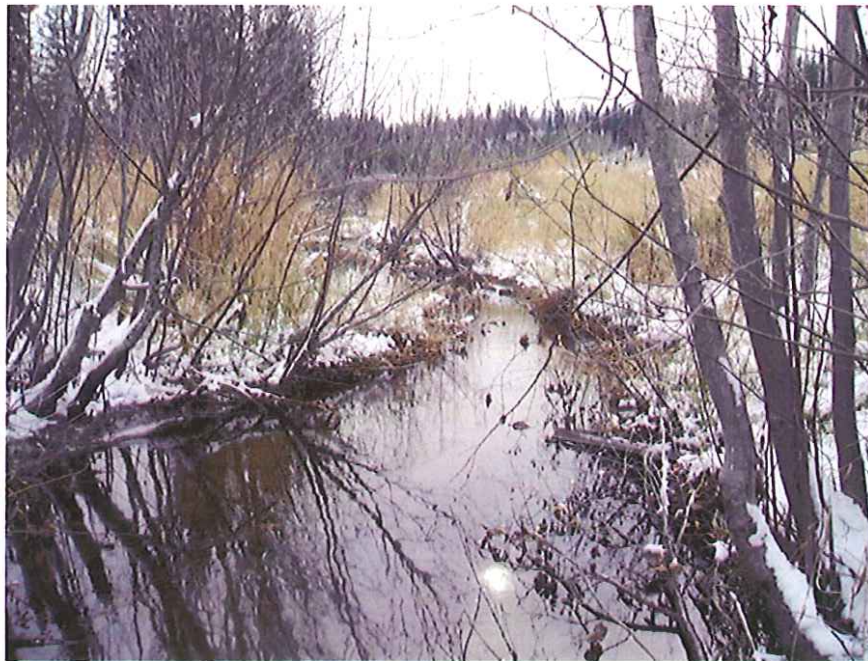
View upstream of inlets.

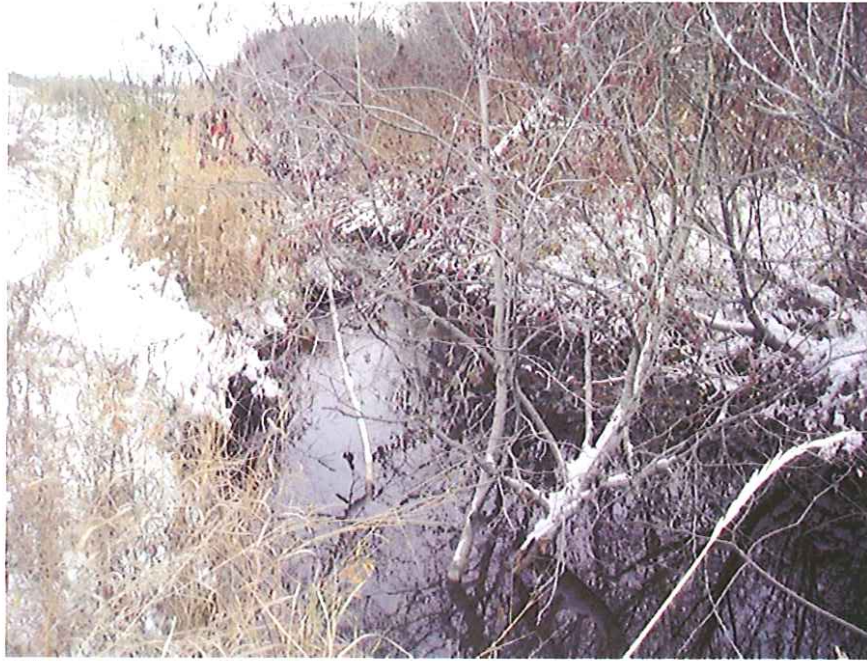
**Site 4 - McMillan Creek (McMillan Ave): Full Barrier, High Priority**

View upstream of inlets.

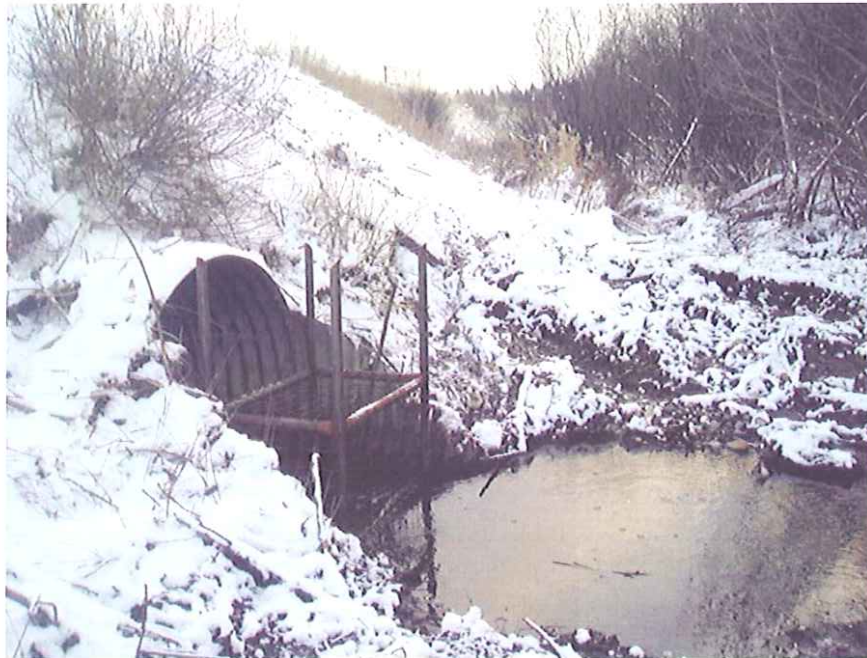
**Site 5 – McMillan Creek (Northwood Pulpmill Road): No Barrier, High Maintenance Issues**

View of inlet

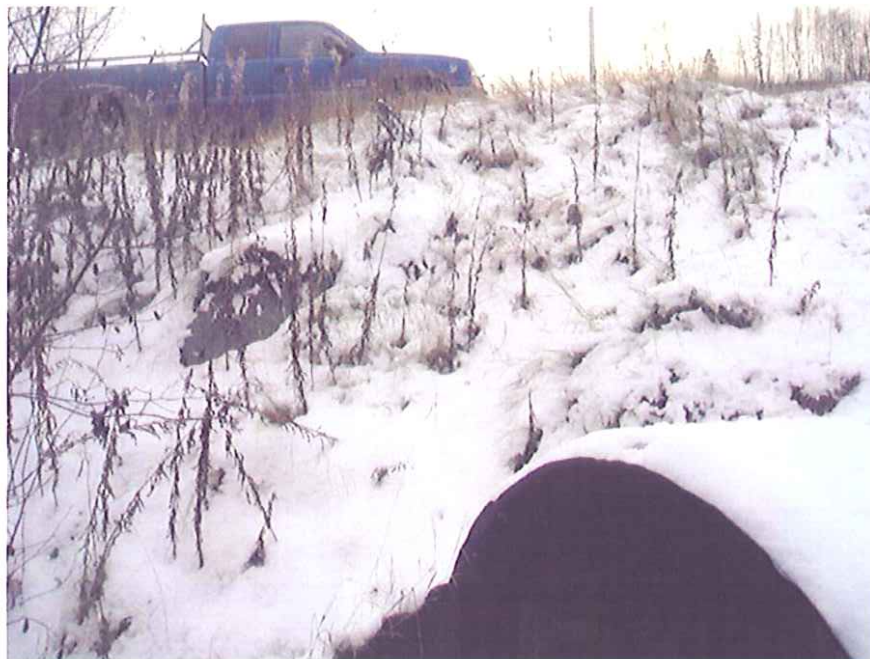
View of outlet

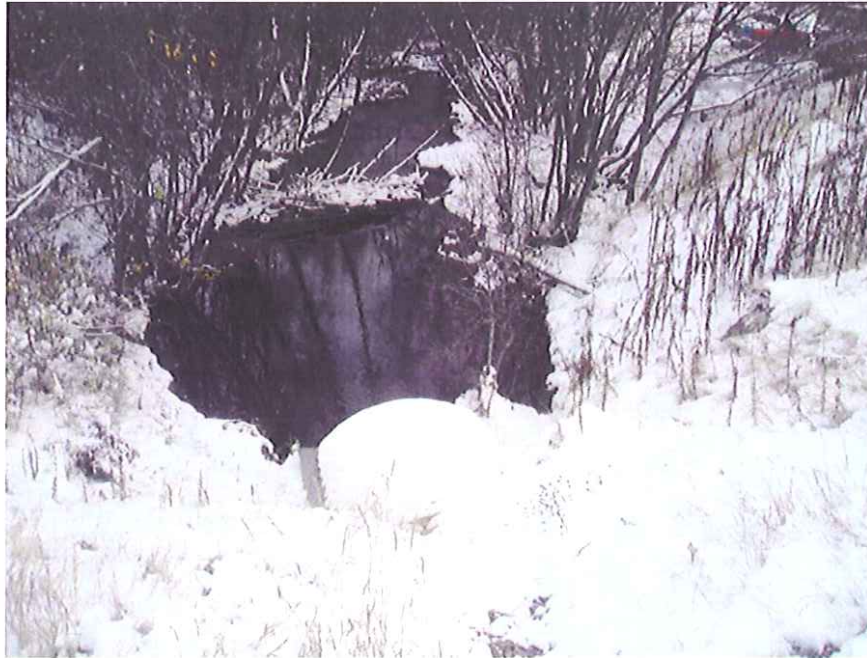
**Site 5 – McMillan Creek (Northwood Pulpmill Road): No Barrier, High Maintenance Issues**

View upstream of inlet.

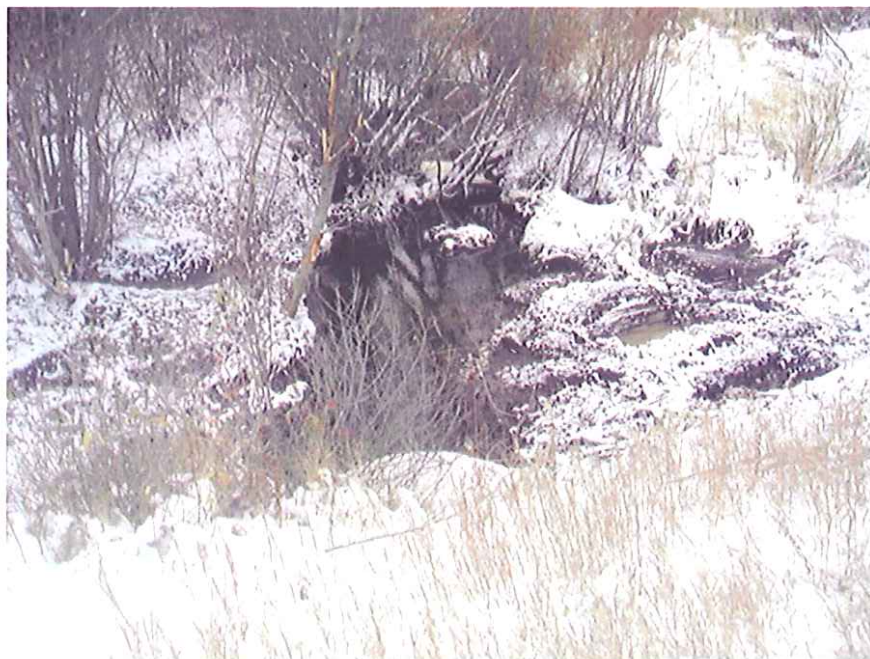
View downstream of outlet

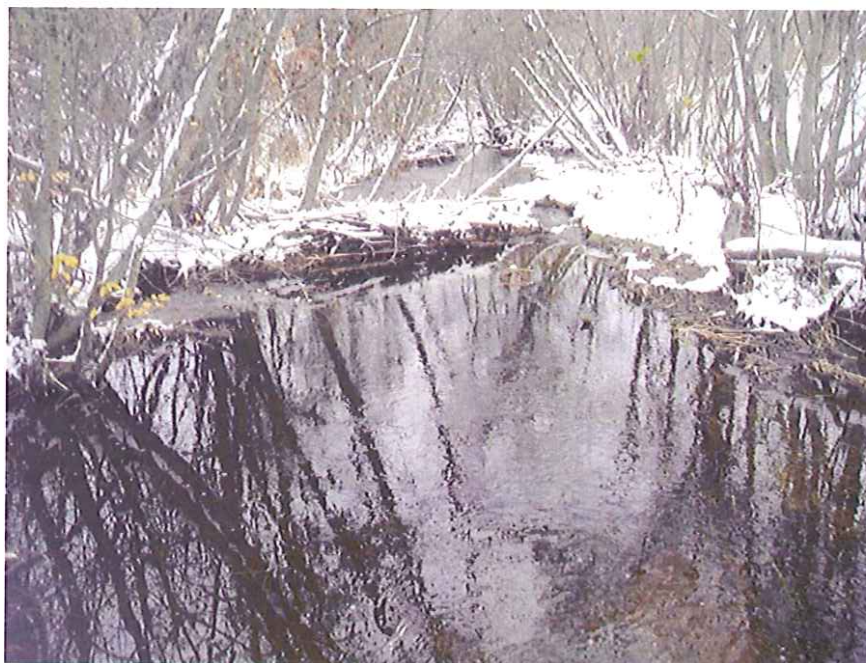
**Site 5 - McMillan Creek (Northwood Pulpmill Road): No Barrier, High Maintenance Issues**

View upstream of inlet.

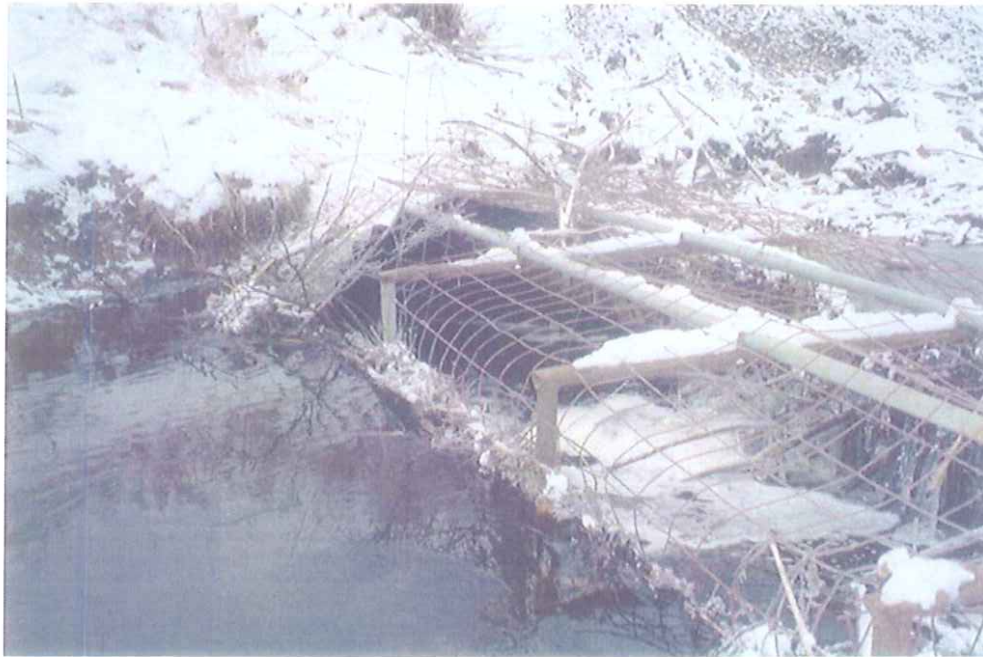
**Site 6 - McMillan Creek (Noranda Road East): No Barrier, High Maintenance Issues**

View of inlet.

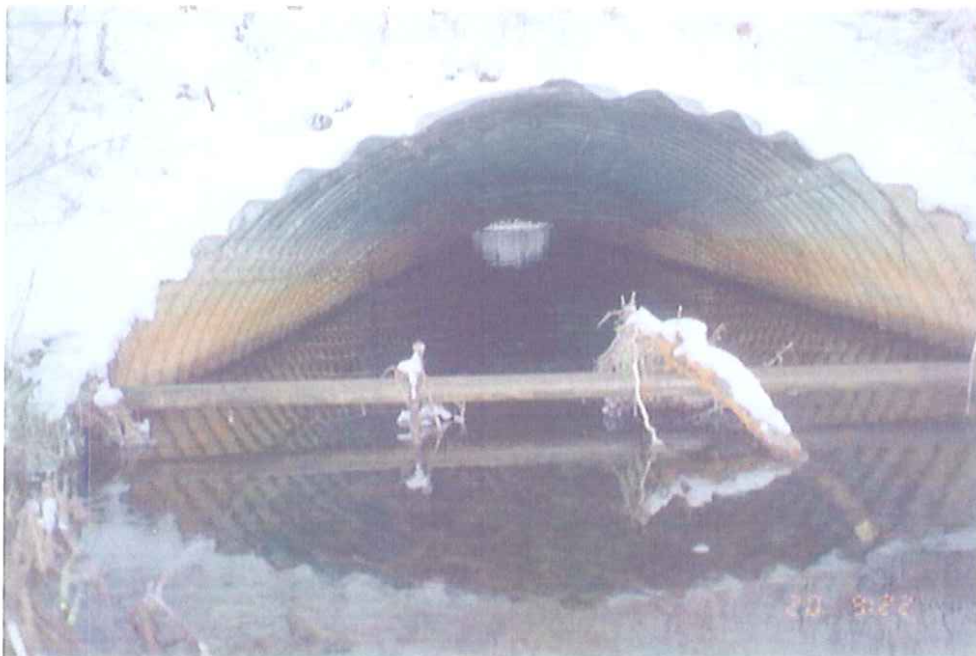
View of outlet.

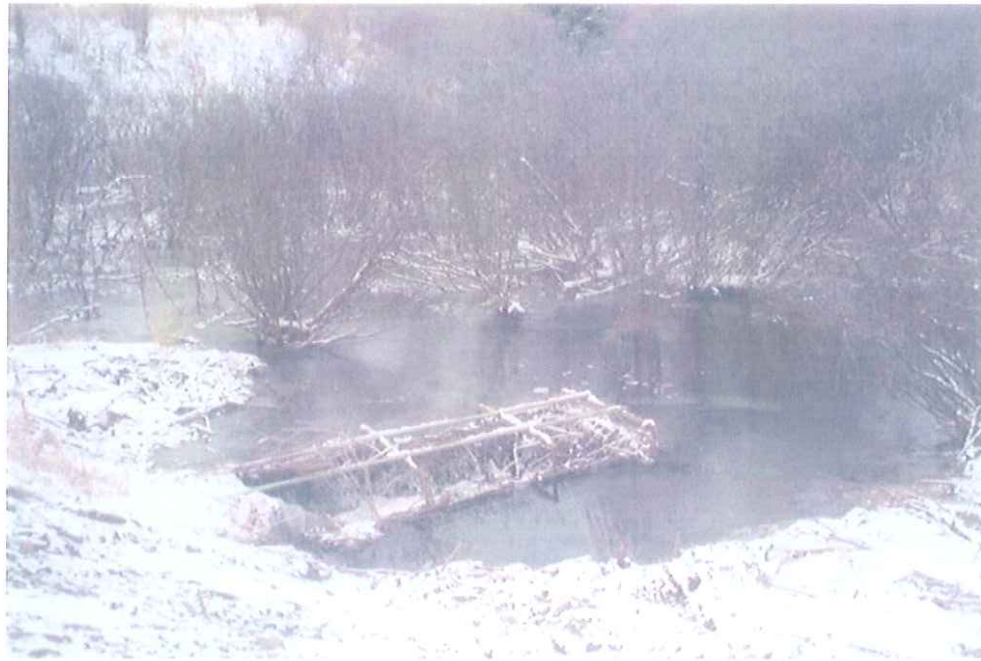
**Site 6 - McMillan Creek (Noranda Road East): No Barrier, High Maintenance Issues**

View of inlet and upstream area.

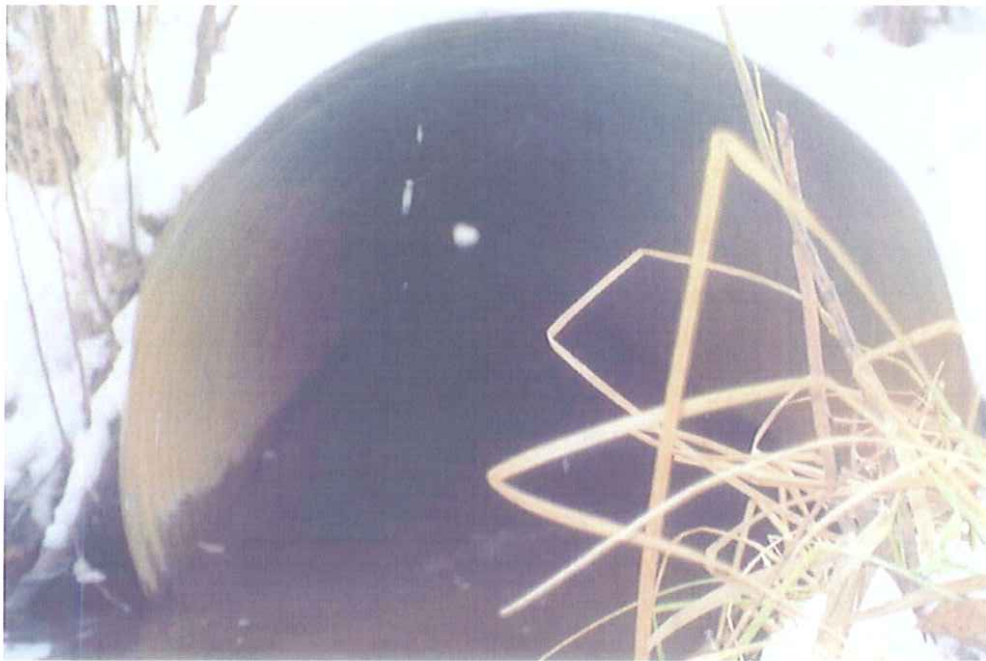
**Site 7 - McMillan Creek(Old Summit Lake Road): No Barrier, No  
Maintenance Issues**

View of inlet.

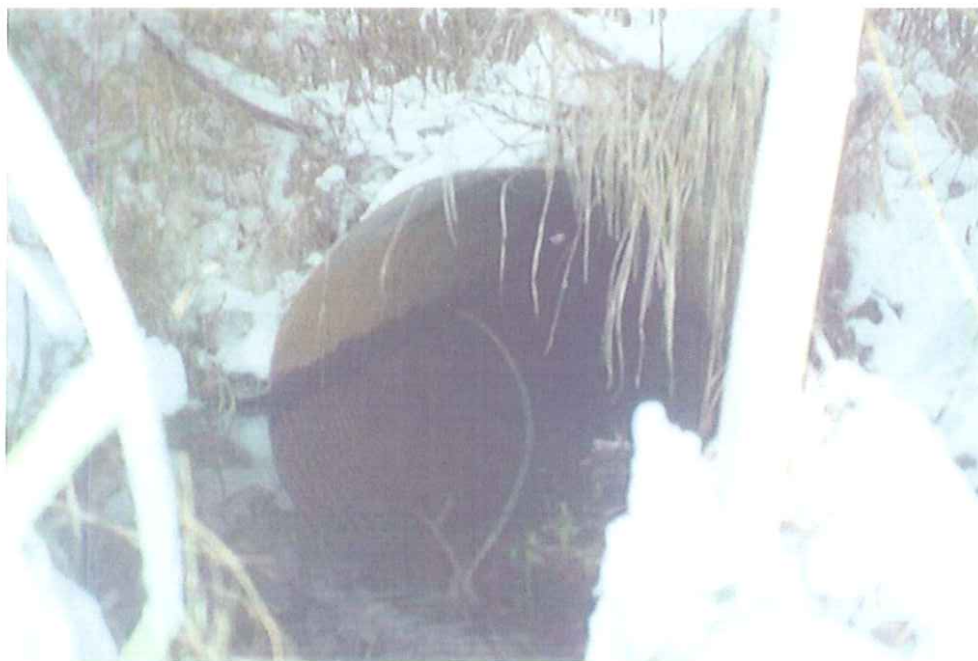
View of outlet.

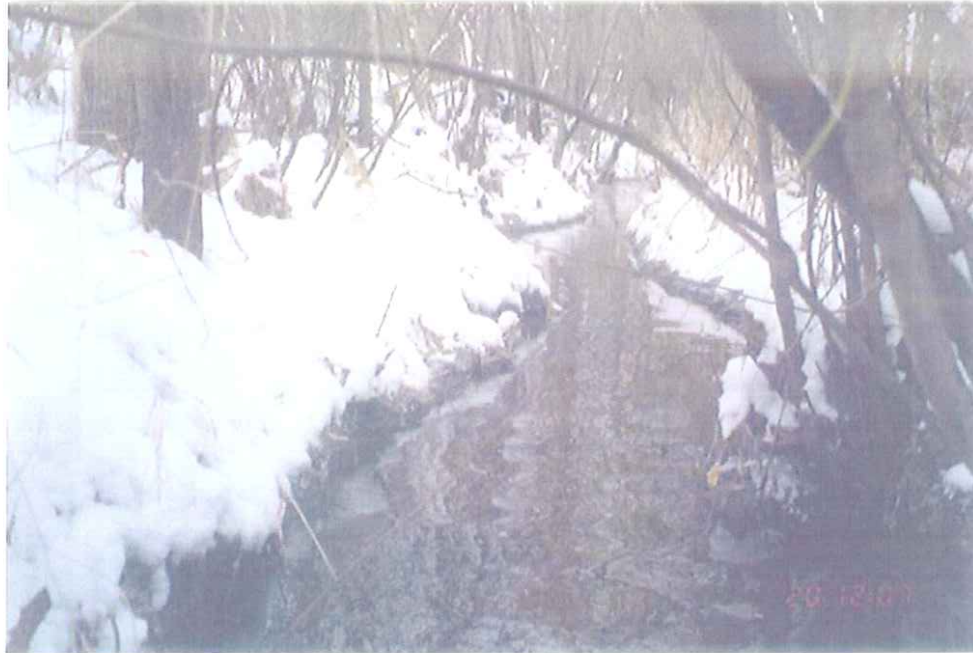
**Site 7 - McMillan Creek (Old Summit Lake Road): No Barrier, No Maintenance Issues**

View upstream of inlet.

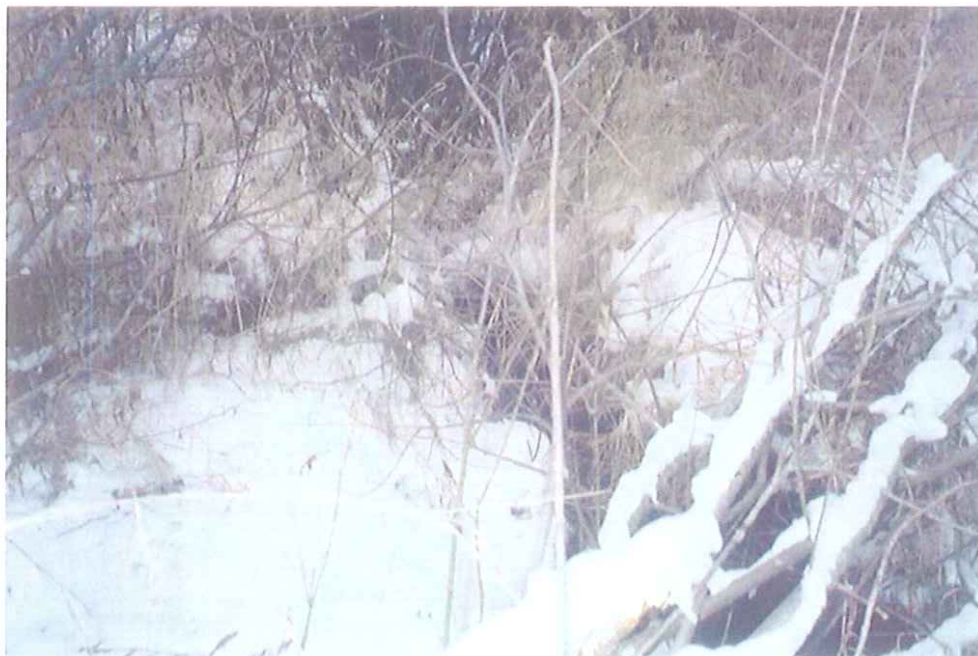
View downstream of outlet.

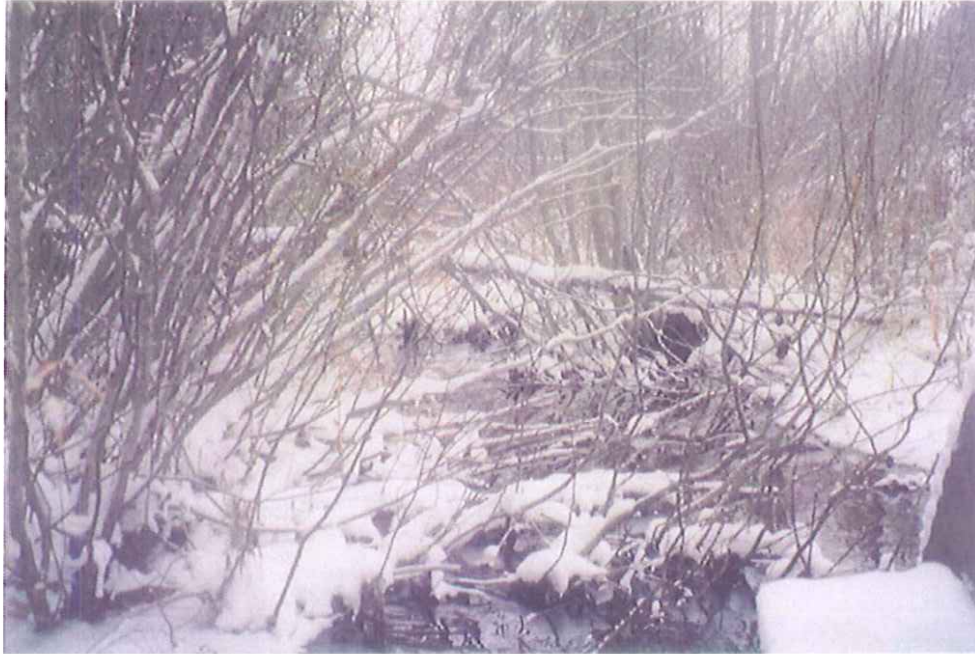
**Site 8 - McMillan Creek(Old Summit Lake Road): No Barrier, No Maintenance Issues**

View upstream of inlet

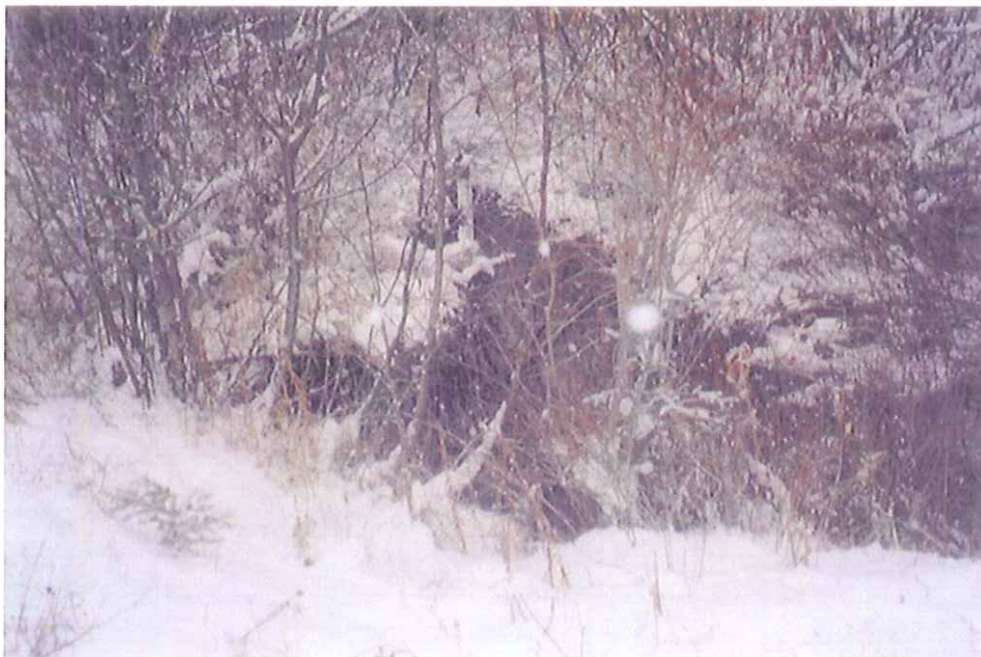
View downstream of outlet.

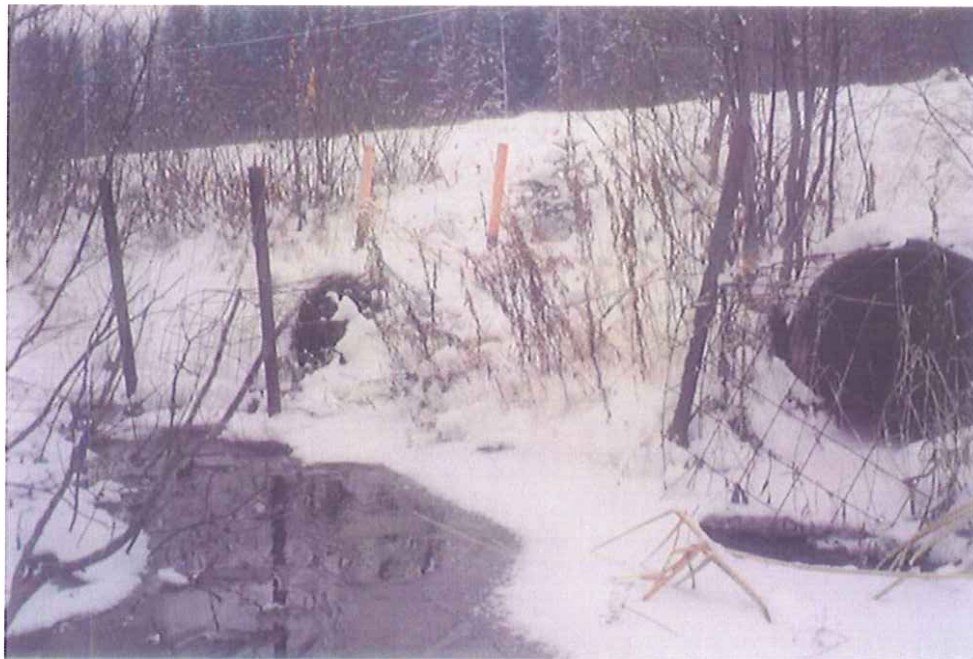
**Site 9 - McMillan Creek (Old Summit Lake Road): No Barrier, No Maintenance Issues**

View of inlets.

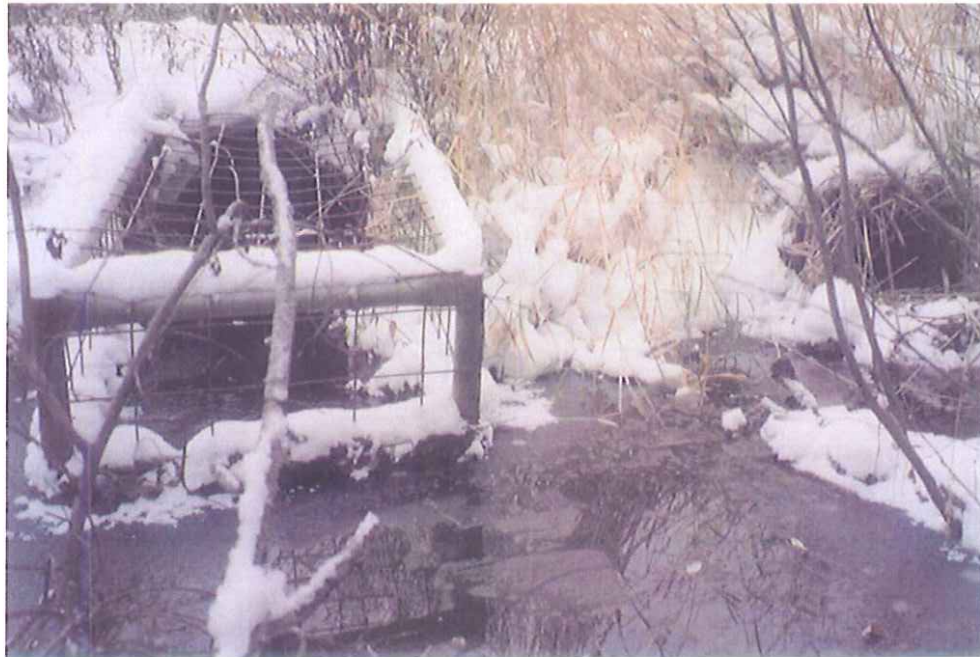
**Site 10 - McMillan Creek (Goose Country Road): No Barrier, No Maintenance Issues**

View of inlets.

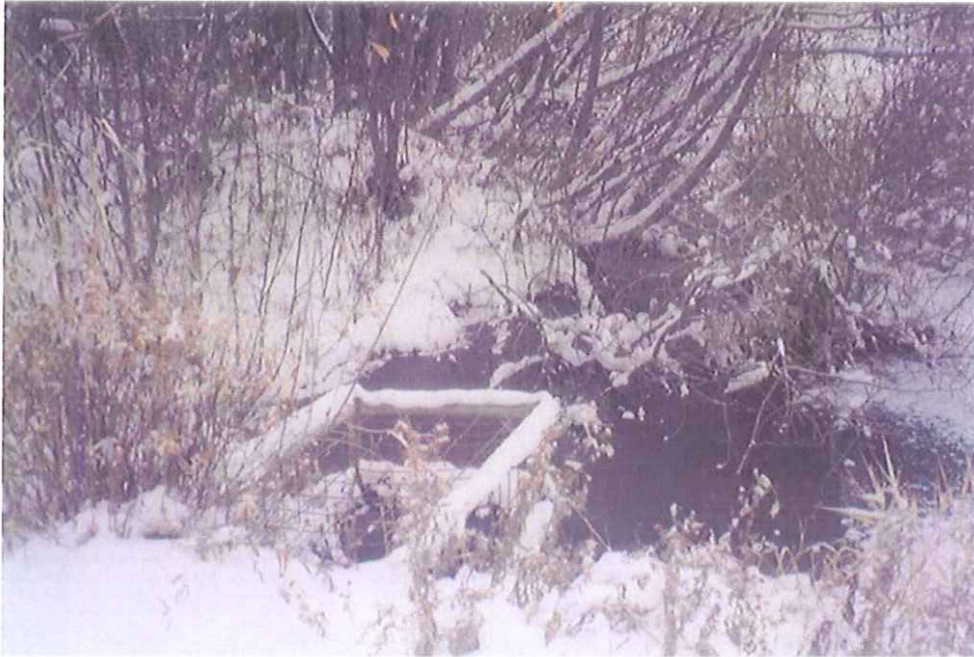
**Site 10 - McMillan Creek (Goose Country Road): No Barrier, No Maintenance Issues**

View upstream of inlet.

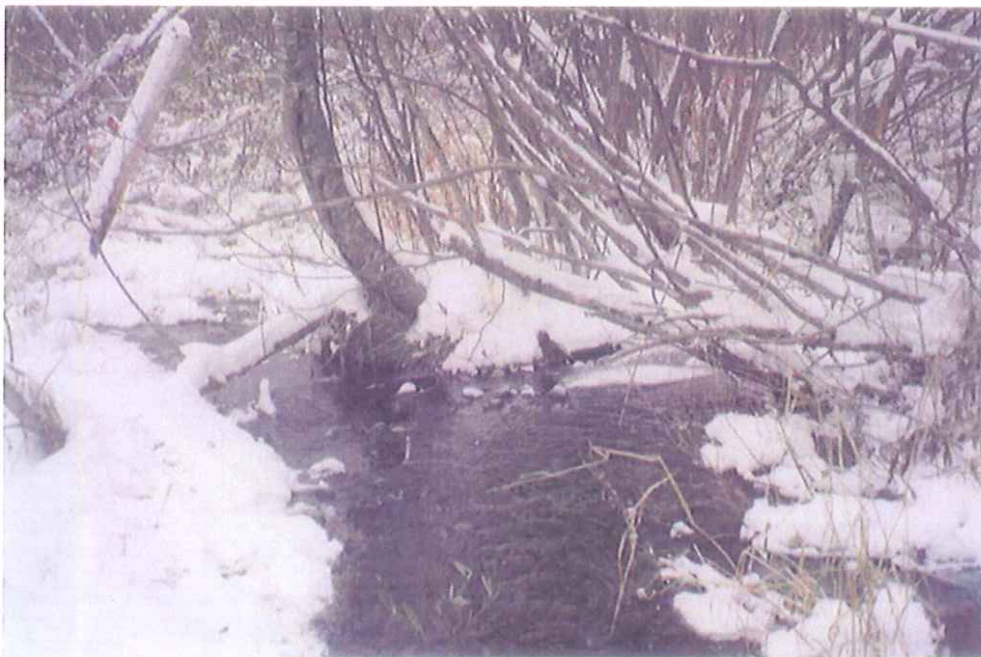
View downstream of outlet.

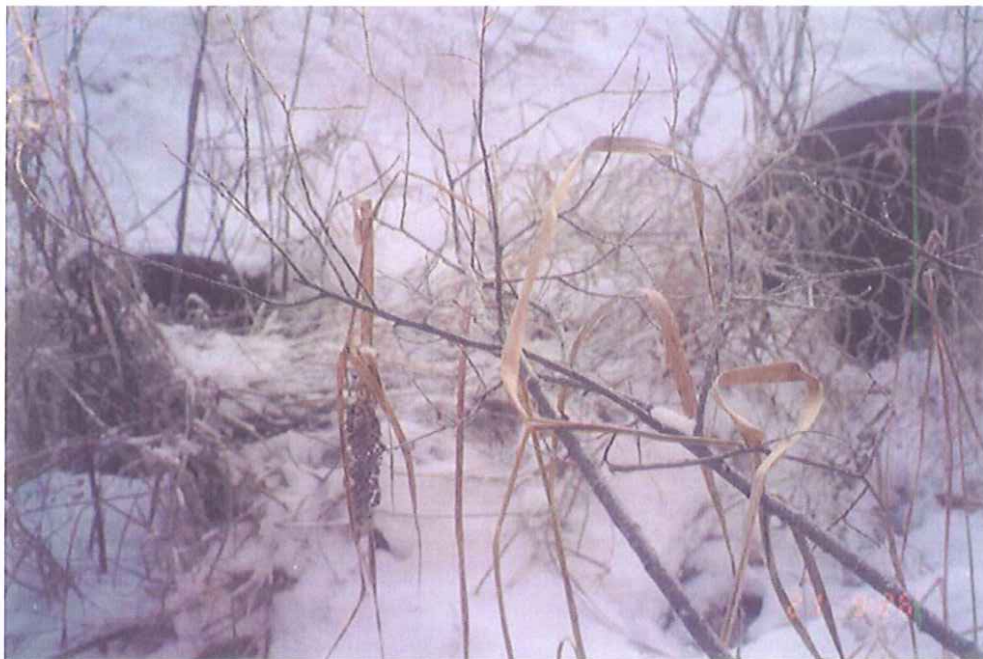
**Site 11 - McMillan Creek (Old Summit Lake Road): No Barrier, No Maintenance Issues**

View of inlets

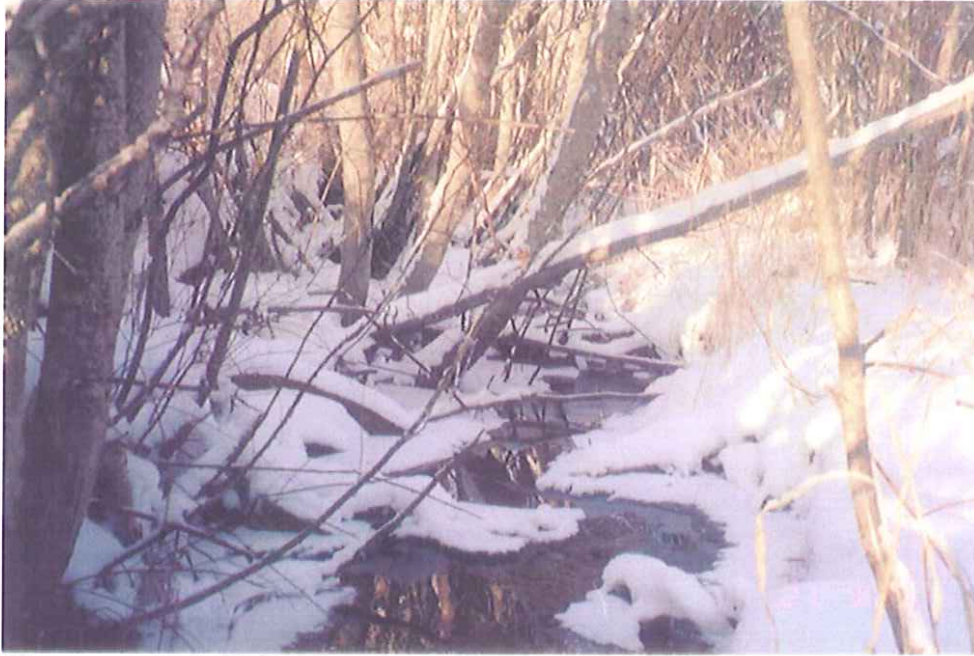
**Site 11 - McMillan Creek (Old Summit Lake Road): No Barrier, No Maintenance Issues**

View upstream of inlet.

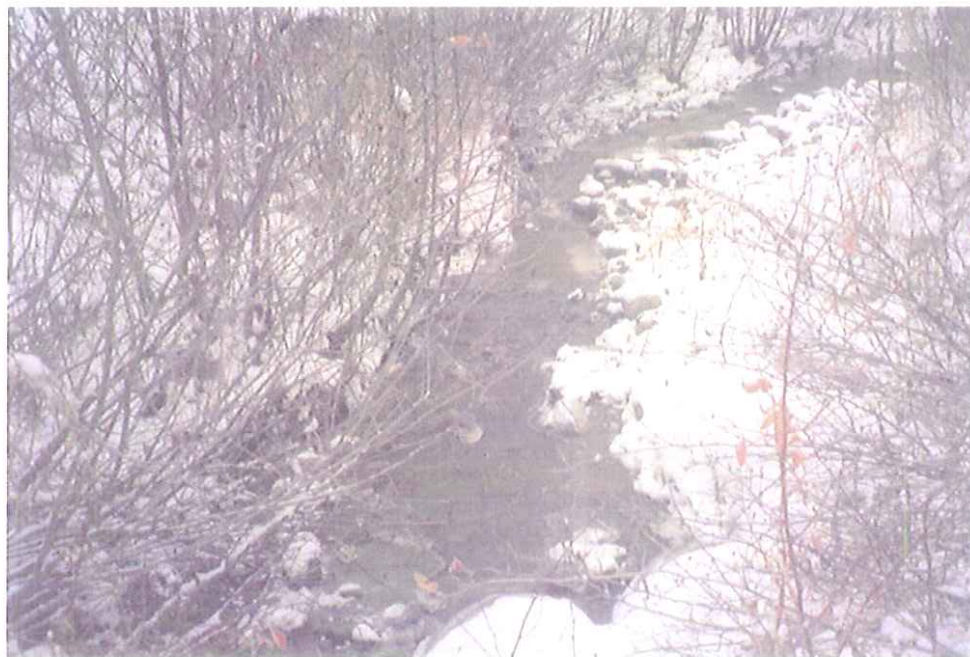
**Site 12 - Unnamed Stream (Indian Reserve Road): Full Seasonal Barrier, High Priority**

View upstream of inlets.

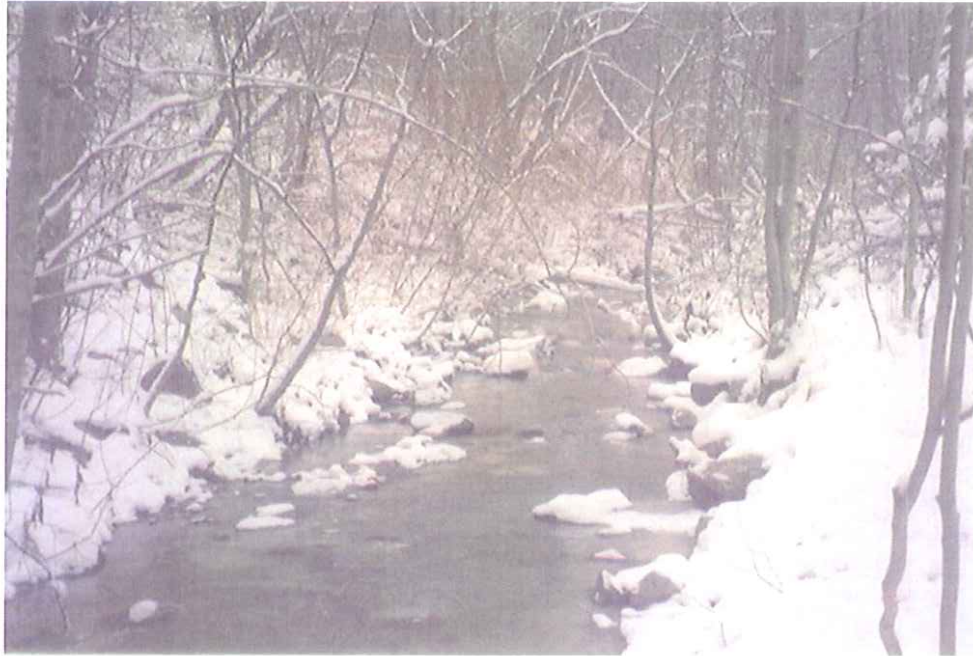
**Site 13 – Unnamed Stream (Indian Reserve Road): Full Seasonal Barrier, High Priority**

View upstream of inlets.

This site was ranked as HIGH priority using the FPCI Scoring Matrix. The current culvert does not meet the recommended Q100 estimated diameter. The recommended Q100 estimated diameter for a replacement structure is a 2200 mm round culvert or a 2440 mm x 1750 mm elliptical/pipe arch culvert. The total culvert area required is 3.14 m<sup>2</sup>. The two culverts at the site give a combined area of 1.22 m<sup>2</sup>. A structure of this size should be engineered, and will require a further site visit by a qualified engineer to determine the appropriate structure for this site.

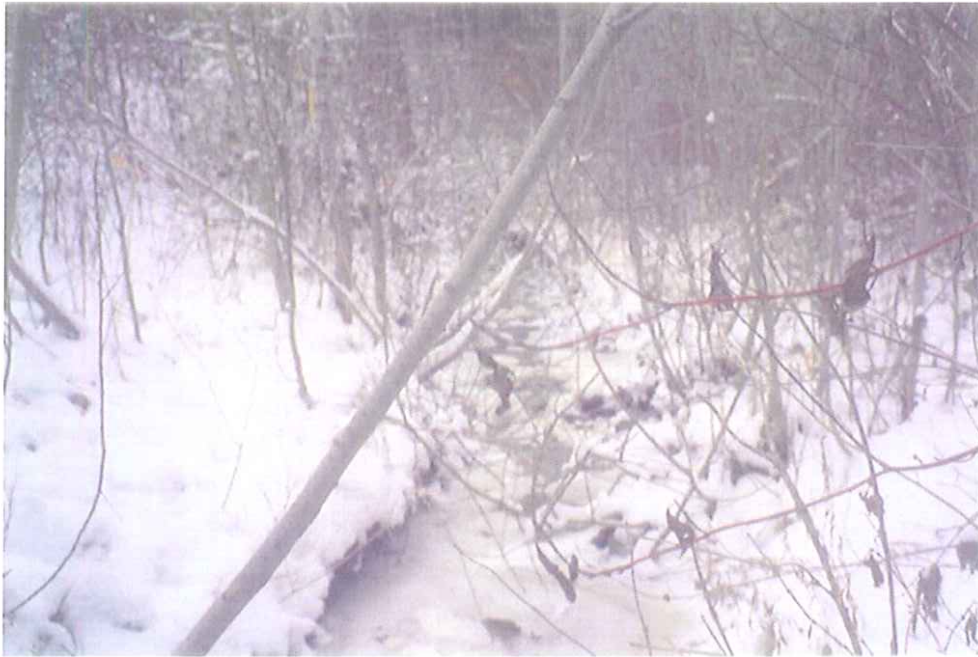
**Site 14 – Parkridge Creek (Domano Road): Full Barrier, High Priority**

View upstream of inlets.

There is 7.5 m of fill above the culvert at this site. Road fill failure at the outlet is contributing continual sediment to the stream.

This site was rated as HIGH using the FPCI Scoring Matrix. The current culvert at the road crossing does not meet the recommended Q100 diameter estimate. The total culvert area of the present culvert is less than half the total culvert area required. The recommended diameter is for a 2000mm round culvert. A structure of this size should be engineered, and will require a further site visit by a qualified engineer before replacement.

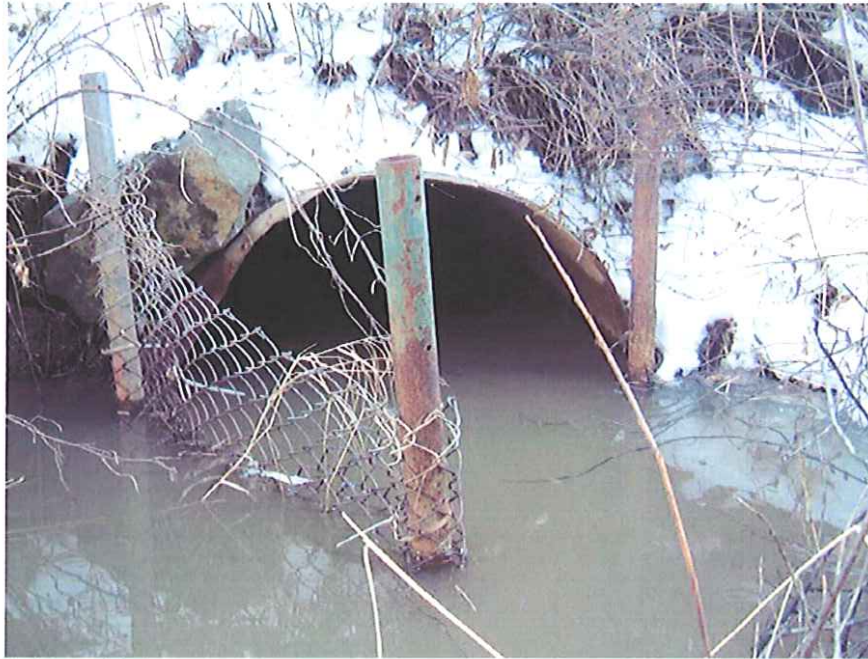
**Site 15 – Unnamed Stream (North Blackburn Road): No Barrier,  
Moderate Maintenance Issues**

View of inlet.

**Culvert Characteristics:** One culvert. Culvert may have been replaced (not recently) as old non-corrugated steel culvert remains discarded in channel. Partial beaver guard remains in inlet. Culvert outlet may be compressed vertically. 25m downstream

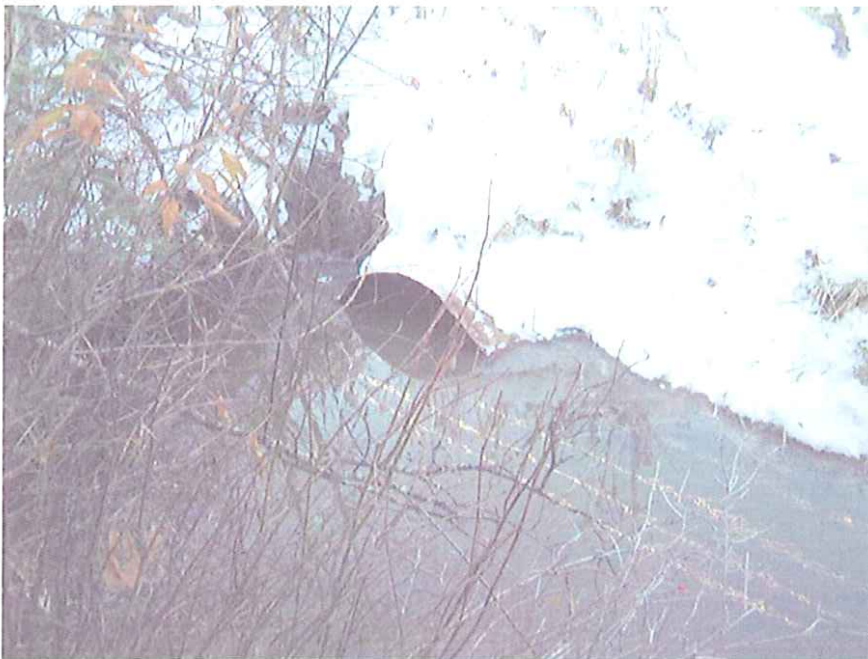
View of outlet.

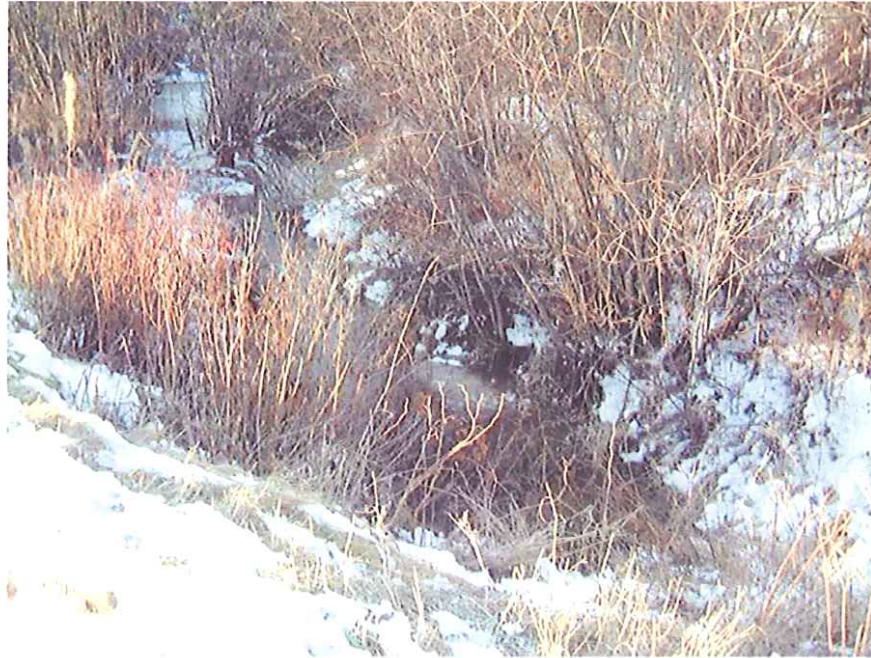
**Site 15 – Unnamed Stream (North Blackburn Road): No Barrier,  
Moderate Maintenance Issues**

View upstream of inlet.

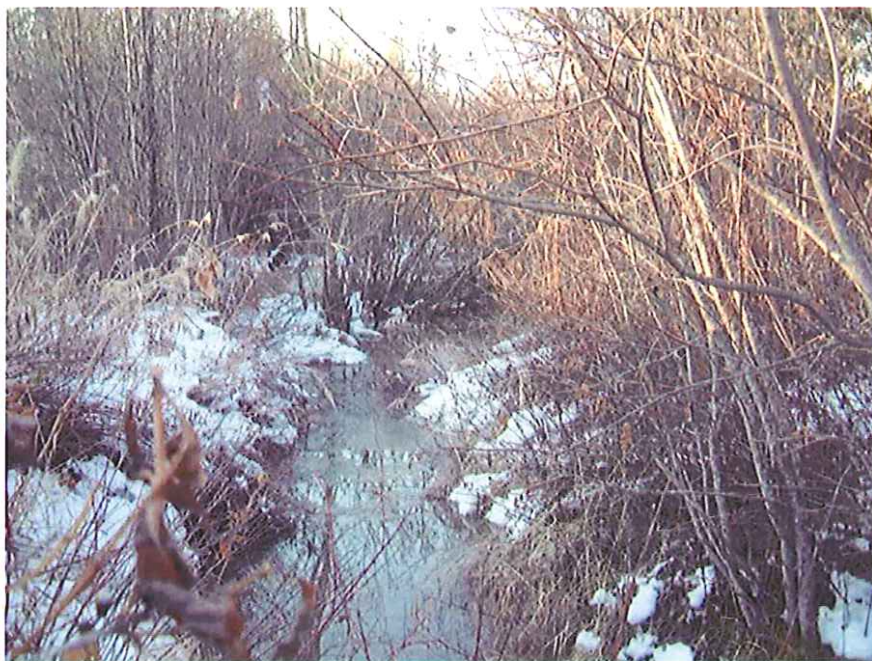
View downstream of outlet.

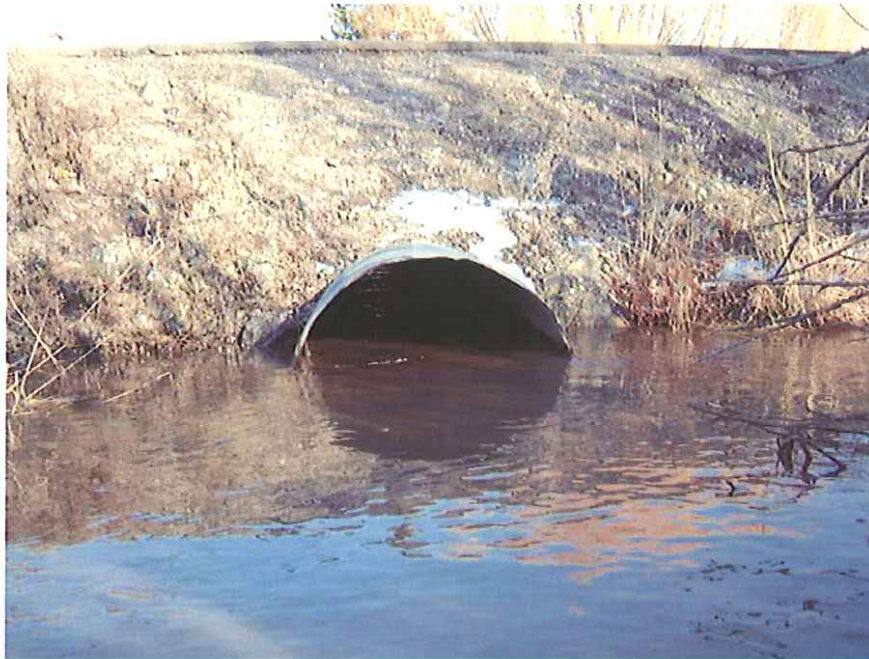
**Site 16 - Bittner Creek (Giscome Road): No Barrier, No Maintenance Issues**

View of left bank inlet.

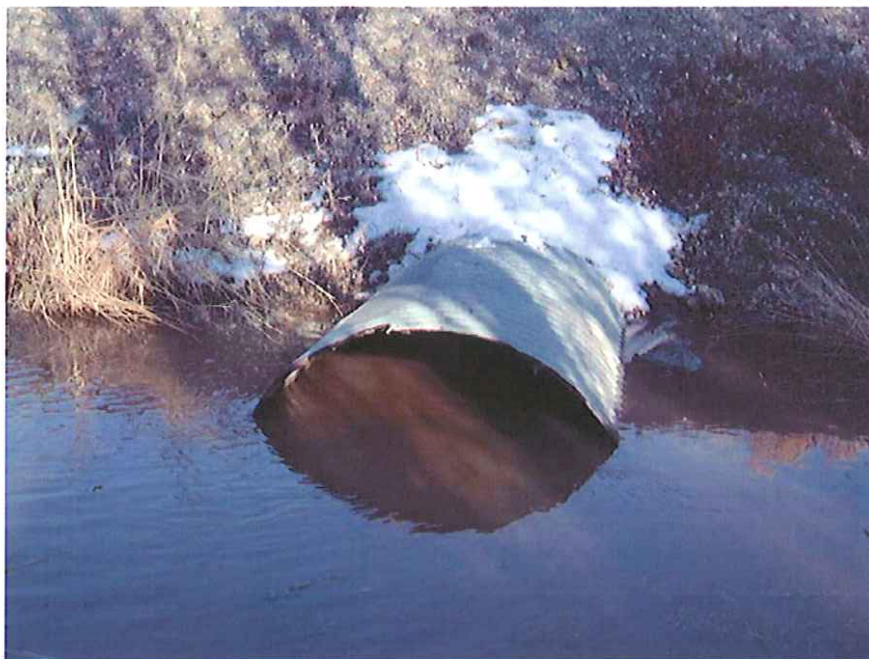
View of right bank inlet.
