## **Fish Passage Culvert Inspection - City of Prince George**

Prepared for:  
**City of Prince George**  
505-4<sup>th</sup> Avenue  
Prince George, British Columbia  
V2L 3H2

EDI Project No.: 04-BC-0104

February 2005

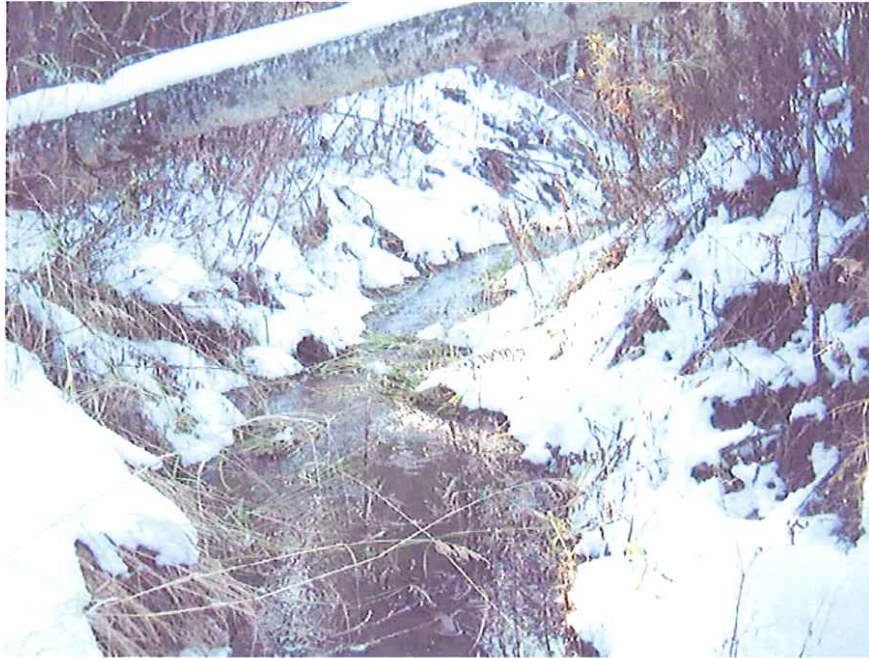
**Site 17 - Unnamed Stream (Giscome Road): Partial Barrier, High Priority**

View upstream of inlets.

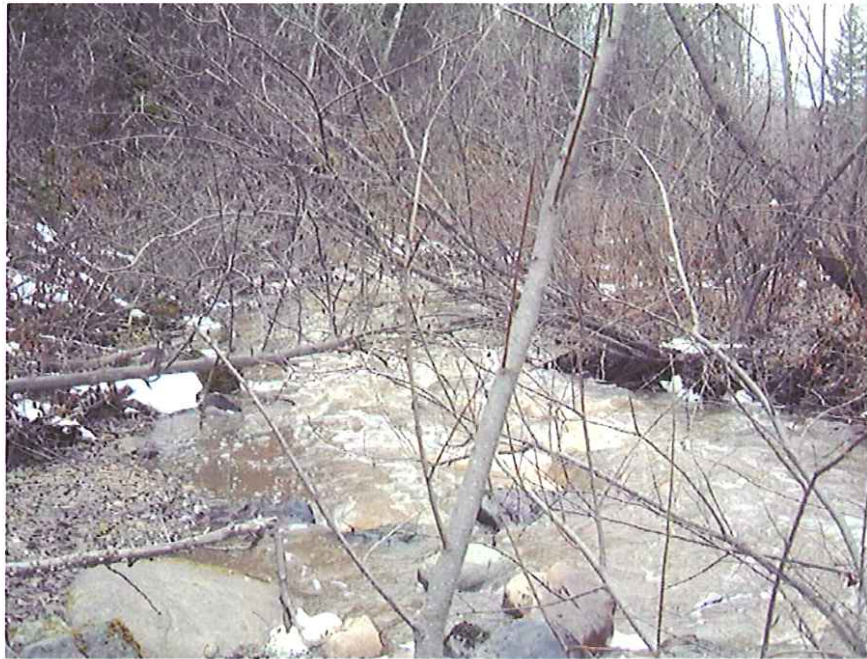
**Site 18 - Haggith Creek (Willow-Cale Road): Full Barrier, High Priority**

View upstream of inlet.

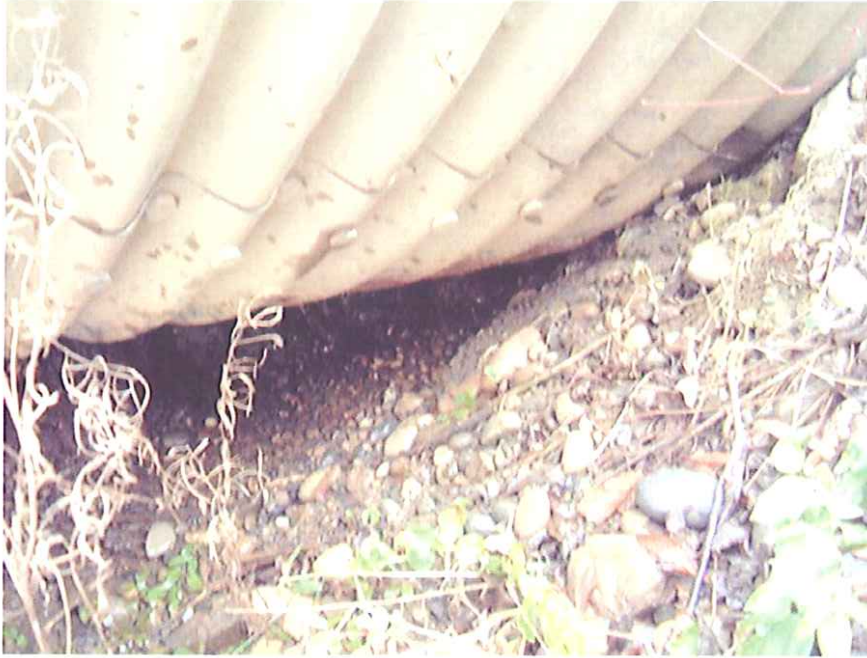
**Site 18 – Haggith Creek (Willow-Cale Road): Full Barrier, High Priority**

View of outlet. Note the water flowing under the culvert.
