STRATHCONA DAM & RESERVOIR
ELK RIVER
CHANNEL STABILITY
AND MITIGATIVE MEASURES

JANUARY, 1992

STRATHCONA DAM AND RESERVOIR ELK RIVER CHANNEL STABILITY, MITIGATIVE MEASURES

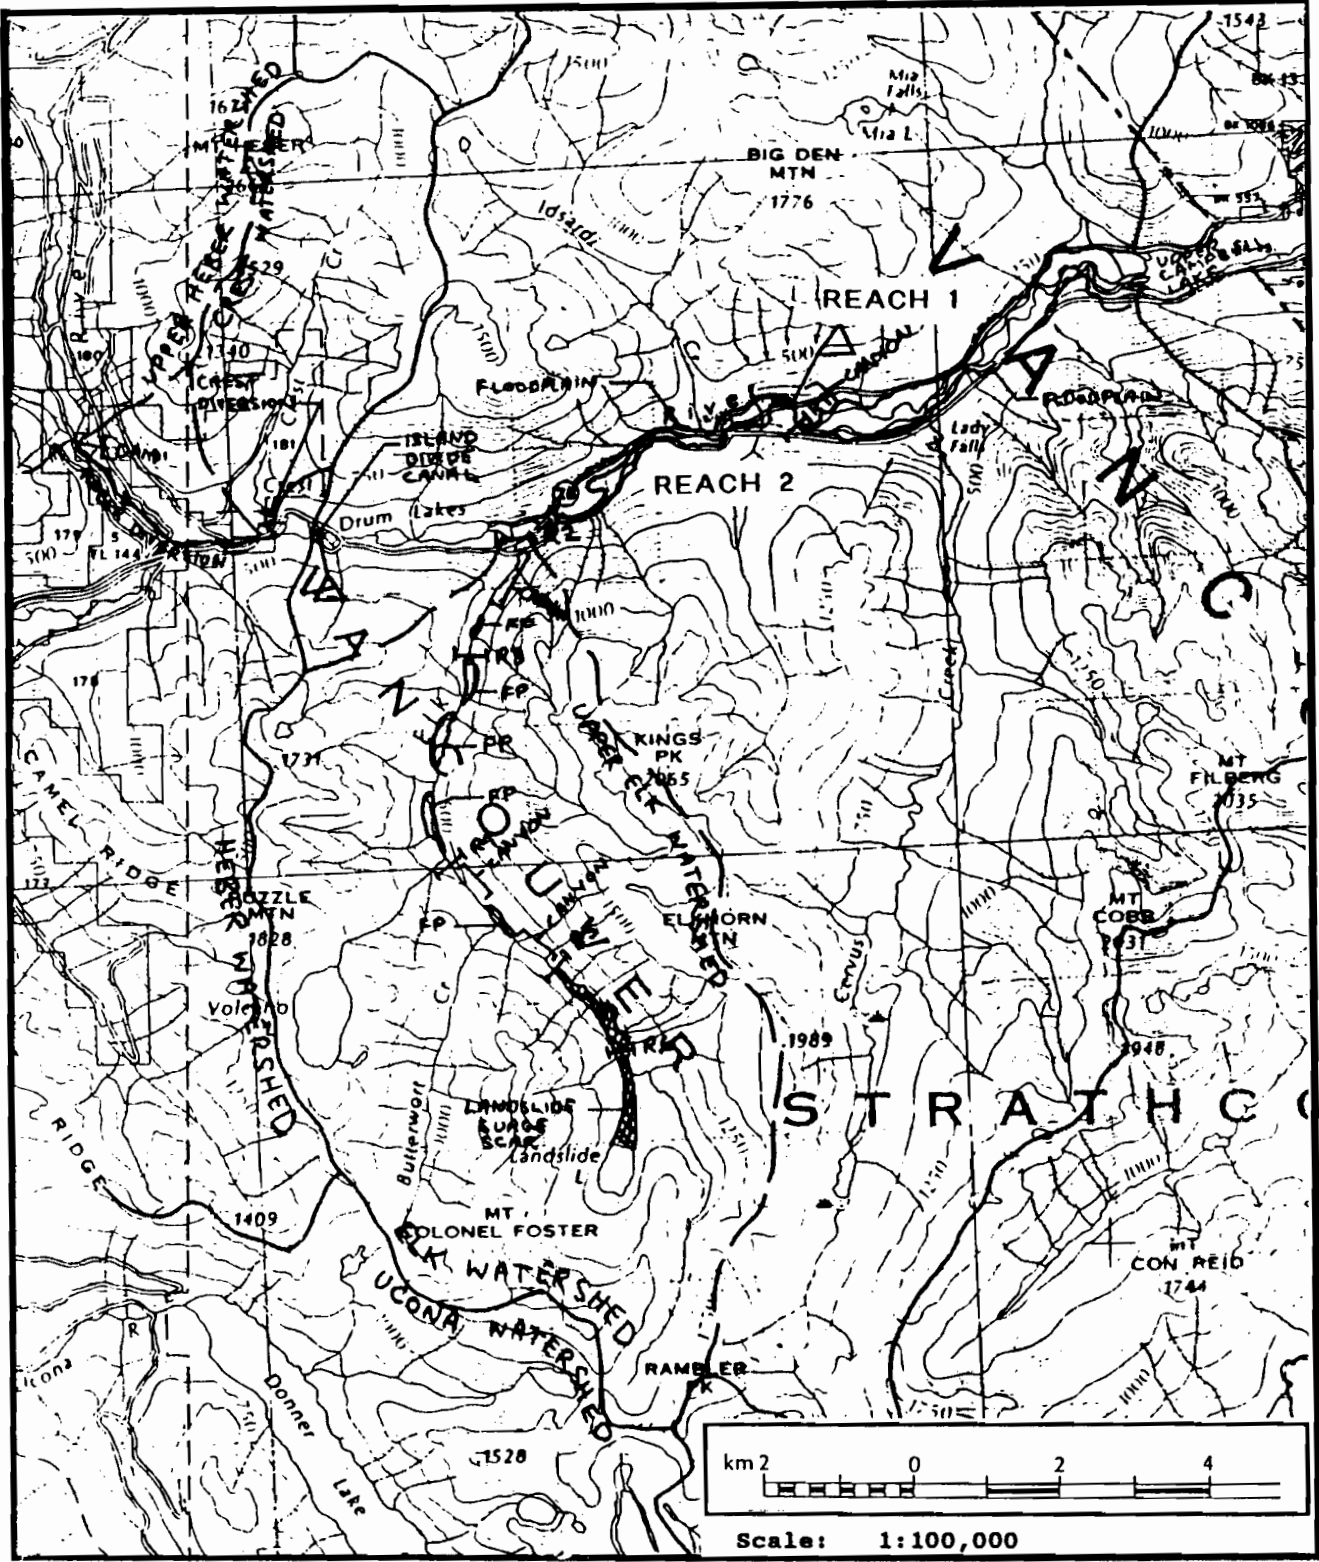
The overall effects of these interferences has been a rather drastic change in river morphology along the two lowermost alluvial reaches of the Elk River (*Figure 1.2*). The active un-vegetated channel zone is now 2 to 3 times as wide as it was before 1940 and this process of flood plain erosion appears to be continuing. Much fish and wildlife habitat has been lost in the process (Tredger et al., 1980; M.W. Patterson, 1989; Aquatic Resources Ltd., 1991).

Figure 1.2: A map of the Elk River watershed showing the location of Reaches 1 and 2 (from Karanka and Kellerhals, 1980).

During the fall of 1990, the Elk River experienced at least 3 large floods, which is an unusual occurrence. It has probably left the river looking less stable than what it might look after a more "normal" winter. However, even with some allowance for this, it is quite evident that neither of the two lower Elk River reaches (*Figure 1.2*) are becoming more stable.
