Final Report

WATERSHED RESTORATION PROGRAM

MISSION CREEK WATERSHED STREAM ASSESSMENT

Project 511.01

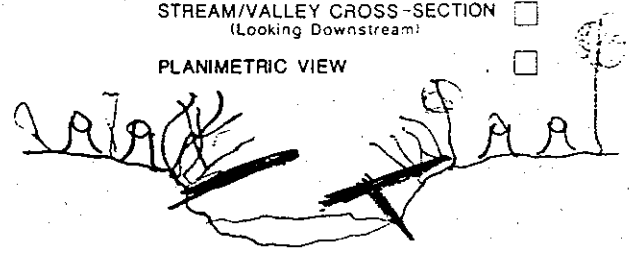
SITE #2

FISH SUMMARY							L		R	
C	Species	No.	Size Range (mm)	Life Phase	Use	Method/Ref.	STREAM/VALLEY CROSS-SECTION (Looking Downstream)		PLANIMETRIC VIEW	
	CT	6	80-140	F2		vis	<input type="checkbox"/>		<input type="checkbox"/>	
COMMENTS										
Channel Stability <input type="checkbox"/> Debris <input type="checkbox"/> Management Concerns <input type="checkbox"/> Obstructions <input type="checkbox"/> Riparian Zone <input type="checkbox"/> Valley Wall Processes <input type="checkbox"/> Etc.										
- excellent fish habitat d/s from BD's										
- abundant gravel - forming gravel										
								Edited by:		
								Date Y M D:

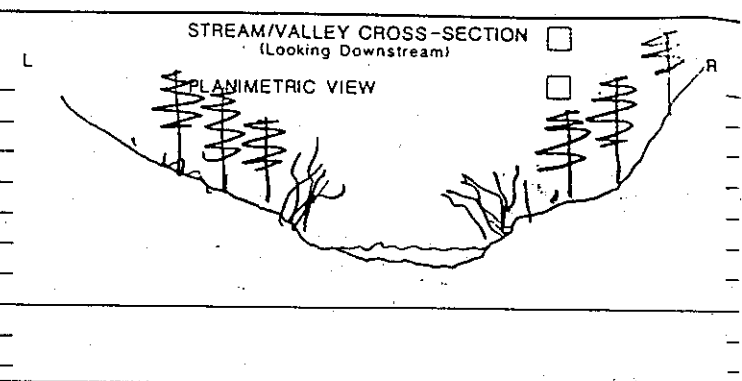
FISH SUMMARY					
Species	No.	Size Range(mm)	Life Phase	Use	Method/Ref.
<u>trout</u>	<u>6</u>	<u>80-100</u>	<u>JUV</u>	<u>VIS</u>	<u>1</u>
