**MIDDLE FORK OF THE WHITE RIVER, MAIYUK, KLOOKUH, AND WINDERMERE  
CREEKS – ROUTINE MONITORING NEAR CANAL FLATS, BRITISH COLUMBIA**

**Slocan Forest Products Ltd.**  
P.O. Box 39  
Radium Hot Springs, British Columbia  
VOA 1M0  
(250) 347-6407

**Applied Aquatic Research Ltd.**  
Calgary, Alberta

March 2001  
File: AAR00-4

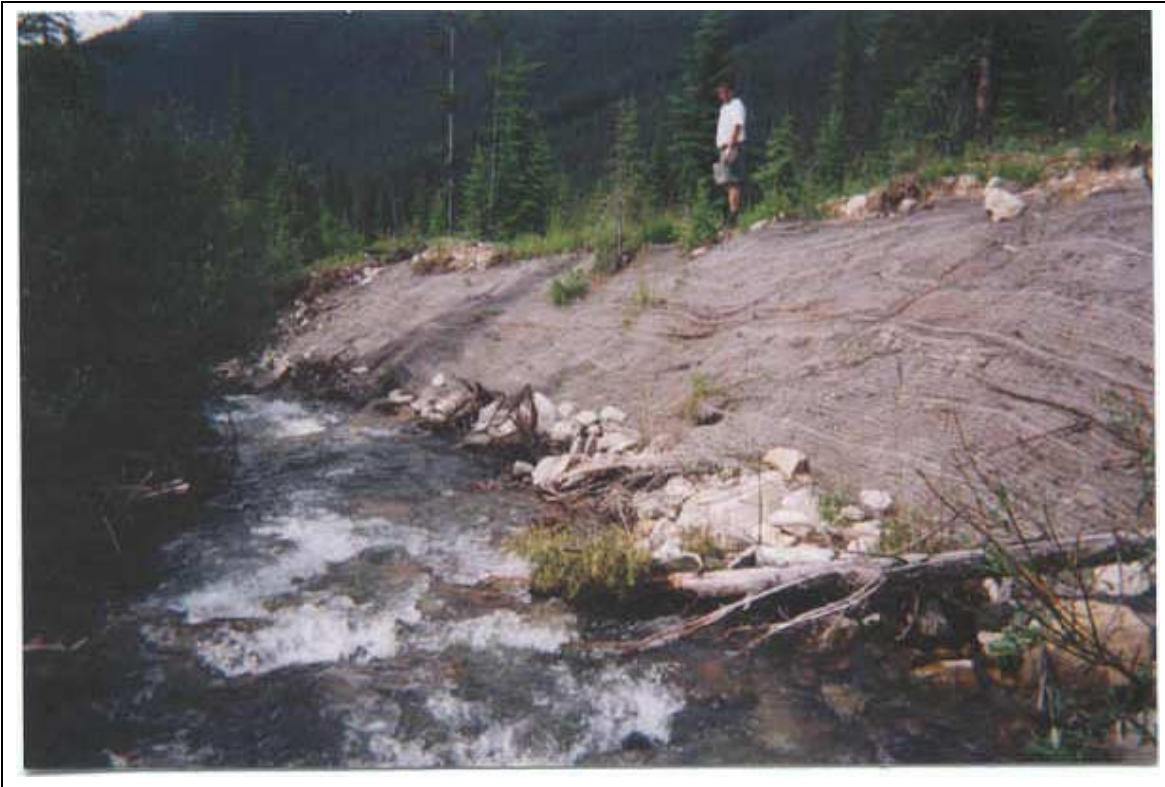
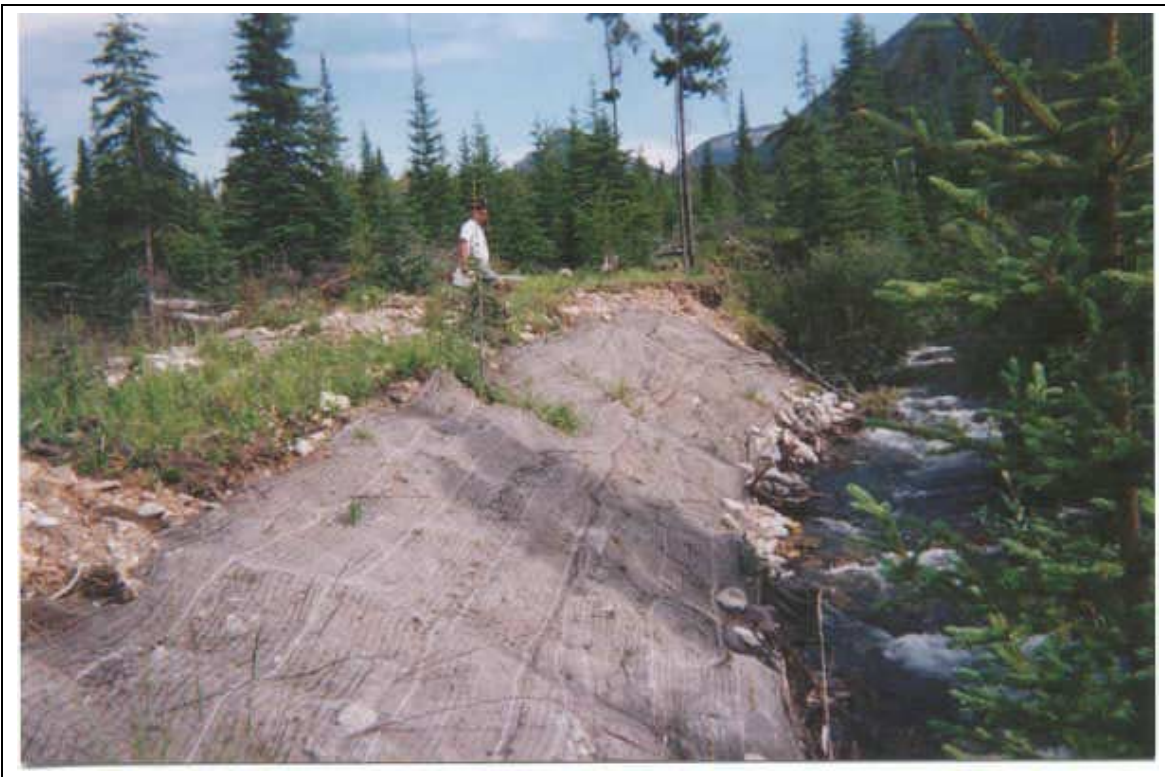
The prescription constructed at this site was a tree revetment. Representative photographs are provided in Plates 1 and 2. The pool next to this site is 49 cm deep. The previous monitoring report identified that riprap used did not meet the design specification; however, the structure

Plate 1 View downstream at Site KK-001, Klookuh Creek. Jim King as scale (July 22, 2000).

Plate 2 View downstream at site KK-01, Klookuh Creek. Jim King as scale (July 22, 2000).

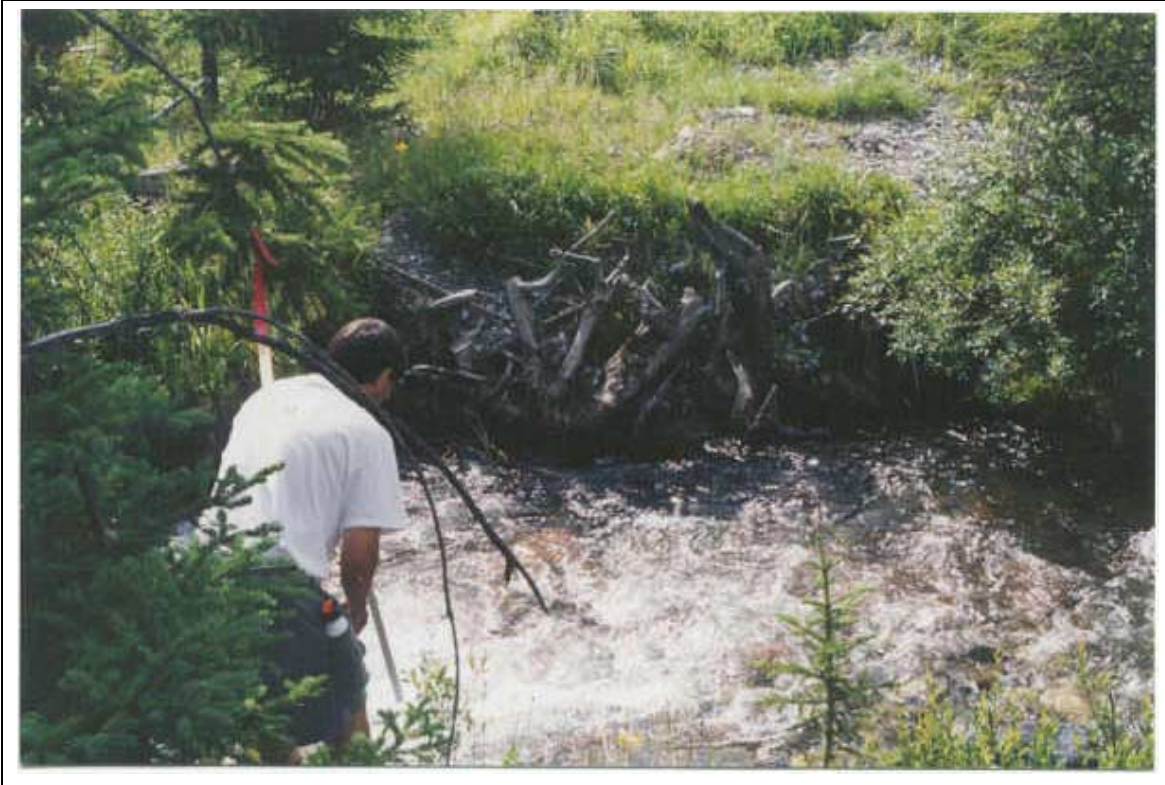
Representative photographs are provided in Plate 3. The pool next to this prescription site was 45 cm deep during the field visit, and its depth has increased slightly compared to that recorded previously. It may take a larger flow event (i.e. 1-in-5 or 1-in-10 year) to change pool depth at this site significantly, because of the large substrates present. No additional maintenance is required at this site.

Plate 3 View across stream channel at tree revetment; site KK-02, Klookuh Creek (July 22, 2000). Jim King as scale

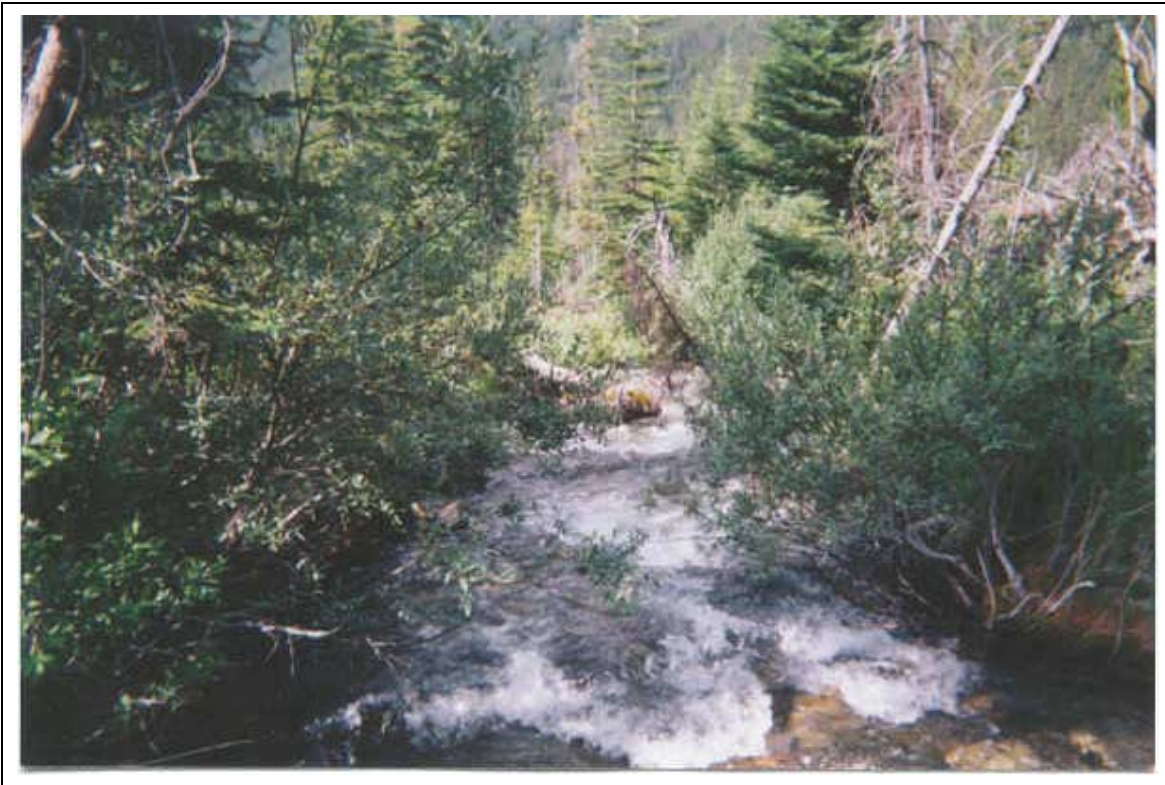
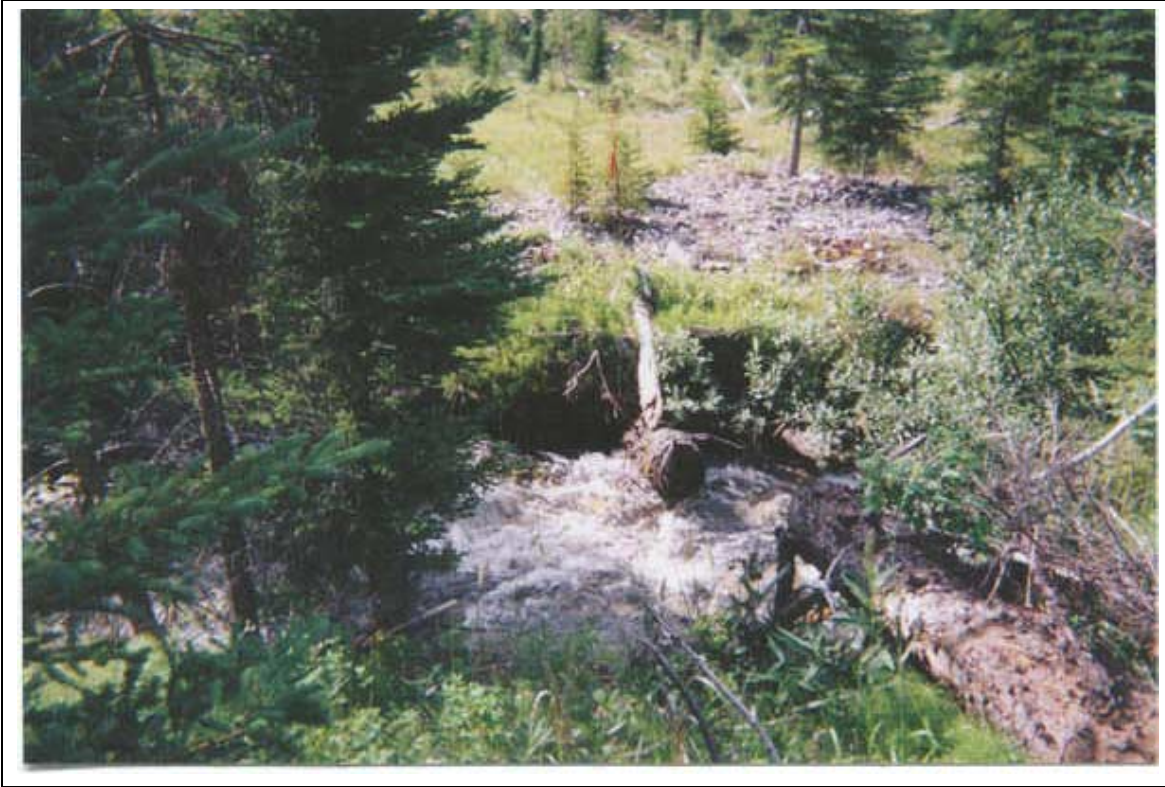
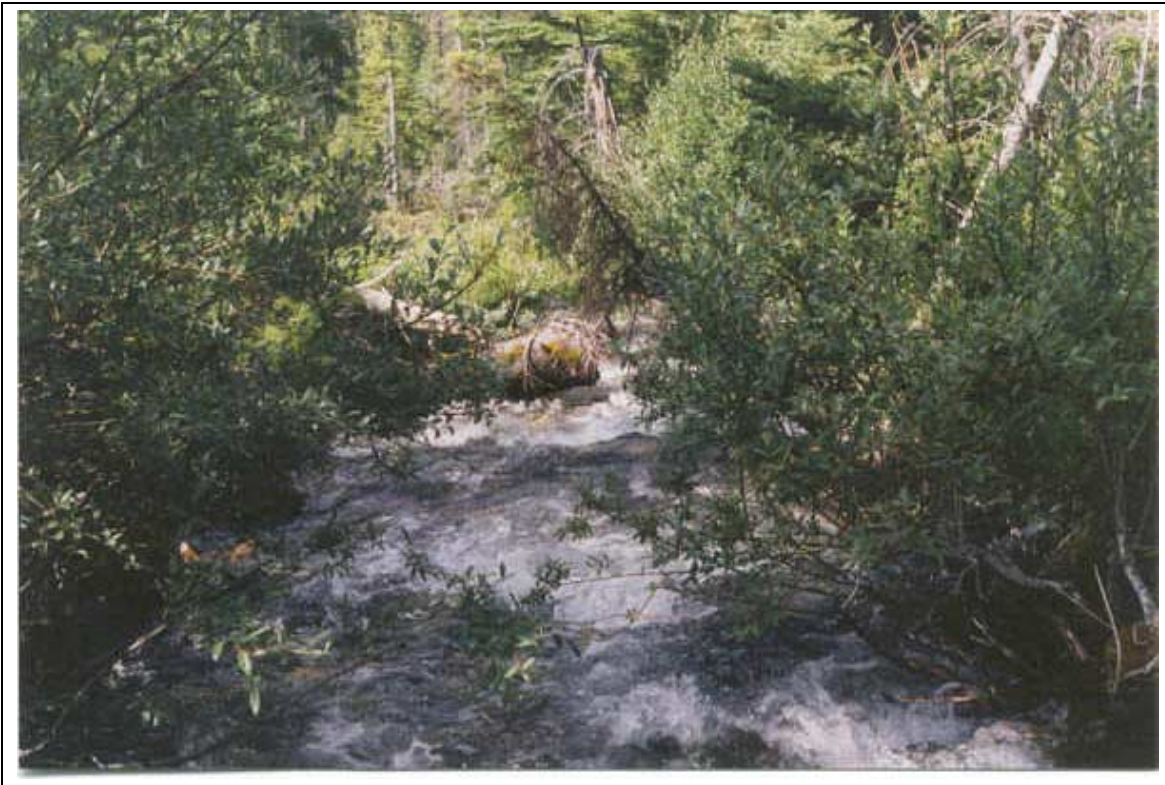
The sediment wedge reported by Wright (2000) has not increased in size. Representative photographs are provided in Plates 4, 5 and 6. Pool depth downstream of the structure was 40 cm. No new barriers have formed, and the placement of the LWD structure has not compromised bank integrity. No maintenance is presently required at this site.

Plate 4 View downstream at tree revetment; site KK-03, Klookuh Creek (July 22, 2000).

Plate 5 View across channel from right bank (looking downstream); site KK-03, Klookuh Creek (July 22, 2000). Flagging tape as scale.

Plate 6 View downstream at site KK-03, Klookuh Creek (July 22, 2000).

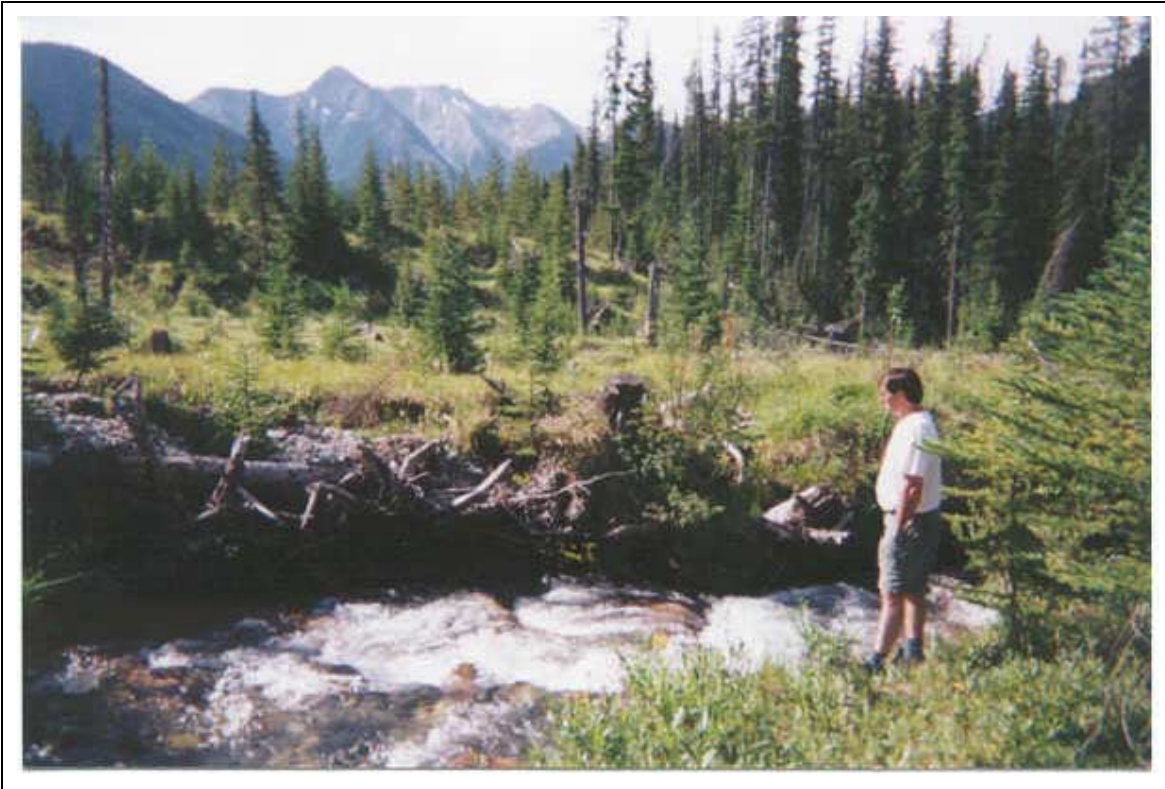
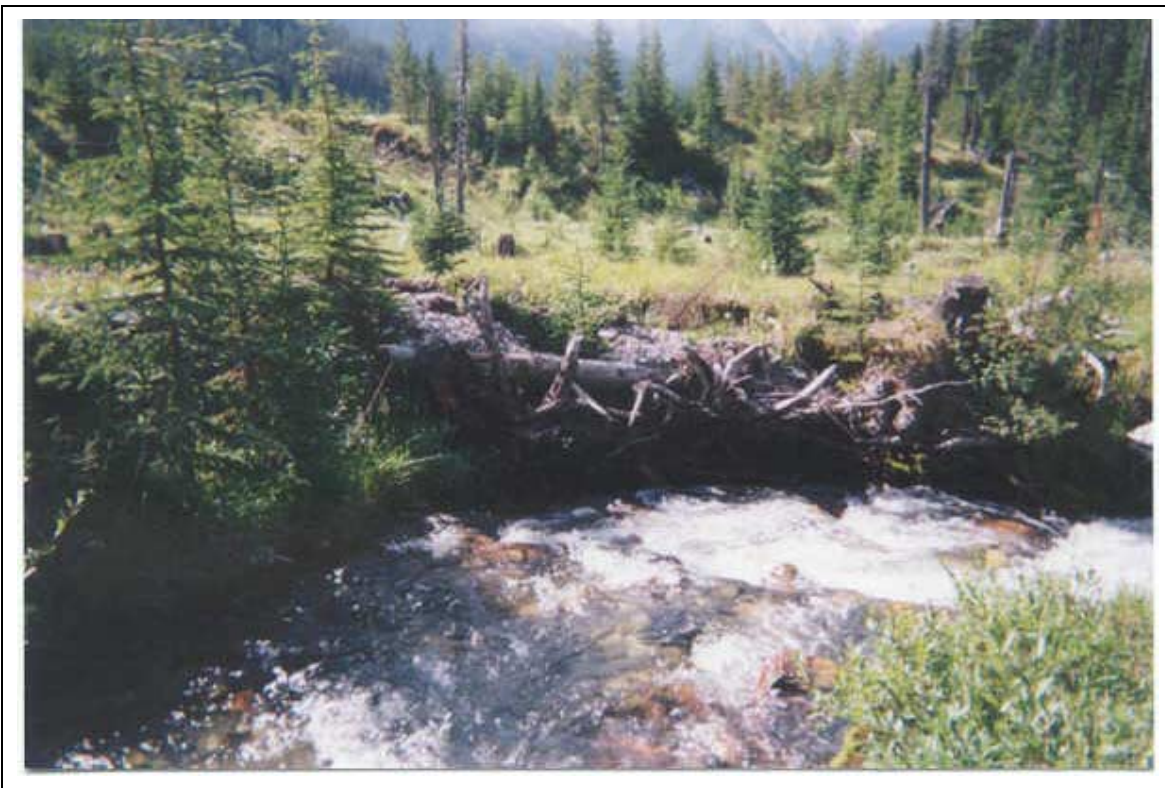
The restoration prescription constructed at this site was a tree revetment to stabilize an eroding bank. Representative photographs are provided in Plates 7 and 8. As described in the previous report (Wright 2000) no maintenance is presently required. The footer logs at the base of the tree revetment and root wad will minimize the risk of the structure being undermined.

Plate 7 View across channel at site KK-04, Klookuh Creek (July 22, 2000). Jim King as scale.

Plate 8 View across and downstream at tree revetment; site KK-04, Klookuh Creek (July 22, 2000).

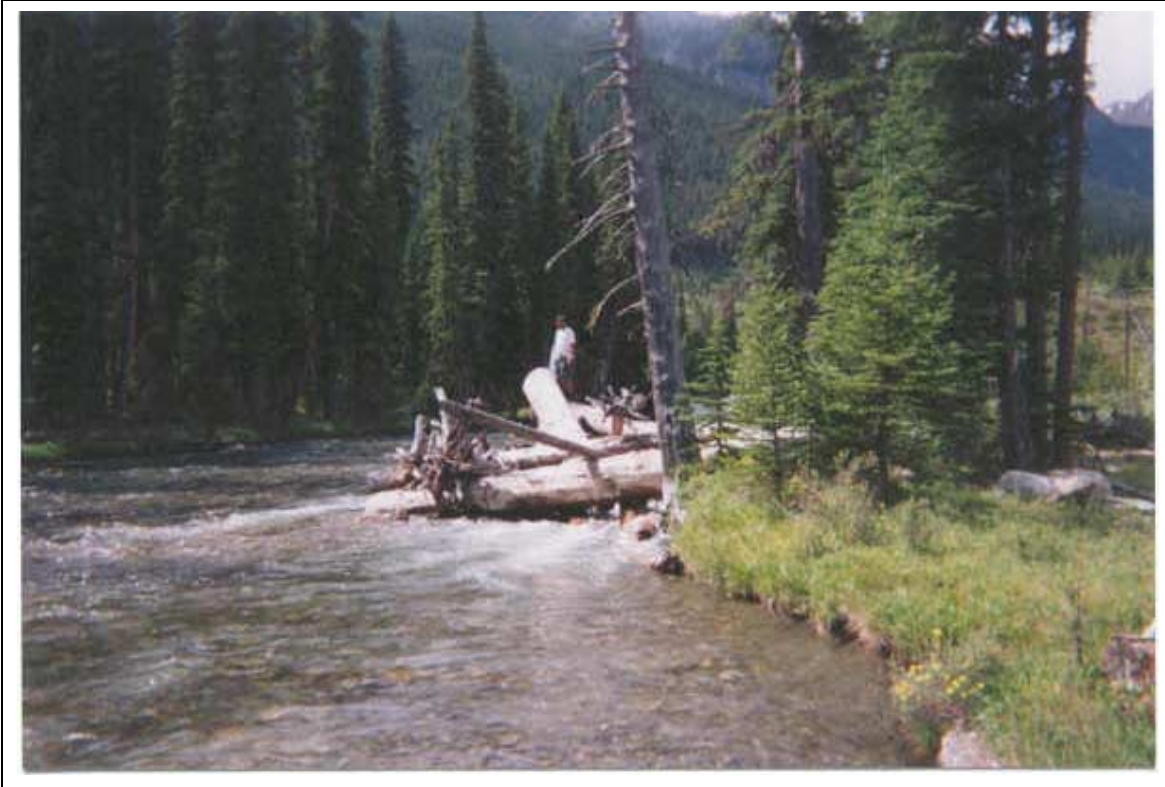
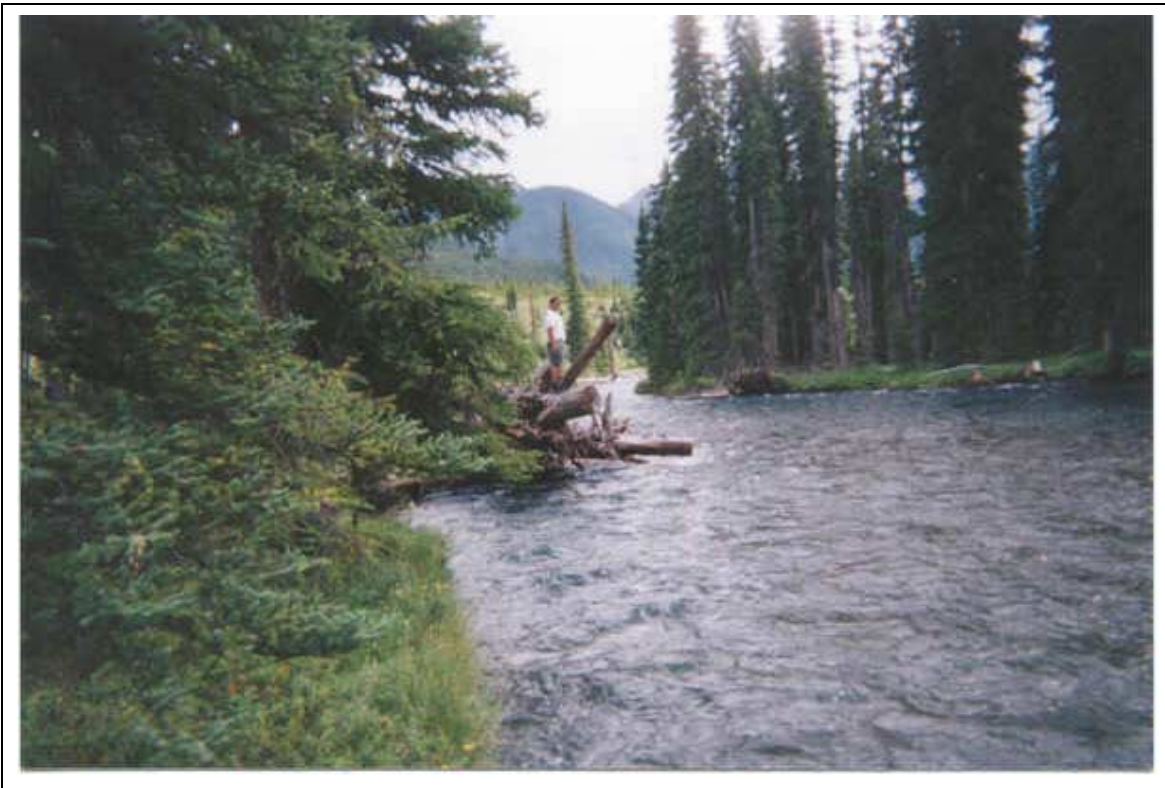
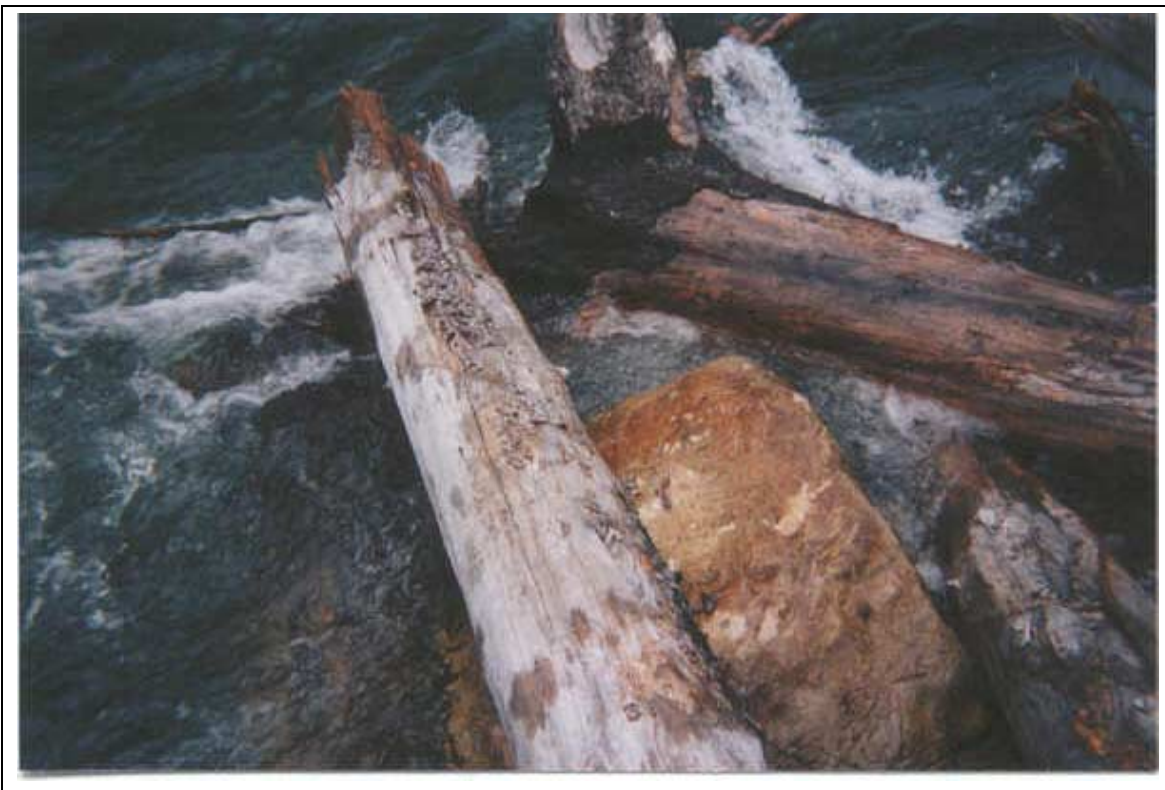
Representative photographs are provided in Plates 23 to 26. The restoration prescription at this site was a lateral triangular logjam. The structure is stable and has not shifted. Rock >1.5 m has been used for ballast. No maintenance is required at this site.

Plate 23 View upstream at triangular logjam; site MF-01, Middle Fork of the White River (July 22, 2000).

Plate 24 View downstream at triangular logjam; site MF-01, Middle Fork of the White River (July 22, 2000).

Plate 26 View toward centre of channel showing ballast rock, triangular logjam MF-01, Middle Fork of the White River (July 22, 2000).

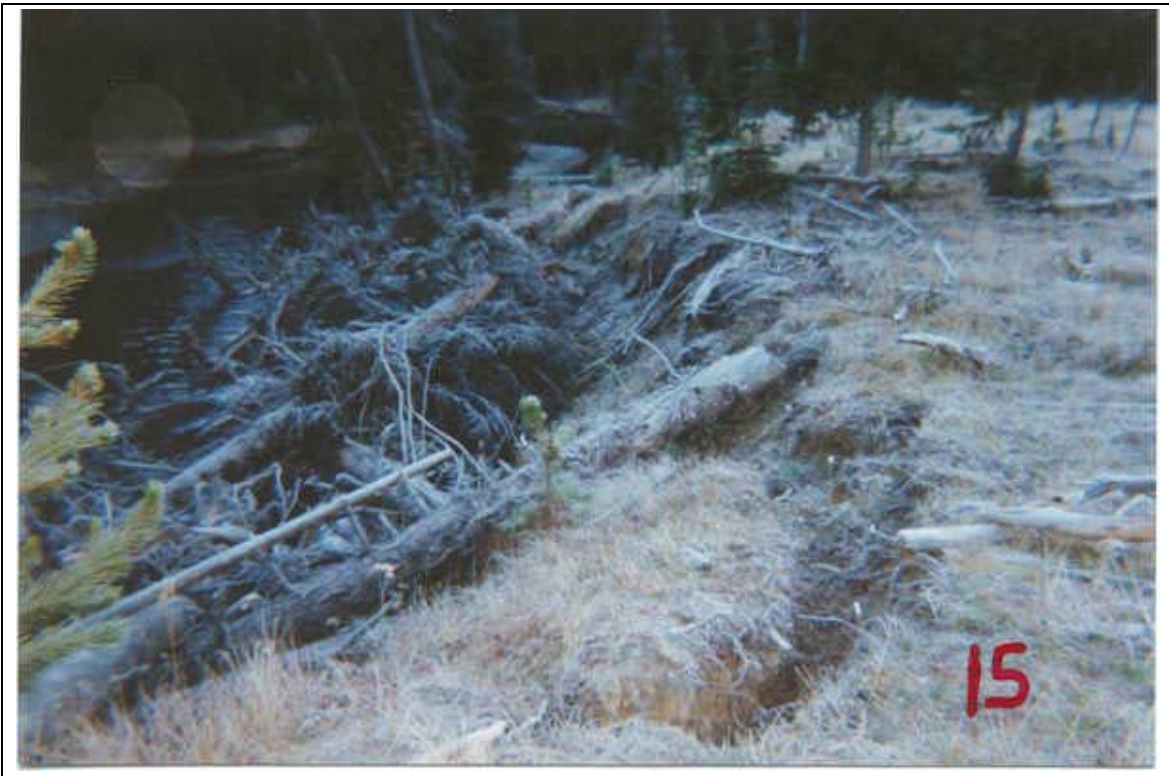
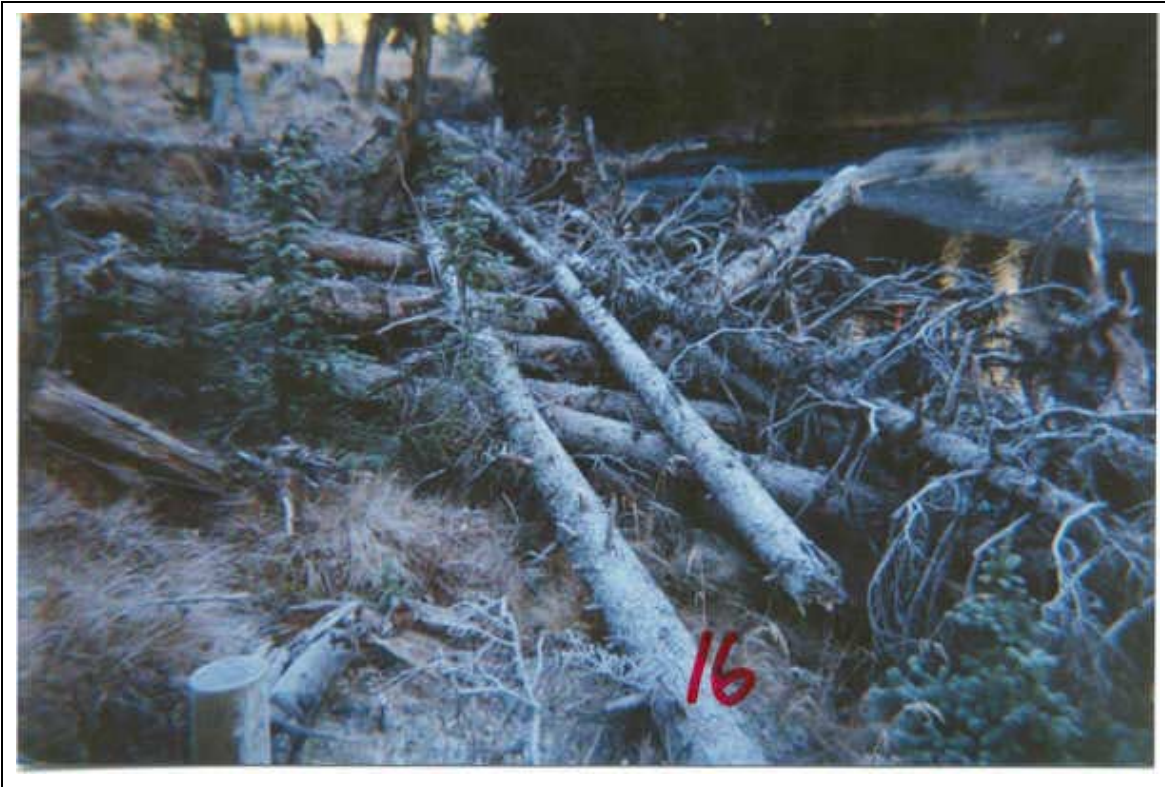
Plate 36 Live stakes planted along bank, Maiyuk Creek (October 23-26, 2000). Note white tops of stakes.

Plate 37 Live stakes planted along bank, Maiyuk Creek (October 23-26, 2000). Note white tops of stakes.

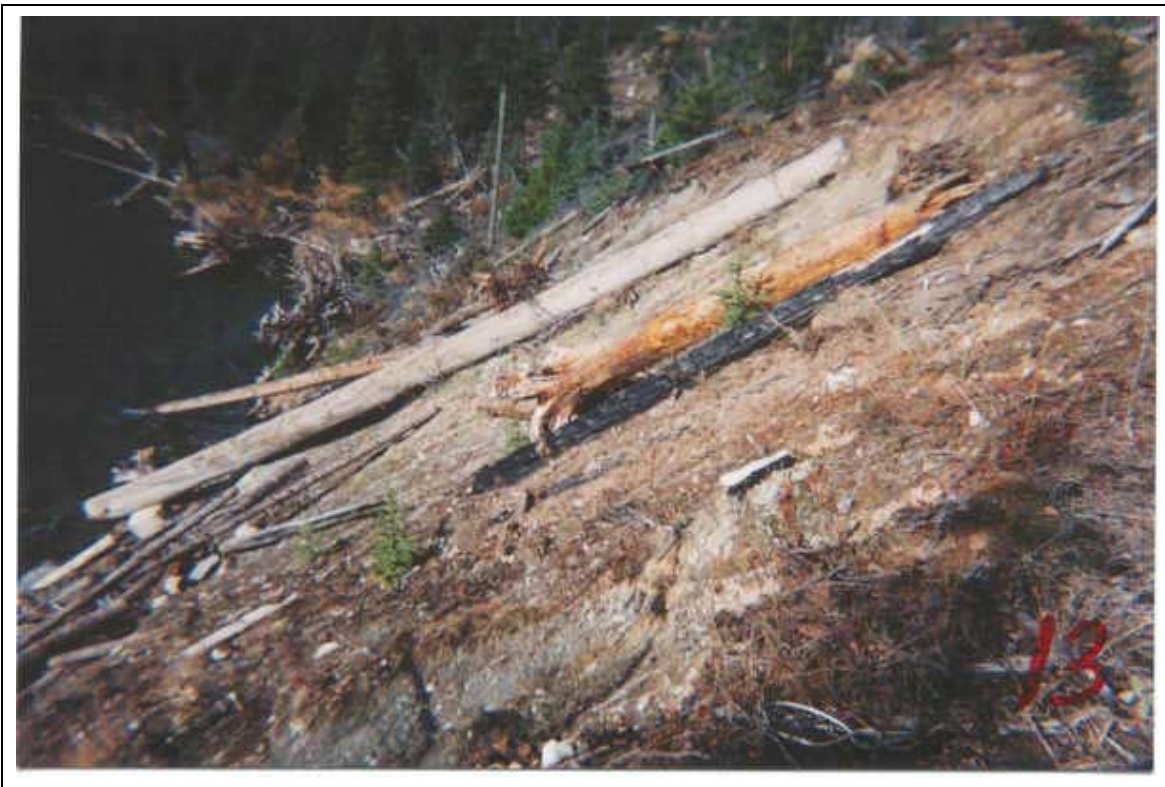
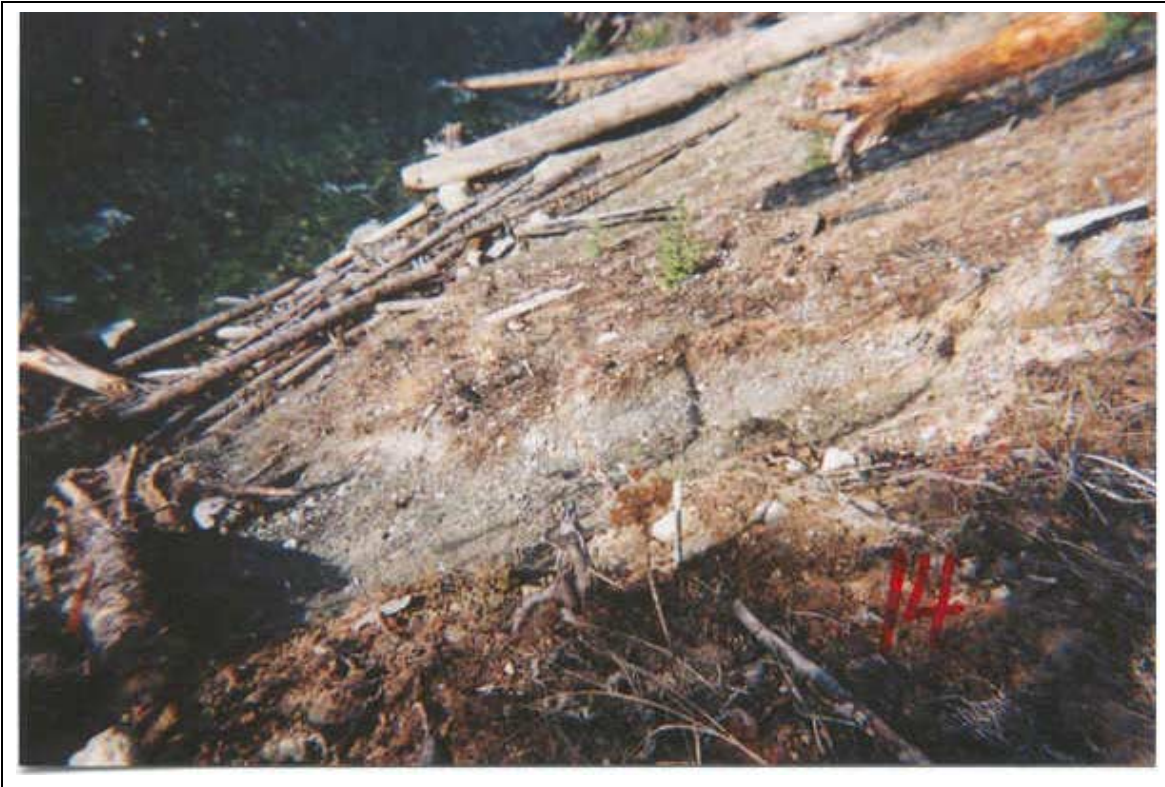
Plate 38 Live stakes planted along bank slope, Middle Fork of the White River (October 23-26, 2000). Note white tops of stakes.

Plate 39 Live stakes planted along bank, Middle Fork of the White River (October 23-26, 2000). Note white tops of stakes.

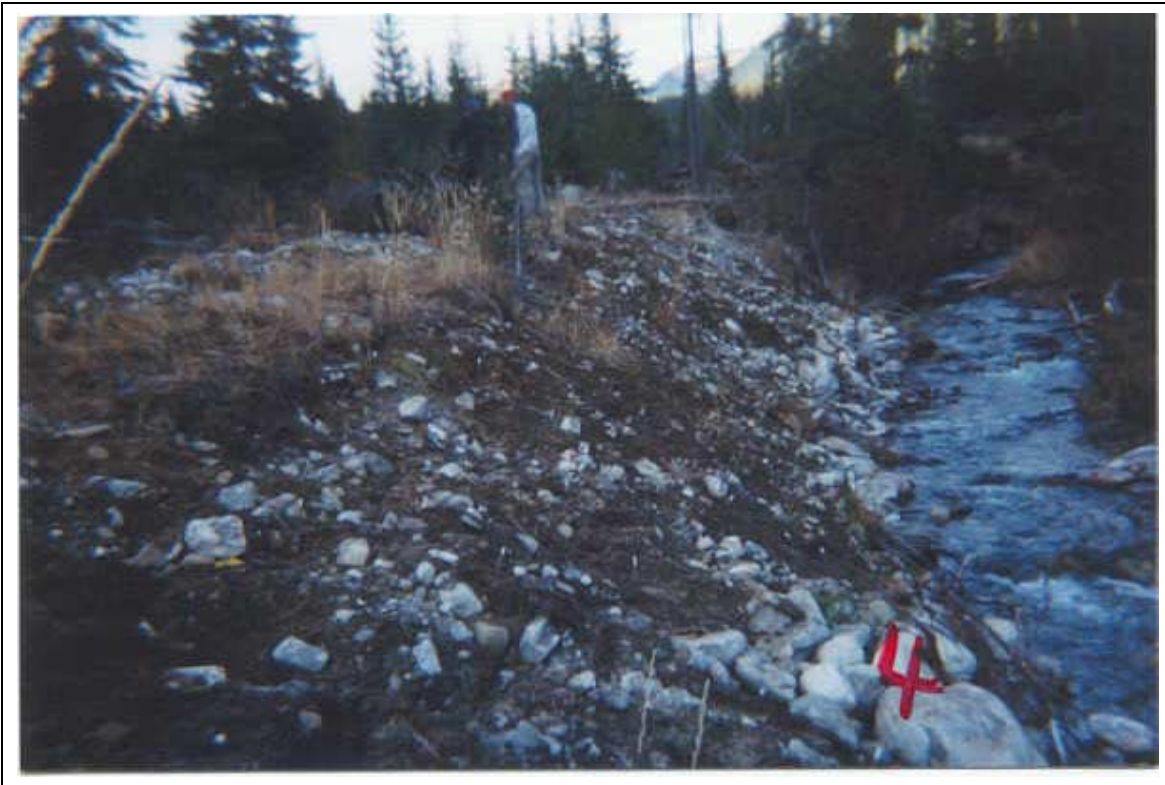
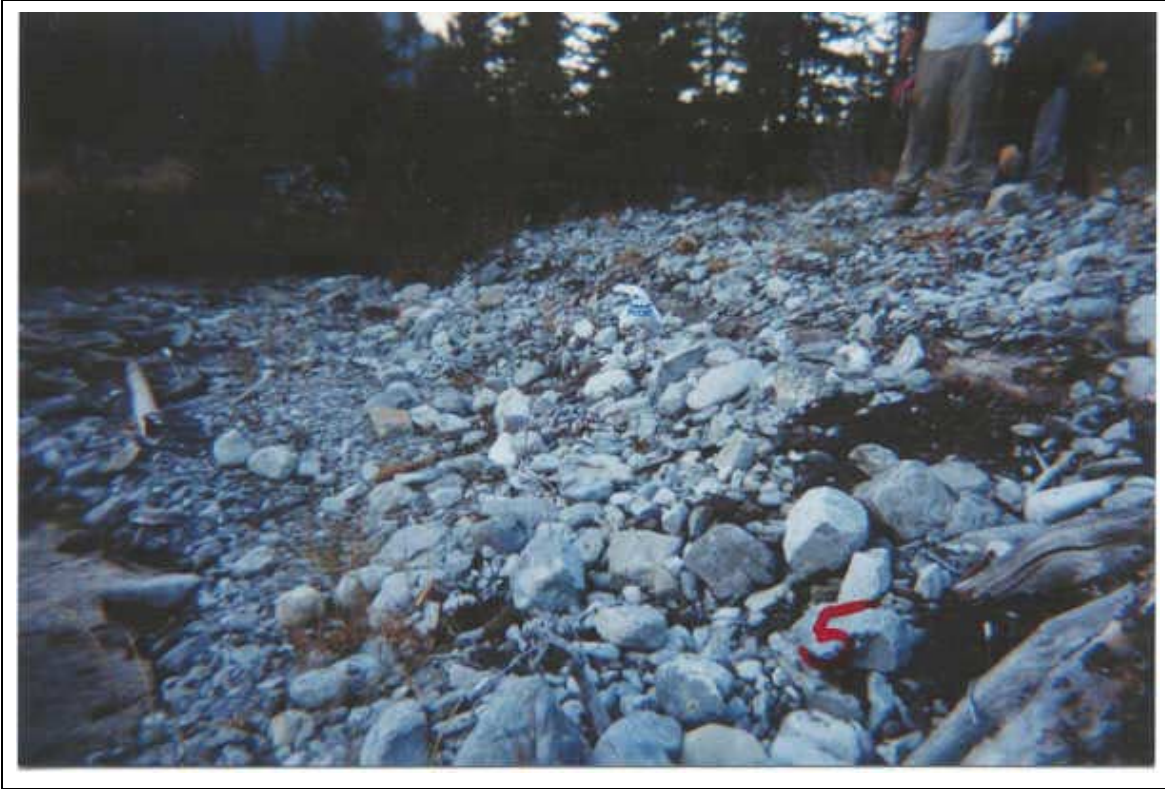
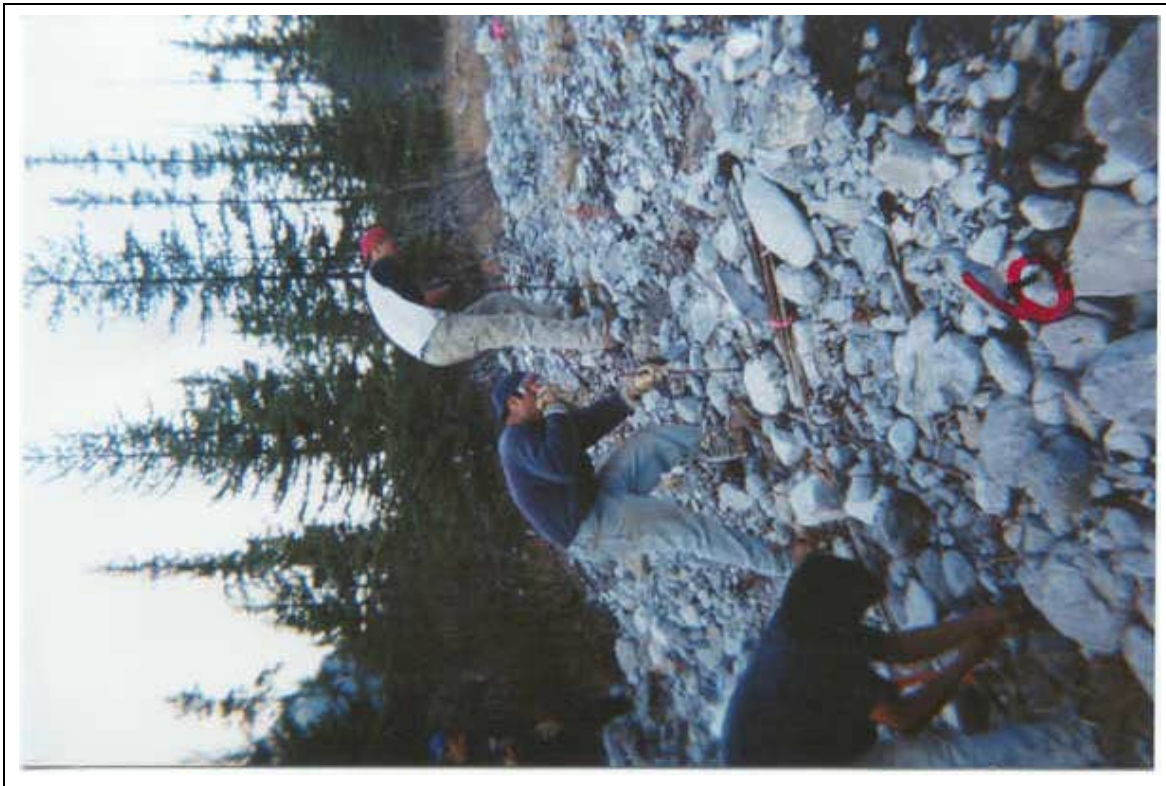
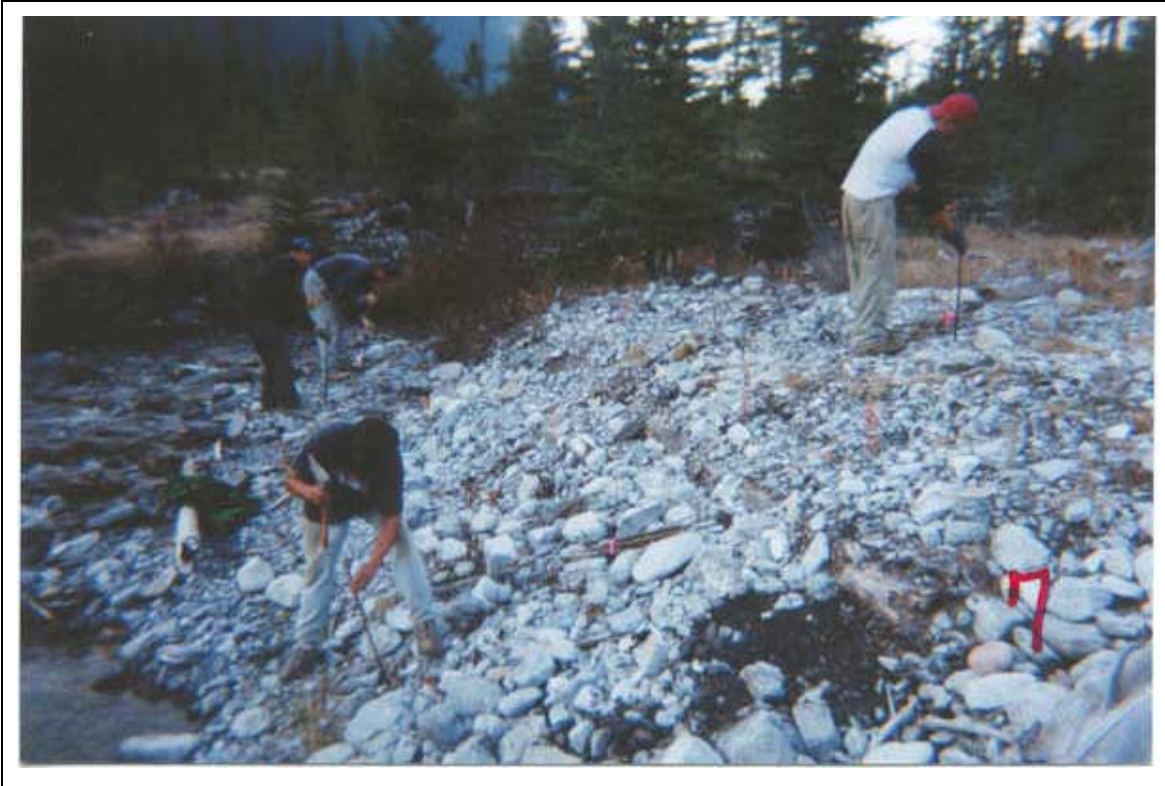
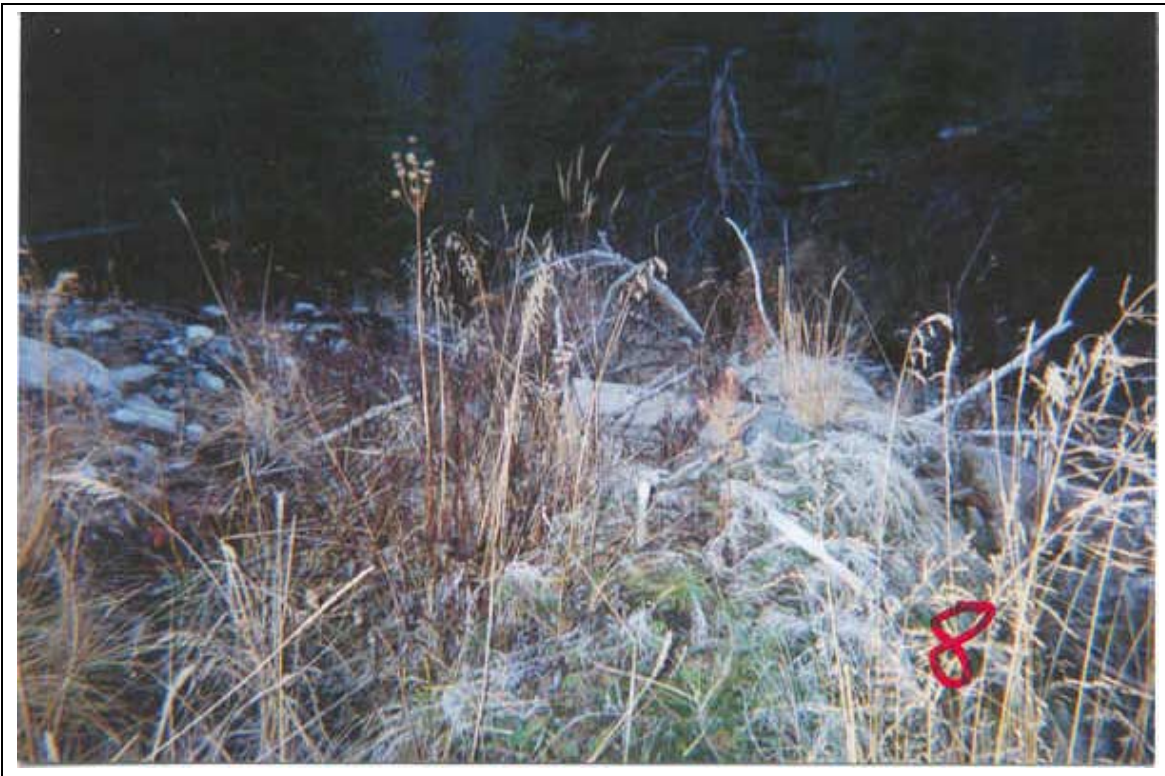
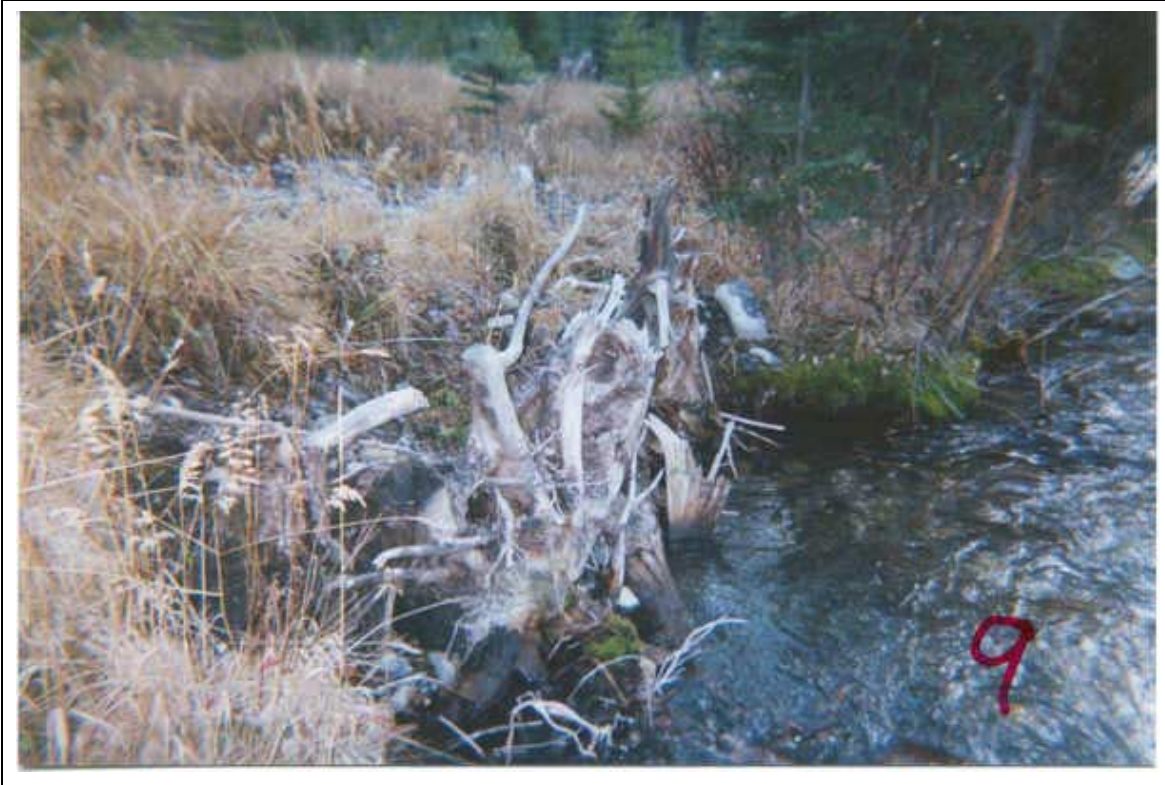
Plate 40 Live stakes planted along bank, Klookuh Creek (October 23-26, 2000). Note white tops of stakes.

Plate 41 Live stakes planted along bank, Klookuh Creek (October 23-26, 2000). Note white tops of stakes.

Plate 42 Live stakes planted along bank, Klookuh Creek (October 23-26, 2000). Note white tops of stakes.

Plate 43 Live stakes planted along bank, Klookuh Creek (October 23-26, 2000). Note white tops of stakes.

Plate 44 Live stakes planted along bank, Klookuh Creek (October 23-26, 2000). Note white tops of stakes.

Plate 45 Live stakes planted along bank, Klookuh Creek (October 23-26, 2000). Note white tops of stakes.

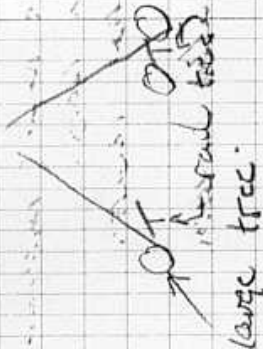
MF-01 - A log jam  
R3F9 - view up S.  
R3F8 - view dls

- structure does not look like it has moved; tied together in series, all cables tight!  
- lot of buried rock under structure.  
- no movement required.

- some of the better rock may have been hidden during JES's assessment;
