# **Watershed Risk Analysis**

## **Tranquille River**

Prepared for:

**March 10, 2009**

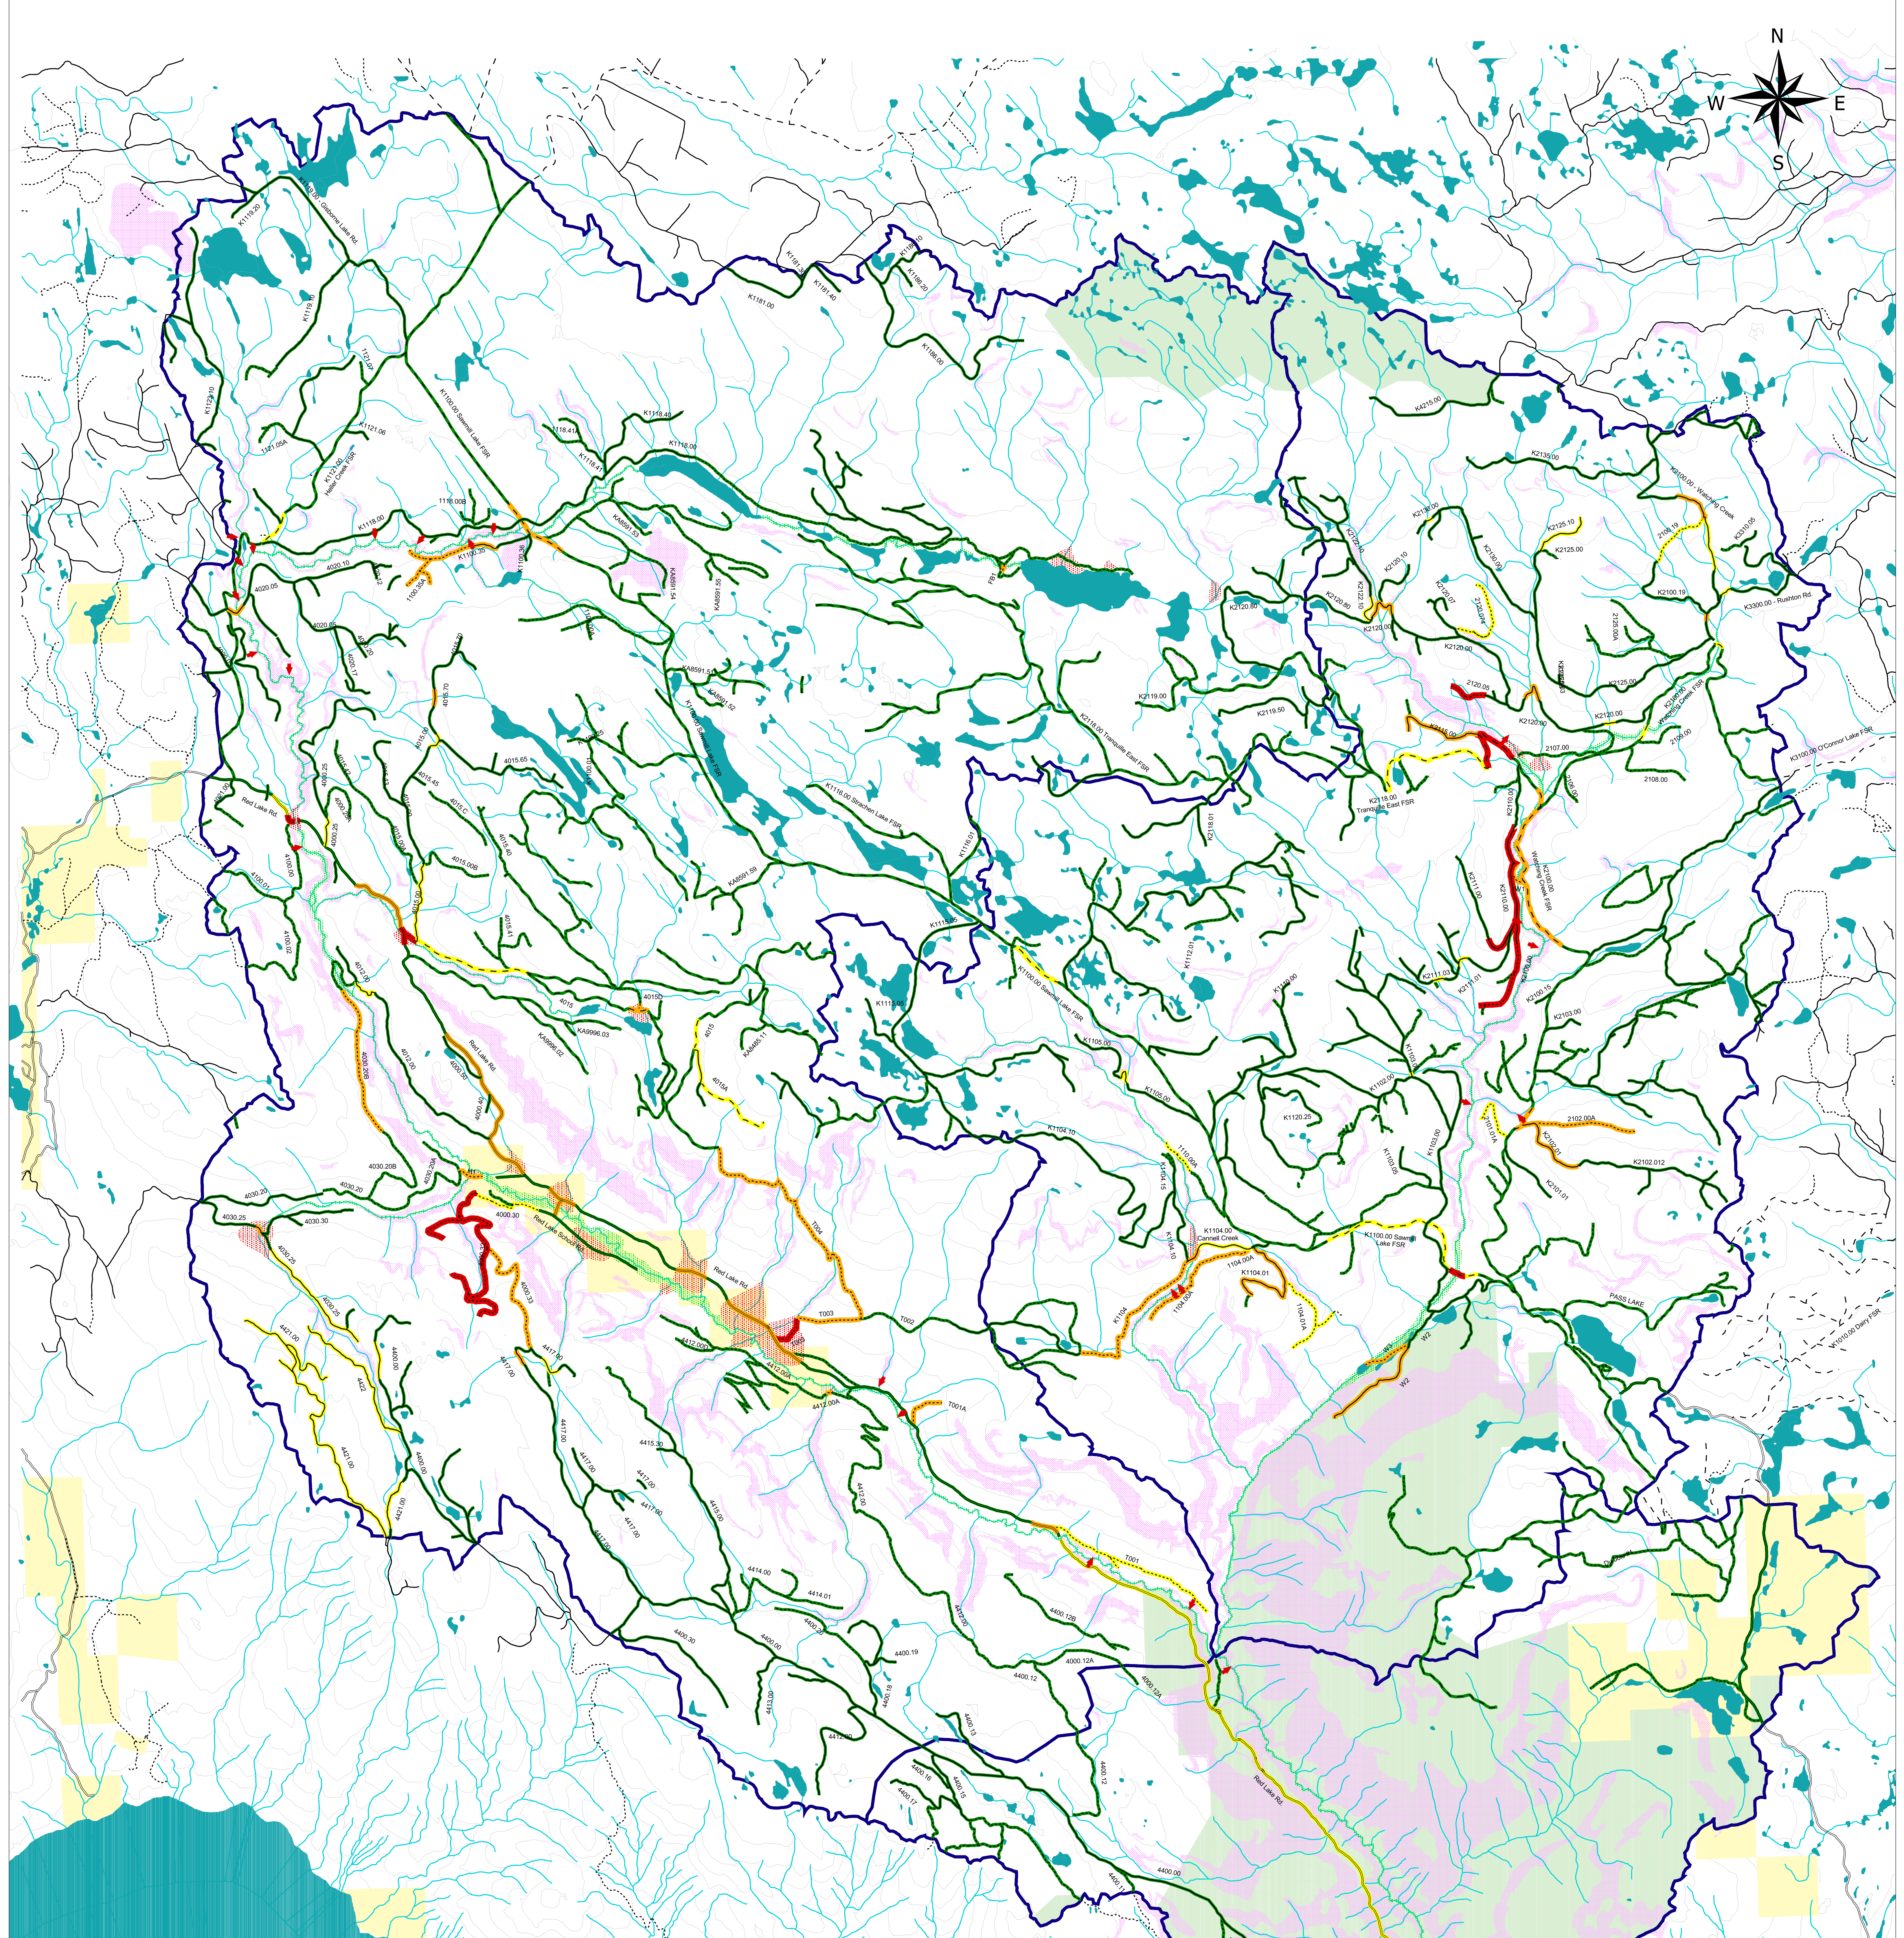
### Tranquille River - Road Risk Map

Tranquille FSR Road Risk								
Road	Basin	Length (m)	Comments	Hazard	Resource at stake	Probability of hazard occurrence	Effect on resource at stake	Risk
4015	Tranquille	199.7	Road on fan, diversion likely onto road or across.	Road erosion, washout, sediment input to Sylvestre Creek	Water quality, fish	H	H	<b>VH</b>
Tranquille East FSR	Watching	1119.9	Drainage issues above steep coupled slopes, one slide already.	Landslides into main tributary, road erosion	Water quality	H	H	<b>VH</b>
K1100.00 Sawmill Lake FSR	Watching	234.3	Undersized span on floodplain. Approaches constrict flow and process heavy erosion or washout expected with increased runoff, bank erosion and debris accumulation.	Erosion, sediment input to mainstem, road washout	Water quality, public safety	H	H	<b>VH</b>
4015	Tranquille	258.2	Road on fan, mobile sediment and debris at culvert, washout likely.	Road damage, sediment delivery to wetland.	Road infrastructure	H	M	<b>H</b>

K1100.00 Sawmill Lake FSR	Tranquille	994.6	Significant input of sediment from downhill approaches during wet weather activity. Cattle guard traps in place but not maintained.	Sediment input to Tranquille River	Water quality	H	M	<b>H</b>
Tranquille East FSR	Watching	287.1	Culvert on large tributary with mobile debris, will fail and erode prism.	Road erosion, sediment input to channels	Water quality	H	M	<b>H</b>
K2100.00 Watching Creek FSR	Watching	2191.6	Portion built on floodplain, armoured but constricts feature and process. Other portion on break above steep coupled slopes, low cross drain frequency, potential for slides with increased runoff.	Road erosion, landslides into mainstem channel.	Water quality	M	H	<b>H</b>
K2100.00 Watching Creek FSR	Watching	373.2	Drainage concentrated along this section above steep coupled slopes from diversions on spurs . 1 old slide from diverted drainage.	Landslides or slumps into tributary	Water quality	H	M	<b>H</b>

Tranquille Non-status Road Risk								
Road	Basin	Length (m)	Comments	Hazard	Resource at stake	Probability of hazard occurrence	Effect on resource at stake	Risk
4000.30	Tranquille	942.5	Steep fill on partly coupled slope, waterbars failing.	Diversion, landslide or slump onto floodplain, private land.	Water quality	M	M	<b>M</b>
T001	Tranquille	2736.6	More than one slide from drainage diversion, frequency low but direct impact on mainstem.	Landslide, road erosion	Water quality	M	M	<b>M</b>
2101.01A	Watching	805.2	Dry site but no waterbars or cross ditches above steep coupled slope.	Landslide or slump into tributary or mainstem	Water quality	L	H	<b>M</b>
2120.074	Watching	1437.8	Diversions above moderate to steep slopes along tributaries.	Slump or slide into tributary	Water quality	M	M	<b>M</b>
2100.19	Watching	1126.3	Failing crossings, erosion of fill.	Sediment input to tributaries	Water quality	M	M	<b>M</b>

1104.01A	Watching	1572.9	Small S6 on road above steep coupled slope.	Landslide onto floodplain or into mainstem	Water quality, fish habitat	M	M	<b>M</b>
1110.00A	Watching	571.9	Snowmobile trail on floodplain. Erosion - direct input of sediment to Cannell Creek.	Erosion, sediment input to Cannell Creek	Water quality	H	L	<b>M</b>

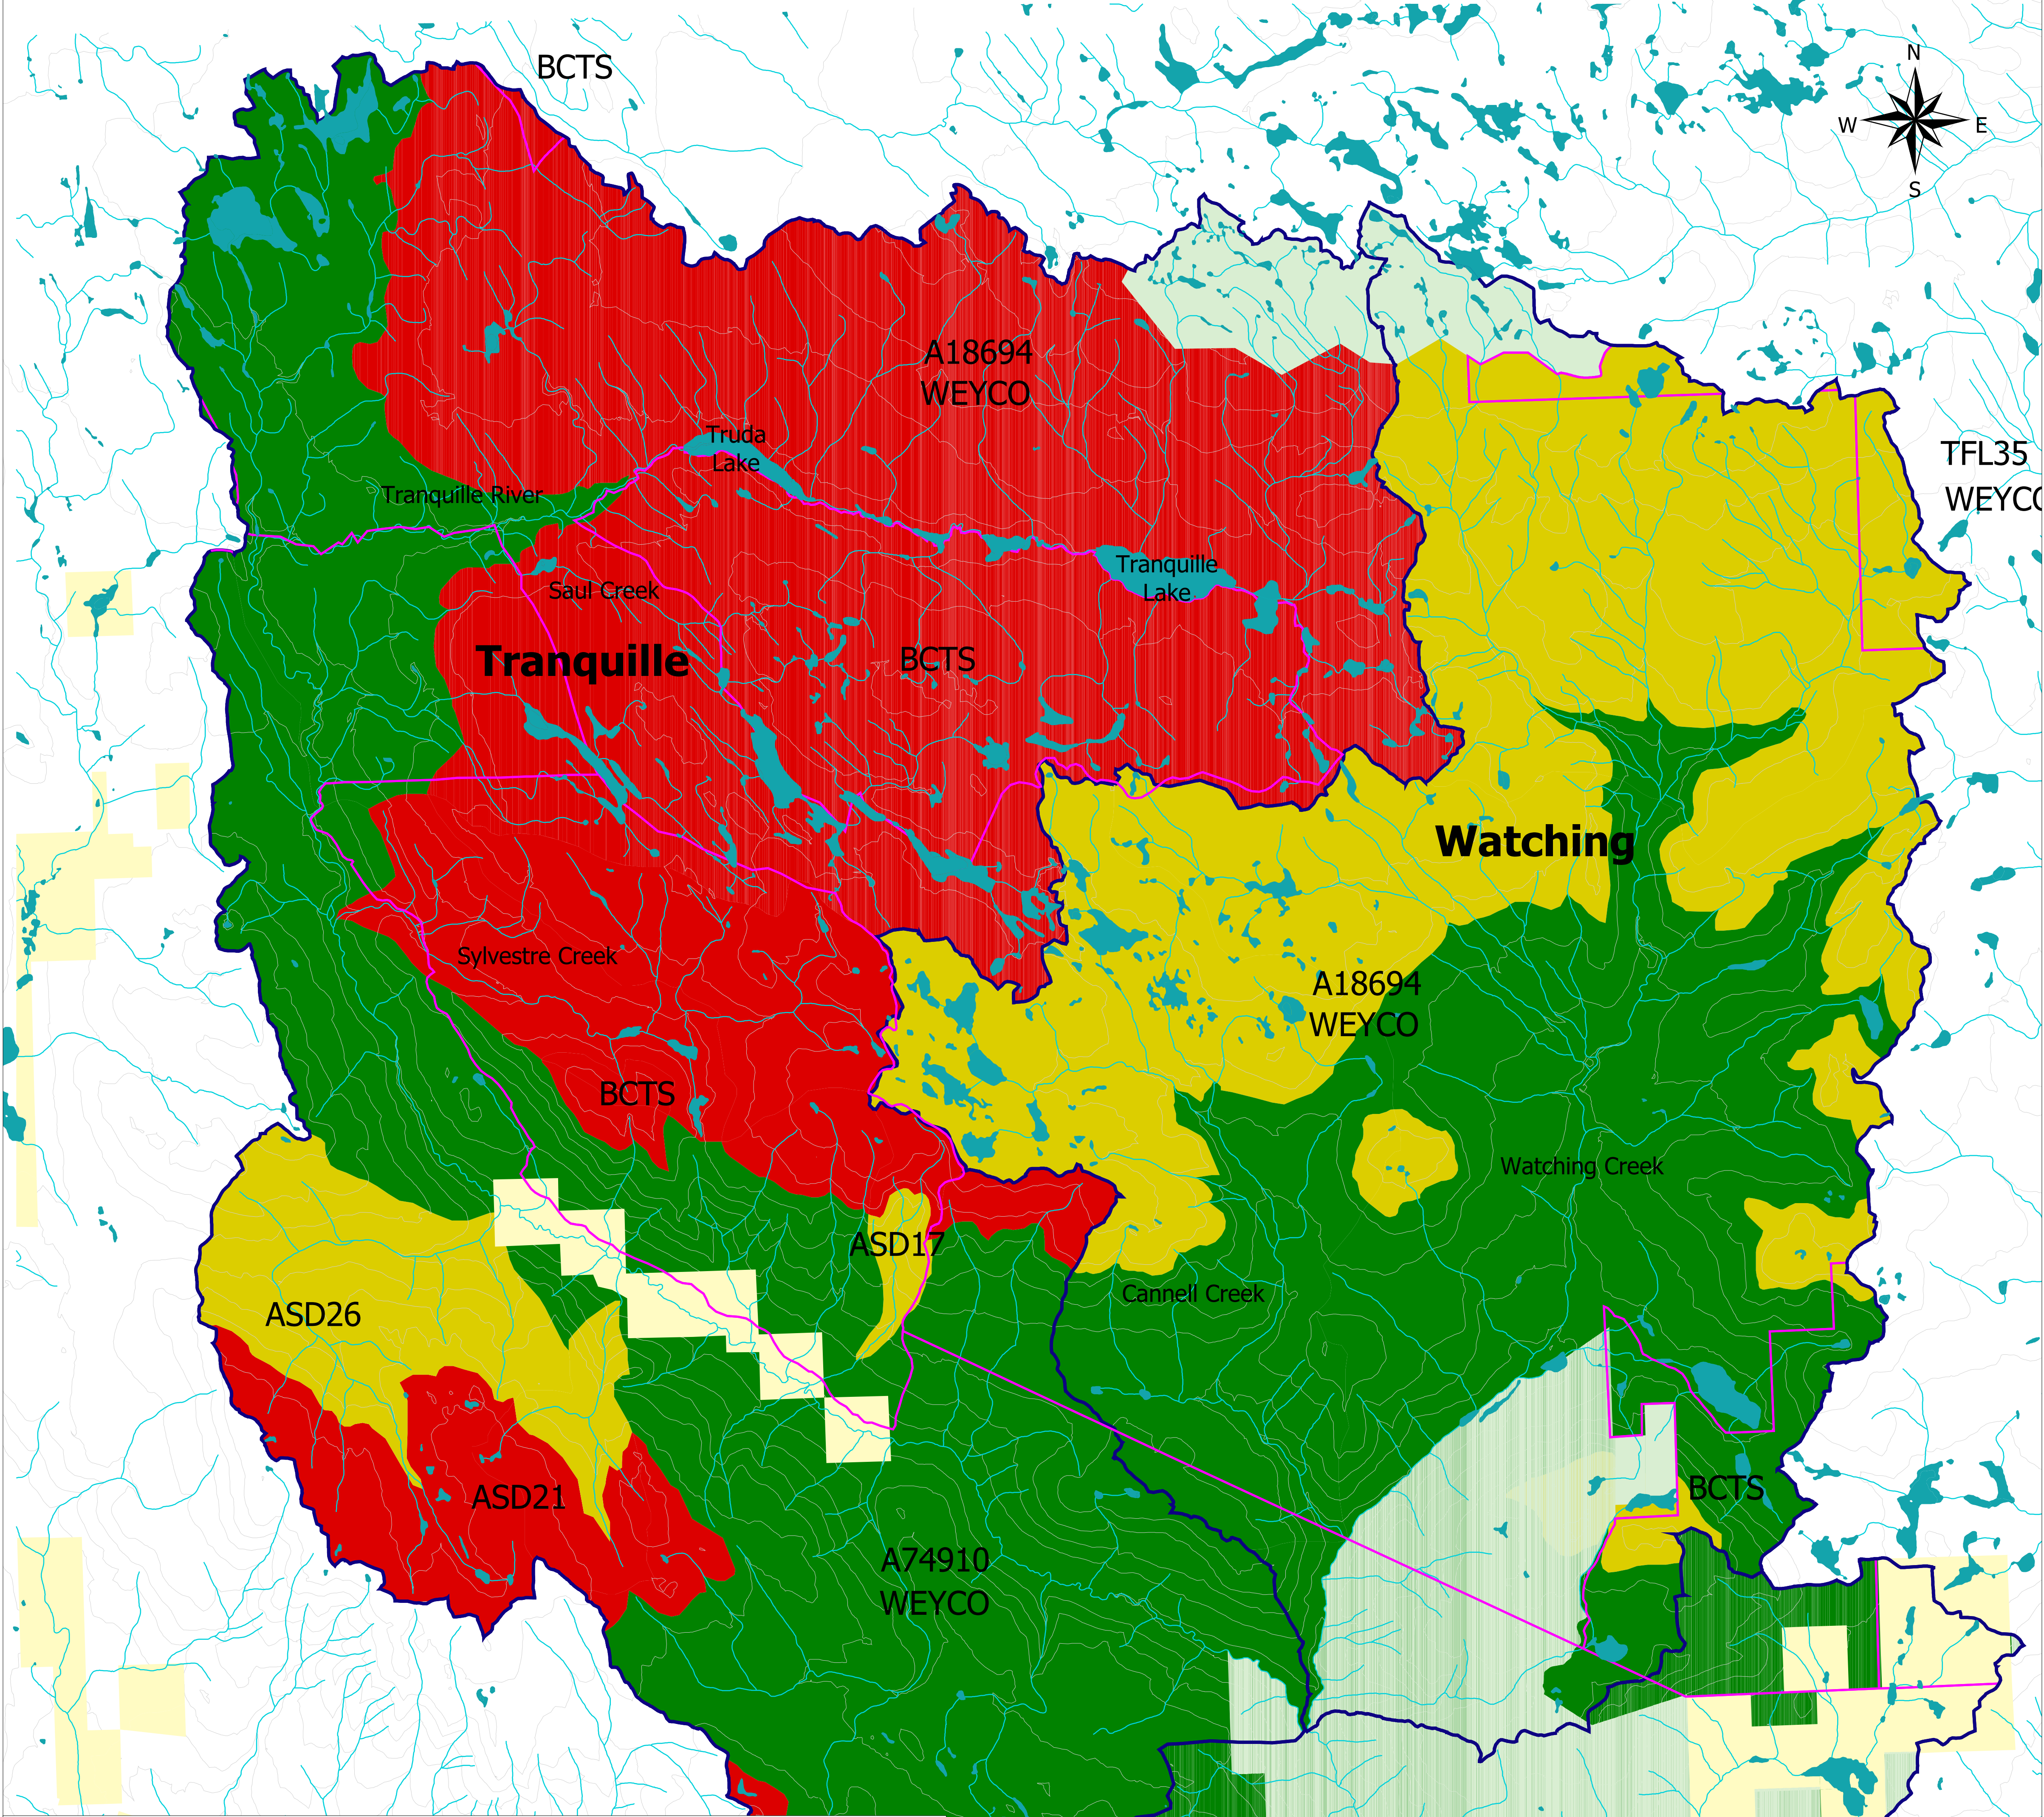
**Tranquille River - Runoff Management Map**

Area expected to contribute runoff at the time of peak flow. No salvage or green wood development at this time. Understory enhancement recommended in MPB affected stands.

Area expected to contribute runoff at the time of peak flow. Stand replacement recommended for forest health reasons - MPB or otherwise, including affected juvenile stands. Treatment is designed to advance runoff from this basin.
