A FISHERIES SURVEY OF THE
UPPER ZYMOETZ RIVER SYSTEM
(HEADWATERS TO RED CANYON CREEK)
WITH PARTICULAR REFERENCE
TO STEELHEAD AND CUTTHROAT TROUT
HABITAT AND ENHANCEMENT OPPORTUNITIES

D.H. Humphries

C. Morley

Fisheries Report No. 78-6 (S.E.P.)
B.C. Fish and Wildlife Branch
Smithers, B. C.
December, 1978

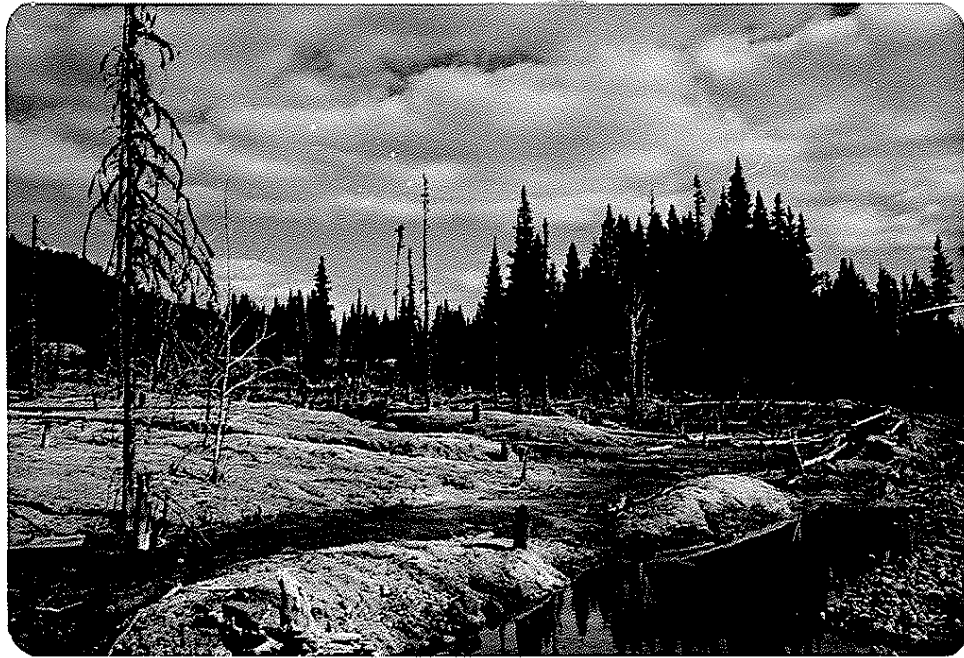
Photo 1. May, 1978. Result of drainage from tailings pond. Stream drains to Aldrich Lake.

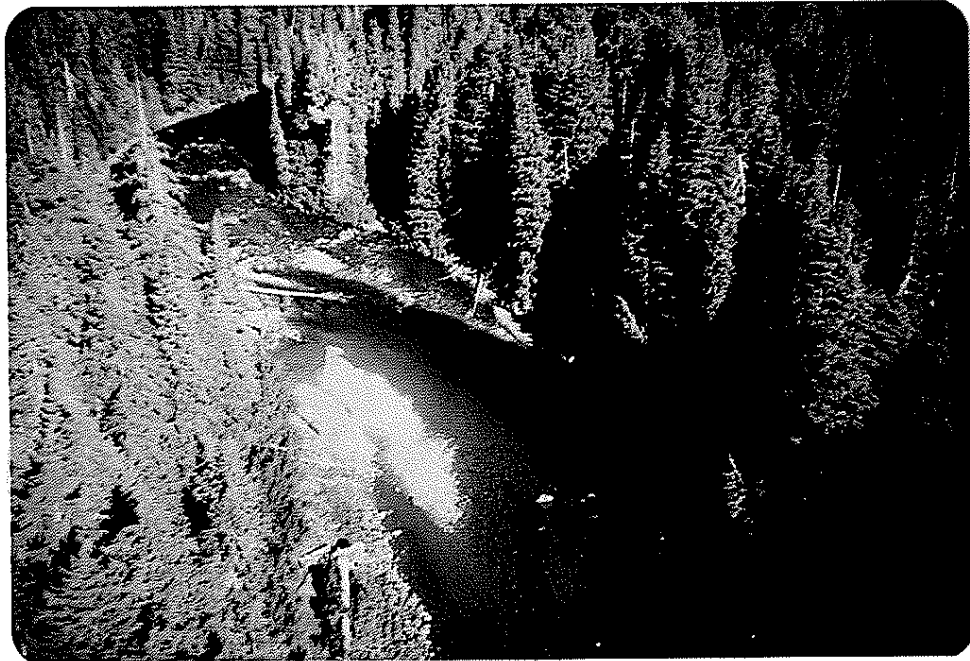
Photo 3. September, 1978. Zymoetz River. Looking upstream, note bedrock outcrop on the left. Outcrops occur frequently and create good holding water in reach A.

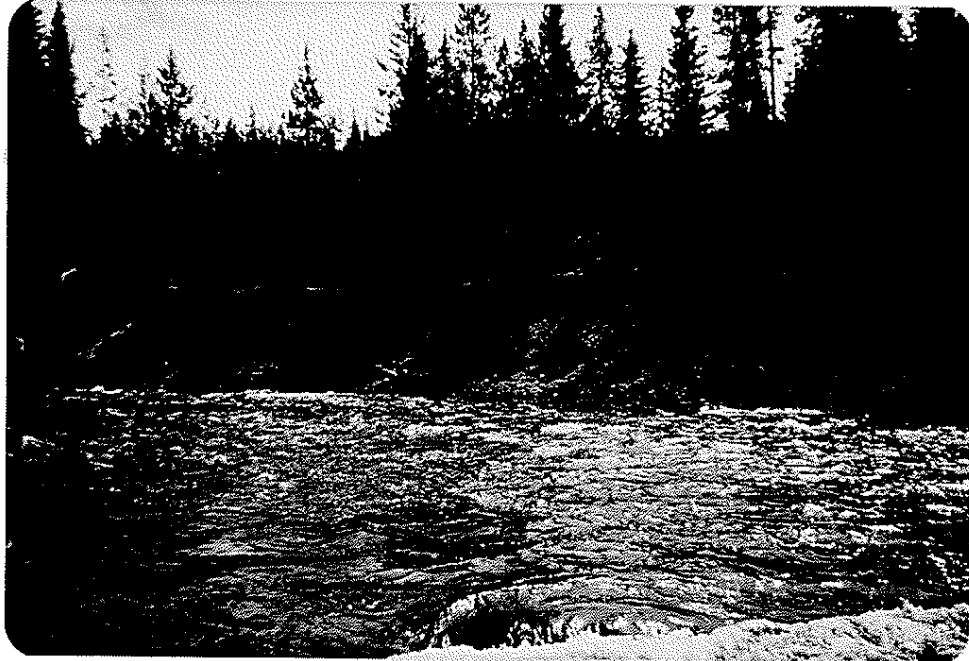
Photo 5. June, 1978. Zymoetz River in the Fisheries Closure area, looking upstream. Note course bank materials in slump.

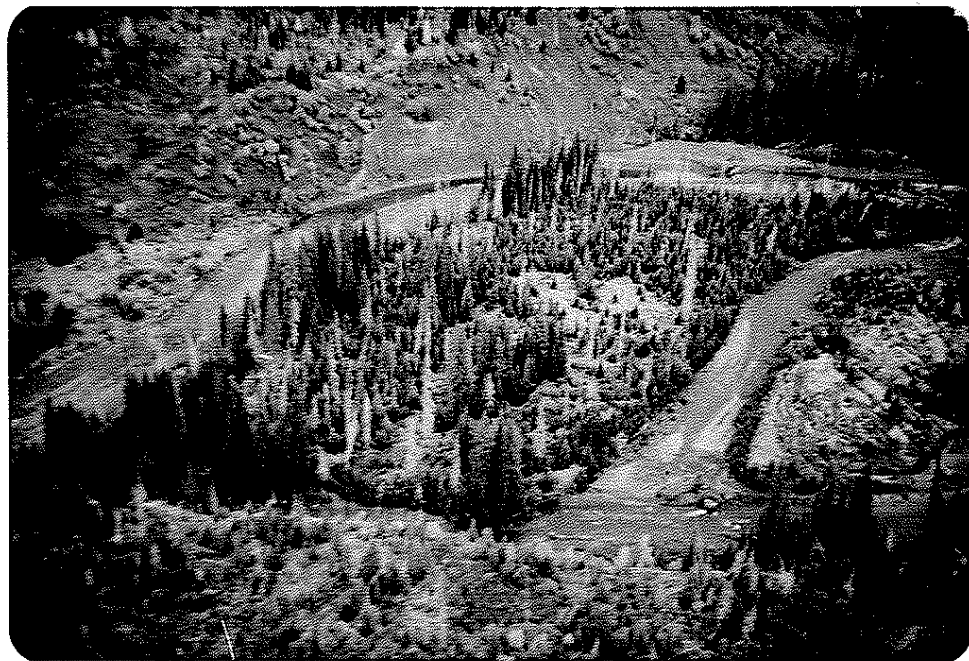
The Zymoetz forms a single channel and is occasionally confined by bedrock outcrops (Photo 3). Meander scars, gravel bars and bank slumps indicate moderate lateral channel movement (Photo 4 and 5) and one main channel diversion was seen at the mouth of Coal Creek (Photo 6). No barriers to fish passage were present. During September, the river below Serb Creek was clear and many areas appeared to have suitable gravel and water velocities for spawning coho and steelhead (Photo 7). Rearing areas and deep bedrock-controlled pools were also abundant. No fish were observed or captured in the lower reach during this time, but several juvenile rainbow trout and coho salmon fry were captured in July (Table 6).

Photo 6. September, 1978. Zymoetz River splits into two channels near Coal Creek. Main channel at bottom of photograph.

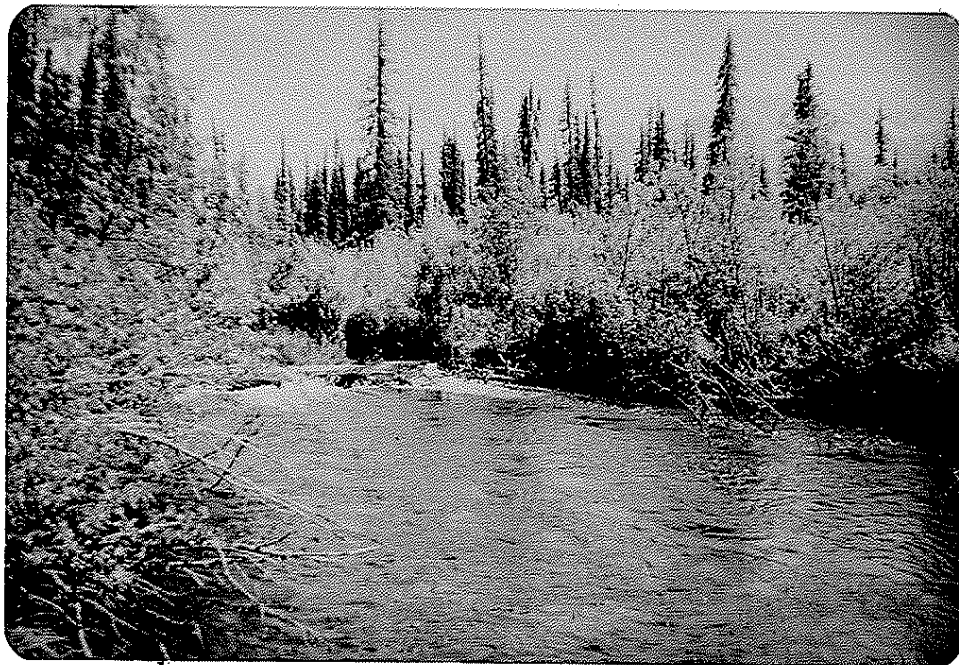
Photo 18. May, 1978. Looking upstream at first beaver dam in reach E. during high water. Dam presented barrier to sockeye in July low water period.

- Removal of beaver dams to facilitate fish passage.

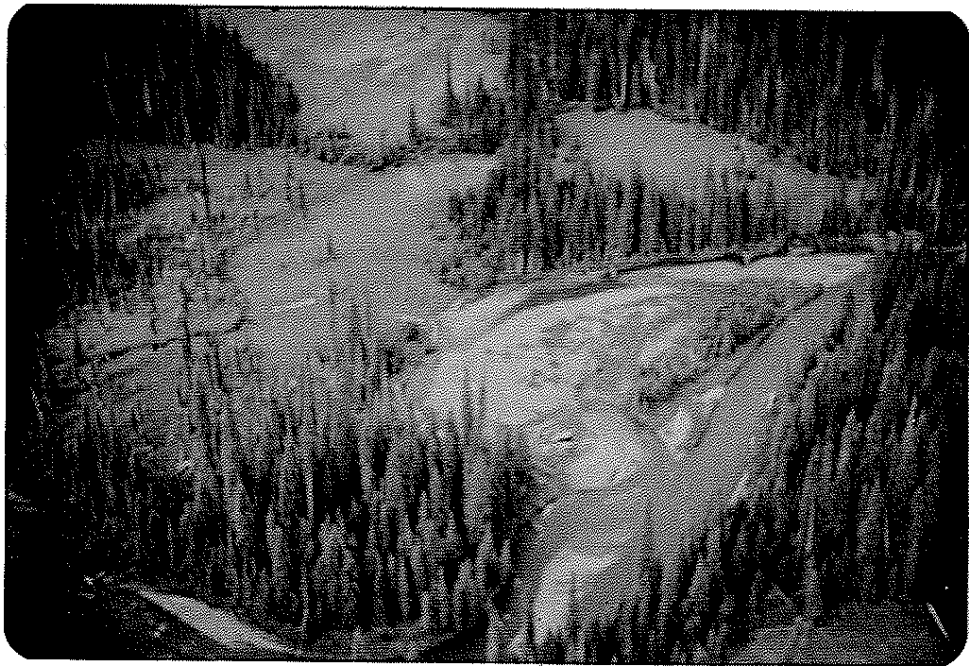
Photo 27. September, 1978. Red Canyon Creek in reach 2 flows in an irregular meander pattern, forming numerous meander cut-offs and side channels.

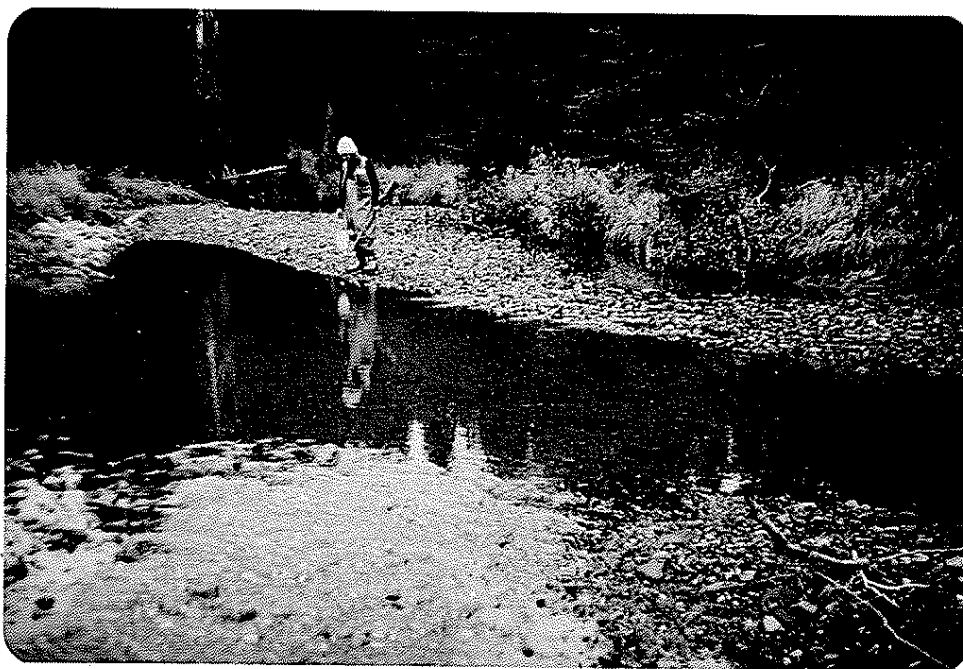
Photo 31. September, 1978. Mature Dolly Varden were captured in this side channel. The fish measured 100 mm.

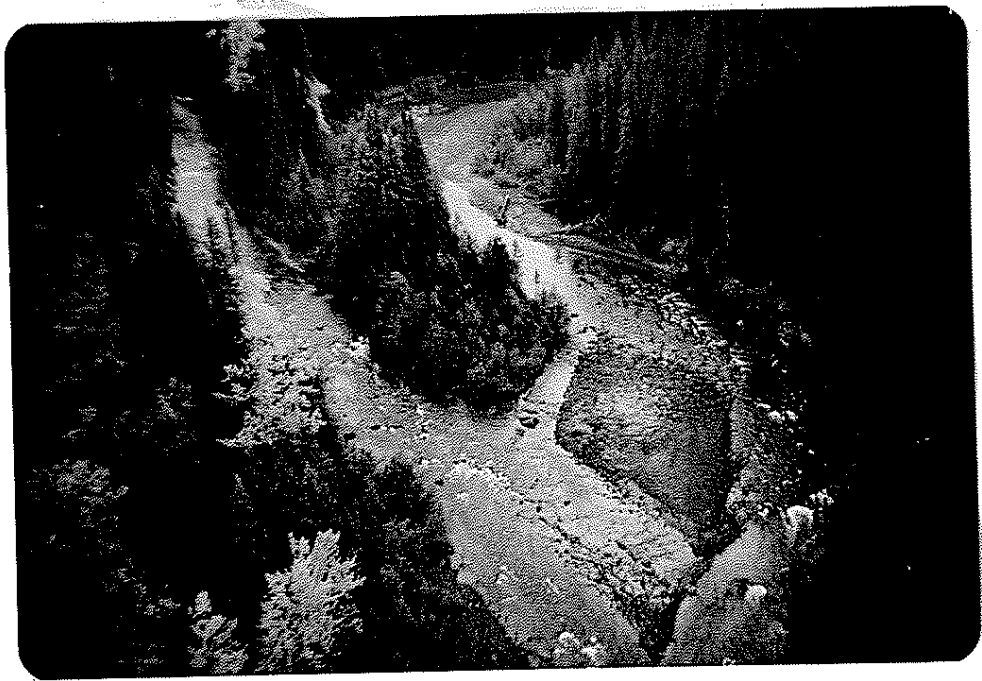
A log jam upstream from the mouth of Serb Creek has caused several small diversions of the main flow (Photo 34). The diversions indicate some instability in the lower end of Serb Creek (Photo 35). An increase in the flow through these diversion channels may result in a reduction of the quality of the large steelhead spawning areas on the Zymoetz (Figure 5, Photo 36).

Photo 35. September, 1978. The confluence of Serb Creek and the Zymoetz River, at the beginning of reach B on the Zymoetz.

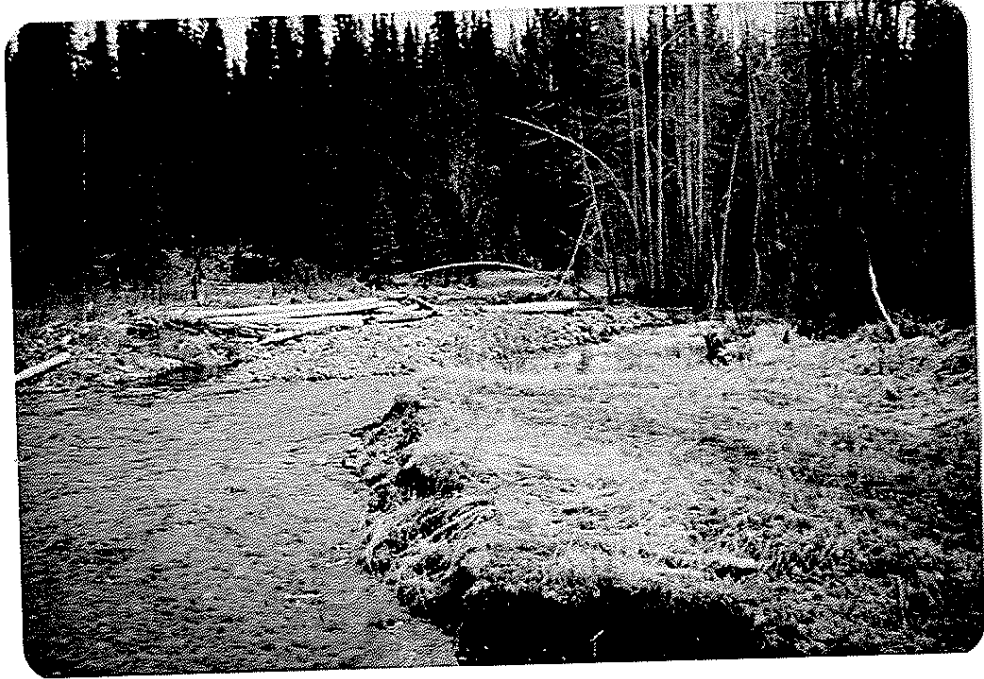
Spawning is not expected to occur in Reach 3. Rearing habitat is low to nil (Photo 39).

Photo 39. June, 1978. Reach 3 at the road crossing. Note previous channel on left bank.

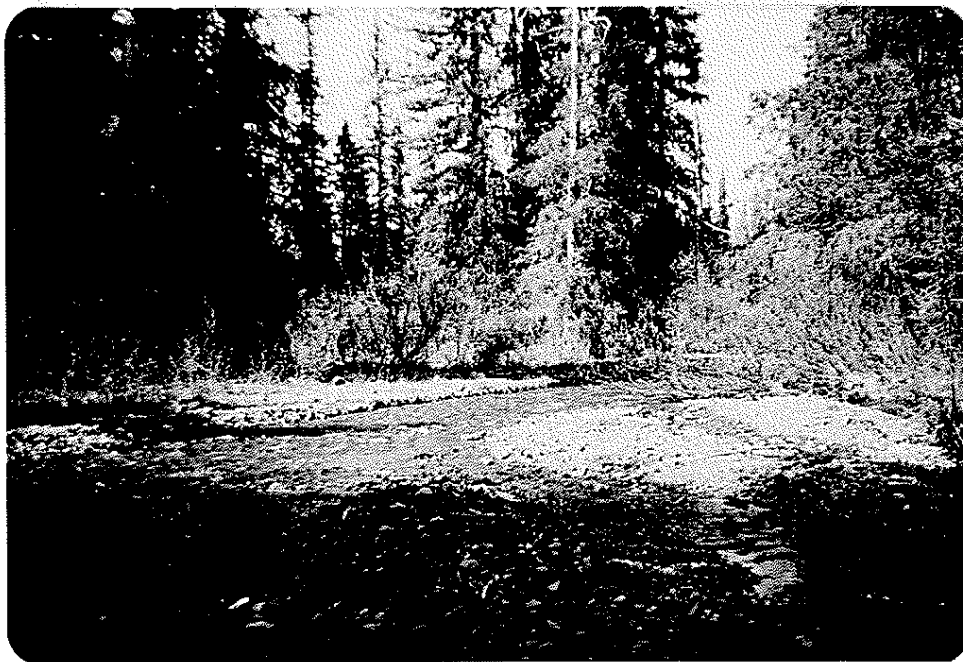
Photo 46. June, 1978. Reach 1 on Unnamed Creek #5, point sample #1. Note green algae on substrate.

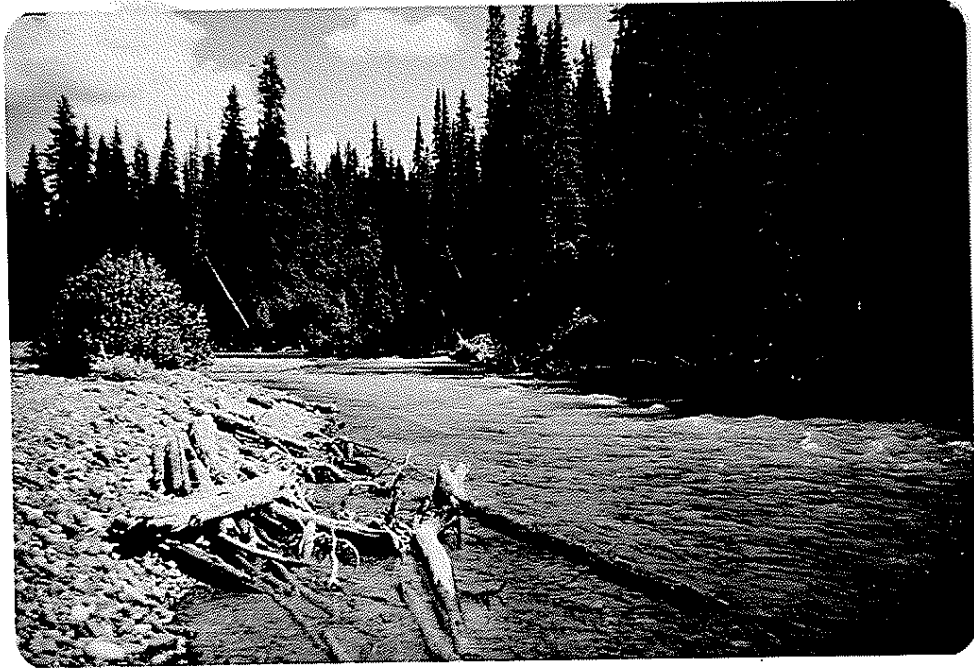
Point sample #2 on Zymoetz River, below Serb
Creek. Note glacial flour. July 1978.

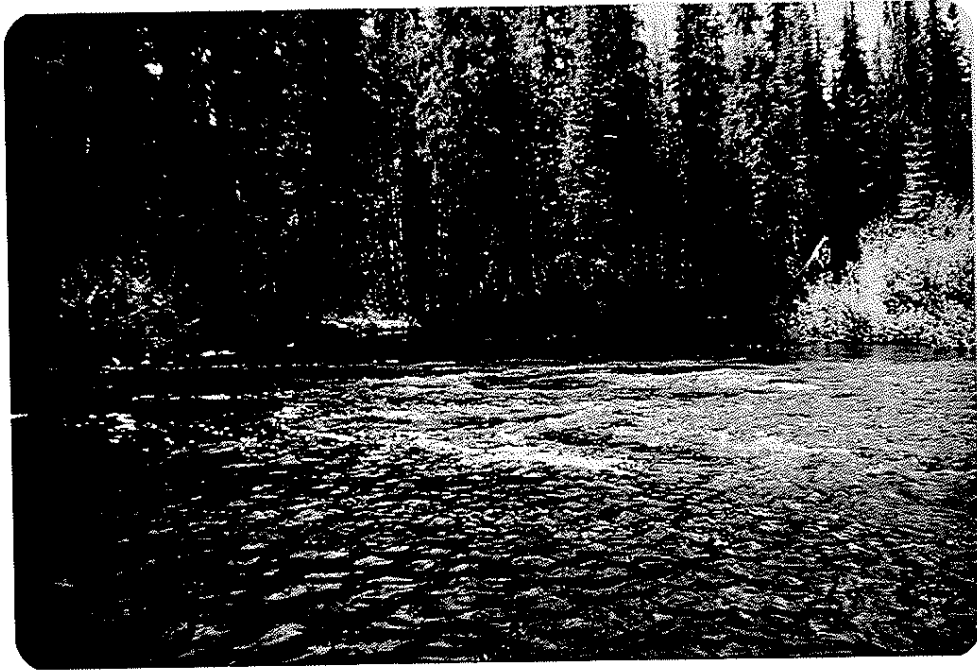
C1 Steelhead spawning area. Site visited frequently and measurements made.

Point sample #3 on Zymoetz River. Steelhead spawning area immediately below this pool. July 1978.

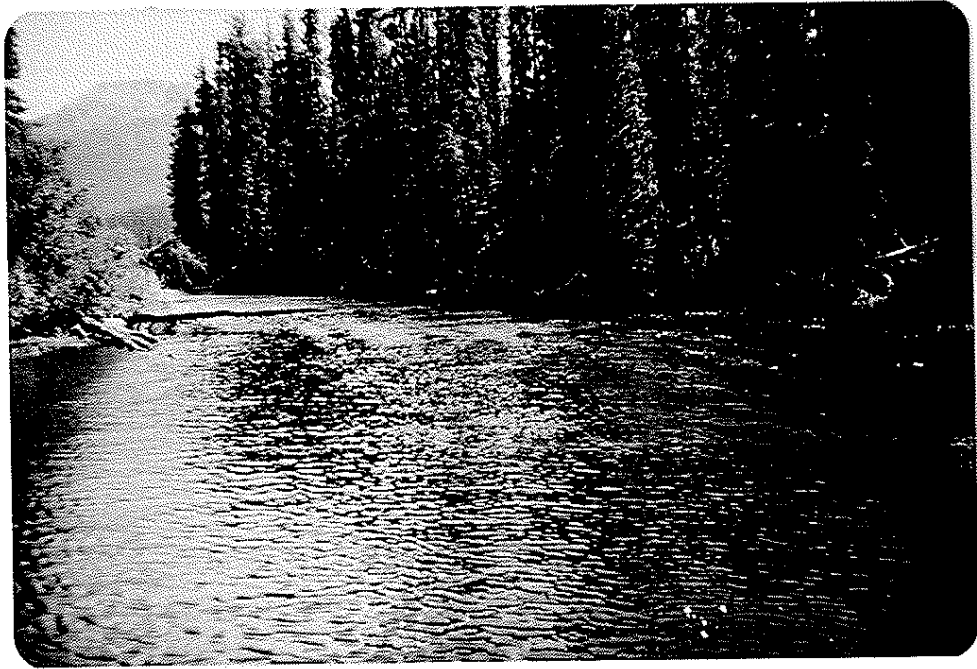
- C1 Algae is long filamentous and white. Very heavy growth immediately below Lake at Pt. sample site the growth is moderate.
- C2 Debris is from bank collapse and slumping.
- C3 30 Sthd. redds counted. Rearing habitat is good but little cover available.
- C4 Springs on left bank.

Point Sample #4 on the Zymoetz, immediately below McDonell Lake. This is a major steelhead spawning area. July 1978.

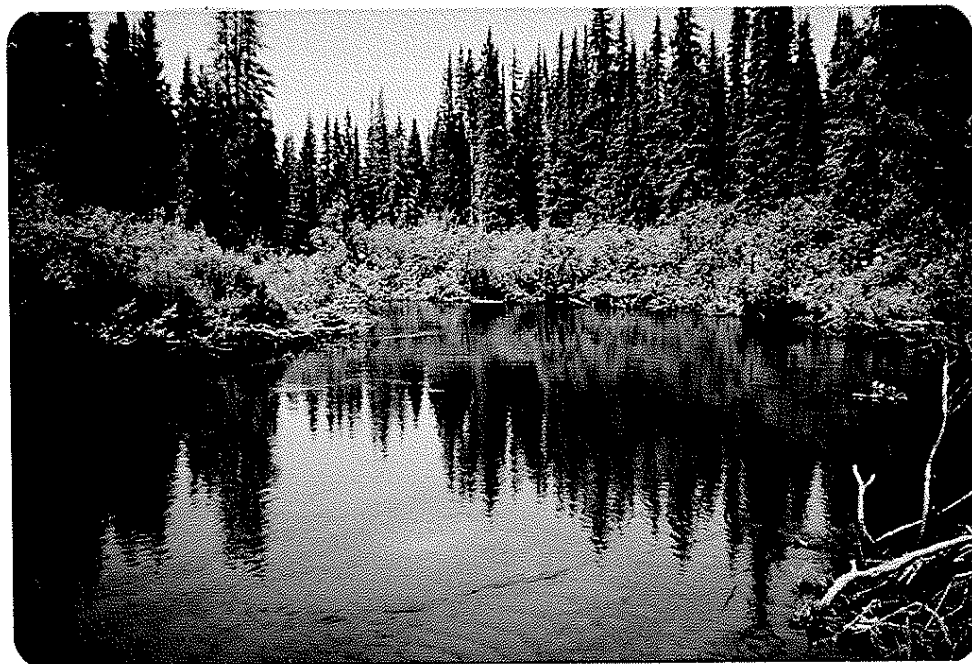
- C1 Excellent rearing habitat - deep, slowmoving water and cover (debris and vegetation). Beaver lodge on Rt. bank downstream of point sample. Seining and trapping produced Co, DV and Ct/Rb. Many Co observed. No other fish captured.

Point sample #5 in reach 'C' of the Zymoetz.
Undercut banks and overhang vegetation -
provide cover for fry. July 1978.

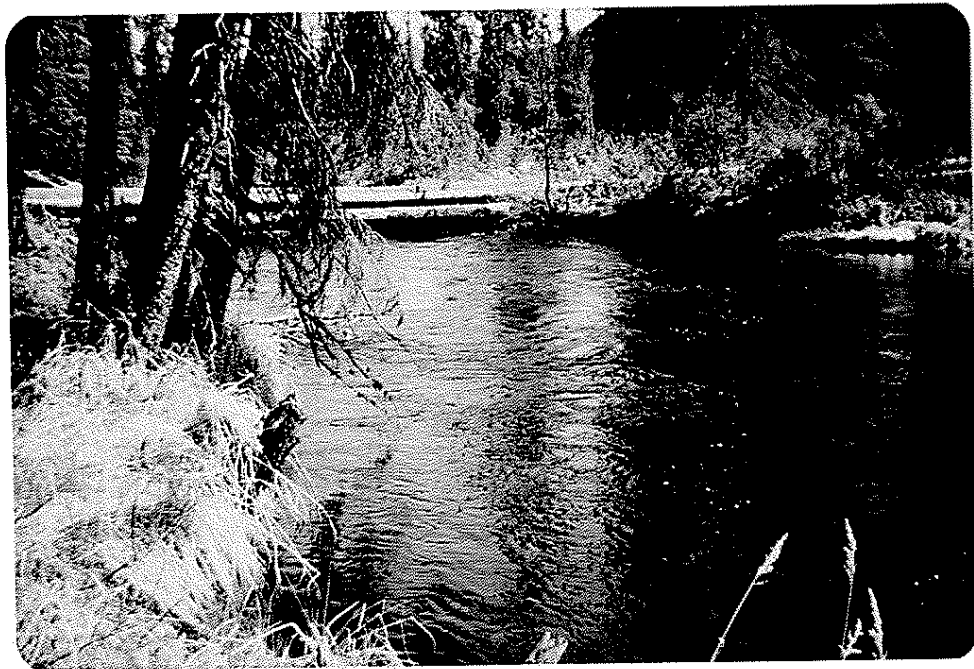
- C1 Unable to see left bank due to overhanging vegetation.
- C2 Site visited frequently.
- C3 Minnow traps, angling and observing produced the results. Appears to be used by anglers. Rearing habitat well-utilized by species indicated. Limited spawning potential immediately below bridge for Ct, DV and Rb.

Point sample #10 on the Zymoetz River. This area is accessible via an old logging road from the McDonnell Lake Road. June 1978

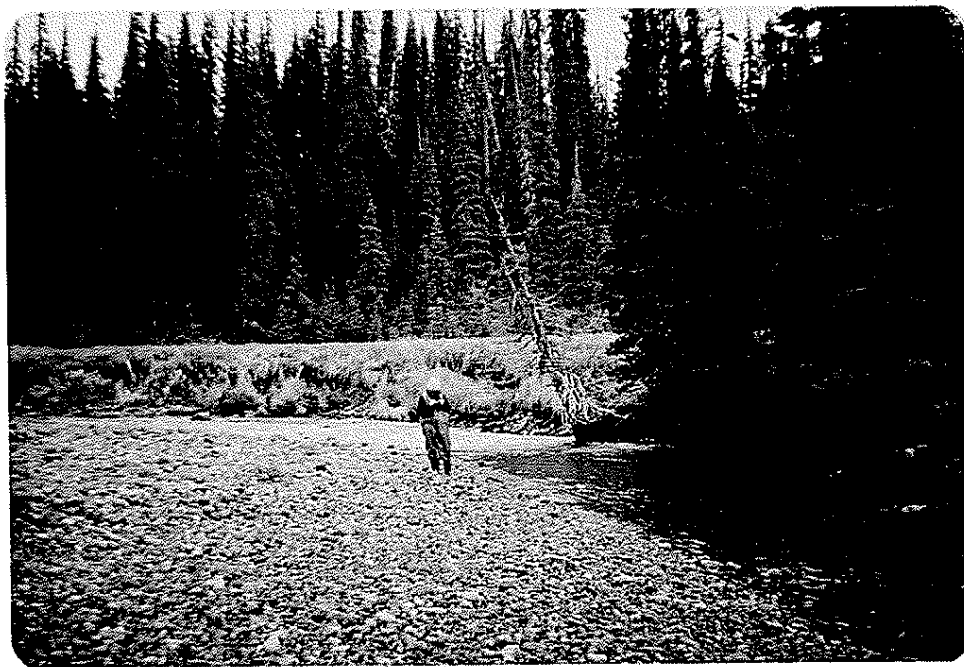
- C1 May fly larvae very abundant.
- C2 Left bank slumping.
- C3 Spawning potential good for reach, but gravel compacted at this point.

Point sample #1 on Red Canyon Creek.
September 1978.

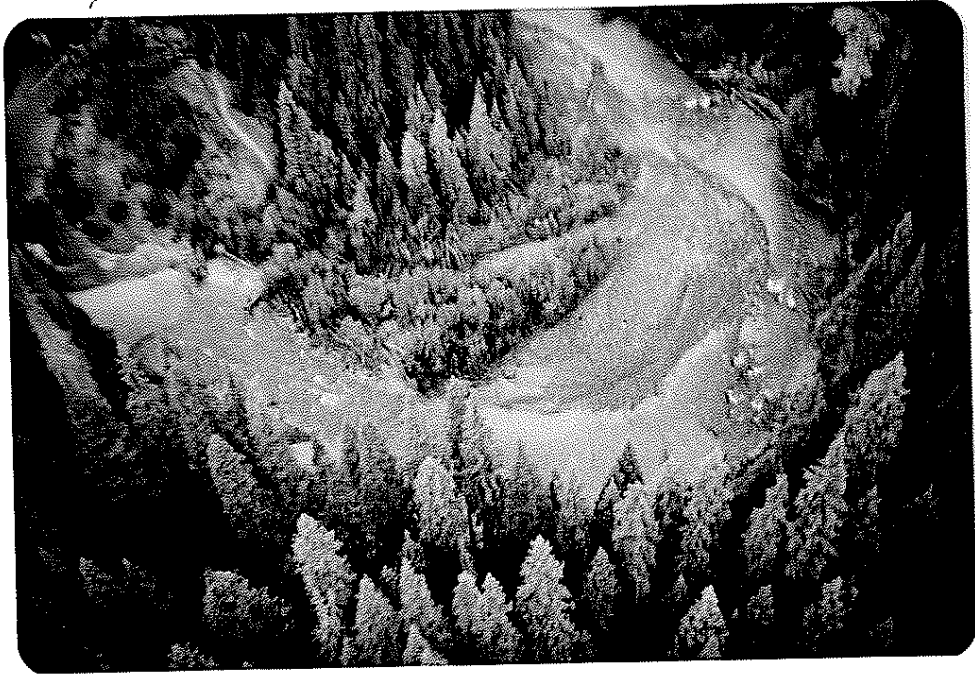
- C1 Gravel bars on both sides of creek.
- C2 Gravel bars - no overhang.
- C3 Small tributary enters on right bank.
- C4 Water is moderately silted.
- C5 No fish caught. Holding water present. Good spawning gravels but water temperature low.

Point sample #1 on Serb Creek. September
1978.
