**UPGRADE OF
TERRAIN CLASSIFICATION, TERRAIN STABILITY, SURFACE
EROSION POTENTIAL, AND SEDIMENT DELIVERY
POTENTIAL OF
TRANQUILLE-WATCHING AND PETERSON-ROSEN
COMMUNITY WATERSHEDS**

WEYERHAEUSER COMPANY LIMITED
Kamloops Operating Unit

Denny Maynard, M.Sc., P.Geo
DENNY MAYNARD & ASSOCIATES LTD.
North Vancouver, BC

March 2002

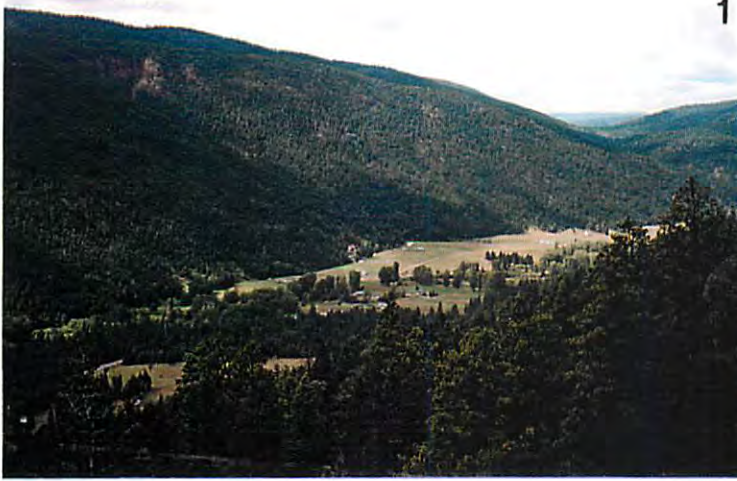
gullies, poorly-sorted deposits have usually resulted from a combination of debris flow-debris flood events which are transitional to mass movement or colluvial processes from purely fluvial activity. Sections of Tranquille River and Watching Creek have relatively broad, valley-floor fluvial surfaces (photo 1), but elsewhere on these creeks and for most of other main creeks, floodplains and low terraces are narrowly confined by high erosional scarps or canyon walls (photos 2, 16, and 18).

- Photo 1 Westerly view across mid Tranquille Valley.
- Photo 2 High bedrock cliffs dominate sections of the canyon walls bordering Peterson Creek; View of site DM 256.
