PACIFIC HYDROLOGY CONSULTANTS LTD.
CONSULTING GROUNDWATER GEOLOGISTS

July 19, 1989

Subject: Water Supply Alternatives for Timberline Ranch North
of Haney, B. C.

TIMBERLINE RANCH AREA LOCATION MAP AND SITE PLAN

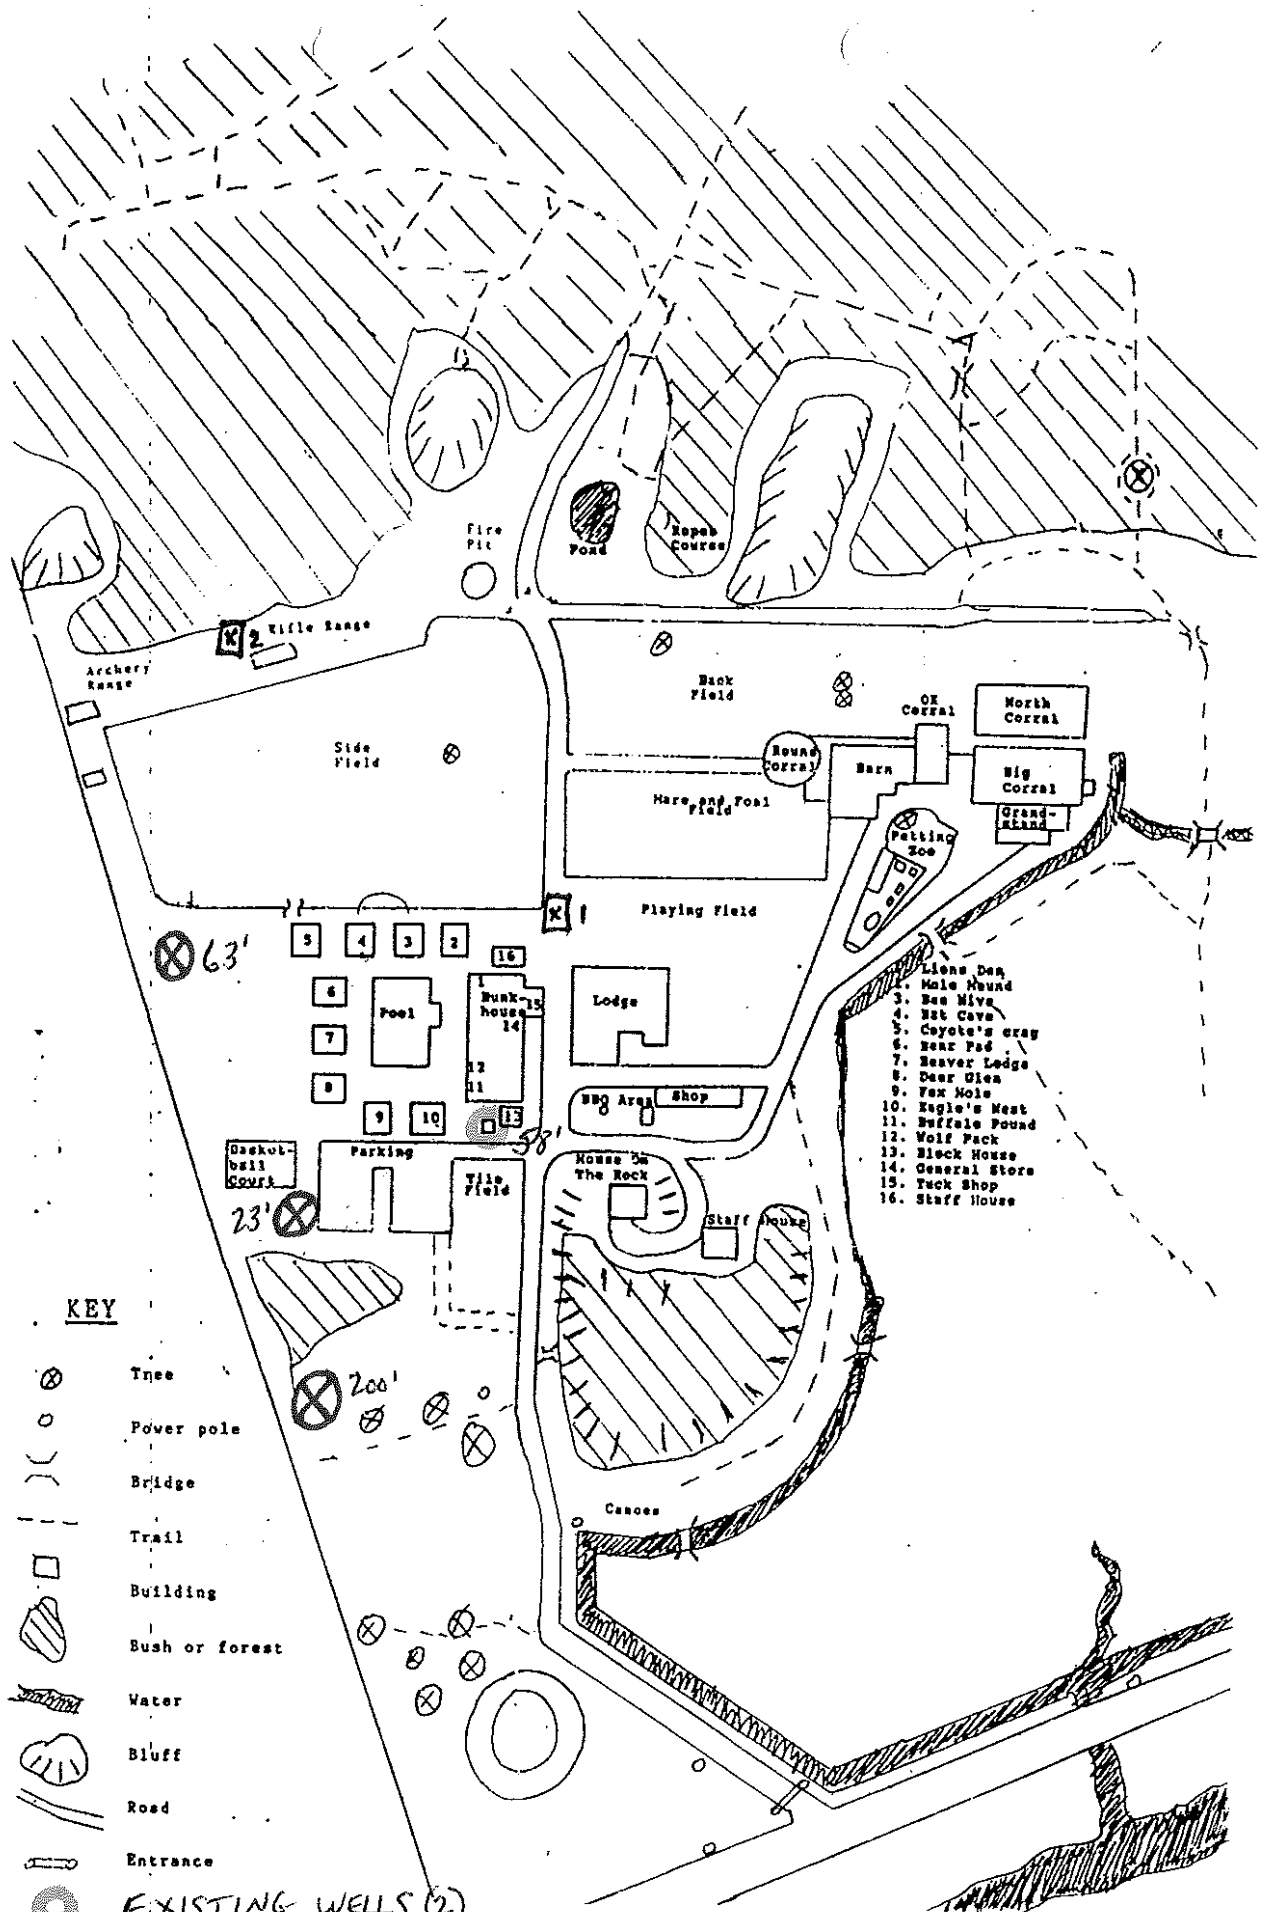
EXISTING WELLS (2)

DRY WELL HOLES

WELL ONE - GOT SULPHUR WATER (MANY YEARS AGO)

SPRING - STILL RUNNING BUT NOT NEAR AS MUCH AS IN PAST.
