LEACH LAKE 3-WAY WATER CONTROL UPGRADE

FINAL PROJECT REPORT – MARCH 2009

Marc-André Beaucher
Creston Valley Wildlife Management Area

FOR
FISH & WILDLIFE COMPENSATION PROGRAM

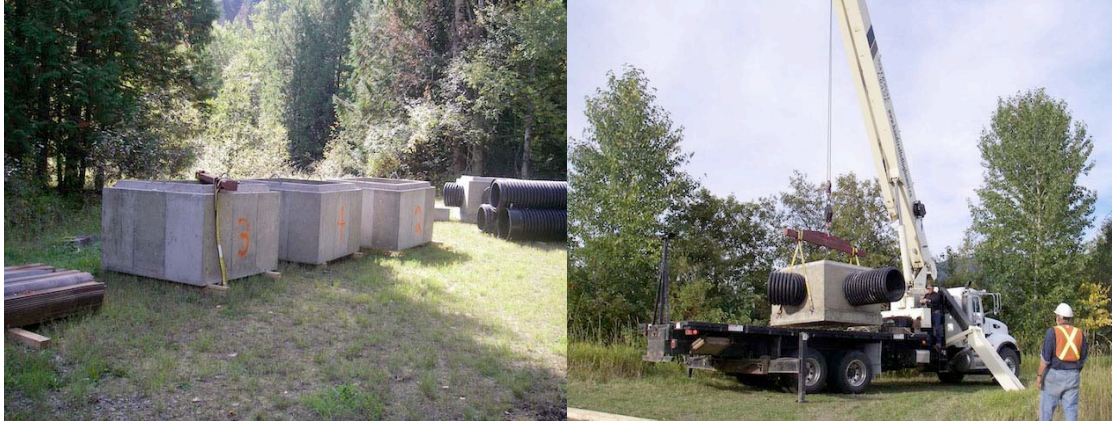
Figure 2 Water control parts (left) being unloaded at the project location (right).

Work began on 27 September 2008 when the new pre-fabricated concrete water control and high density polyethylene (HDPE) pipes were delivered and moved to the project location (Figure 2).

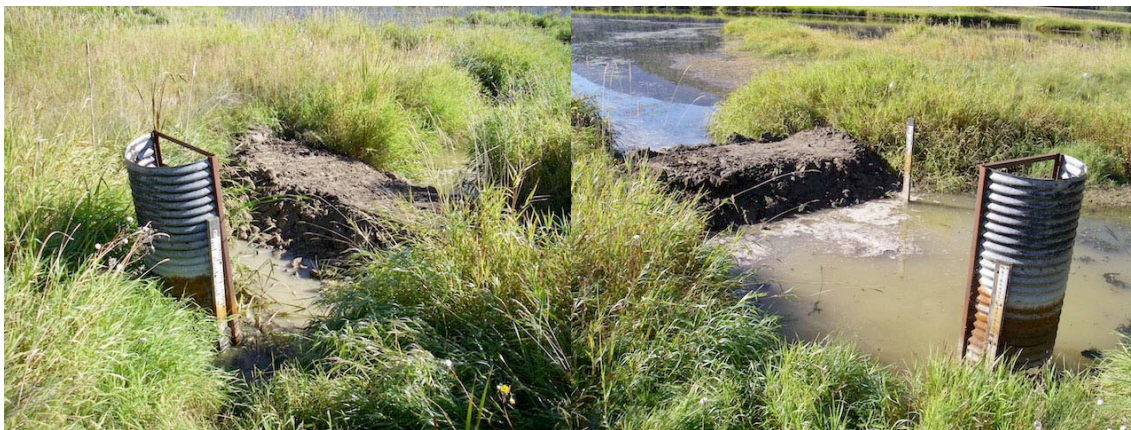
Figure 3 Earth dams built in front of outlets to pond 3 (right) and pond 4 (left).

On 30 September 2008, an excavator was brought onto the site and earth dams were built, in front of each culvert outlet, to secure the work site from water fluctuations (Figure 3). A larger and stronger earth dam was built on the Kootenay River side to hold back water level fluctuations throughout the work period. A silt fence was built to reduce siltation in the river (Figure 4). Excess water within the work site was pumped out every morning using a 3-in trash pump.

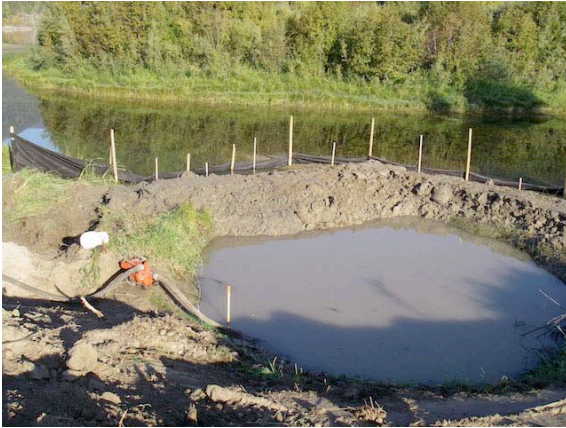
Figure 4 Earth dam on Kootenay River side and silt fence.

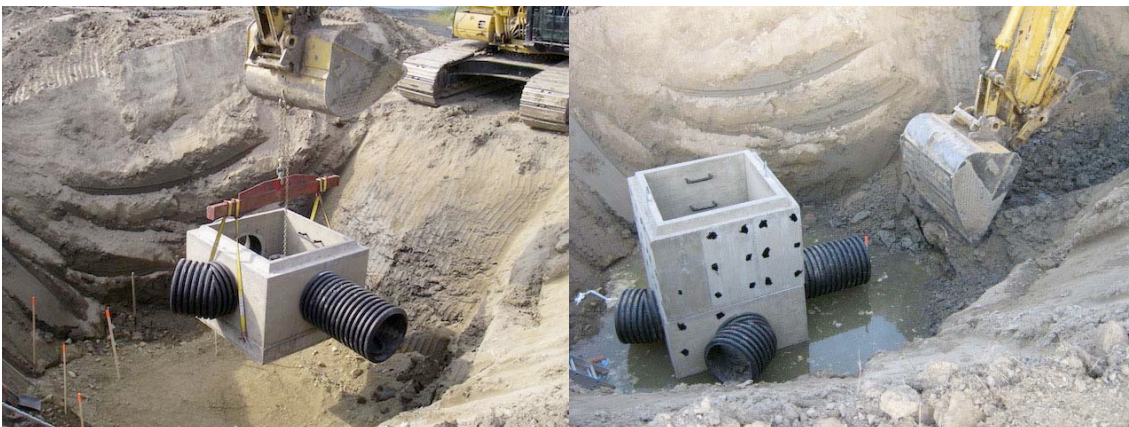
Figure 6 Main concrete control structure being put in the ground (left) and second section added (right).

The new concrete control box was put in the ground on 2 October 2008 and a second section was added to it on the same day (Figure 6).

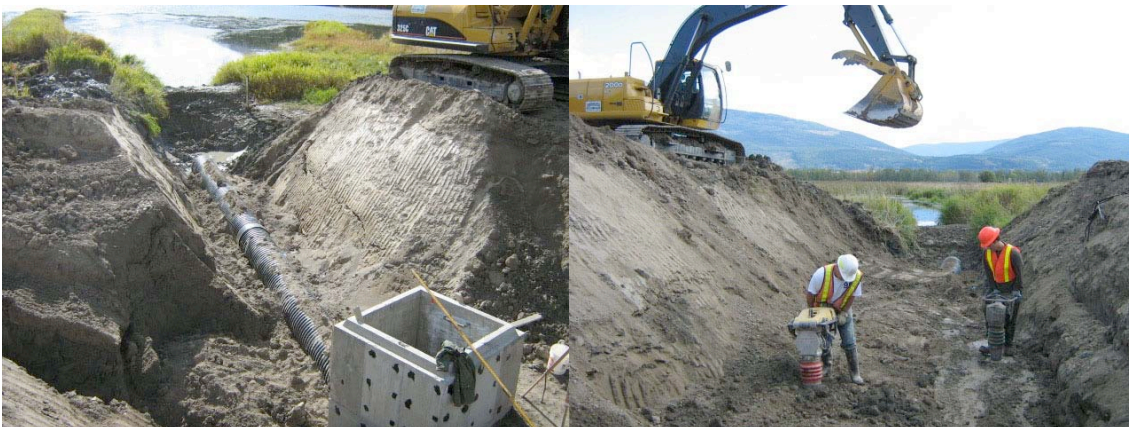
Figure 8 Outlets to pond 3 (left) and pond 4 (right) being put in the ground and buried on 7 and 8 October 2008.

On 6, 7, and 8 October 2008, the outlets from the main control to the Kootenay River, pond 3 and pond 4 were put together and buried into the ground and two more concrete sections were added to the main control structure (Figure 8).

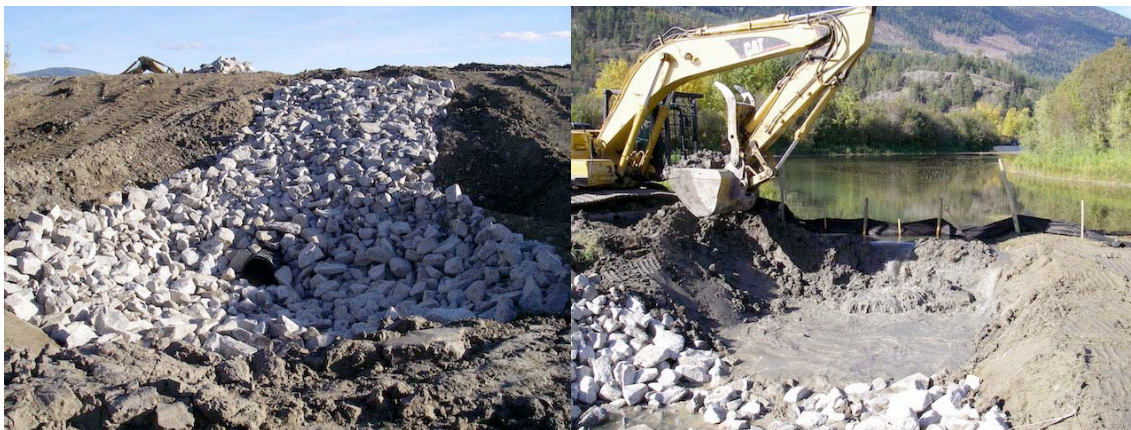
Figure 10 Riprap around the outlet to the Kootenay River (left) and earth dam on Kootenay River side being removed.

Clean up and finishing up work started on 10 October 2008 and the project was completed by 16 October 2008 when the excavator was moved out. During that period, riprap was placed on the dyke slopes around the 3 outlets to prevent erosion, and the earth dams and silt fence were removed (Figure 10). Banks were sloped and smoothed out; a lockable cover was installed on the lid hole; and 2 new staff gauges were installed near the outlets of pond 3 and pond 4. Finally, the work area was seeded over with a reclamation mix on 21 November 2008 to reduce weed invasion in the coming spring.

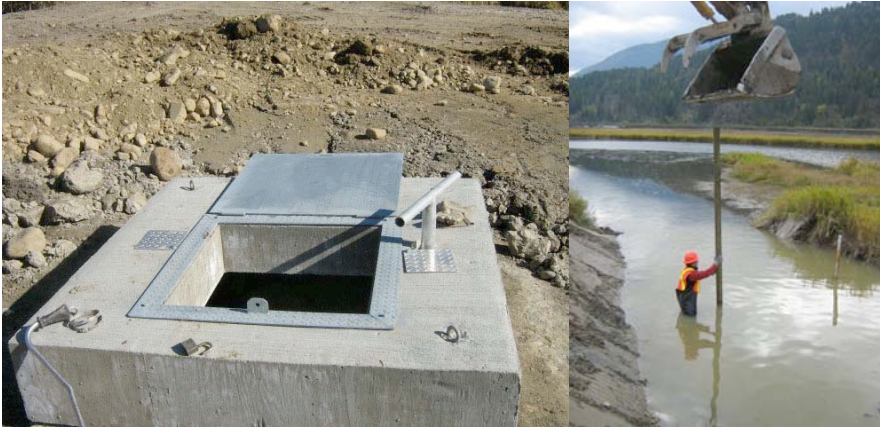
Figure 11 A lockable cover was put on the control structure (left) and a new staff gauge near the outlet to pond 3 was installed (right).
