EN12TCF048

Fish Passage Assessments - Lower Fraser Watershed Group

March 2012

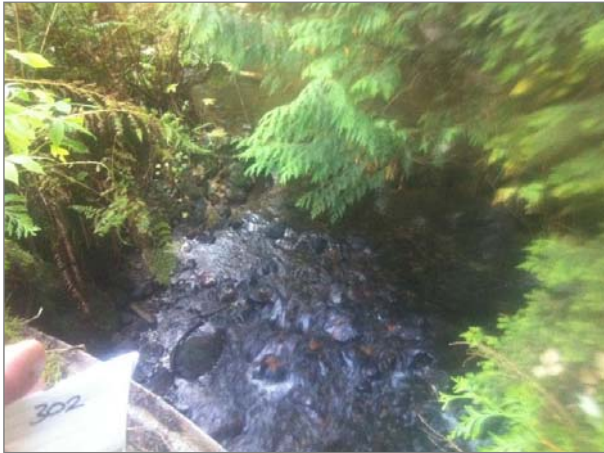
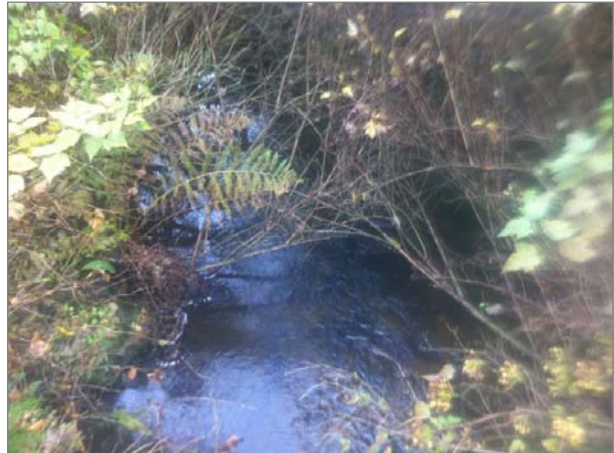
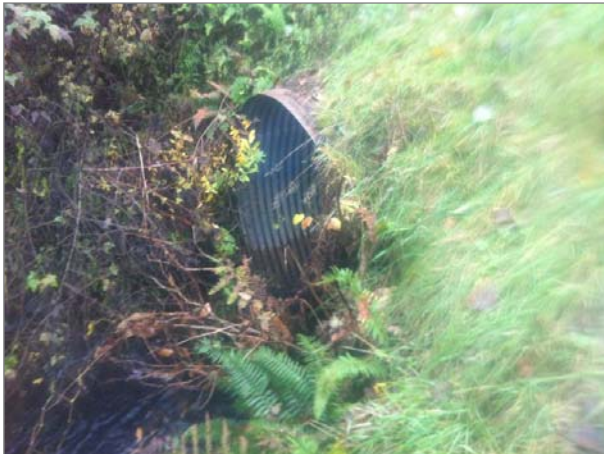
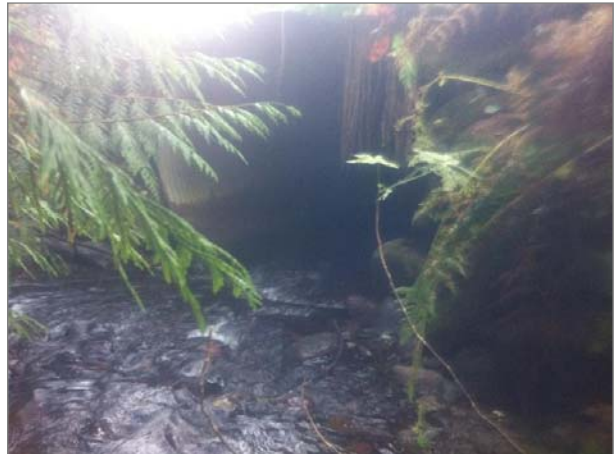
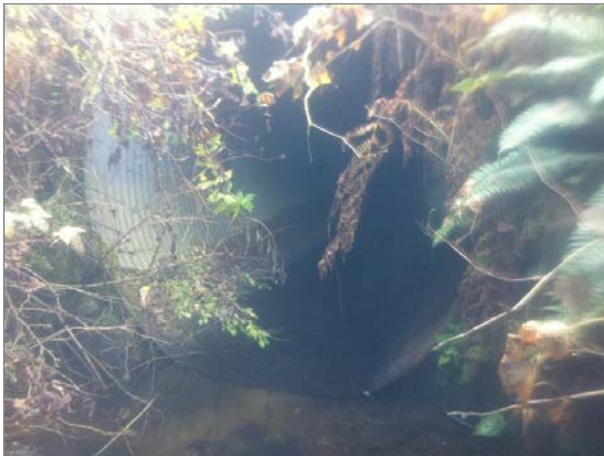
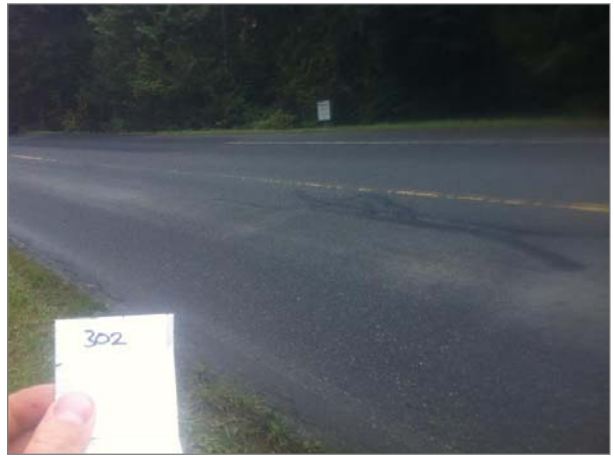
302

Fish presence not confirmed. May not be a barrier to larger fish. Hairsine provides good habitat. Looks like it might be more backwatered at higher flows. Appears to be large enough for storm flows plus capacity for internal works for streambed bedload retention. Candidate for outlet works to ensure backwatering.

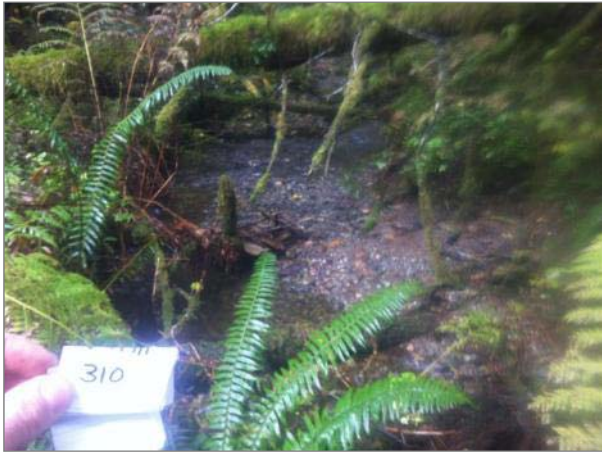
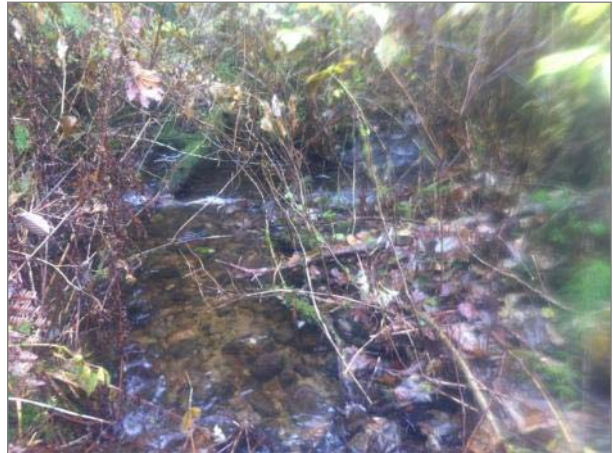
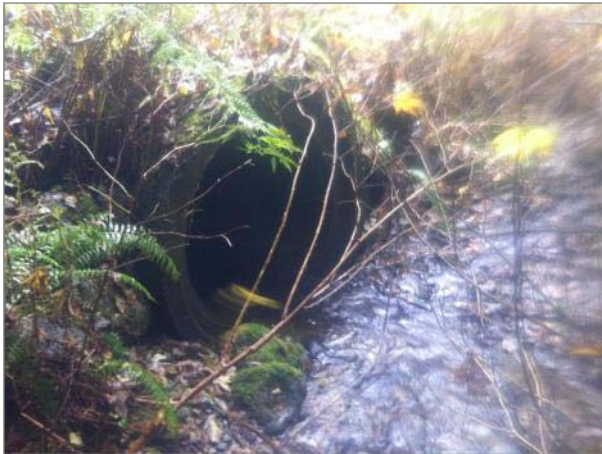
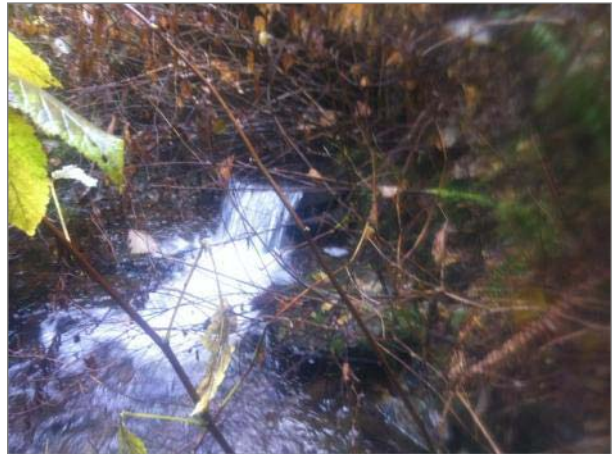
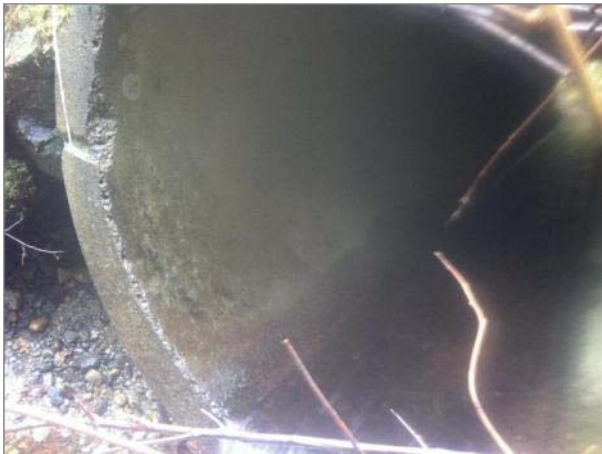
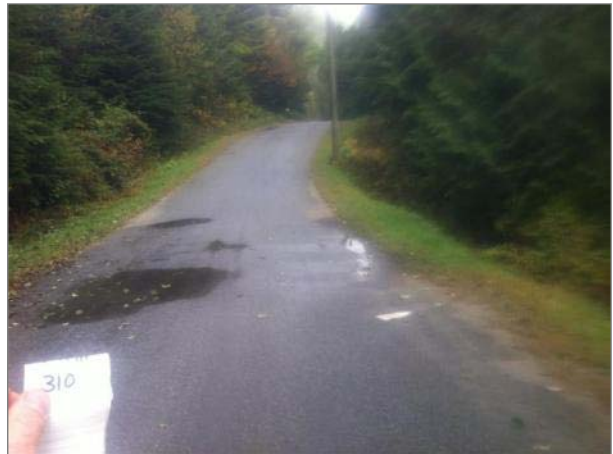
310

Spawning gravels present. Nice little stream. Not sure where it comes from. Road is downhill, north-facing with a turn immediately after the crossing, dangerous for bridge due to icing.

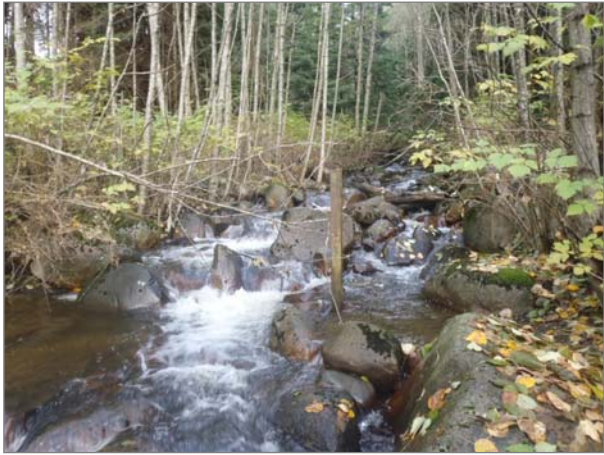
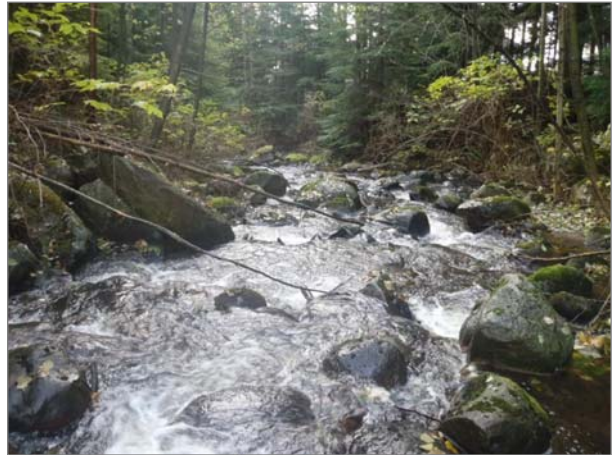
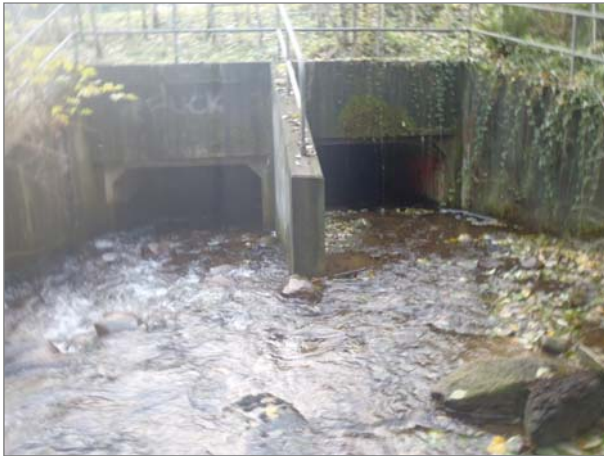
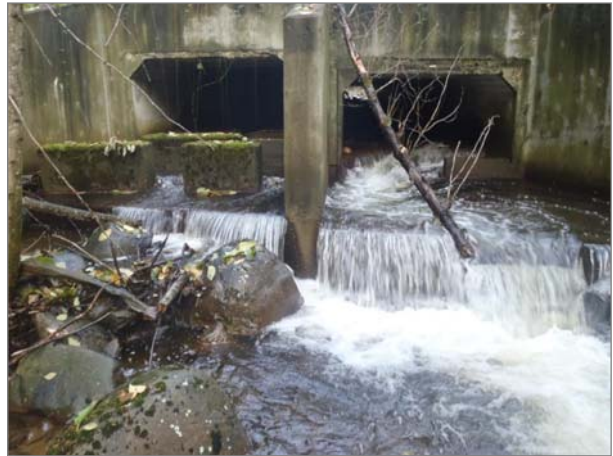
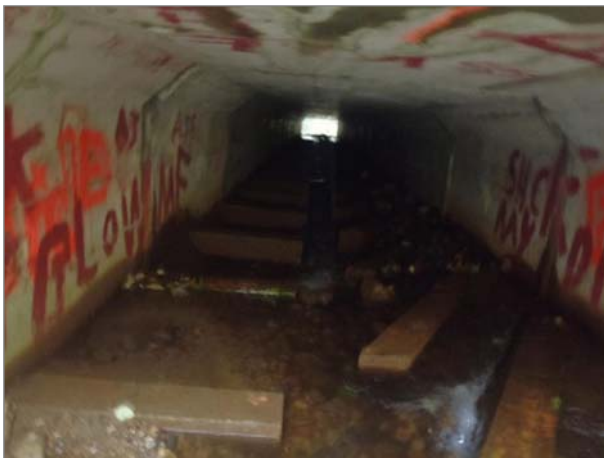
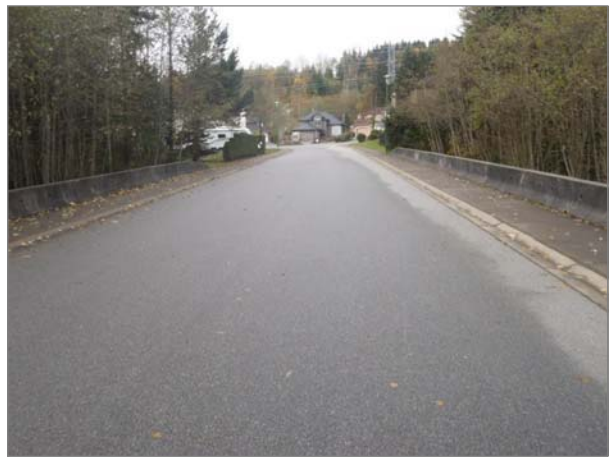
545835

Excellent habitat. Step-pool boulder morphology. Abundant deep pools, boulder cover, undercut banks and overhanging vegetation. Baffled structure with outlet controls. Drop at outlet is barrier to small fish. Structure has baffles. Could make one culvert accessible to fish, the other for stormflow water flows (dedicated flow side). Candidate for outlet weir works and substrate addition.

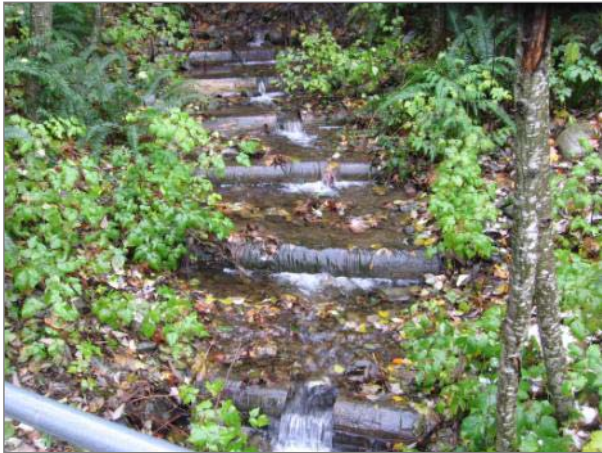
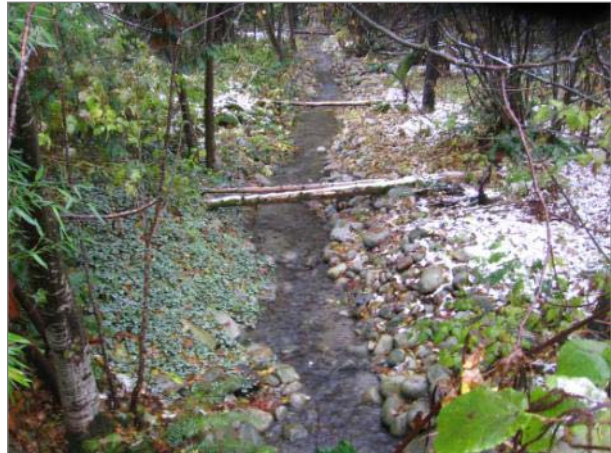
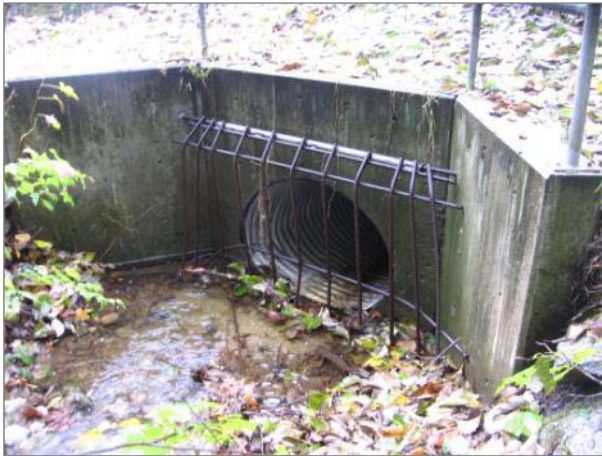
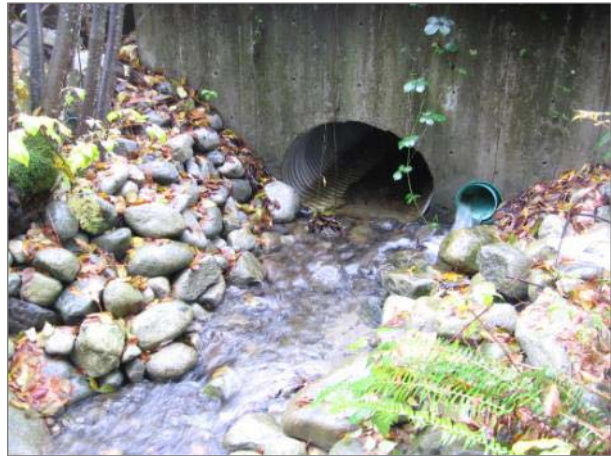
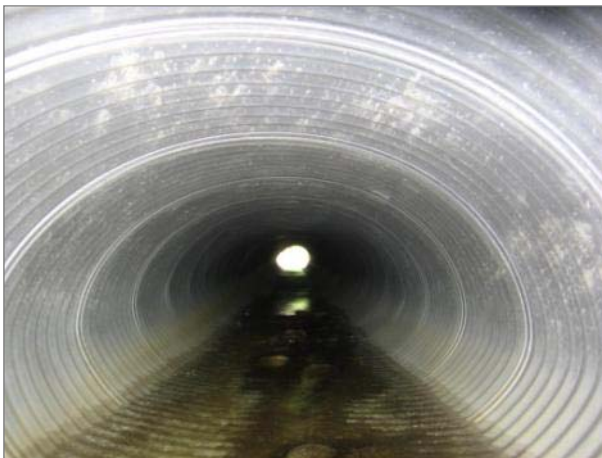
546179

Excellent spawning habitat. Log structures built into stream to form spawning channel upstream. Downstream is channelized with river rock. Candidate for open bottom arch 1800 X 900.

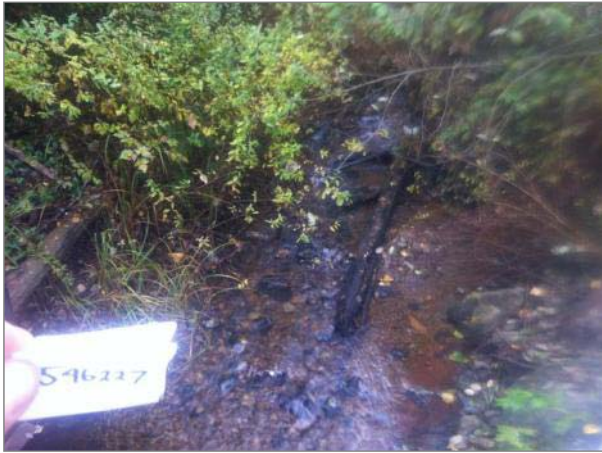
Upstream View

Some odd baffles present in culvert. Nice looking stream above. Good size and flow. Fish presence not confirmed. Candidate for outlet weir and substrate addition.

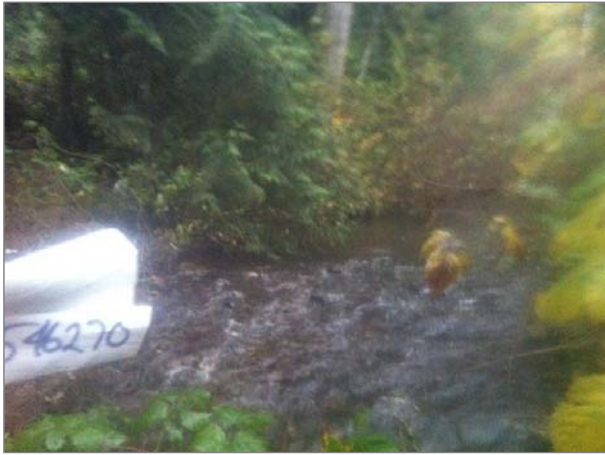
Upstream View

May allow passage for larger fish. Crossing is Steelhead Creek. Excellent habitat. Candidate for streambed retention structures in the CBS, likely at haunches. Pipe large enough to work in safely and large enough for stormflows (P Eng to certify).

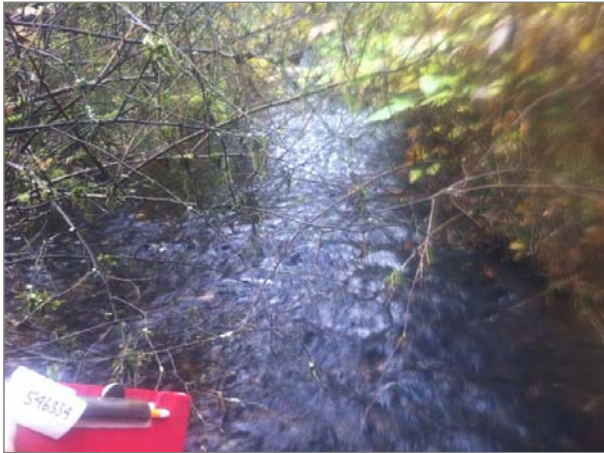
Upstream View

Probably passable to larger fish. Nice habitat u/s and d/s. Structure is old but remaining life of 25 years expected. Size of structure and apparent lack of high water flows due to gentle gradient make structure candidate for substrate addition and backwatering.

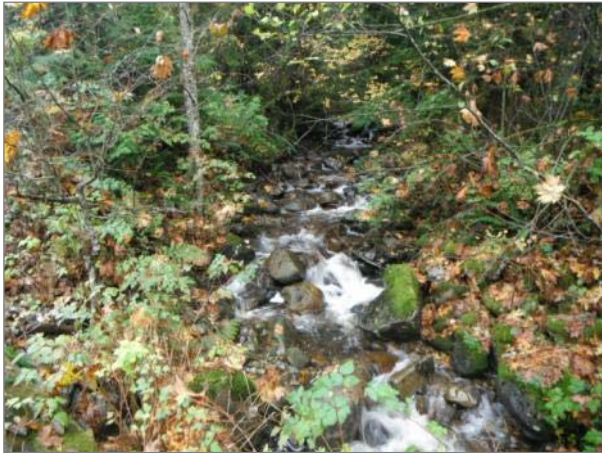
Upstream View

Excellent habitat. Abundant cover in the form of boulders, deep pools, overhanging vegetation. Some pockets of gravel present. candidate for concrete panel bridge

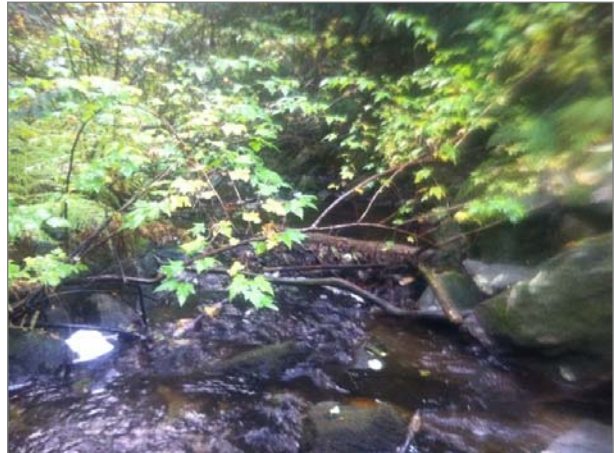
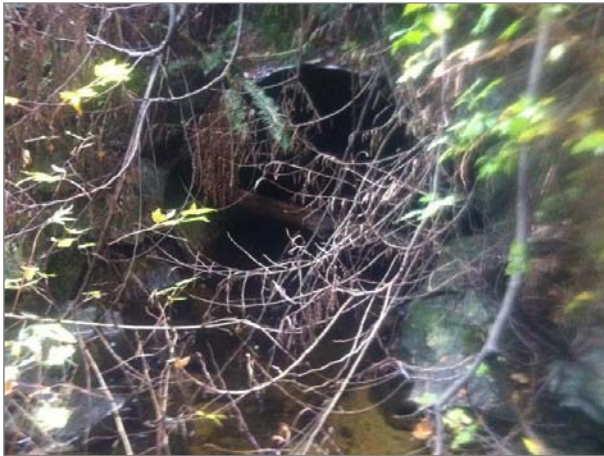
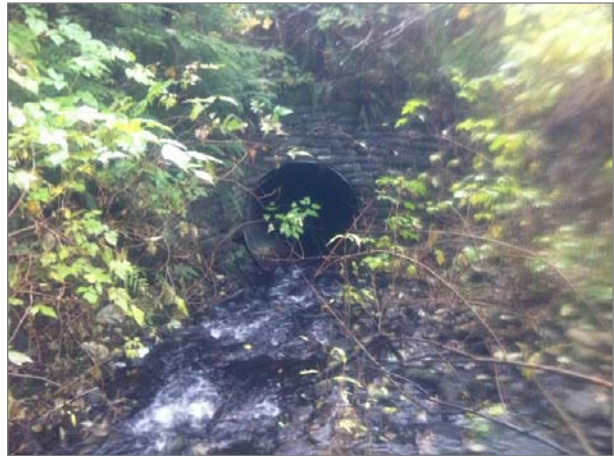
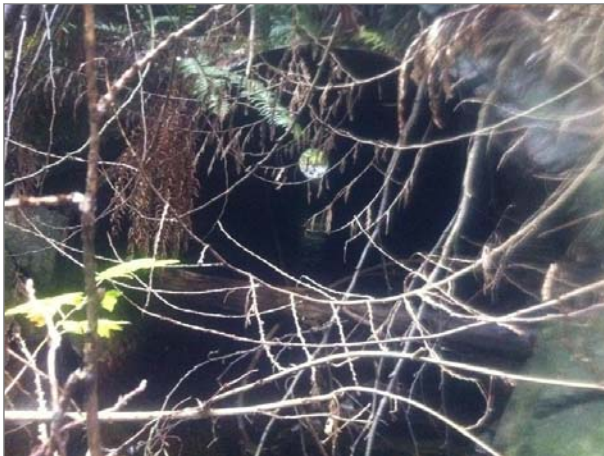
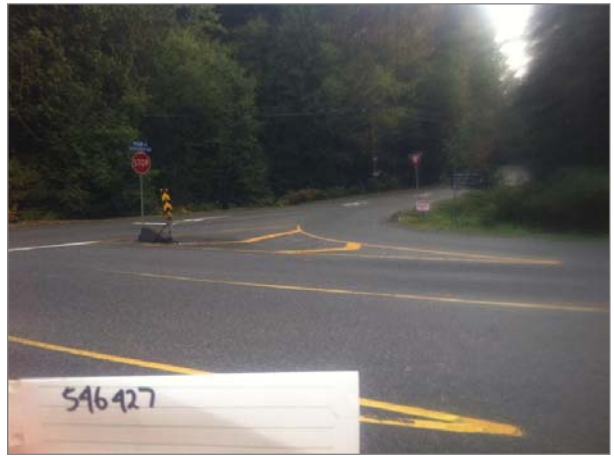
Beaver dam u/s at manmade rock groin. Nice ponds u/s. Cutthroat reported upstream. Candidate for backwatering. Ultimately replace with open bottom arch (3.4 x 30 m).

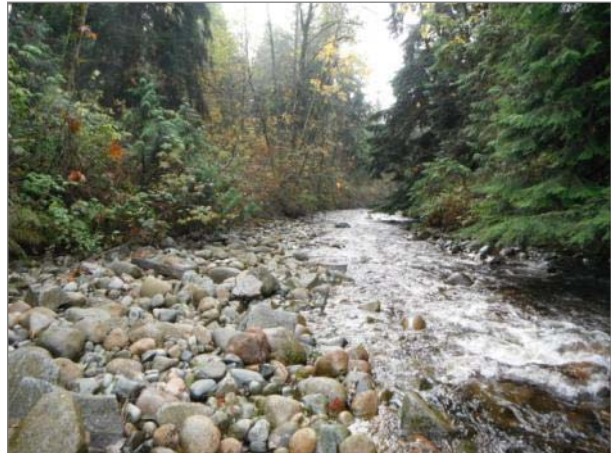
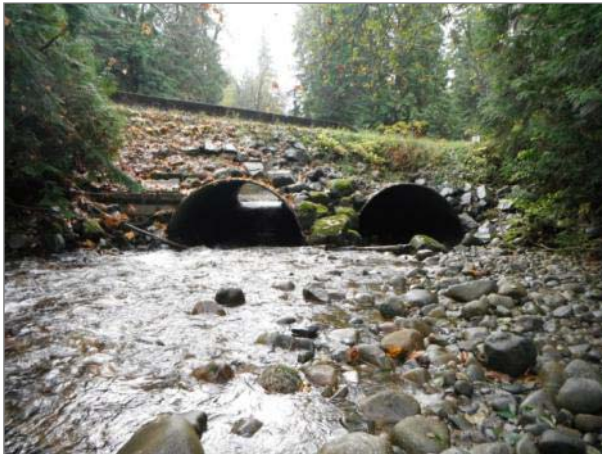
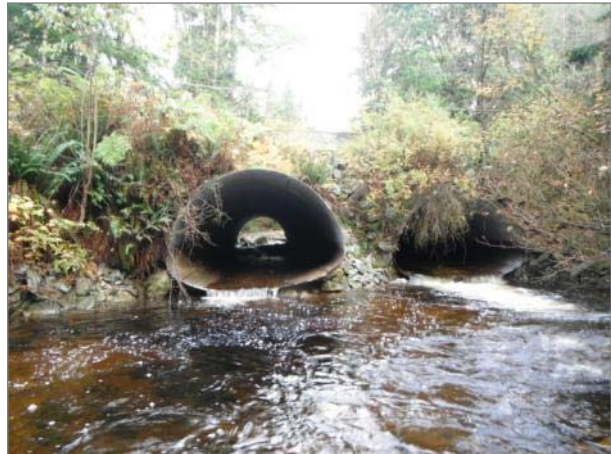
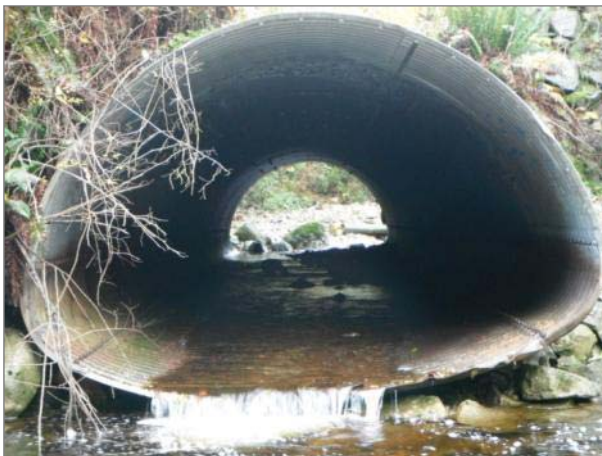
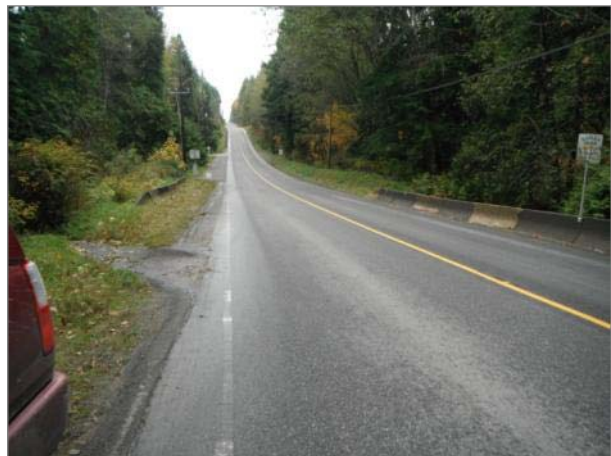
Excellent habitat. Low gradient. Cover in the form of boulders, deep pools, overhanging vegetation. No gravels observed. Candidate for installing baffles, substrate addition and backwatering. Alternatively concrete bridge installation (12 m span).

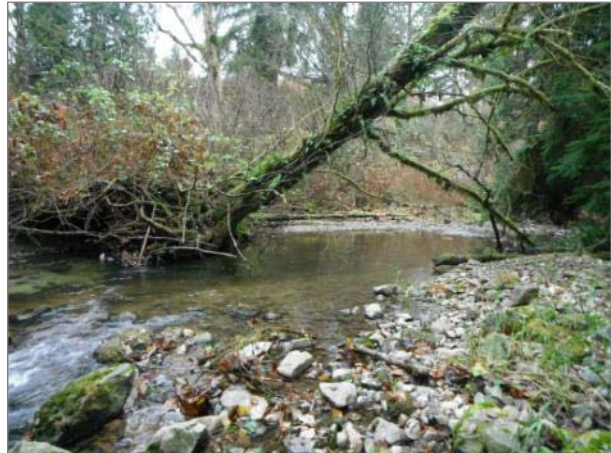
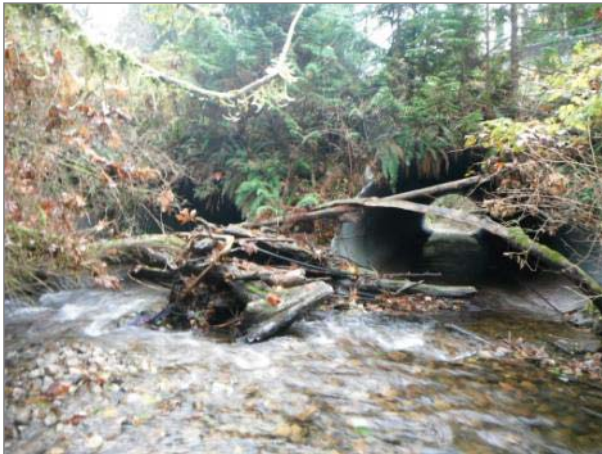
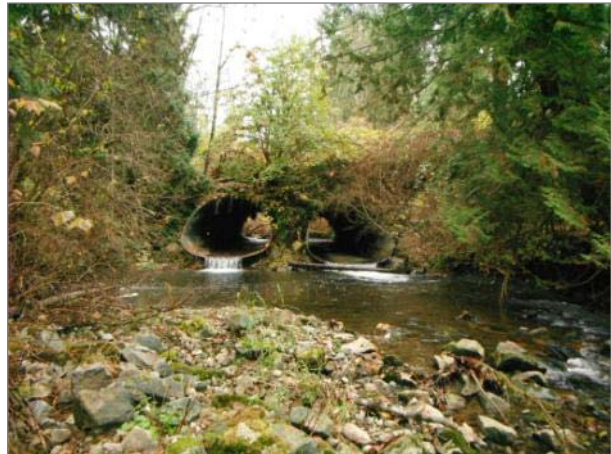
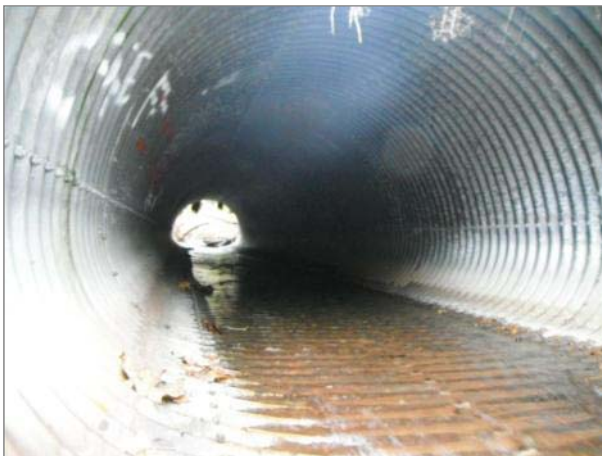
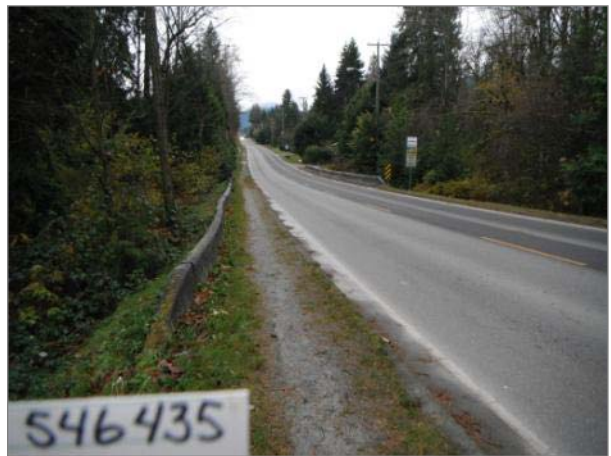
Twin culverts, 4 m each span. No fish observed but fish bearing. Excellent habitat with abundant deep pools, large woody debris, overstream vegetation. Gravel abundant for spawning. Candidate for works on the southern smaller pipe including backwater and substrate addition. Outlet weir works will be extensive due to accommodating flow in the large pipe and enabling step-pool and/or backwater weir . Alternatively, replace with bridge.

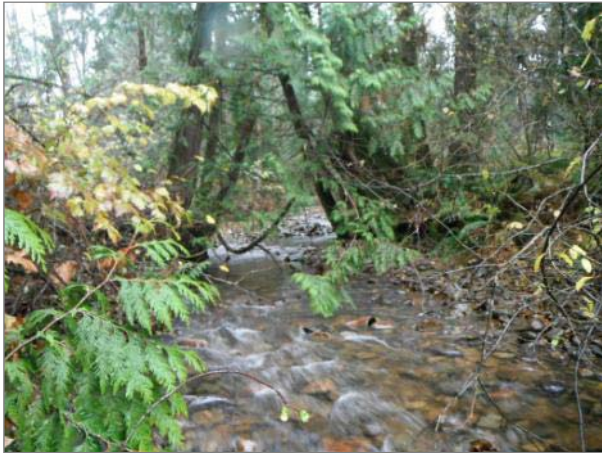
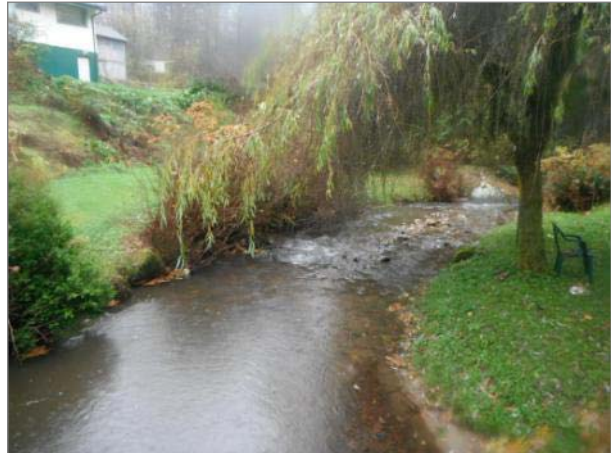
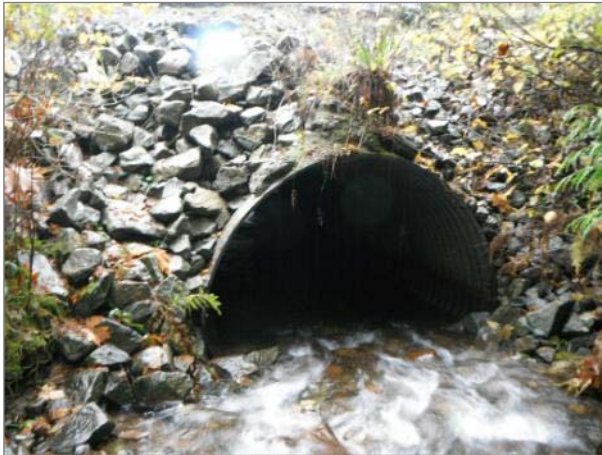
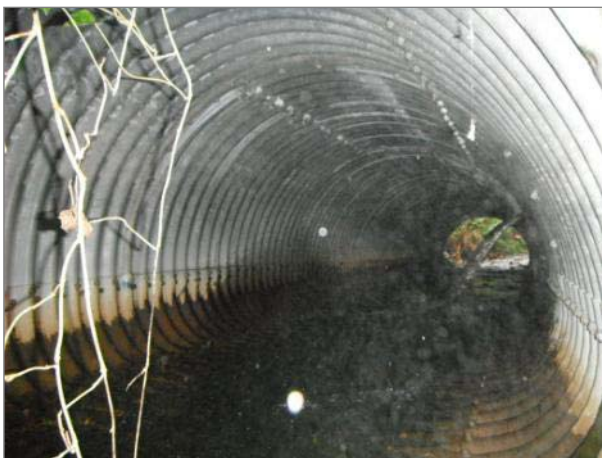
546440

Salmon habitat sign. Excellent habitat upstream with complex habitat, large woody debris and deep pools present. Gravel present for spawning. Riparian removed downstream by property owner. Candidate for substrate installation with retaining devices or implements and backwatering.

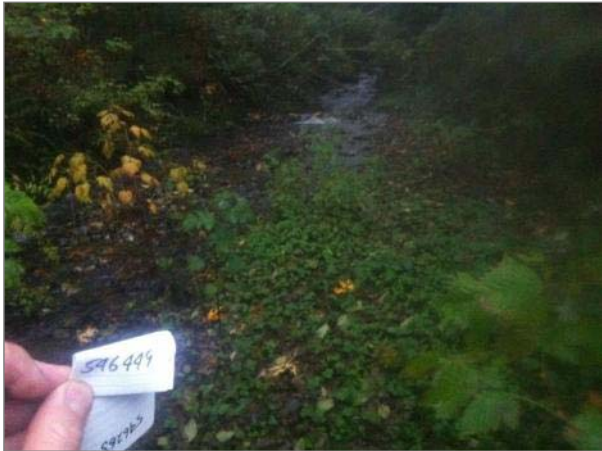
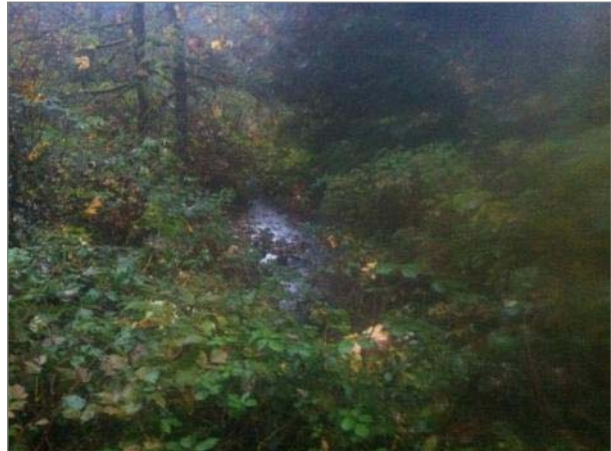
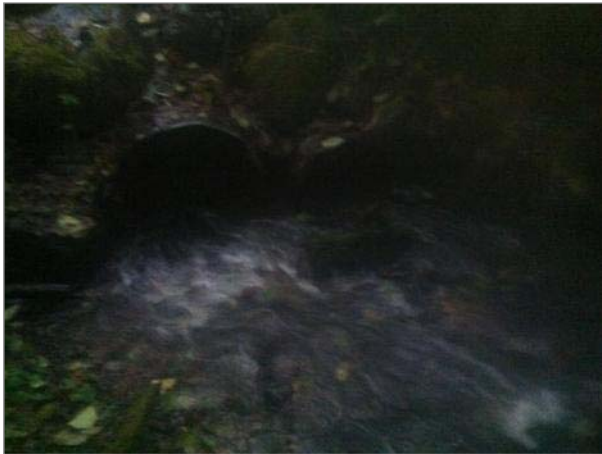
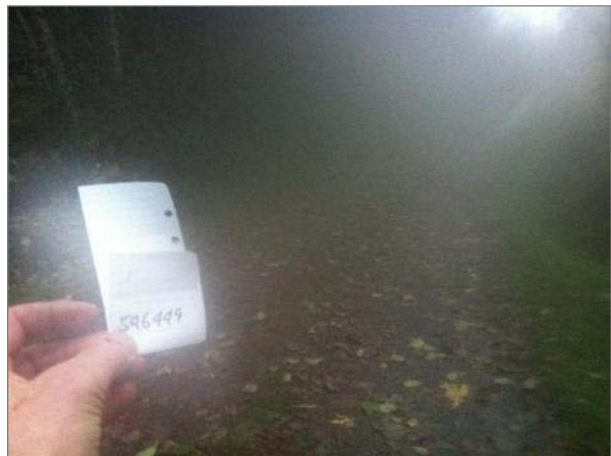
546449

Culvert under railway trail. Stream measurements made u/s as reservoir is downstream. Spawning habitat present. Photos poor due to low light. Candidate for open bottom arch.

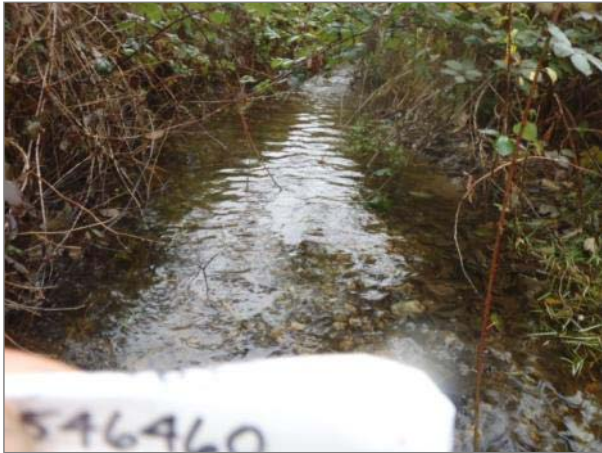
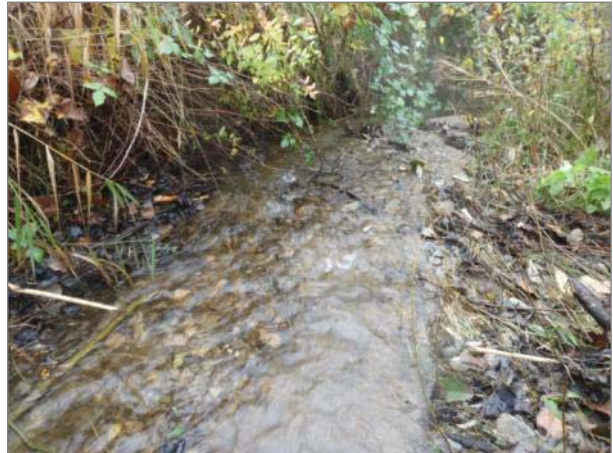
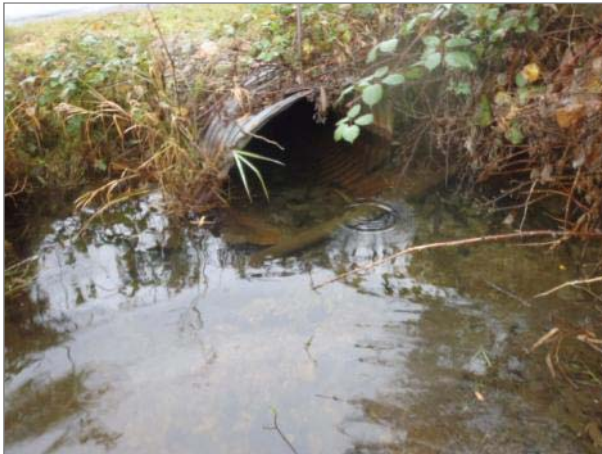
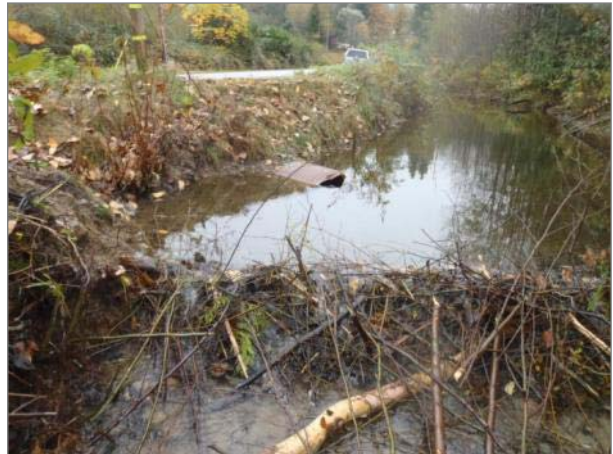
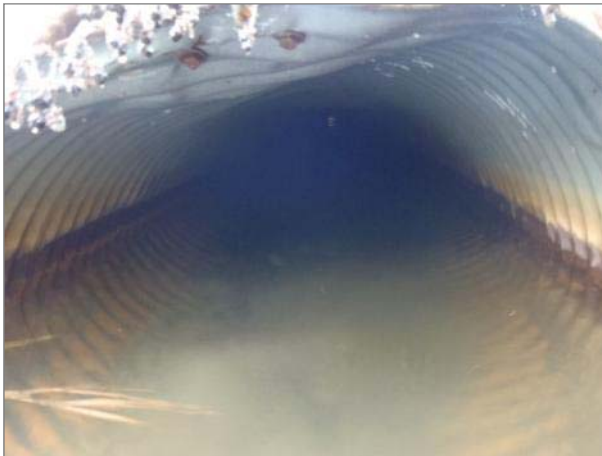
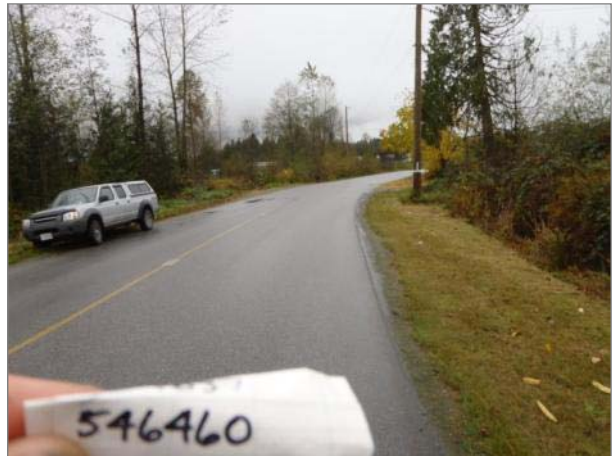
546460

Abundant gravels upstream. Beaver dam backwaters culvert. Good low gradient spawning habitat. Culvert probably not passable if beaver dam removed. Crossing is a candidate for backwatering and structure is large enough for man-work to install streambed retention implements and substrate addition.

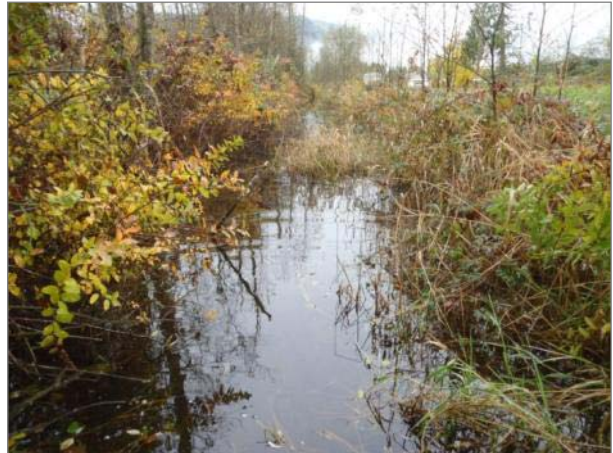
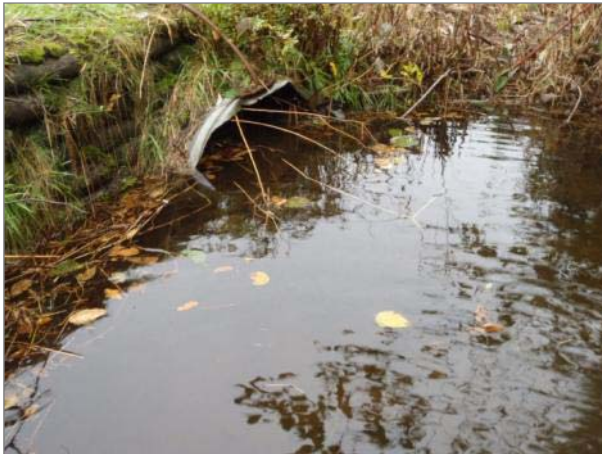
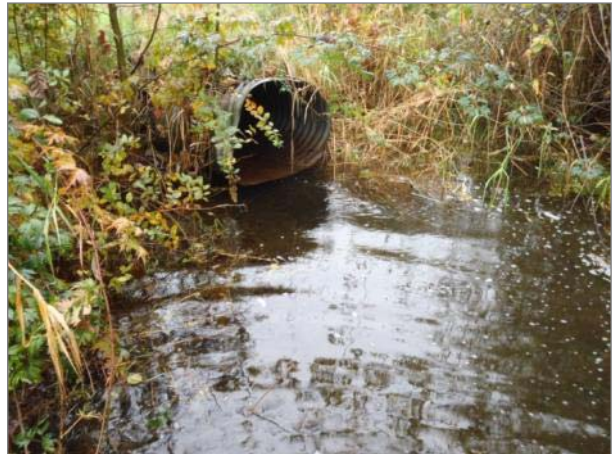
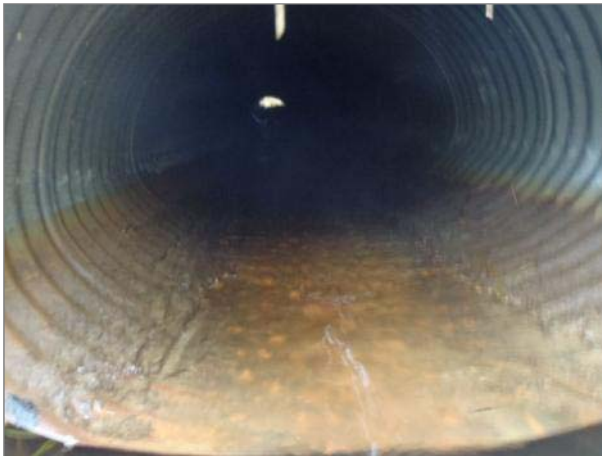
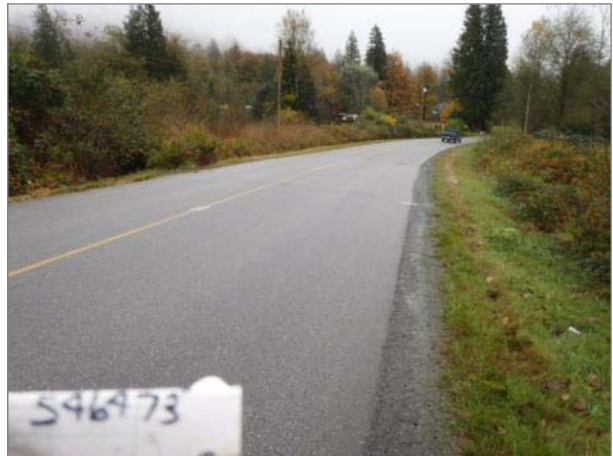
Ditches u/s and d/s. Backwatered by beaver dam 100m downstream, therefore adjusted SWR (Stream is 4.1 m). Low gradient. Culvert probably not passable if beaver dam removed. Further action recommended. Candidate for open bottom arch.

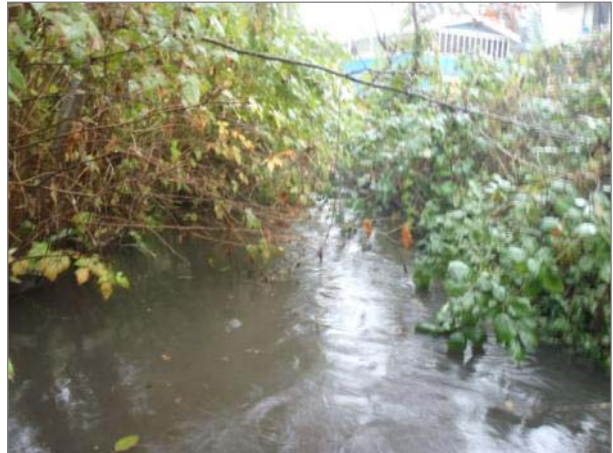
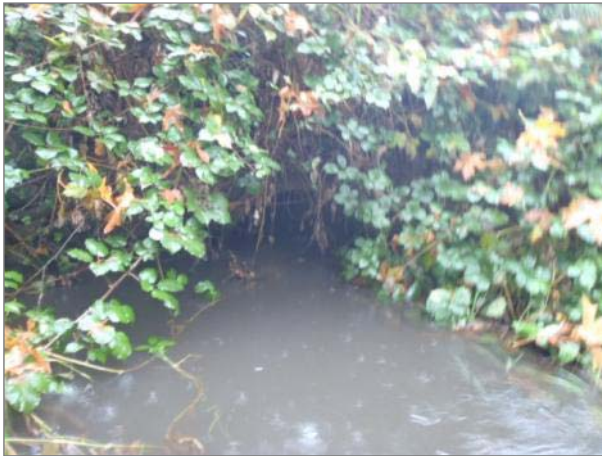
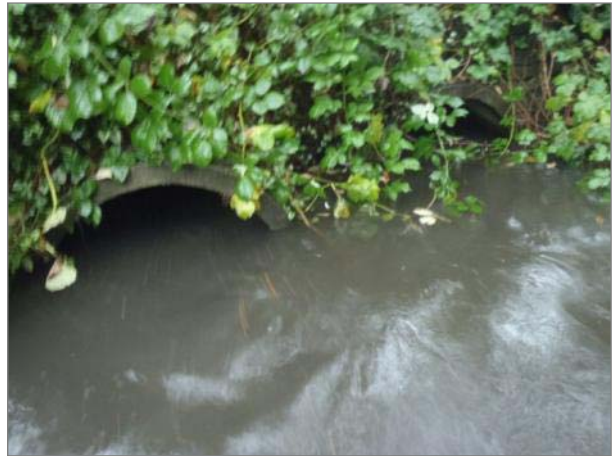
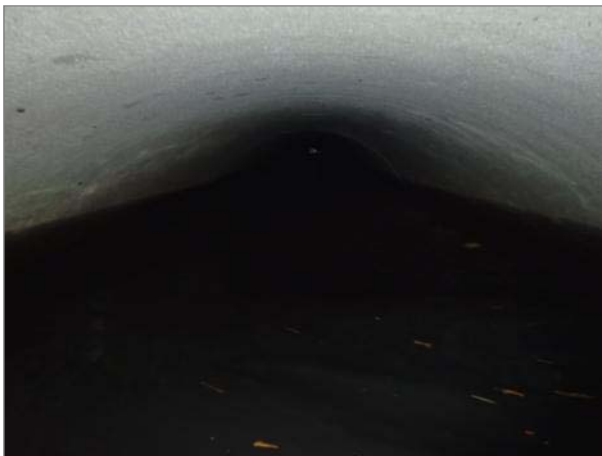
Revegetation project along creek with browse protection. High volume and turbid during precipitation events. Heavily covered in vegetation. Potential for CO rearing. Embedded, difficult to determine due to high turbidity. Small size of pipes would normally preclude streambed simulation, however this site has two pipes, one of which could be a candidate for backwatering to a deeper level with a creative split-type outlet weir. Replacement structure is a 2440mm x 1270mm Open bottom arch.

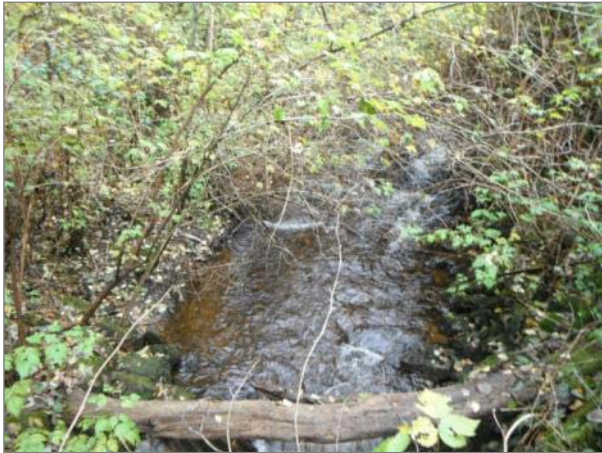
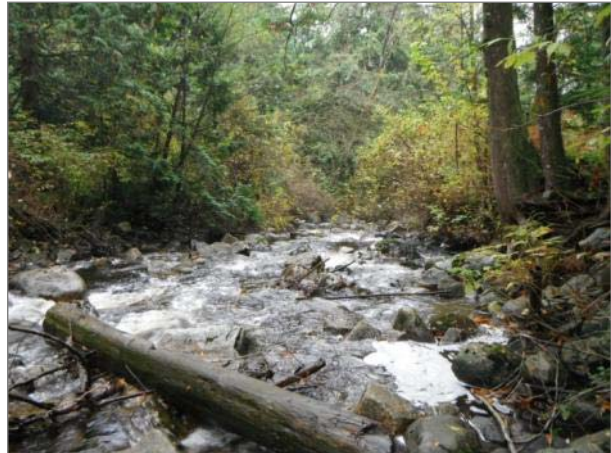
546506

Excellent habitat, abundant boulder cover, deep pools. Backwatering? Road is on a Junction and slight compression curve which normally would require a open bottom arch. Stream size is a candidate for a 12M bridge on spread footings with batter walls likely 4M high.

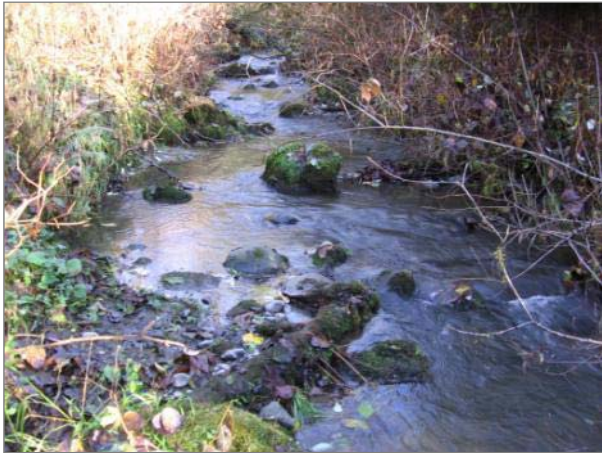
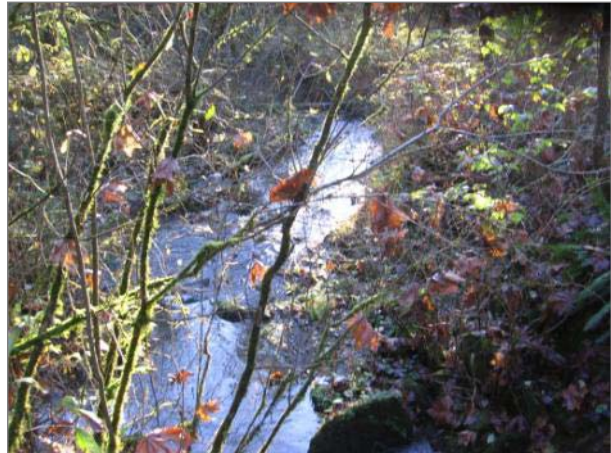
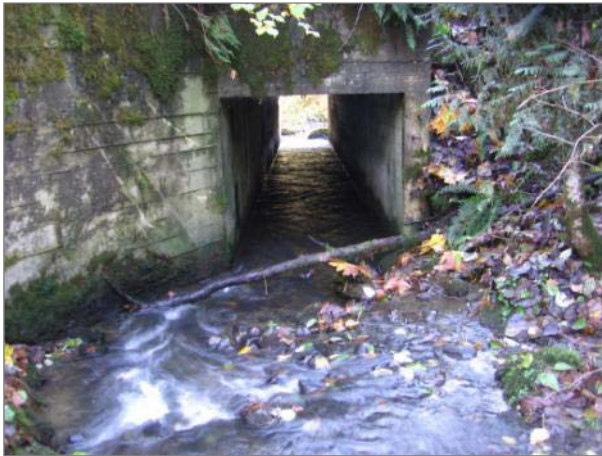
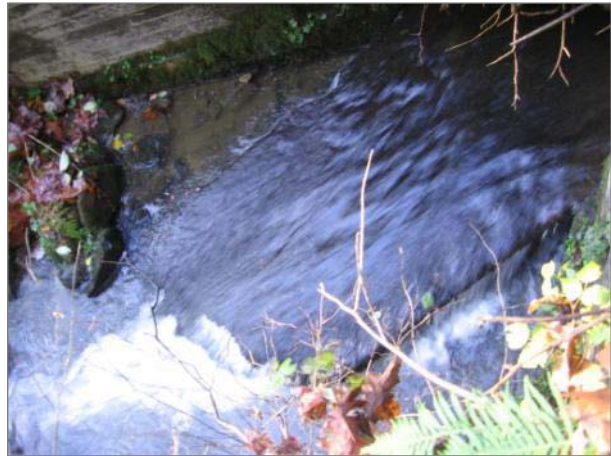
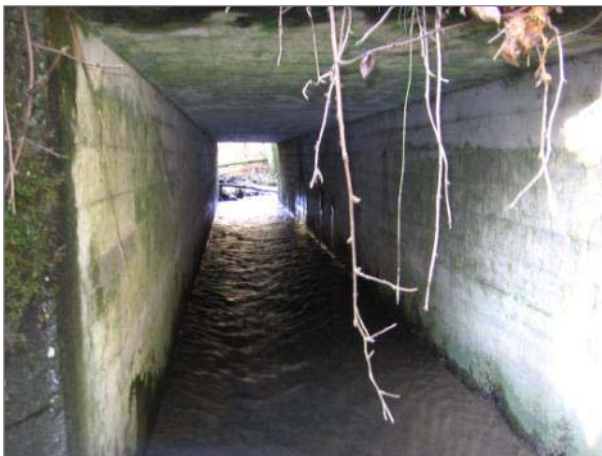
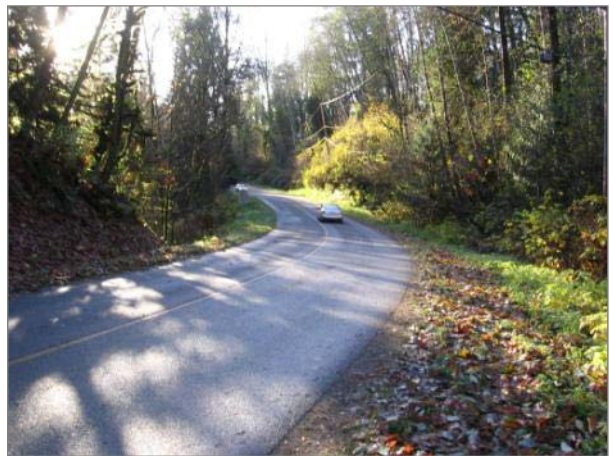
546516

Excellent habitat. Candidate for streambed simulation internal structures and outlet weir works consistent with internal works.

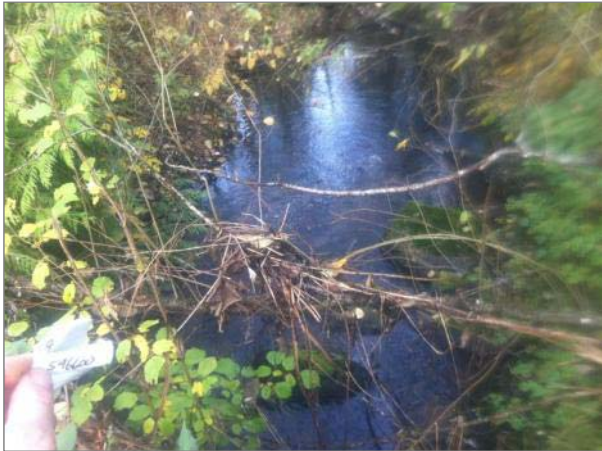
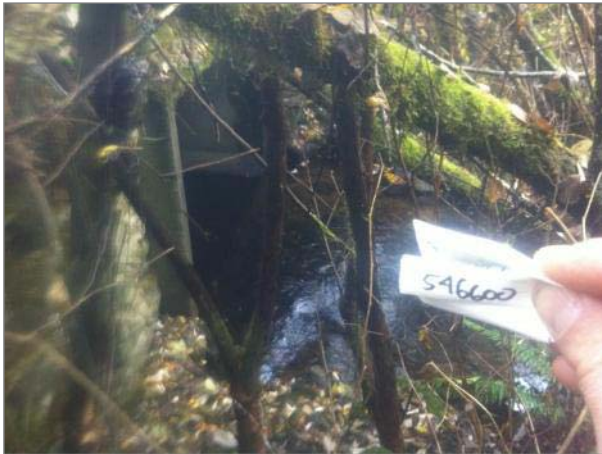
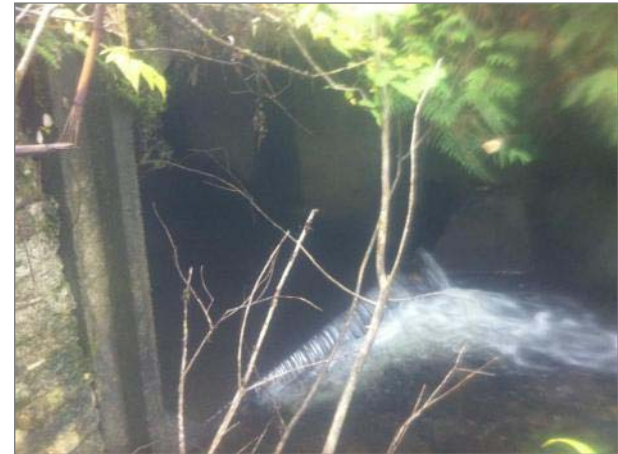
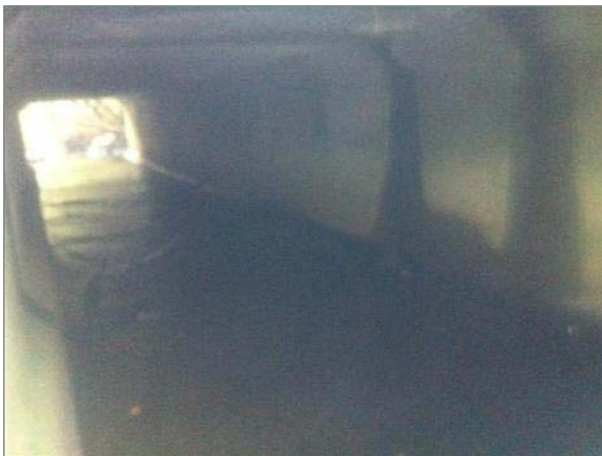
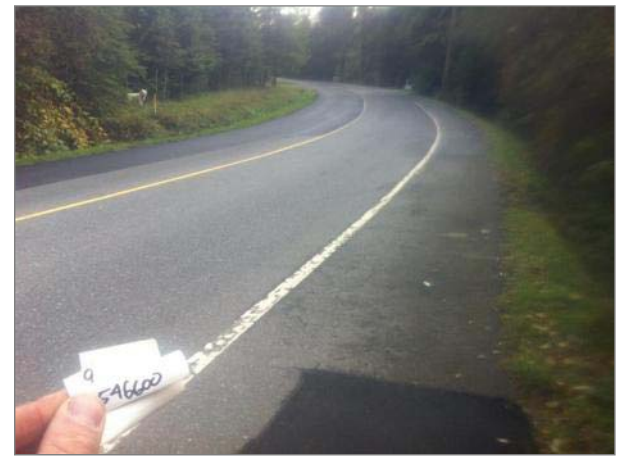
546600

Looks like some small baffles in culvert. Should allow passage for larger fish. Good habitat in Harisine. Candidate for backwatering and embeddment by installing internal devices
