EN12TCF048

Fish Passage Assessments - Lower Fraser Watershed Group

March 2012

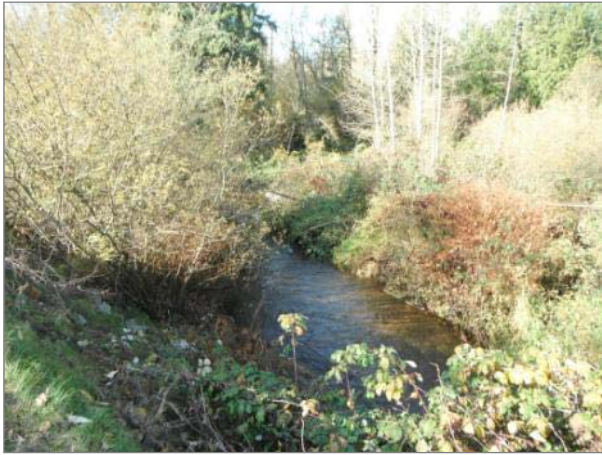
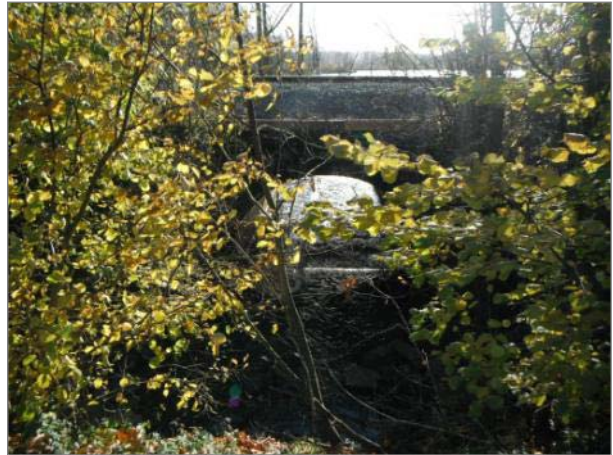
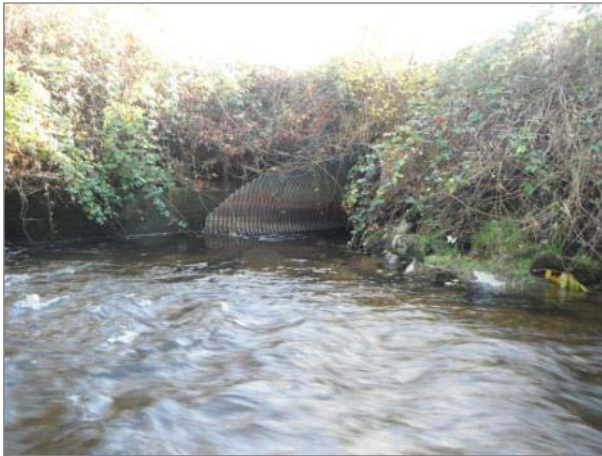
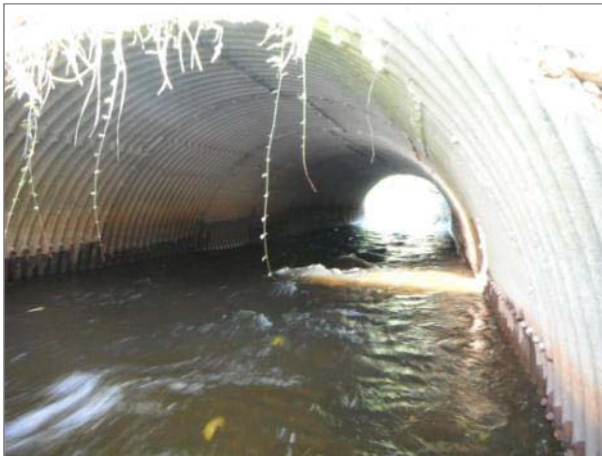
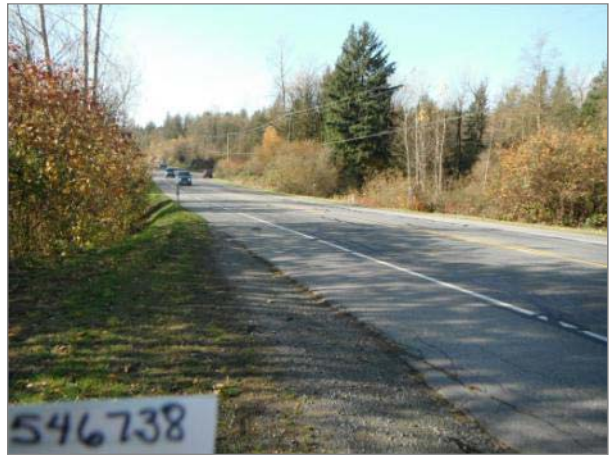
546738

Excellent habitat upstream, pools, abundant gravel for spawning. Chum dead upstream and downstream of culvert. Fish ladder on railway crossing. Measurements taken upstream. Candidate for fish passage structures installed into haunches, jointly designed by P. Eng and RP Bio.

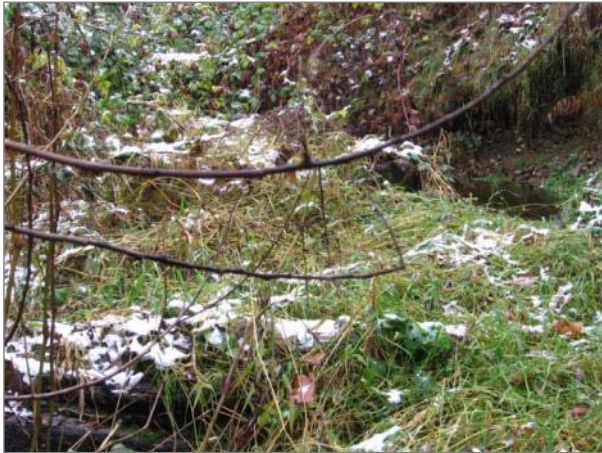
546882

Good gravels, pools, overhanging vegetation, large woody debris. (CV 414 on card and photo) Outlet control rockwork appears to be eroded or shifted. Candidate for outlet control works to a Q100 standard.

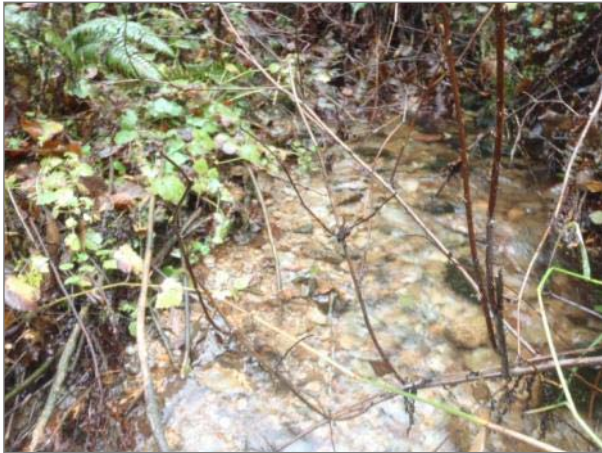
Upstream View

Abundant gravels suitable for CO, CT DV spawning. Abundant LWD, deeply undercut banks and overhanging vegetation for cover. Particularly during higher flow period. Fair to good habitat for spawning and rearing. CO downstream. Concrete culvert. Candidate for open bottom arch.
