# Monitoring Black Bear Den Enhancement and Creation in the Jordan River and Campbell River Watersheds: 2016 year-end report

December 2016

Prepared for the Fish and Wildlife Compensation Program  
(FWCP project **COA-F17-W-1186**)

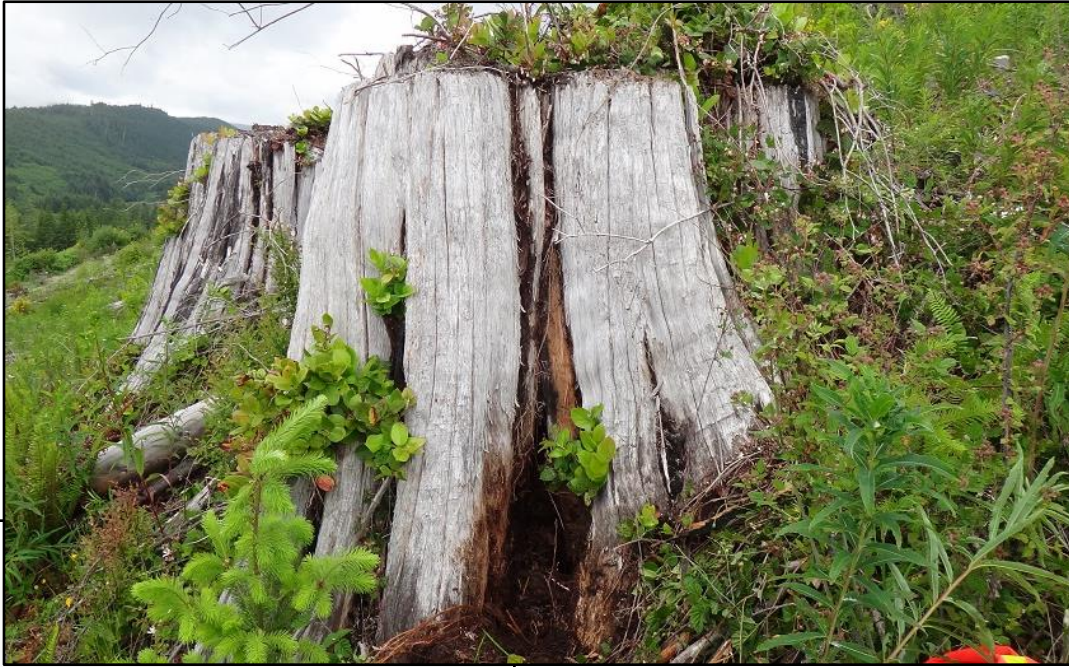
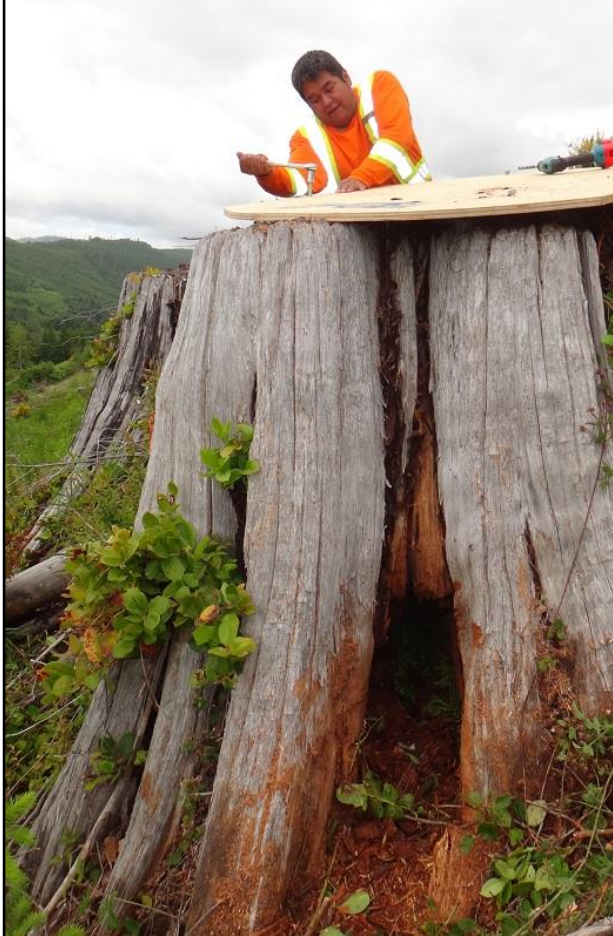
*Structure #7: Enhanced natural structure (stump)*

Notes: Cutting the entrance to this tree did not work very well. The thickness of solid wood was too wide to create a nice entrance into the cavity. In 2015 we did more cutting to improve the entrance. It will be interesting to see the progression of decay in this structure. No monitoring camera deployed.

Modifications (2014 & 2015): Entrance cut into tree at split, large amount of decayed wood removed from inside.

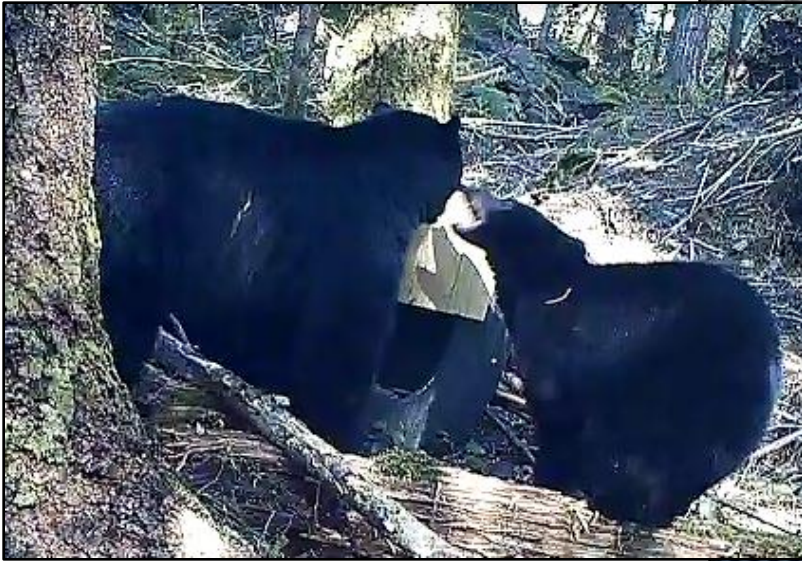
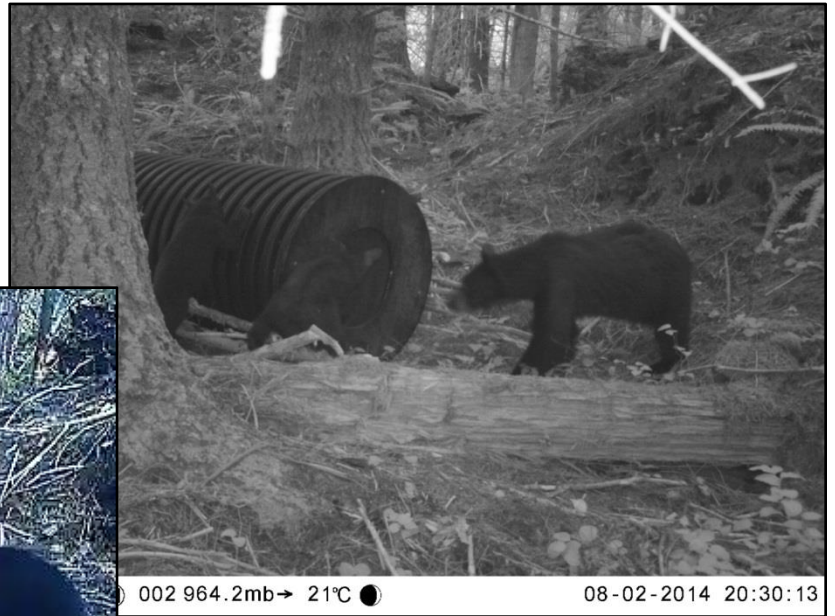
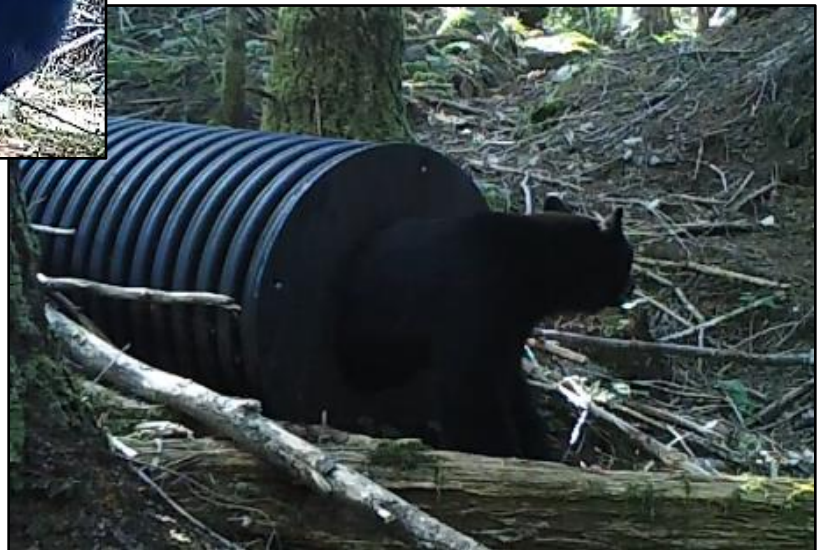
*Structure #11: artificial den (culvert)*

Notes: Monitoring camera deployed. The structure has been investigated by bears 31 times between 2014-2016 there were 9 instances of a bear fully entering the structure.

Modifications (2014): Installed, bedding added, motion-sensitive camera installed, temperature data loggers installed.

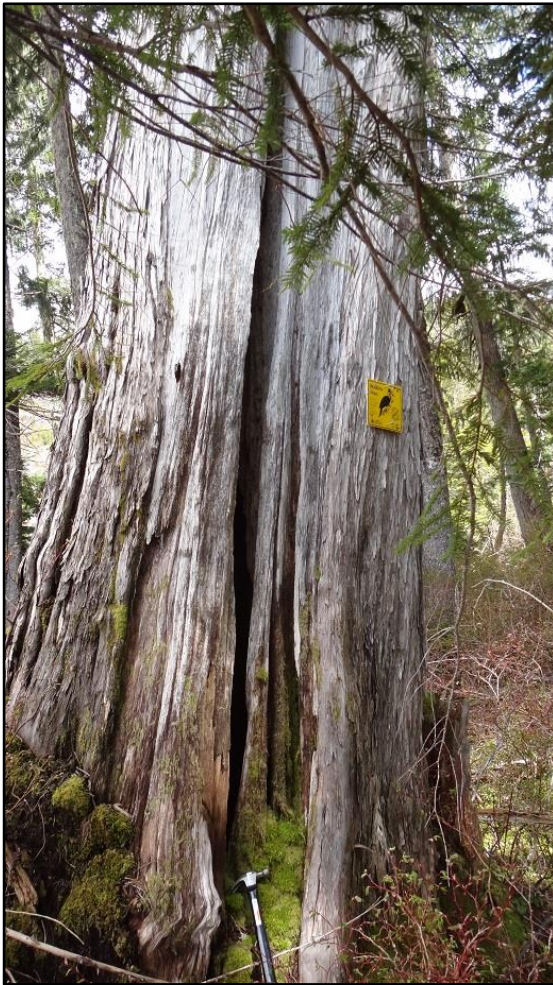
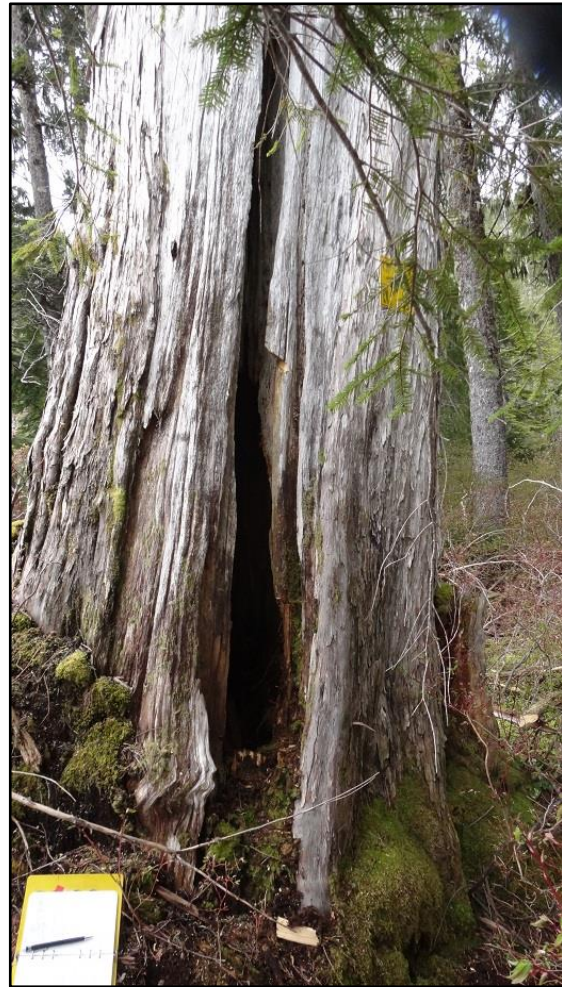
*Structure #15: Enhanced natural structure (tree)*

Notes: Found during searches for trees for enhancement. No bears have ever been photographed at tree despite continuous monitoring 2015-2016. May be too high elevation (~913 m)?

Modifications (2015): entrance widened with chainsaw. Decayed wood inside excavated to create chamber. Blueberry shrubs added as bedding.

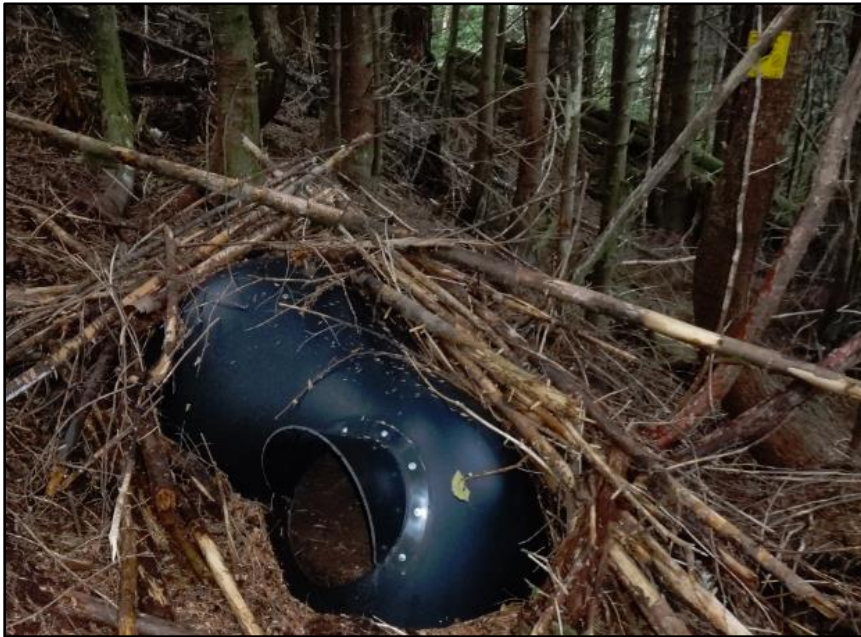
*Structure #18: artificial den (den pod)*

Notes: Installed 2015, camera at site malfunctioned and had to be replaced so very little monitoring data in 2015. However, one bear was filmed July 25<sup>th</sup>, 8 days after installation. In 2016, 5 bears were recorded at the structure, including sticking their head inside.

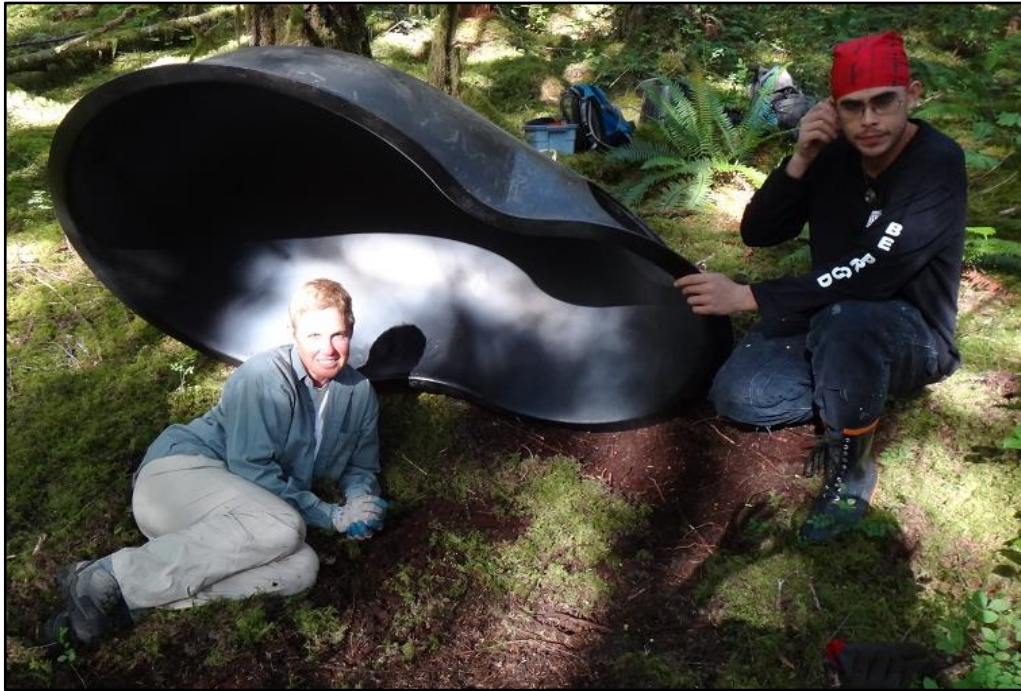
Structure #CR001: artificial den (den pod)

Notes: Installed 2015. Bedding and bear hair added. Motion sensitive camera installed but has not worked consistently (replaced Nov. 2016). Investigated 4 times by

bears (at least 2 different bears). Bear hair on entrance in Oct. 2016 but no accompanying video.

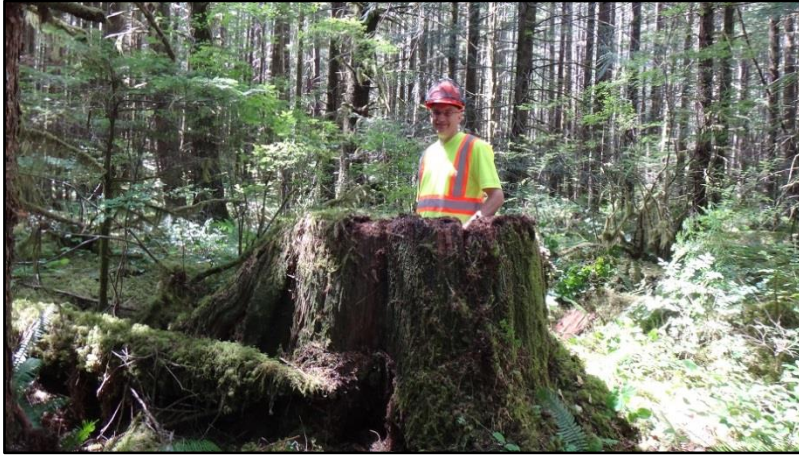
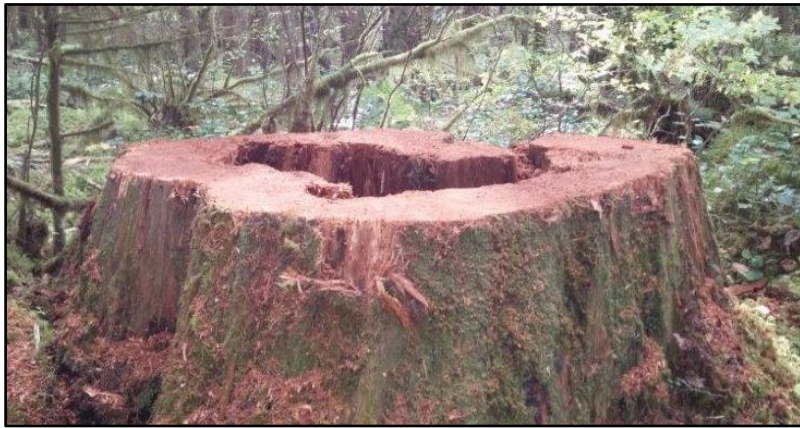
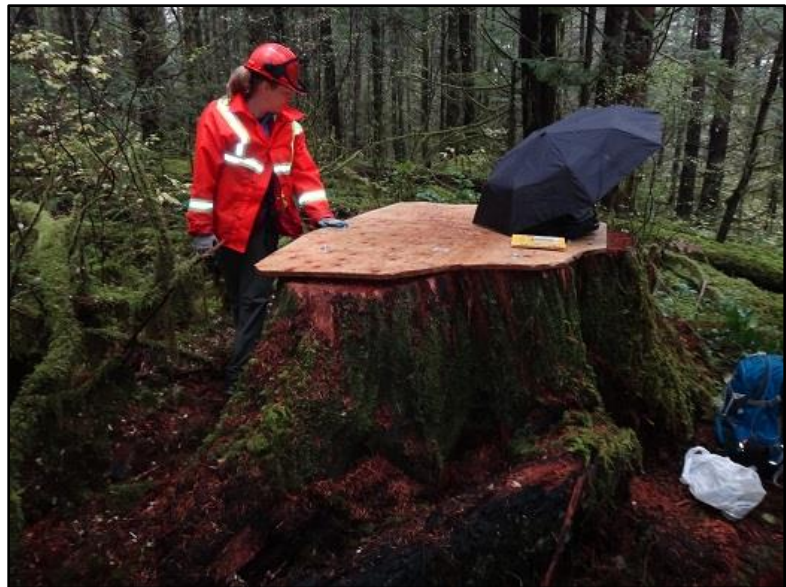
*Structure #CR004: Enhanced natural structure (stump)*

Notes: Motion-sensitive camera (on loan from COS) installed. Stump is about 20 m from CR001. No bears were detected investigating structure in 2015 but 3 bears were detected in 2016 including one who climbed inside (photo on cover of report, bottom right). Top photo: Rob Martin (BCTS) in stump before modification. Middle photo: stump levelled before plywood installation. Bottom photo: Laura Chessor (BCTS) at finished stump.

Modifications: entrance slightly enlarged, stump levelled, top capped with ¾" plywood. A 1-2" lip of plywood was left where it hung over so ensure the rain stayed off the stump. The plywood was held in place with 6 lag bolts (4", 6", 8") with washers and a couple of 10" spikes. One soft side/crack of the stump was filled in with slabs and shavings. A

thick layer of moss was added for bedding.
