Mr. T.A.J. Leach, Asst. Chief Engineer

J.C. Foweraker, Geological Engineer

B.C. Water Resources Service

Preliminary Geological Investigation
of Stocking Lake Dam Site

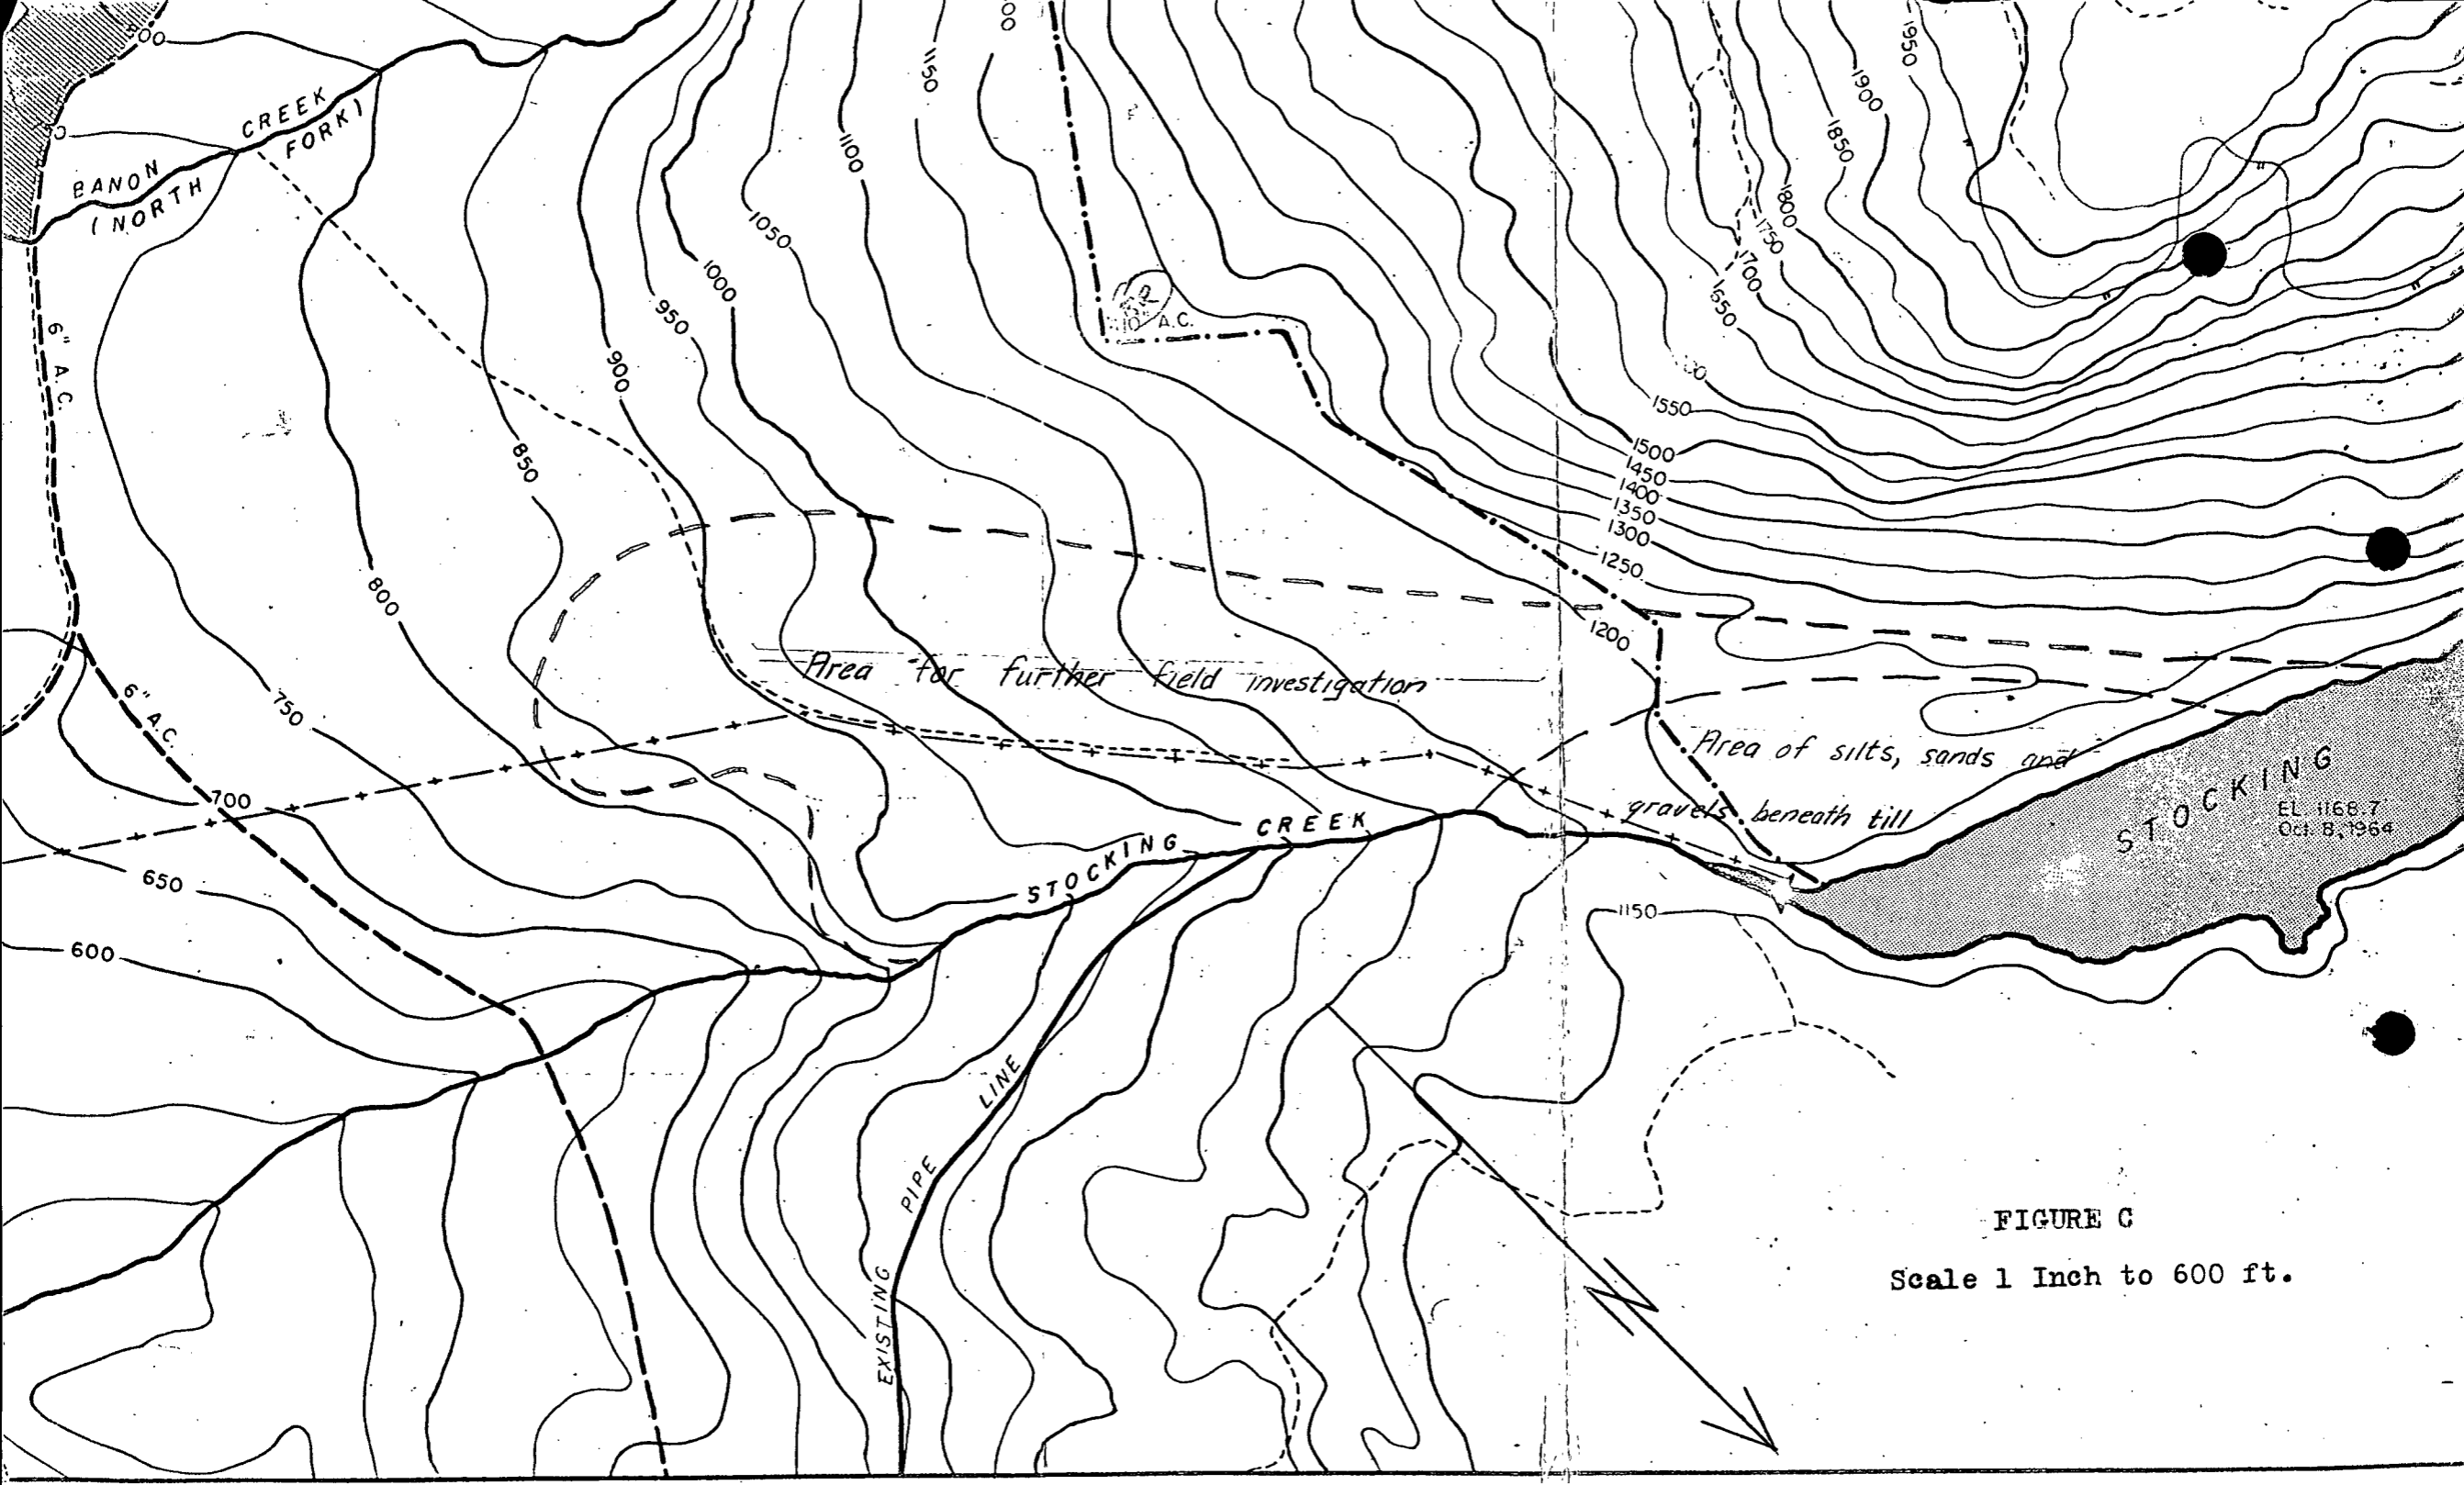
FIGURE C

Water has been observed seeping out of sands below till, which is exposed in the right bank of the outlet trench, at a location opposite Station 2 in Fig. 3. Similar sand-beds below till are exposed elsewhere in the right bank of the outlet trench, as in Sections A-A' and B-B' (Figs. 4 and 5).
