MEMORANDUM

SUBJECT Saltspring Island
Field Investigations

3. Isabella Point Road Investigations

Isabella Point Road Landslide -
Saltspring Island

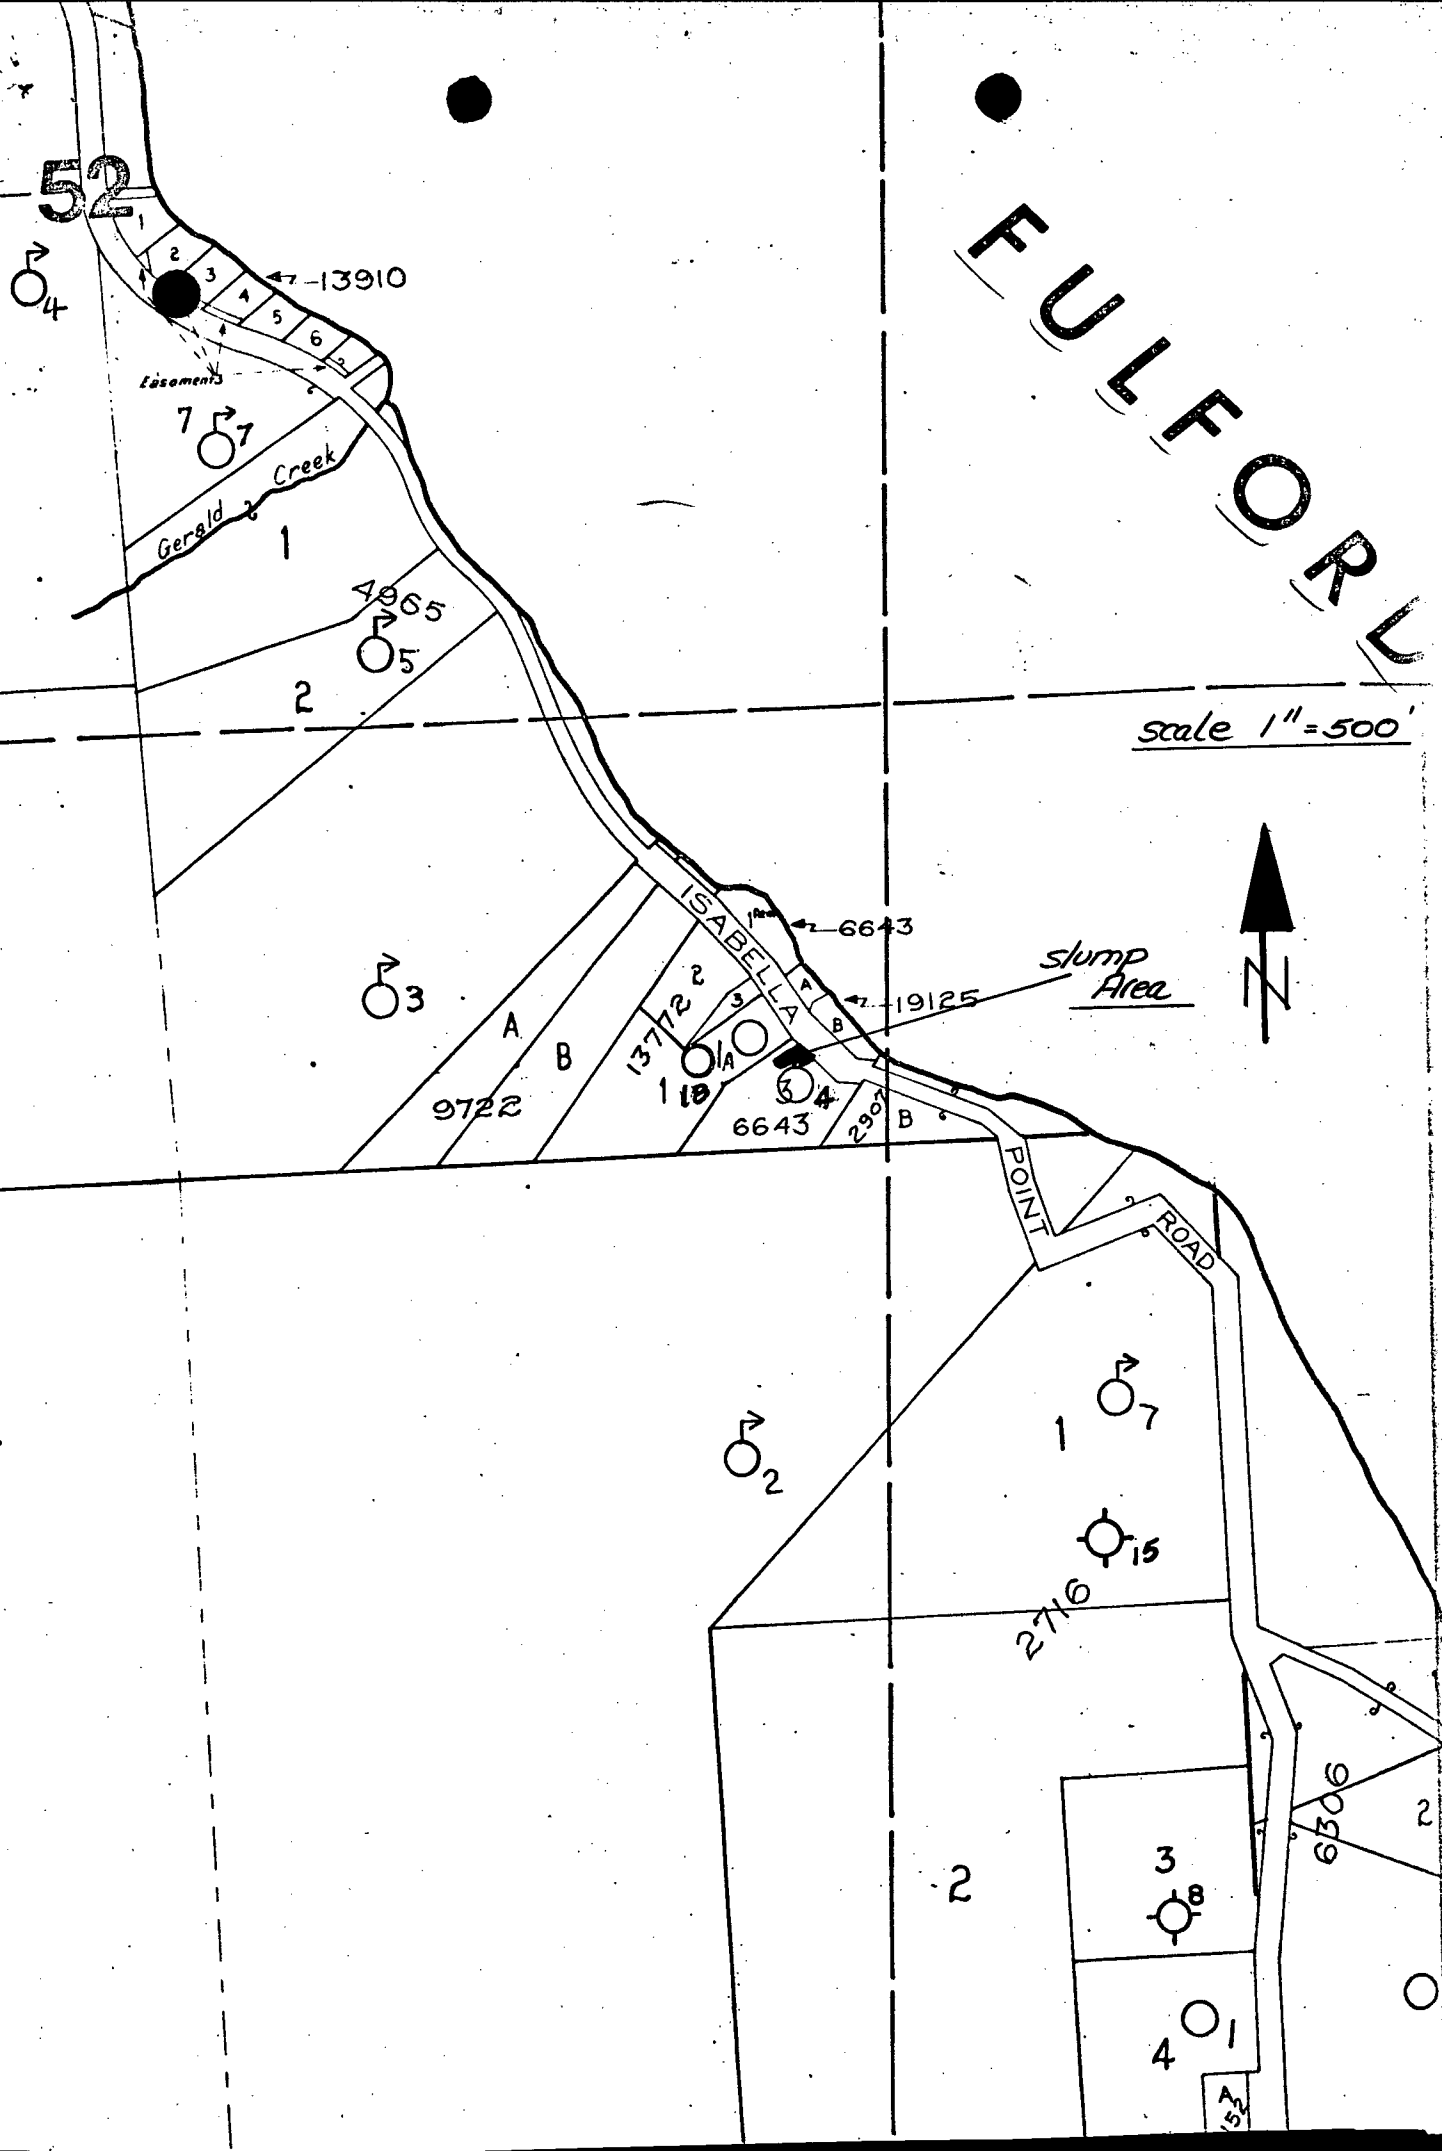
Isabella Point Road Slide Area

1. The slump or depression is located on Lot 3, Plan 6654 off Isabella Point Road.
2. The major portion of the slump is approximately 20' wide by 50' long and borders on Isabella Point Road.
3. Mr. Archer's spring is approximately 8' west of the immediate slump area and water is gravity fed to a holding tank on the other side of Isabella Point Road.
4. The material in the immediate slump area consists of dark silty sand and sand with some sand and gravel interbeds. Some cobbles and large boulders were noted. Some clay was present near the centre of the slump retaining some water.
5. The material above the area is mainly rotting logs lying on sandy topsoil with some large boulders present. The area behind the slump area is heavily treed with Cedar and Alder and beyond this area is open pasture land (Lacy Property)?

slump Area
