SPLITROCK
ENVIRONMENTAL
SEKW'EL'WÁS

FINAL REPORT 2016 -17

Powerhouse Foreshore Restoration Project

Maintenance Program Year 3

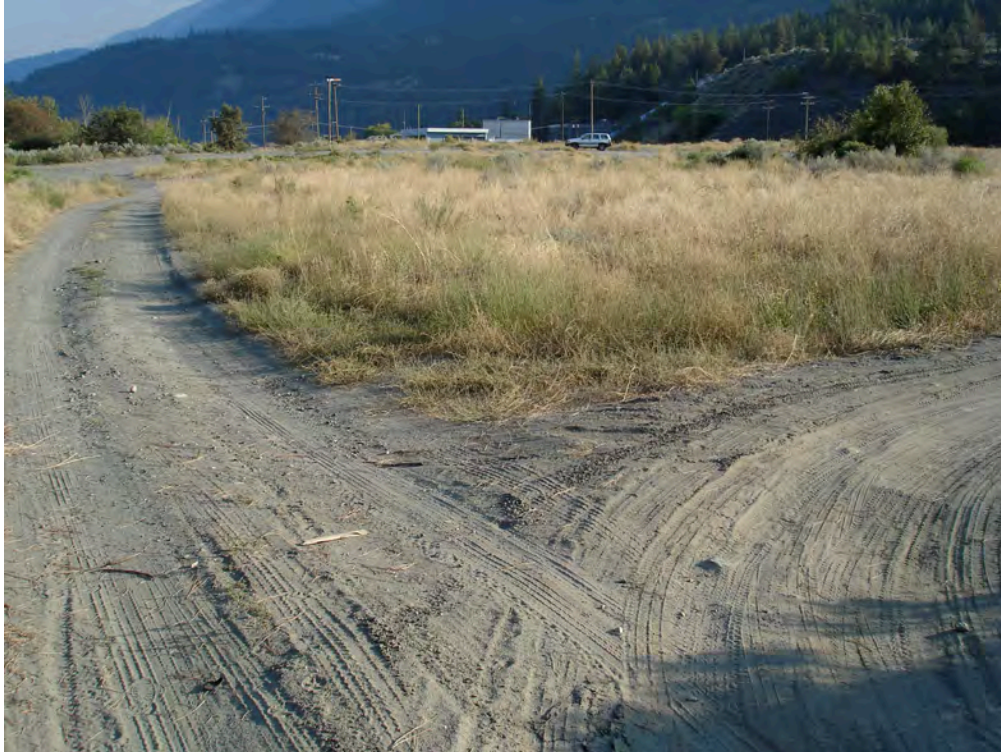
Figure 4 Upland bench - roads and weeds. Note the only small native shrub island top right

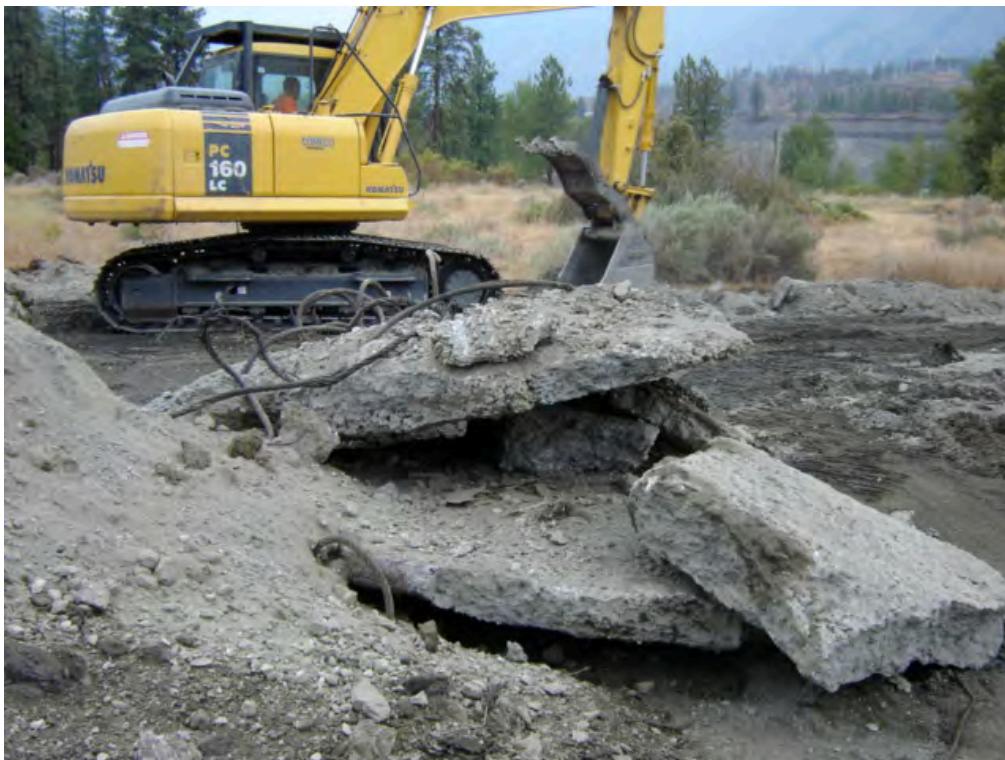
Figure 6 Concrete slabs being removed August 2009

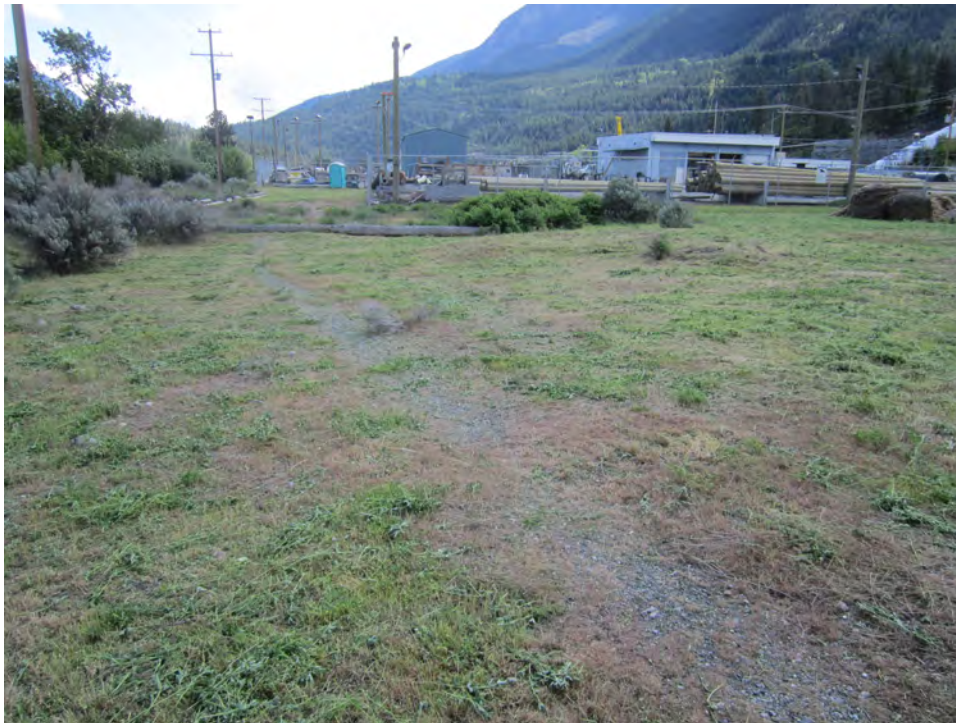
Figure 11 Same hydro yard area after trimming (looking south from restoration site) 25 April 2016

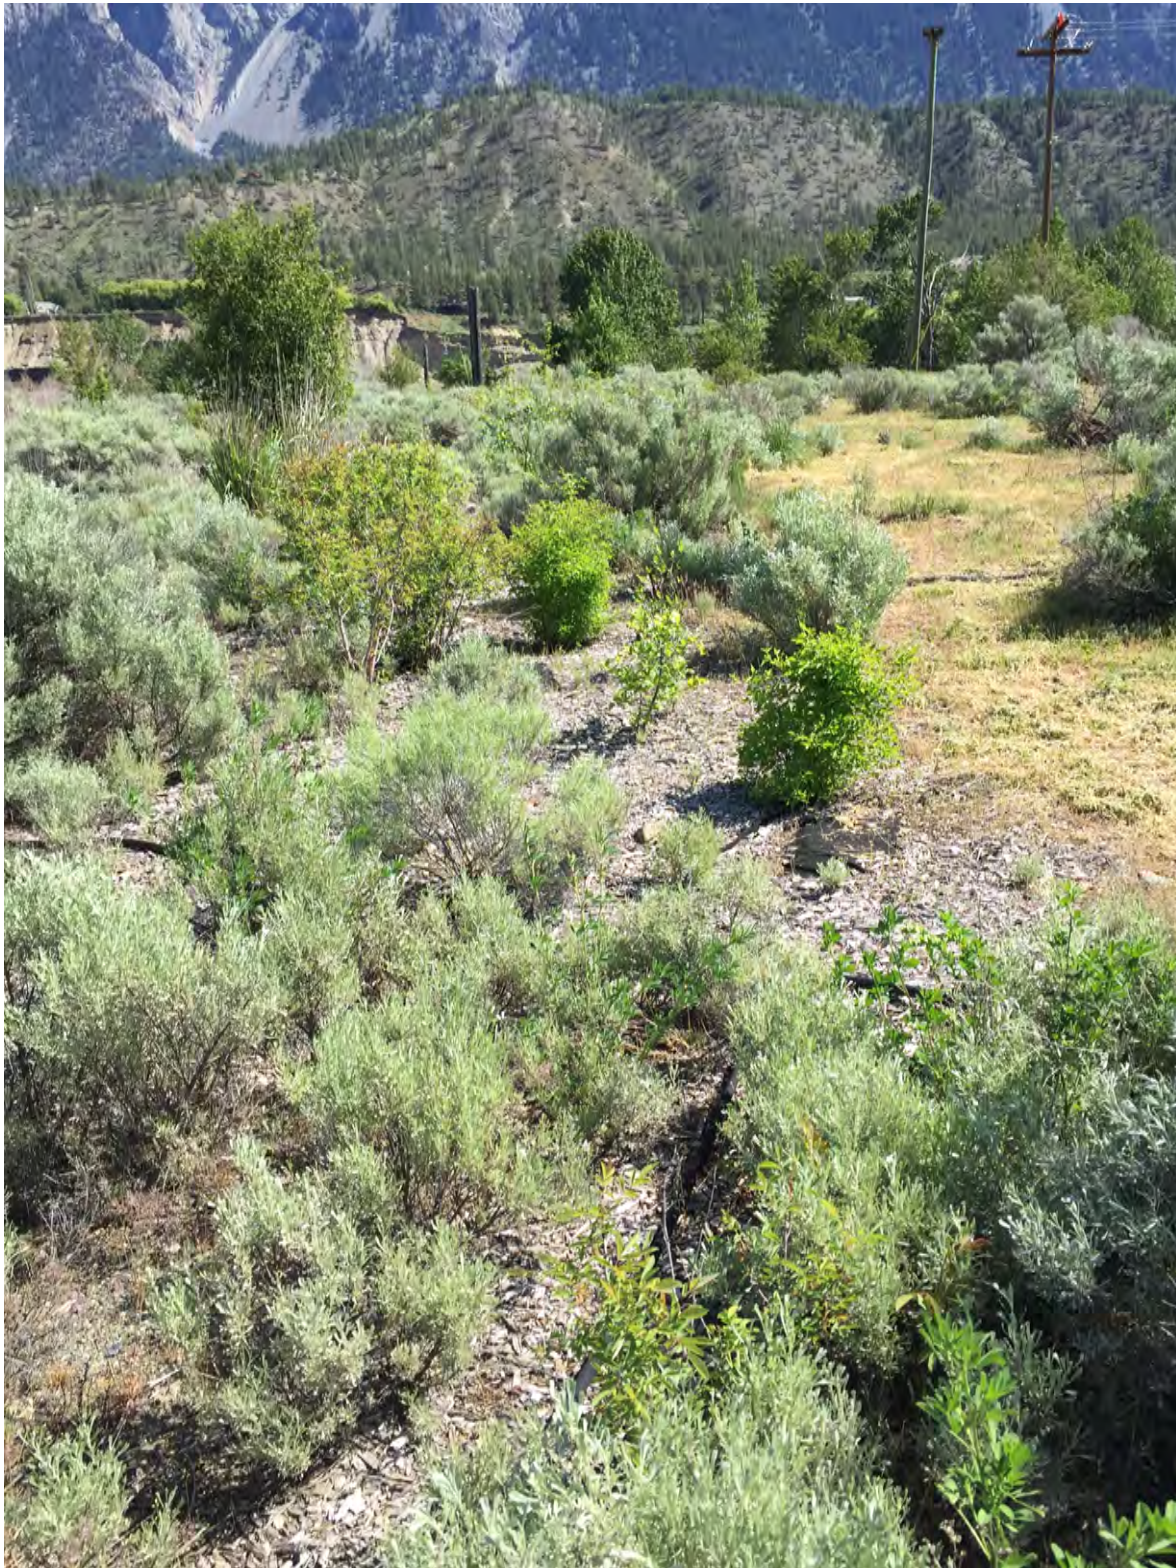
Figure 13 View showing shrub layer (centre) and native plant cover (left) -v- trimmed hydro yard area (right) 30 April 2016

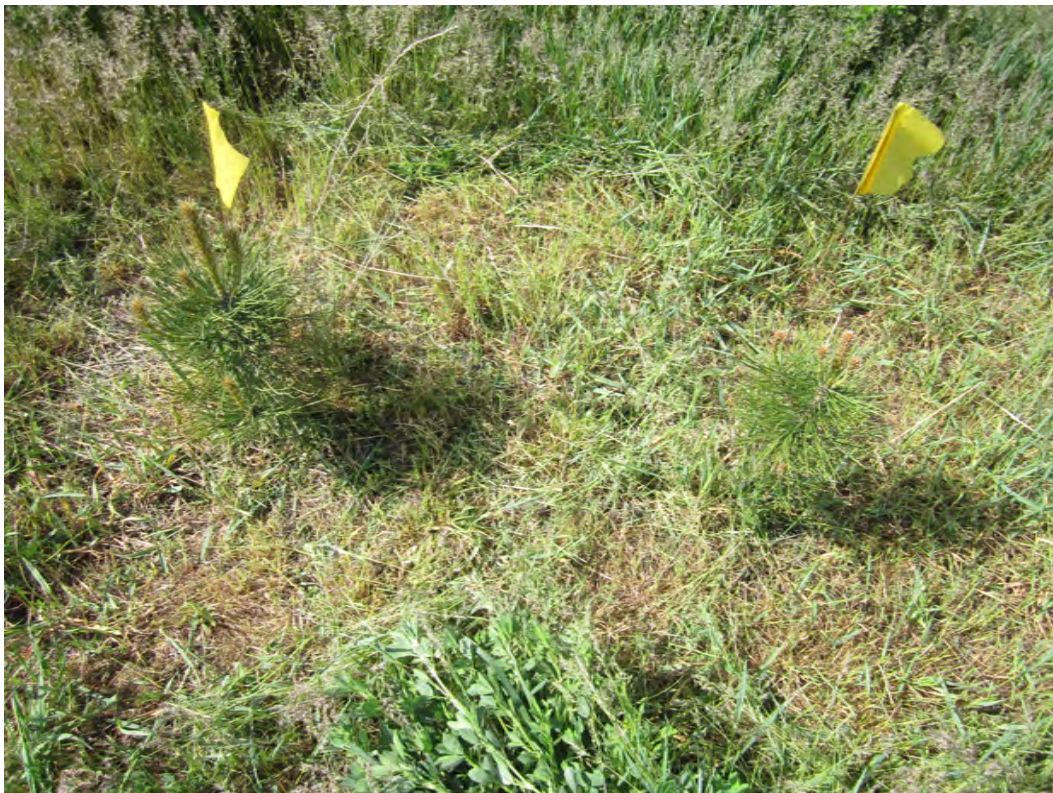
Figure 14 Polygon 4 (Map 4) Small ponderosa pines being watered and weeded. Showing good growth 25 April 2016

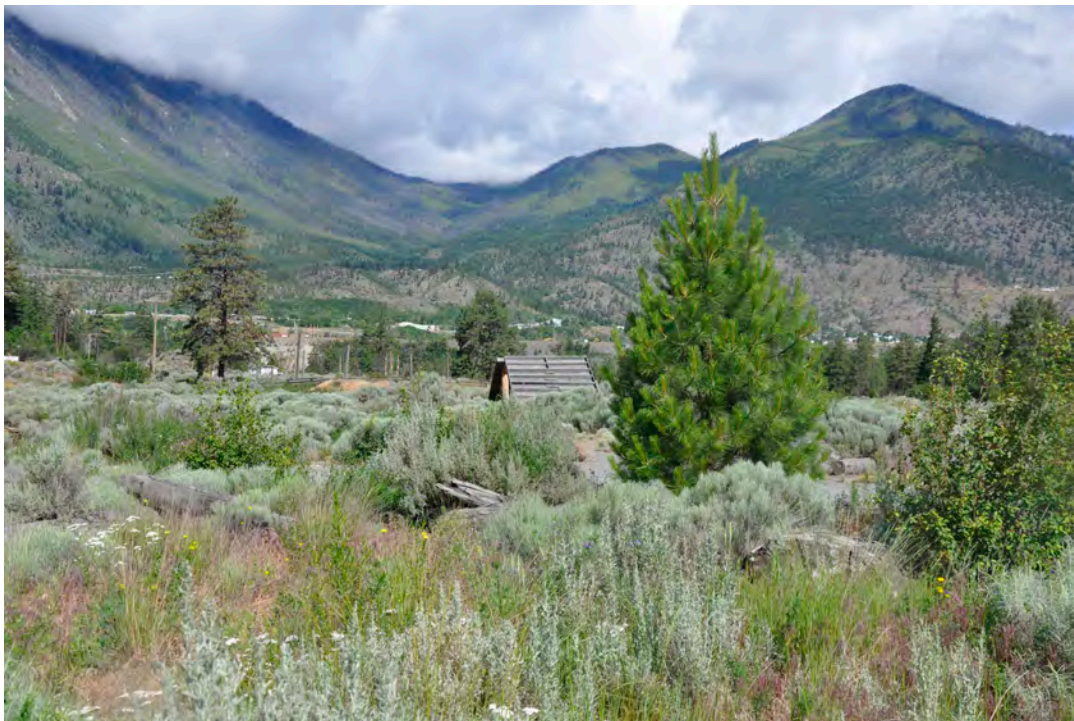
Figure 18 Example of an area near established parking lot that had almost 100% weedy species, now showing good growth of native trees, shrubs and forbs going to seed, with only minimal salsify and mustard plants 29 May 2016
