# Gates Creek Level 2 Fish and Riparian Habitat Survey (COA-F18- F-2438)

Implementation Year: 2018

April, 19, 2018

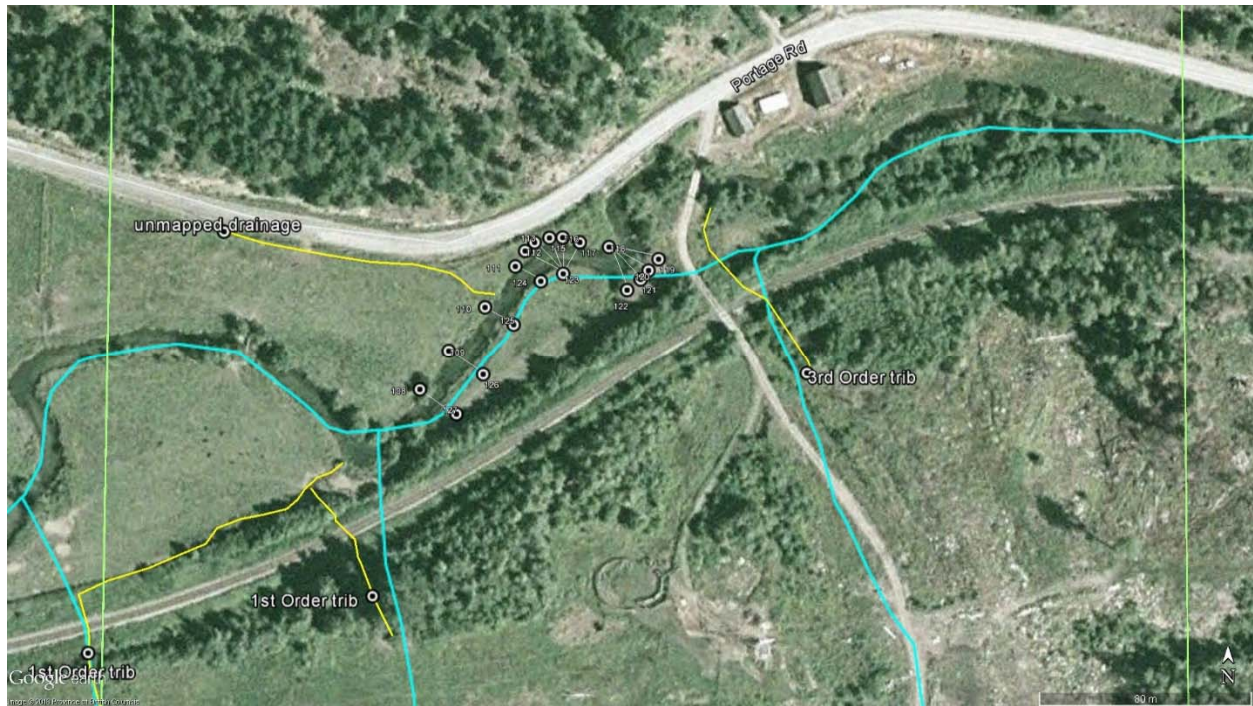
Although the entire length of the Gates Creek channel within the property was examined for this assessment, the primary area of focus for instream prescription development was a section of channel approximately 150 m long upstream of the bridge. No discharge measurements were collected for this assessment. Stage at the time of the survey was deemed to be low given the timing of the survey (early fall) and lack of recent rainfall. Within the area surveyed a series of 13 channel cross sections were established to document the existing channel conditions (Appendix 1). The average wetted width of perpendicular cross sections was 8.6 m, and the channel width was 9.8 m. The average maximum depth of all transects was 1.6 m (range 1.25 - 2.25 m). Channel banks and bottom substrate were comprised almost entirely of fines. Most of the channel had near vertical banks with some areas of undercutting and evidence of banks sloughing into the channel. Riparian vegetation was dominated by reed canary grass, although there were clusters of immature deciduous trees and shrubs (Figure 6). Sedges were also present

in lower elevation areas subject to frequent inundation. Channel gradient was  $< 1\%$  and velocities, although not measured, were estimated to be less than 0.3 m/sec in the thalweg of the channel during the survey. Instream cover was almost non-existent and limited to undercut banks and occasional pieces of small woody debris. Overstream cover was also limited by the dominant vegetation present along the banks (grass).

Figure 5. Overview of FWCP owned property at 9523 Portage Road. While lines indicate depth-velocity transects from October 2017. Blue lines indicate mapped drainages. Green lines indicate property boundaries, and yellow lines indicate observed drainage locations.

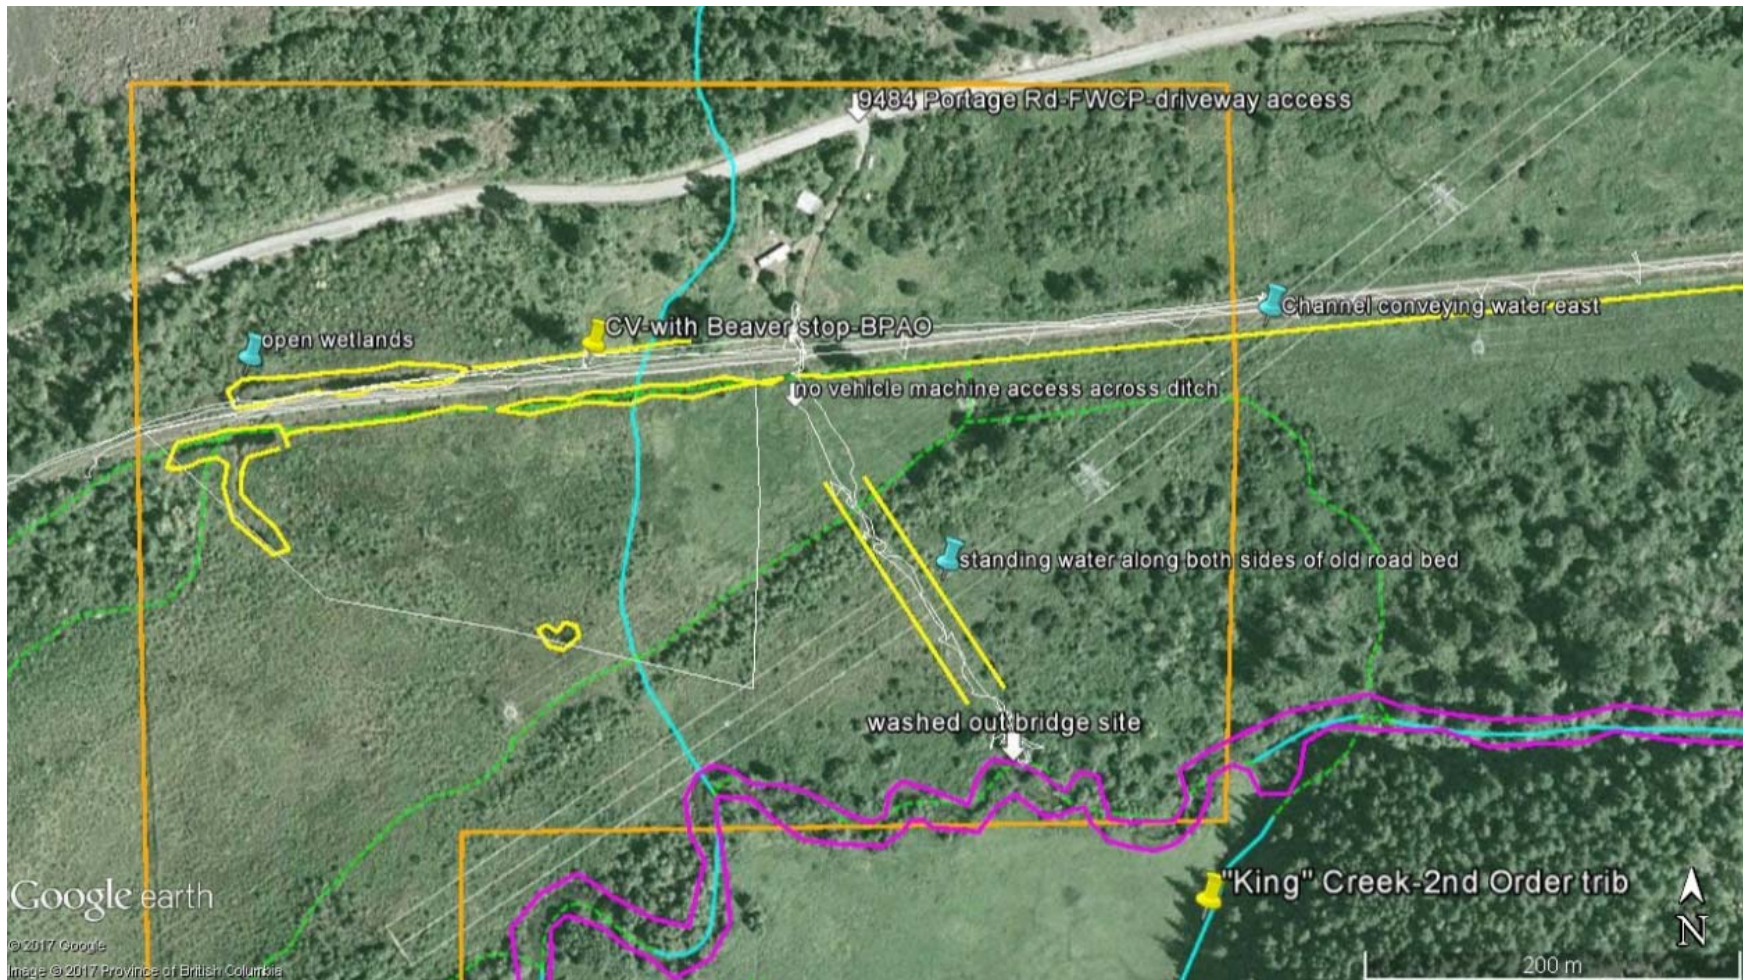
The only mapped drainage from the north within the assessment area is a second order tributary originating from the north side of Portage Road and shown to drain due south to Gates Creek (Figure 7). However, the mapped drainage pattern (Figure 7) did not coincide with field observations (Figure 8). Field observations indicate water from this drainage is intercepted and conveyed east along the CN track by a channel/ditch paralleling the track. This channel had a top width of approximately 5 m and depths ranging from 2 m to 3 m, with typical wetted widths between 1 m and 2 m, and wetted depth of 0.3 m to 0.5 m. A series of open water wetlands were also observed west of the driveway connecting to the ditch, on both sides of the CN track (Figure 8). Beaver activity was observed both north and south of the CN track, including recent dam construction in the ditch and partial blockage of the culvert draining under the CN track (Figure 9). The installation of a plastic beaver proof add-on structure (BPAO<sup>3</sup>), combined with multiple beaver traps alongside the track indicate recent beaver activity causing drainage concerns for the rail line. The area south of this channel to Gates Creek is dominated by large fields of grass, with small pockets of cattail, native shrubs, and/or immature deciduous trees. This area appears to have been historically used for agricultural production (*e.g.*, grazing, or hay fields). Saturated soil, and open wetlands were observed at various locations in the fields along with standing water along both sides of what appeared to be a historical road bed running from the driveway to Gates Creek (Figure 8). Most of the area surveyed was dominated by large tracts reed canary grass (former agricultural fields) which is suppressing the successional recovery of native vegetation.

Figure 8. Overview of primary survey area and drainage at 9484 Portage Road. Orange line indicates “presumed” limit of FWCP ownership for this survey. Blue lines indicate scale mapped drainages. Dashed green lines indicate mapped wetlands. Yellow lines indicate observed drainage locations, and open wetlands. Purple line indicates TOB for Gates Creek from air photos. White line indicates GPS tracks from field survey. Data from imapBC.

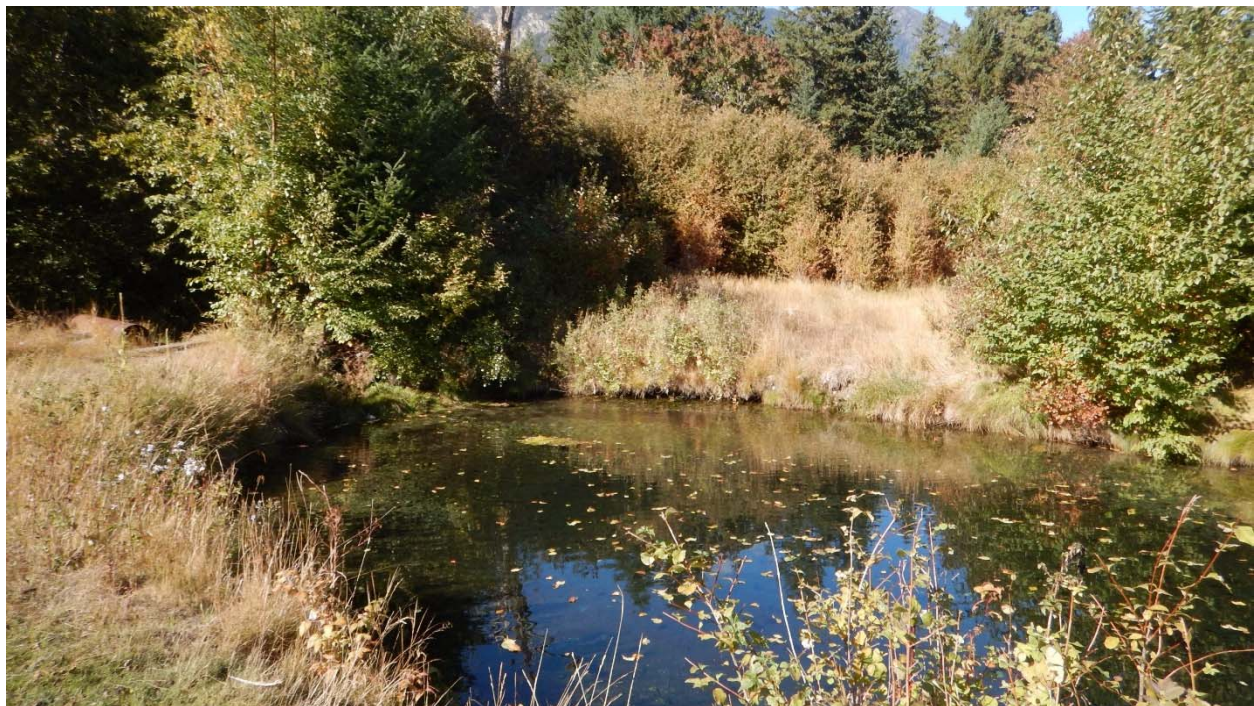
The wetland contains a number of large ground water ponds (Figures 17 & 18). Hillaby (2012) identified the Anderson Lake foreshore including the wetland complex and ponds as a rearing area for juvenile Coho Salmon. Spawning Coho Salmon have been observed in the channels between the ground water ponds in the wetland complex (Harry O'Donaghey pers. comm). However, it is unlikely the few adults observed spawning produced the number of juvenile Coho Salmon captured during the Hillaby (2012) study. Therefore, it is speculated that Coho Salmon juveniles from Gates Creek disperse into the Young John Creek wetland and ponds. Adult Pink Salmon were observed at the time of this survey (October 2017).

Figure 18. Example of large ground water ponds found in Young John Creek wetland.

- Channel modifications to increase depth and/or improve connectivity within the wetland
- Installation of habitat cover structures (*e.g.*, LWD) such as logs with root wads as described in section 2.2.1)
- Riparian planting to increase shade and overhead cover (red-osier dogwood, willow, balsam poplar).
- Improving culverts associated with the wetland complex
- Adding substrate for spawning and rearing (*i.e.*, gravel and cobble).

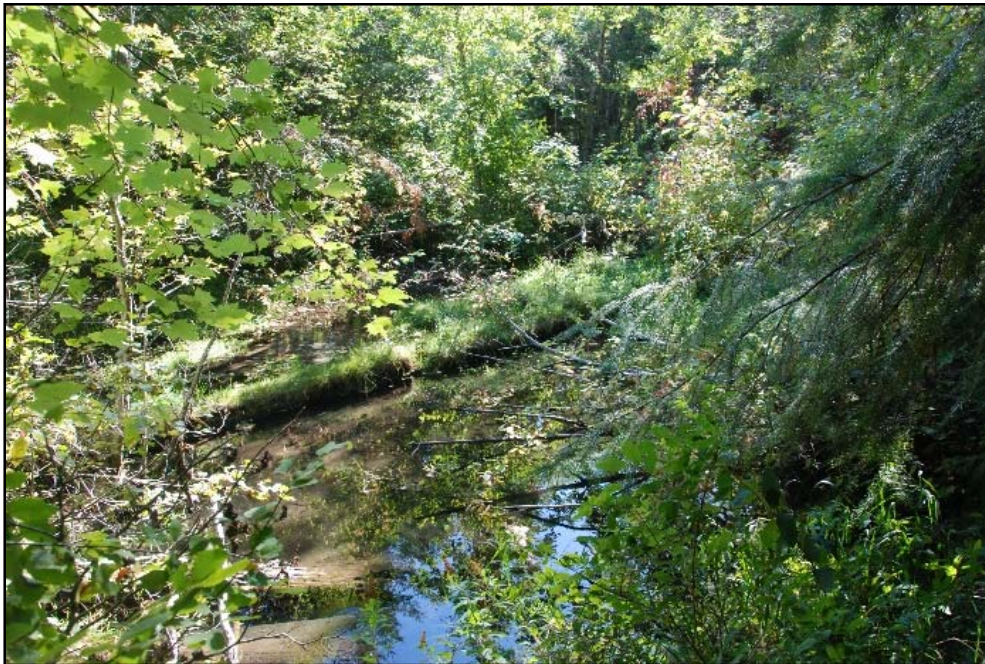
A series of off-channel ponds were identified along the north side of Gates Creek, near the confluence with Anderson Lake (Figure 20). An overhead visual assessment indicated these ponds were primarily formed by beaver dams, although the ponds also appeared to be intermittently connected to the floodplain through high flow channels that entered the pond complex at several locations from Gates Creek. The visual survey suggested the off-channel habitat could already be providing good habitat for juvenile Coho Salmon rearing. The riparian area was well established, the ponds had areas of variable depth (up to 1 m or greater), and LWD was present at multiple locations (Figure 21). However, beaver activity, that created the ponds, was also identified as a potential limiting factor to habitat productivity. While beaver can create large complexes of wetlands, providing excellent rearing habitat, the dams themselves can also limit the ability of fish to enter the pond complex, and may prevent juveniles from migrating out in the spring. In summary, the assessment indicated this off-channel beaver habitat appears to be functioning to provide habitat for juvenile fish.

Figure 21. Photo of pond created by beavers adjacent to Gates Creek approximately 200 m upstream of the confluence with Anderson Lake.

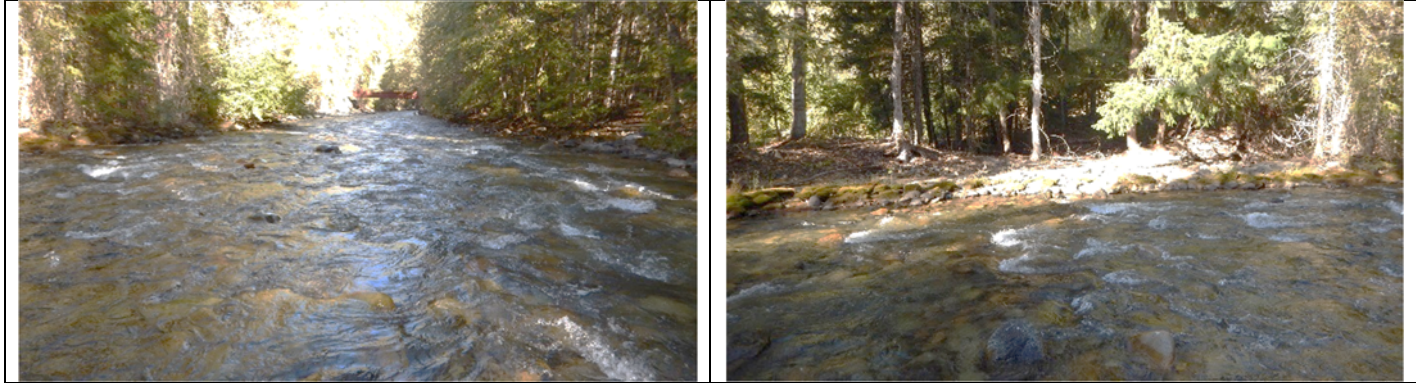
elevated approximately 8 m above the river level (Figure 25). The wetted width of Gates Creek was approximately 20 m (Figure 25), with a typical bankfull channel width of approximately 25 m (determined based on the presence of stable, mature vegetation close to the wetted edge). However, the river has low natural banks, providing an 80 m wide floodplain corridor, between the higher banks created by the linear transportation corridors and private property. Substrate in both Gates Creek and Haylmore Creek is coarse, dominated by boulder, cobble, and gravel, and is indicative of the gradient (2-3%) and semi-confined nature of the channels (Figure 25).

Figure 25. Left: Downstream view of Gates Creek in vicinity of Haylmore Creek confluence and private clear span bridge (visible in the background on the left). Right: East margin of Gates Creek showing stable, mature vegetation, near wetted edge but low bank height providing a wide floodplain.

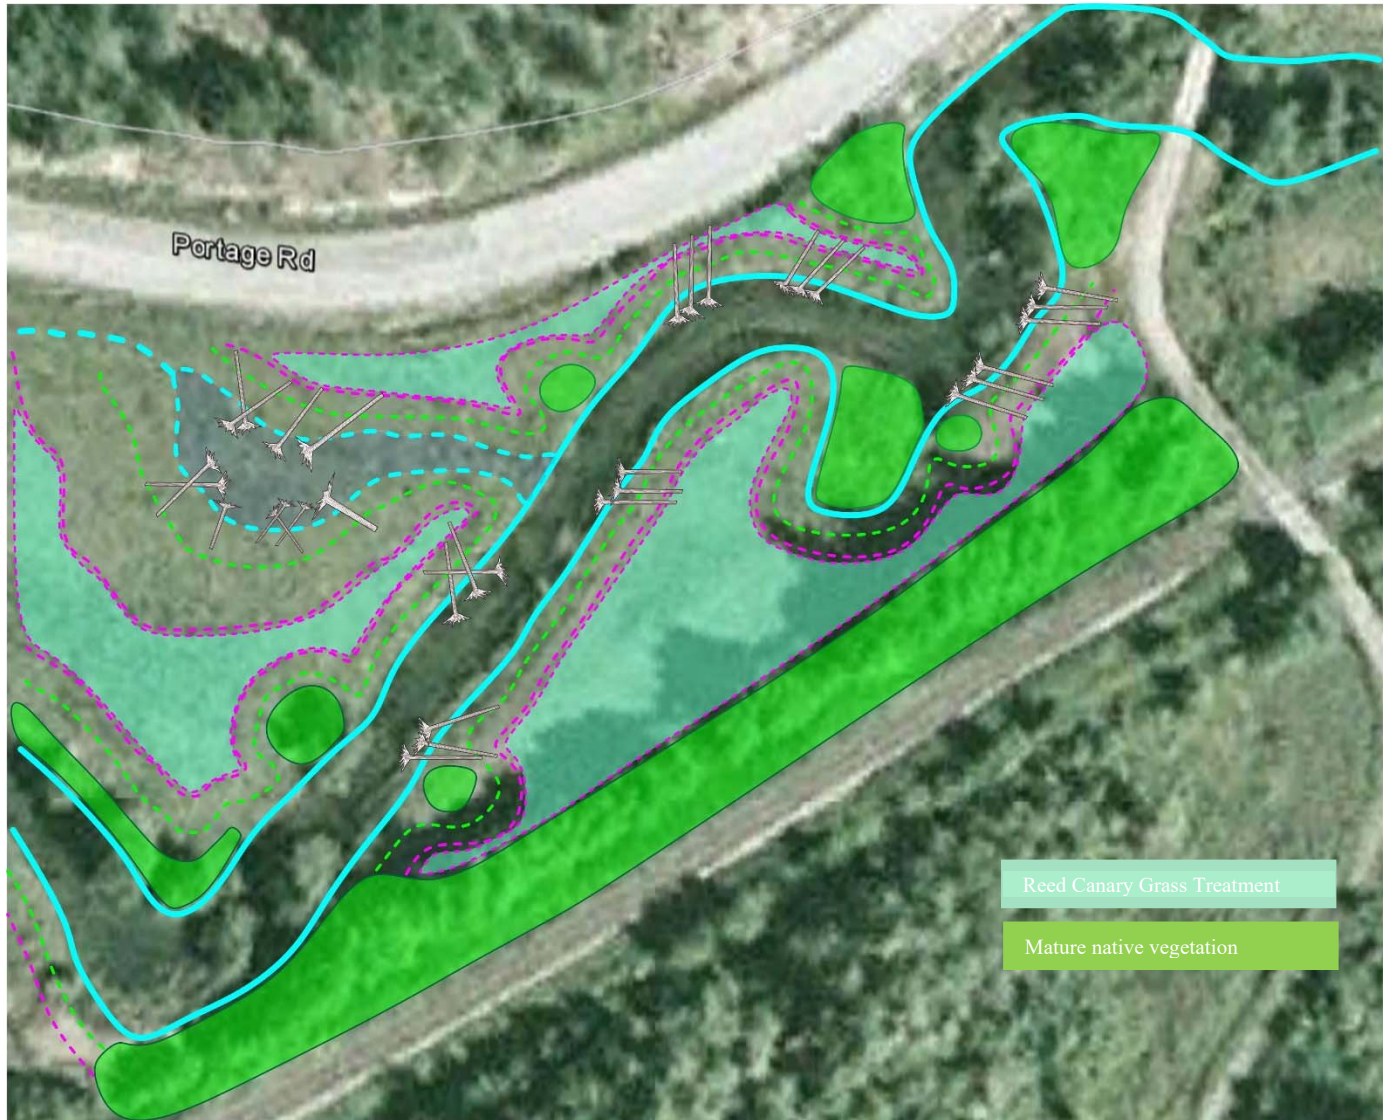
Fish habitat at the property owned by FWCP at 9523 Portage Road has been negatively impacted by agricultural practices. These practices have resulted in the removal of native riparian vegetation, and channelization of Gates Creek. These changes have reduced bank stability, channel complexity, and instream cover. There has also been a loss of off-channel and wetland habitat. The objective of the proposed restoration project is to aid in the recovery of the riparian habitat back to a functioning forest and increase channel complexity, instream cover, and channel stability. Techniques proposed to achieve these objectives should focus on accelerating natural recovery by improving conditions for early successional vegetation. Channel complexity could be increased by the installation of LWD features, and excavation of the off-channel habitat (Figure 27). The restoration measures outlined in this report currently encompass the low land-flood plain area of the property. The upland sections are recovering naturally and do not require intervention at this time.

Figure 27. Overview of proposed restoration measures at 9523 Portage Road. Solid blue lines indicate Gates Creek Top of Bank (TOB). Dashed blue line indicates proposed off-channel habitat. Dashed green line indicates approximate limit of vegetation stripping at TOB. Dashed purple line infilled with mint-green shading indicates approximate limit of reed canary grass treatment. Bright-green shading indicates area of mature native riparian vegetation to be retained.

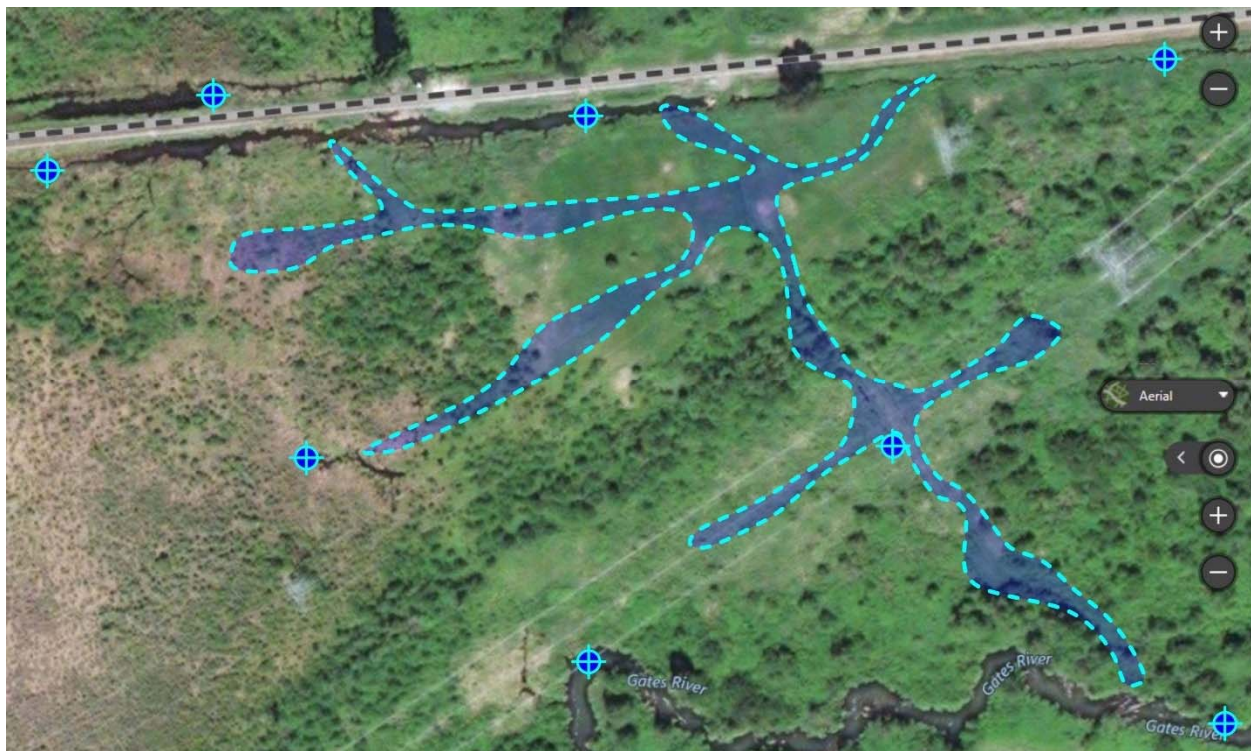
Figure 28. Overview of 9484 Portage Road restoration concept. Blue cross-hairs indicate recommended areas for collection of elevation data. Channel and Pond target wetted depth will be 0.5-1.5 m. Target wetted widths will be 3 m – 5 m.

Coho Salmon as well as multiple species of wildlife would benefit from this project. The conceptual design for the off-channel habitat would include re-establishing a more natural drainage pattern (*i.e.*, across the valley rather than along the CN track). To accomplish this, a series of fish accessible wetland ponds would be excavated around the property with drainage channels to collect and store water (Figure 28). Depth and width of ponds and connecting channels will be dictated by the amount of available water to supply the wetland with sufficient flow for aeration. However, the proposed target width of the channels would be 3 - 5 metres of wetted with. Target wetted depth of the connecting channels would be 0.5 m. Target depth of the ponds would be 1.5 m deep. Single log (20 - 50 cm diameter) and rootward

A major challenge of this project will be designing to manage potential beaver dam building activity. Building sections of the wetland complex greater than 1 m in depth may aid in deterring dam building by providing suitable habitat for beaver lodges (Hartman and Tornlov 2006). Planting of less palatable species to beavers in the riparian area may also serve to reduce beaver dam building (e.g., cascara or twinberry) (Washington Department of Wildlife); however, many of the species listed as less preferred by beavers do not grow in the interior climatic zone around Gates Creek. Some restoration professionals, in the nearby Bridge River watershed, have found red-osier dogwood to be less favorable to beavers (Kim North pers.comm.). Consultation with a specialist in beaver ecology is recommended during project development to ensure the project would not result in additional flooding concerns for the CN rail line.
