Deer Creek Drawdown Zone Fish Habitat Enhancement: A Pilot Study (Phase II) for Lower Arrow Lakes Tributary Access Improvements 2016 – 2017

FWCP # COL-F17-F-1450

Evan Smith, B.Sc., BIT and Michael Zimmer, M.Sc., R.P.Bio
Okanagan Nation Alliance
L2 – 1444 Columbia Ave.
Castlegar, BC, V1N 3K3

June 2018

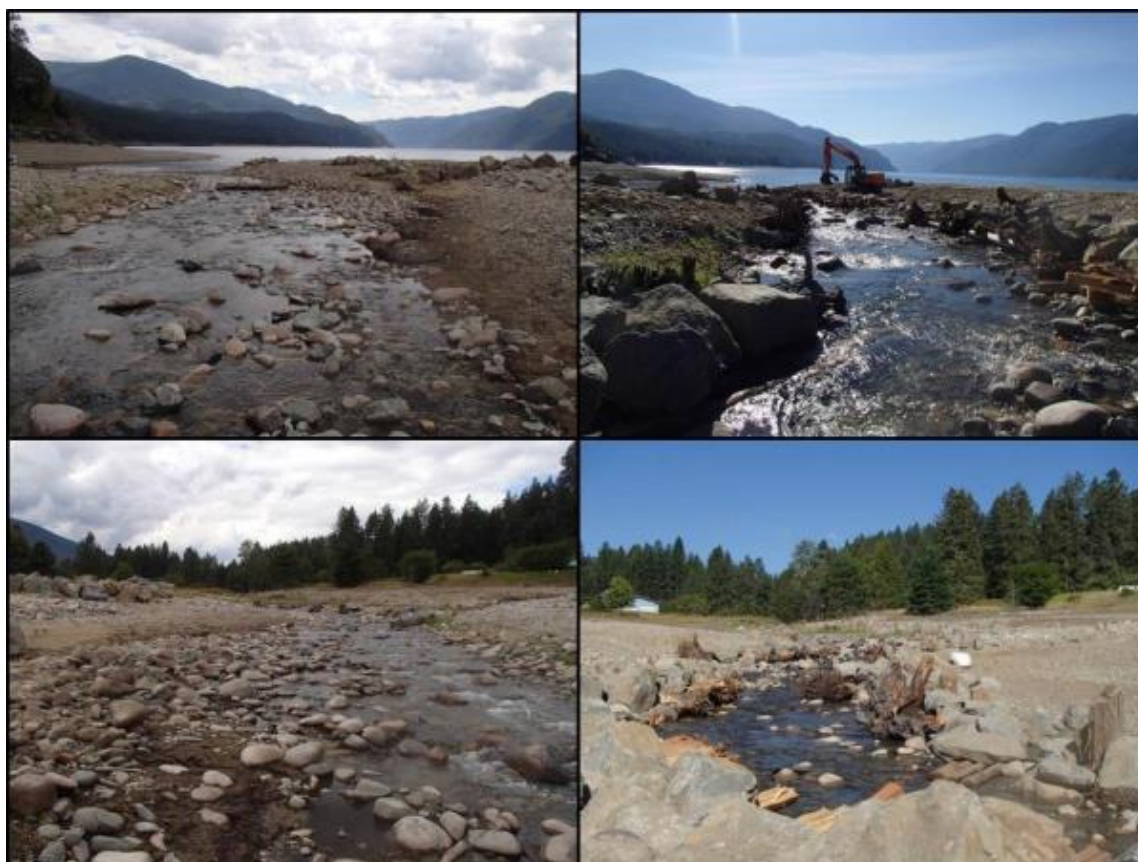
Eleven structures were constructed within the 75 m study area immediately downstream of the end of Phase I within the drawdown zone of Deer Creek (Fig 4). These structures included wood, root-wad and boulder anchored structures, root structures ballast by boulders, and boulder-lined banks. Boulders used to anchor large wood were an average diameter of 1.20 m b-axis. Three or four of these boulders were used on each wood component, and additional 40 – 60 cm size rock was used as fill. For a breakdown of each structure's components see Appendix A. Structures were numbered consecutively following those placed in Phase I. Minor excavation took place in front of Structures 18 and 19 to increase the wetted width depth profile. Layout maps were created to document structure positions following construction (Fig 5 and 6).

Figure 4. A downstream perspective from Phase I of Phase II before (top left) and after (top right) structure construction, and an upstream perspective from within the drawdown zone of Phase II before (bottom left) and after (bottom right) structure construction Photos by Evan Smith, Okanagan Nation Alliance, August 2016.

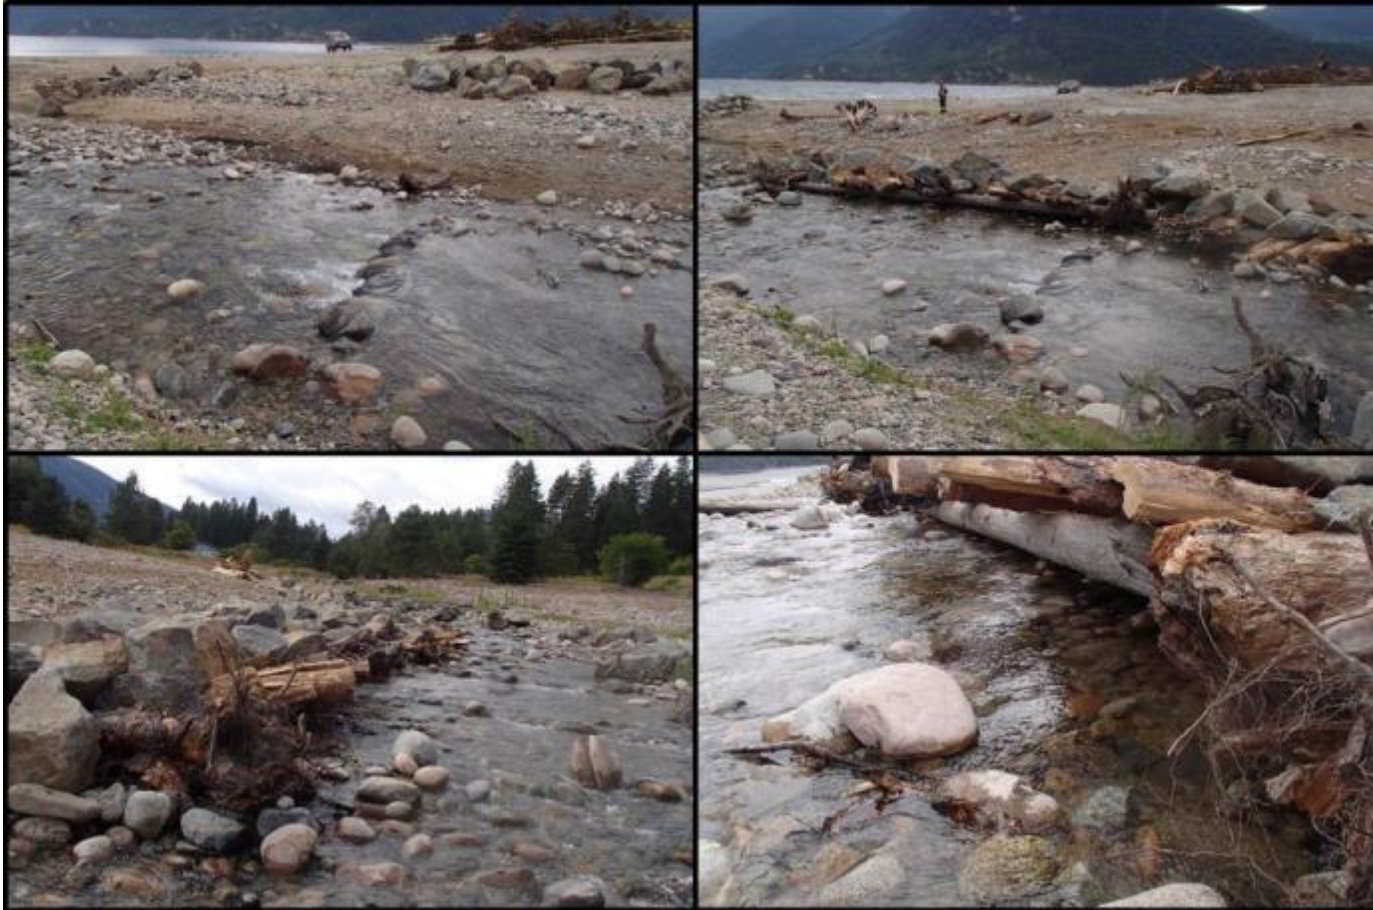
Structure 9 is made up of two log-root-rock structures and is used to promote low-flow channel definition (Fig 7). This feature provides cover for fish during high and low reservoir levels. Wood shelves were constructed to mimic cut banks for use as overhead cover.

Figure 7. Before (top left) and after (top right) comparison from a upstream perspective of Structure 9 on the right bank in the section of Deer Creek within the drawdown zone; (bottom left) closer view of Structure 9 from a downstream perspective depicting overhanging cover for Kokanee; (bottom right) Close up of the artificial cut banks that fish can utilize for cover. Photos by Evan Smith, Okanagan Nation Alliance, August 2016.

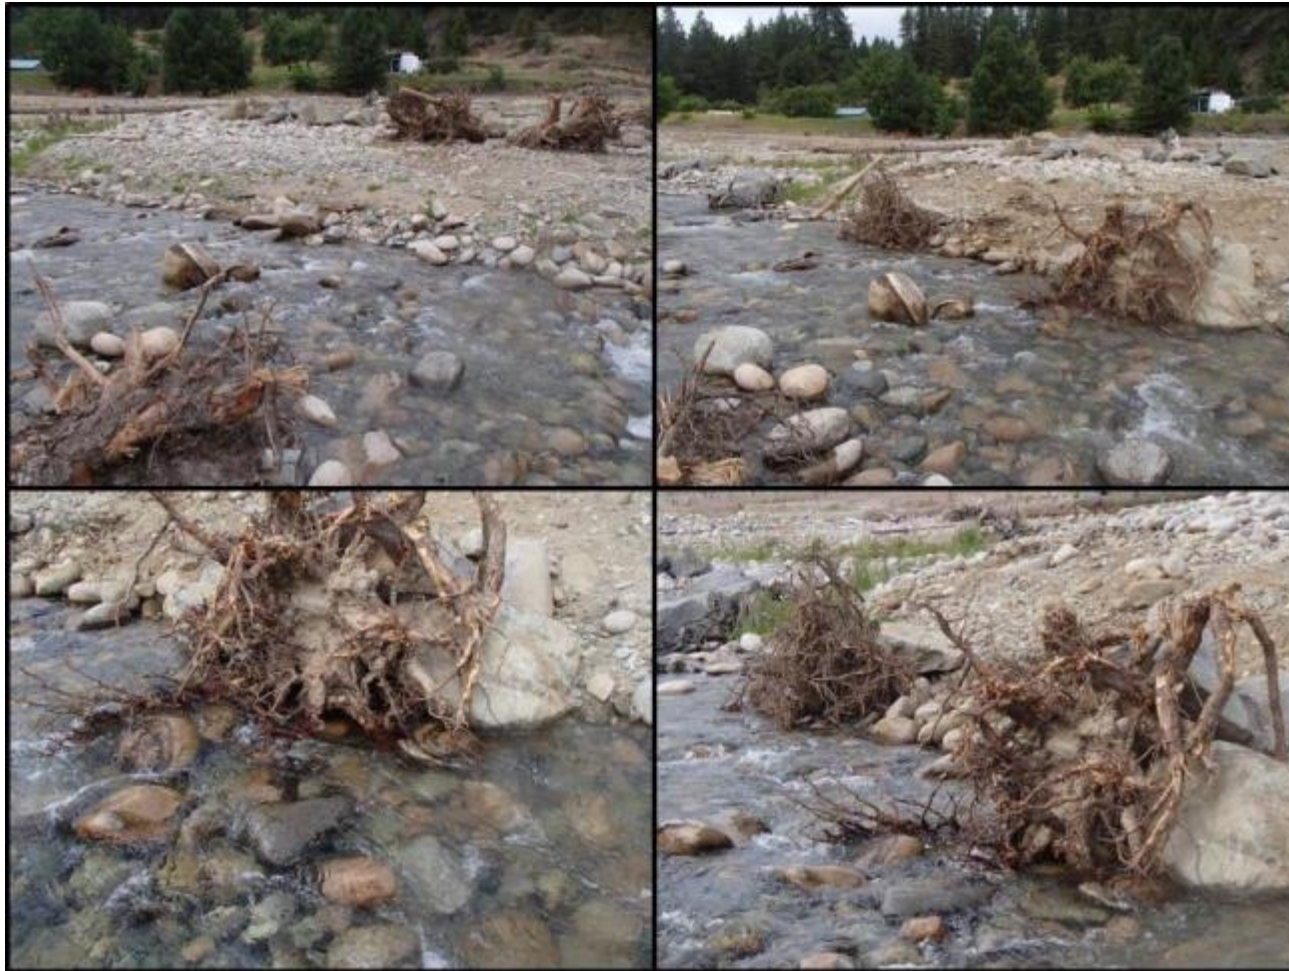
Structure 10 is two root wads ballasted with rock (Fig 8). A third root wad was added later to utilize available material. This structures' function is to deflect water from the left bank into the center of the stream while providing cover for Kokanee during high and low water periods.

Figure 8. Before (top left) and after (top right) comparison from a downstream perspective of Structure 10 on the left bank in the section of Deer Creek within the drawdown zone; (bottom left) close view of one root in Structure 10 from a downstream perspective depicting its value as cover and refuge; (bottom right) Closer view of two of three root structures comprising Structure 10. Photos by Evan Smith, Okanagan Nation Alliance, August 2016.

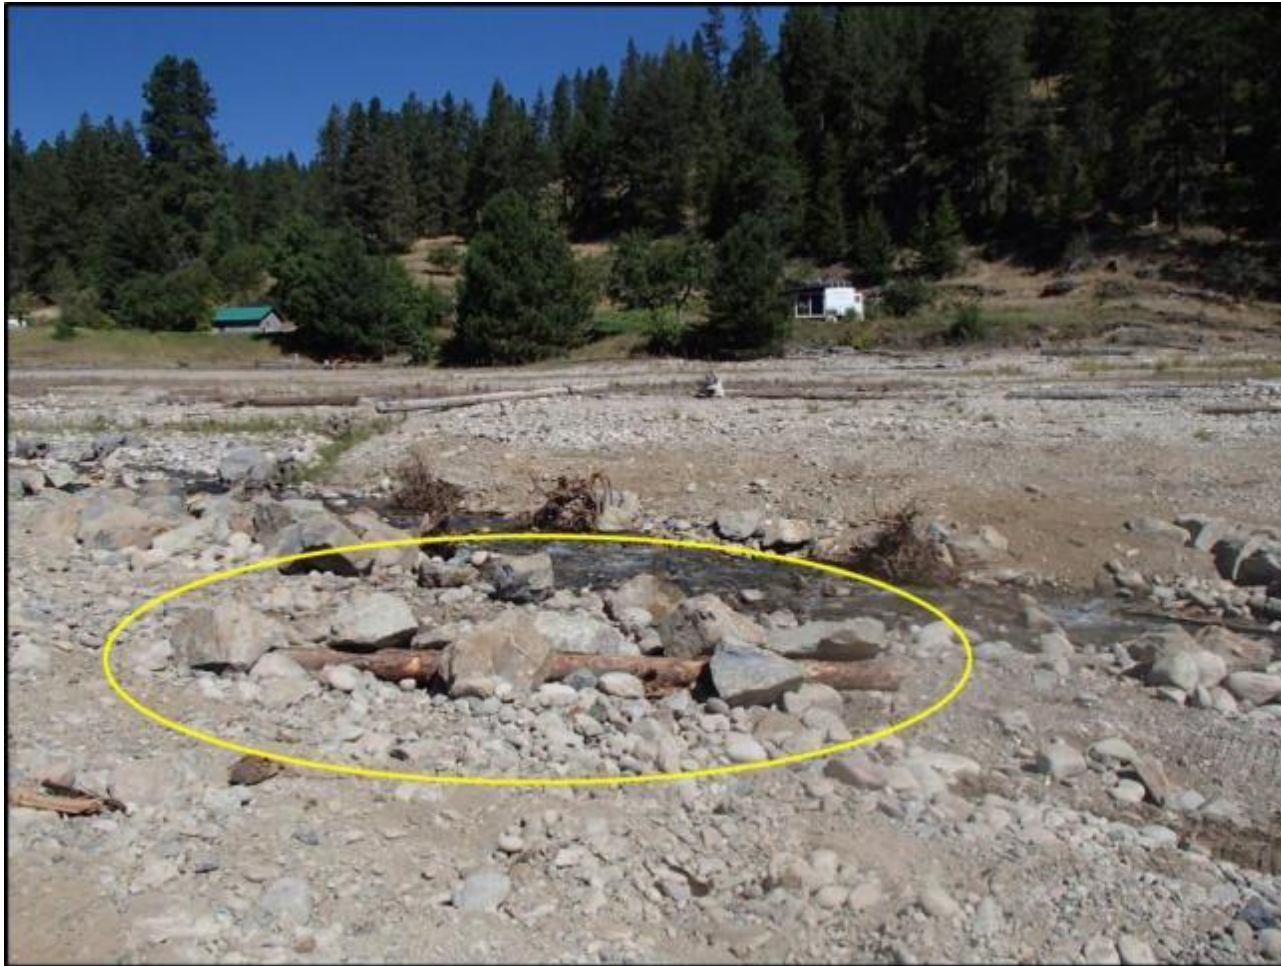
Structure 11 is a deflection structure located above the bankfull channel elevation, made of a log with ballast rock to guide water back into the stream (Fig 9). On-site evidence suggests at some point in the year the creek may be high enough to flow behind the structures in this zone. Deflection structures such as this one are designed to encourage the water to return to the newly-defined main channel when high flows recede.

Figure 9. Structure 11 from a right bank perspective designed to deflect water into the original stream bed as higher flows recede. Photo by Evan Smith, Okanagan Nation Alliance, August 2016.

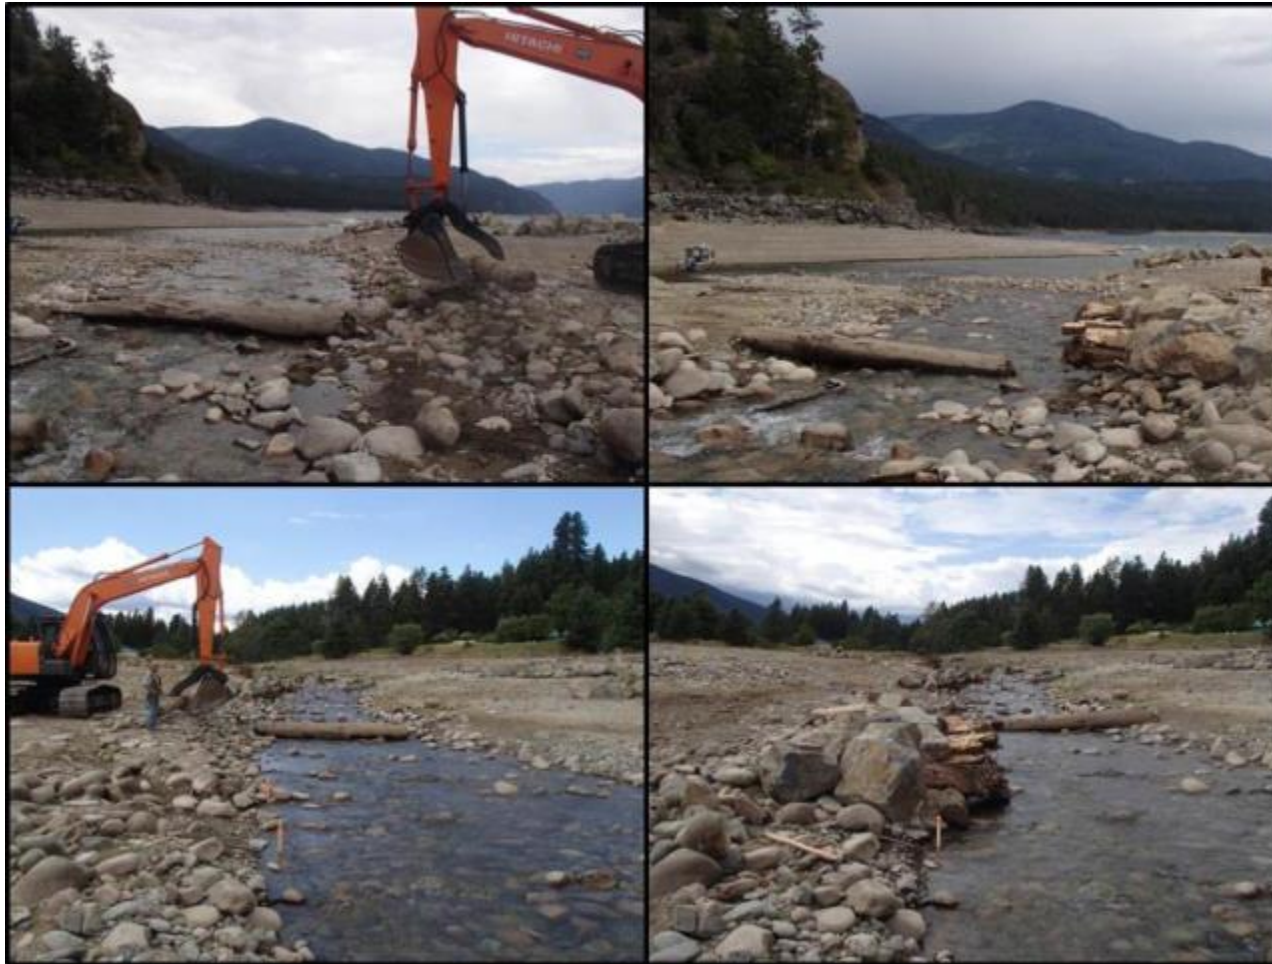
Structure 12 is similar to Structure 9 but consists of one log-root-rock structure designed to promote low-flow channel definition (Fig 10). This feature provides cover for fish during high and low reservoir periods while deflecting water from the right bank to the center of the creek during low flows. Wood shelves were constructed to mimic cut banks which fish use as overhead cover.

Figure 10. Before (top left and bottom left) and after (top right and bottom right) comparison from upstream and downstream perspectives, respectively, of Structure 12 on the right bank in the Deer Creek drawdown zone Photos by Evan Smith, Okanagan Nation Alliance, August 2016.

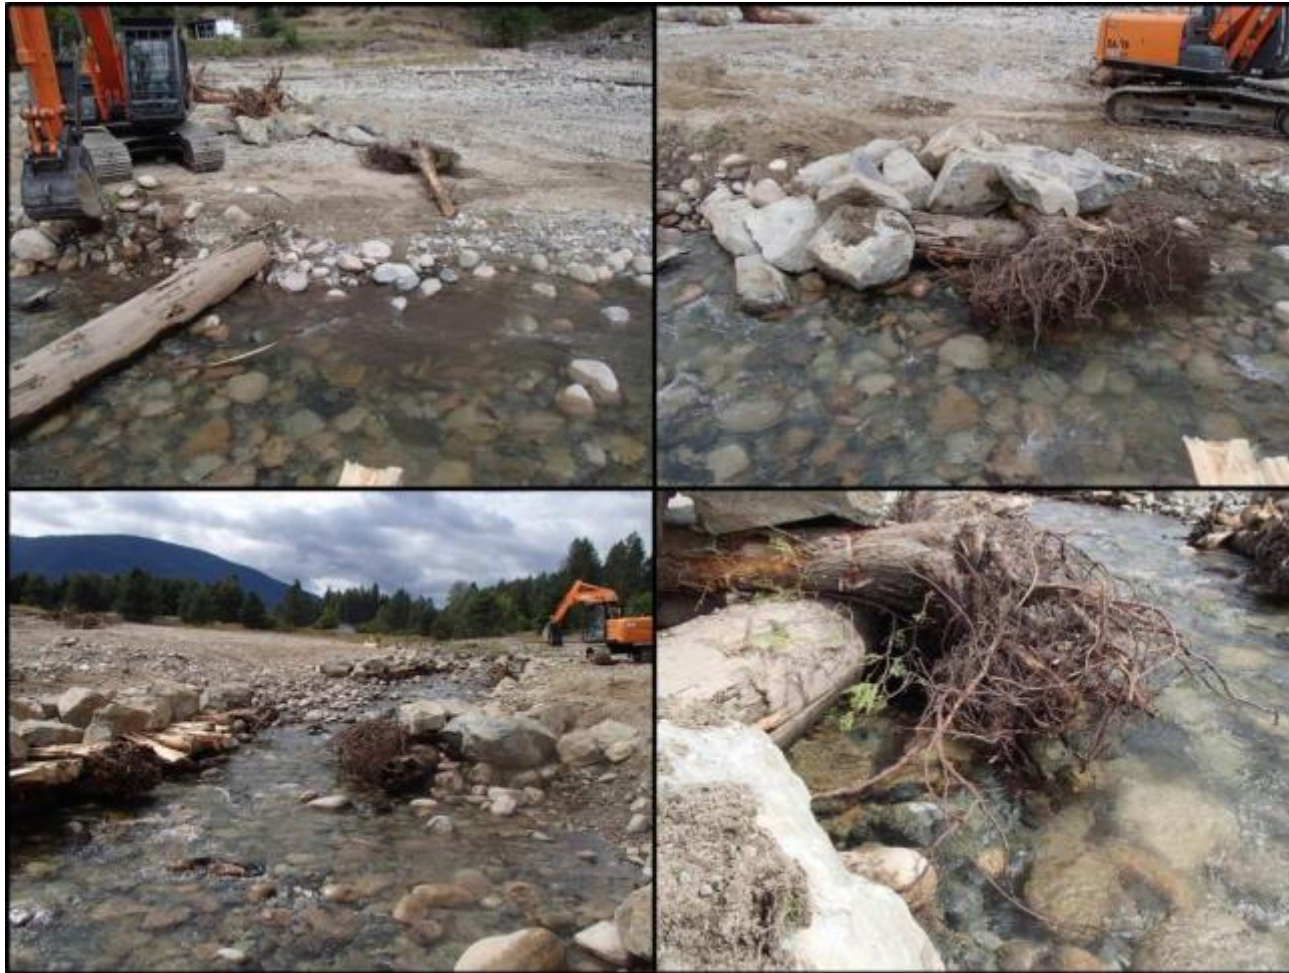
Structure 13 is made of a large log and root ballasted by boulders (Fig 11). This feature provides pool habitat for refuge and cover from predators in high and low water while deflecting flows from the left bank to the right bank, reducing braiding and increasing low flow water depth.

Figure 11. Before (top left) and after (top right) comparison of Structure 13 on the left bank in the section of Deer Creek within the drawdown zone from across the stream; (bottom left) a downstream perspective of Structure 13 in relation to Structure 12; (bottom right) a close up of Structure 13 from an upstream perspective depicting its effectiveness of creating pools and cover for fish. Photos by Evan Smith, Okanagan Nation Alliance, August 2016.

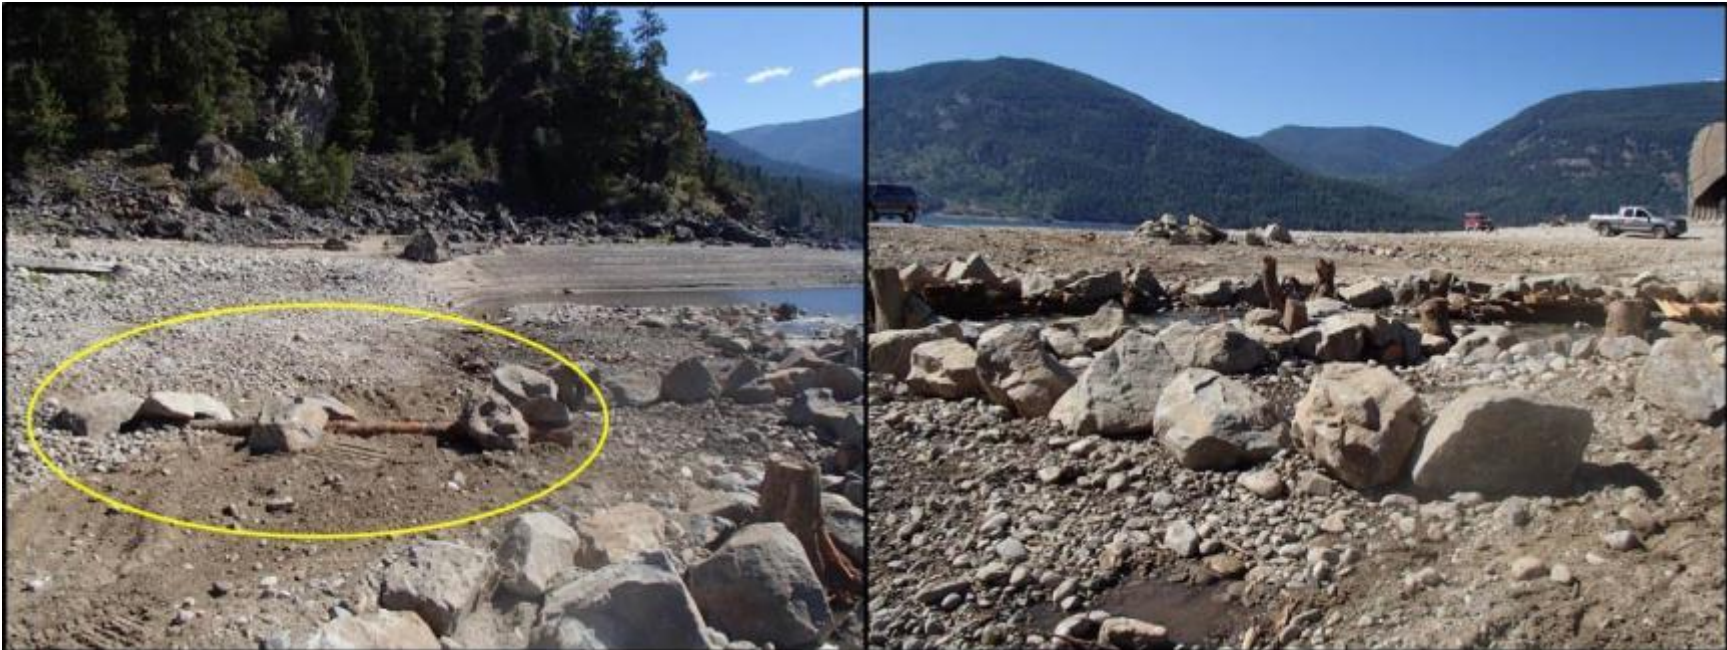
Structures 14 and 15 are similar to Structure 11 in composition and function (Fig 12). Like Structure 11, Structure 14 is comprised of a log with ballast rock. Structure 15, however, is constructed entirely of rock. Both these structures work to deflect water back into the newly-defined channel when higher water levels recede.

Figure 12. Structure 14 (left) and Structure 15 (right) located on the left bank in the Deer Creek drawdown zone between Structures 13 and 16. Photos by Evan Smith, Okanagan Nation Alliance, August 2016.

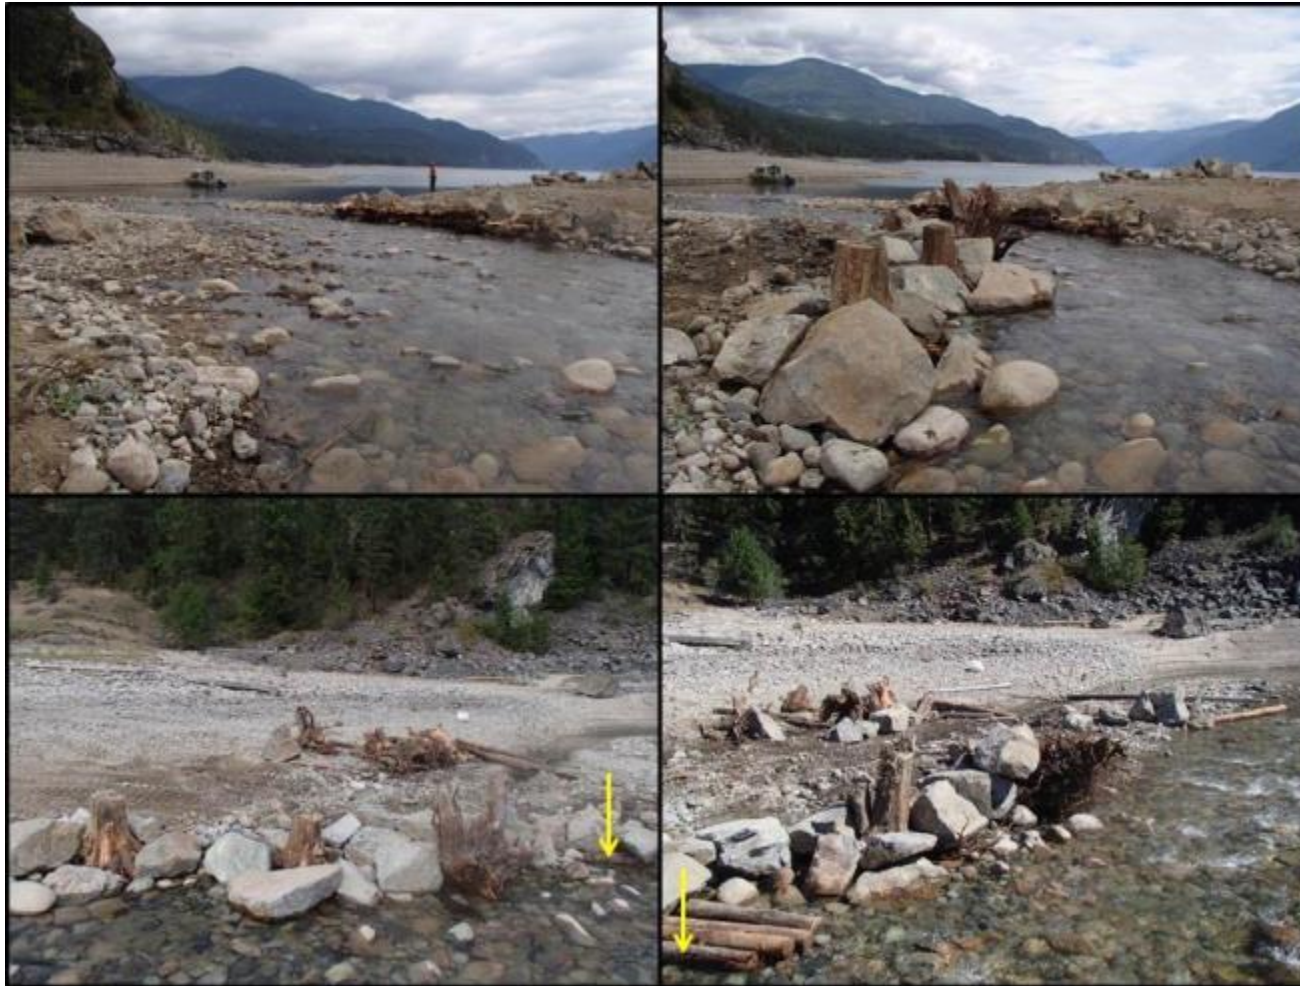
Structure 16 is a large structure with a combination of vertical roots, horizontal roots and cover logs all ballasted with rock (Fig 13). This structure reduces braiding, increases water depth and provides cover for fish during both high and low water levels.

Figure 13. Before (top left) and after (top right) comparison of Structure 16 from an upstream perspective located on the left bank of the Deer Creek drawdown zone; (bottom left) view of Structure 16 from across the stream; (bottom right) continuation of Structure 16 from across the stream (point of reference indicated via yellow arrows. Photos by Evan Smith, Okanagan Nation Alliance, August 2016.

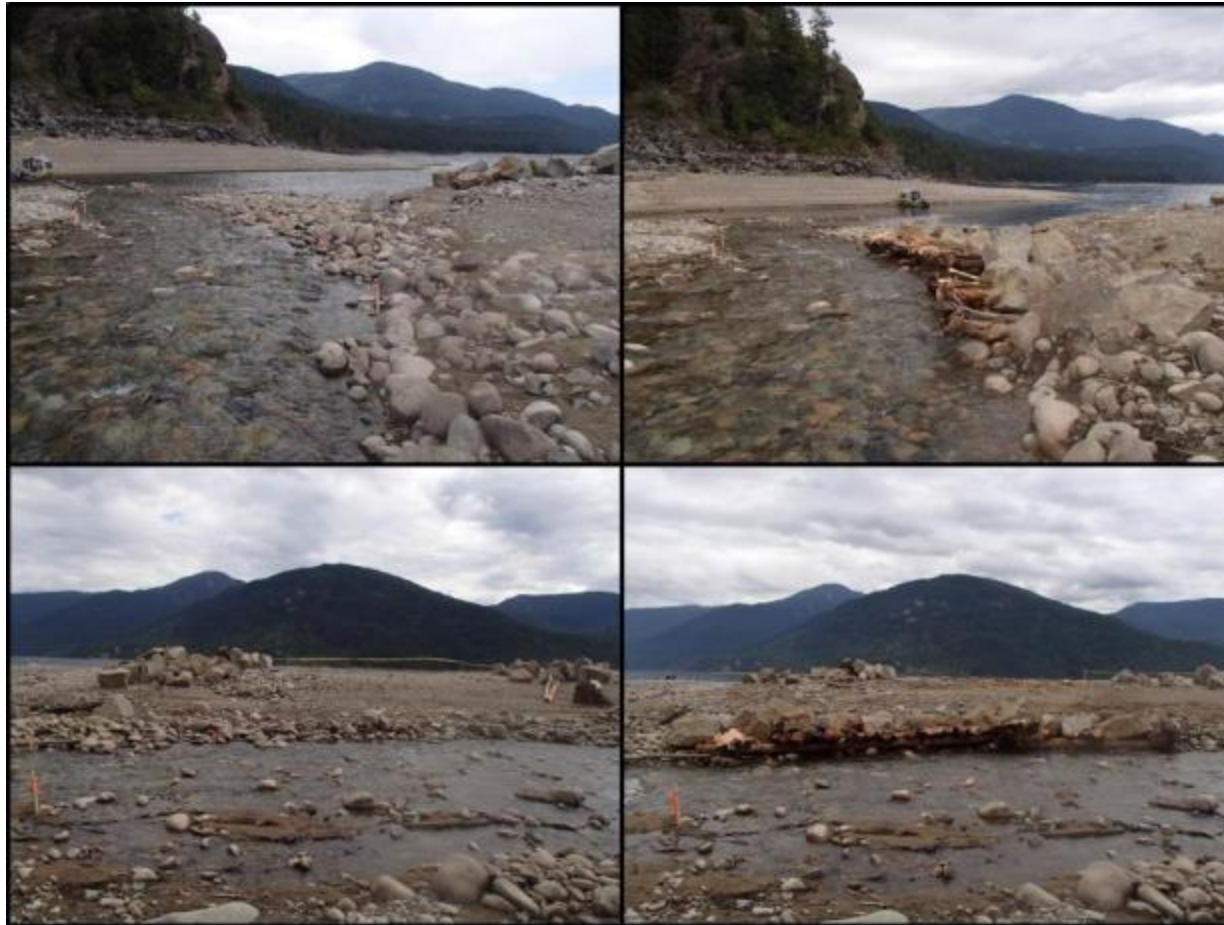
Structure 17 is a replicate of Structure 12 consisting of one log-root-rock structure to promote low-flow channel definition (Fig 14). This feature provides cover for fish during high and low reservoir levels while deflecting water from the right bank to the center of the creek during low flows. Wood shelves were constructed to mimic cut banks for fish to use as overhead cover and boulders were placed on top of the structure for reinforcement and added bank protection.

Figure 14. Before (top left) and after (top right) comparison from an upstream perspective of Structure 12 on the right bank in the section of Deer Creek within the drawdown zone. Before (bottom left) and after (bottom Right) comparison of Structure 12 from across the stream. Photos by Evan Smith, Okanagan Nation Alliance, August 2016.

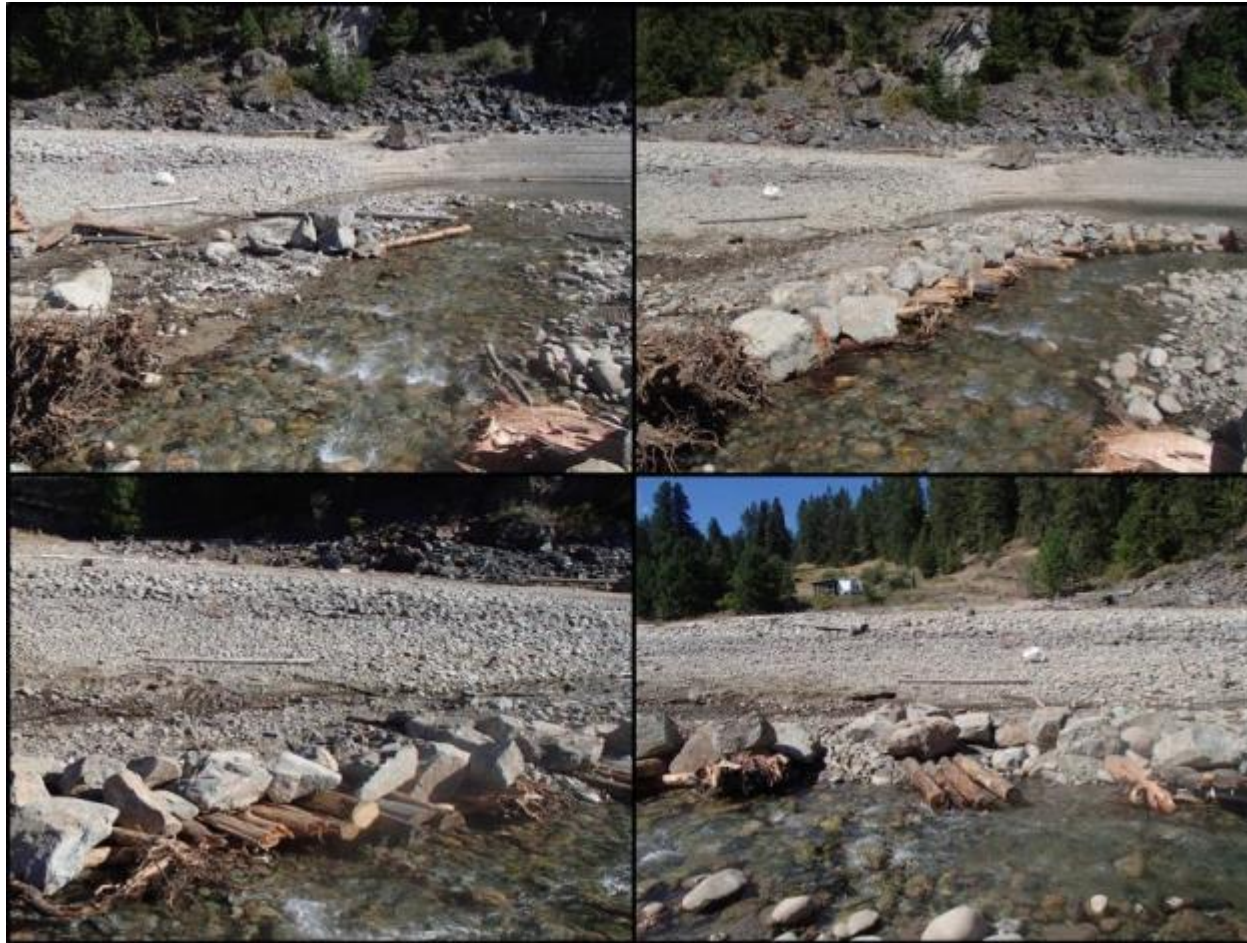
Structure 18 is similar to Structure 17 and Structure 12 consisting of a log-root-rock structure to promote channel definition, but also has an added log structure to provide cover and promote scouring of a pool (Fig 15). This structure design was based on monitoring Structure 8 in Phase I and is designed to provide cover during high and low water levels, form a pool for Kokanee refuge and encourage channel definition.

Figure 15. Before (top left) and after (top right) comparison of Structure 18 from an upstream perspective on the left bank in the Deer Creek drawdown zone; (bottom left) closer view of Structure 18 shows its use as cover; (bottom right) four logs at the end of Structure 18 that are designed to create a pool for Kokanee refuge based on monitoring results of Structure 8 in Phase I. Photos by Evan Smith, Okanagan Nation Alliance, August 2016.

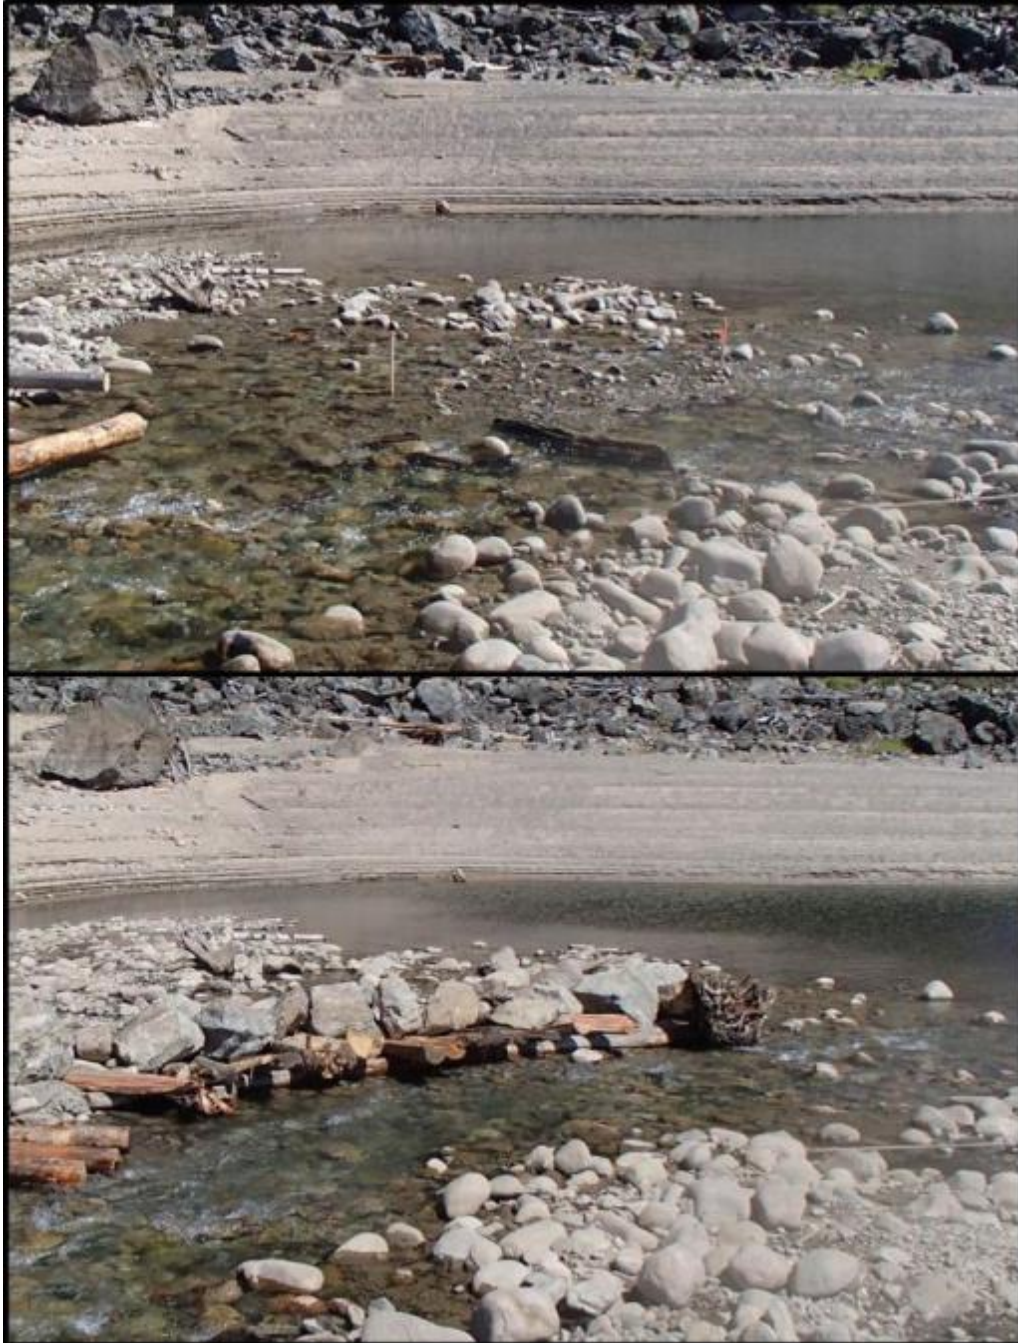
Structure 19 is a log-root-rock structure reinforced to promote channel definition at the creek bend (Fig 16). This structure is designed to provide cover at high and low water levels and to reduce braiding in the drawdown zone. Having this structure on the bend of the creek is expected to increase velocity downstream, with the intention of scouring the sand and promoting channel definition.

Figure 16. Before (top left) and after (top right) comparison of Structure 19 from an upstream perspective on the left bank in the Deer Creek drawdown zone. Photos by Evan Smith, Okanagan Nation Alliance, August 2016.

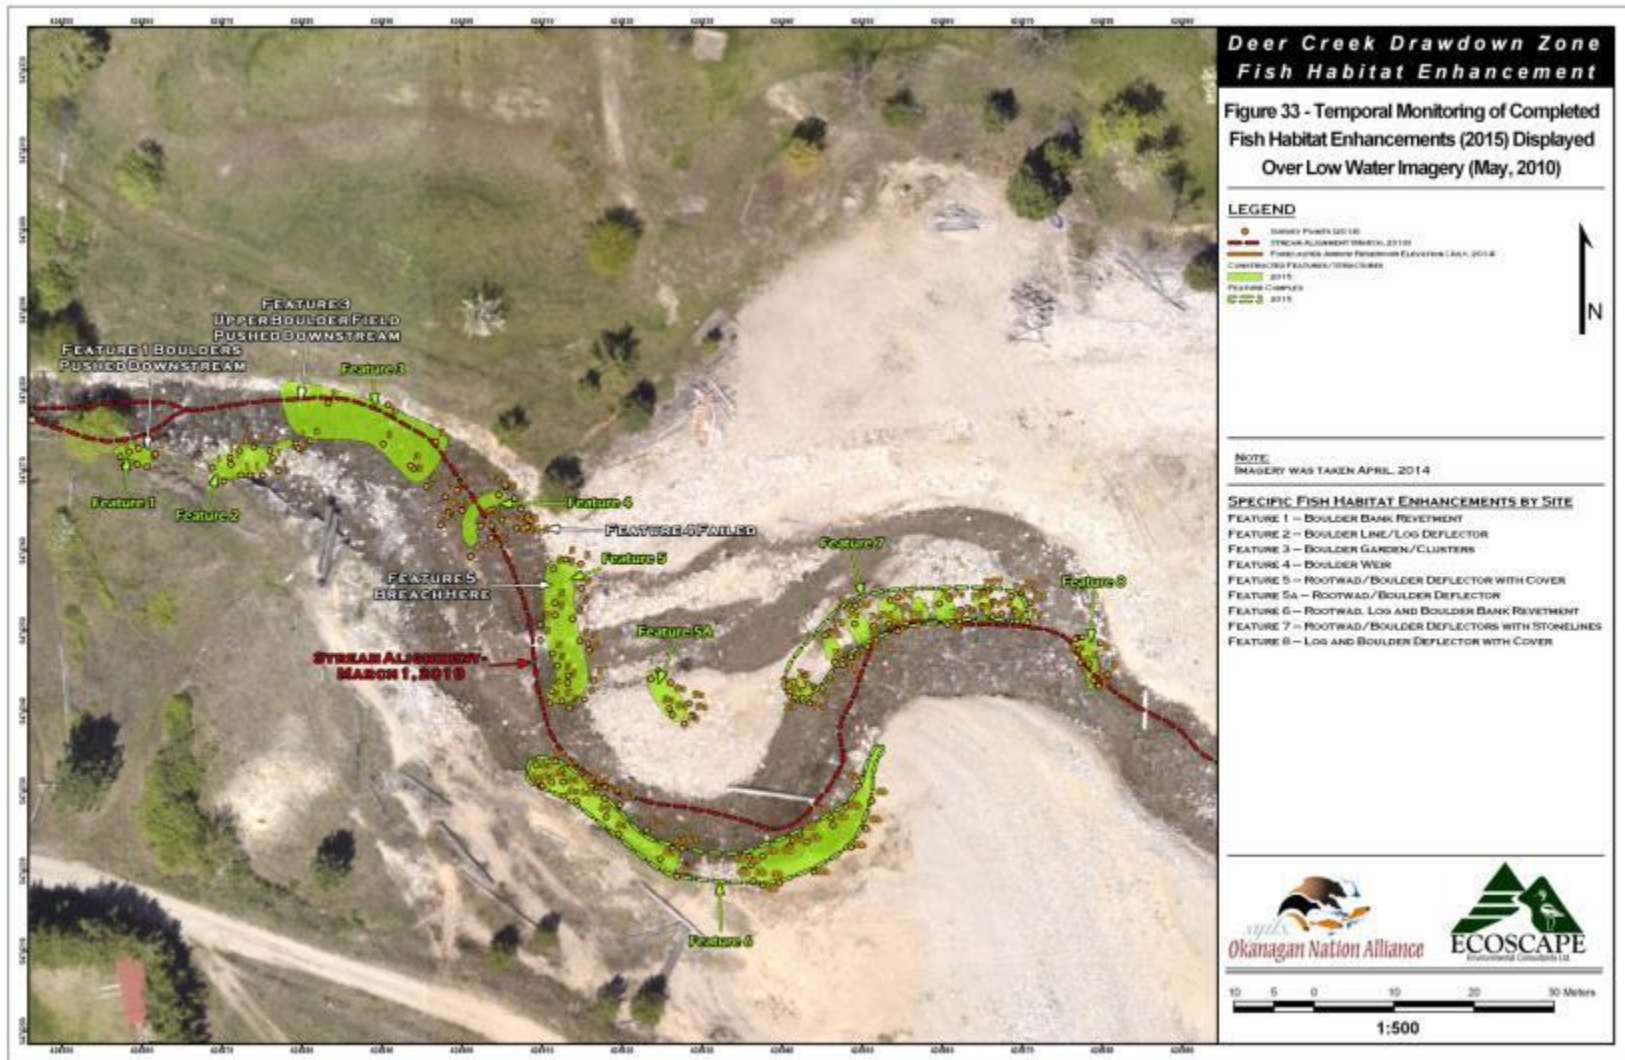
Structures were monitored for stability and function on March 2 2018 to assess the effects of the 2017 freshet and reservoir infilling. Minimal structure movement and degradation was identified at this time (Table 1). Photos were taken to document the movements of specific components in each structure (Fig 20 - 32). Deer Creek remained in a defined channel from the tree line through the drawdown zone to its confluence with the Arrow Lakes Reservoir. All previously identified side channels were dry, or contained very little water (< 3.0 cm). Channel width in the drawdown zone (1.5 – 5 m) was comparable to channel width upstream based on measurements taken in 2015. A detailed georeferenced topographic survey was completed to identify overall structure positions and hydraulic changes (Fig 34 and 35).

Figure 34. Post-freshet and inundation monitoring results in Phase I depicting structure placement before (2015; green polygons) and after (2018; yellow dots) two years of in the upper Deer Creek Draw Down Zone (map created by Ecoscape, 2018).
