April 27, 2020

Thompson Creek Fish ladder, Replanting and Assessments Stave River Watershed- Restoring Salmon Habitat

Prepared for:
Fish Wildlife Compensation Program
Project number: COA-F20-F-3110

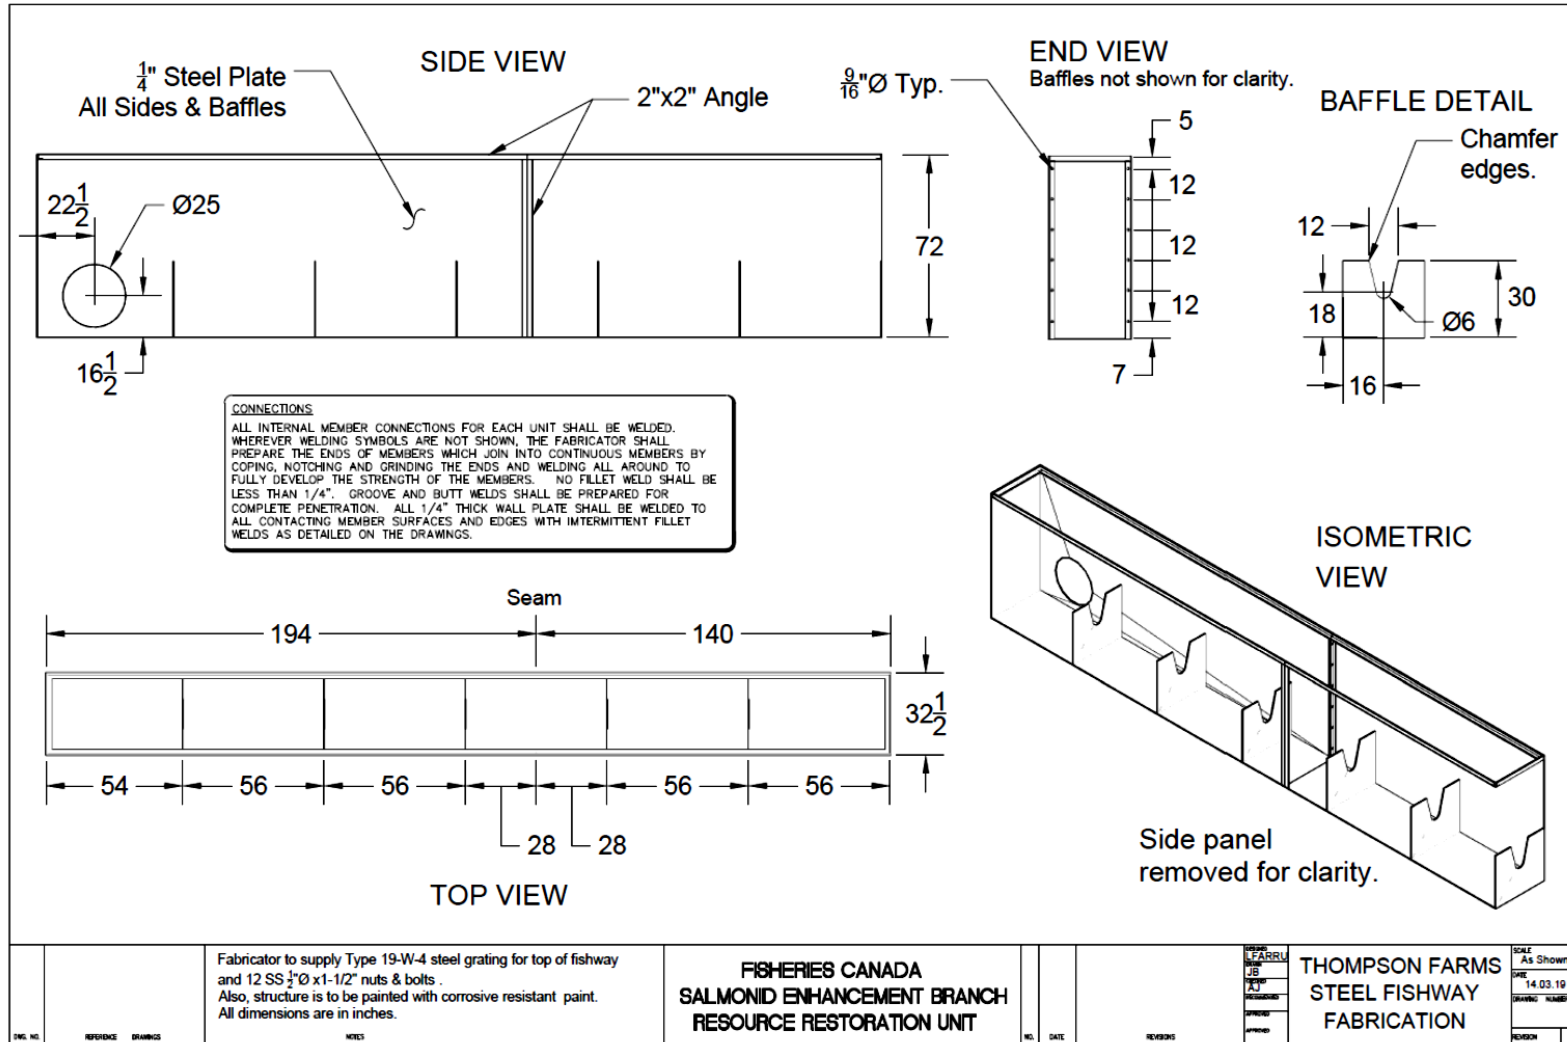
Design for the Thompson Creek fish ladder.

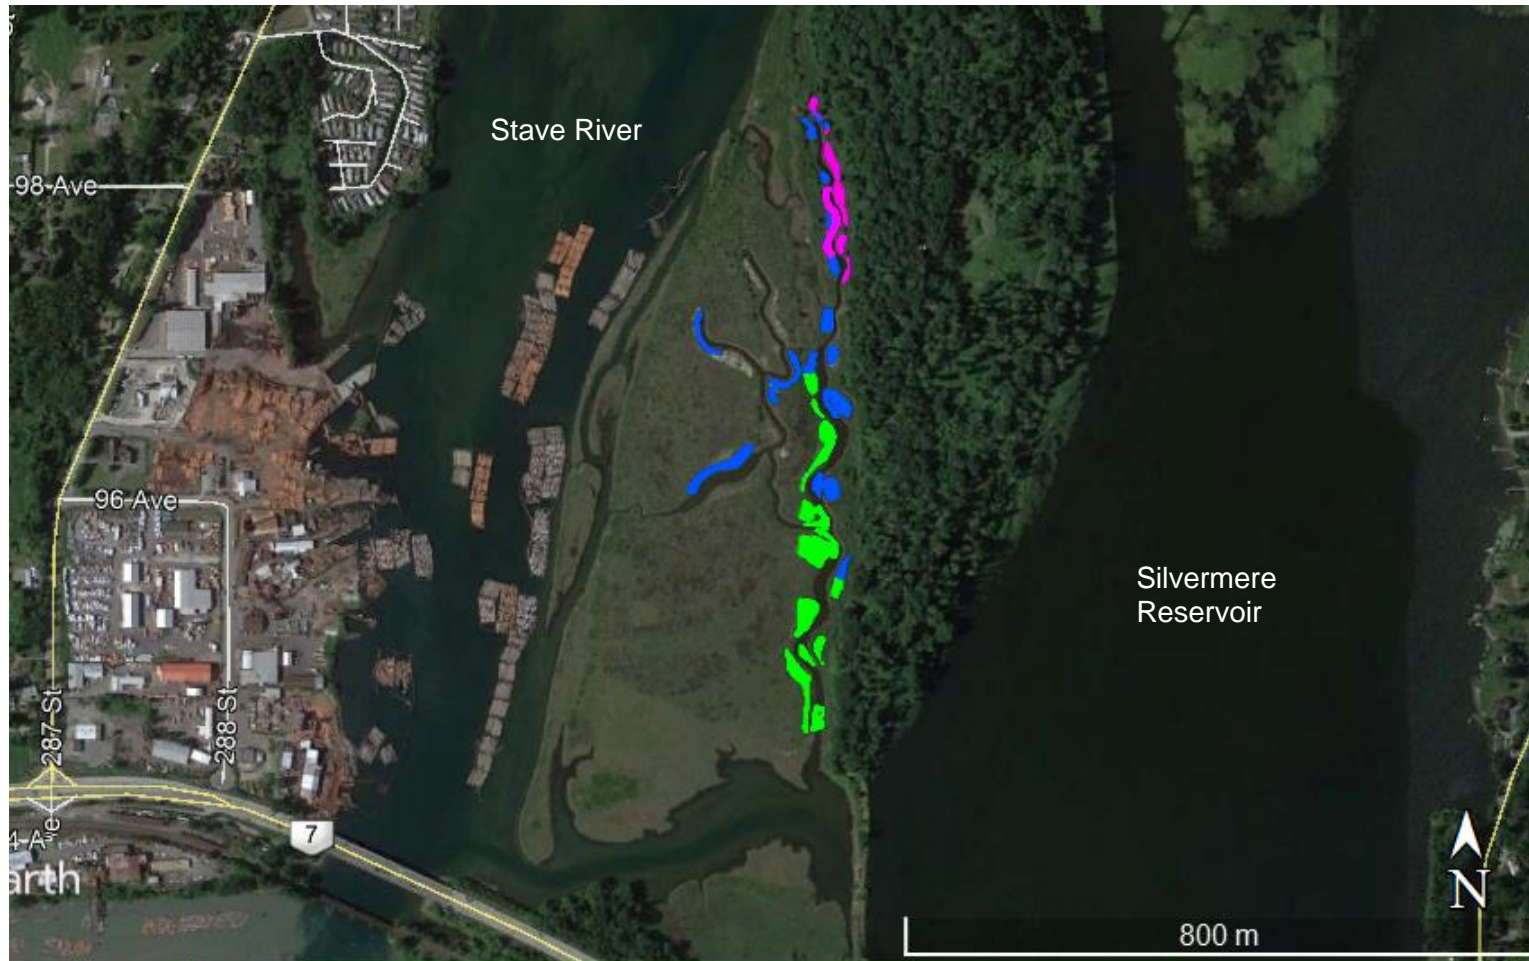
Cumulative planting areas (totalling 8416m² and represents 16% of total replanting potential of KFN IR3 within the lower floodplain). Pink polygons show areas planted in the fall 2019/winter 2020. Green and blue polygons show plantings from previous years.

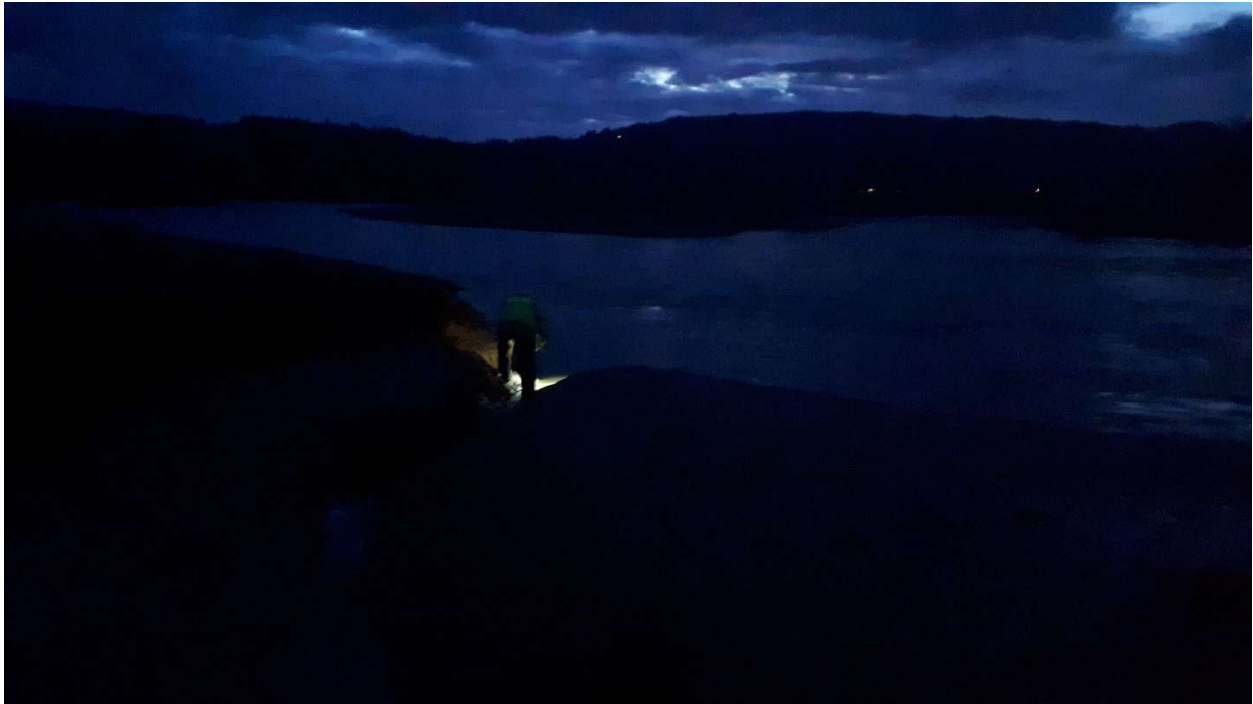
Figure 2. Survey by flashlight at 6:30 am.

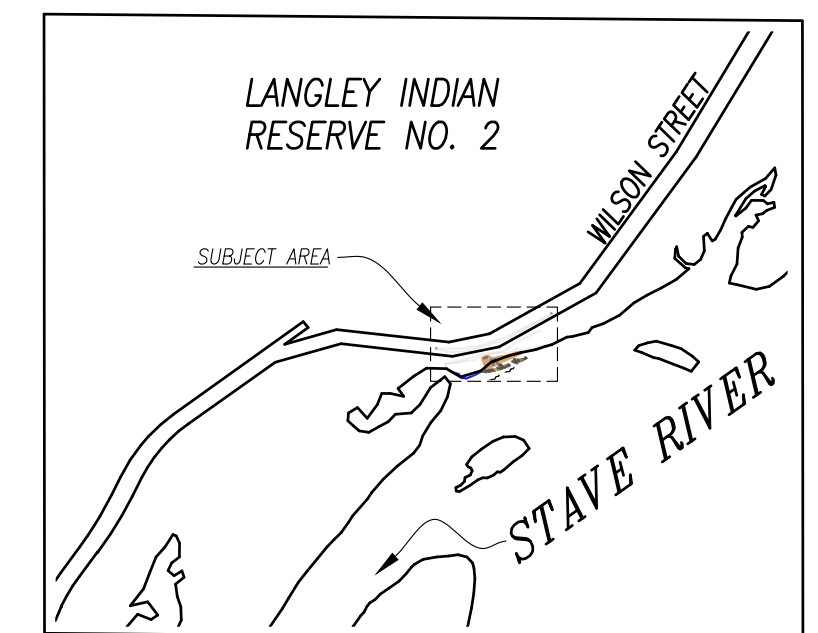
Some erosion has occurred within and around the reef structure, represented as purple shading in the surveyed drawing, ranging from 0.3m to 1.04m. Particularly, it is occurring at the uppermost section where the mainstem flows intercept the right bank. Further downstream there is minimal erosion until nearing the end of the reef where some erosion action is still observed.

Further downstream where no reef structure was installed, the surveyors measured the banks between March 2019 and February 2020, shaded as light grey in the surveyed drawing. Downstream erosion of the cut-bank ranges from 0.25m to 1.61m of active erosion. Just Upstream of boulder 52, where no rootwads were installed active erosion has been surveyed and observed.

REEF ANALYSIS
 PLEASE REFER TO SPREADSHEET FOR COMPARISON BETWEEN ROCKS AND LOGS THAT WERE OBSERVED MARCH 21, 2019 AND FEBRUARY 13, 2020
 LEGEND
 A-A' = MOVEMENT OF LOGS (2019-03-21 - 2020-02-14)
 1-1' = MOVEMENT OF ROCKS (2019-03-21 - 2020-02-14)
