November 18, 2021  
File: 2019-8475-000

**Re: COMPLETION REPORT FOR BOAT LAUNCH DREDGE CONDUCTED ON KALAMALKA LAKE, COLDSTREAM, BC**

District of Coldstream  
Kalavista Boat Launch Dredging

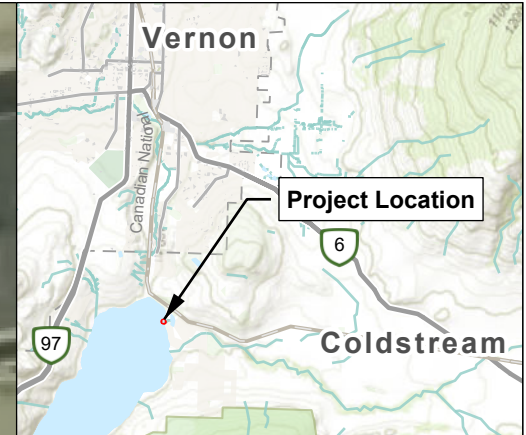
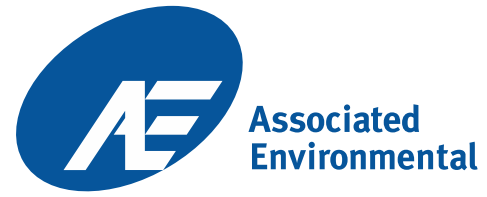
**FIGURE 1: DREDGING AREAS**

The dredging works began with a small excavator walking out onto the sediment bar and removing the sediment from the south side of the work area (Photo 3). Afterwards, the excavator dredged the remaining sediment from the sediment bar in the south bank of the lagoon leaving a 0.4 to 0.8 m wide trench from the base of the lagoon to the lake (Photo 4) for a total approximate area of 300 m<sup>2</sup>. Approximately 30 cubic meters of accumulated sediment was removed from the lake (five partial dump truck loads; each truck load could hold approximately 10 cubic metres at full capacity). A mix of fine textured organics and sand was excavated from the channel. Substrates were removed from the work area and were placed directly into the dump truck. The depth of excavation (i.e., approximately 0.5 m) conformed to the figures provided in the Environmental Management Plan<sup>1</sup>. The area dredged extended outside of the proposed dredging area because of the extend of sediment (Photo 5) – Figure 1. No vegetation was disturbed or removed during the dredging works.
