**Project Title: Salmo River Instream Enhancement Program (Phase 2)**

**FWCP Project No: FWCP: COL-F22-F-3438**

# Effectiveness Monitoring and Maintenance Report (EMMR) for Salmo River Watershed Instream Restoration Project (SRWIRP) Phase 2

Project #16,731: Site A – Casey, Site B –Nelson Nordic Ski Club (NNSC): Columbia Basin Trust, Fish and Wildlife Compensation Program Project COL-F22-F-3348

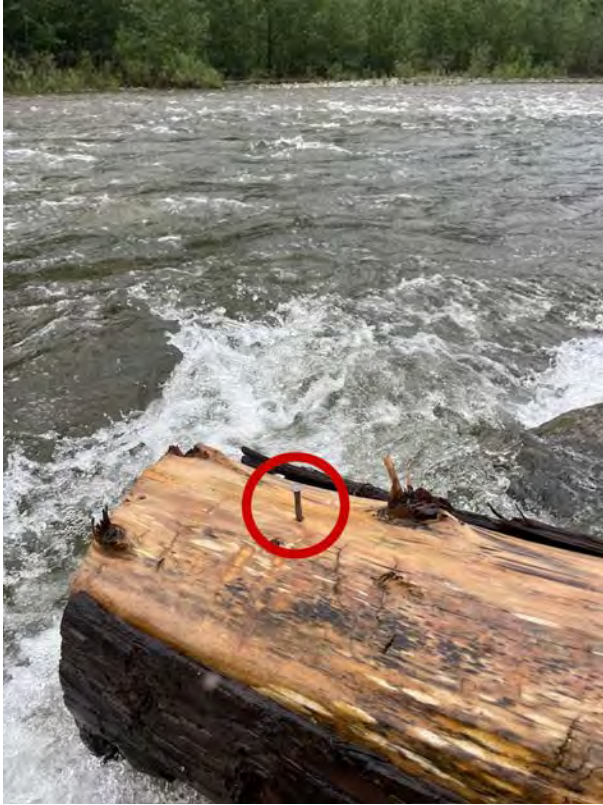
Figure 5. Debris Catcher. Downstream top log.

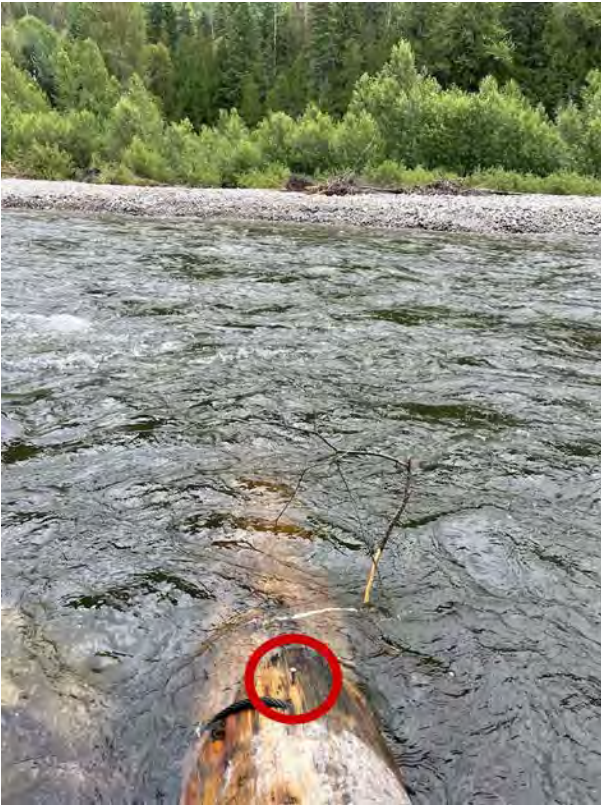
Figure 18. First W structure. Downstream key log.

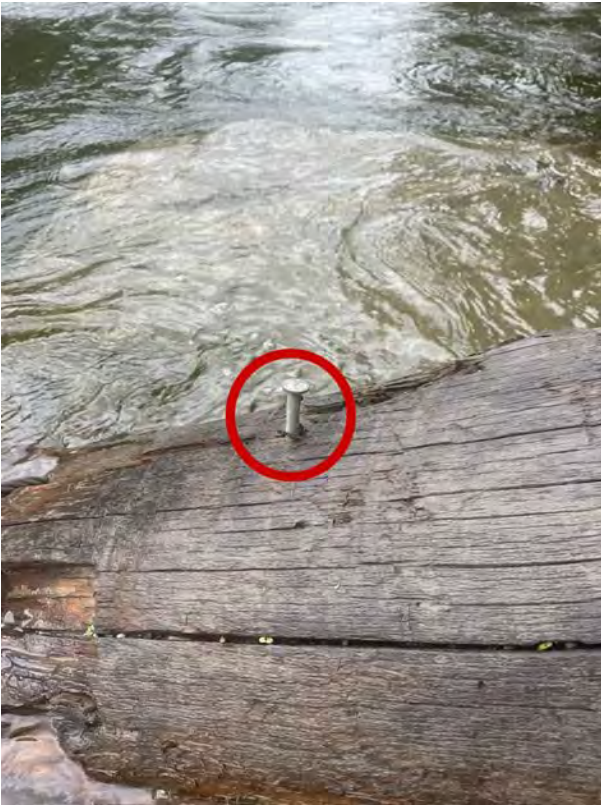
Figure 20. Second W structure. Downstream key log.
