## Appendix - Phase 1 Fish Passage Assessment Data and Photos

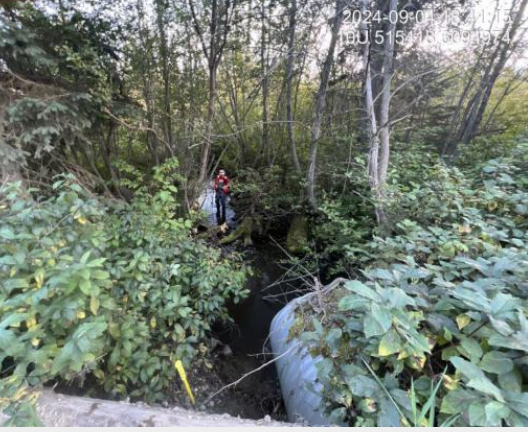
Photos: PSCIS ID 16602610. From top left clockwise: Road/Site Card, Barrel, Outlet, Downstream, Upstream, Inlet.

Comments: The system has good flow and a significant outlet drop. Upstream substrate consists primarily of fine materials, likely indicating limited habitat complexity for fish.. 18:21:40

| Location and Stream Data | • | Crossing Characteristics | – |
|---|---|---|---|
| Fix type | Replace with New Open Bottom Structure | Fix Span / Diameter | 15 |
