**TOLKO INDUSTRIES LTD., LAVINGTON  
INTERIM INTERIOR WATERSHED  
ASSESSMENT PROCEDURE  
UPPER CREIGHTON CREEK and  
FERRY CREEK**

**Project No. 0808-98-90481**

**March 1999**

EBA ENGINEERING CONSULTANTS LTD.  
Vancouver, B.C.

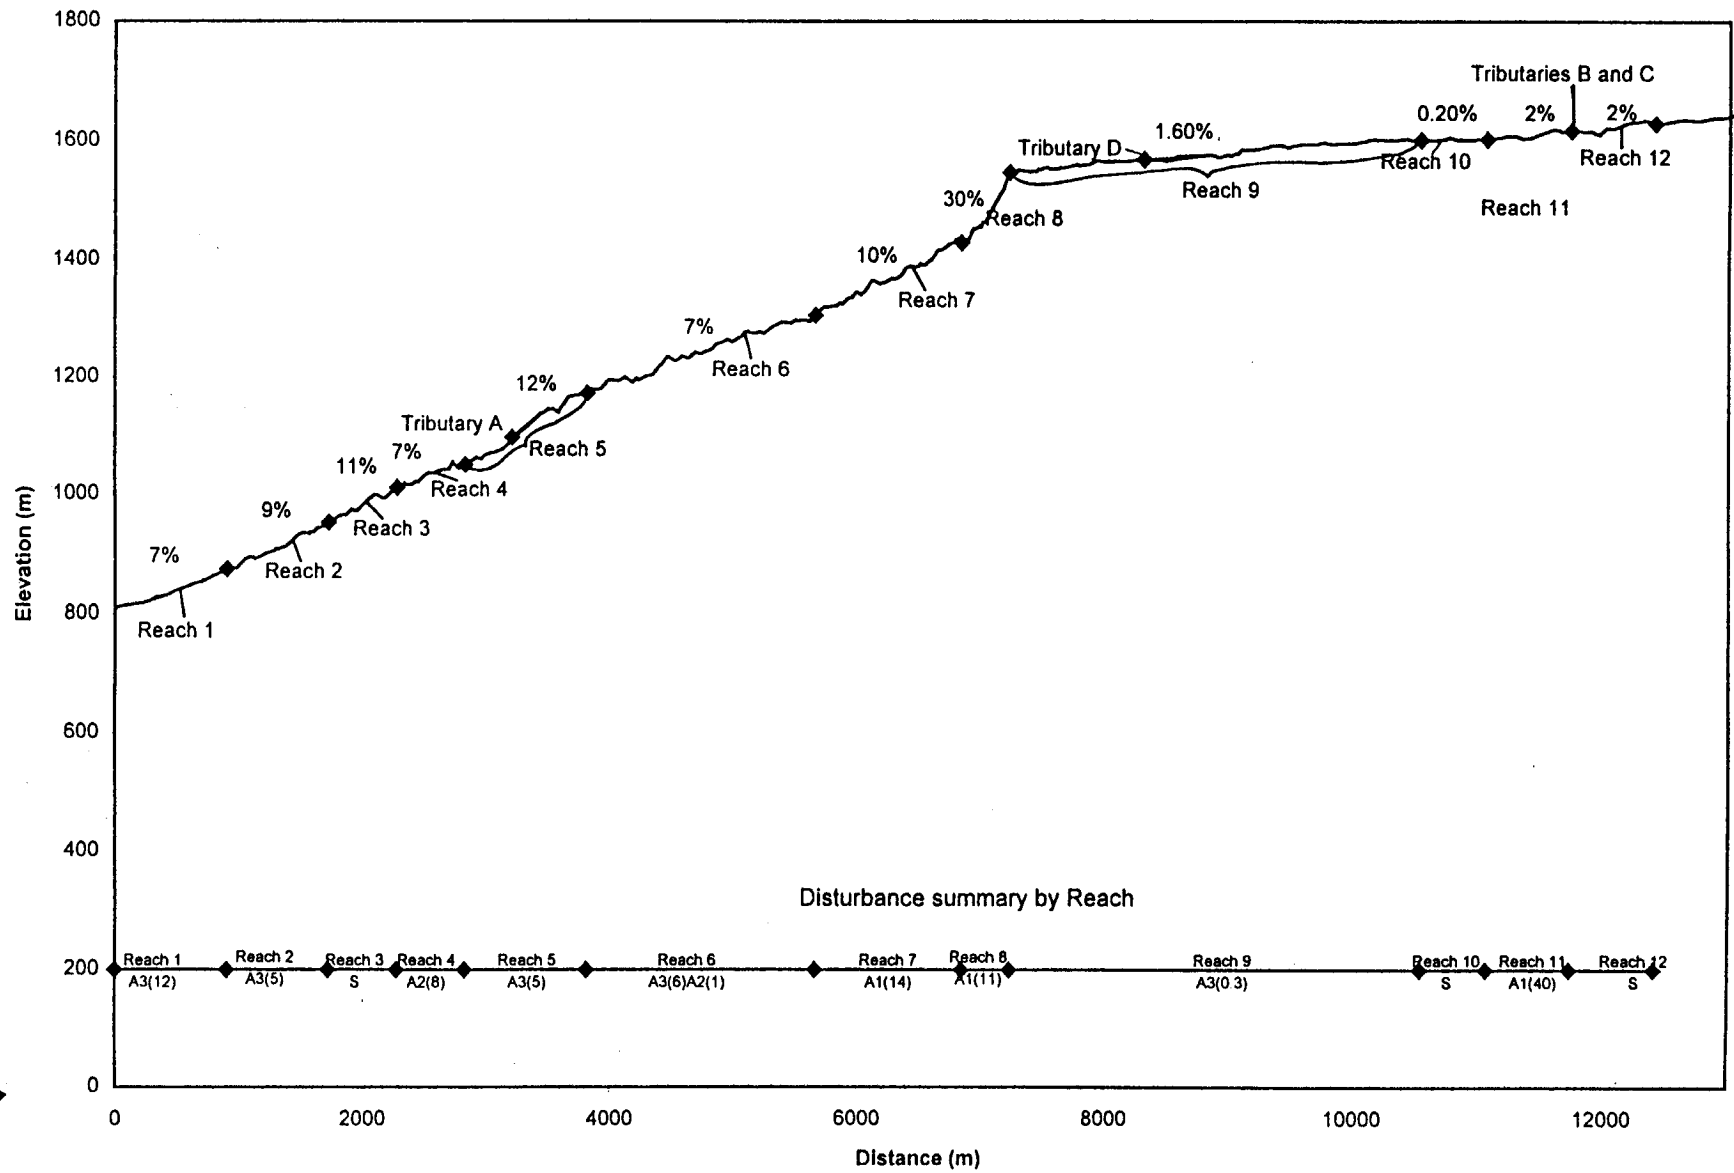
Figure 4. Bonneau Creek Stream Profile (TRIM)

Detailed reach descriptions for Bonneau are included in Appendix A2. Reach breaks and disturbances summaries are found on both the ReCAP map (Map 4) and the stream profile constructed from 1:20,000 TRIM data (Figure 4). A summary of forestry related disturbances and recommendations for further detailed assessment are outlined below. Recommendations were generally limited to identification of reaches requiring a detailed Channel Assessment Procedure (CAP).

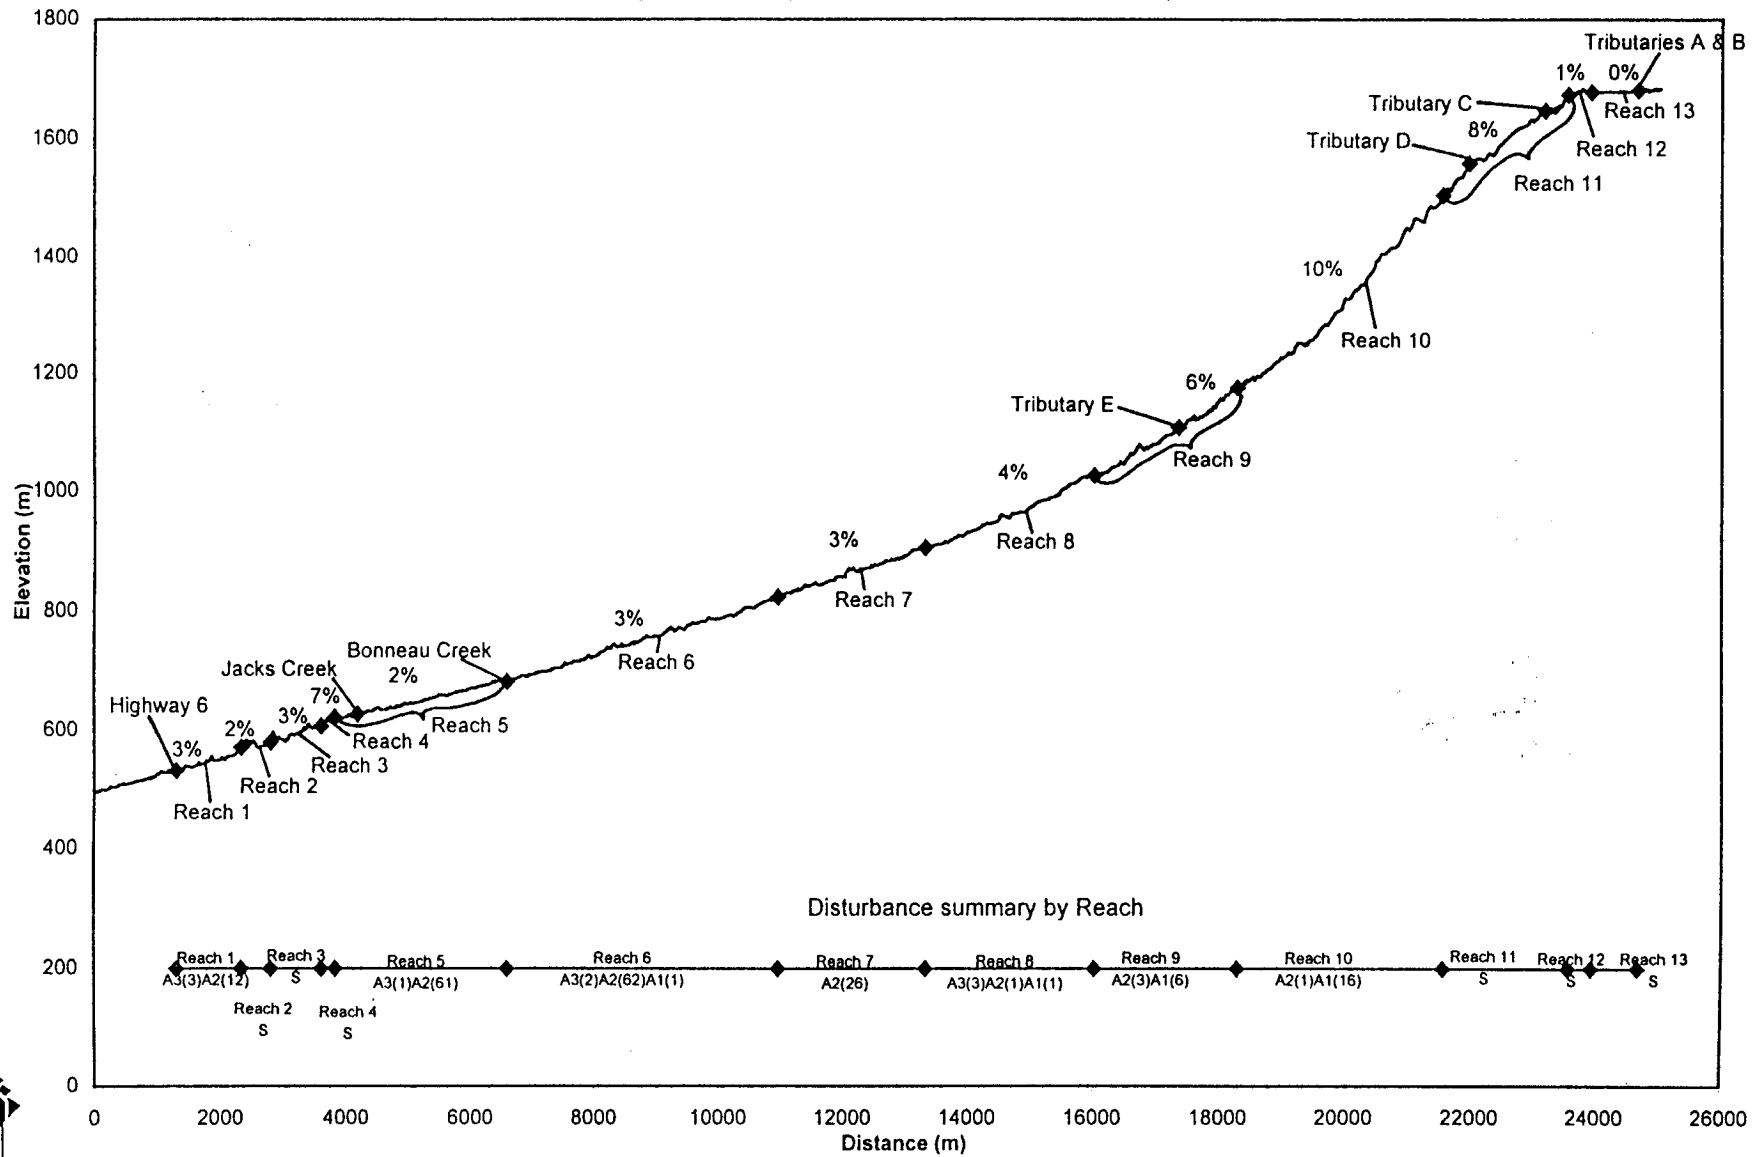
Figure 6. Ferry Creek Stream Profile (TRIM)

Detailed reach descriptions for Upper Ferry Creek are included in Appendix A3. Reach breaks and disturbance summaries are found on both the ReCAP map (Map 6) and the stream profile constructed from 1:20,000 TRIM data (Figure 6). A summary of forestry related disturbances and recommendations for further detailed assessment are outlined below. Recommendations were generally limited to identification of reaches requiring a detailed Level II CAP.
