FINAL REPORT

**UPPER BONAPARTE RIVER
WATERSHED – CHANNEL, RIPARIAN
AND SEDIMENT SOURCE
ASSESSMENT**

VOLUME 1: TEXT AND APPENDICES

Project #754

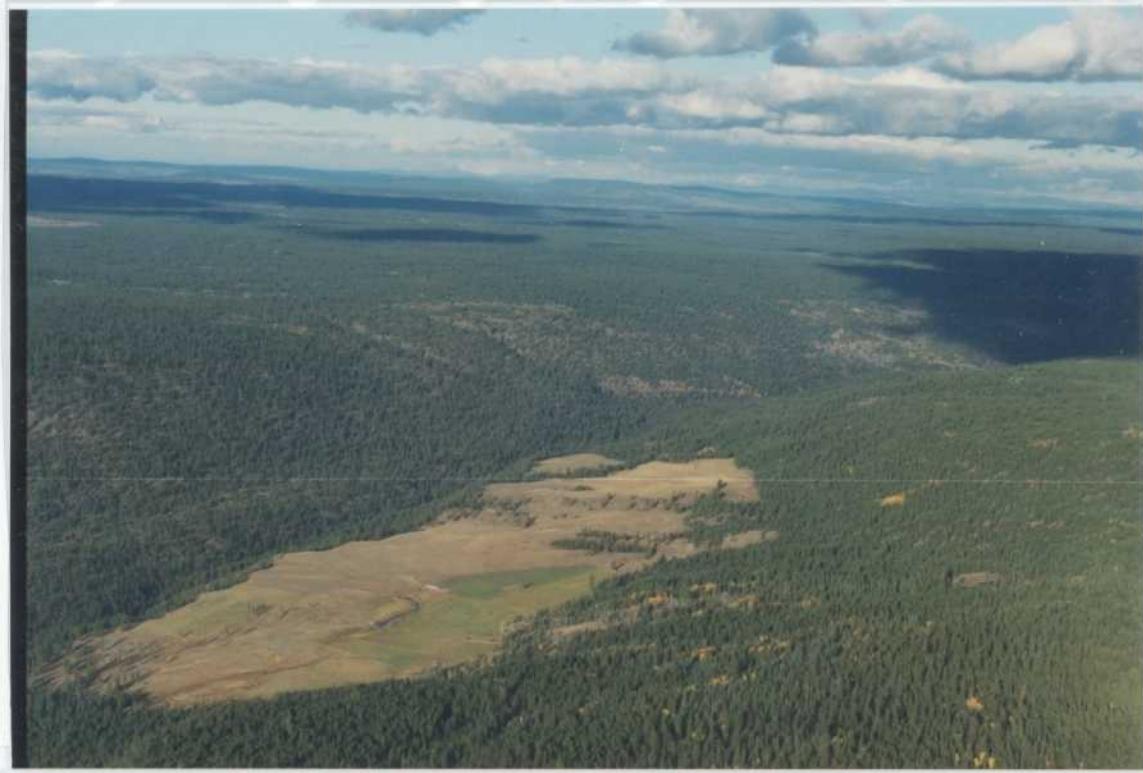
SUB-BASIN: BONAPARTE RIVER RESIDUAL Photo: 8
CREEK: BONAPARTE RIVER Roll: 1
Description: VIEW NORTH - EAST Date: 16/10/98

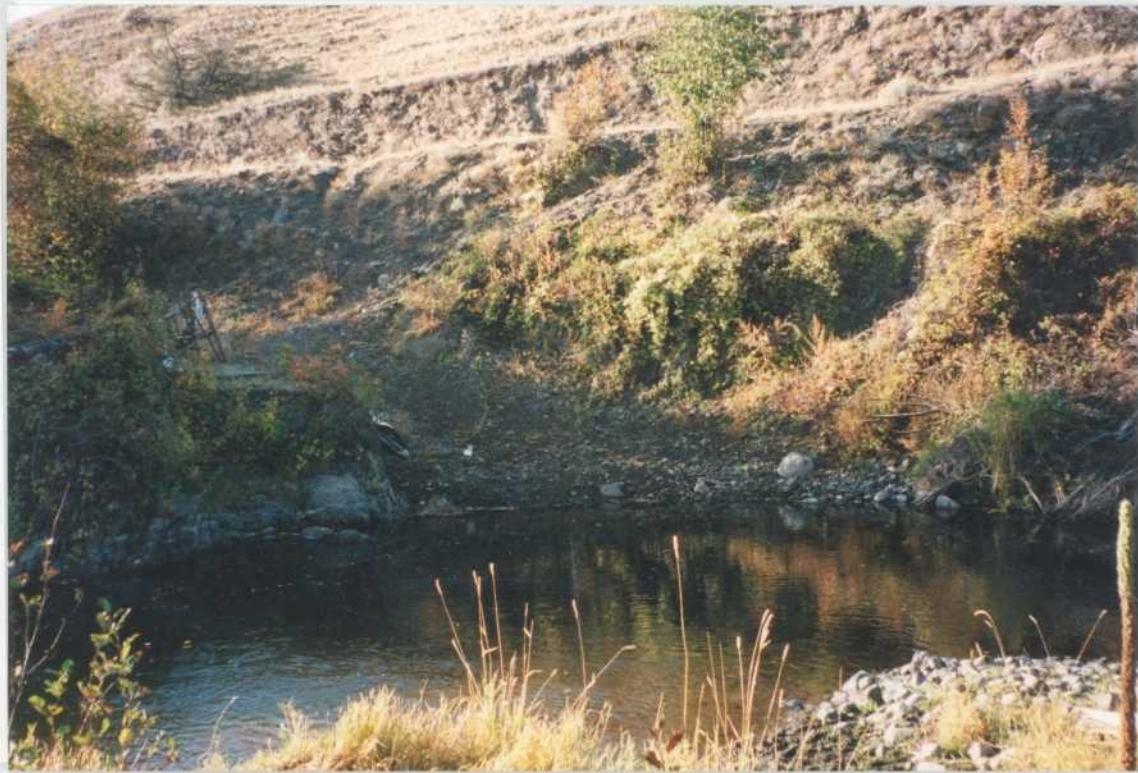
SUB-BASIN: BONAPARTE RIVER RESIDUAL Photo: 25
CREEK: BONAPARTE RIVER Roll: 2
Description: REACH 1, SITE BRR - B1.1 Date: 16/10/98

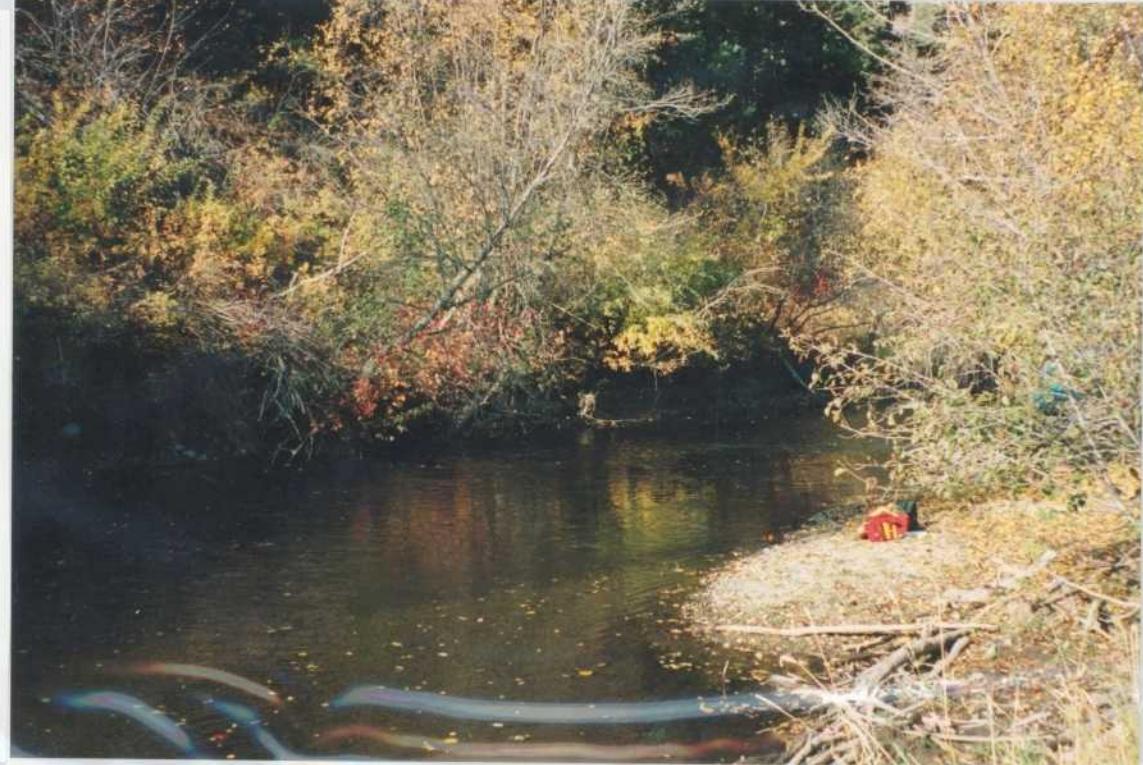
SUB-BASIN: BONAPARTE RIVER RESIDUAL Photo: 24
CREEK: BONAPARTE RIVER Roll: 2
Description: VIEW UPSTREAM AT REP BRR - 1.1 Date: 16/10/98

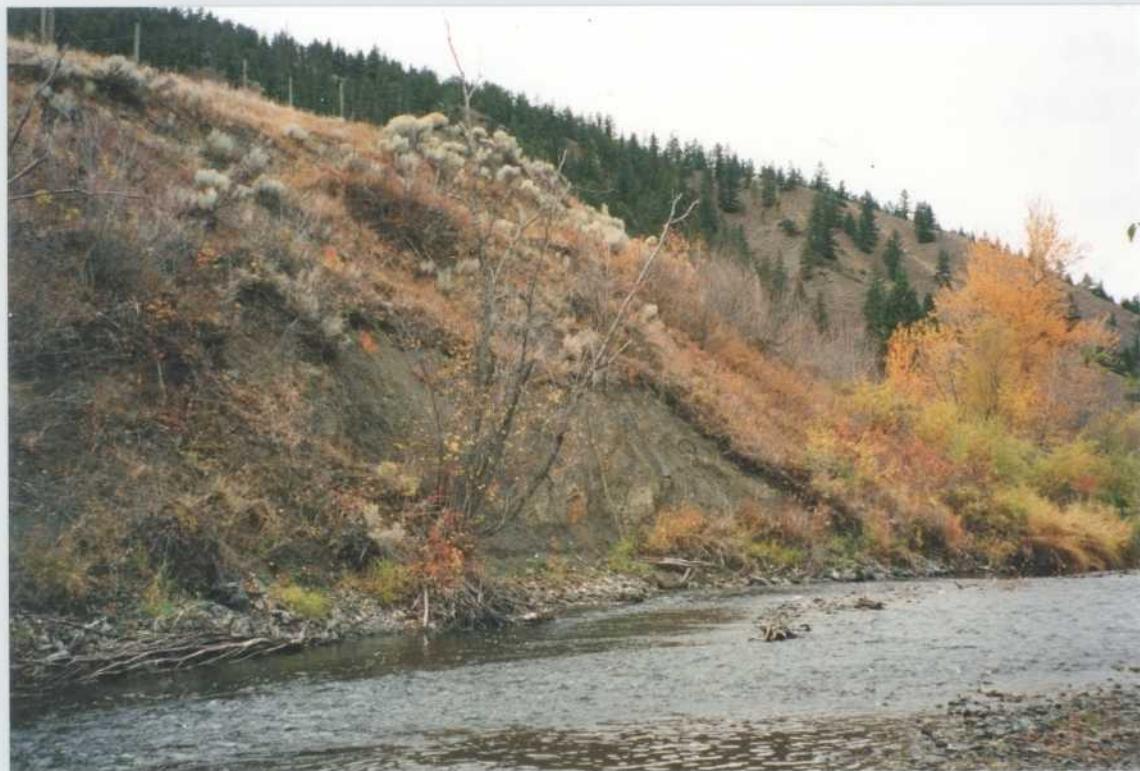
Photo: 2
Roll: 2
Date: 17/10/98

SUB-BASIN: BONAPARTE RIVER RESIDUAL
CREEK: BONAPARTE RIVER
Description: VIEW UPSTREAM REACH 1
SITE BRR - B1.4

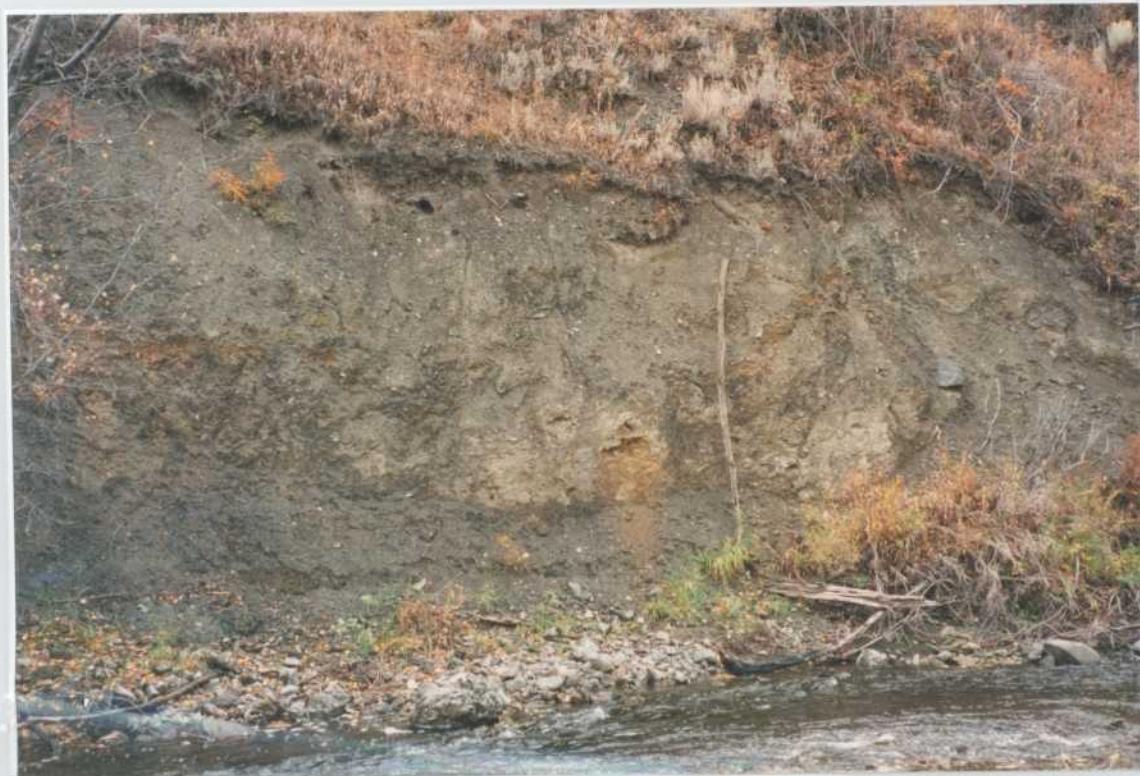
Photo: 1
Roll: 2
Date: 17/10/98

SUB-BASIN: BONAPARTE RIVER RESIDUAL
CREEK: BONAPARTE RIVER
Description: FOCUSED VIEW OF
SITE BRR - B1.4

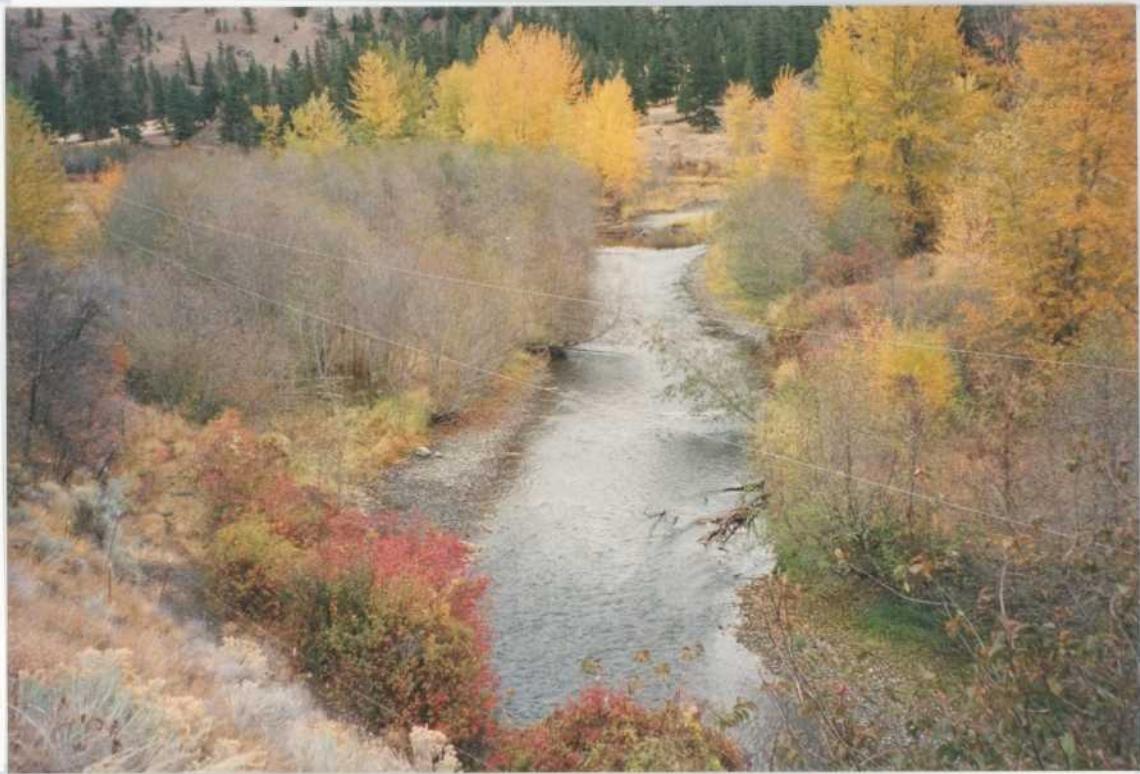
SUB-BASIN: BONAPARTE RIVER RESIDUAL Photo: 10
CREEK: BONAPARTE RIVER Roll: 4
Description: REACH 2.1; VIEW DOWNSTREAM Date: 20/10/98
OF REACH 2

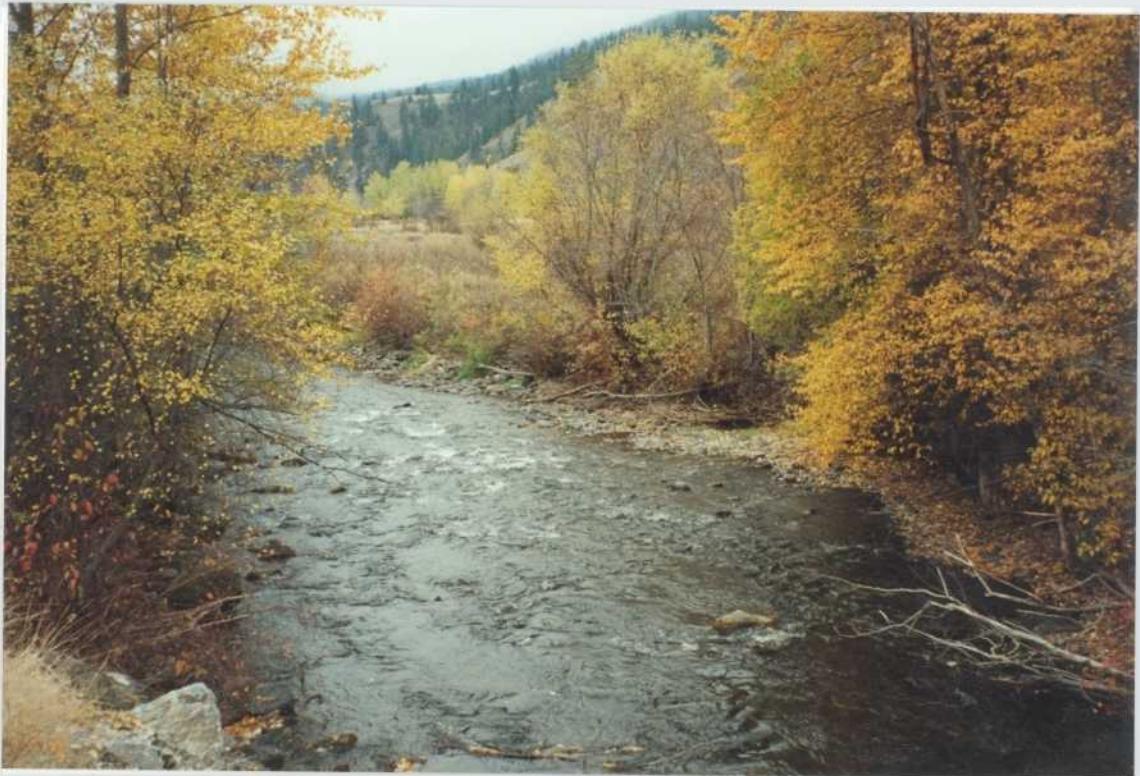
SUB-BASIN: BONAPARTE RIVER RESIDUAL Photo: 12
CREEK: BONAPARTE RIVER Roll: 4
Description: VIEW DOWNSTREAM OF Date: 20/10/98
REACH 4

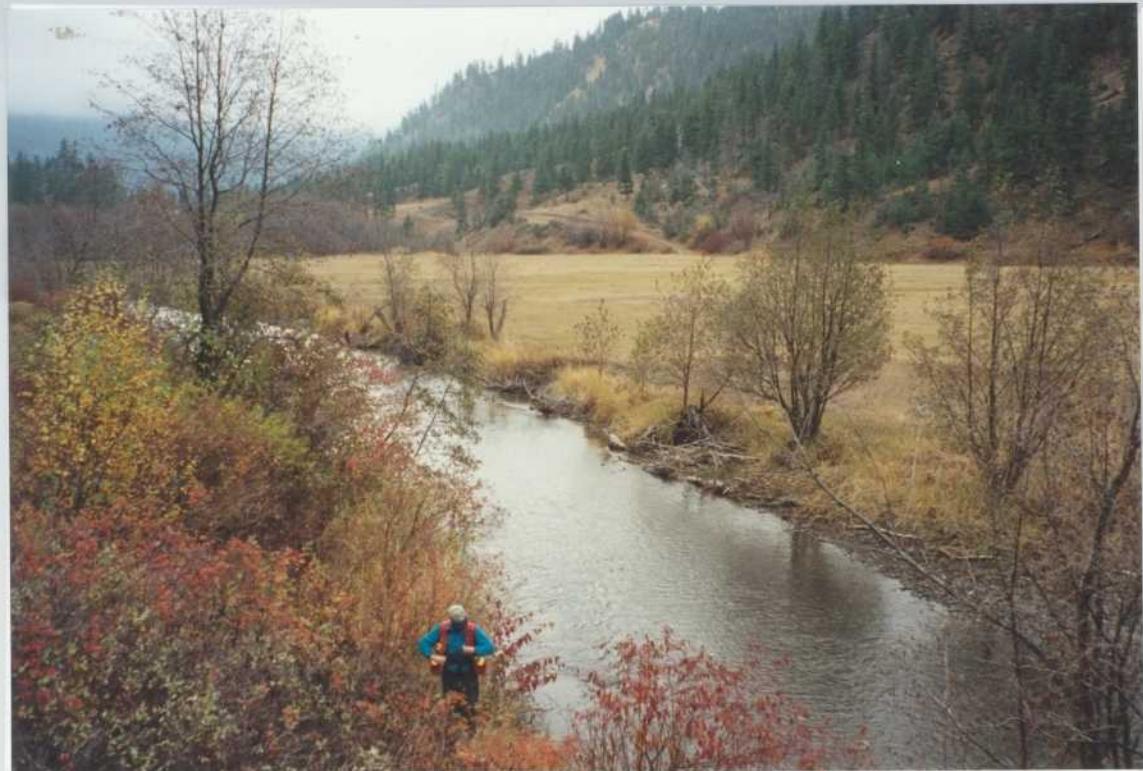
Photo: 11
Roll: 4
Date: 20/10/98

SUB-BASIN: BONAPARTE RIVER RESIDUAL
CREEK: BONAPARTE RIVER
Description: REP 4.1 ; VIEW DOWNSTREAM
ON RIGHT BANK FLOODPLAIN

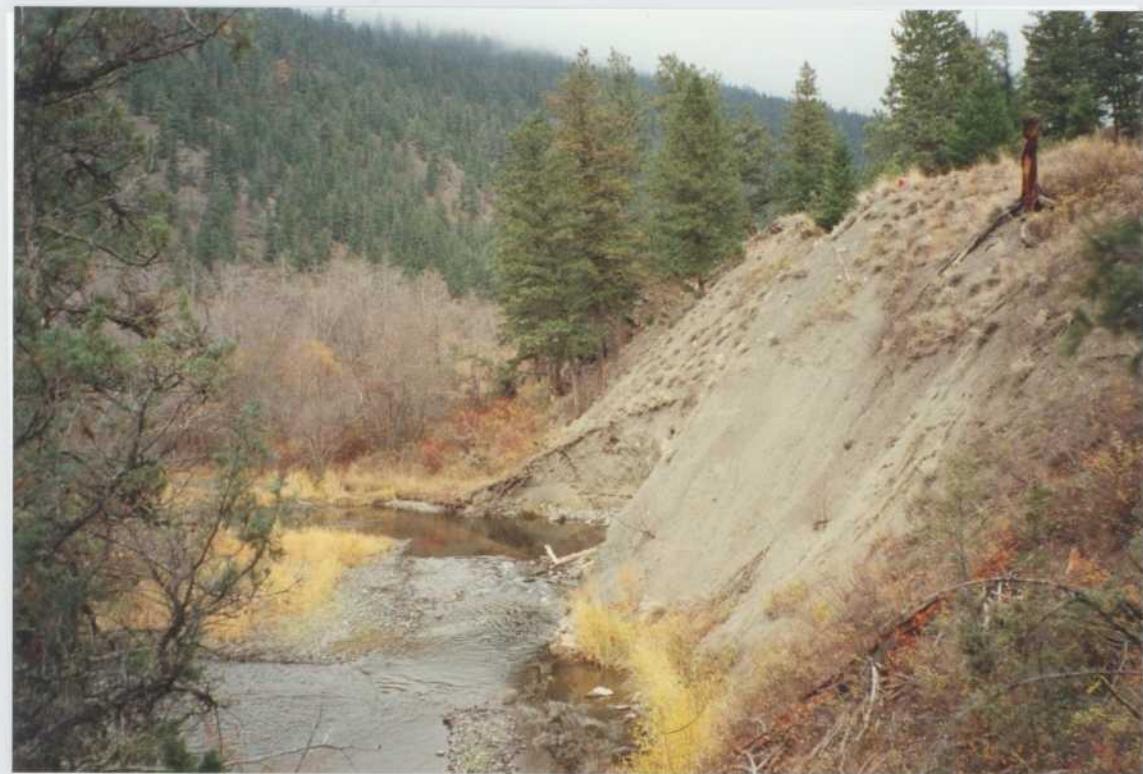
Photo: 13
Roll: 4
Date: 20/10/98

SUB-BASIN: BONAPARTE RIVER RESIDUAL
CREEK: BONAPARTE RIVER
Description: SITE B.4.1 ; VIEW UPSTREAM
OF REACH 4

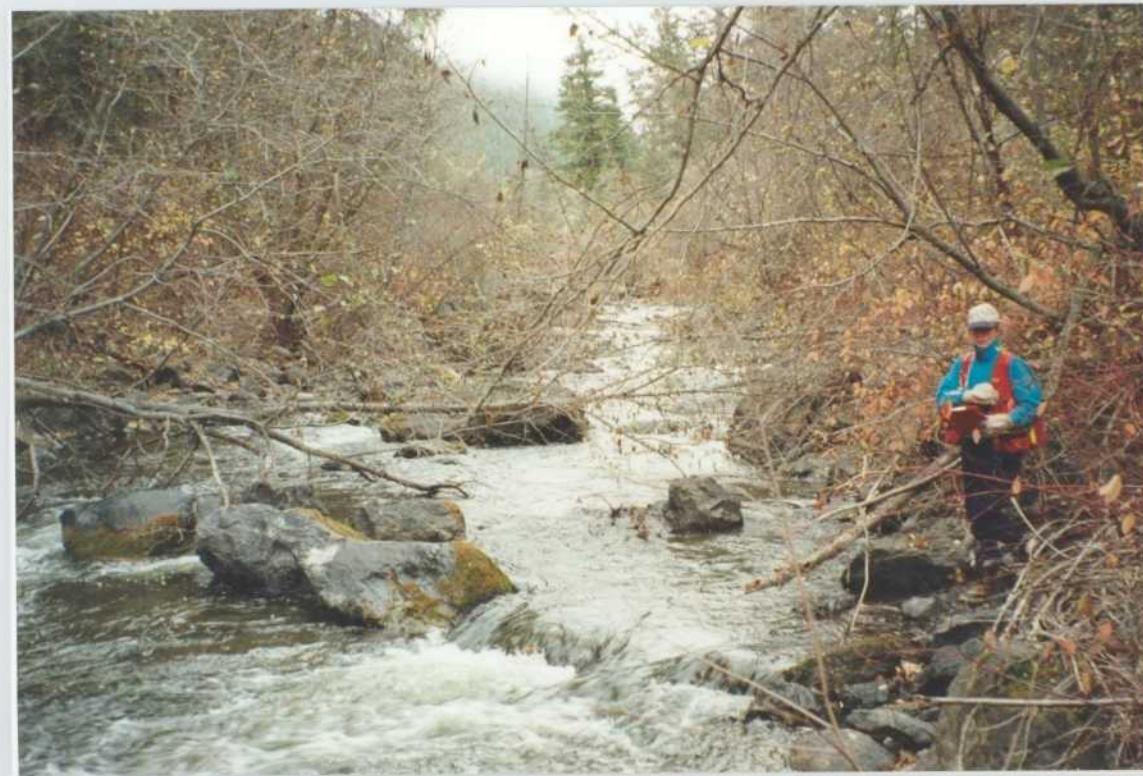
Photo: 14
Roll: 4
Date: 20/10/98

SUB-BASIN: BONAPARTE RIVER RESIDUAL
CREEK: BONAPARTE RIVER
Description: VIEW UPSTREAM AT REPS-1.1, Date: 20/10/98
REACH 5-1

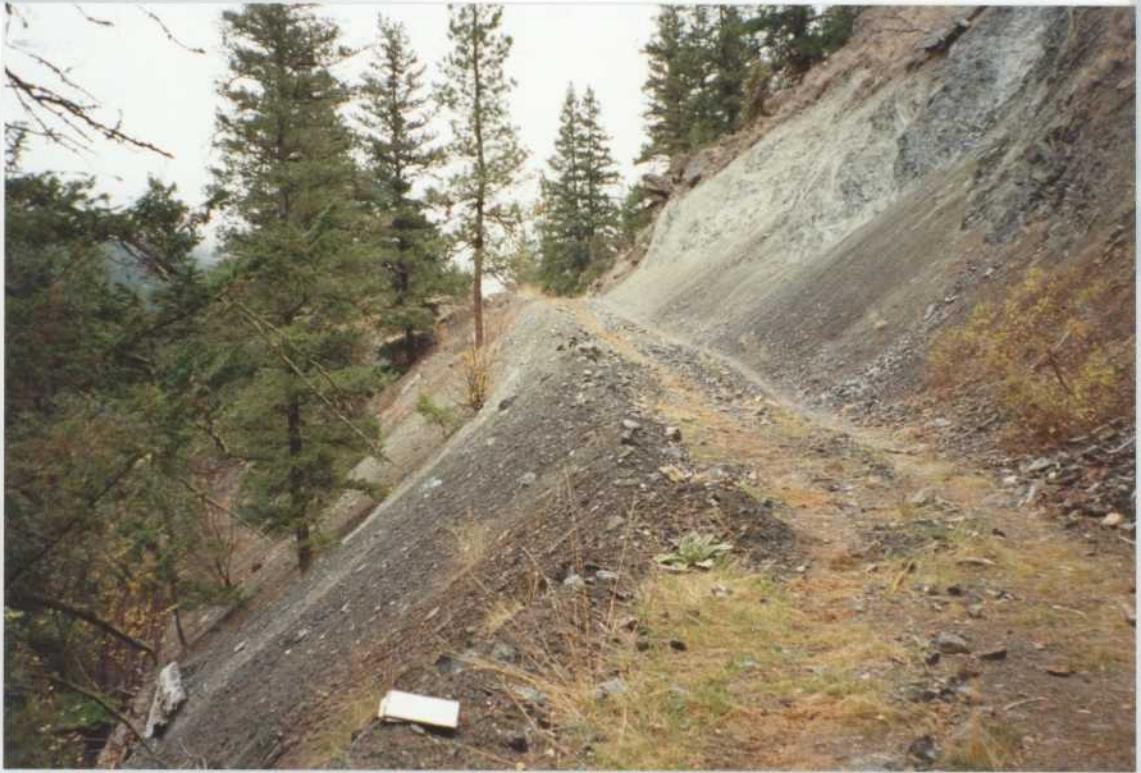
SUB-BASIN: BONAPARTE RIVER RESIDUAL Photo: 16
CREEK: BONAPARTE RIVER Roll: 2
Description: VIEW DOWNSTREAM REP BRR 6 - 2.1 Date: 16/10/98

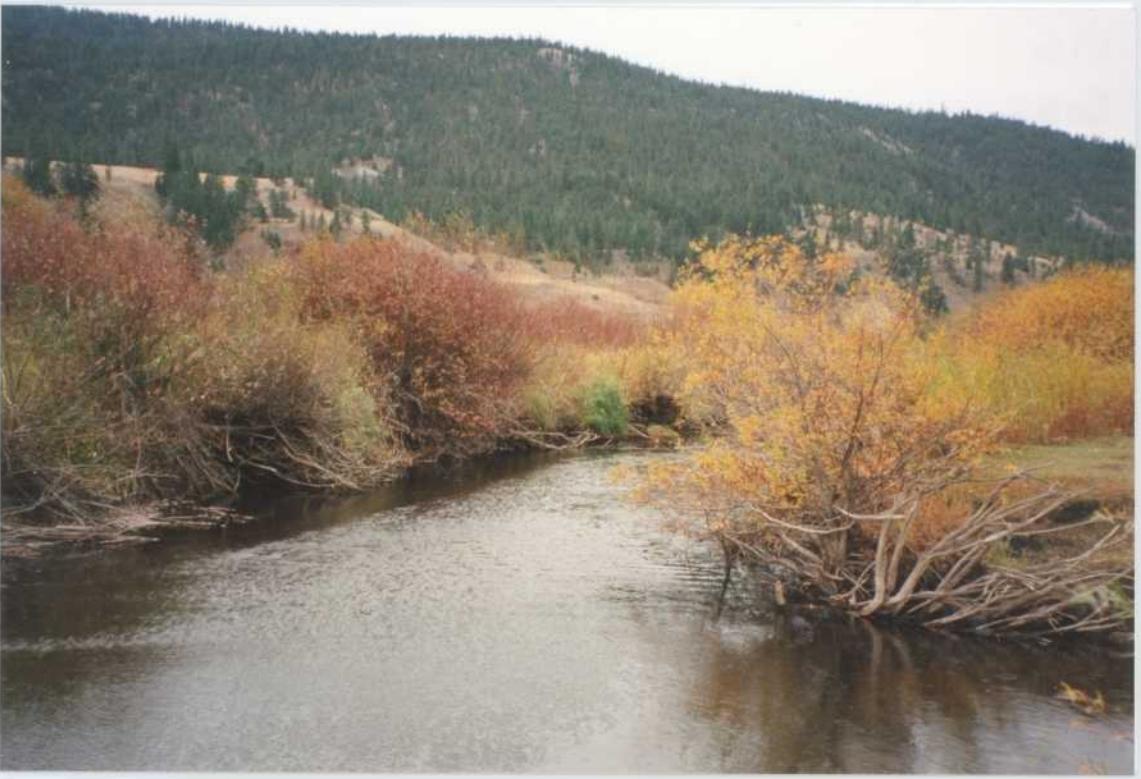
SUB-BASIN: BONAPARTE RIVER RESIDUAL Photo: 3
CREEK: BONAPARTE RIVER Roll: 5
Description: REP 8-1.1, VIEW UPSTREAM OF REACH 8.2 Date: 23/10/98

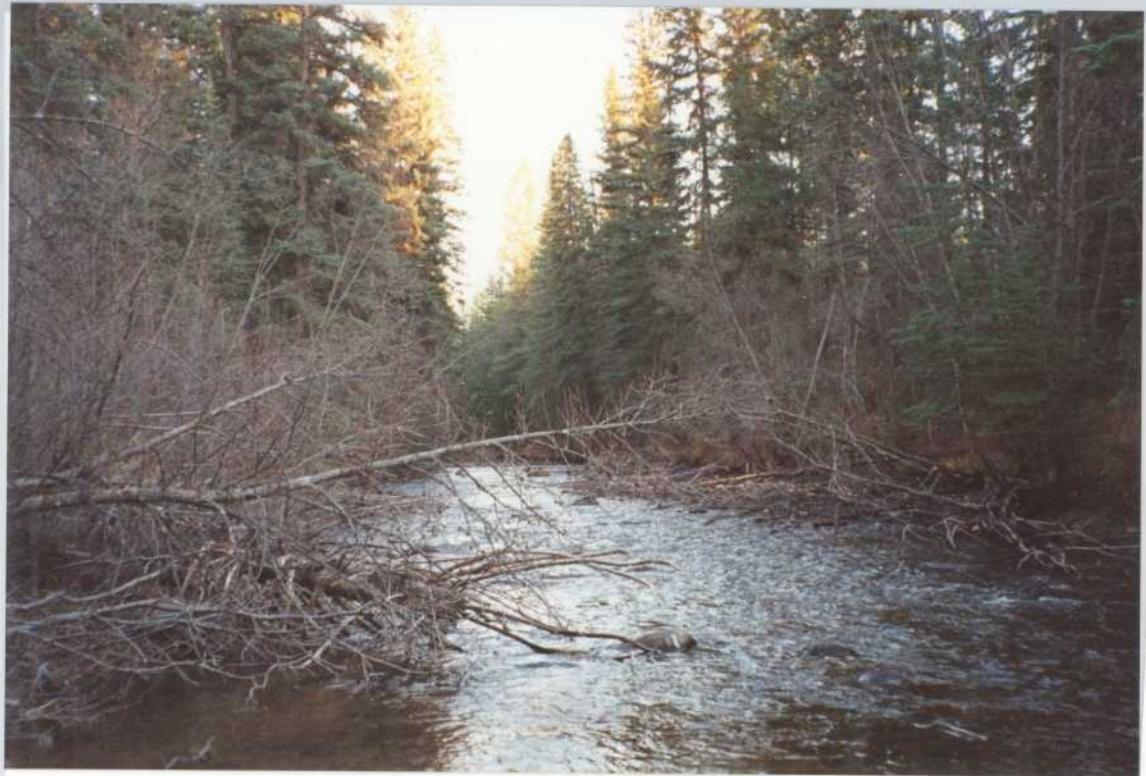
SUB-BASIN: BONAPARTE RIVER RESIDUAL Photo: 12
CREEK: BONAPARTE RIVER Roll: 5
Description: VIEW UPSTREAM, REP ID: 1
Date: 22/10/98

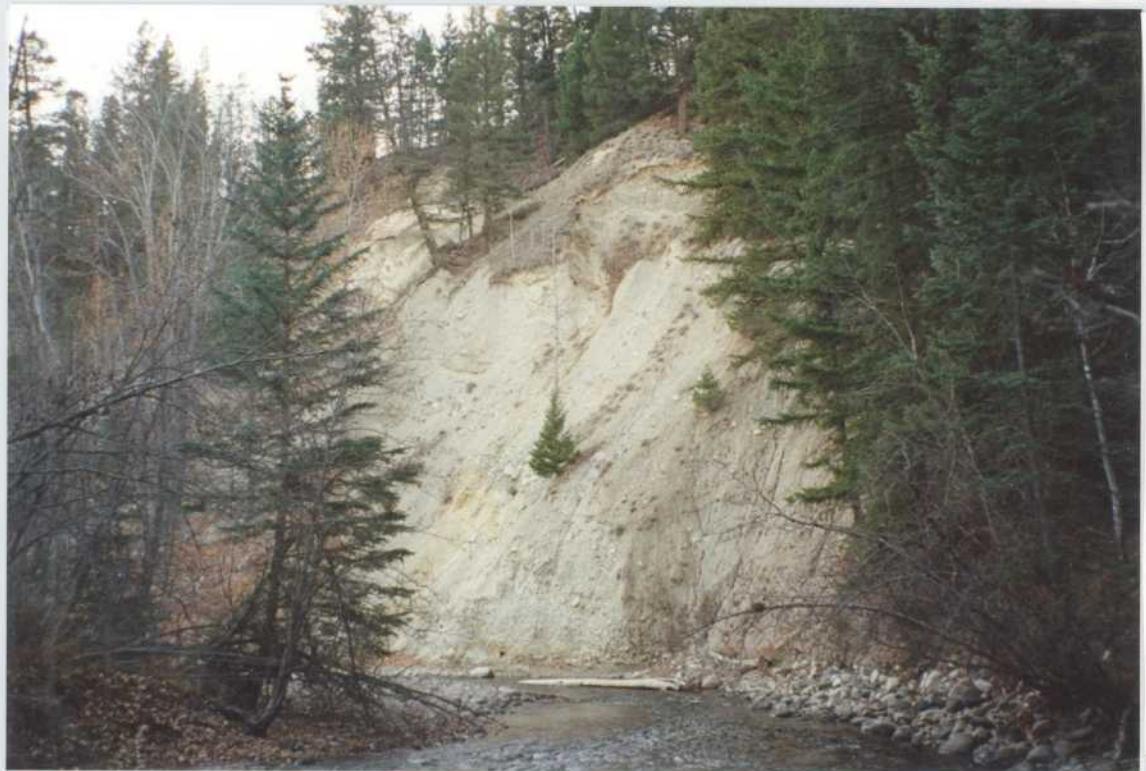
SUB-BASIN: BONAPARTE RIVER RESIDUAL Photo: 16
CREEK: BONAPARTE RIVER Roll: 5
REACH¹⁰ Description: SITE B 10-7, VIEW
Downstream Date: 22/10/98

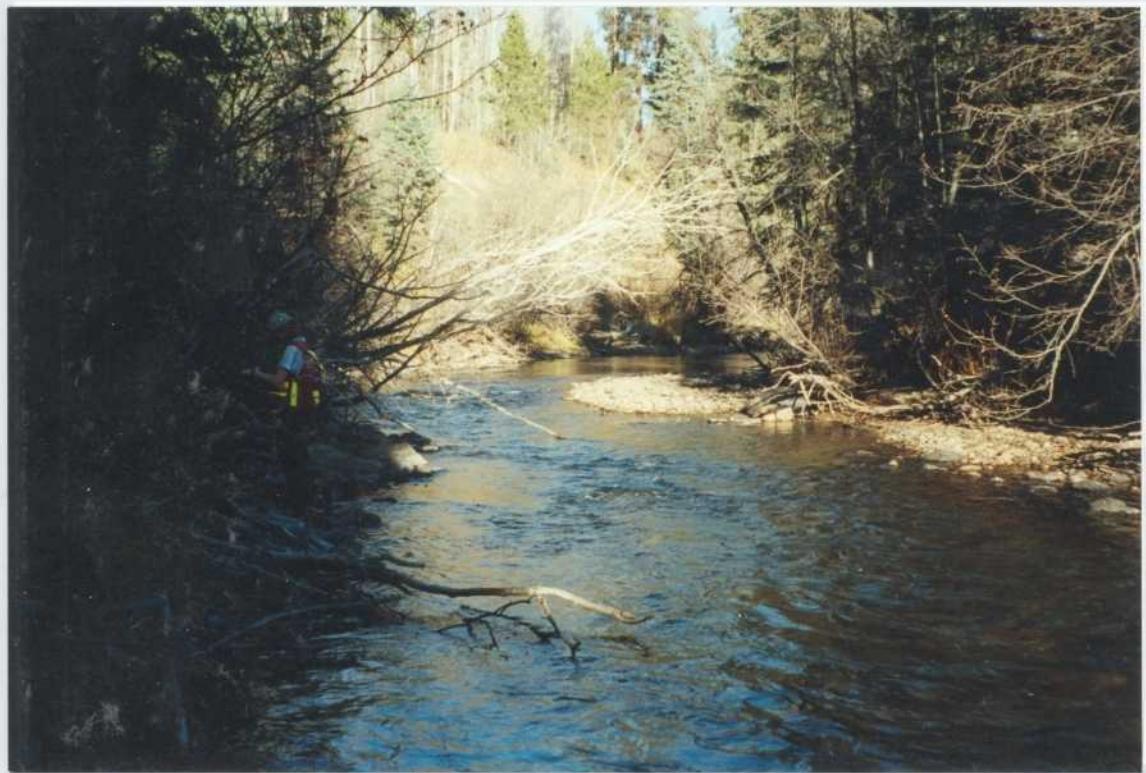
SUB-BASIN: BONAPARTE RIVER RESIDUAL Photo: 15
CREEK: BONAPARTE RIVER Roll: 5
Description: REP 11-1.1, VIEW Date: 22/10/98
UPSTREAM

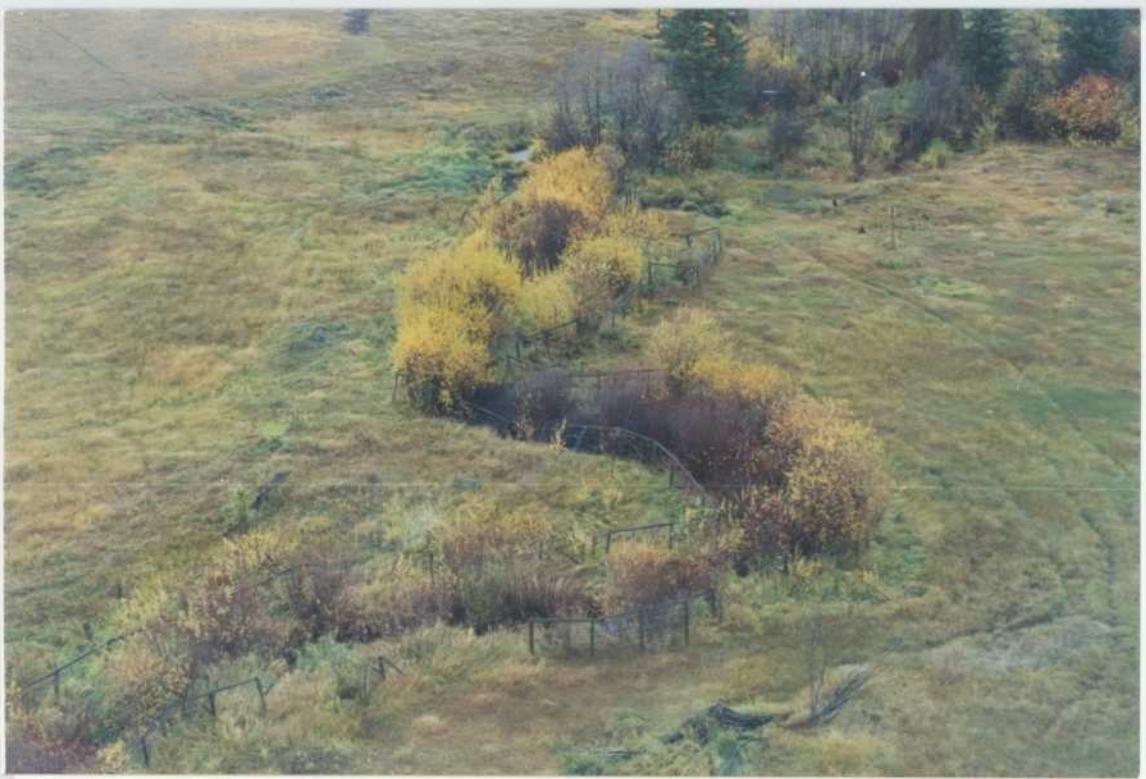
SUB-BASIN: LOON CREEK
CREEK: LOON CREEK
Description: REACH 8 RIPARIAN FENCE

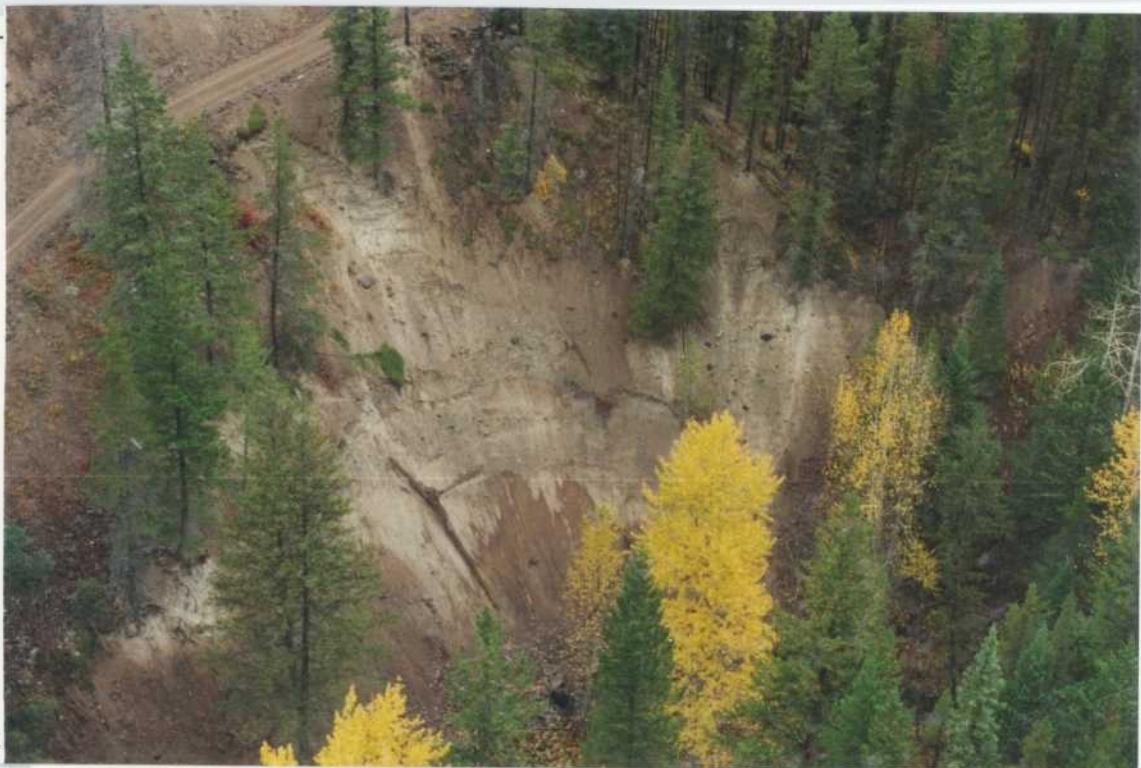
Photo: 2
SUB-BASIN: LOON CREEK
CREEK: HIGHLIGHT CREEK
Description: SLIDE, SITE 53.6 Date: 14/10/98

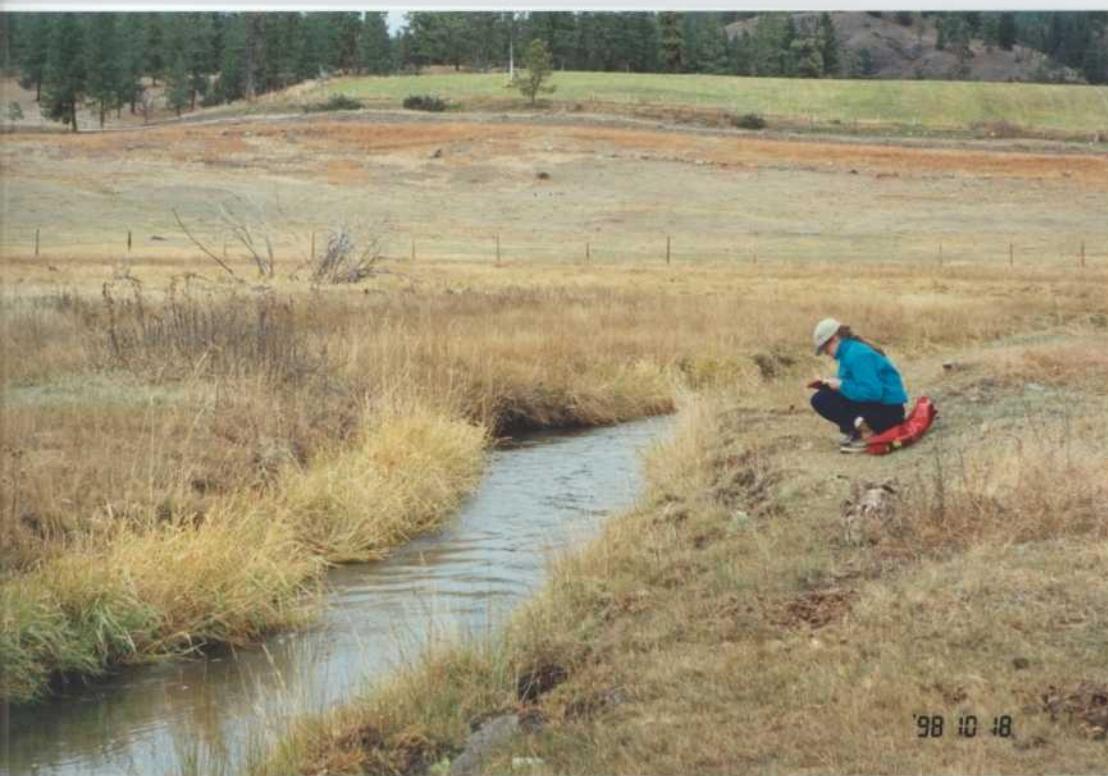
SUB-BASIN: CLINTON CREEK
CREEK: CLINTON CREEK
Description: REACH 6 view downstream
Photo: 16
Roll: 3
Date: 18/10/98

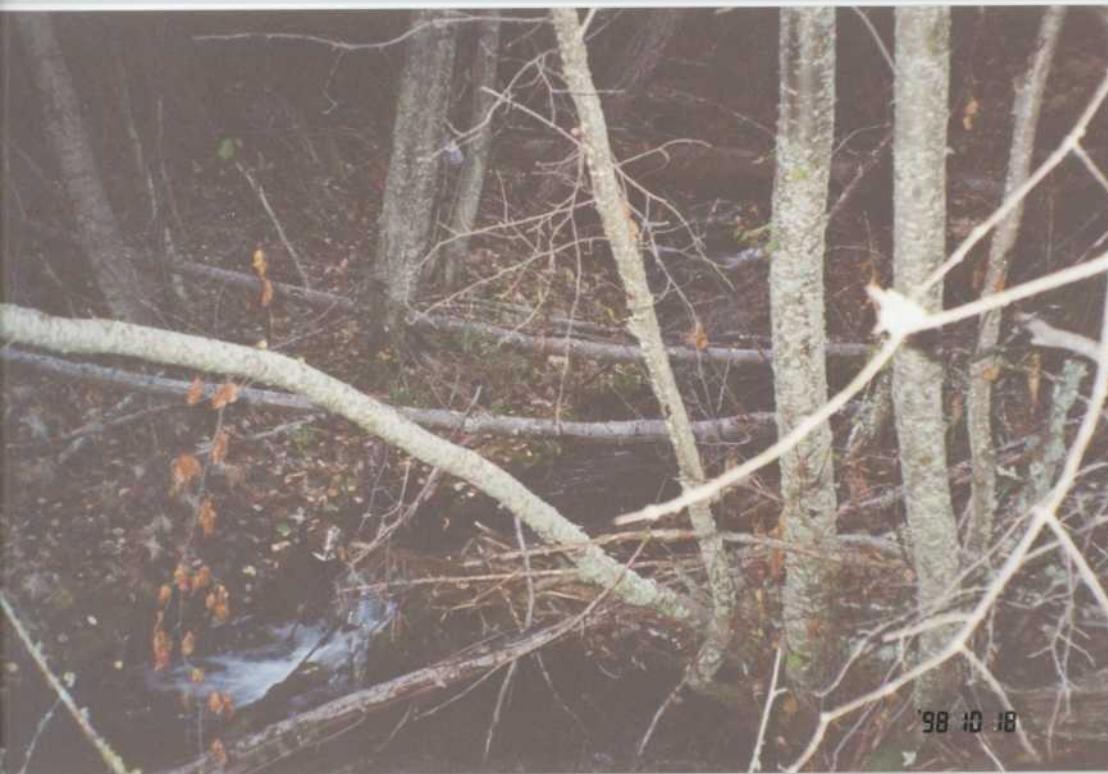
SUB-BASIN: CLINTON CREEK
CREEK: CLINTON CREEK
Description: REACH 8 view upstream
Photo: 15
Roll: 3
Date: 18/10/98

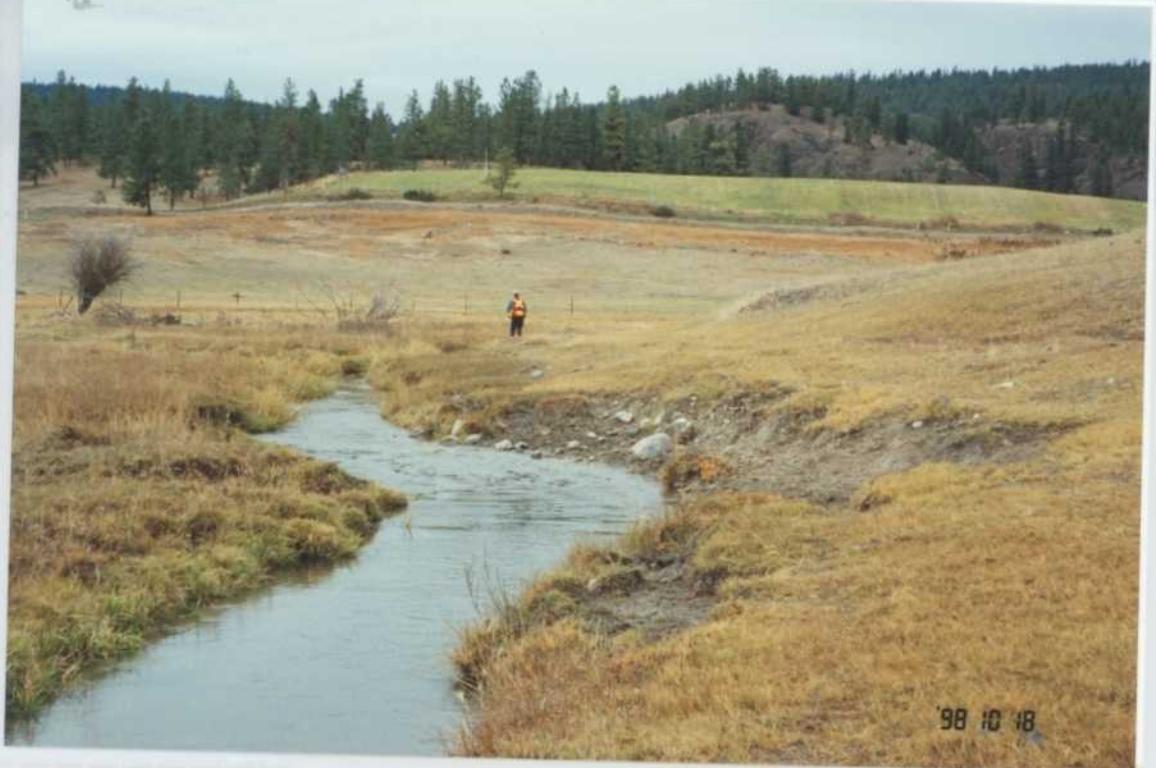
Photo: 17
Roll: 3
Date: 18/10/98

Description: view downstream
site # B6.2

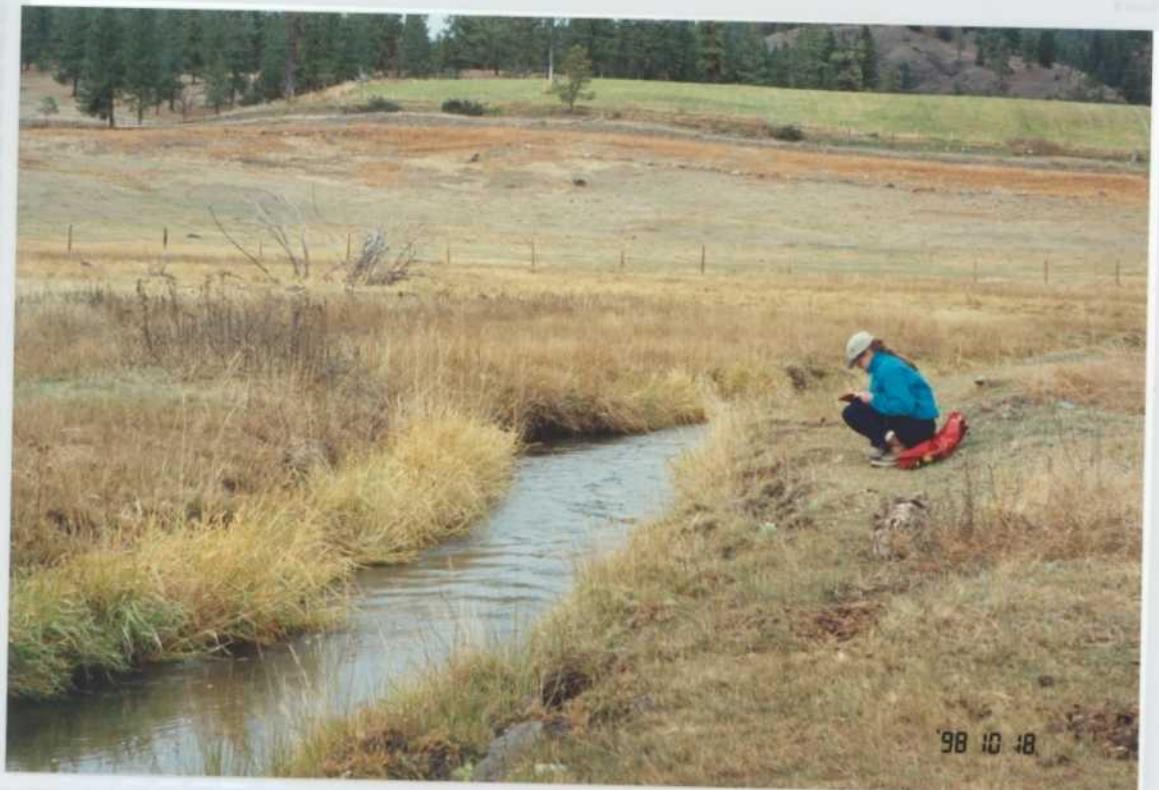
Photo: 16
Roll: 3
Date: 18/10/98

Description: REACH 6
view downstream
REP. 1

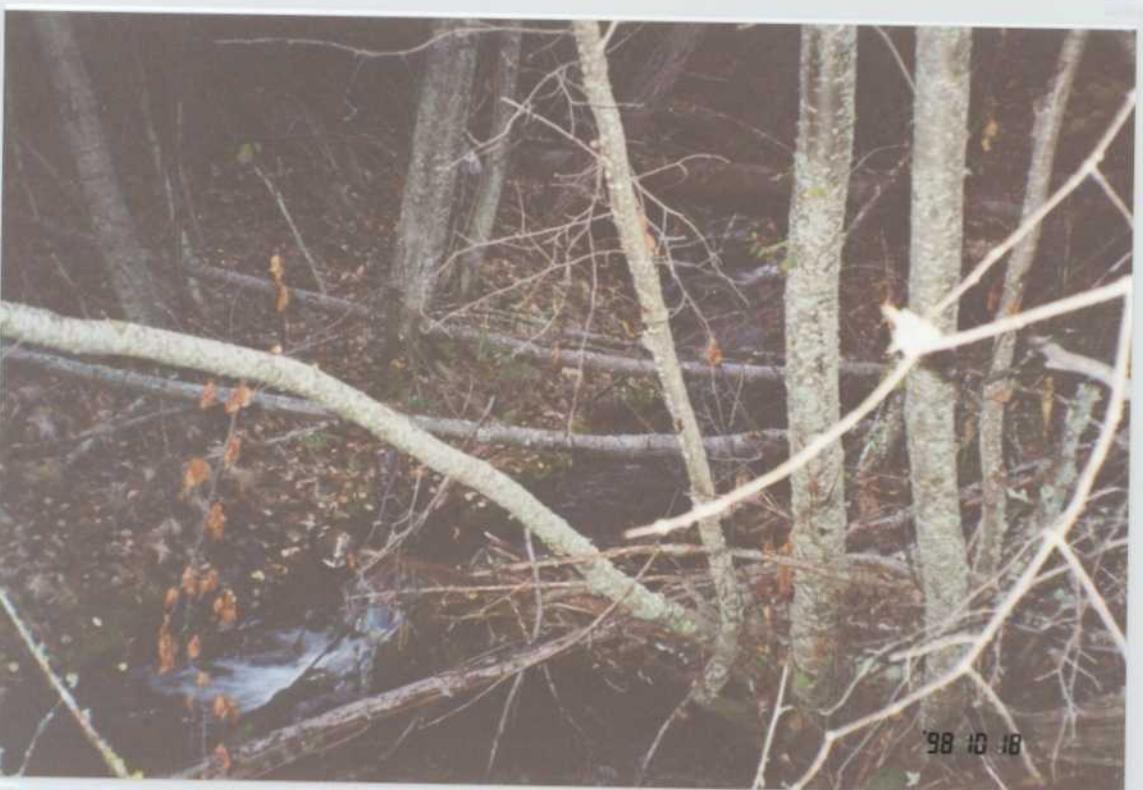
Photo: 15
Roll: 3
Date: 18/10/98

Description: REACH 8
view upstream
REP. 8.1

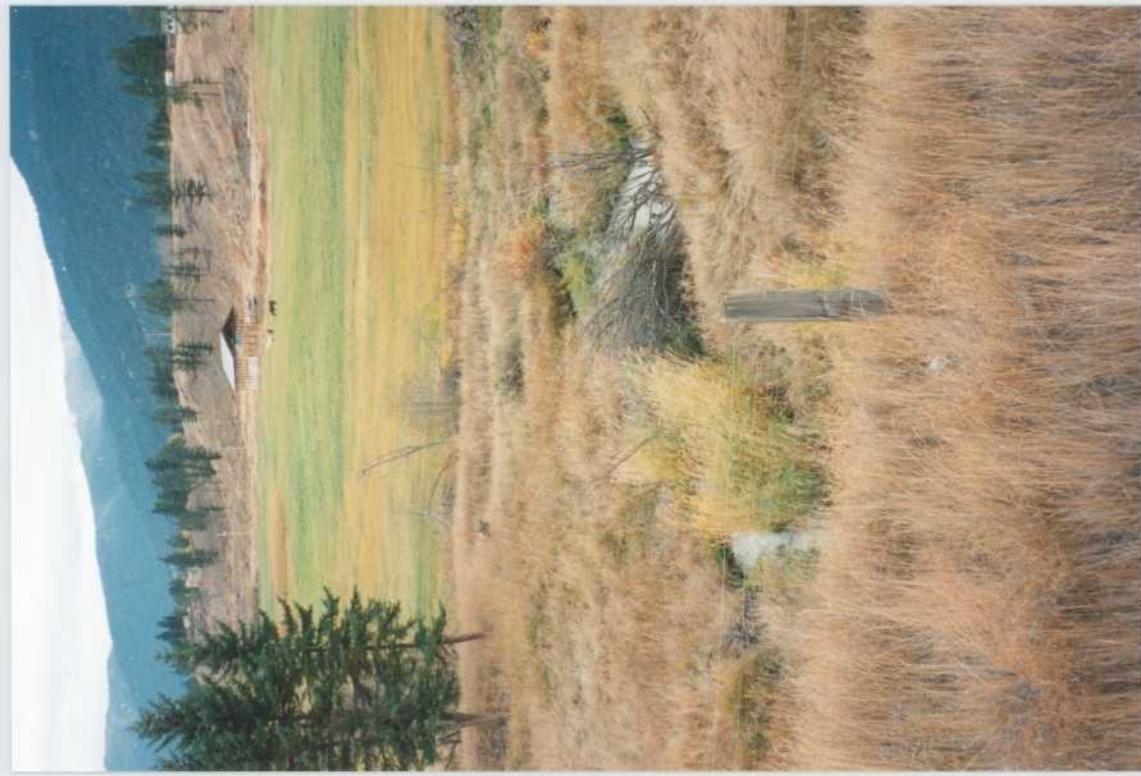
SUB-BASIN: CLINTON CREEK
Photo: 19
CREEK: CUTOFF VALLEY CREEK
Description: VIEW UPSTREAM REACH 1
REP CC-COV-1.1
Date: 16/10/98

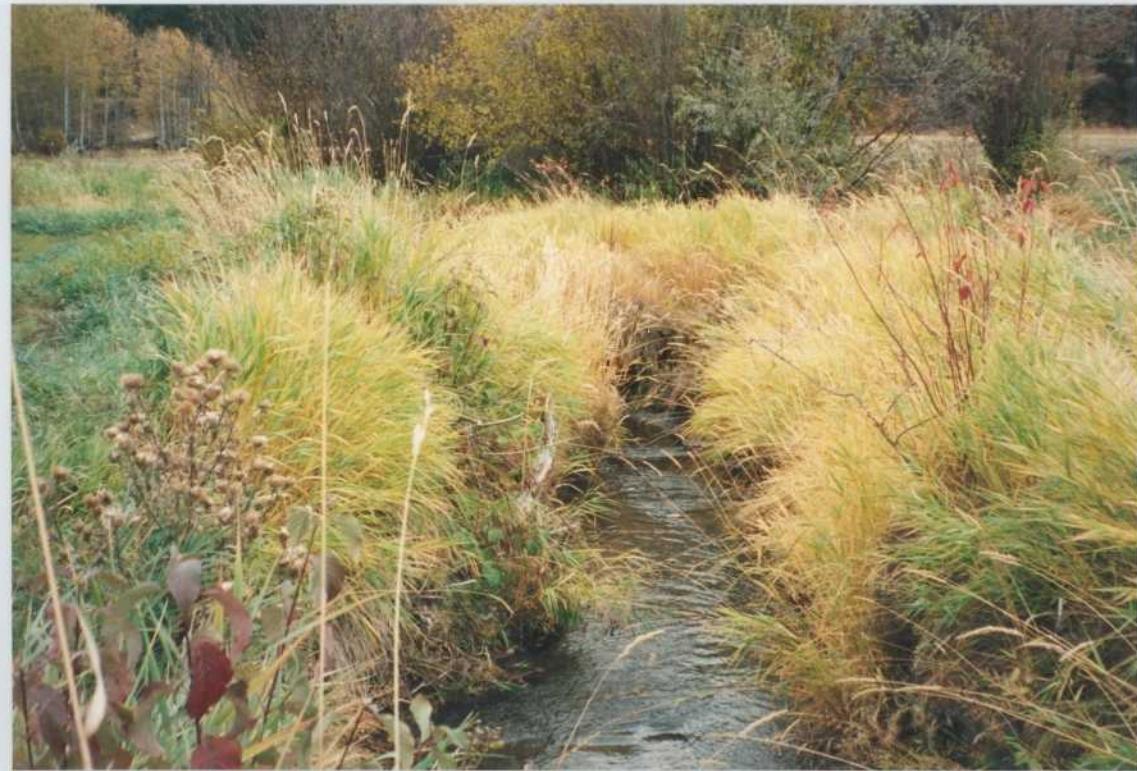
SUB-BASIN: CLINTON CREEK
Photo: 20
CREEK: CUTOFF VALLEY CREEK
Description: VIEW DOWNSTREAM REACH 8 Date: 16/10/98
REP CC-COV-8.1

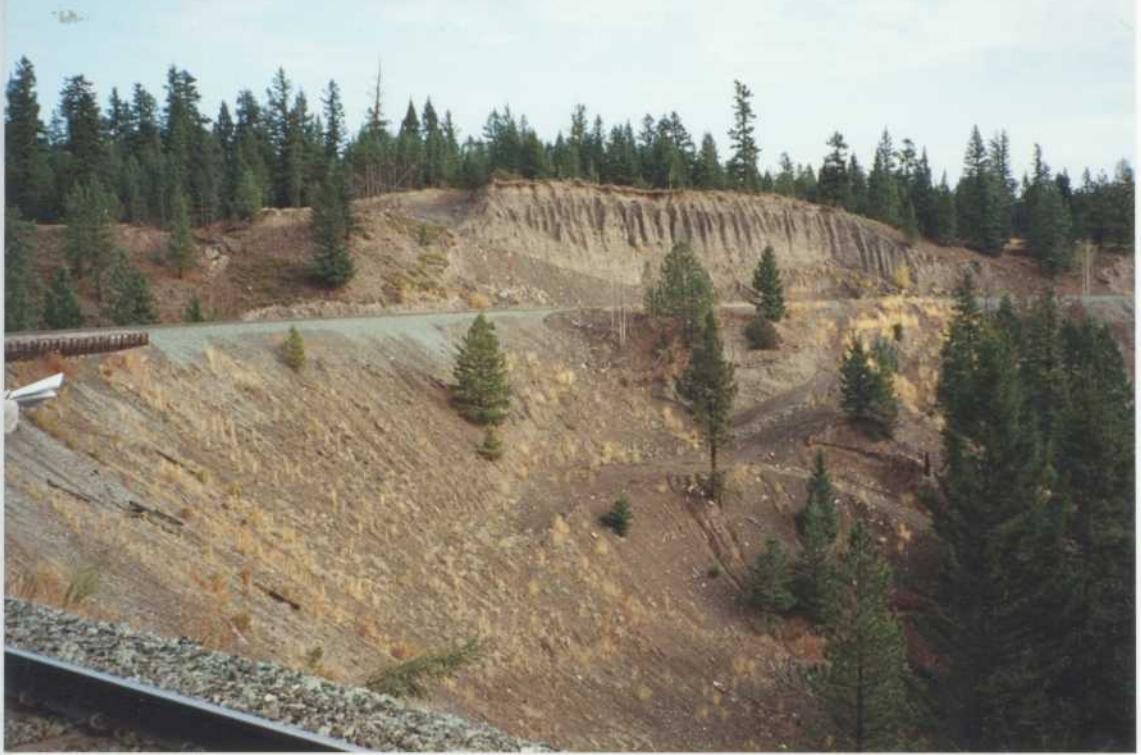
Photo: 10
Roll: 3
Date: 19/10/98

SUB-BASIN: FIFTY SEVEN CREEK
CREEK: FIFTY SEVEN CREEK
REACH: REACH 5
VIEW DOWNSTREAM
near SITE # SS.1
