FINAL REPORT

**UPPER BONAPARTE RIVER
WATERSHED – CHANNEL, RIPARIAN
AND SEDIMENT SOURCE
ASSESSMENT**

VOLUME 1: TEXT AND APPENDICES

Project #754

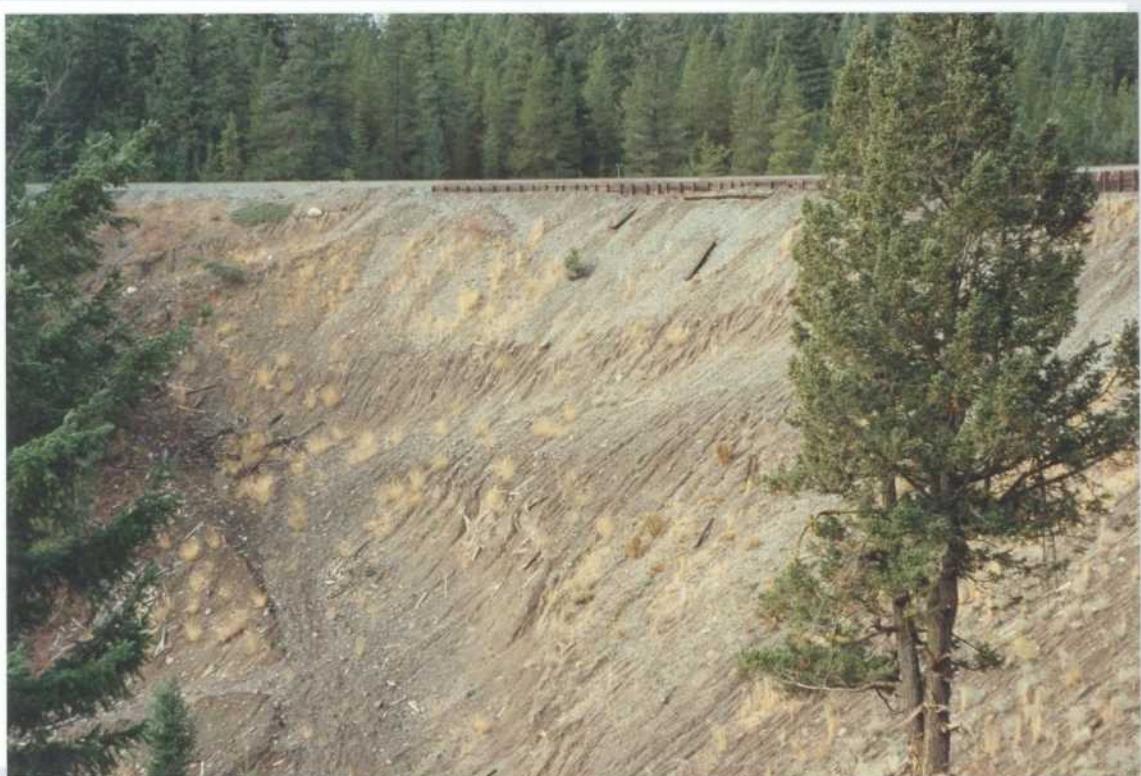
Photo: 9
Roll: 3
Date: 19/10/98

SUB-BASIN: FIFTY SEVEN CREEK
CREEK: FIFTY SEVEN CREEK
REACH: REACH 5
VIEW DOWNSTREAM
near SITE # SS.1

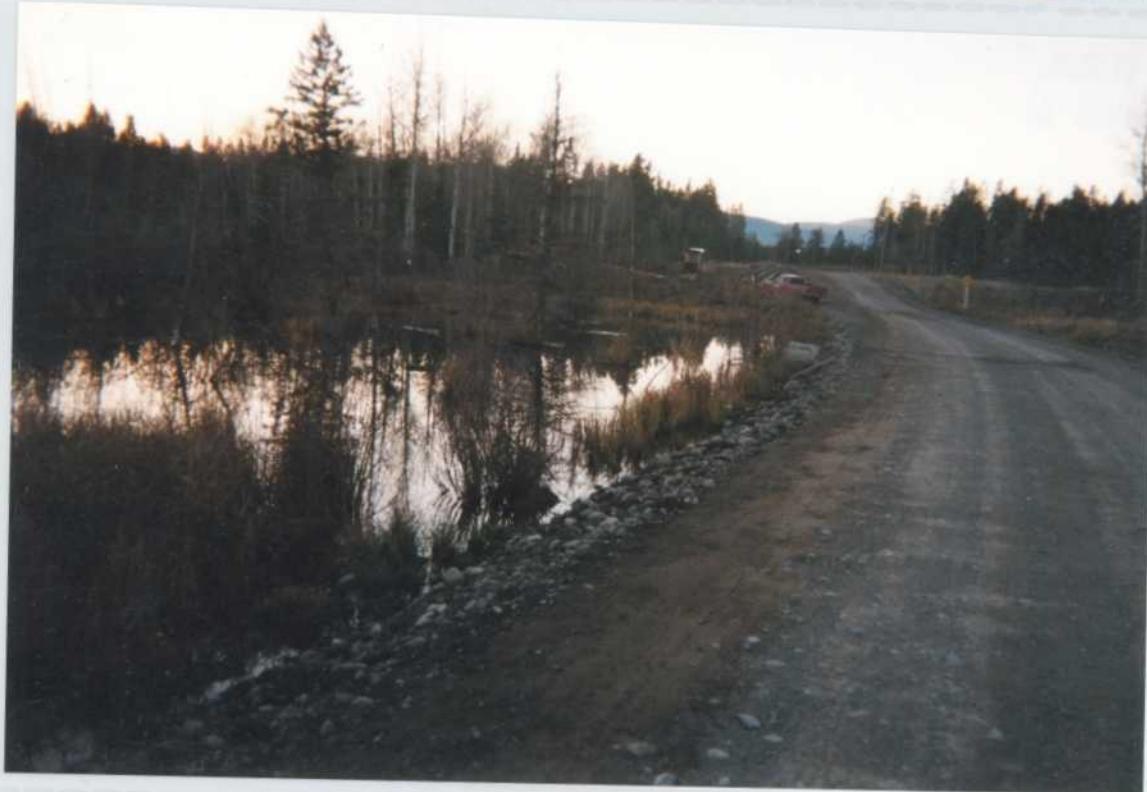
Photo: 21
Roll: 6
Date: 23/10/98

SUB-BASIN: CHASM CREEK
CREEK: FIFTYNINE CREEK
Description: SITE B 41.1, VIEW DOWNSTREAM (REACH 41)

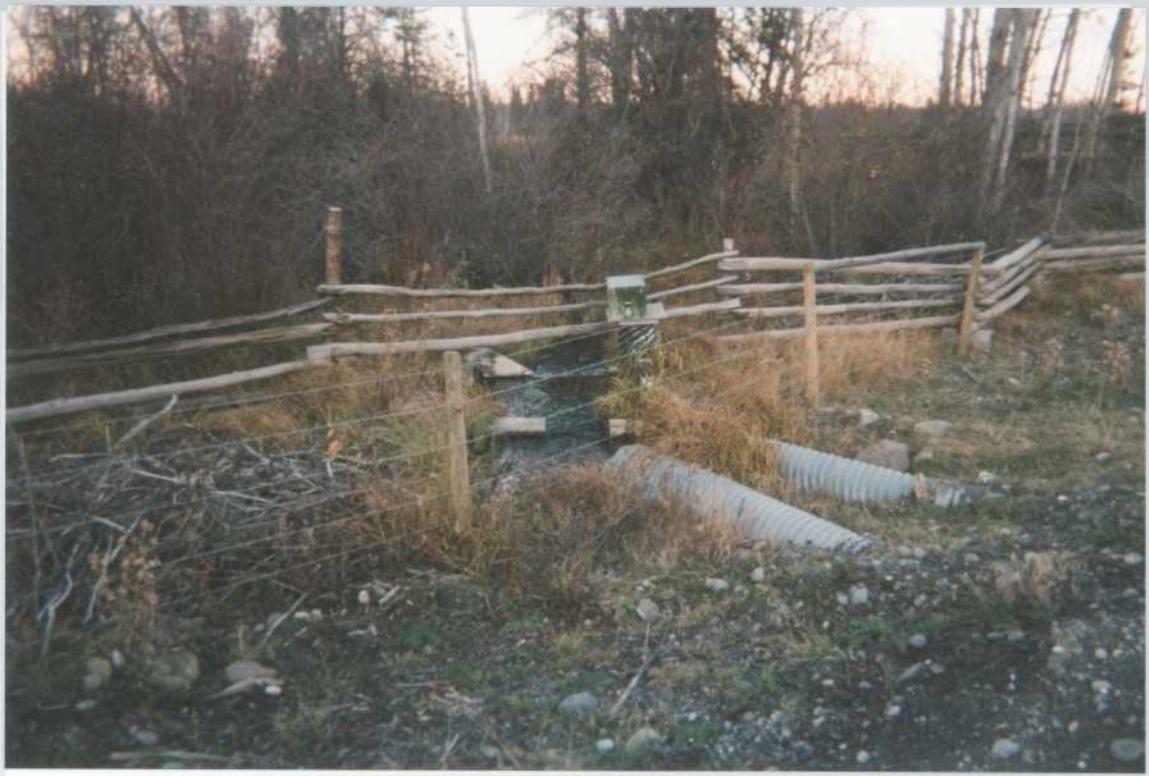
Photo: 20
Roll: 6
Date: 23/10/98

SUB-BASIN: CHASM CREEK
CREEK: FIFTYNINE CREEK
Description: SITE B 41.1, VIEW SOUTH (REACH 41)
