**INTERIOR WATERSHED
ASSESSMENT PROCEDURE
for the
CORNING CREEK WATERSHED**

February 2000

A Watershed Restoration Project Funded by Forest Renewal BC.

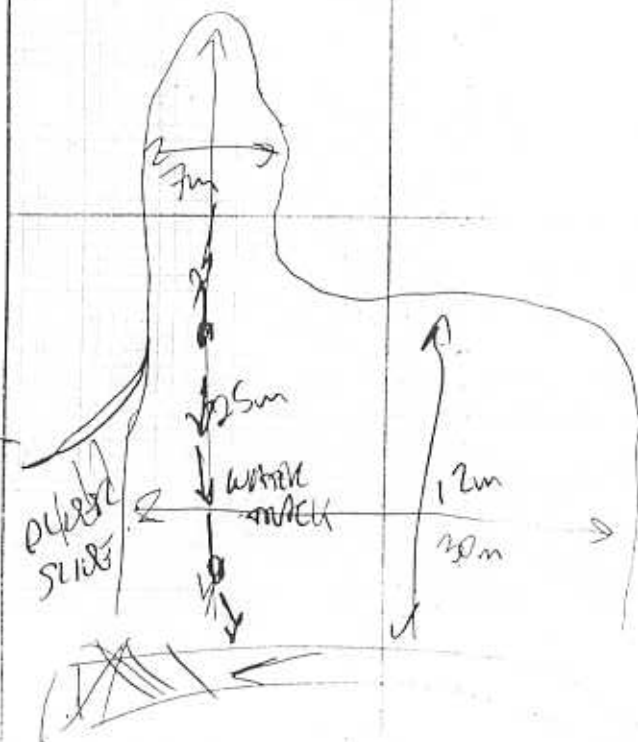
CORNING CREEK CC4 13/1/89
AB/SD

01747 - OLD (APPARENT) DEBRIS
FLOW LOBE - RAISED DAM
ON LB - SURFACE COURSES
REMARKABLE
- OWNS UP TO UNDER DEPOSIT
AS OF DAM - LOTS OF
SURFACE CEDAR, ETC.
