**FINAL REPORT**

**WATERSHED ASSESSMENT:  
SITKUM, BOURKE, AND  
CLAYTON CREEKS**

**Project 039-04.02**

**November 2000**

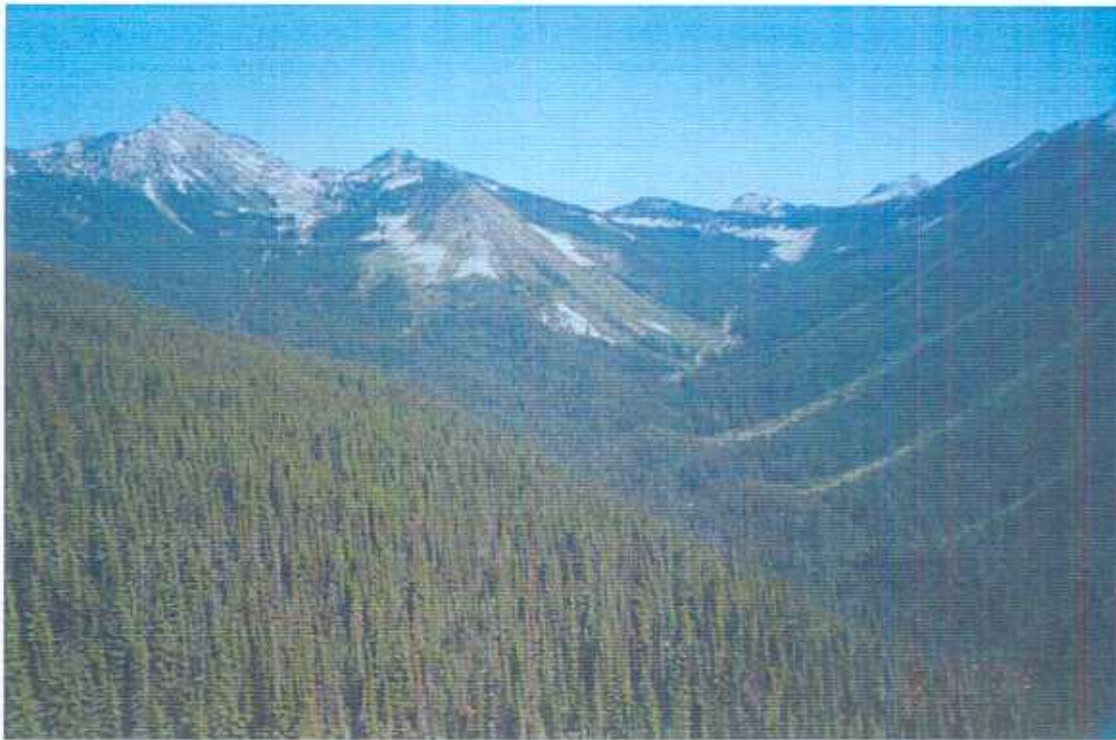
Plate 1: View upvalley of Sitkum Creek watershed through channel Macro-reaches H and I.  
 Date: 02-Aug-2000                      Photograph 2-13

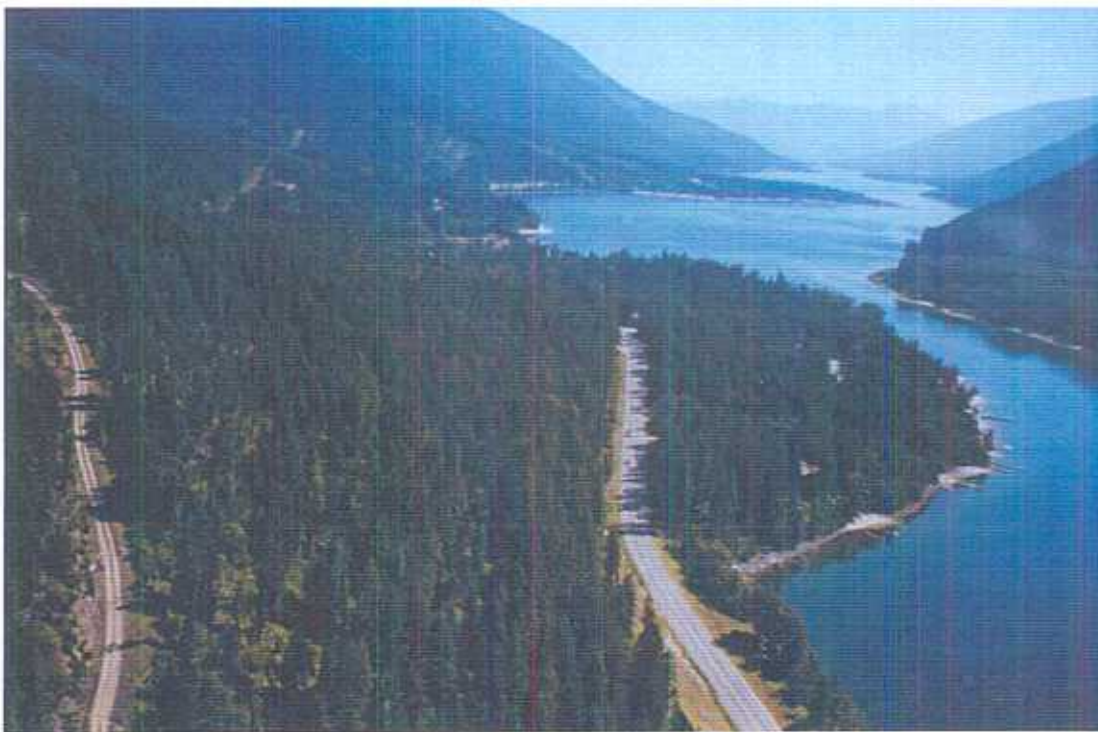
- the downstream-most macro-reaches (A and B) include the Sitkum Creek fan and have relatively erodible banks and an aggrading bed (Plate 2);
- the mid-lower macro-reaches (C to E) are highly canyonized and have extensive lengths of predominantly non-alluvial bed and banks (Plate 3);
- the mid-upper macro-reaches (F to H) have predominantly alluvial bed and banks, but large colluvial material is provided to the channel via direct hillslope coupling (Plate 4);
- the upper macro-reach (I) has extensive lengths of predominantly non-alluvial bed and banks, with the channel armoured by colluvial boulders and cobbles (Plate 5).

Plate 2: View east towards the Sitkum Creek fan at Kootenay Lake. Highway 3A crosses  
 the fan and the Sitkum Face Road is at left.  
 Date: 02-Aug-2000                      Photograph 3-22

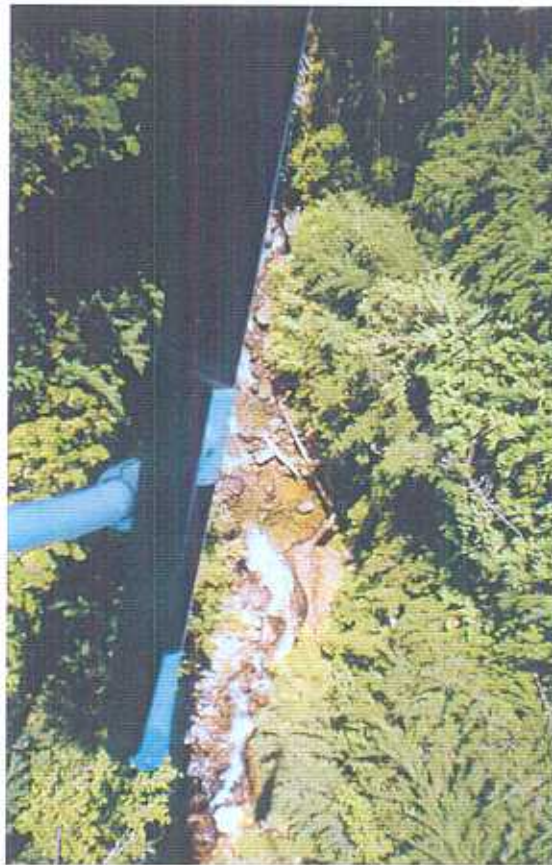
Plate 3: Sitkum Creek Macro-reach D. Step-pool channel with bedrock chutes  
and a boulder/cobble bed.  
Date: 02-Aug-2000      Photograph 1-20

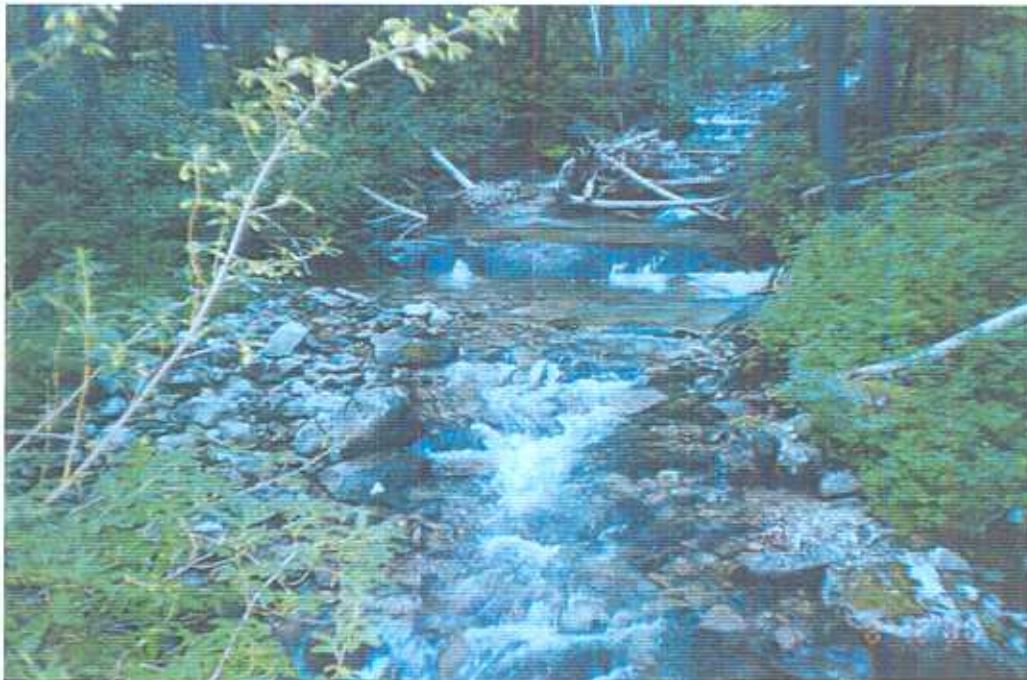
Plate 4: Sitkum Creek Macro-reach H. A cascade-pool channel with common  
bedrock steps.  
Date: 02-Aug-2000      Photograph 4-28

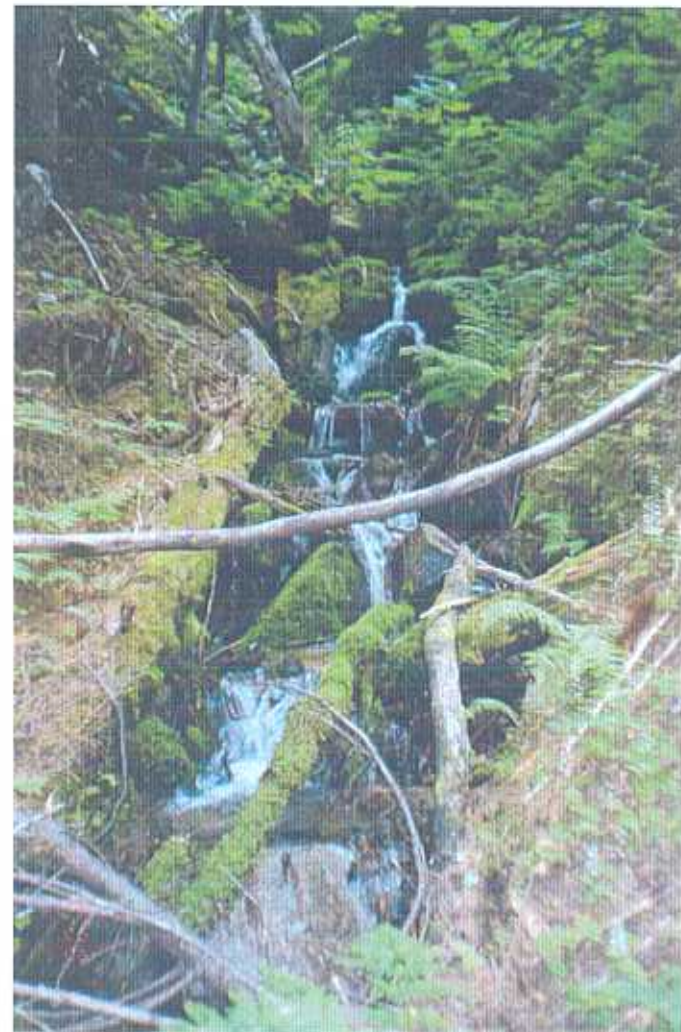
Plate 8: Bourke Creek Reach 6. A steep-cascade channel with colluvial lag boulders.  
Date: 03-Aug-2000      Photograph 5-5

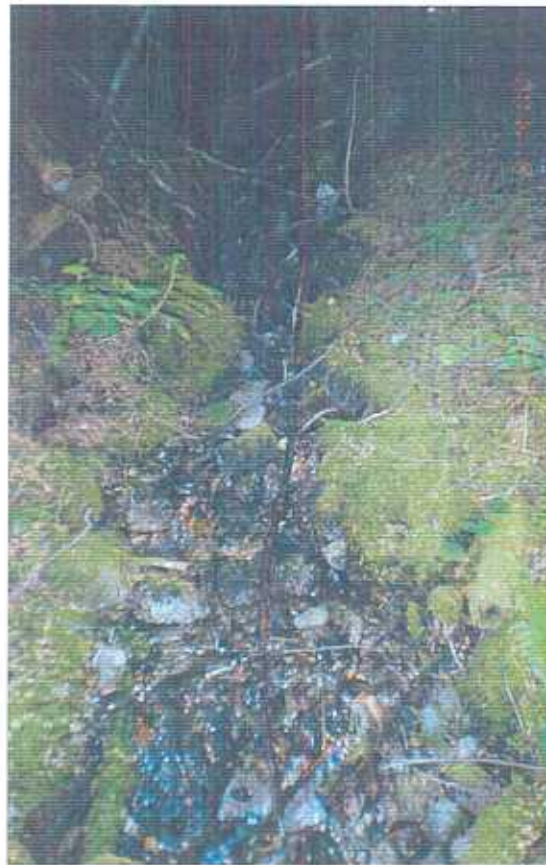
Plate 9: Clayton Creek Reach 3. A steep-cascade channel with a cobble/boulder bed.

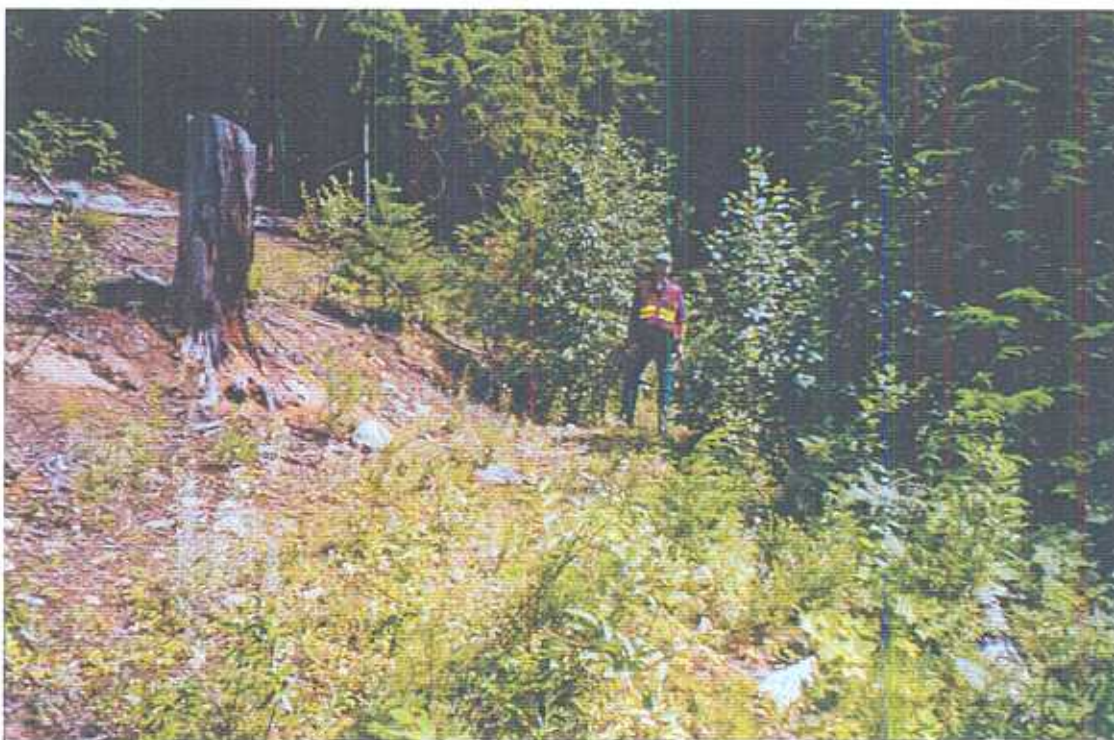
A foot traverse of about 300 m of this trail network, upslope of the Sitkum Creek FSR, indicated there are no stability issues associated with these old trails, as vegetation is becoming well established over the surfaces (Plate 16), and there are no significant drainage issues remaining.

Plate 16: Skid trail in cutblock (90% hydrologically recovered) between Sitkum  
 Creek FSR and the old road to the burn.  
 Date: 03-Aug-2000                      Photograph 5-1
